Terraced Landscapes and Hydrogeological Risk. Effects of Land Abandonment in Cinque Terre (Italy) during Severe Rainfall Events

Mauro Agnoletti, Alessandro Errico, Antonio Santoro *, Andrea Dani and Federico Preti

Abstract: During 25 October 2011, an extremely intense rainfall event occurred in Eastern Liguria and Northern Tuscany. Severe damages were registered in the Monterosso and Vernazza basins, located in the famous area of Cinque Terre, which have been affected by hundreds of landslides, mud flows, and erosions. The main feature of the Cinque Terre landscape is the presence of terraced cultivations on steep slopes facing the sea. The area represents a remarkable cultural landscape, is a National Park, and is included in the World Heritage List of the UNESCO. This work aims to analyze the effect of abandoned terraced land on hydrogeological risks and in landslide prevention, by comparing what happened in Cinque Terre to other experiences presented in scientific literature. The cessation of maintenance of dry stone terraces due to the crisis of traditional agriculture was identified as the main cause of failure during the heavy rainfall event. However, we found some contrast

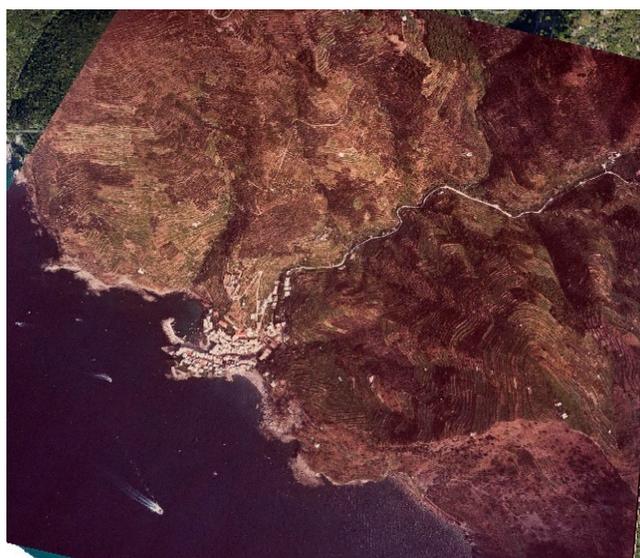
Figure 1. Coastal part of the Vernazza catchment in 1973. Almost the whole surface is terraced. The dark green areas were olive groves.

From the 1970s onward (Figure 1), Cinque Terre witnessed a more than 70% decline of its agriculture and fishing. The towns of Vernazza and Riomaggiore were those that experienced the worst decline of viticulture; for example, the loss of over 52 ha was reported in Riomaggiore between 1982 and 1990, and 24 ha in Vernazza [35]. This decrease of vineyard surface can be regarded as a constant trend over the last thirty years. The depopulation of the countryside has determined a constant reduction of the maintenance required by the terraces. Terraced viticulture in the Cinque Terre area is an economic, historical, and cultural heritage, a landscape modeled by human beings with the sweat of their brow to guarantee their livelihood. But if the population declines, this heritage is placed in jeopardy.

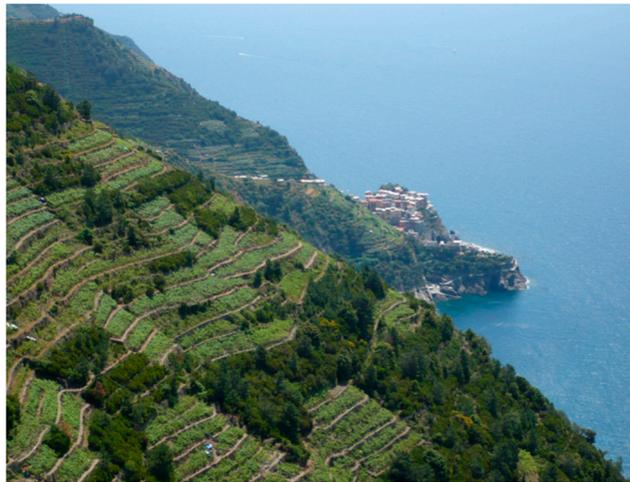
Figure 3. In the Cinque Terre area, terracing, besides having great historical and aesthetic value, plays a fundamental role in agricultural production and in the reduction of hydrogeological risk.

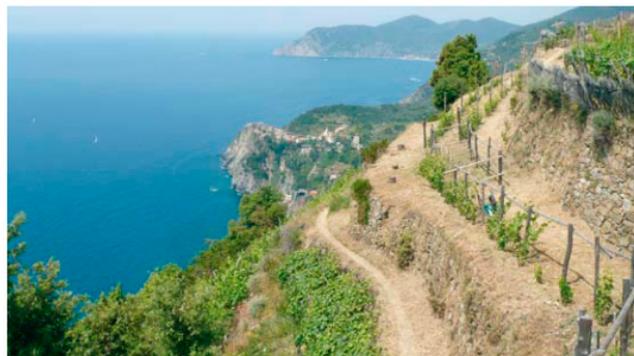
Figure 4. Terracing models the slopes of Cinque Terre, preserving many traditional practices not only as regards building materials, but also grape-growing techniques (photo by Agnoletti).

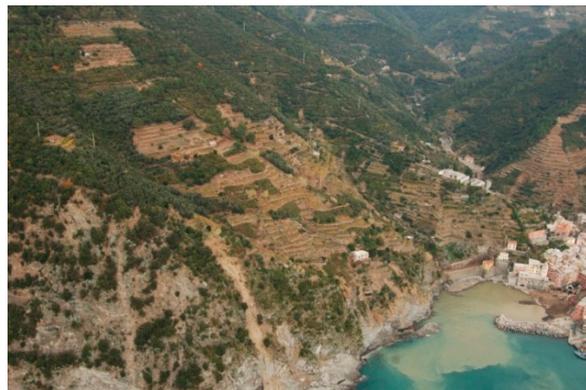
Figure 5. The settlement of Vernazza. The picture highlights the magnitude of the landslide that dragged solid material all the way down to the sea.

On 25 October 2011, in less than 24 h, a high intense rainstorm affected the northern part of Tuscany and the eastern part of Liguria, in the provinces of La Spezia and Massa-Carrara. The rain gauges located in the surroundings of the terraced area of Cinque Terre show cumulative rainfalls ranging between 111 and 382 mm/24 h, with peaks of 111 mm/h, 195 mm/3 h and 350 mm/6 h [30,38]. The consequences were dramatic in terms of loss of lives (13 casualties), and structural and economic damages. Hundreds of shallow landslides, debris and mud flows triggered from the very steep slopes facing the sea, caused the flooding and the partial burial of the famous settlements of Monterosso and Vernazza (Figure 5).

Landslides mainly occurred because of the failure of the layer between debris and bedrock [38], bringing high amounts of sediment into the streams. Consequently, debris-floods reached the settlements located at the mouths, causing fatalities and severe damages to structures and business activities. During the event, several agricultural terraces failed; the relationship between land use and proneness to landslides has been investigated by Cevasco et al. [28], Galve et al. [29], and will be further discussed in this paper.

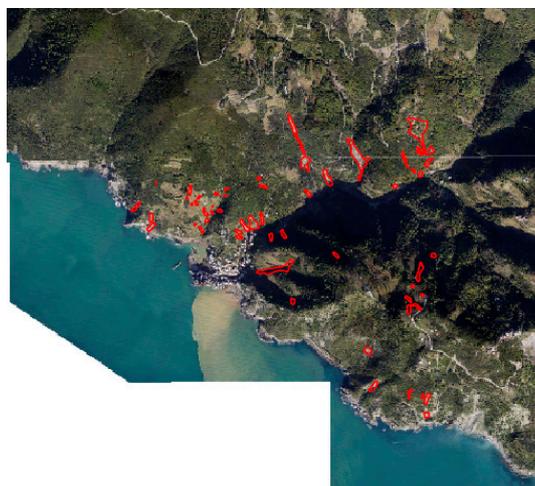
Figure 6. The same area of Figure 1 on November 2011 after the rainfall event of 25 October 2011. The landslides are emphasized in red. It's clear how woodland substituted agriculture in the last 40 years.

The current ongoing deterioration of terracing is an issue at the district level, due both to the extension of the terraces and to the fact that they lie uphill and downhill of roads and settlements on hills and mountains (Figure 6). Large areas are presently in critical conditions. Action is necessary for hydrogeological and cultural reasons. With the industrialization of agriculture and the migration

To provide a short overview of the consequences of land abandonment on landslide risk a simple analysis of the landslide distribution in the Vernazza area was carried out, focusing on the differences in land use. In particular, land use was categorized in three classes. (a) 'Succession on terrace', which includes all terraced areas in which cultivation activities ceased, and is currently substituted by both wood and shrub cover; (b) 'Cultivated terrace', which includes all areas which are still under any kind of cultivation, from olive groves, to vineyards, to other crops; (c) 'Vegetated natural slopes', which refer to those areas covered by spontaneous vegetation which have never been terraced. Landslide mapping was made through the photointerpretation of aerial imagery taken immediately after the event. The choice to investigate only wider failures was motivated by the fact that landslides smaller than 100 m² can have different micro-scale causes, which are not the object of this study. The land use of each failure was assigned according to the one observed at the head scarp of each landslide.

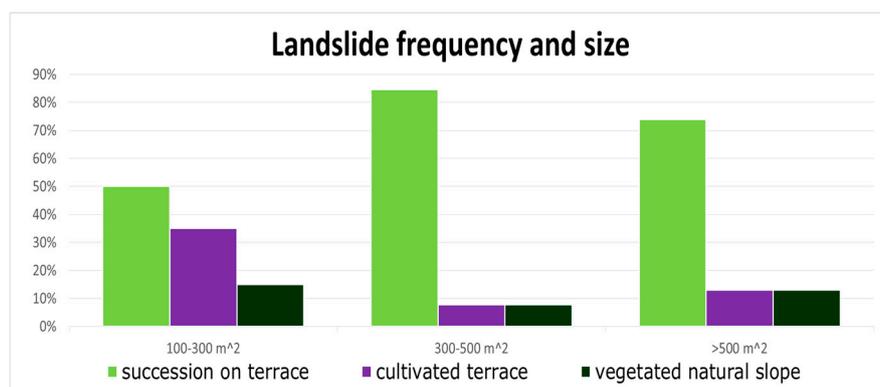
In Figure 7 the landslide frequency is sorted by size and land use macro-classes. We used a dataset of 62 landslides that occurred on 25 October 2011 within the Cinque Terre area. As presented in the graph, the frequency of failures on cultivated terraced land is higher for the smallest class. The category “succession on terrace”, which is composed by both wood and shrub cover on terraces, resulted in the most unstable land use for all the three classes of size. For non-terraced wooded areas, the percentage of failures is equal to or lower than that for cultivated terraces. The distribution seems to be not strongly related to the size. The frequency of wider failures is lower for cultivated terraces, but it has to be considered that the extent of cultivated lands is considerably smaller than the abandoned or wooded ones.

Figure 7. Landslide frequency distribution and size. The frequency for cultivated terraces is higher for small failures, while the frequency of bigger failures is higher on abandoned terraces. The minimum considered size was 100 m², due to the impossibility of recognizing smaller landslides by aerial images.
