# Bioengineering Techniques Adopted for Controlling Riverbanks' Superficial Erosion of the Simplício Hydroelectric Power Plant, Brazil

Received: 13 July 2020; Accepted: 17 September 2020; Published: 24 September 2020

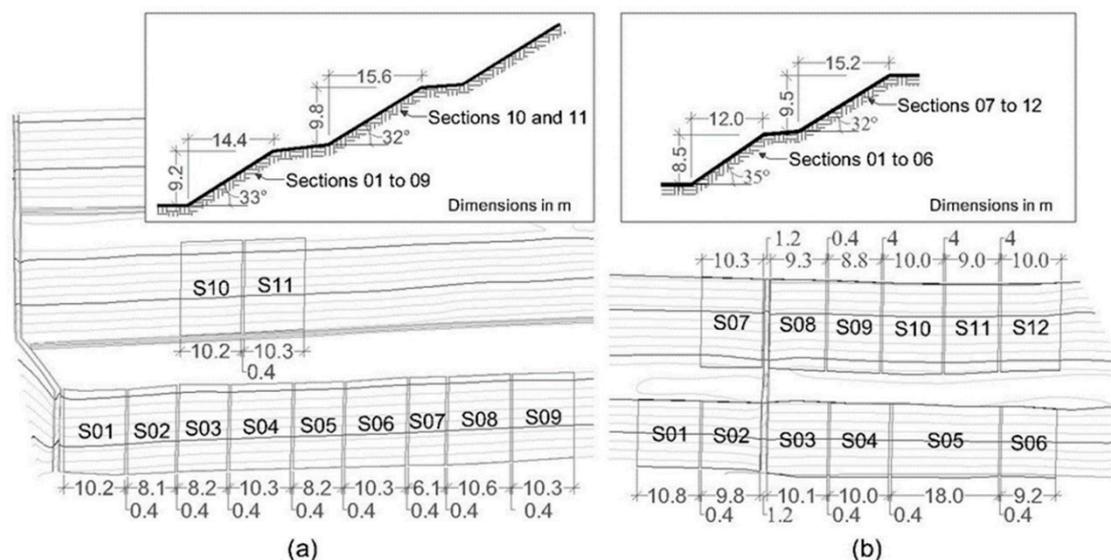
**Figure 2.** Topographic and division of the experimental units (a) I (EU1) and (b) II (EU2) into sections. [Note: Representative cross-sections are shown in the figure's upper region].

Experimental unit I (EU1) consists of two 90-m-long slopes (west facing slope) of approximately 9.5 m height (H) and a slope angle ( $\alpha$ ) close to  $32^{\circ}$ , as indicated in Figure 2a. Similarly, the experimental unit II (EU2) consists of two 70-m-long slopes (northwest facing slope): the bottom one with 8.5 m height (H) and  $\alpha$  equal to  $35^{\circ}$ , and the upper one with H = 9.5 m and  $\alpha = 32^{\circ}$  (Figure 2b). To avoid people traffic and animal trampling, the units were demarcated with fences (appropriate materials and equipment were used). The soil samples were collected 300 mm deep from the slopes' surfaces (15 m distant apart from each other) along both units (EU1 and EU2) to provide a representative

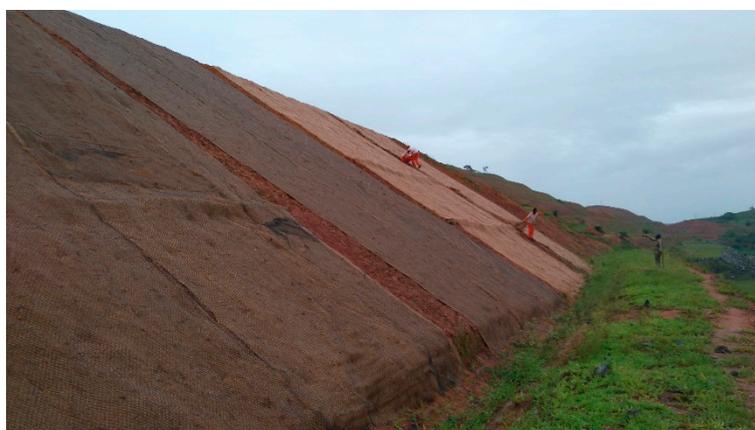
Figure 3. Contiguous execution of the bioengineering techniques with the experimental unit.

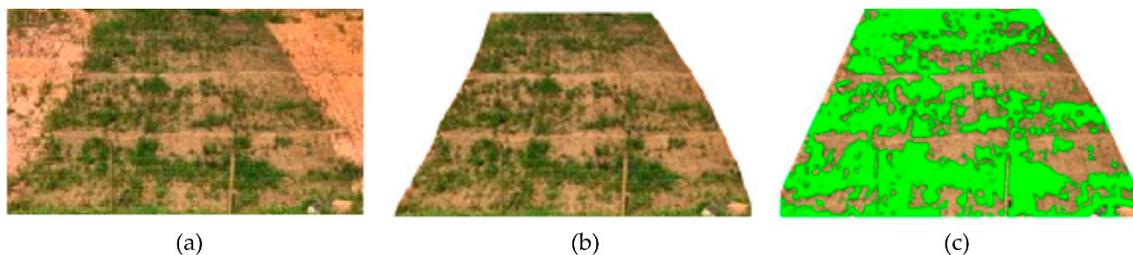
**Figure 4.** Image analysis processes: (a) original image; (b) treated image submitted to the computer algorithm; and (c) comparison between the vegetation pixels provided by the computer algorithm and the treated image.

The  $ExG$  value for each pixel was compared to a minimum threshold value that was determined for each image. Thus, if the pixel's  $ExG$  value is greater than this threshold value, the pixel is set to represent vegetative covered areas (that means a vegetation pixel). The vegetative cover index is determined for each image by the ratio between the number of green pixels and the total number of pixels in the treated image (white pixels are not considered). In addition, the vegetation pixels were superimposed in the treated image for a visual comparison (Figure 4c).

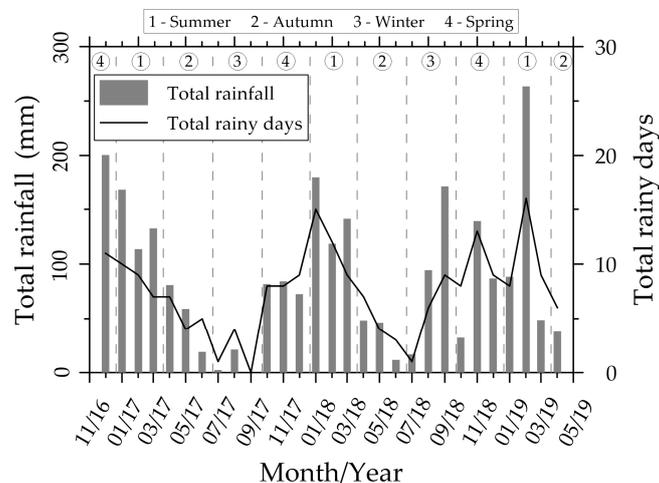
**Figure 5.** Total rainfall and number of rainy days obtained in a weather station located 31 km distant from the experimental units' location.

To compare the evolution of the vegetative cover index with the regional seasons, climatological data was obtained from the closest working weather station, 31 km from the experimental units. The precipitation data (in mm), obtained with a rain gauge, are summarized in Figure 5 for the inspection period adopted herein. In summary, the local climatological condition is comprised of a rainy (wet) period during the spring and summer seasons and a dry period during the autumn and winter seasons.

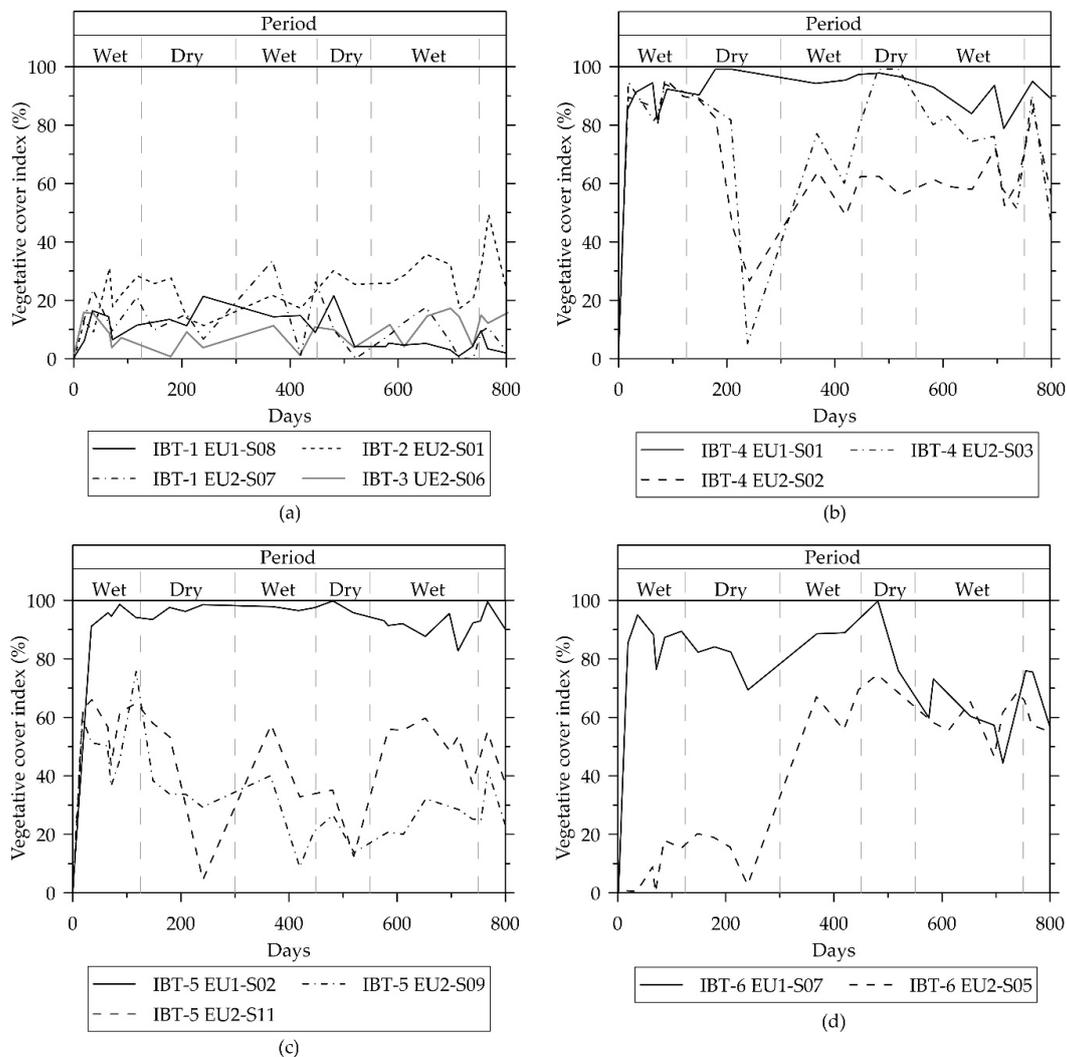
**Figure 6.** Vegetative cover index evolution for different in-isolation bioengineering techniques: (a) manual seeding (IBT-1; EU1-S08 and EU2-S07), live stakes (IBT-2; EU2-S01), and live organic sediment retainers (L-OSRs; IBT-3; EU2-S06); (b) live rolled erosion control products (L-RECPs; IBT-4; EU1-S01, EU2-S02, and EU2-S03); (c) rolled erosion control products (RECPs; IBT-5; EU1-S02, EU2-S09, and EU2-S110); and (d) geocellular containment system (GCSs; IBT-6; EU1-S07 and EU2-S05).

The third group identified in Figure 6 comprises L-RECPs installed at the second experimental unit (IBT-4; EU2-S02 and EU2-S03) and the geocellular containment system (GCS) installed in EU1-S07. Similar to the second group, this group exhibited satisfactory vegetative cover index values very soon (25 days after its implementation). However, there was a significant reduction in the index values during the first dry period (softer reduction for the GCS-EU1-S07) followed by an increase in the following two periods, and a small reduction in the index values at the third wet period. RECPs installed in the second experimental unit (RECP-2 in EU2-S09 and RECP-03 in EU2-S11) are

considered the fourth group and showed a high variation in the vegetative cover index values during the period investigated (increases in the wet periods and sharp decreases in the dry ones). A particular case in Figure 6 (the fifth group) is the GCS installed at EU2-S05 that started a significant increase in the vegetative cover index values at the middle of the first dry period and maintained a value close to 60% until the end of the investigated period.

The results presented in Figure 6a indicate that the adoption of the in-isolation manual seeding technique (IBT-1) can be insufficient to prevent and control slope superficial soil erosion. Considering the vegetation establishment, difficulties can be observed since the first wet period, and it proves to be highly influenced by the changes in the climatological condition (especially during the dry periods). In addition, widespread laminar erosion and small grooves were reported in EU1-S08 at the end of the inspection period, proving the inefficiency of this technique.

Adopting live stakes in an isolated condition (IBT-2; EU2-S01) presented minimal effectiveness for the soil conditions and vegetation species used in this study. Three main factors impair its application: the values of the vegetative cover index for IBT-2 were slightly higher than the ones obtained with IBT-1

(Figure 6a), the time consumed for the cultivation of the stakes, and the costs involved in the processes. Similarly, adopting live organic sediment retainers (L-OSRs) in isolation conditions (IBT-3; EU2-S06) proves to be inefficient. In fact, this technique (IBT-3) provided values of vegetative cover index smaller than the ones obtained with IBT-1 (Figure 6a).

Three types of rolled erosion control products (RECPs) commercially available on the Brazilian market were installed in isolated conditions (IBT-5). RECP-01 (EU1-S02) exhibited a quick establishment of the vegetation—less than 30 days after it was implanted—and it has not been significantly influenced by climate changes (Figure 6c). Similar results were reported by Álvarez-Mozos et al. [46]. RECP-02 (EU2-S11) and RECP-03 (EU2-S09) also presented a quick establishment of the vegetation, but sharp drops and sensitive reductions in the vegetative cover index values are clear (Figure 6c).

Despite the similar behavior of the vegetative cover index evolution, RECP-02 exhibited a better re-establishment of the vegetation in the third wet period. Thus, one must consider that RECPs comprising coconut fibers could be more susceptible to vegetation development than the ones comprising vegetable fiber (straw). It is worth mentioning that these conclusions are specific for the conditions of soil and vegetation species used in this study. Furthermore, these products are indicated for temporary slope protection, as high degrees of deterioration were evident at the end of the inspection period—similar results were reported by Vishnudas [47].

One must be aware of the shortcomings of comparing the performance of the in-isolation techniques in the experimental units one (EU-1) and two (EU-2). As shown by the results of the manual seeding (IBT-1; Figure 6a), L-RECPs (IBT-4; Figure 6b), and GCS (IBT-6; Figure 6d) techniques, differences in the vegetation development (and establishment) between sections installed in EU-1 and EU-2 were noted (especially in the dry periods). Overall, these results show that the sections of the second experimental unit (EU2) were more sensitive to climatological changes. In fact, because of the experimental units' different orientation (slope aspects stated in topic 2.1), the sections of EU2 face sunlight exposure for a longer period compared to the sections of EU1. This difference hampers the comparison between the results obtained with the RECPs' isolated technique (IBT-5, Figure 6c). It is not ideal to compare the results obtained with RECP-01 with RECP-02 and/or RECP-03, because they

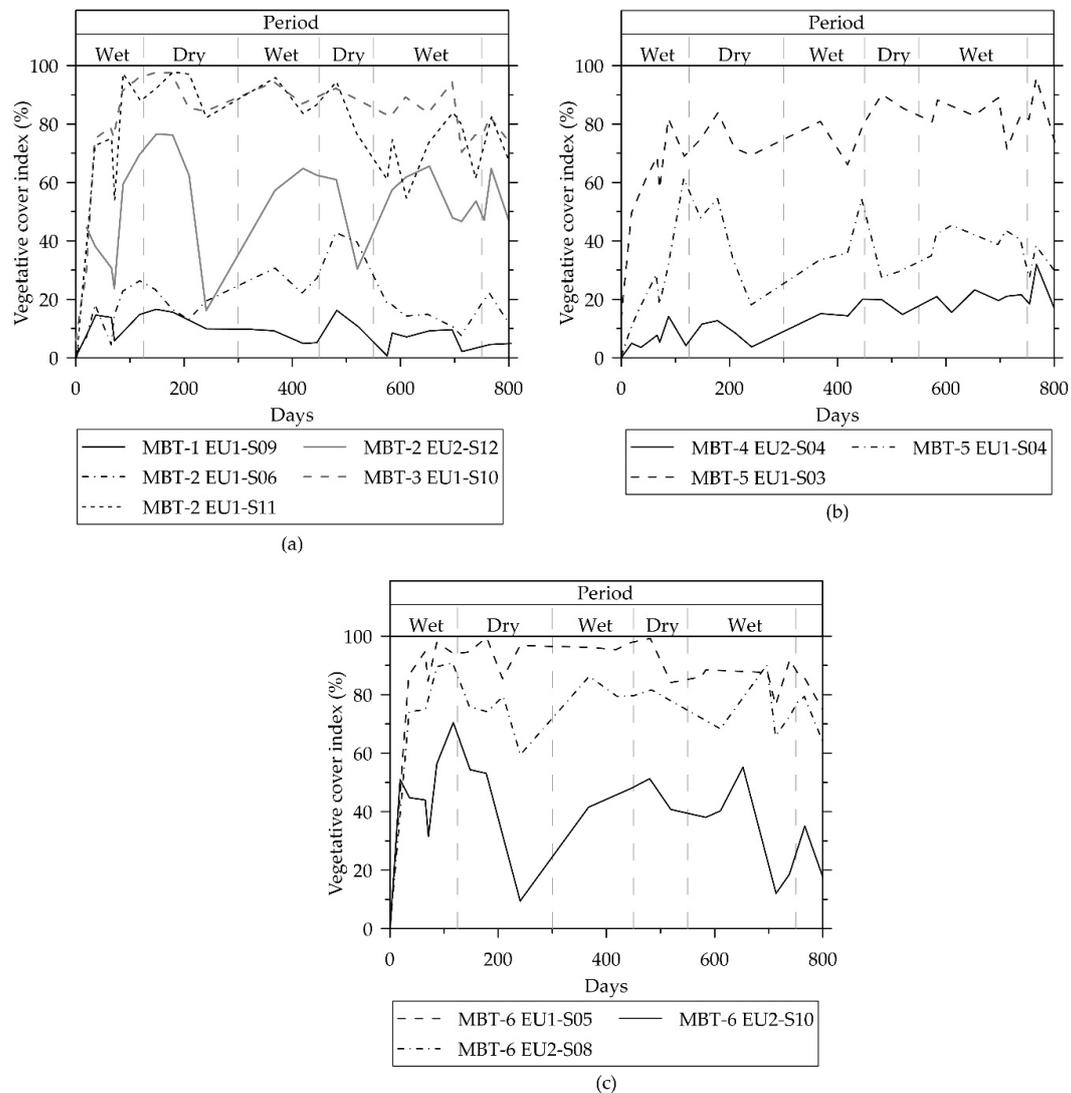
**Figure 7.** Vegetative cover index evolution for different mixed bioengineering techniques: (a) manual seeding and cellulose mulch (MBT-1; EU1-S09); manual seeding and organic sediment retainers (OSRs; MBT-2; EU1-S06, EU1-S11 and EU2-S12); and manual seeding, cellulose mulch and OSRs (MBT-3, EU1-S10); (b) live stakes and live organic sediment retainers (L-OSRs; MBT-4; EU2-S04) and live stakes, L-OSRs and manual seeding (MBT-5; EU1-S03 and EU1-S04); and (c) rolled erosion control products (RECPs; MBT-6; EU1-S05, EU2-S08, and EU2-S10).

The results presented in Figure 7a revealed that adopting organic material (cellulose mulch) attached with manual seeding (MBT-1) did not provide any improvement in the vegetation establishment compared with the in-isolation manual seeding technique (IBT-1; Figure 6a). In addition, widespread laminar erosion and small grooves were reported in the section (EU1-S09) at the end of the inspection period. Thus, adding organic material attached to the manual seeding technique does not seem to be an effective technique for the soil conditions studied in this paper. Further studies are required to assess other types of organic material attached to the manual seeding technique.

The combination of live stakes (IBT-02) and L-OSRs (IBT-03) techniques (MBT-4; EU2-S04; Figure 7b) did not provide an improvement in the vegetation development compared to its in-isolation techniques (IBT-02 and IBT-03; Figure 6a). Despite the slight influence of the climatological condition in the vegetative cover index values, difficulties in the vegetation establishment occurred even during the wet period. Moreover, laminar erosion and grouting processes were reported during the inspections.

On the other hand, the combination of live stakes, live organic sediment retainers (L-OSRs), and manual seeding (MBT-5; EU1-S03 and EU1-S04) exhibited an improvement of the vegetation

establishment (Figure 7) compared to its applications in isolation conditions (IBT-1, IBT-2, and IBT-3; Figure 6a). However, this technique exhibits an unexpected variability (MBT-5): vegetative cover index evolution between sections EU1-S03 and EU1-S04 is very different. As both sections are located side-by-side (Figure 2) and under identical climatological conditions, the difference in the vegetation evolution may be caused due to intrinsic variability of the technique—more than one material can contribute with its own variability.

Finally, the last mixed bioengineering technique (MBT-6) evaluated comprised the combination of RECPs and OSRs (Figure 7c). RECP-2 installed with OSRs (EU1-S05 and EU2-S08) exhibited better vegetation establishment, compared to RECP-3 installed with OSRs, during the whole period investigated (EU2-S10). Once again, the RECPs comprised by coconut fibers proves to be more susceptible for vegetation development than the ones comprised of vegetable fiber (straw) for similar conditions (soil and vegetation species used), as considered in this study.

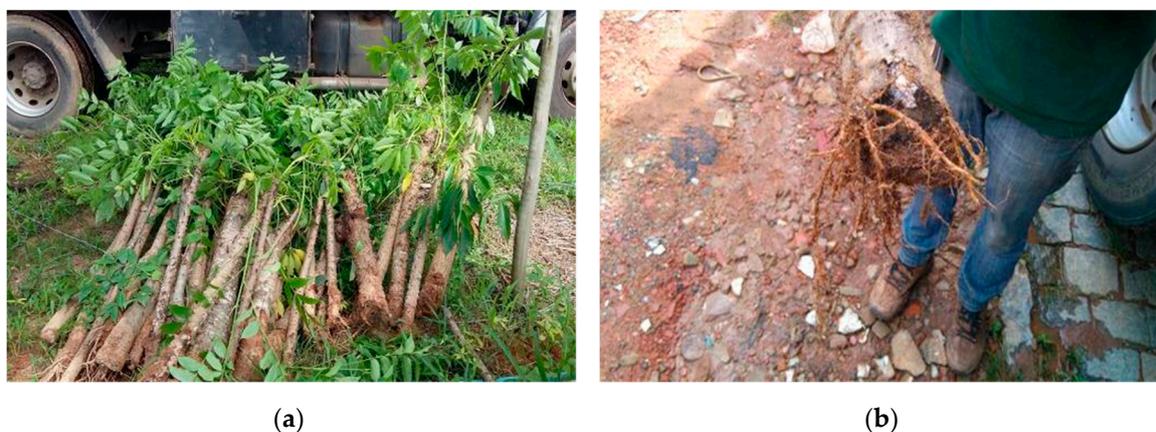
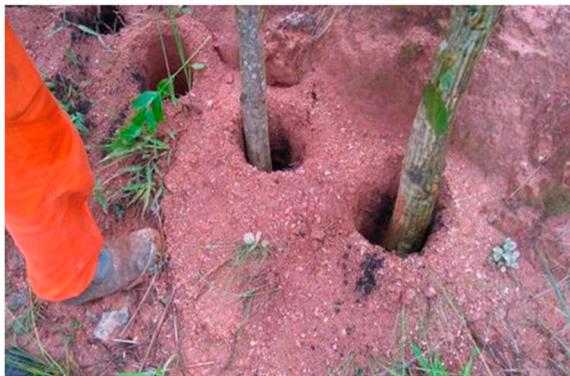
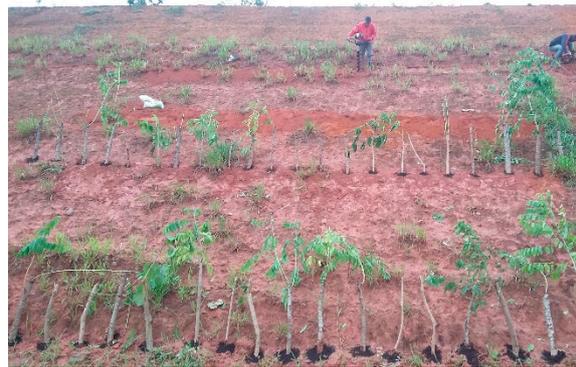
**Figure A1.** Live stakes: (a) storage after transport in an air-conditioned environment, (b) root system detail, (c) installation procedure in manually excavated cavities, and (d) substrate material application.

and native (*Hymenea corbaril*, *Caesalpinia leiostachya* and *Inga* sp.) species. Images of the root system and installation procedures are available in Appendix A (Figure A1).

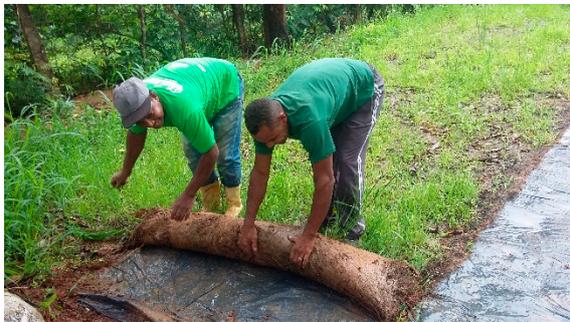
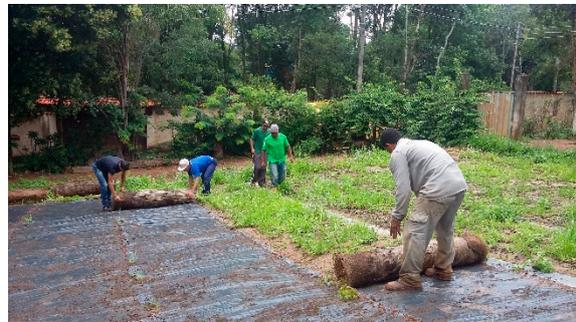
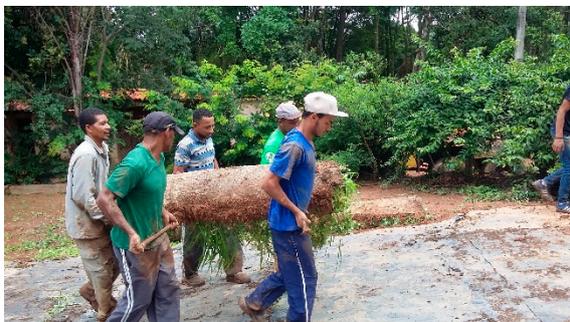
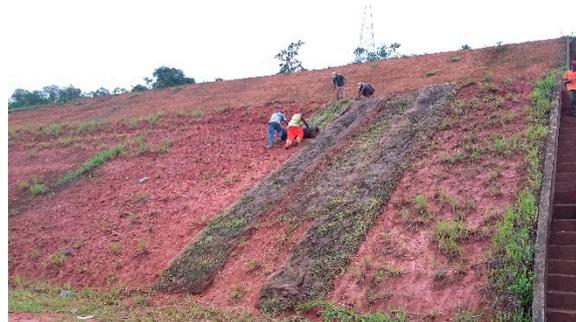
**Figure A2.** Live rolled erosion control products (L-RECPs): (a) cultivation at greenhouses, (b) coil-shaped collection, (c) transportation, and (d) installation of the elements in the experimental units slopes.

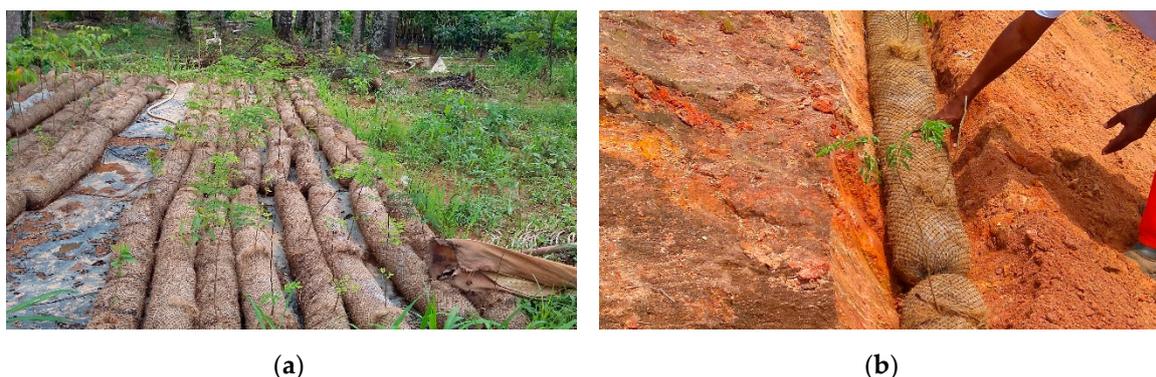
**Figure A3.** Organic sediment retainers associated with live elements (L-OSRs): (a) storage in the experimental units; and (b) installation of the elements in manually excavated trenches.
