# Integrated Evaluation Model of Construction Vulnerability in Anthropogenic Fill Areas (IALV). Case Study: District of Villaverde in the City of Madrid, Spain

**Abstract:** Over the coming years, developments of large urban areas are expected, many of them on plots where soil conditions may not be the most suitable for building. This is the case of plots that previously have been used for dumping anthropic fill deposits. The term anthropic fill included a large variety of materials, all of them related with human activity; but this paper is mainly focused on natural materials extracted from nearby excavations or construction debris that form non-contaminated lands. In a review of literature related to risks, it is observed that in the last 10 years there have been abundant investigations to determine vulnerability in urban areas. However, the risks derived from the presence of anthropic landfills have generally been overlooked. For this reason, there is a real need to quantify construction vulnerability in areas settled on anthropic landfills. A methodology, up to now unknown, must be created to estimate and extrapolate it to any part of the world. The aim is to avoid the likelih

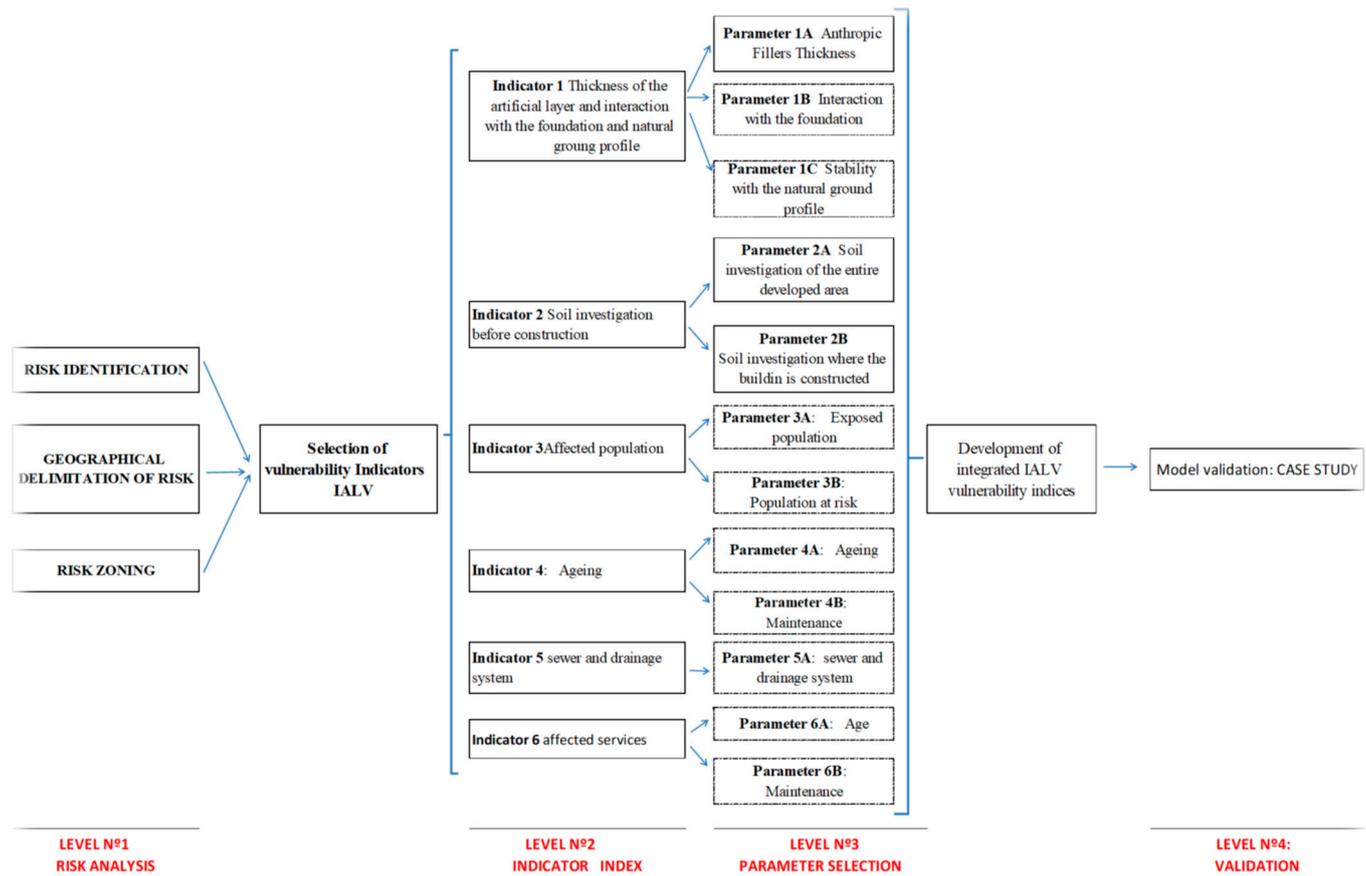
Figure 1. Research methodology diagram.

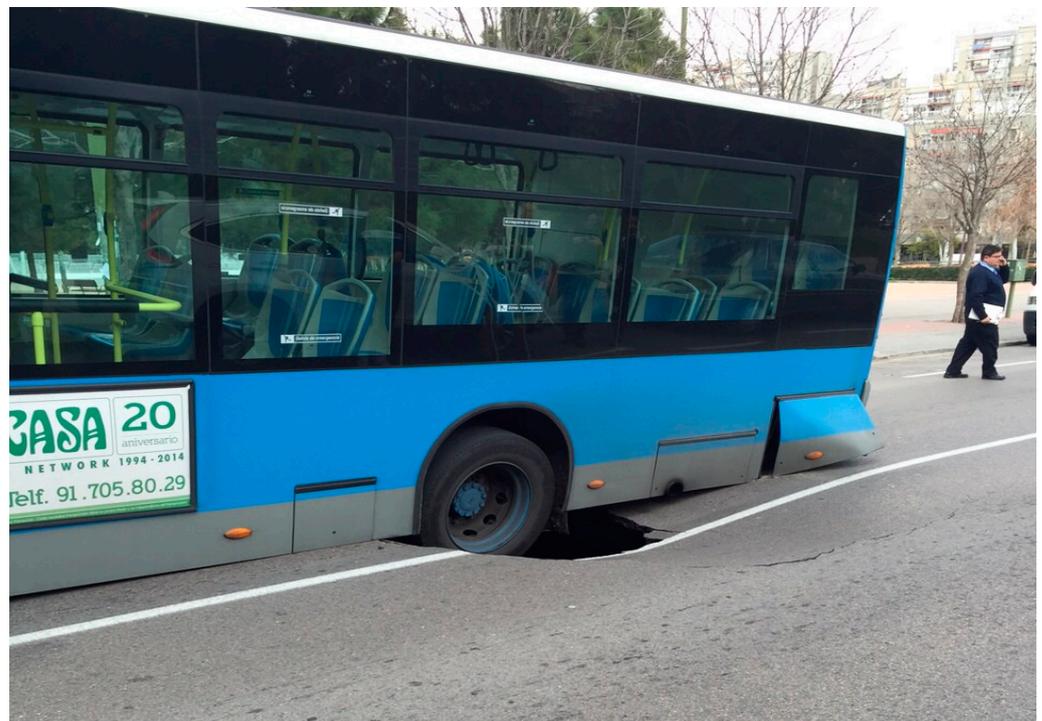
The breakage or leaks of water pipes or drains cause serious damage to the building itself and its vicinity (Figure 2), because the variation of the moisture content causes changes on the fill properties.

**Figure 2.** Sinking of a vial constructed of man-made due to sewer collapse.

A leak due to the failure of the pipes from age or lack of maintenance would cause water to enter the landfill (characterized by its high porosity), further impoverishing the poor geotechnical properties of this type of terrain and resistance of the land supporting the buildings, causing the so-called “fine washing” and dragging effect. The structure could not support the stress to overcome cracking and splitting, especially in the façade enclosures. The weight of each index is established (see Tables 7 and 8) depending on this conditioning aspect (maintenance).

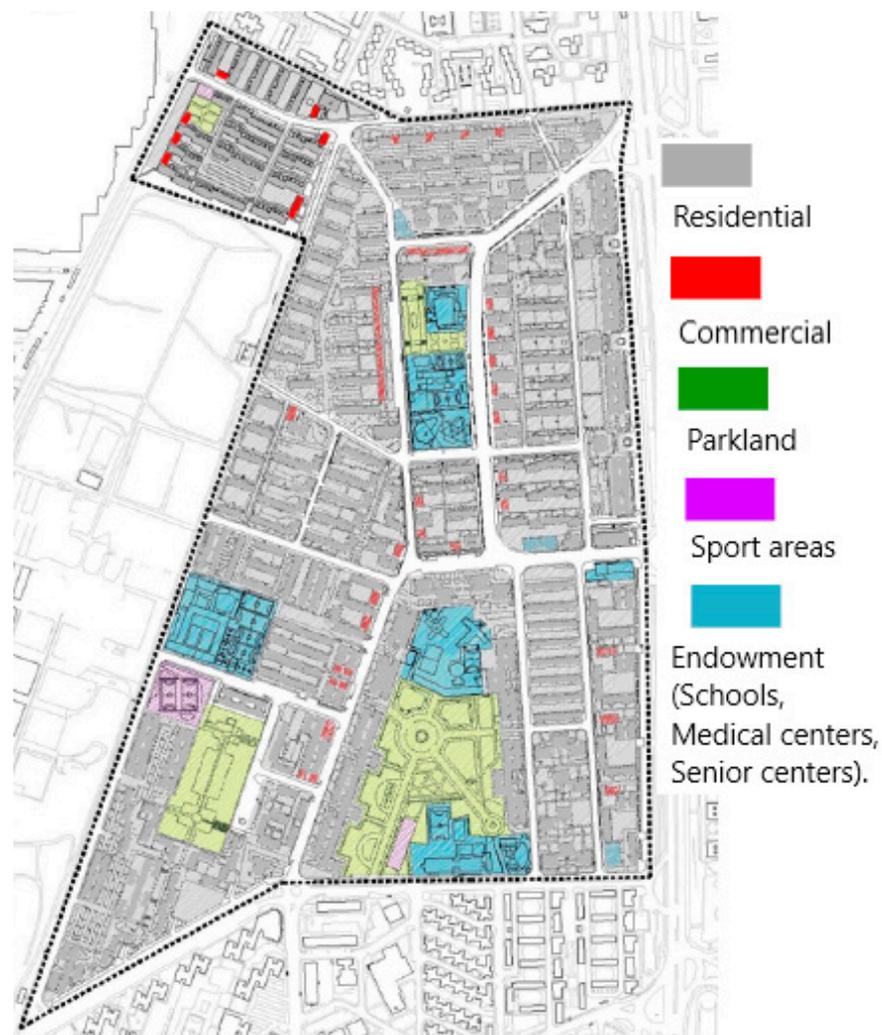
**Figure 4.** Urban planning: distribution of the building and equipment of the study area.

The residential block area is completed with endowment areas located in the central part of the neighborhood with an area of 2.50 Ha, adjacent to another large area (9.0 Ha). The neighborhood's public park is located there along with various educational centers and the perimeter of which the buildings' ground floors present the neighborhood's two most important commercial axes. They gave rise to a typical urban structure of the European rationalism of the moment, with the best Spanish architects participating in its design.

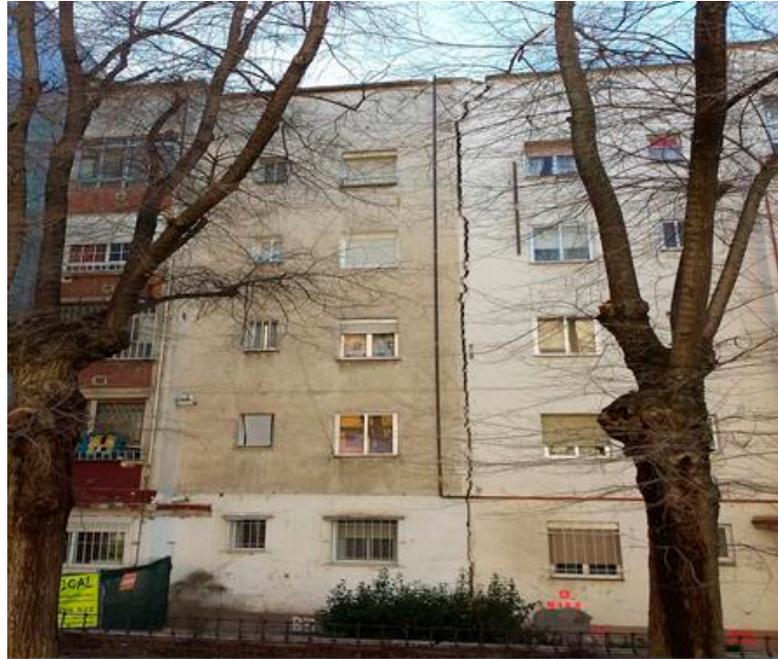
Under these circumstances, 35% of buildings are noted as having a structural problem due to inadequate foundation (Figure 5), the design and dimensioning is not consistent with the land’s geotechnical characteristics. It is very common for the foundation to be supported directly on anthropic fillers of low consolidation status. Despite having achieved a balance between the foundation and the ground over the years, this has been truncated by the poor state of the water pipes (mainly sanitation and rainwater collection), which

Figure 5. Overview of the type of pathologies observed.

breaks the tension balance. The foundation, already deficient in itself, has not adapted to the new stress field, triggering the pathologies due in differential bases not assimilated by the structure.

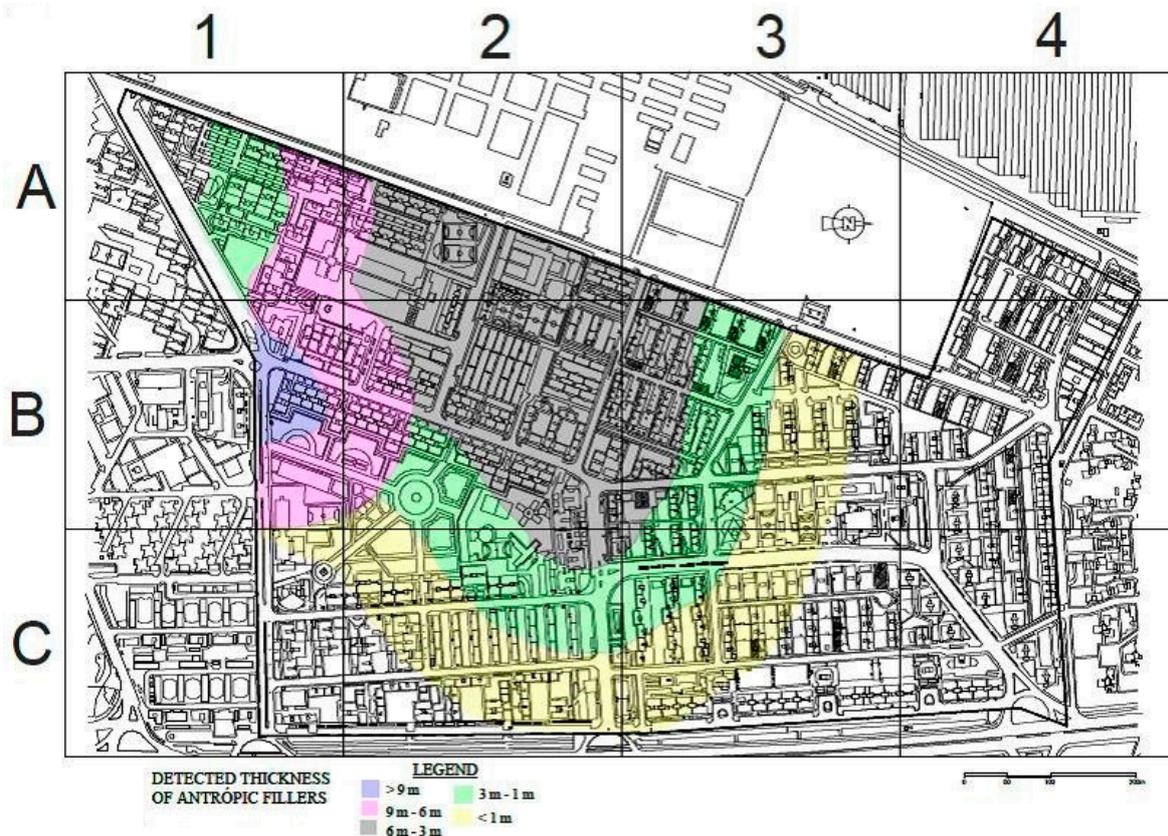
This zoning was carried out by reviewing the evidence of 36 geotechnical boreholes, with the performance of standard penetration tests (SPT) and pressure gauge tests at

regular depths, collected in this sector, and their comparison with aerial photographs from 1950. Its purpose was to delimit its geographical distribution (Figure 6). This work made it possible to define that the contact between the anthropic fills and the natural terrain is horizontal, it also allowed zoning based on the thickness of the fills detected and limiting the size of the risk due to the presence of anthropic fills, the analysis of which yields data of evident interest. Next, the aerial anthropic fill areas were classified into 3 categories ranging from low, medium to high, according to the thickness of the fillings detected, as described in Table 11.

Figure 6. Anthropic fill zoning plan.
