# Effectiveness of Pedestrian Safety Service Provision Using Sensing Technology

Ki-Man Hong <sup>1</sup>, Sang-Hoon Son <sup>2</sup> and Jong-Hoon Kim <sup>1,\*</sup>

<sup>1</sup> Department of Highway & Transportation Research, Korea Institute of Civil Engineering and Building Technology, Goyang-si 10223, Korea; kmhong@kict.re.kr

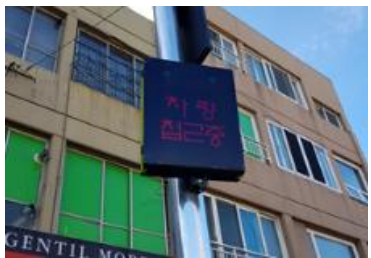
| No. | Device & Sensor | Specifications | Image |
|---|---|---|---|
| | | <ul style="list-style-type: none"> <li>- VMS</li> </ul> Size: 330 mm (horizontal) $\times$ 330 mm (vertical)<br>LED Color: Yellow, Green, Red<br>Specification: High-brightness 5Φ LED<br>Case size: 400 mm $\times$ 800 mm $\times$ 60 mm | |

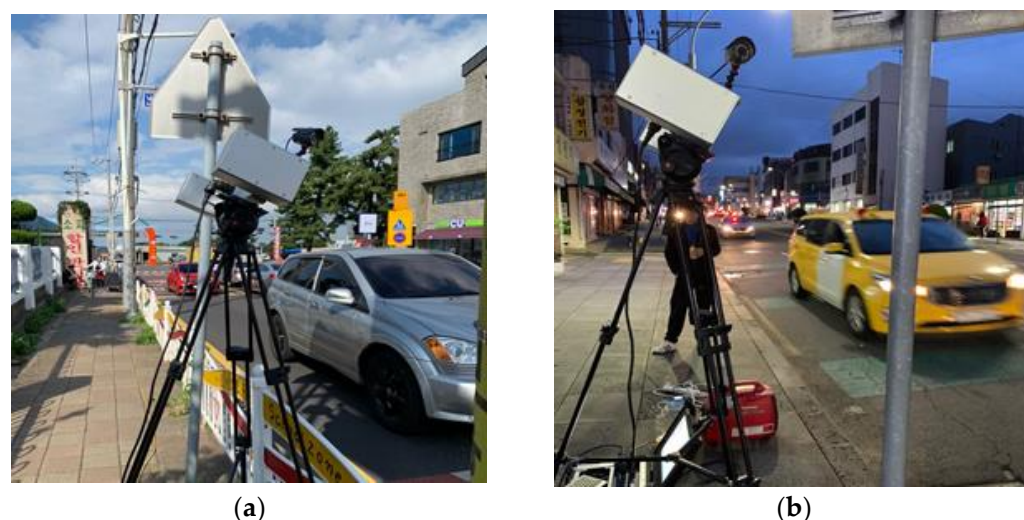
**Figure 6.** Vehicle speed survey equipment: (a) Wollang Elementary School; and (b) Borim Pharmacy.

the effectiveness of the service by comparing the travel speed of vehicles before and after the service provision, at the speed survey points shown in Figure 5, at the point adjacent to the crosswalk (2 m apart from the crosswalk; point 1), and at the point separated by 19 m (point 2) from the crosswalk, where the driver was expected to be fully informed. We measured the speed of the same vehicle. For the speed survey, equipment from the KICT (Korea Institute of Civil engineering and building Technology) was used; that is, a portable roadway detector evaluation system. The vehicle speed was investigated, as shown in Figure 6, with a measuring device using the radar wave Doppler effect.

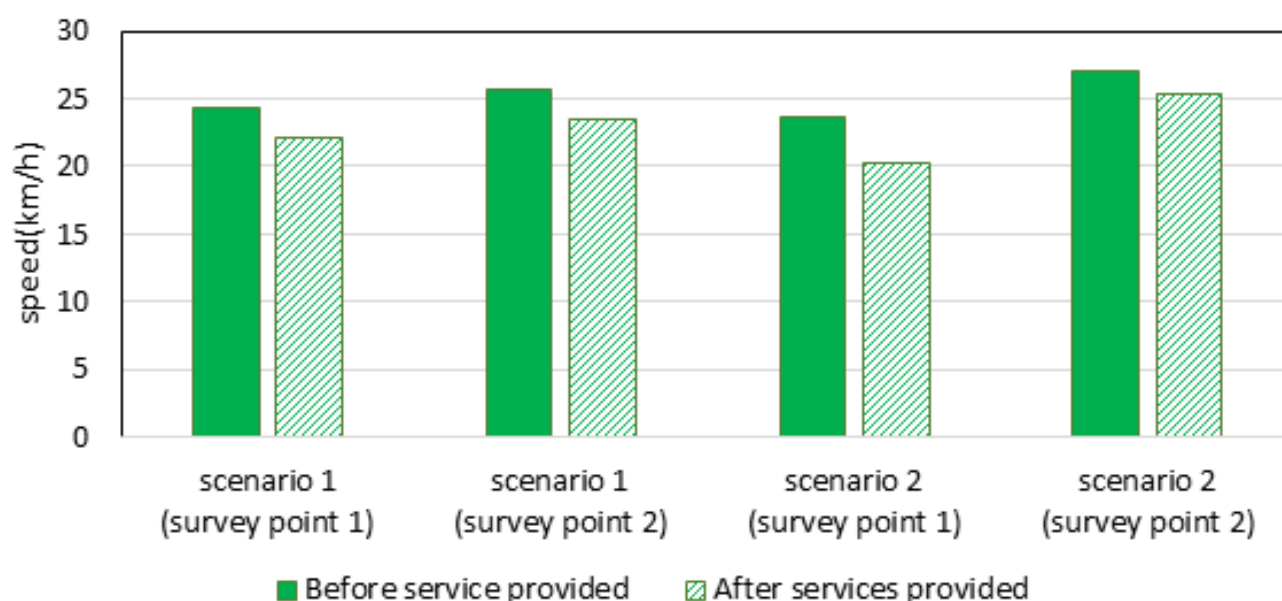
Figure 7. Average point speed change (Wollang Elementary School).

Looking at the change in the speed of the vehicles approaching from point 2 to point 1, as shown in Table 11 and Figure 7, the average point speed before the service (548 vehicles) in scenario 1 decreased by 1.23 km/h (4.80%) from point 2 (25.60 km/h) to point 1 (24.37 km/h) and, after the service (492 vehicles), decreased by 1.45 km/h (6.17%) from point 2 (23.53 km/h) to point 1 (22.07 km/h). Looking at the change in average point speed due to service availability at the same point, at point 1 decreased by 2.29 km/h (9.42%) while, at point 2, it decreased by 2.07 km/h (8.10%).

In scenario 2, before the service (335 vehicles), it decreased by 3.40 km/h (12.61%) from point 2 (27.01 km/h) to point 1 (23.60 km/h), while after the service (288 vehicles) it decreased by 5.11 (20.12%) from point 2 25.42 km/h to point 1 20.30 km/h. In addition, analysis at the same point showed a decrease at point 1 by 3.30 km/h (13.99%) and point 2 by 1.59 km/h (5.90%). Analysis of the change in speed at different points in the direction of the vehicle's progress showed that, for both scenarios, a decrease in the speed of the vehicle at all points was clearly observed.
