Article

Impact of Green Stormwater Infrastructure Age and Type on Water Quality

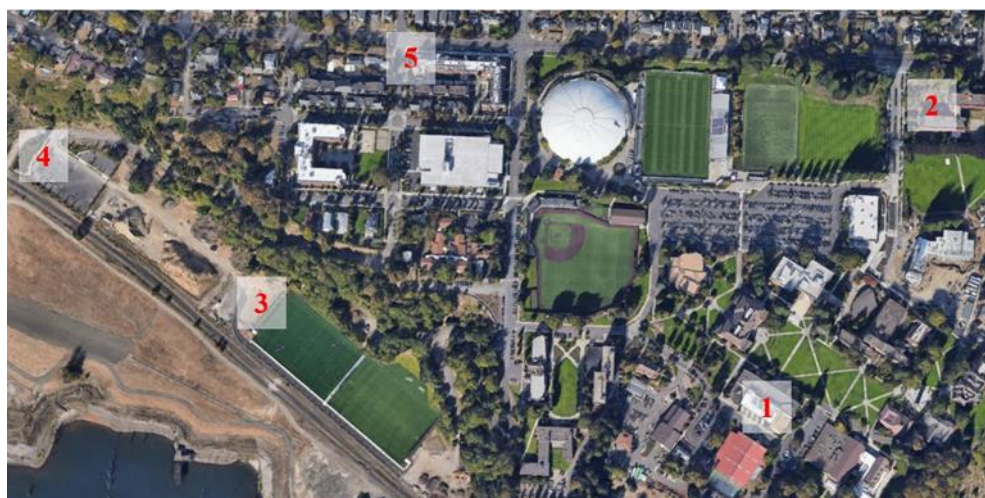
All GSI systems are located at the University of Portland (Figure 1). Each system has vegetation, mulch, an 18-inch soil layer consisting of 60% sandy loam and 40% compost, and a 12-inch gravel drainage layer. Stormwater infiltrates directly to the native soil below. All systems are maintained by the University of Portland facilities department, which includes annual vegetation pruning. The main differences between each site are the amount of stormwater that is treated, GSI size, and the date of installation. A summary of the site characteristics is shown in Table 1 below.

Figure 1. Sampling sites. 1 = Bioswale, 2 = Infiltration Basin, 3 = Bioretention Planter, 4 = Bioretention Basin, 5 = Bioretention Curb Extension (aerial photo source: Google.com).

The results of the ANOVA analysis are shown in Table 3. Numbers correspond to the GSI locations in Figure 1 and are identified in Tables 1 and 2. Significant differences in water quality were observed between the GSI sites.

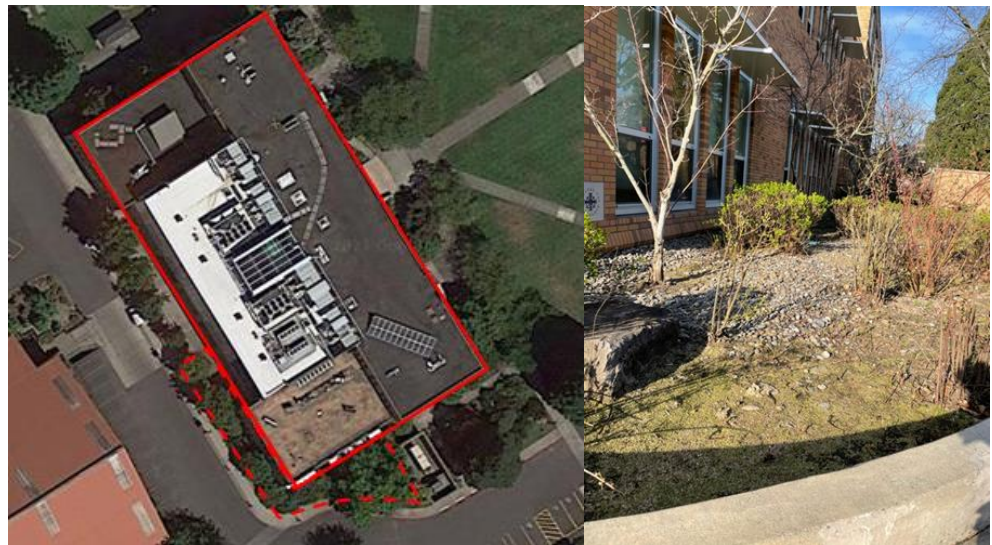
The bioswale wraps around Shiley Hall on the southeast corner of the University of Portland (Figure 2). Runoff from the roof of Shiley Hall drains into the bioswale and infiltrates through the soil or flows into dry well drains located in the bioswale. The roof consists of a 520 m² built-up membrane roof and a 256 m² green roof. The bioswale is designed to treat and convey the water quality design storm (6-month, 24 h storm) for the City of Portland. Vegetation includes *Cornus sericea* (red-twig dogwood), *Acer circinatum* (vine maple), *Rosa nutkana* (nootka rose), and *Buddleja davidii* (butterfly bush).

Figure 2. Bioswale adjacent to Shiley Hall. The solid red line indicates the catchment area, and the dashed line indicates the surface area of the bioswale (aerial photo source: Google.com).

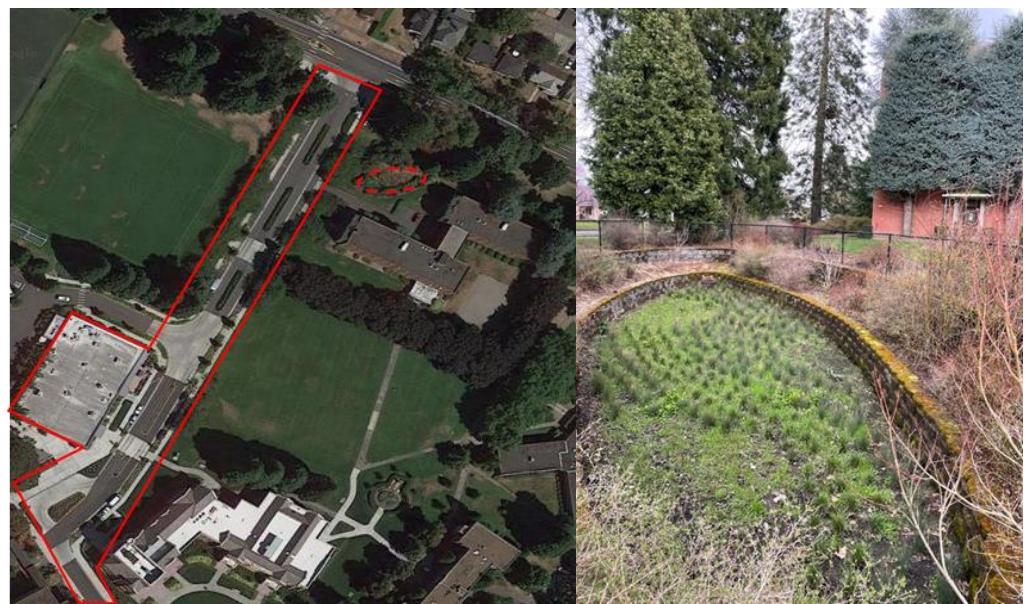
The infiltration basin is adjacent to Shipstad Hall on the northeast corner of the University of Portland (Figure 3). It has a flat bottom with structural walls supporting the basin. Stormwater runoff is collected from the adjacent streets and buildings into a catch basin that drains to the infiltration basin. The infiltration basin is designed to collect and infiltrate the 10-year storm, with an overflow structure for higher flows. Vegetation is primarily *Juncus effuses* (soft rush).

Figure 3. Infiltration Basin. The solid red line indicates the catchment area, and the dashed line indicates the surface area of the bioswale (aerial photo source: Google.com).

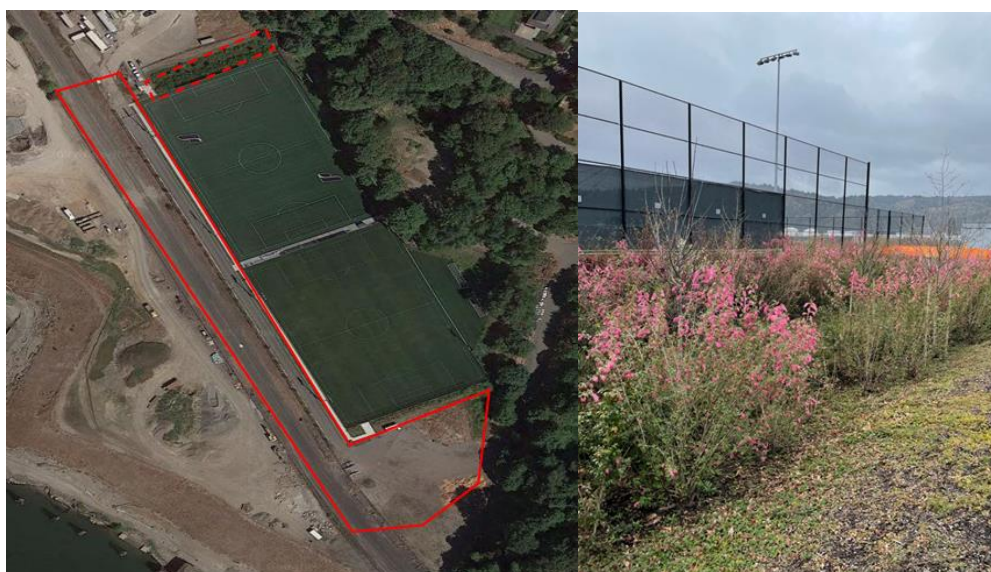
The bioretention planter is adjacent to the soccer fields on the northwest corner of the University of Portland (Figure 4). Stormwater runoff is collected from the adjacent street and parking lot, and it discharges into the planters. The bioretention planters are designed to treat and convey the water quality design storm (6-month, 24 h storm) for the City of Portland, with an overflow structure for larger storms that conveys runoff to the Willamette River. Vegetation includes *Viburnum plicatum* (doublefile viburnum), *Acer circinatum* (vine maple), and *Juncus effuses* (soft rush).

Figure 4. Bioretention Planter. The solid red line indicates the catchment area, and the dashed line indicates the surface area of the bioswale (aerial photo source: Google.com).

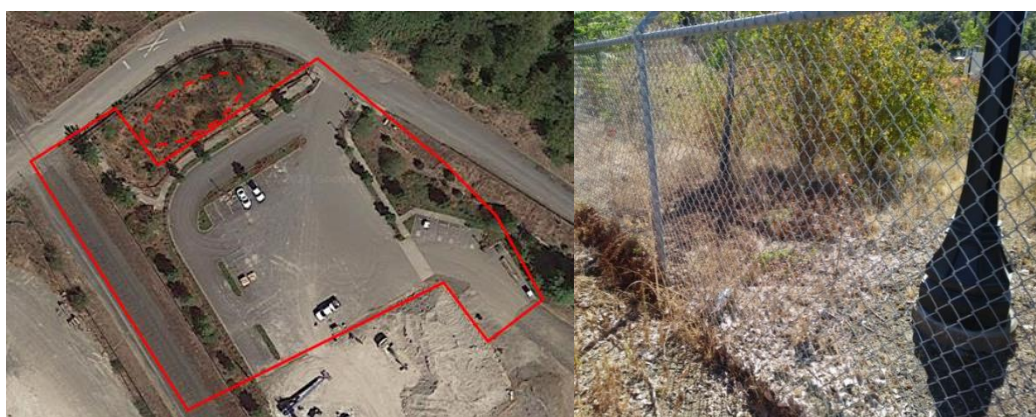
The bioretention basin, adjacent to North Van Houten Place, is located on the north-western corner of the University of Portland (Figure 5). Stormwater runoff is collected from the adjacent parking lot and discharges into the basin. The bioretention basin is designed to treat and convey the water quality design storm (6-month, 24 h storm) for the City of Portland, with an overflow structure for larger storms that conveys runoff to the Willamette River. Vegetation includes *Mahonia aquifolium* (Oregon grape), *Buddleja davidii* (butterfly bush), *Ribes sanguineum* (red flowering currant), *Populus trichocarpa* (black cottonwood), and *Lupinus bicolor* (bicolor lupine).

Figure 5. Bioretention Basin. The solid red line indicates the catchment area, and the dashed line indicates the surface area of the bioswale (aerial photo source: Google.com).

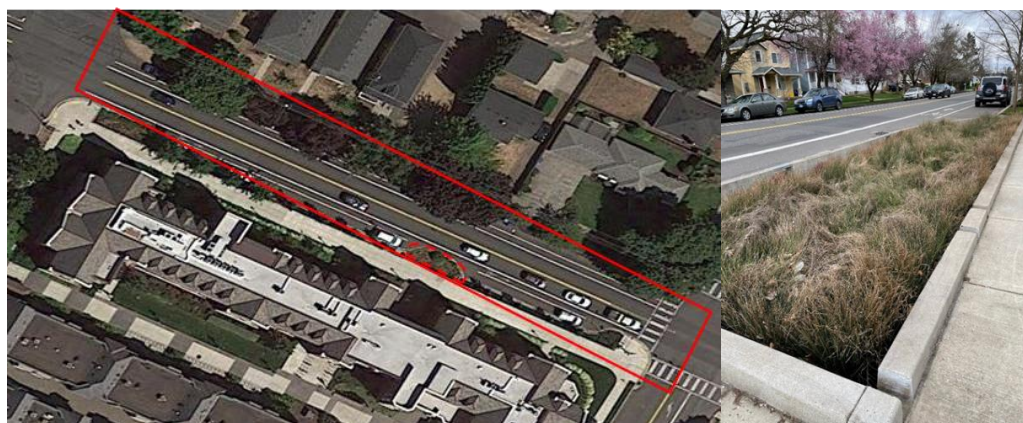
The bioretention curb extension, adjacent to North Willamette Boulevard, is located on the northern corner of the University of Portland (Figure 6). Stormwater runoff is collected from the adjacent street and sidewalk, which discharges into the cell. The bioretention basin is designed to treat and convey the water quality design storm (6-month, 24 h storm) for the City of Portland, with an overflow structure for larger storms that conveys runoff to the storm sewer. Vegetation is *Juncus effuses* (soft rush).

Figure 6. Bioretention Curb Extension. The solid red line indicates the catchment area, and the dashed line indicates the surface area of the bioswale (aerial photo source: Google.com).
