## Article

# Mechanical Performance of Lime Mortar Coatings for Rehabilitation of Masonry Elements in Old and Historical Buildings

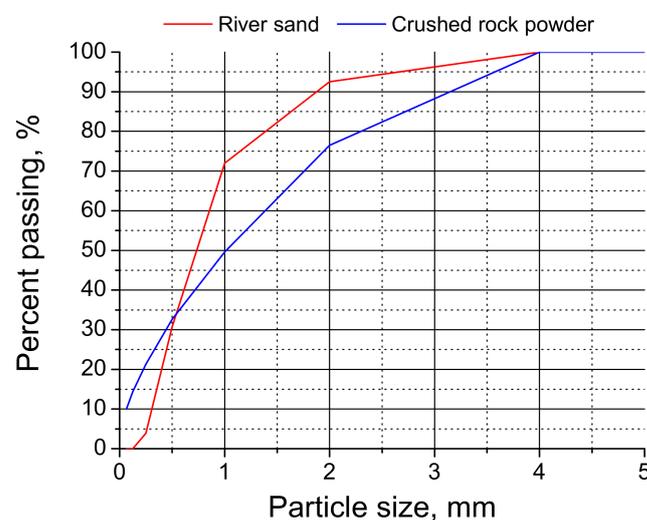
The grain size distributions of the aggregates, obtained according to the standard NP EN 933-1 [22], are shown in Figure 1. Their maximum ( $D_{max}$ ) and minimum ( $d_{min}$ ) diameters are indicated in Table 1. The density of the sand and crushed rock powder used as aggregates, determined according to the standard Portuguese Standard NP EN 1097-6 [23], and their bulk density obtained following the standard NP EN 1097-3 [24], can be also observed in Table 1.

Figure 1. Grain size distribution of sand and crushed rock powder used as aggregates.

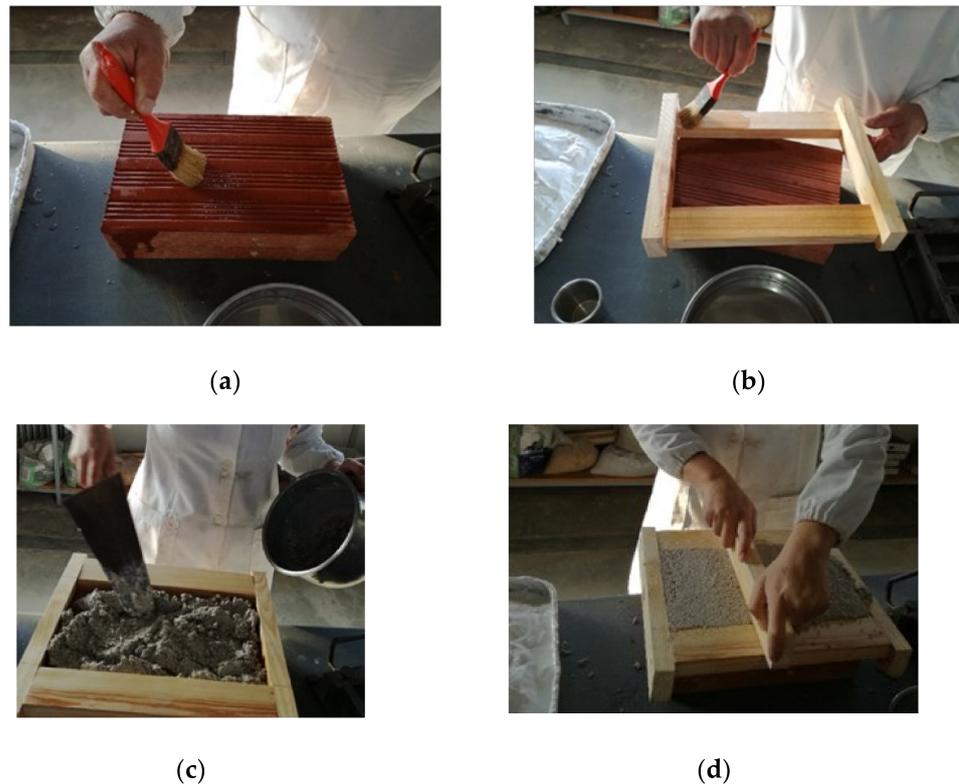
The setting of the mortars was carried out in accordance with standard EN 1015-2 [26]. Two different types of specimens were made. Prismatic samples with dimensions  $40\text{ mm} \times 40\text{ mm} \times 160\text{ mm}$  were prepared according to standard EN 1015-11 [28]. Specimens of mortars on ceramic bricks were also prepared. This type of specimen consisted of applying a layer of mortar with 20 mm thickness on the top surface of a brick with dimensions  $300\text{ mm} \times 200\text{ mm} \times 90\text{ mm}$ , simulating a coating layer. All the bricks used were moistened using a brush before the application of the mortar (see Figure 2a). In addition to this, a wooden frame, also moistened, was placed on the brick as a formwork to delimit the mortar and allow the application of a layer of a constant thickness (see Figure 2b). After that, the mortar coating was applied on the surface of the brick (see Figure 2c) and it was compacted. Finally, with the help of a board the surface was leveled (see Figure 2d).

**Figure 2.** (a) Moistening of the surface of the brick; (b) detail of the wooden frame used as formwork; (c) application of the mortar coating layer; (d) leveling of the surface using a board.

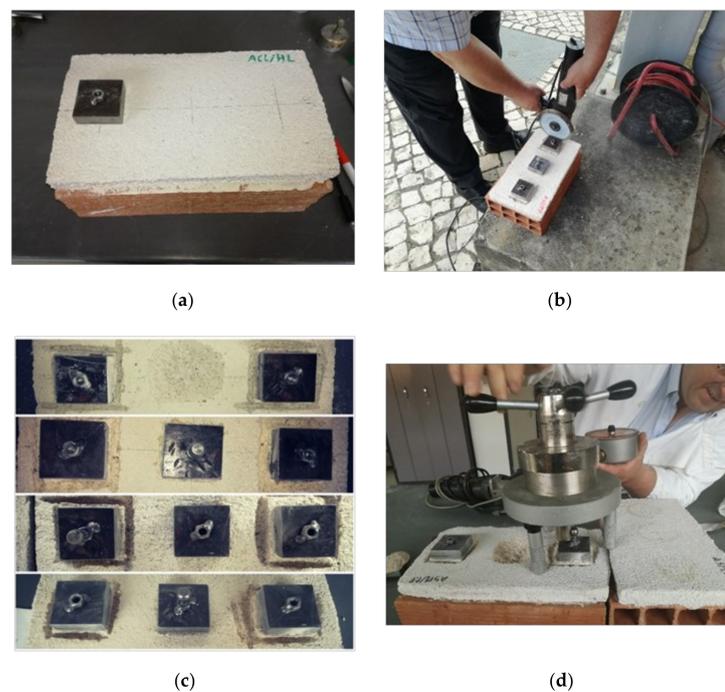
Before starting the test, the position of the three square metallic slabs in the coating was marked (see Figure 3a). According to other authors [29,31,32], the use of square slabs for this test was chosen, instead of circular ones, due to the fragility of the lime mortars, which could be damaged inside the notches when they are carried out with a crown drill. The square metallic slabs were glued to the mortar coating using a quick epoxy resin manufactured by UHU Company (Bolton Adhesives group, Rotterdam, Nederland). After that, the notches were executed using a circular saw (see Figure 3b) in the mortar coating beside the sides of two of the three square slabs (see Figure 3c), in order to assess the possible differences in the behavior related to pulling in the cases with and without these notches. Finally, the square slabs were pulled out with the equipment for the direct tension test (see Figure 3d).

**Figure 3.** (a) Marking of the position of the square metallic slabs in the mortar coating of a specimen (one of the slabs is already glued in the coating); (b) execution of the notches using a circular saw; (c) detail of the notches already finished in the perimeter of the left and right square slab, while the central slab was tested without notch; (d) equipment for direct tension test used for pulling out the slabs.

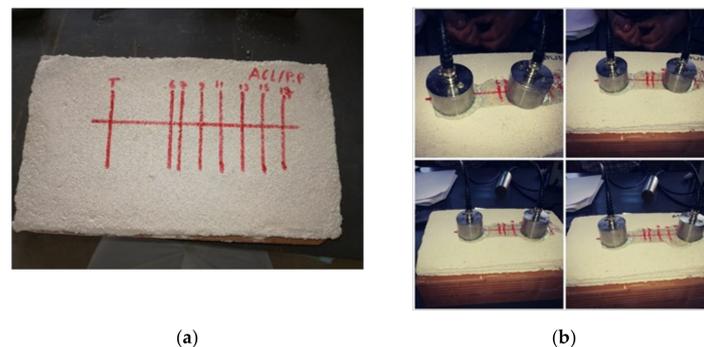
The ultrasonic pulse velocity (UPV) provides information about the mechanical characteristics, the homogeneity, and the presence of cracks and defects in the mortars. This parameter was determined according to the standard NP EN 12504-4 [33] at 90 hardening days. The equipment used was a Pundit manufactured by C.N.S. Electronics LTD. (London, England). The ultrasonic pulse velocity was obtained in prismatic samples with dimensions 40 mm  $\times$  40 mm  $\times$  160 mm using direct transmission. This parameter was also determined in the specimens of mortars on ceramic bricks as coating layer using indirect transmission, with both transducers on the surface of the mortar layer. For each mortar type and kind of specimen, three samples were tested and three measurements were taken in the same sample. In addition to this, for specimens of coating mortars on bricks, several measurements were made at different distances (6, 7, 9, 11, 13, 15, and 17 cm, respectively) between the centers of transducers (see Figure 4a,b).

**Figure 4.** (a) Marking of ultrasonic pulse velocity (UPV) measuring points in the surface of a coating mortar; (b) measurement process for the same sample.

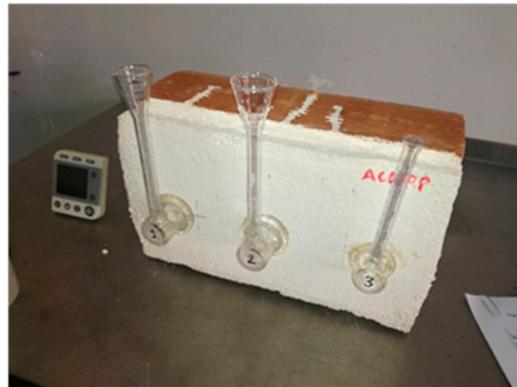
Before preparing the setup of the test, the specimens were dried in a ventilated oven at  $60 \pm 5$  °C temperature. Three Karsten tubes with a capacity of 4 ml were fixed to each sample (see Figure 5) using silicone. Prior to initiating the test, it was given 24 h for silicone drying. Once the tubes were filled with water, the test started and readings of the amount of water absorbed were taken at 15 s, 30 s, 1 min, 1.5 min, 2 min, 3 min, 4 min, and 5 min. No measurements at later times were noted because in all mortars total water absorption was finished in 5 min or less. The final result obtained from this test is the absorption coefficient. For each mortar type, three samples were tested at 90 hardening days.

**Figure 5.** Position of the Karsten tubes in the sample for performing the test.

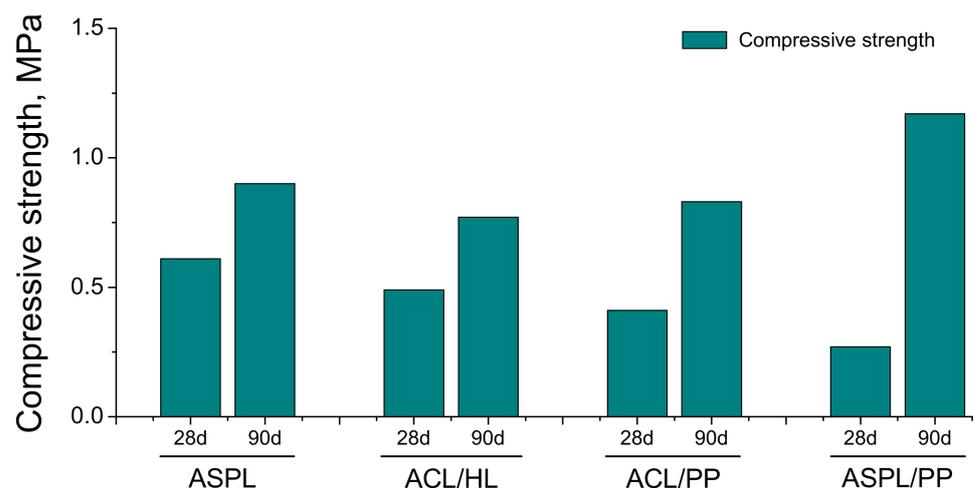
The compressive strength results obtained are depicted in Figure 6. All the studied mortars showed an increase of this parameter between 28 and 90 days. At 28 days the highest compressive strength was noted for mortars with lime putty and sand (ASPL series), followed by the specimens which incorporated both aerial and hydraulic lime with sand as aggregate (ACL/PP series). On the other hand, the lowest values of compressive strength at 28 days were noted for samples prepared with lime putty, sand, and crushed rock powder (ASPL/PP series). However, the abovementioned ASPL/PP mortars showed the highest compressive strength at 90 hardening days, compared to the other studied series. The values of this parameter were relatively similar for ASPL, ACL/HL, and ACL/PP specimens at 90 days of age, although it was slightly higher for ASPL ones.

**Figure 6.** Compressive strength results for the studied mortars.

In view of the results of the compressive and flexural strengths obtained for the studied mortars (see Figures 6 and 7), it seems that the incorporation of crushed rock powder as aggregate produced a reduction of both parameters in the short-term (28 days), although it has a beneficial effect in the middle-term (90 days), improving the mechanical performance, especially when it is combined with lime putty. With respect to the different types of limes studied, in view of the results obtained, the use of lime putty (totally or partially in the binder) overall gave higher strengths after 90 days. This would agree with other authors [11], which noted that the evolution of mechanical properties was slower when aerial lime is used in the binder. Then, specimens with aerial lime would probably need more time than 90 days for reaching similar mechanical strengths than mortars with lime putty. In addition to this, there are authors [14] who also reported that aerial lime binders would reduce the mechanical performance of mortars, in keeping with the results obtained in this work.

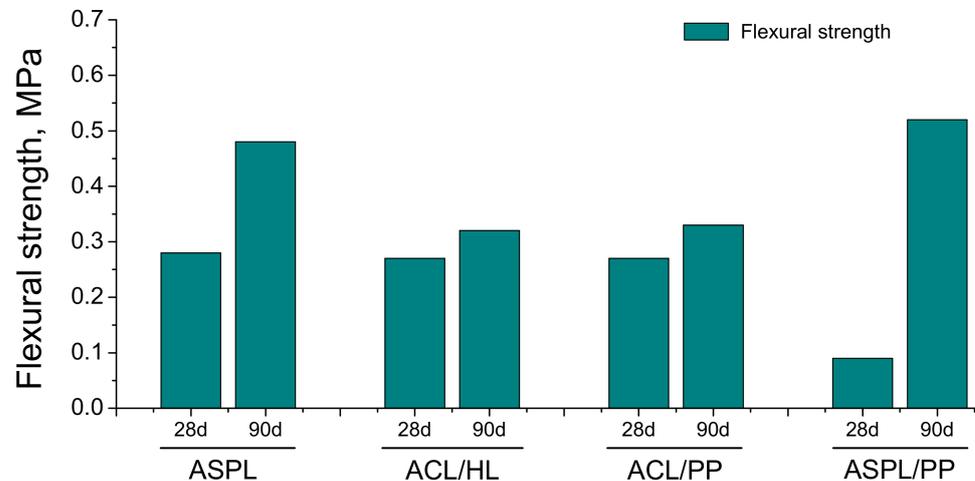
Regarding the flexural strength, the results of this parameter can be observed in Figure 7. At 28 days, the flexural strength was very similar for ASPL, ACL/HL, and ACL/PP mortars, being lower for ASPL/PP ones. This parameter showed an important increase at 90 hardening days for mortars that incorporate lime putty (ASPL and ASPL/PP series) and this rise was more noticeable for specimens that combined lime putty, sand and

crushed rock powder (ASPL/PP series). The flexural strength for mortars with aerial lime (ACL/HL and ACL/PP series) was lower compared to mortars with lime putty (ASPL and ASPL/PP series).

Figure 7. Flexural strengths noted for the different kinds of mortar analyzed.

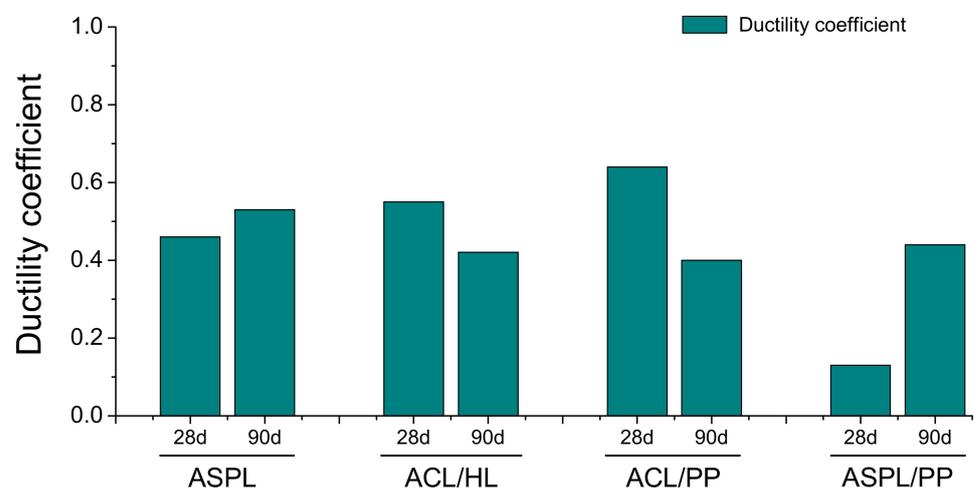
The ductility coefficient results are represented in Figure 8. For mortars with lime putty, this parameter rose between 28 and 90 days, having a more notable increase for ASPL/PP specimens. On the other hand, the ductility coefficient decreased with age for mortars which included aerial limes (ACL/HL and ACL/PP series). These specimens with aerial lime showed higher values of this coefficient at 28 days, while at 90 days it was slightly greater for mortars with lime putty.

Figure 8. Ductility coefficients for the studied mortars.

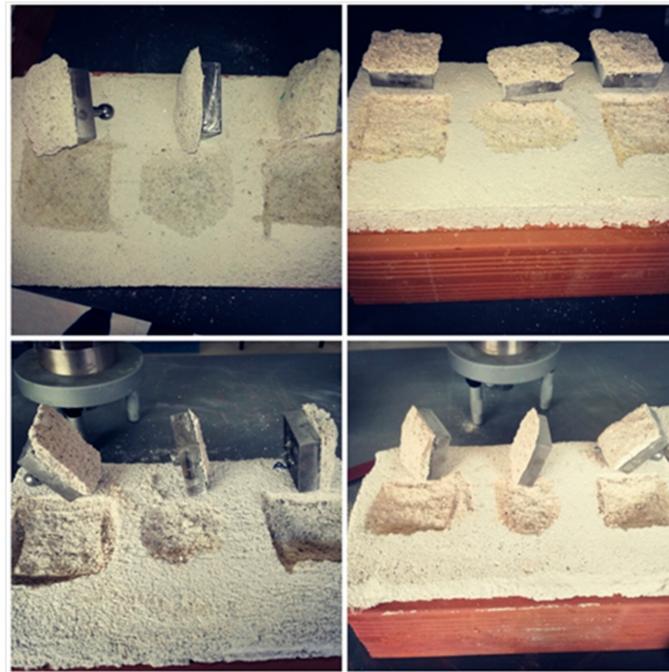
All the kinds of mortars showed a cohesive fracture once we finished the pull-off test, as can be seen in Figure 9. The pull-off strength results at 90 days of age are depicted in Figure 10. As can be observed, the highest value of this parameter corresponded to specimens with lime putty, crushed rock powder, and sand (ASPL/PP series), followed by ASPL samples. The pull-off strength was lower for mortars of the series ACL/HL and ACL/PP compared to those with lime putty.

**Figure 9.** Images of cohesive fractures observed in the studied mortar coatings after performing the pull-off test.

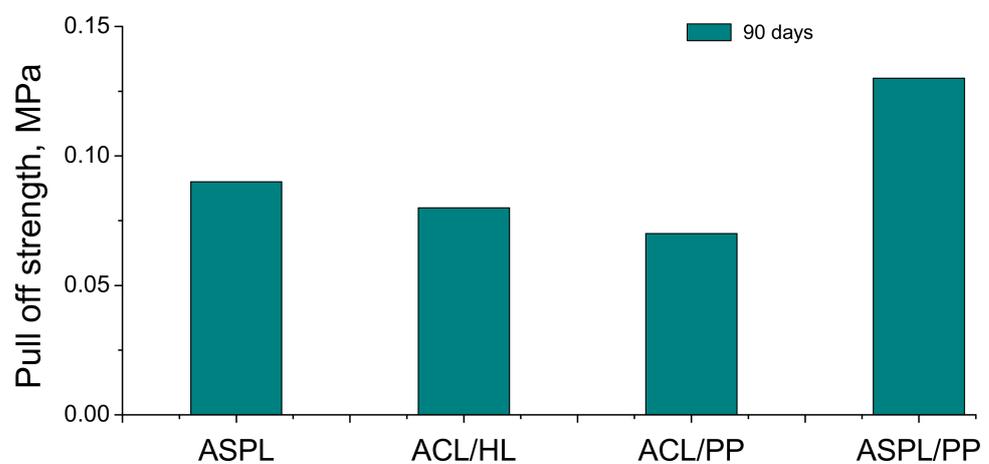
**Figure 10.** Pull-off strength results for the analyzed mortar coatings at 90 days.

On the other hand, the pull-off strength results (see Figure 10) reveal that the incorporation of lime putty produced a beneficial effect in relation to pull-off strength. This result would be in line with other works [12], which pointed out that lime mortars made with putties could improve the general behavior of the mortars. In addition to this, higher pull-off strength has been observed for mortars that combined hydraulic and aerial lime in the binder, in comparison with those made with aerial lime only. This would confirm the beneficial effects of using blended mortars with both aerial and hydraulic lime, also in agreement with other authors [15].

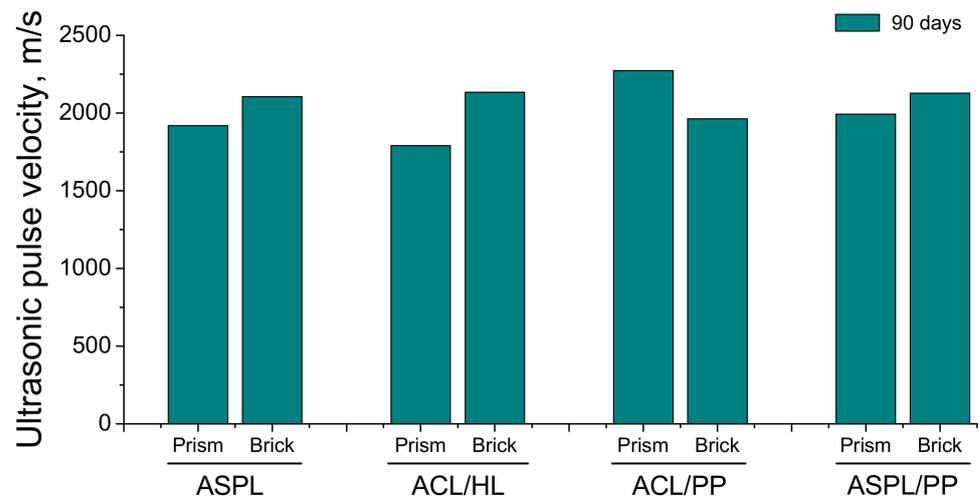
The ultrasonic pulse velocity was determined for prismatic samples as well as for specimens of mortar coatings on ceramic bricks. The results of this parameter for both types of samples are shown in Figure 11. In general, scarce differences in this parameter were observed for all the studied mortars, which would indicate that they would have a similar porosity, with slight differences.

In relation to the prismatic samples, the ultrasonic pulse velocity was very similar for lime putty mortars (ASPL and ASPL/PP series), although this parameter was higher for mortars with aerial lime and both sand and crushed rock powder as aggregates (ACL/PP series). The lowest ultrasonic pulse velocity was noted for mortars which incorporated both aerial and hydraulic lime (ACL/HL series).

Regarding the specimens consisting of mortar coatings on ceramic bricks, the ultrasonic pulse velocity was very similar for ASPL, ACL/HL, and ASPL/PP series and scarce lower for ACL/PP mortars.

**Figure 11.** Ultrasonic pulse velocity obtained for prismatic samples (designated as “prism” in the graph) and in mortar coatings on ceramic bricks (designated as “brick” in the graph) at 90 hardening days.

Regarding the ultrasonic pulse velocity, the results obtained in prismatic samples (see Figure 11) would suggest that the mortars with aerial lime and crushed rock powder would be slightly less porous compared to the rest of the mortars studied, while those with both aerial and hydraulic lime would have scarce higher porosity. Several authors have pointed out that the aggregate used in lime mortars has an influence on the porosity and pore size distribution of lime mortars [18], as well as that lime powder mortars generally present higher porosity [10]. Therefore, the possible lower porosity suggested by the ultrasonic pulse velocity results obtained in this work for the studied mortars with aerial lime and crushed rock powder would indicate a beneficial effect of crushed rock powder. Finally, the ultrasonic pulse velocity results obtained in prismatic samples using direct transmission were overall in agreement with those noted for other authors [35,36], which reported values of this parameter between 1340 and 2570 m/s for samples made using mortars for applications such as exterior plasters and coatings for old building refurbishment.

In relation to the specimens consisting of mortar coatings on ceramic bricks, the ultrasonic pulse velocity results would indicate that mortars with lime putty and those which combined aerial and hydraulic lime had a similar porosity when they are applied as a coating layer. On the other hand, the ultrasonic pulse velocity results would suggest that coatings made using mortar with aerial lime and crushed rock powder would have a slightly higher porosity. This result differs from that observed for prismatic specimens and it could be due to a possible higher formation of internal shrinkage cracks compared to the rest of the mortars analyzed, although this phenomenon had not been observed in the surface of the specimens with coating layers. The values of ultrasonic pulse velocity for mortar coatings on ceramic bricks from indirect transmission measurements also agreed with other researchers [35,36], which pointed out values of this parameter from 1524 to 2920 m/s taken in mortars applied as coatings in surfaces of exterior elements of old buildings [35].

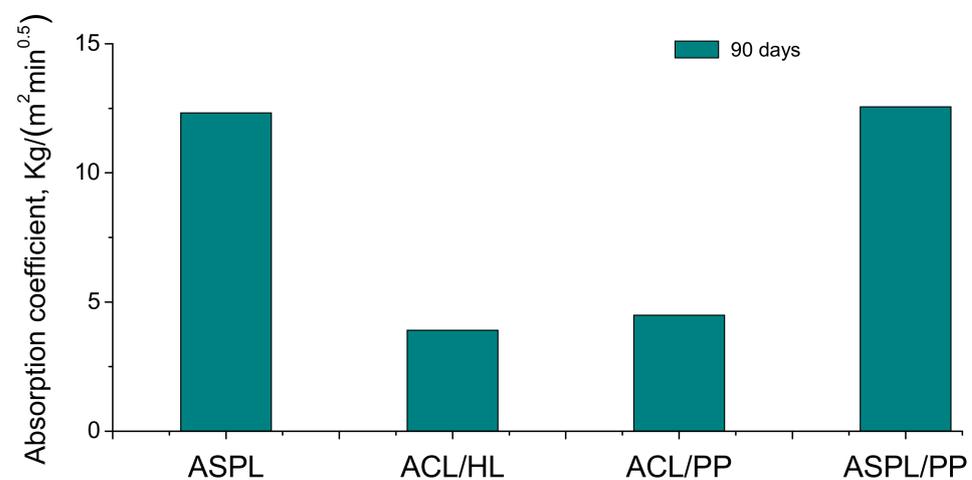
The values of the absorption coefficient at 90 hardening days determined using the Karsten method are depicted in Figure 12. The highest coefficients were noted for mortars with lime putty (ASPL and ASPL/PP series), whereas the lowest values of this parameter corresponded to specimens that incorporated aerial lime (ACL/HL and ACL/PP series).

**Figure 12.** Absorption coefficients at 90 days obtained using the procedure of the Karsten method.

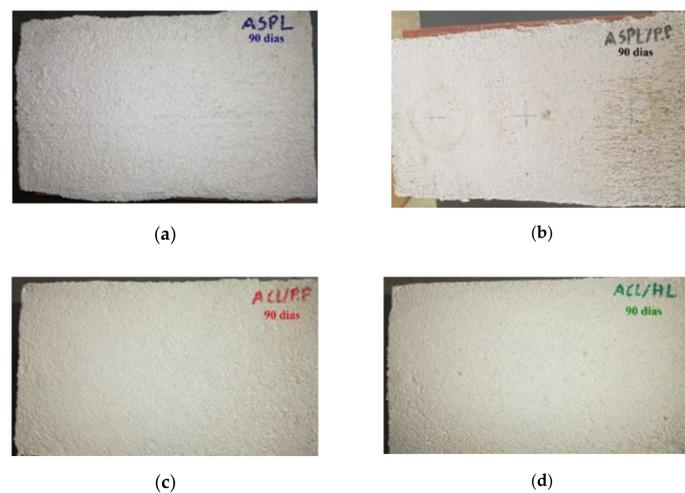
The visual evaluation of the specimens of mortars applied on ceramic bricks surface as coating layer did not reveal any formation of shrinkage cracks at 28 and 90 hardening days. Figure 13 shows images of the surfaces of all the mortar’s coatings analyzed taken at the age of 90 days.

**Figure 13.** (a) Surface of lime putty and sand (ASPL) mortar coating specimen at 90 days; (b) surface of lime putty, sand and crushed rock powder (ASPL/PP) mortar coating specimen at 90 days; (c) surface of aerial and hydraulic lime with sand as aggregate (ACL/PP) mortar coating specimen at 90 days; (d) surface of aerial lime, hydraulic lime, and sand (ACL/HL) mortar coating specimen at 90 days.

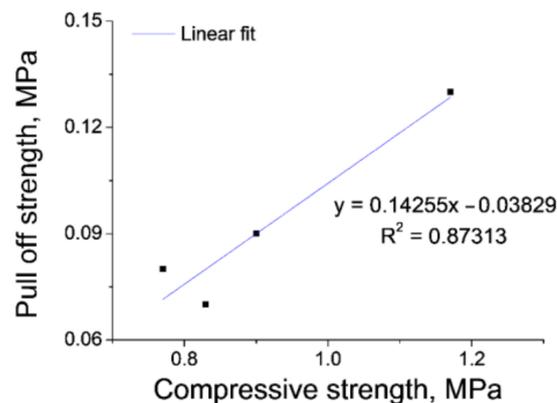
Furthermore, it has been noted that the results of pull-off strength obtained were overall in keeping with those noted for compressive and flexural strengths. In view of that, for checking if there is a direct relation between pull-off and mechanical strengths, a linear fit between compressive and pull-off strengths values obtained for all the mortars studied has been performed (see Figure 14), obtaining a  $R^2$  value equal to 0.87313, which would show a good correlation, confirming that higher compressive strength entails higher pull-off strength. The results noted for the pull-off strength were also consistent with those obtained by other authors [35], which reported that the values of this parameter were in the range between 0.61 and 1.66 MPa for mortars applied in external elements of old buildings as plasters and coatings.

**Figure 14.** Linear fit between compressive and pull-off strengths values obtained for the studied mortars.
