Floods and Their Impact on Cultural Heritage—A Case Study of Southern and Eastern Serbia

Abstract: This paper analyzes flood impact on the historical objects and cultural heritage in Southern and Eastern Serbia. The basic research problem is the lack of systematized databases regarding the flood impact on the cultural heritage, in addition to the lack of official manuals or other types of educational material dealing with the management of the assets with monumental properties in flood situations. The goal of the paper is to indicate this problem to the professional and wider public through systematization and classification of the observed damages on the buildings. The paper first provides a brief overview of the development of flood protection throughout history with particular reference to the research area. In addition, the history of floods in Serbia is also analyzed in order to point to the frequency and scale of this problem in the researched area. Through the research of archival materials in the appropriate institutions as well as direct recording of assets in the field, the degree of flood impact on historical objects in the territories of Southern and Eastern Serbia is

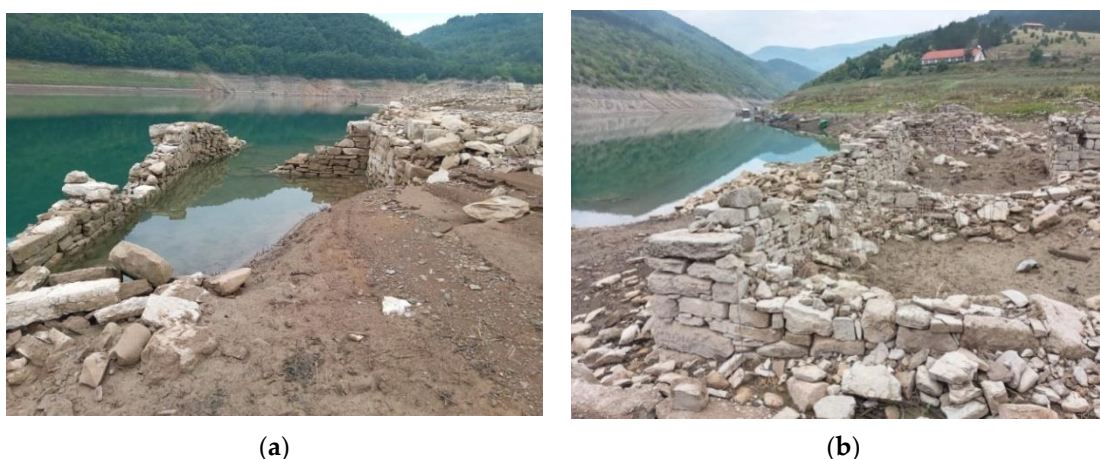
Figure 4. (a) Remains of the village cooperative; (b) remains of the housing buildings in the flooded village of Velika Lukanja at the time of low water level (photo A. M. Petronijević).

The entire architectural heritage of the above-mentioned villages, including a few hundred houses, is irretrievably lost (Figure 3a). At the bottom of the current dam lake, which was built from 1982 to 1988, in addition to the remains of the houses, there is also a three-arched stone bridge as well as the former school building. Currently, at low water level, the outlines of the foundations and stone walls of the houses are visible (Figure 4a,b).

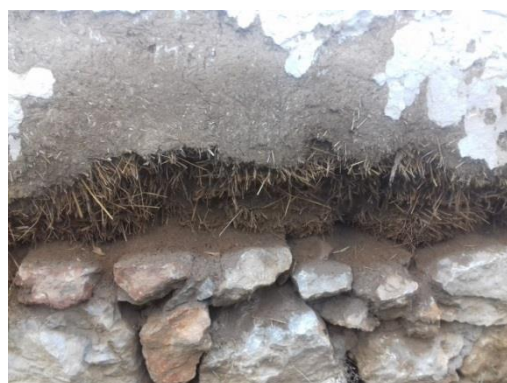
Figure 9. After water receding, a part of mortar is “washed away.” On the remaining mortar one may observe straw, which is a form micro reinforcement.

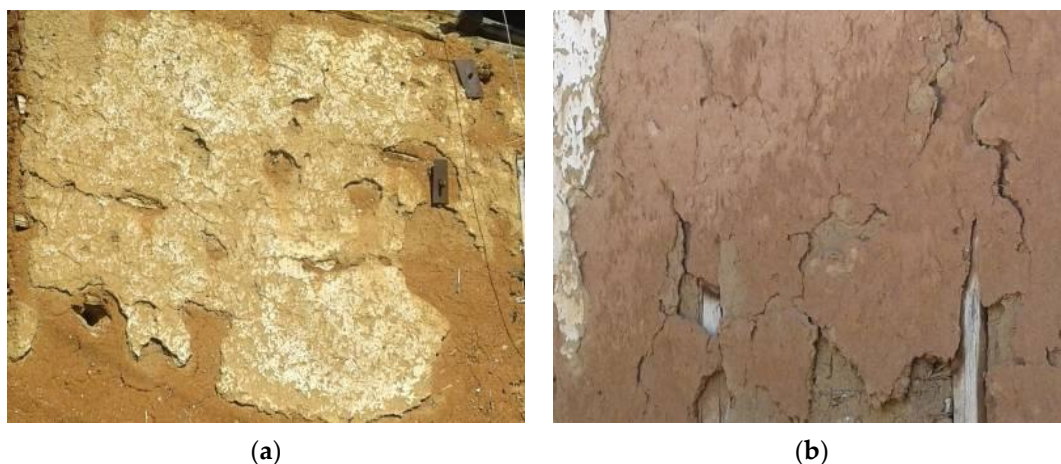
Physical degradation and anomalies in the structure occur as an aftermath of the moisture to which the building was exposed during the flood. In the buildings that are predominantly built in the post and pan system, with a wooden frame and infill of some sort, most often earthen material, damages occur due to the differences in the behavior of these two types of materials (Figure 9). Due to the cyclical swelling of wood with increasing humidity and shrinkage due to drying in the walls, expansions occur. They are significantly larger than the limit values that can be sustained by mud mortar. Thus, volume changes in the wooden structural elements due to the changes in humidity percentage result in damages that occur on the plaster of external and internal wall surfaces, such as

disintegration (crumbling and turning into dust), blistering, flaking, fragmentation and peeling (Figure 10a,b).

Figure 10. Characteristics damages to mud mortar: (a) falling of the finish lime mortar; (b) total peeling of the mud mortar from the adobe wall (photo A. M. Petronijević).

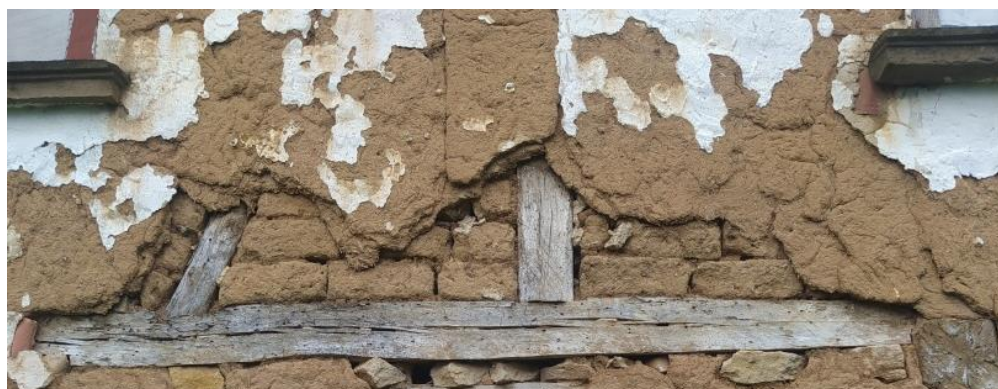
After wetting, the wooden parts of the building are subject to rotting. In the case of a wooden post and pan, the beams dry out faster than the mortar. Thus, the mortar shrinks and cracks in that place. In this way, the wooden parts of the building (beams, columns, braces, etc.) are additionally exposed to weather effects, which considerably shorten their lifespan (Figure 11). The weak points of post and pan are indentations and cuts, for plugs and other connections, where moisture can retain the longest; therefore, they are most susceptible to rotting [42].

Figure 11. Falling off of mortar due to swelling of timber.

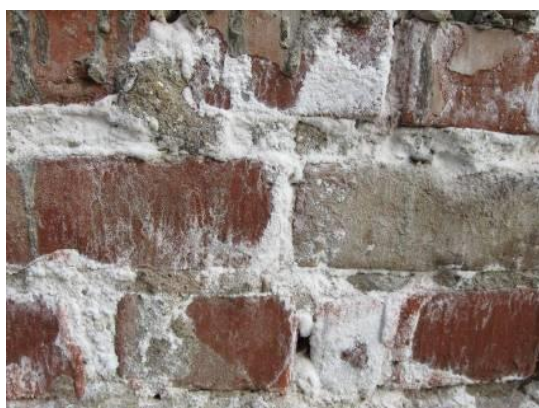
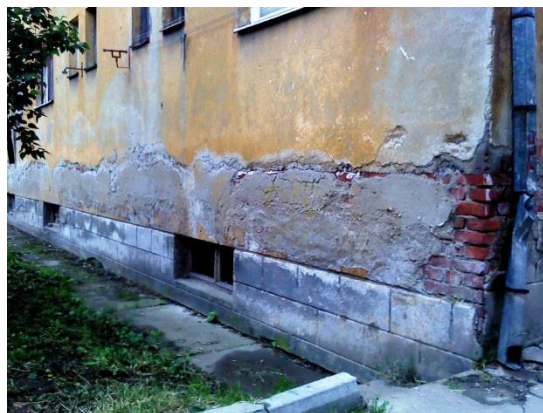
Brick walls that are exposed to flooding can be damaged during drying by the salts that are the aftermath of leaching due to high groundwater levels. The salts reach the surface of the brick and after drying they appear in the form of a white powdery material. On the buildings that are still in use, which are built of brick and plastered, significant leaching on the face of the walls is noted and so is the formation of mineral layers with significant coloring on the wall surfaces (Figure 12a,b). This phenomenon mainly has an aesthetic connotation. The problem arises when this process occurs behind an impermeable outer surface. The salts crystallize and expand, leading to the so-called flaking of brick or stone.

Figure 12. Leaching on the wall face due to floods: (a) detail; (b) large wall area (photo A. M. Petronijević).

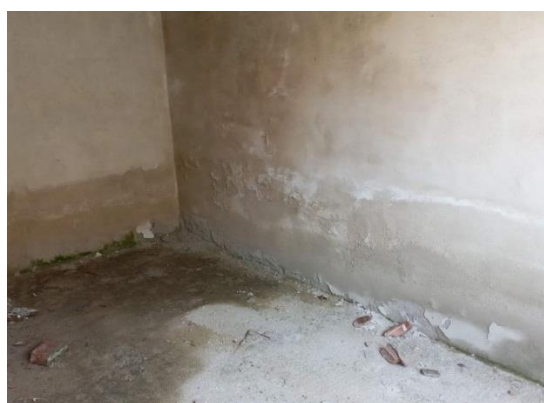
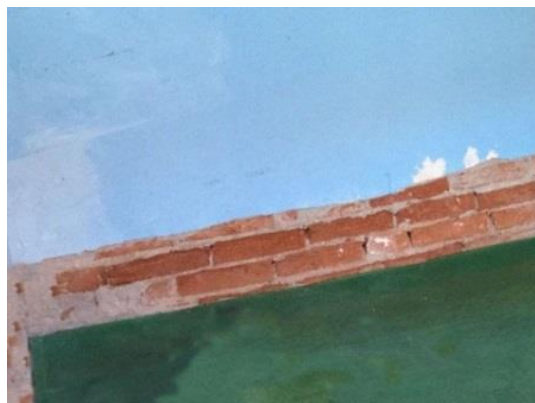
For all types of materials, the degradation is significantly worsened by the frost effect (Figure 13b). Freezing and thawing cycles of wet walls are the second dominant factor of their physical degradation. Freezing after buildings' exposure to floods is very common, considering that after getting wet, the objects do not have time to completely dry before the winter months.

Figure 13. (a) Moisture inside the building after water receding; (b) separation of mortar from the interior wall after freezing (photo A. M. Petronijević).

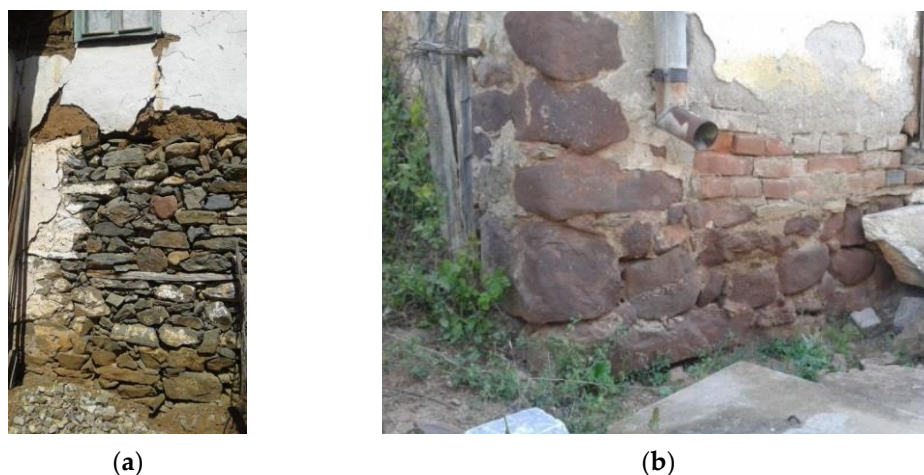
An additional problem with the damage of such buildings from moisture is caused by the fact that during the construction period of the observed buildings, no type of prevention of capillary rise of moisture was applied. The capillary rise of water, which is not exclusively related to the flood process itself, causes a significant damage to buildings. The impact is first noticed on the parts of the plinth, where the damages are the greatest (Figure 14). Through capillary rise, the water then migrates to other parts of the structure of the building, which leads to wetting and then to the falling off of the plaster from the walls, and all this is due to long-term exposure and the rotting of the beams and other elements.

Figure 14. (a) The capillary rise of water has led to the falling off of the plaster from the lower part of the building due to exposure to the action of water; (b) complete falling off of the plaster from the plinth wall (photo A. M. Petronijević).

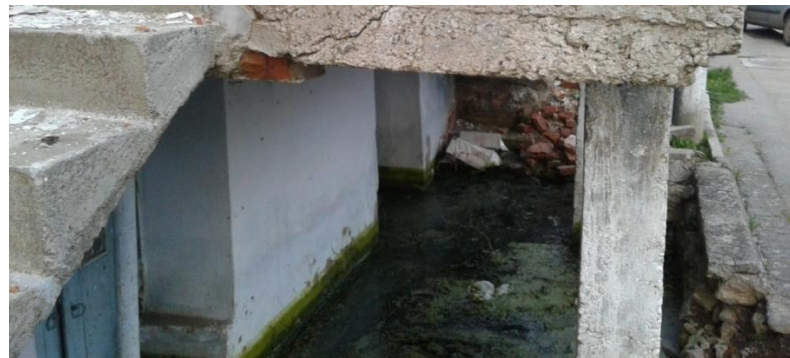
In many cases, biodegradation is a significant factor in the deterioration of assets. These assets are mainly the buildings that are neither permanently inhabited nor provided with regular maintenance. Upon their surfaces exposed to wetting, whether as a result of flooding or not, a layer is formed or even bushy structures up to several centimeters thick. There abound numerous microorganisms such as algae (Figure 15), mold and mildew, and, if the wetting process continues, lichens and mosses as well. A more significant presence of low and high vegetation is characteristic of places with increased humidity in

the zone of the contact of the building with the ground. Biodegradation is classified as a contaminating damage.

Figure 15. Algal colonization in the areas from which water has not been drained (photo A. M. Petronijević).

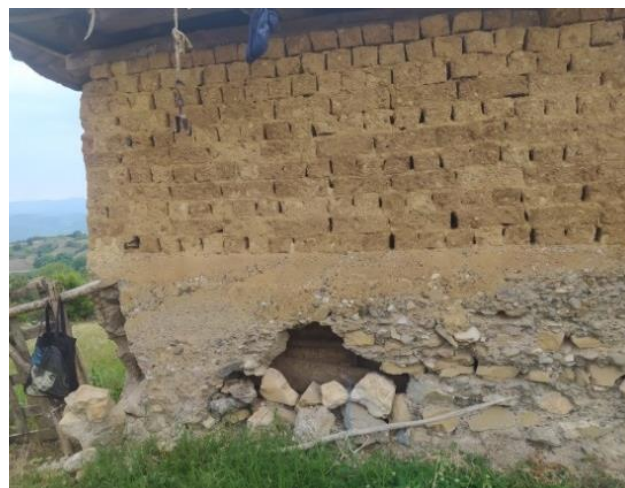
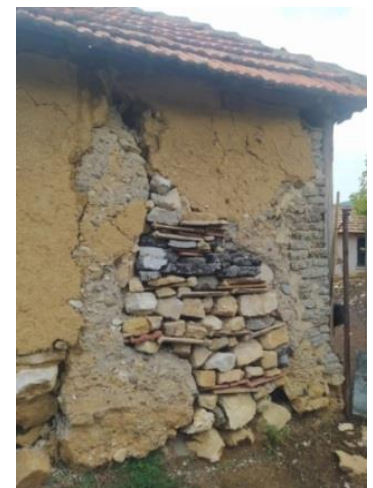
Due to the shock wave of water, materials from some parts of the building (Figure 16) may be carried away, washed away, or even entire walls may collapse.

Figure 16. (a) Structural damage; (b) attempt at rehabilitation of the given damage (photo A. M. Petronijević).

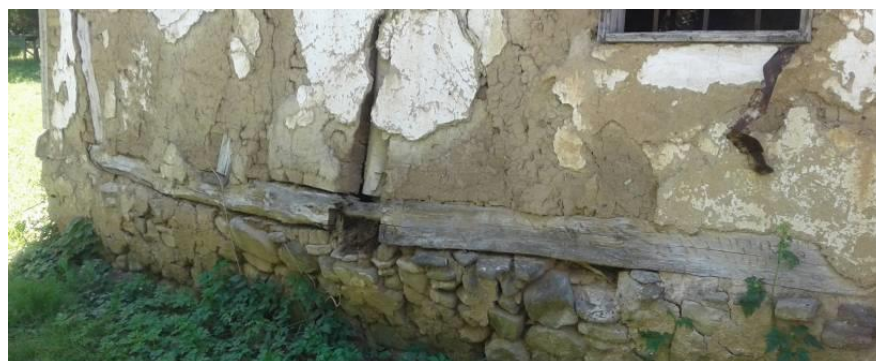
Furthermore, the impact force of water, a high pressure or undermining the soil beneath the building may give rise to cracks in the walls (Figure 17) or tilting and bulging of the walls (Figure 18). Structural damages may even occur later as well, after the building is restored to function, if there are wooden structural elements that continue to rot over time due to the presence of moisture. In this case, cracks would appear later.

Figure 18. Wall bulging (photo A. M. Petronijević).
