Article

Post-Occupancy Evaluation in Post-Disaster Social Housing in a Hot-Humid Climate Zone in Mexico

Citation: Aguilar-Perez, Y.; Rodrigues, L.; Beccarelli, P.; Tubelo, R. Post-Occupancy Evaluation in Post-Disaster Social Housing in a Hot-Humid Climate Zone in Mexico. *Sustainability* **2023**, *15*, 13443. <https://doi.org/10.3390/su151813443>

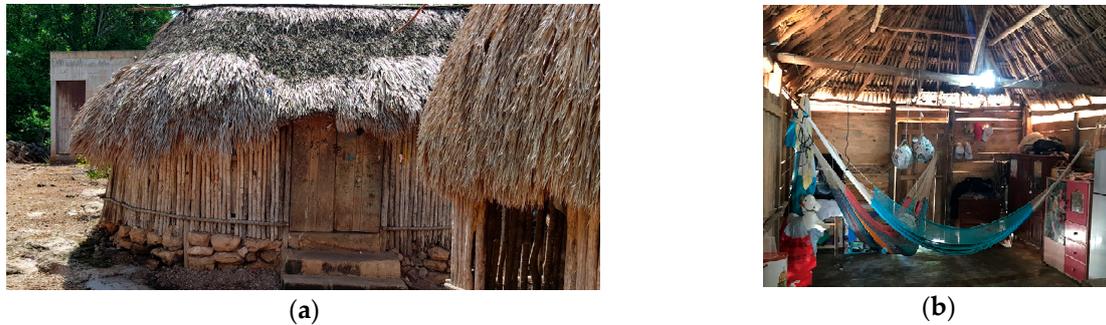
The vernacular house (Figure 1) in the geographical area considered in this study is composed of a single room with a size of 9 m by 5 m, typically with an apsidal floor plan and a thatched roof of 4 m height, the roof's lowest point being around 1.7 m—([26] p. 17).

Figure 1. (a) Exterior view of a vernacular house, (b) interior view of a vernacular house. Source: author.

Vernacular houses typically have two double doors allowing an opening of 1 m on each side, one in front of each other, and they are 1.7 m high and have no windows. However, natural ventilation is enhanced through the structure, having gaps between the vertical components of the external wall and through the thatched roof. The house is constructed with locally sourced natural materials, including stones, earth, leaves, and tree branches [38].

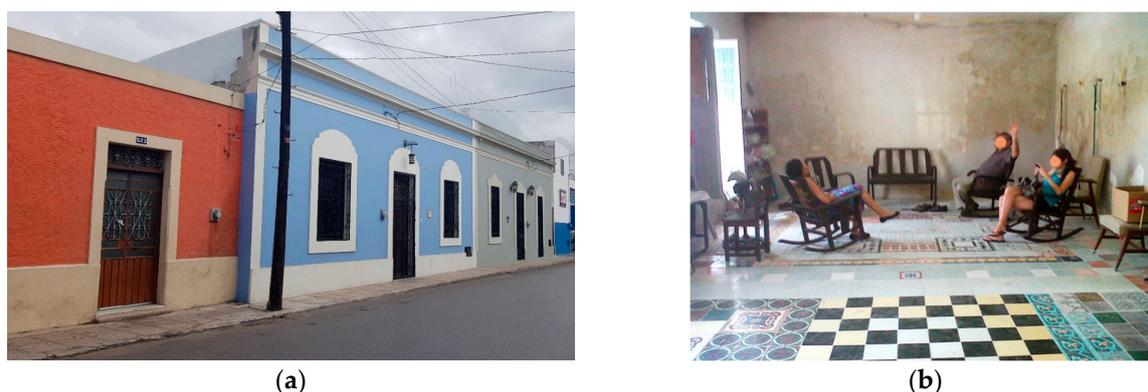
Colonial housing was built in the zone from the XVI century to the early 20th century (Figure 2). The constructive system includes 40 to 90 cm thick limestone walls and flat concrete roofs over wooden beams cast in situ [41]. It features high ceilings ranging from over 4 m to 7 m in height, rectangular and extensive floorplans, and casement windows and doors that allow cross ventilation [41]. The U -value of a wall of a colonial house could vary from 1.49 $W/m^2 \cdot K$ to 0.66 $W/m^2 \cdot K$, depending on the wall thickness [42].

Figure 2. (a) Exterior view of a colonial house, (b) interior view of a colonial house. Source: author.

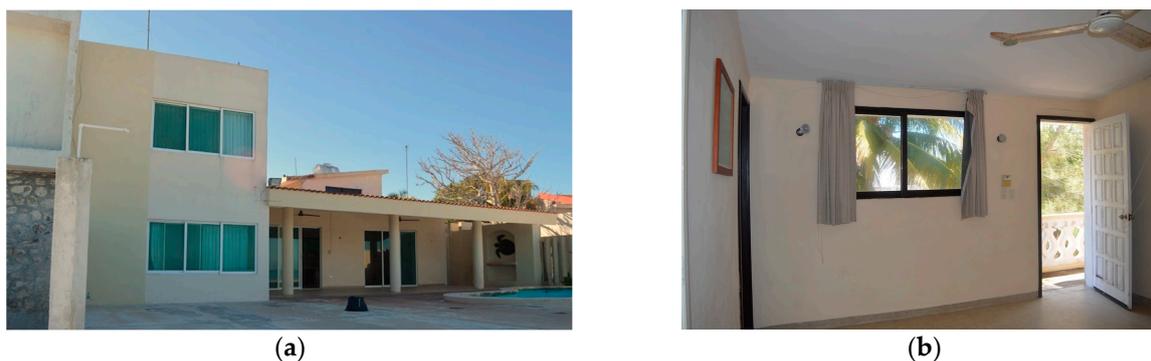
During the XX century, with industrial development, the construction system changed into a more cost-efficient and quick-to-build system based on hollow concrete blocks and industrialised modular T beams and hollow concrete filler blocks as roofing systems [43] as exemplified in Figure 3a,b. These building fabrics corresponded to a thermal transmissivity of $2.84 \text{ W/m}^2 \cdot \text{K}$ for the walls and roofs [44,45] p. 280.

Figure 3. (a) Exterior view of a modern house, (b) interior view of a modern house. Source: author.

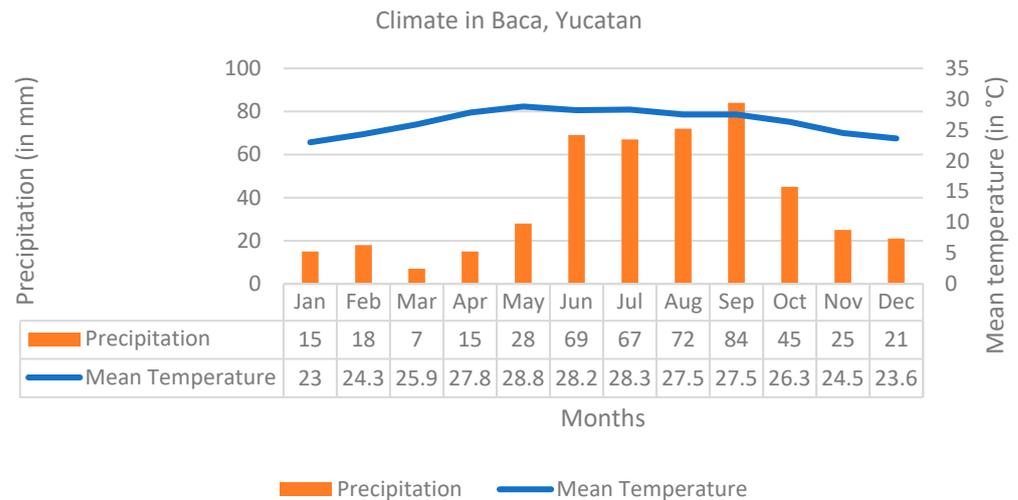
Prevailing mean outdoor temperature $t_{pma(out)}$ considered the meteorological monthly means of each of the studied months according to Figure 4.

Figure 4. Local climate in Baca, Yucatan, using weather data from [51].

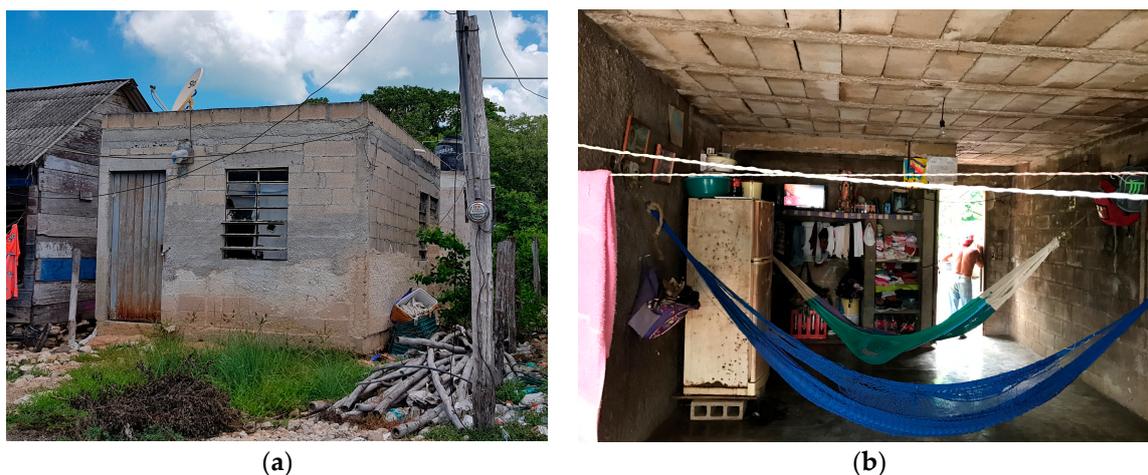
FONDEN houses were occupied by low-income households. Figure 6a illustrates a typical FONDEN house as built and its aspect after 17 years of use. Figure 6b displays an interior view of a typical FONDEN house as built, with the typical living conditions and cultural adaptations held inside.

Figure 6. (a) Exterior view of a FONDEN house, (b) interior view of a FONDEN house. Source: author.

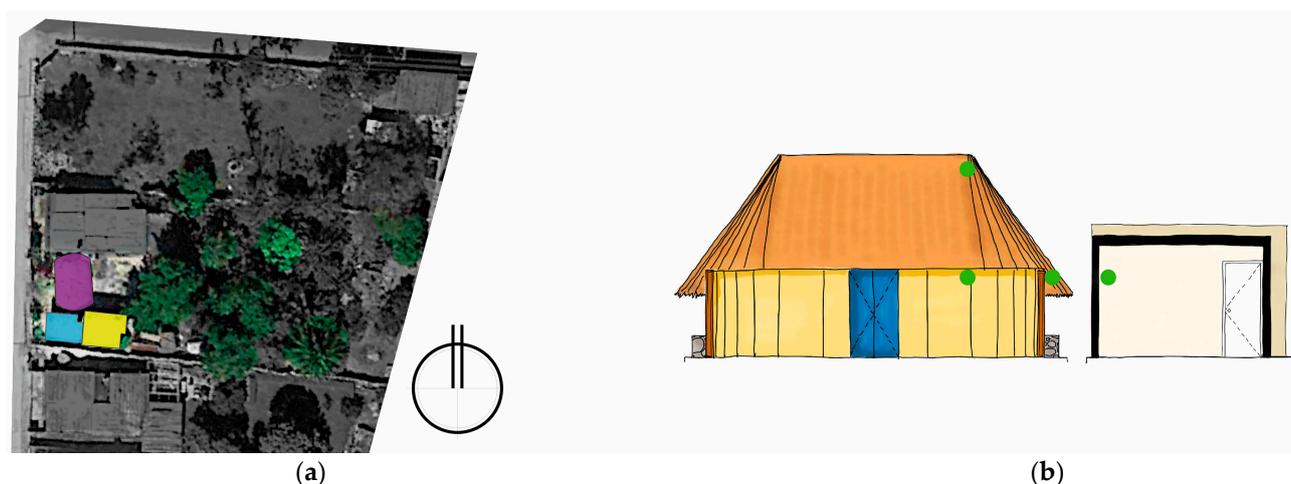
As described in Figure 7 through the green dots, the first and second devices were installed in the interior of the vernacular house, one positioned at the top of the ceiling (4 m) and the other at the height of people's activities (1.80 m). The third device was placed in the FONDEN house, also located at the same height of 1.80 m. Finally, a fourth data logger was installed at the same height of 1.80 m in an open-air area between the two houses to record the exterior conditions. This external device was protected from solar radiation through the overhanging thatched roof (Figure 7).

Figure 7. (a) Location of FONDEN house and vernacular house in the land plot, (b) location of data loggers inside and outside the FONDEN and vernacular houses represented by green dots.

The authors acknowledge that the position of the dataloggers were not within the recommended height of 1.1 m above the floor, which accounts for the head for seated occupants ([46] p. 4). However, the study was conducted during the time of use of these indoor spaces and monitoring had to prevent disturbance to the occupant's daily activities, as well as to prevent the reach of children whose hands temperature could damage the accuracy of data. The adopted height is similar to the values of 1.7 m for standing occupants ([46] p. 4).

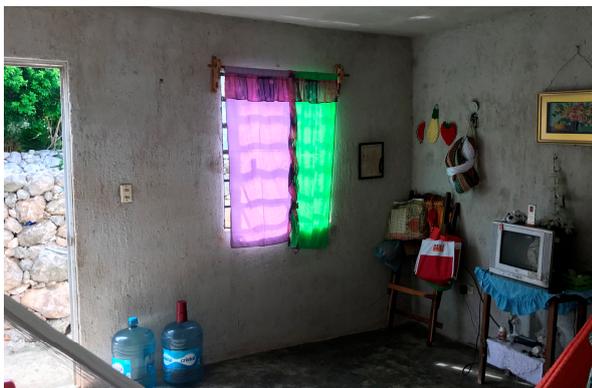
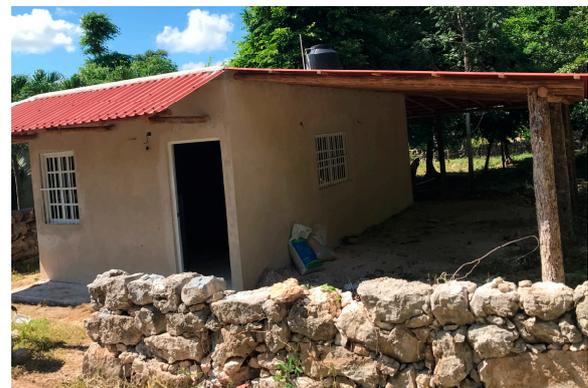
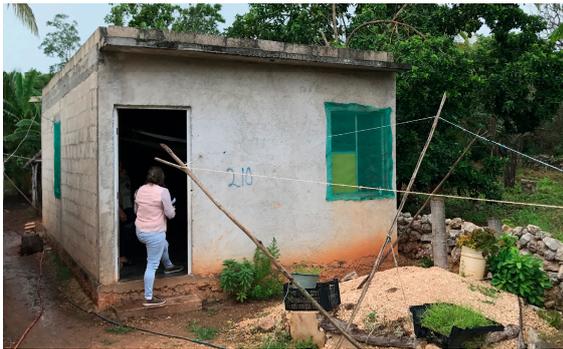
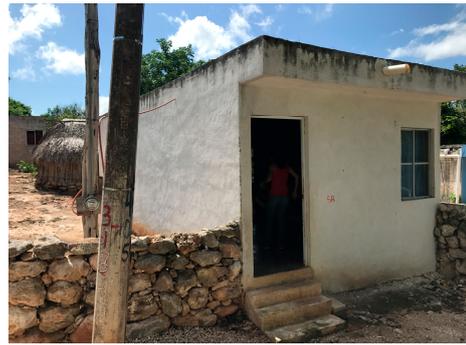
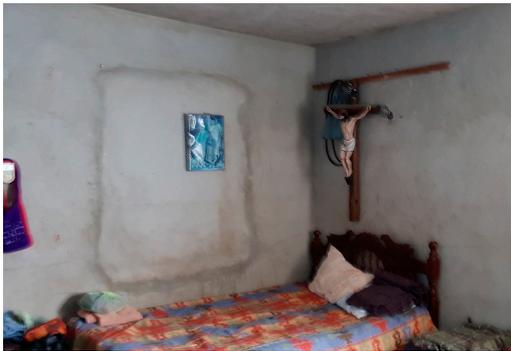
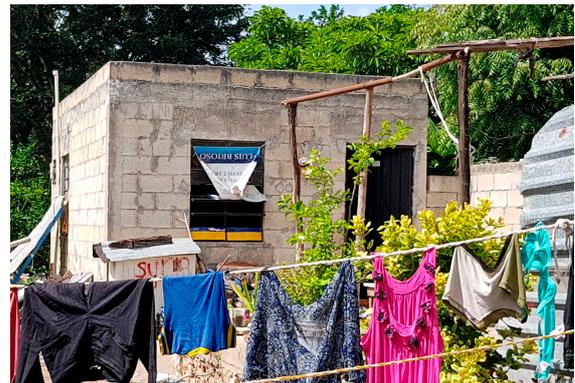
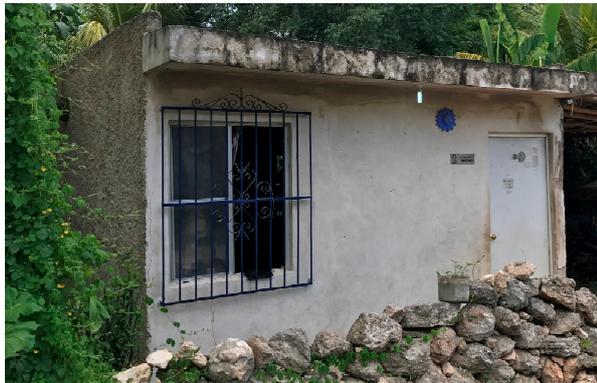
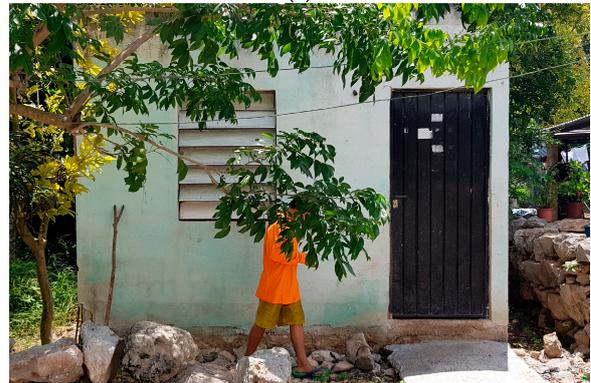
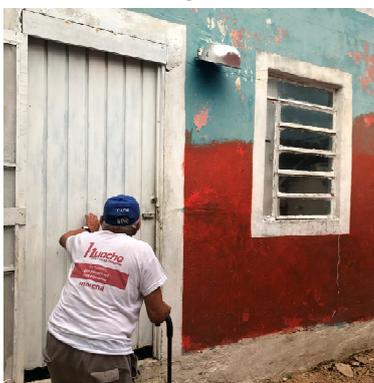
The observation was carried out in 83 houses and further investigated key aspects of use and occupancy indicated by occupants' responses to the questionnaire. The majority of the occupied houses were found to be in a bad state of repair just 17 years after their construction, even though the motivation of FONDEN houses was to deliver durable and resilient housing units, and the expected lifespan of a concrete-based house in a tropical zone should be between 25 and 30 years ([26] p. 163). The most common improvements made by the occupants were the integration of extra layers to the walls, such as rendering or plaster, as Figure 10 exemplifies.

Figure 10. Example of improvements made by occupants to their FONDEN houses. (a) Interior curtains, (b) attached lightweight structure, (c) mosquito mesh, (d) canopy, (e) cancelling windows, (f) exterior curtain-like shading, (g) safety protection, (h) painting window glazing, (i) painting door white. Source: authors.

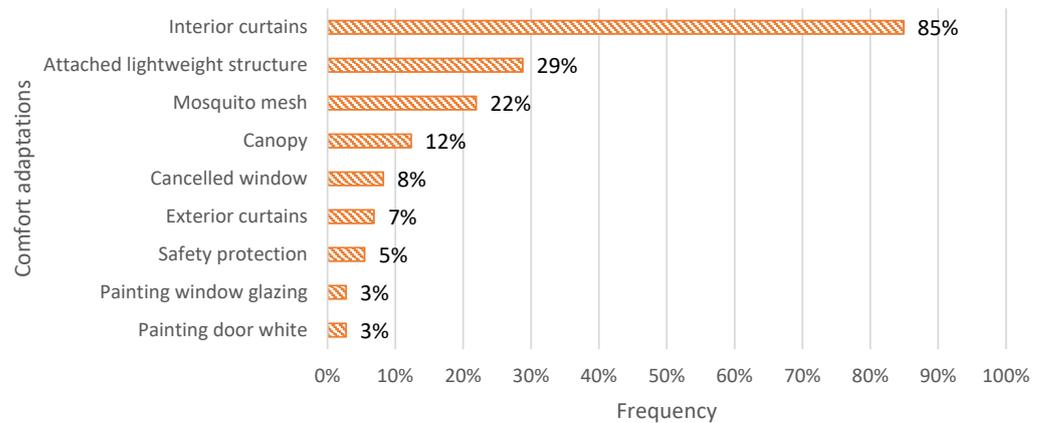
Figure 11 presents the figures of the presence of these strategies in the observed homes to adapt their house to achieve indoor thermal comfort.

Figure 11. Percentage of building control systems in the surveyed homes.

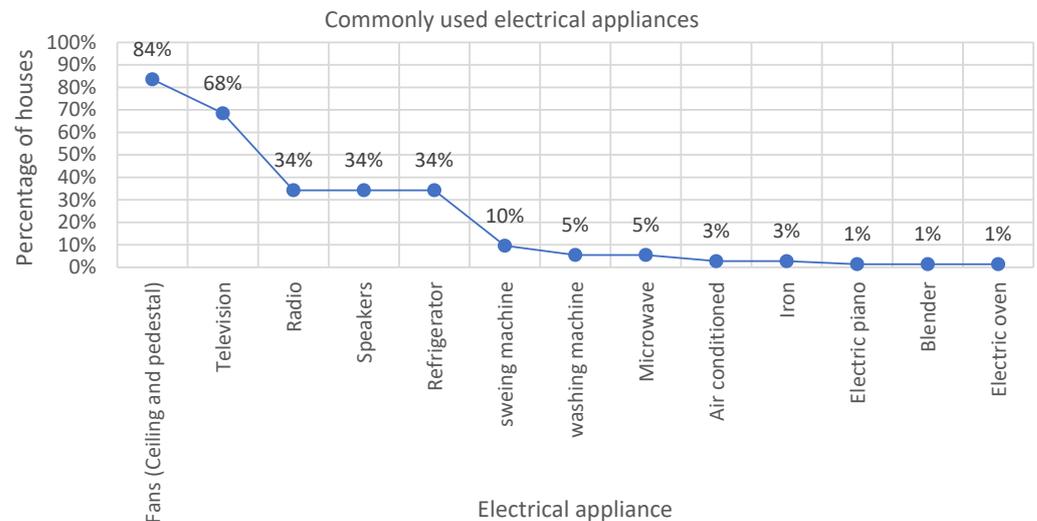
Figure 12. Percentage of the presence of common electrical appliances in documented homes.

Figure 12 illustrates the percentage of houses that accounted for at least one of the appliances listed. From observing the ownership of electrical appliances, it was possible to notice that the average number of electrical appliances per house was three. Surprisingly, fans were the most common device, and appeared in 84% of the houses surveyed, followed by televisions, presented in 68% of the houses, and radios, speakers, and refrigerators, which appeared in 34% of the houses.

In addition, data from observation through photographic documentation in the houses visited suggested that 61 households out of 73 samples (84% of the households) integrated an air movement devices, being fans (including the pedestal and ceiling types) the most common electrical appliance within the households. Data from monitoring revealed a predicted thermal discomfort for 92% of the time during September, when conditions prevailed above thermal comfort.

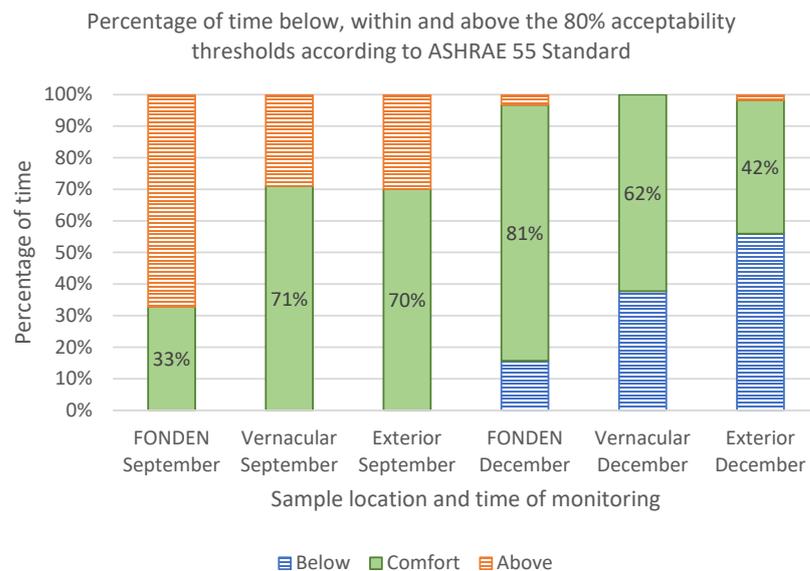
As seen in Figure 13, the analysis of the monitored data indicated that the FONDEN house was uncomfortable for 67% of the time, when outdoor conditions were warm and humid (in September), whilst the vernacular house was uncomfortable for only 29% of the time under the same outdoor conditions, revealing the better suitability of the vernacular house to warmer conditions. This seems to be due to the high ventilation rates and specific thermal properties of the building fabric in the vernacular building.

Figure 13. Percentage of time below, within and above the 80% acceptability thresholds according to ASHRAE 55 Standard.

On the other hand, in December, when temperatures were lower, FONDEN houses were found to be within thermal comfort for 81% of the time, while vernacular houses, were comfortable for 62% of the time (Figure 13). This revealed that the FONDEN houses are more suitable for colder environments, while the conditions in the zone are generally warmer. This is because the vernacular house allows more ventilation due to the characteristic of the wall, while the FONDEN house has a more airtight envelope comparatively with limited operable doors and windows, which reduces the airflow and, consequently, the heat transfer through the envelope.

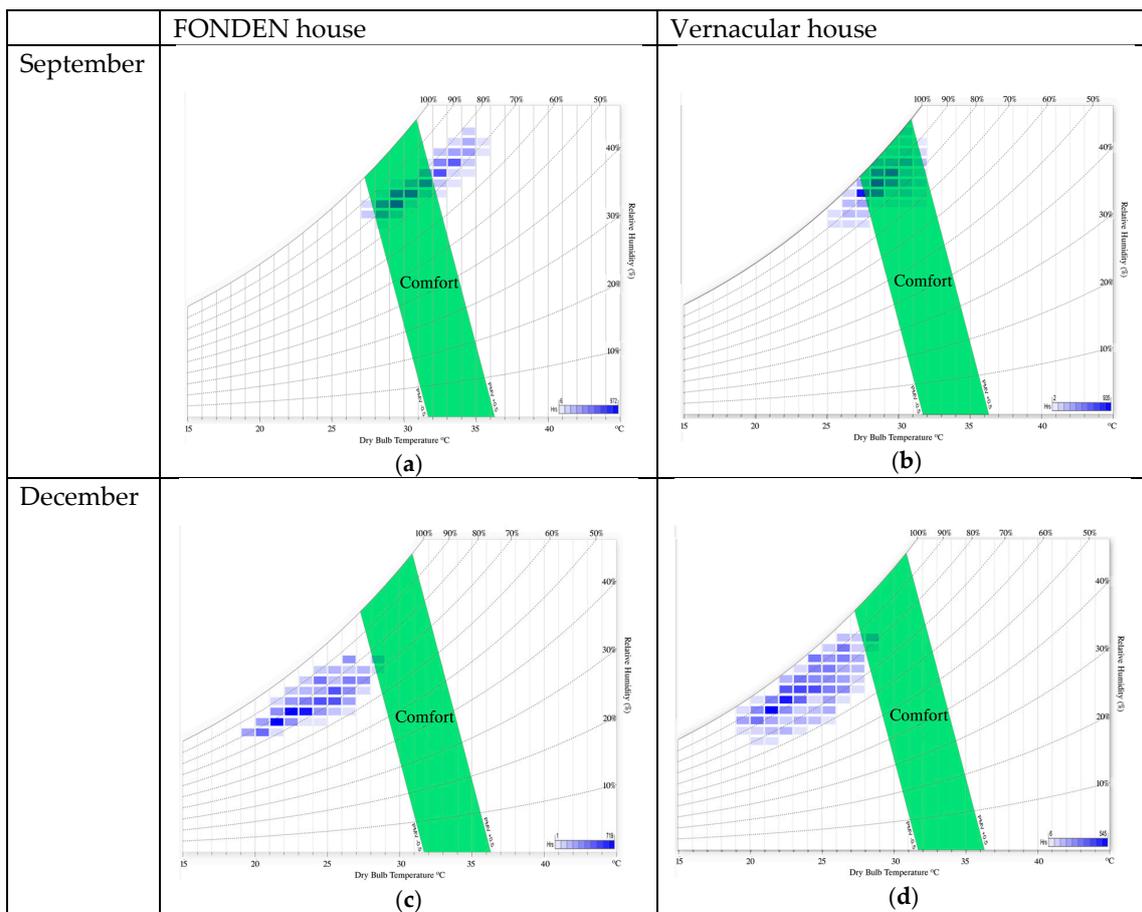
Figure 14. (a) Psychrometric chart of environmental conditions recorded in FONDEN house in September, (b) psychrometric chart of environmental conditions recorded in vernacular house in September, (c) psychrometric chart of environmental conditions recorded in FONDEN house in December, and (d) psychrometric chart of environmental conditions recorded in vernacular house in December. Assumptions: air velocity value <0.1 m/s and mean radiant temperature equal to air temperature (uniform conditions).

Considering this, most of the recorded conditions from Figure 14 remained out of the thermal comfort zone, above thermal comfort in September and below thermal comfort in December, both with high levels of humidity (above 80%). The humidity levels were higher in the vernacular houses on both occasions; a combination with lower dry bulb temperatures in September delivered more comfort than in the FONDEN house. However, conditions were less comfortable during winter, since dry bulb temperatures were lower than in the FONDEN house.

Despite the fact that the PMV model was conceived for mechanically conditioned spaces where the adaptation phenomena are limited [55,56], a further analysis based upon the well-known ASHRAE thermal comfort chart was carried out. The psychrometric charts (Figure 14) illustrate monitored data of dry bulb temperature and humidity data plotted against the thermal comfort threshold, shown in green. FONDEN and vernacular houses were comparatively analysed for the two periods monitored, which were September and December. The threshold considered for this analysis was chosen according to Table 1, assuming the typical clothing insulation for summer equivalent to 0.5 clo for people who are engaged in near-sedentary physical activity [46].
