An Engineering Case History of the Prevention and Remediation of Sinkholes Induced by Limestone Quarrying

Abstract: This paper introduces an engineering case history of the prevention and remediation of sinkholes induced by limestone quarrying in Longmen county, Huizhou city, China, through karst groundwater-air pressure monitoring, the design and construction of a grouting curtain, and grouting effect detection. Based on hydrogeological surveys, the location of the main karst development zones and faults can be accurately delineated by combining geophysical exploration with drilling, providing a basis for curtain setting. According to the interpretation results of geophysical exploration, the monitoring boreholes of groundwater-air pressure were set up, which provided support for mine construction, optimization of prevention and remediation of the sinkhole scheme, and reduction of sinkhole risk. In order to prevent the further expansion of sinkhole hazards, grouting curtain technology was used for engineering treatment of the water inflow points of the quarry. After construction of the grouting curtain was completed, comprehensive detection methods were used to evaluate the grout

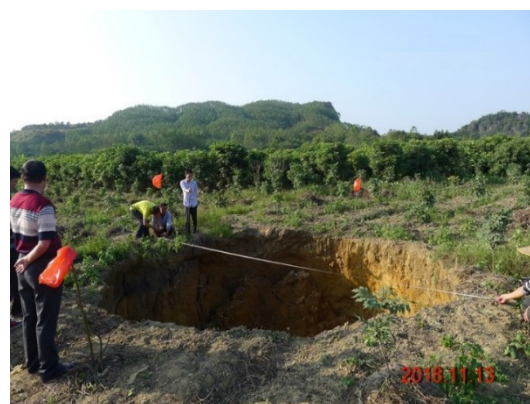
Figure 3. Sinkhole caused by mine water inflow.

In mid-October 2018, in the northeastern corner of the south pit of the quarry, the karst fissure zones accidentally broke through and water inflow occurred at a water inflow rate of about 3500 m³/day. Since 12 November 2018, 17 sinkholes have formed around the mining area, the largest of which is 8 m in diameter and 6 m in depth. Furthermore, many water wells in the nearby village have dried up, and 107 houses have fractured due to mine water inflow (Figure 3). In March 2019, we conducted an emergency investigation, and the results showed that the northeastern corner of the south pit was in the intersection area of faults F1 and F6, and this area was characterized by relatively broken rocks and strong karst development.

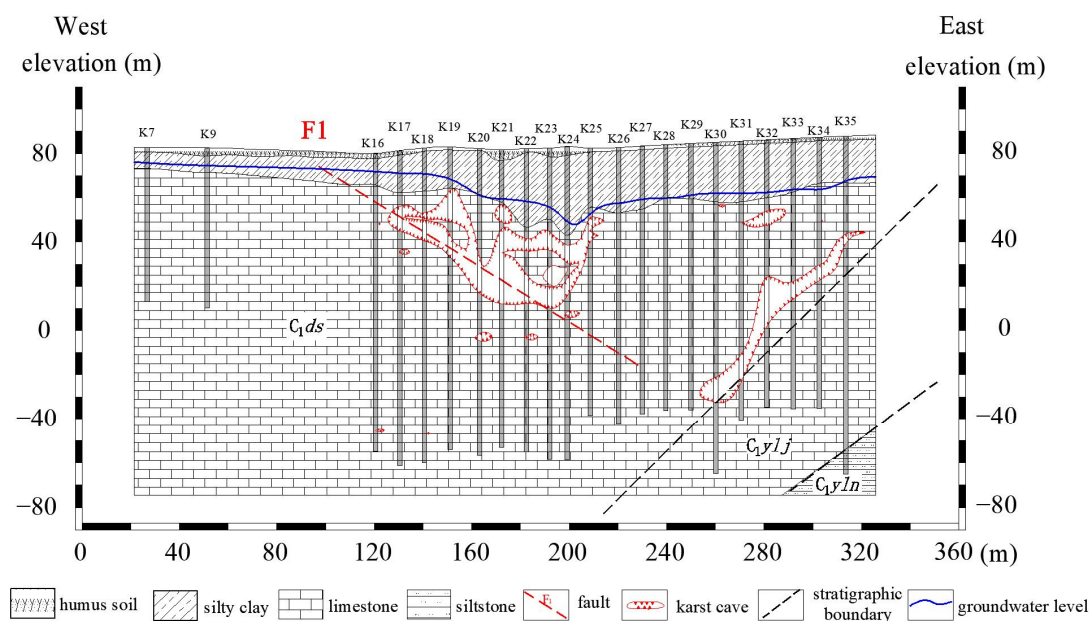
Figure 7. Profile of grouting curtain.

The karst caves were exposed in grouting boreholes K22, K23, and K24 at roughly the same elevation, and they consisted of filled or semi-filled caves. Water leakage occurred during drilling, and the adjacent boreholes channeled each other during grouting, indicating that the karst caves exposed along the curtain axis were interconnected and were the main runoff zones for groundwater. Additionally, during drilling, two major void zones were discovered. The formations of the west void zones were closely related to the fault position, and the east void zones were developed at the stratigraphic boundary (Figure 7).

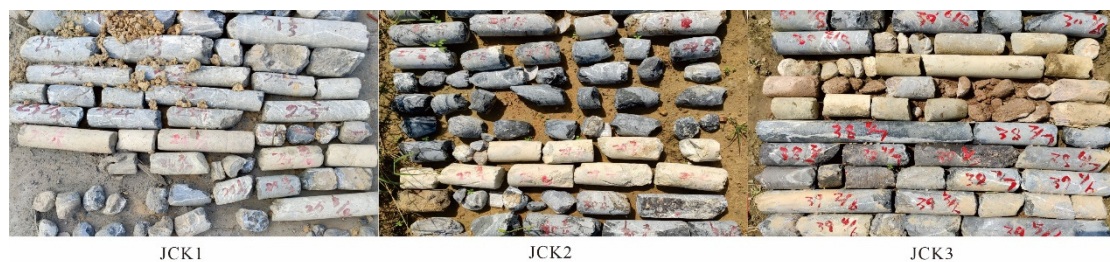
Figure 11. Photos of the cores from the verification boreholes.

Verification boreholes are the most direct method of checking the cross-linking state between the grouting boreholes, specifically to check for the presence of permeable cracks and caves, as well as to assess their filling conditions and distribution in the grouting areas. Based on analysis of the sinkhole locations, karst development distribution, grouting amount, and apparent resistivity section maps, verification boreholes JCK1, JCK2, and JCK3 were drilled between grouting boreholes K20 and K21, K23 and K24, and K30 and K31, respectively. According to the photos of the cores from the verification boreholes, cement slurry stones were found in the fracture zones and karst caves at different depths in the boreholes, and a thin layer of cement was found on many fracture surfaces, indicating that the grout filled the void zones effectively (Figure 11).

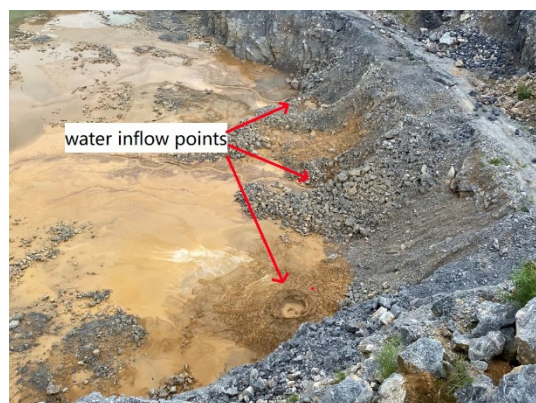
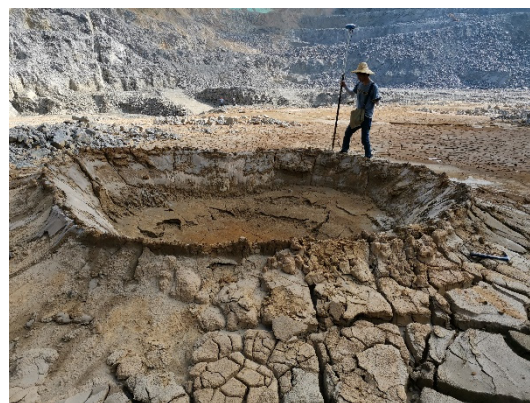
Figure 13. Photos of water inflow points in different periods. (a) Photo of water inflow points exposed after pumping in mining pit. (b) Photo of main water inflow point after grouting.

After completion of the curtain, the water channel connected to the main water inflow point was filled with grout, and the soil contained cement slurry (Figure 13). At the remaining two water inflow points, water still flowed out of the fracture flow channels, but the water inflow was reduced from 3500 to 500 m³/day.
