# Structural Stability Evaluation of Existing Buildings by Reverse Engineering with 3D Laser Scanner

Arum Jang , Young K. Ju and Min Jae Park \*

**Citation:** Jang, A.; Ju, Y.K.; Park, M.J. Structural Stability Evaluation of Existing Buildings by Reverse Engineering with 3D Laser Scanner. *Remote Sens.* **2022**, *14*, 2325. <https://doi.org/10.3390/rs14102325>

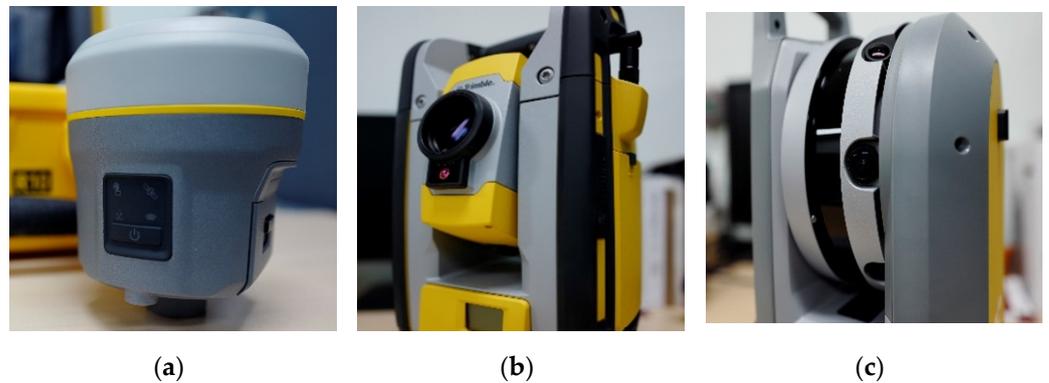
Figure 1. Equipment: (a) R10 (GNSS); (b) RTS-773 (total station); and (c) X7 (laser scanner).

An evaluation system using a 3D laser scanner is a safety inspection system that quickly and accurately diagnoses the structural information of a building. After acquiring a point cloud based on digital information using LIDAR technology, a precise safety diagnosis of buildings was performed based on the condition evaluation criteria. The goal of the evaluation system using 3D laser scanners is to achieve accuracy, time reduction, and economic feasibility compared with existing safety diagnoses. Trimble R10, RTS-773, and X7 were used in this research and are shown in Figure 1.

<b>Trimble R10 (GNSS)</b>	
Accuracy	3 mm
GPS Channel	672
Weight	1.12 kg
<b>Trimble RTS-773 (Total Station)</b>	
Accuracy	2 mm @ 50 m
Range	500~700 m
Resolution	2048 × 1536
<b>Trimble X7 (3D Laser Scanner)</b>	
Scanning Speed	500,000 points/s
Range	0.6~80 m
Range Accuracy	2 mm
Imaging Sensors	3 coaxial, 10MP camera
Automatic Level accuracy	0.3 mm @ 20 m
Weight	5.8 kg
Size	178 × 353 × 170 (mm)
Export Formats	RCP, E57, LAS, PTX, RWP, TDX, TZF

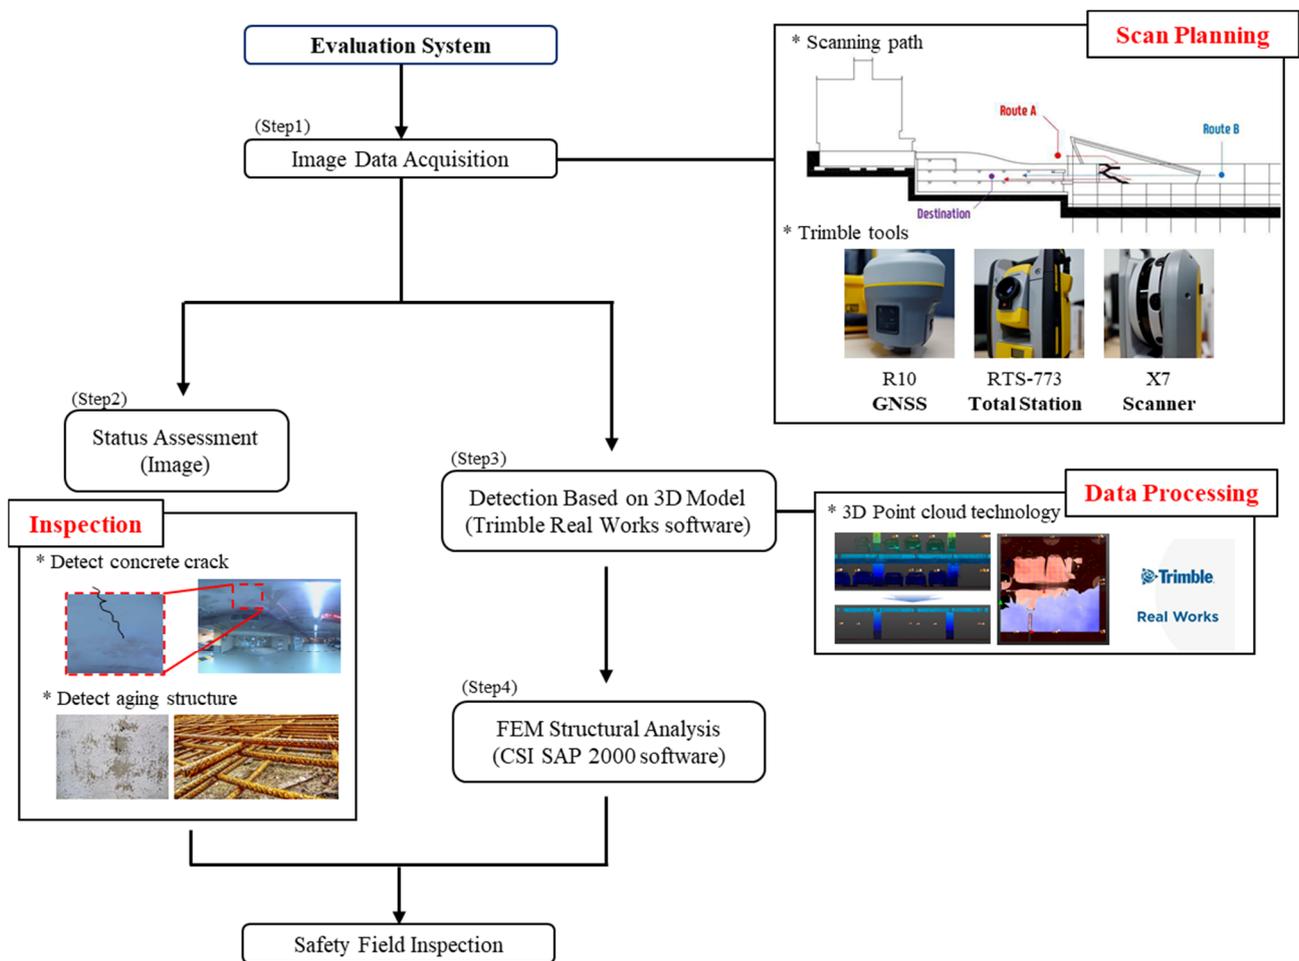
Figure 2. The process of structural evaluation system using 3D laser scanner.

Figure 2 shows the entire process of the evaluation system using a 3D laser scanner. The first step was to acquire structural data. The data acquisition process was divided into targeting and scanning steps. The reference coordinate point is measured using the GNSS equipment and the coordinate point data measured by the total station are entered. Subsequently, the targeting step was completed by measuring the coordinate point of the starting point of the scanning step using the total station. This step can enter the location information (GPS) of the scanned data. This process can increase the objectivity and accuracy of the scan data. Scanning starts at the time of targeting and is performed

The second step is status assessment. Structure status inspection is conducted using the acquired image. The data are high-definition panorama images that can locate cracks and deteriorated structures through images in the office.

The third step involves 3D modeling using a dedicated program based on point cloud data (PCD). In this study, the PCD editing program, Trimble Real Works, was used. The Real Works program removes noise from the acquired data and sets the necessary parts.

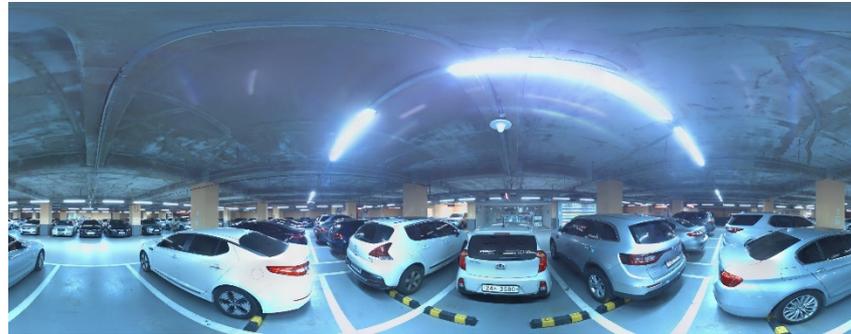
**Figure 3.** Acquired image data from scanning.

After the scanning was completed, the data were processed. The data acquired two types of results: image data (Figure 3) and digital PCD data due to initial processing, such as noise removal and section setup in the acquired PCD.

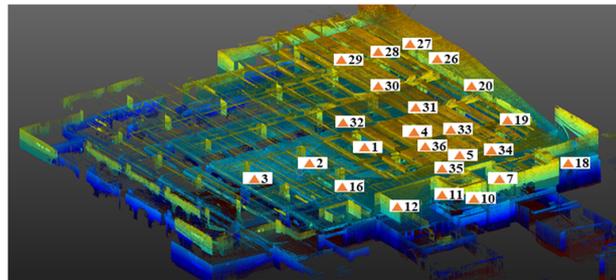
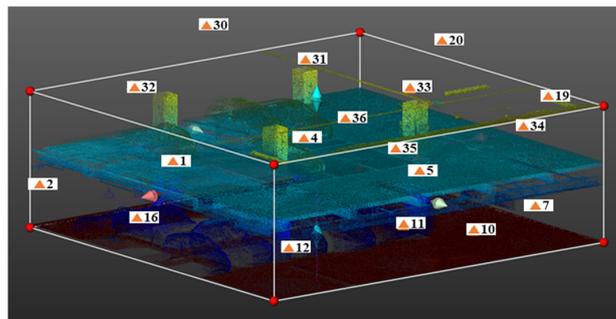
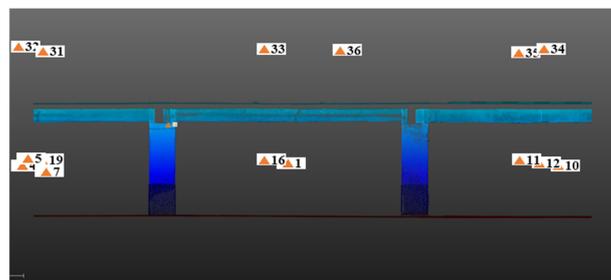
**Figure 4.** Point cloud data (PCD) by steps: (a) Raw data from scan; (b) Initial processed data (Auto-Classify); and (c) Post-processed data for structural evaluation.

Post-processing is the task of classifying data according to their purpose. Post-processing automatically classifies and organizes data for each object using an automatic classification technique (Auto-Classify (Indoor)) among 'Real Works'. The technique automatically classifies the objects, such as structural members, men, vehicles, etc. Sometimes, it is not possible to classify structural members, such as a small object located in a corner, similar in color to other structural member. Under this condition, classification is performed manually. Subsequently, a structural evaluation is conducted, focusing on the data of the structure. Therefore, the data classified as non-structural members can be classified. In addition, the scanner location data are represented by a triangle within the program. Through this, the measurement location can be confirmed (Figure 4).

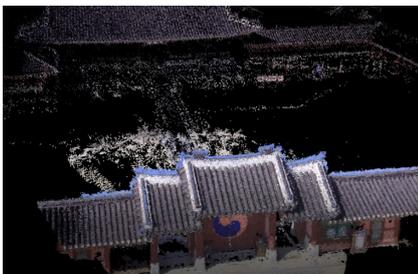
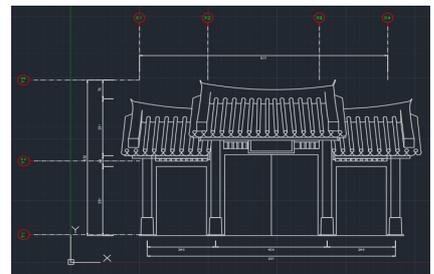
**Figure 5.** Reverse engineering data by steps: (a) Initial point cloud data (PCD); (b) 3D modeling data (BIM); and (c) Drawing from BIM data.

used to detect building tilt and vertical displacement measurements through comparative analysis with existing drawings (Figure 5). Inspecting aging buildings without drawings can be performed faster and more accurately than conventional methods using reverse engineering.

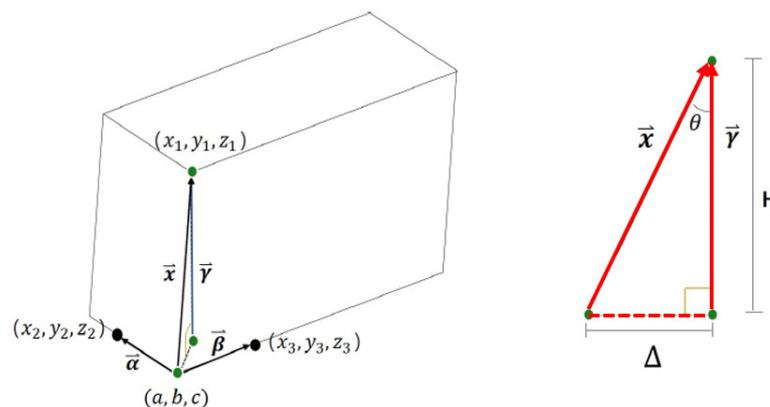
**Figure 6.** Tilt evaluation procedure adapted from Jeong.

The 3D point cloud model can measure deflection and deformation, such as tilting and vertical displacements. Point clouds were generated from the GPS data and represented in a 3D coordinate space with the transformed GPS data. With the locations developed, it was possible to measure the deflection of the slab and column deformation. The edges were calculated as vectors, and slopes were measured as the angles between the sides and floor. Vertical and horizontal displacements of the edge of the building were estimated through comparisons with 3D coordinate location data of each floor points. The 3D model, generated using the laser scanner, uses GPS to calculate the position coordinate of each point of the point cloud, which can be used for measuring the selection and deformation. It is possible to calculate the height and lateral displacement and check the value of the election and deformation given in Equation (1) (Figure 6) [37–39].

$$\tan \theta = \frac{\Delta}{H} = \frac{\sqrt{1 - \cos^2 \theta}}{\cos \theta} \quad (1)$$

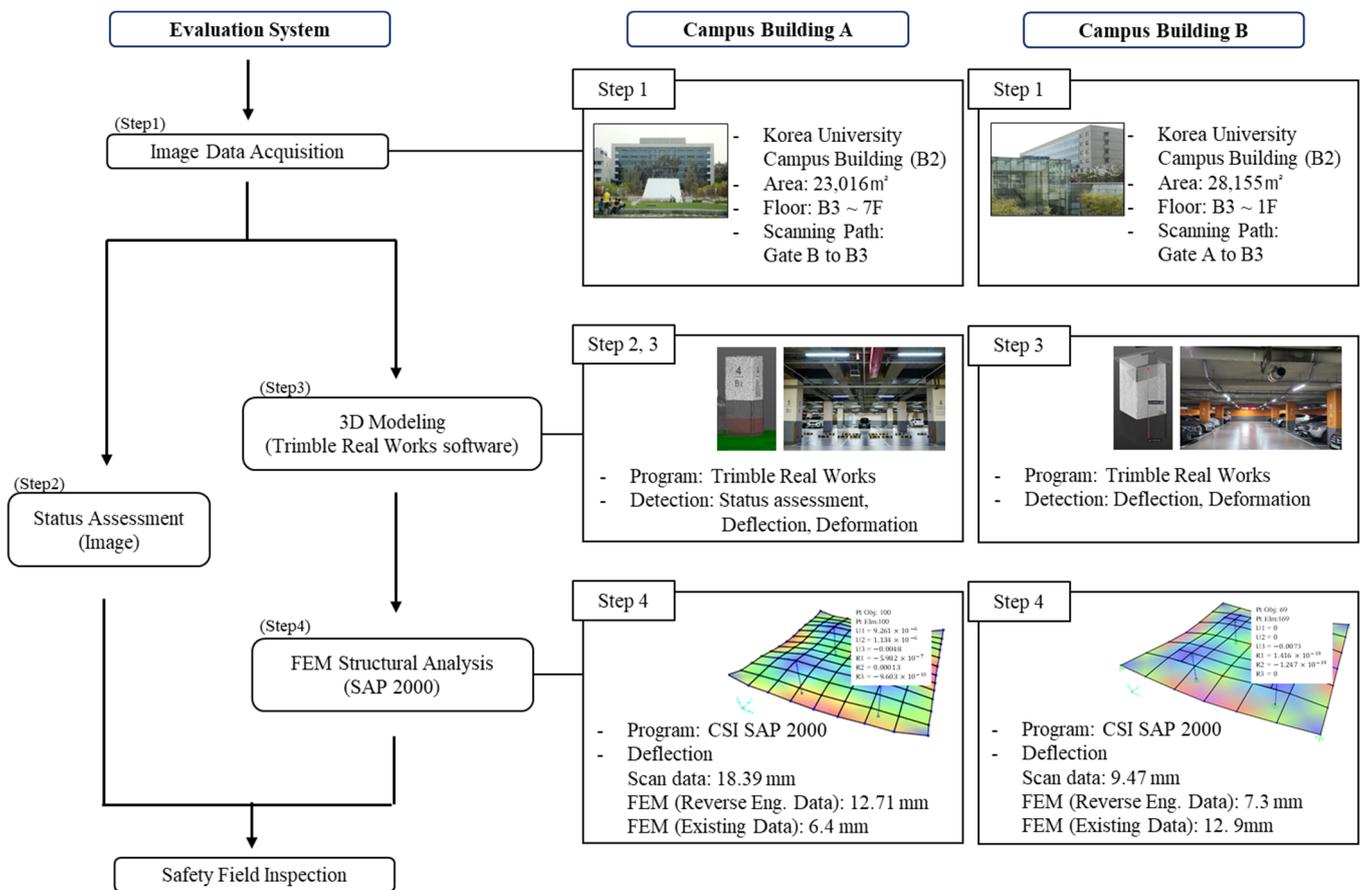
Figure 7. Summary of the evaluation system using 3D laser scanner applications (Campus Building A and B in Seoul).

Two pilot projects were conducted to test the applicability of the developed method to practical situations (Figure 7). The two cases discussed below used all technologies of the evaluation structure using a 3D laser scanner.

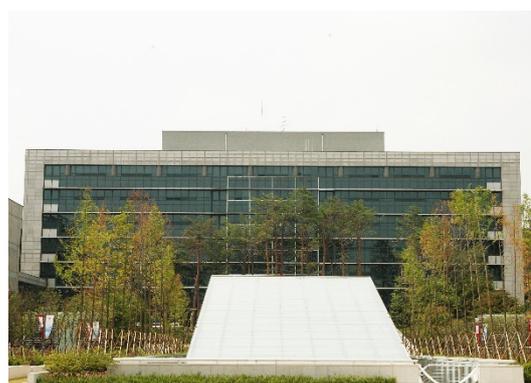
Figure 8. Campus building A (R&D Center).

The entire procedure was applied to a campus building in Seoul, South Korea (Figure 8). Trimble X7 was used for inspection. The construction of the building was completed in 1996. The building was not sufficiently old to develop defects. However, because it is located on campus and has an underground parking space with exposed structural frames, this building was appropriate for applying the proposed method. Additionally, there were already existing drawings for this building with which the results of the proposed process could be compared.

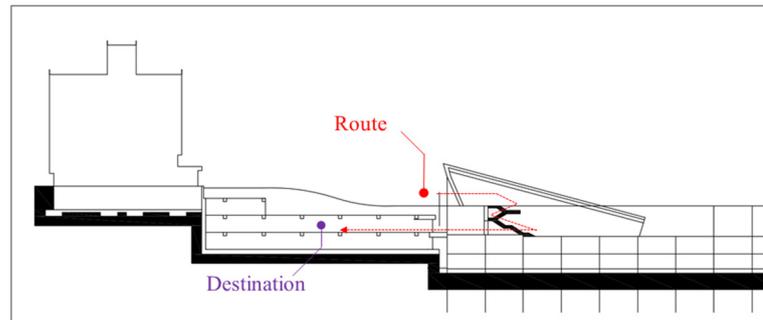
**Figure 9.** Scanning path of Case 1 (Campus building A).

started from Gate B, which could recognize two location points prepared in the previous stage, targeting (Figure 9). It continued from the ground to the basement, and the shape information of the underground parking space was obtained using a 3D laser scanner. Scanning was conducted by focusing on the slabs and columns. Therefore, the second and third basement floors were scanned. This project progressed for two and half hours over 27 times. The scanner measured 77,581,248 points, and the target section points were 70,112,787 points; the remaining points after classifying only structural members were 30,658,694 points.

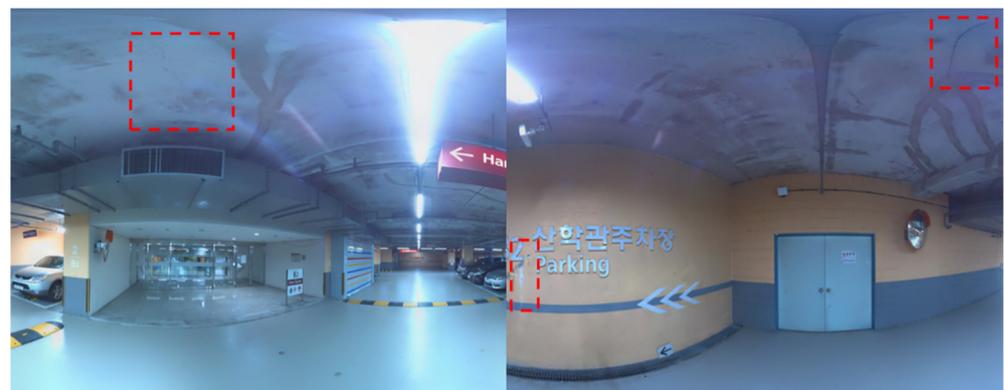
**Figure 10.** Acquired image from scanning for visual inspection.

The presence of cracks was determined based on the image captured through the laser scanner for the section where the safety inspection was performed. There were no cracks in the columns, slabs, or walls of the target section, but some microcracks were confirmed, as shown in Figure 10. Only some parts were outside of the inspection section. According to the concrete structure design standard (KDS 14 20 30), cracks do not exist in the target section; thus, they can be classified as grade A. If cracks are identified, the crack length and width can be specified through a program to evaluate the grade.

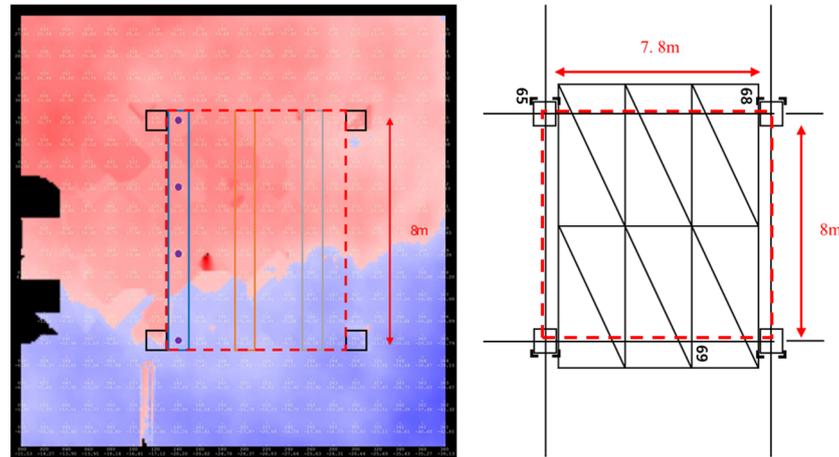
**Figure 11.** Relative deflection of slab floor from 'Floor Inspection' function of program (Post-processing step of target part).

The section of the slab floor was obtained from the PCD through the post-processing step; the 'Floor Inspection' function of the program was used. Based on the average value of the height, a position higher than the standard was marked in red. The lower part is marked in blue to indicate the relative deflection value, which confirms that the height of the position is relatively low (Figure 11).

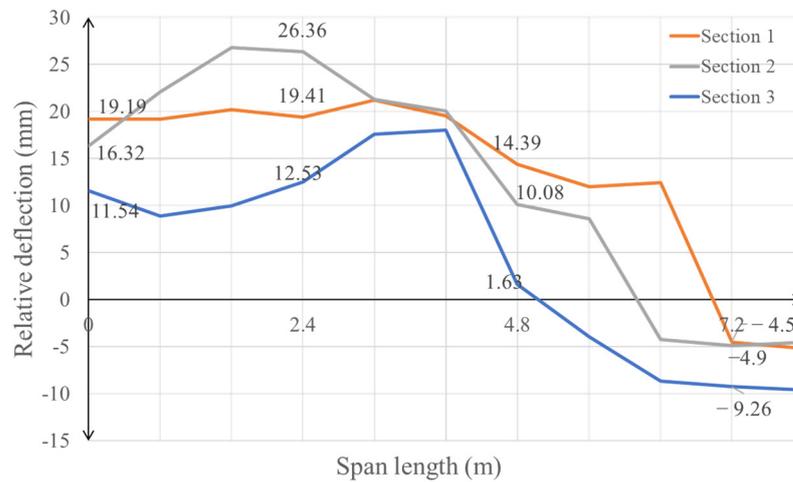
**Figure 12.** Relative deflection graph of the three sections.

The deflection value was obtained for the deflection and deformation by checking three beam and slab sections according to the span length (L). The span length was 8 m and the distance between the columns was defined as the difference between the maximum and minimum relative deflections of the three sections (Figure 12).

Table 2 lists the deflection values for each section. According to the concrete structure design standard (Table 3), the results were estimated as grade C to use the maximum value of 30.91 mm [34].

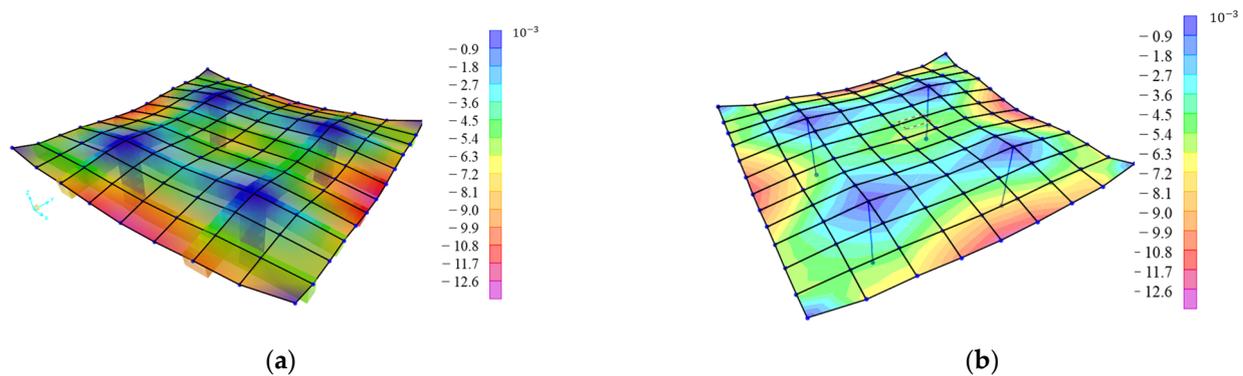
**Figure 13.** Structural analysis results: (a) Based on existing drawings; (b) Based on reverse engineering drawing.

The results of analysis are shown in Figure 13. As a result of analysis based on the existing drawings, the deformation value was the largest at 6.4 mm owing to the vehicle

load (concentrated load) at the center. The slab was 20 mm thinner than the existing drawings by checking the drawings through reverse engineering. The data should compare the data with the measurements of the same objects using a total station to have a more consistent accuracy. However, considering the stage of comparative analysis in the FEM analysis between the existing drawings and the scan data, only the existing drawings and the measured data were compared for accuracy check. In conclusion, it showed an error of 10%. The comparative analysis used the actual building measurements, not the drawings. Consequently, the error value included errors in construction and measurement. From reanalysis based on the drawings from reverse engineering, the deformation value was 5.9 mm. Through scanning, the deformation value of the B2 floor slab was 12.71 mm.

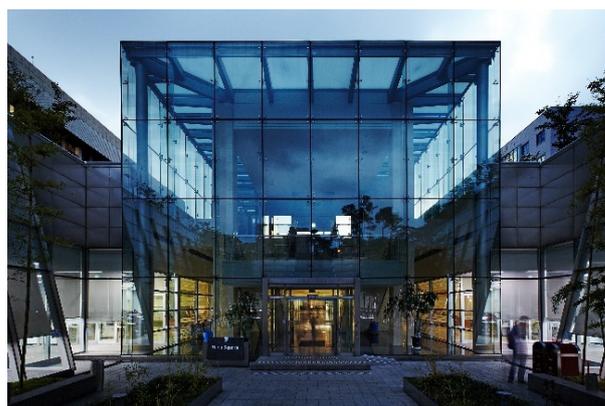
**Figure 14.** Campus Building B (Hana Square).

The entire procedure was applied to a campus building in Seoul, South Korea (Figure 14). Trimble X7 was used for inspection. The construction of the building was completed in 2003. This building is located on campus and has an underground parking space with exposed structural frames. This building is appropriate for applying the proposed method.

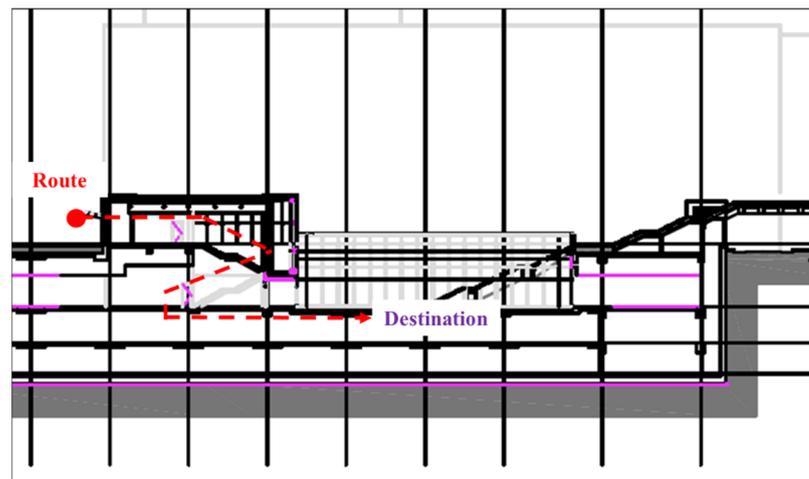
**Figure 15.** Scanning path of Case 2 (Campus building B).

The experiment was conducted on weekends as in Case 1. The scanning started from Gate A, which could recognize two location points prepared in the previous stage, targeting (Figure 15). It continued from the ground to the basement, and the shape information of the underground parking space was obtained using a 3D laser scanner. The scanning was conducted by focusing on the slabs and columns.

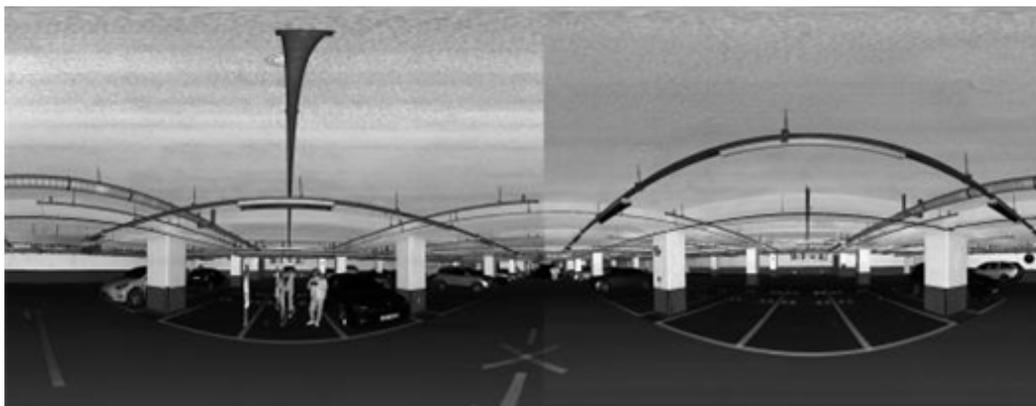
**Figure 16.** Acquired image from scanning.

The surveyed PCD processed post-processing information such as registration and noise removal (Figure 16). The scanner measured 282,100,808 points, and the target section points were 66,075,281 points; the remaining points after classifying only structural members were 45,973,224 points.

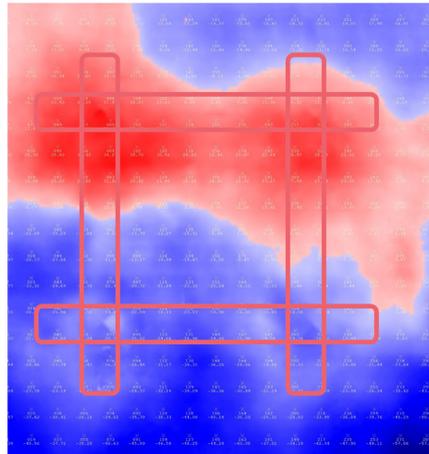
**Figure 17.** Relative deflection of slab from 'Floor Inspection' function of the 'Real Works' program (Post-processing step).

The deflection degree of the slab that received the most load continuously was measured, and the structural estimation for deflection was performed accordingly. The section of the slab floor is obtained from the PCD through the post-processing step; the 'Floor Inspection' function of the 'Real Works' program was used. Based on the average value of the height, a position higher than the standard was marked in red. The lower part is marked in blue to indicate the relative deflection value, confirming that the height of the position is relatively low (Figure 17).

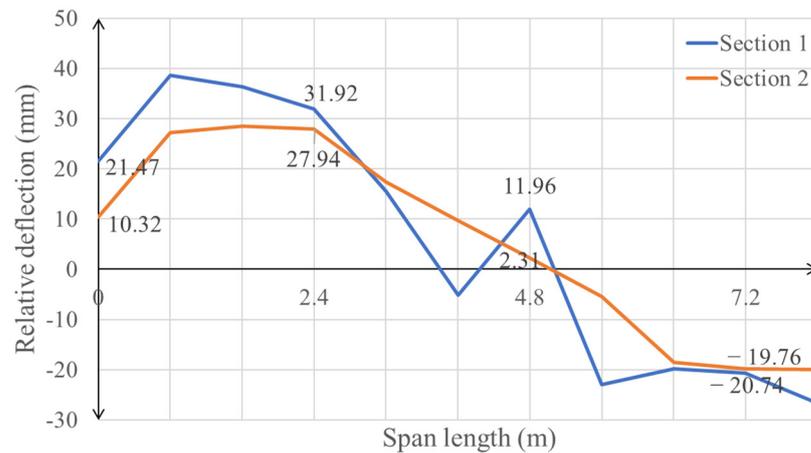
**Figure 18.** Relative deflection graph of the two sections.

The deflection value was obtained by evaluating two sections according to the span length ( $L$ ). The span length was 8 m, the distance between the columns was defined as the difference between the maximum and minimum relative deflections of the two sections (Figure 18).

Table 6 lists the deflection values for each section. According to the concrete structure design standard, the results were estimated as E grade using the maximum value of 65.38 mm.

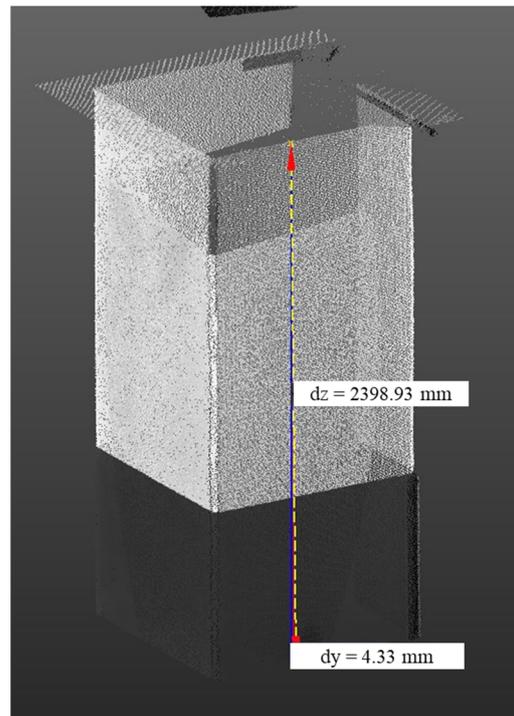
**Figure 19.** Point cloud data of column for deformation evaluation (the largest value of deformation).

Safety diagnosis was performed on a section of the underground parking space. Therefore, a deformation evaluation was conducted on the columns instead of on the walls. The location of the points was confirmed for the four columns in the target section. In the case of the deformation (slope), the evaluation was performed using the values of the horizontal displacement (dy) and vertical displacement (dz) of the column wall. Among the four columns, when  $dy = 4.33$  mm and  $dz = 2398.93$  mm, the value of  $dy/dz$  was the largest (Figure 19). This is much smaller than 1/500 of the KDS and is estimated as grade B.

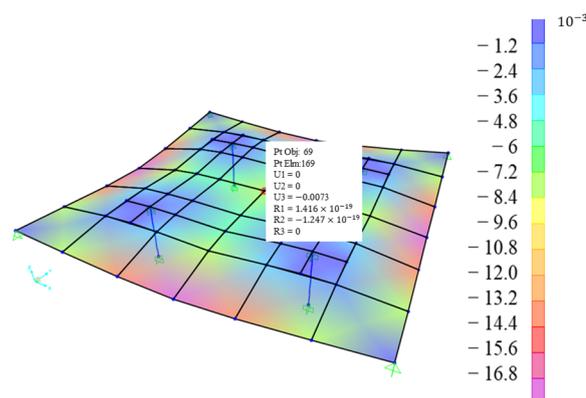
**Figure 20.** Structural analysis results (based on reverse engineering drawing).

The results of analysis are shown in Figure 20. As a result of analysis based on the existing drawings, the deformation value was the largest at 12.9 mm owing to the vehicle load (concentrated load) at the center. By checking the drawings through reverse engineering, the thickness of the slab was found to be 10 mm thicker than the existing drawings. In conclusion, it showed an error of 4%, which might include errors in construction. From the reanalysis based on the drawings from reverse engineering, the deformation value was 7.28 mm. Through scanning, the deformation value of the B2 floor slab was 9.47 mm.
