War Related Building Damage Assessment in Kyiv, Ukraine, Using Sentinel-1 Radar and Sentinel-2 Optical Images

Citation: Aimaiti, Y.; Sanon, C.; Koch, M.; Baise, L.G.; Moaveni, B. War Related Building Damage Assessment in Kyiv, Ukraine, Using Sentinel-1 Radar and Sentinel-2 Optical Images. *Remote Sens.* **2022**, *14*, 6239. <https://doi.org/10.3390/rs14246239>

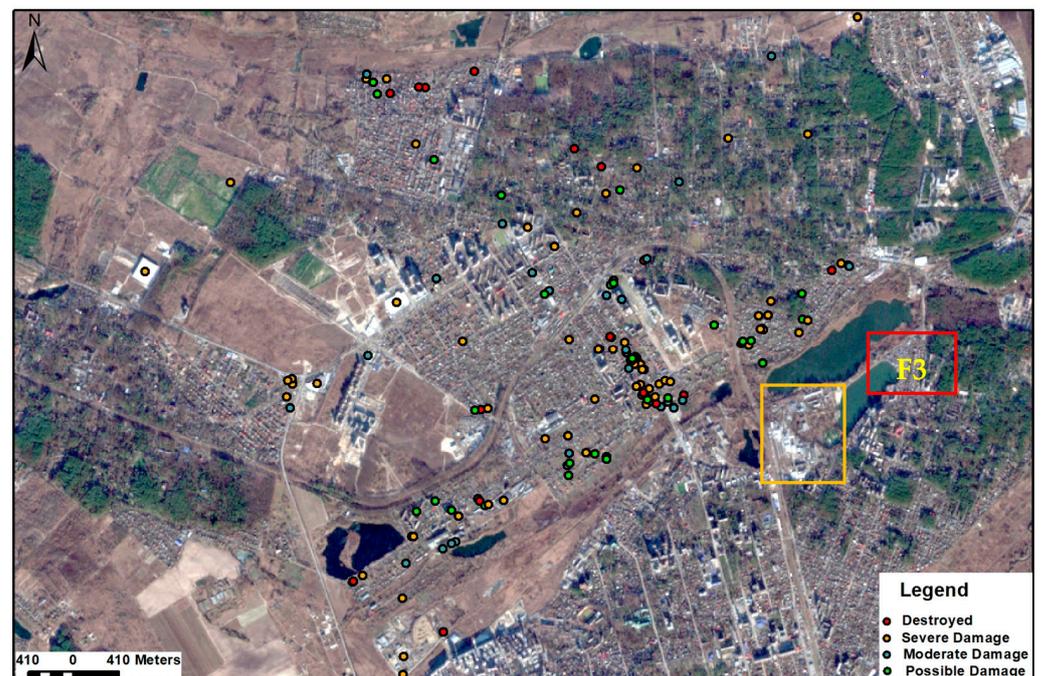
Figure 2. UNOSAT damage assessment map of Bucha city. The background image is from Sentinel-2 acquired on 2 January 2022. The red rectangular box denotes the area shown in Figure 3, and the orange rectangular box shows the AOI for threshold selection.

The rapid building damage assessment published by UNOSAT for the city of Bucha was used to validate the methodology presented herein. Figure 2 shows the UNOSAT survey area (dots); and the AOI (orange box) denoting the area used for optimal threshold selection (Section 3.2 for SAR and Section 3.3 for optical). UNOSAT generated a point-based inventory of damaged buildings based on a visual survey of WV-3 and WV-2 satellite imagery acquired between 20 February 2022, and 31 March 2022. The data is published through an open-source geodatabase and is, at the time of publication, the only accepted data source of damages across Ukraine. Each point is geolocated to match a building and is labeled with one of four damage attributes: "destroyed", "severe damage", "moderate damage", and "possible damage". Their findings are preliminary and have not yet been field verified [32].

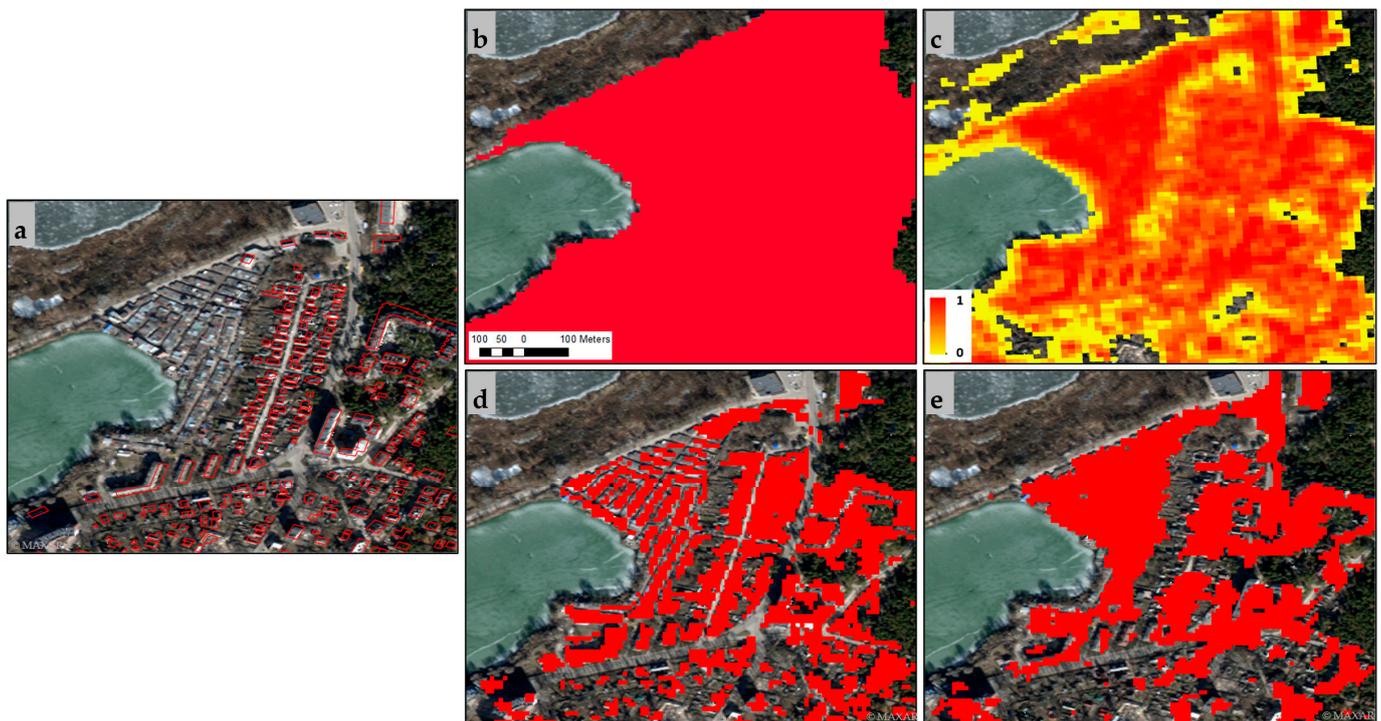
Figure 3. The comparison of (a) OSM building footprint with the (b) ESRI land use/land cover, (c) GHSL, (d) WSF, and (e) ESA WorldCover map. The location of the area is shown in Figure 2.

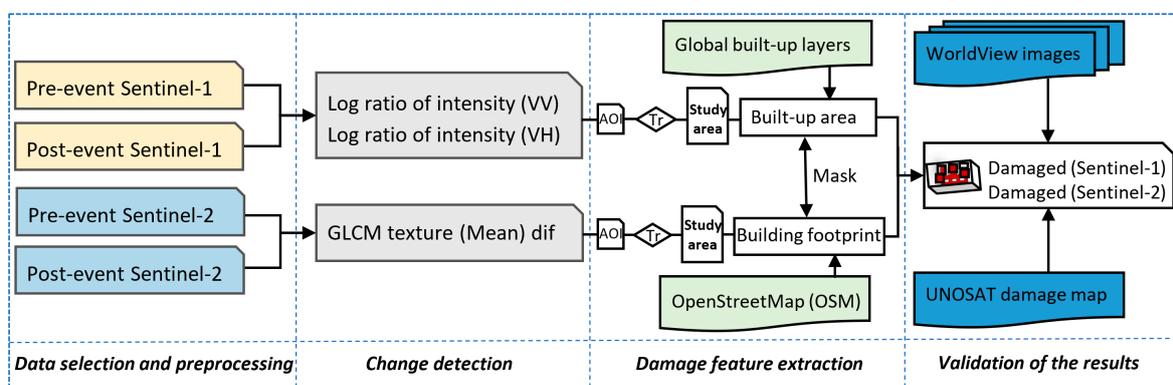
Figure 4. The processing workflow for building damage mapping using Sentinel-1 and Sentinel-2 images. Note: dif, AOI, and Tr refer to the difference, selected area for threshold determination, and threshold.

In this work, the damaged buildings were mapped using Sentinel-1 and Sentinel-2 data. The workflow is divided into four phases (Figure 4). In the data selection and pre-processing steps, after screening all available images, suitable pre-and post- event image pairs are selected, and pre-processing steps are performed. In the change detection phase, we conducted change detection analysis using two well-known methods, the log ratio of intensity [42,43] and the Gray Level Co-occurrence Matrix (GLCM) [44–47] on the pre-processed Sentinel-1 and Sentinel-2 images, respectively. Then, an Area of Interest (AOI) was selected, and the optimal threshold was determined based on the obtained highest F1 score value. The changed and unchanged areas are separated by applying the selected threshold to the whole study area and a mask of the built-up area using the OSM and Global built-up layers, respectively. In the last step, the results are validated using the high-resolution WorldView images and the UNOSAT damage assessment map.

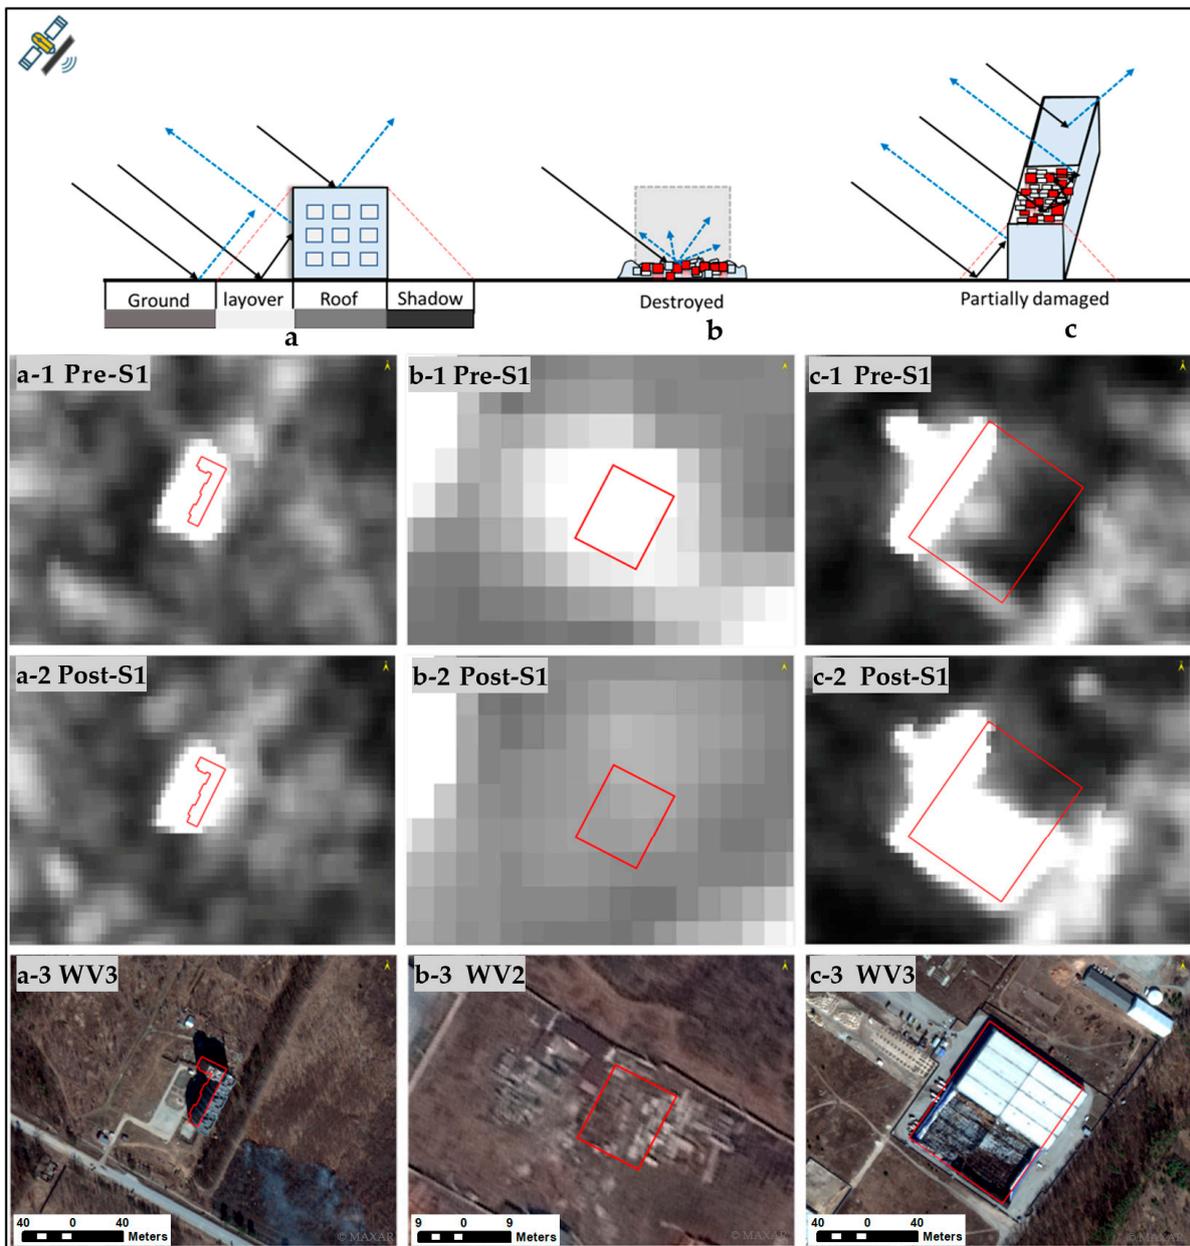
Figure 5. Schematic diagram of backscatter intensity from (a) intact buildings (b) destroyed buildings, and (c) partially damaged buildings in synthetic aperture radar (SAR) images; (a-1,a-2,b-1,b-2,c-1,c-2) are pre- and post-event Sentinel-1 images (19 February 2022 & 8 April 2022); (a-3,b-3,c-3) are corresponding WorldView images (25 & 31 March 2022).

As shown in Figure 5, a collapsed building has a different backscatter structure than an intact building. The strong backscattering from the building usually disappears or decreases when a building collapses due to a disaster. In the case of the partially damaged building (Figure 5c), where parts of the wall together with the roof collapsed, the remaining walls, debris, and ground may have formed a corner reflector and hence triggered a strong double-bounce effects and an overall increased backscattering intensity (Figure 5(c-2)) [53,54]. Therefore, the damaged and nondamaged buildings can be identified by using the SAR backscattering intensity change detection. In this study, the simple but robust SAR log ratio of intensity was implemented for this purpose.

where I_N is the pre-event SAR intensity and I_{N+1} is the post-event SAR intensity image. The damage detection using the log ratio value is based on the hypothesis that the disaster event, such as an earthquake/explosion, changes the backscattering characteristics of the target area. Depending on the backscattering property of the object and its changes before and after the disaster (e.g., earthquake, tsunamis, and anthropogenic causes such as war), the log ratio can be either positive or negative [42,43]. An increase on backscatter may occur (negative log ratio value) on a low story damaged building (Figure 5(c-2)), while a reduced

backscatter (positive log ratio value) may occur on a High-rise building, where the damage is concentrated to their sidewalls and lower stories or collapsed [50]. The phenomenon is also evident in congested building areas [15]. The log ratio can either be calculated with the band math or the change detection tool in SNAP 8.0 software.

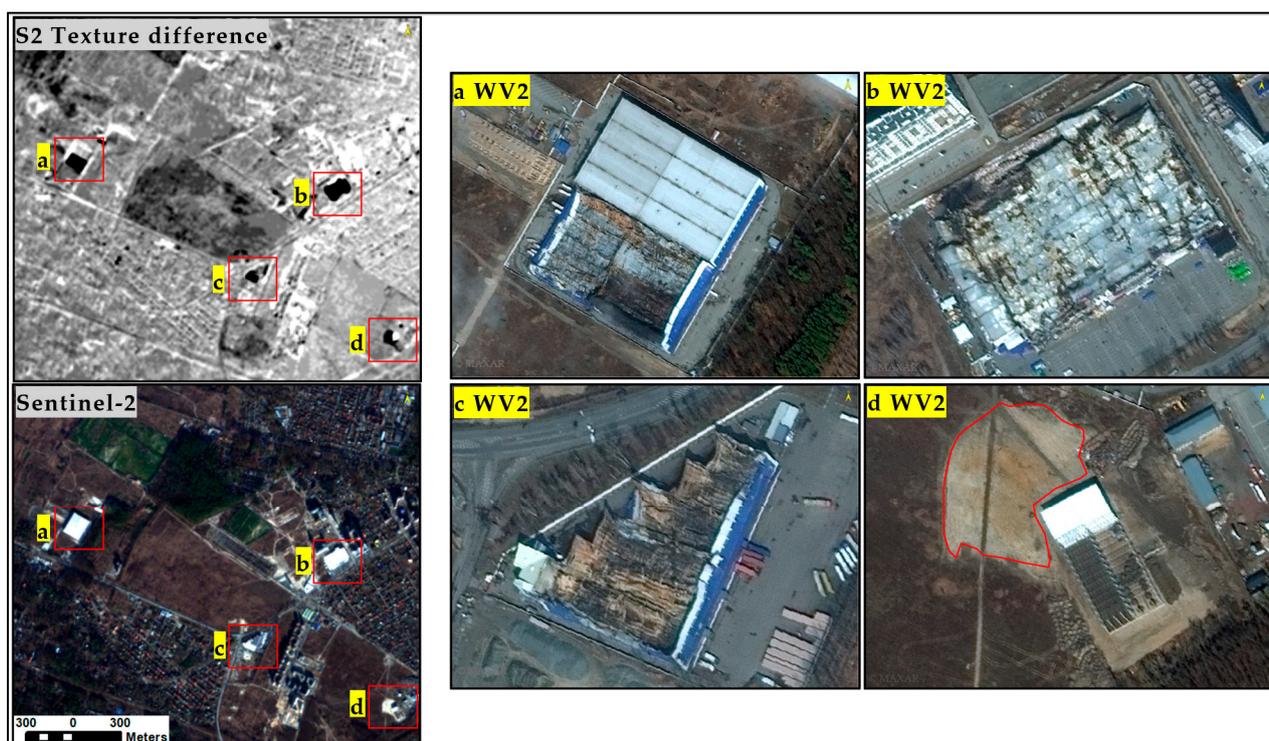
Figure 6. The GLCM texture difference and the corresponding optical images. (a–d) are selected examples that have significant texture changes, and those locations are shown on the WorldView-2 image.

statistics with a window size of 3×3 using the co-occurrence measuring tool available in ENVI software (release 5.6.1). First, the average of the pre-event images taken on 28 March 2021, and 2 January 2022, was calculated to create a singular pre-event texture image. Then, the texture difference between the newly generated pre-event and the post-event texture was computed. The identical procedure used for the SAR intensity was performed to select the optimal threshold value for the texture difference analysis. The selected threshold value was 0.4; each pixel in the texture change raster was classified as damaged if the pixel value was smaller than the threshold value. Figure 6 shows the texture difference and the corresponding post-event optical images. The results showed that GLCM Mean has the potential of distinguishing damaged buildings from undamaged buildings (Figure 6). However, the brightness changes on other non-building objects on the optical images may also be misinterpreted as building change and may be misclassified as damaged (Figure 6d).

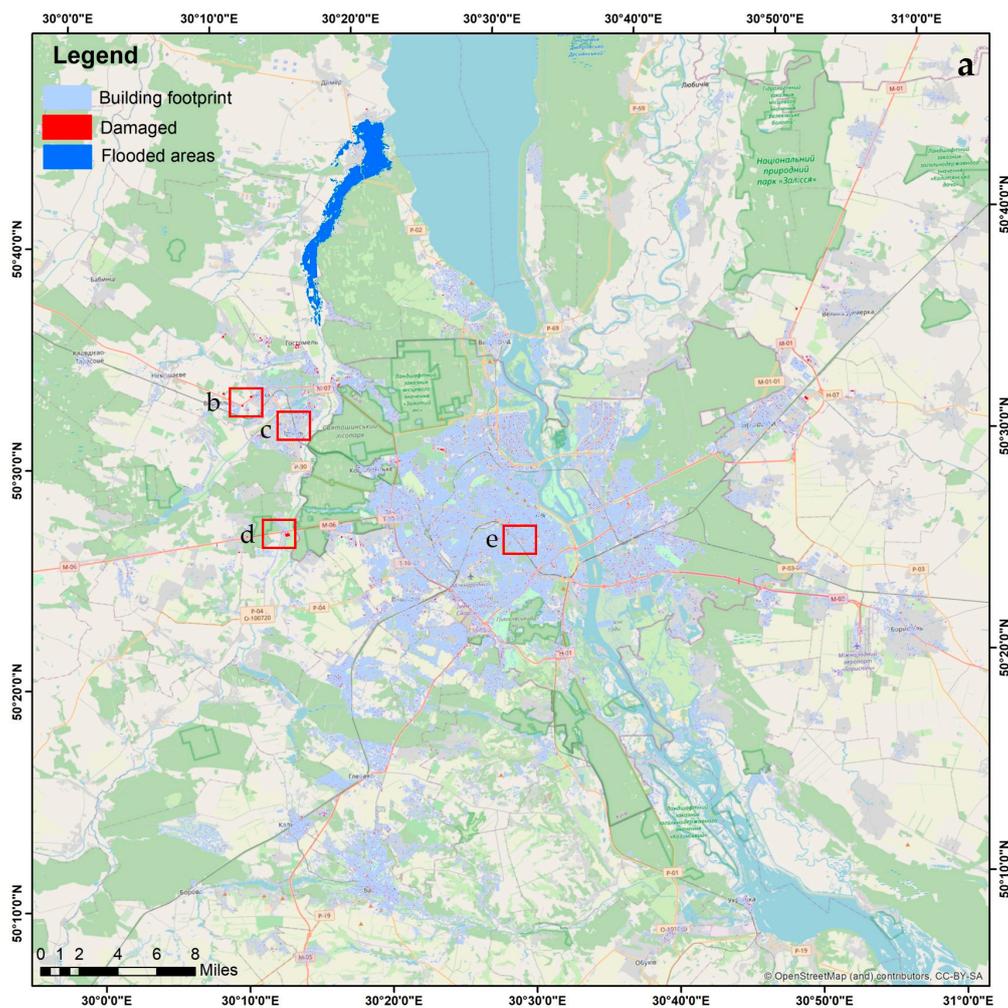
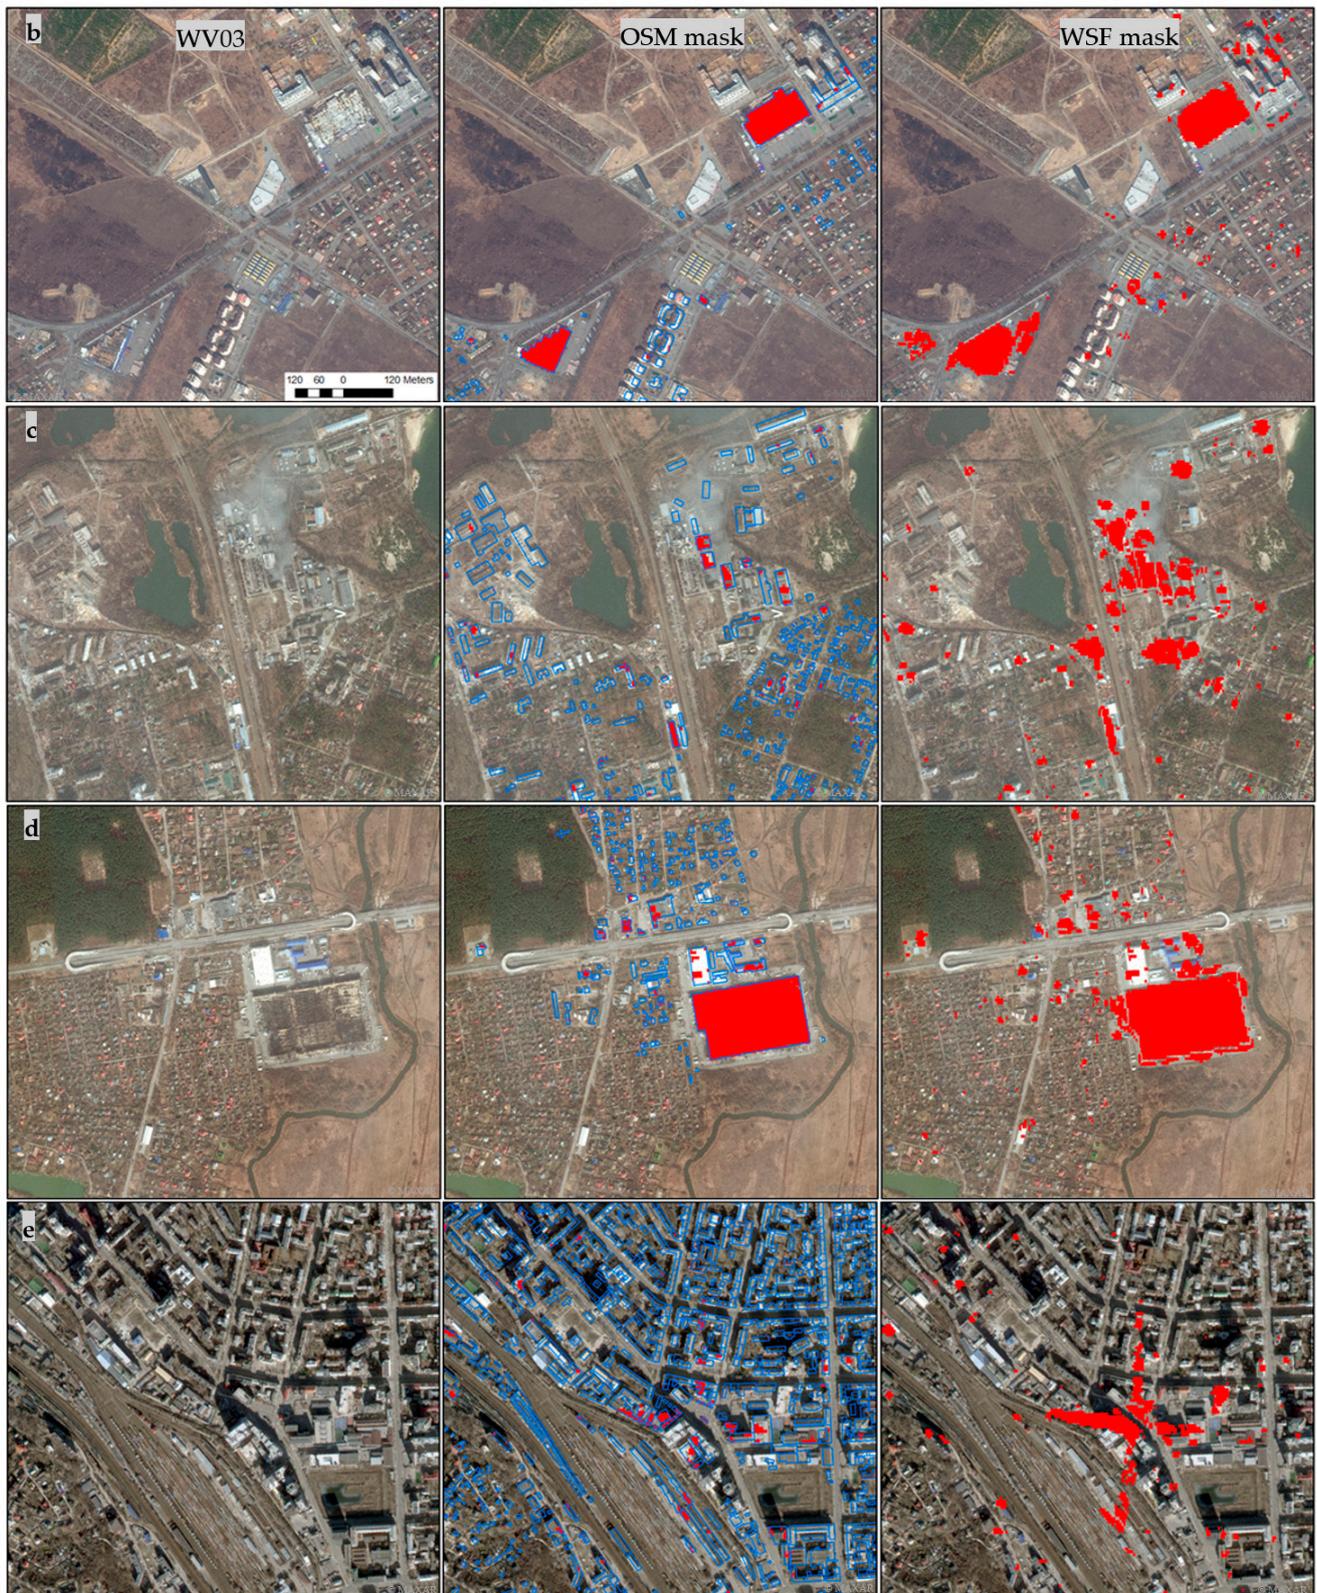
Figure 7. Cont.

Figure 7. Comparison of Sentinel-1 damaged building results using two different masks (OSM&WSF). (a) shows the SAR intensity-based results for the entire area. The locations (b–e) were selected as representative areas for comparison with the high-resolution WorldView image. The columns from left to right indicate the WorldView image (31 March 2022), OSM and WSF mask results of the damaged buildings. The scale shown in (b) is the same for (c–e).

The damage assessment result from the Sentinel-1 intensity analysis is shown in Figure 7 for the entire area. Prior to the use of built-up mask, the log ratio of intensity result shows an area of significant flooding along the Irpin River in the northwestern part of the study region (Figure 7a). Even though the flooding can be considered an indirect effect of the war because of the circumstances surrounding the flood [57] and it may have caused certain damages to the affected area, we omitted the analysis of the flooded region as we are primarily assessing building/infrastructure damages related to the direct effects of the war. We selected four representative locations that match the high-resolution WorldView images to perform a visual assessment. In each of the four areas, we compare the results using the OSM mask versus using the WSF built-up layer mask. The log ratio of intensity result shows good match with the reference WorldView images. Per our assessment, the damaged buildings are shown to be concentrated mainly in the northwestern part of Kyiv Oblast,

most notably in the regions of Irpin, Bucha and Hostomel, which confirms the deliberate plan by Russian intelligence to encircle and capture Kyiv, the capital city of Ukraine. Using the augmented OSM polygons, the damaged building statistics calculated with the ArcGIS Desktop software (version 10.8.1) showed the detected building areas ranged between 85 m² and 74,156 m². Most of the buildings detected by the SAR intensity analysis are medium to large-scale buildings (e.g., multi-story apartment towers, government facilities, supermarkets, warehouse, and crop storage facilities). The damaged residential buildings that are surrounded by vegetation or are of smaller scale, like one-story houses, were not well detected by SAR analysis regardless of the mask used. This may be related to the medium spatial resolution of Sentinel-1 and limited penetration ability of C-band SAR sensor and the disruption from the vegetation change. Yet, although per our analysis, the high-rise buildings (shown in Figure 7e) were detected as being damaged, our visual assessment of the regions using the WorldView imagery did not corroborate this finding. This may be the result of backscattering change of the high-rise buildings on the SAR images induced by differing incidence angle or the dielectric property of SAR image at the time of acquisition (February and April). Furthermore, compared to the OSM mask result, the WSF mask showed more false positives as it classifies large continuous areas as built-up whereas OSM provides single scale building polygons. On the other hand, the incomplete building footprint from the OSM data excluded certain medium to small scale damaged buildings that were retained by the WSF mask results (Figure 7b–d).

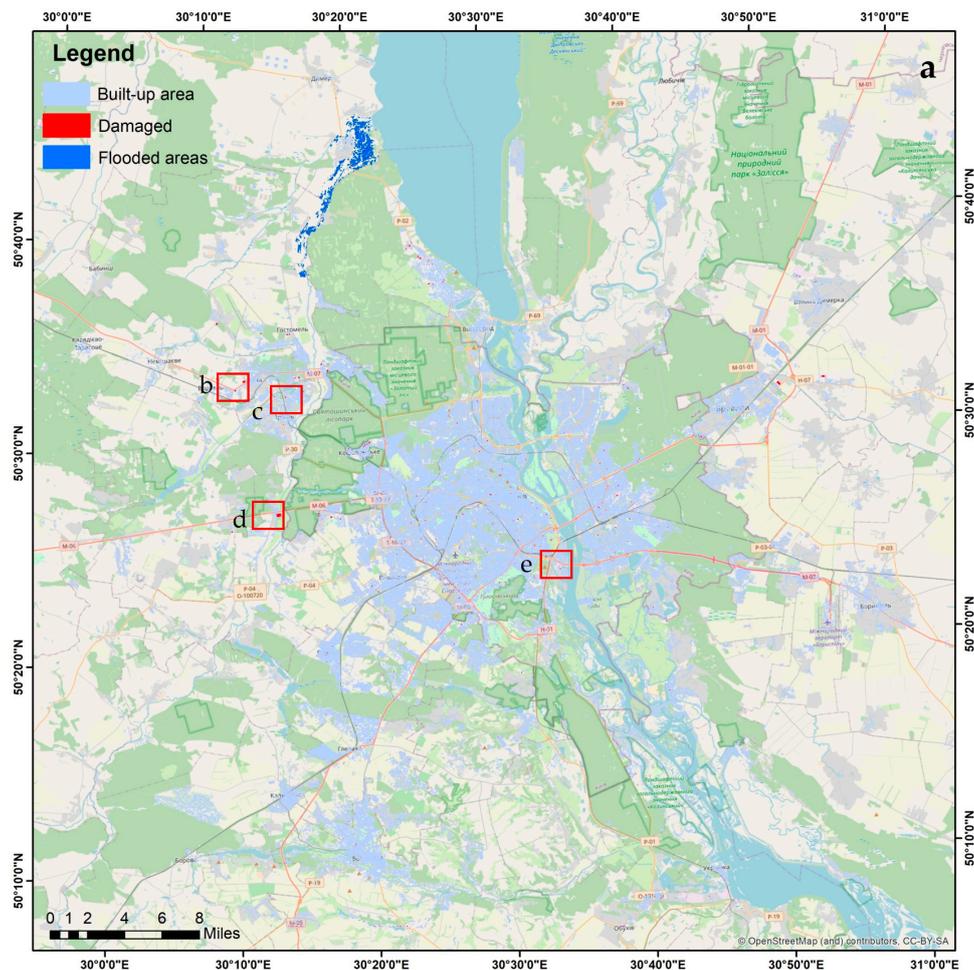
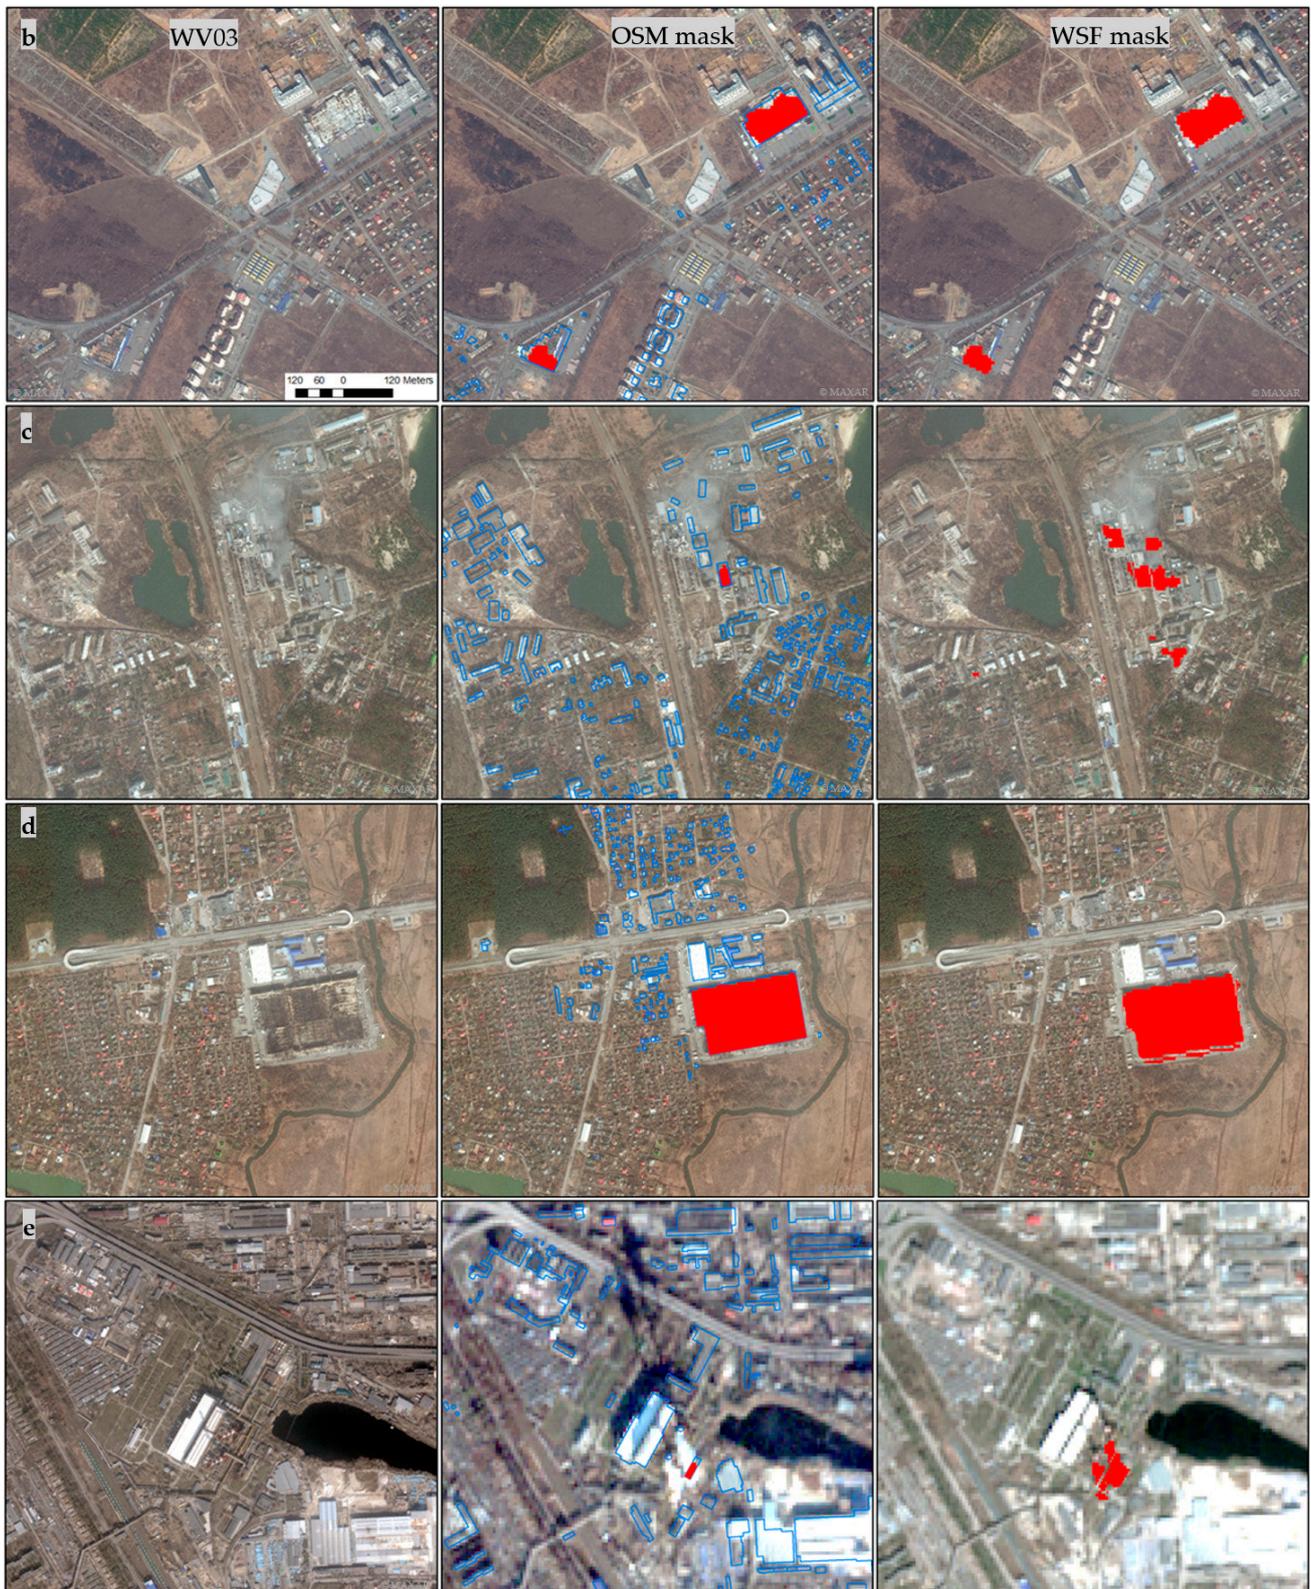
Figure 8. Cont.

Figure 8. The result of Sentinel-2 texture-based analysis for study region (a). (b–e) are comparison of Sentinel-2 damaged building results using two different masks (OSM&WSF). The locations (b–e) are referenced in (a) and were selected as representative areas for comparison with the high-resolution WorldView image. The columns from left to right indicate the WorldView image (25 March 2022 & 31 March 2022), OSM and WSF mask results of the damaged buildings. The scale shown in (b) is the same for (c–e).

The damage assessment result from the Sentinel-2 texture analysis is summarized in Figure 8. The texture analysis was able to detect the same flooded area along the Irpin River as the SAR intensity analysis (Figure 7a). However, the extent of the flooded region in this analysis is smaller than the SAR intensity flooded region. We selected four representative areas, three in the northwestern region of the study area (Figure 8b–d), which is the same location referenced in Section 4.1, and one in the southern region (Figure 8e) that matches the high-resolution WorldView images. In each of the four areas, we compare the results using the OSM mask versus using the WSF built-up layer mask. The effects of using the OSM and WSF building mask are less significant than applying it to the SAR intensity analysis, indicating that there are fewer false positives in unmasked damage labels. The comparison results with the high-resolution WorldView images showed that damages on the large buildings with clear boundaries were mainly detected by the Sentinel-2 texture analysis (Figure 8b–d). However, as shown in Figure 10, buildings with dark roofs were not detected as damaged buildings. This may be related to the fact that the brightness intensity of the damaged building for the pre- and post-event optical images are similar (lower on both images). Moreover, those smaller damaged buildings which do not have distinct texture features compared to their surroundings were also not captured in the texture analysis (Figure 8c). Furthermore, the changes in intensity values of bright objects, that represent either bare ground (Figure 6d) or tall structures that show different reflectance at different times (Figure 8e) were misclassified as damaged buildings. Overall, the texture difference highlighted mostly large, damaged buildings with fewer false positives.

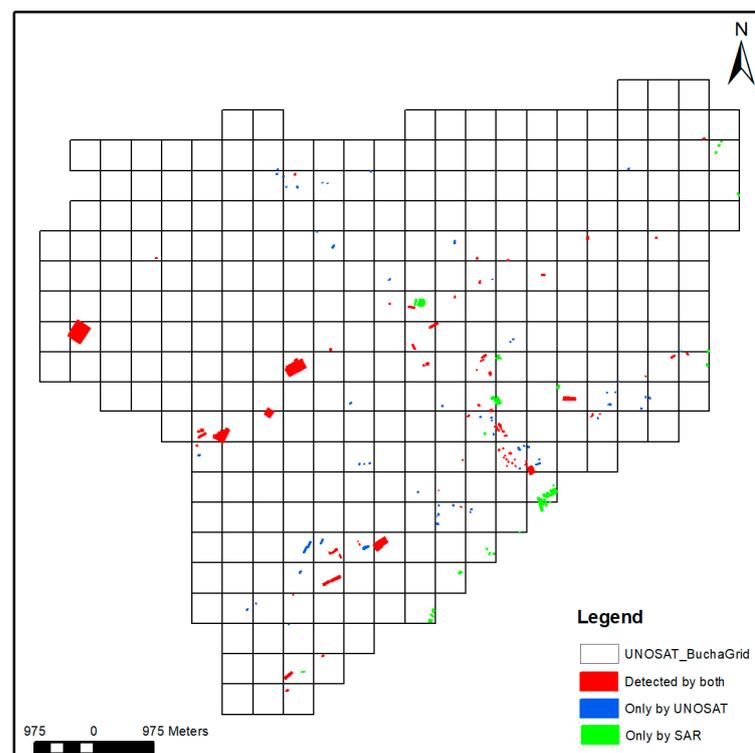
Figure 9. The comparison of the Sentinel-1 SAR intensity-based results with the UNOSAT's building damage assessment report.

Figure 9 is the comparison of the Sentinel-1 SAR intensity-based results with the UNOSAT building damage assessment report for Bucha. The UNOSAT damage assessment was performed visually on WorldView images on the region of interest- UNOSAT-BuchaGrid. Most buildings in the region are small to medium scale. Their results show (Table 3) 145 damaged buildings with an average building area of 867 m²; the smallest building area is 149 m² (destroyed), and the largest one measures 1280 m² (severe damage). As the Sentinel-2 texture results only highlighted large-scaled damaged buildings, the quantitative validation was carried out on the Sentinel-1 intensity results. The OSM building footprint was used to locate the UNOSAT damaged (point-based labels) buildings with a result of 45 building labels that fell in a OSM building footprint. For the remaining 100 buildings without an OSM building footprint, we created footprints by visually comparing them with the WorldView image acquired on 28 February 2022. Because our augmented OSM footprint focused on the buildings with UNOSAT labels, we are only able to quantify the true positive rate. The False positives, True negatives, and False negatives will be biased due to the incomplete nature of the OSM footprint layer.

The UNOSAT damage labels included four labels: destroyed, severe damage, moderate damage and possible damage. Including all four classes as a single damaged class, the comparison of SAR intensity-based results with the UNOSAT report showed that 58% of the damaged buildings (84 out of 145 buildings) were correctly classified. The comparison of UNOSAT building damage levels showed that severe damage class had the highest match with an accuracy of 64%, while the possible damage and destroyed class had the lowest match with a 50 and 47% accuracy, respectively. The lower accuracy rates may be a combination of the applied method and the medium resolution of the imagery. A majority of the destroyed class were small buildings with an average area of 149 m², which may be difficult to detect as a result of the image resolution: 10 m. If we ignore all buildings with building footprints less than 300 m², the True positive rate increases from 58% to 76%. The SAR intensity change results more favorably highlighted the significant backscatter changes (severe damage) paired with larger building footprints than the small changes (moderate and possibly damage). This is also consistent with the previous research results that it is challenging to detect lower damage grades from the medium resolution images [3,21,51]. Additionally, there were 23 damaged buildings, as shown by the green polygons in Figure 9, that were detected by the SAR intensity analysis, but were not included in the UNOSAT damage assessment report. From inspection, we expect that some of these false positives may be true positives because of missing labels in the UNOSAT dataset. The missing labels may be the result of the different dates between the image used by UNOSAT to assess the damage (31 March) and the SAR images used in this study (5/8 April).

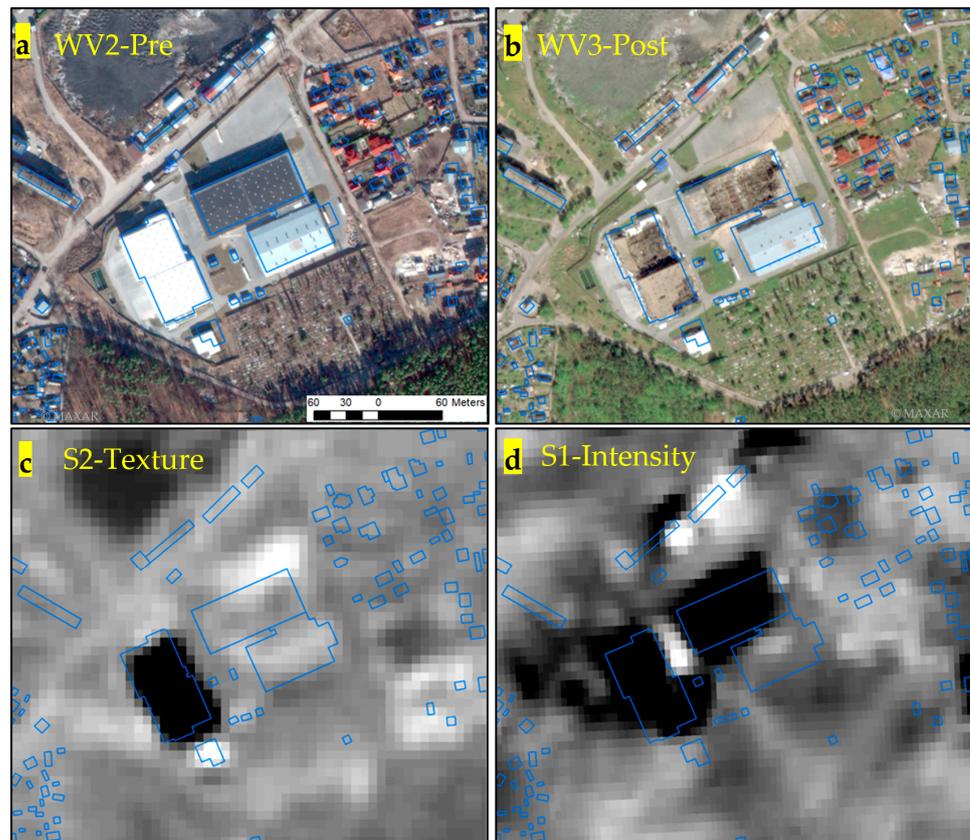
Figure 10. The Sentinel-1 SAR intensity versus Sentinel-2 texture (c,d) and the corresponding World-View imagery taken on 28 February 2022, and 9 May 2022 (a,b). The blue polygons are the OSM building footprints overlaid on the images for better comparison.

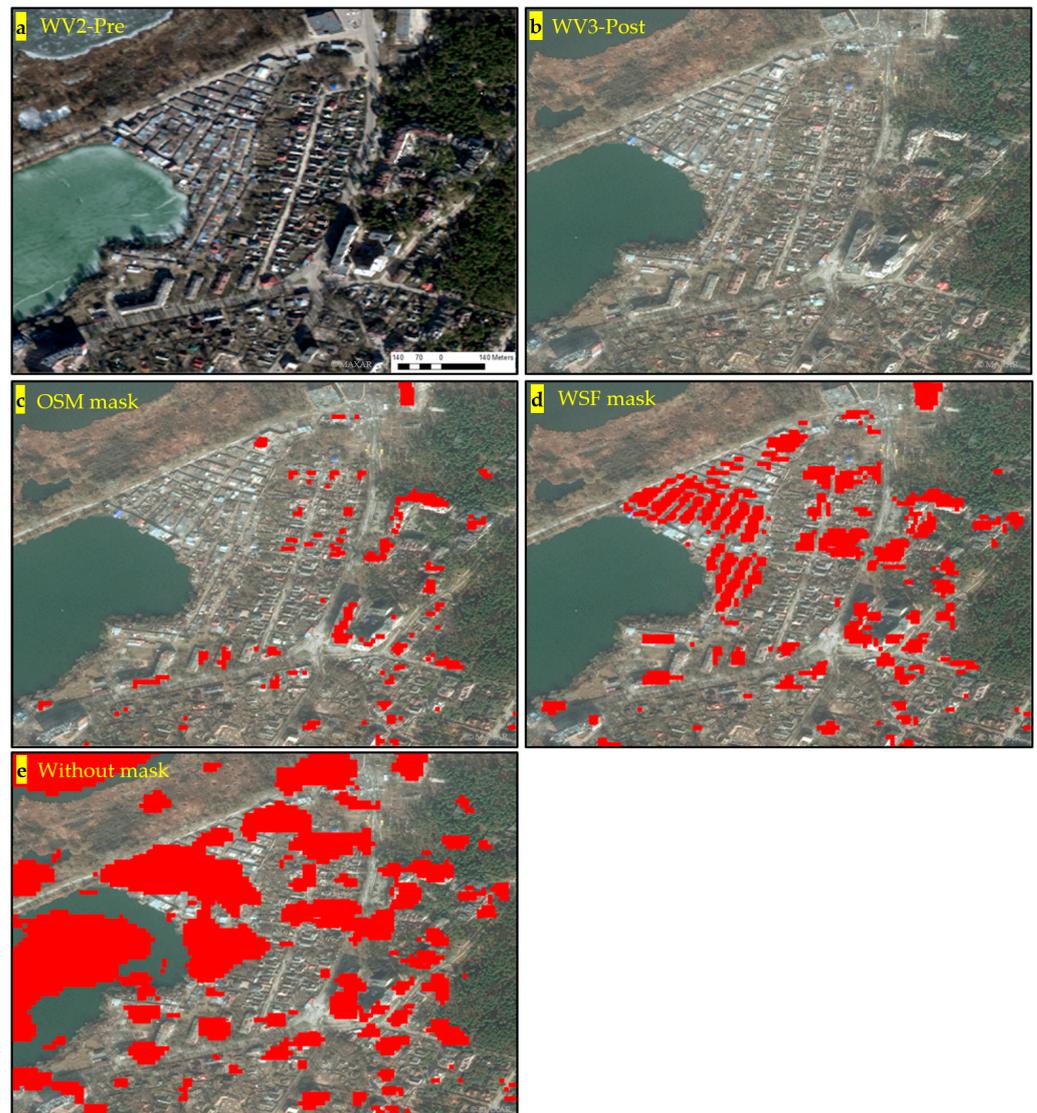
Figure 11. WSF VS OSM building footprint mask on the SAR intensity results. (a,b) are pre- and post-event WorldView images taken on 28 February 2022 and 31 March 2022; (c–e) are the results after applying OSM and WSF building mask, and without mask.

prints. In this study, we applied the original building footprint to mask building areas and augmented the OSM building footprints in the UNOSAT surveyed area. As shown in Figure 11, we noticed (during the validation with high resolution optical image) that the building footprint was incomplete and lead to the exclusion of certain damaged buildings in the result. A visual assessment of the area by two experts referencing the pre- and post-WorldView images showed 122 damaged buildings. We tested the WSF built-up layer to use as a mask and we were able to assess more damaged buildings (77), some of which were excluded by the OSM building mask (39). Considering the amount of superfluous land cover types excluded by the masks, both layers provide useful building information (e.g., location and geometry) that can accelerate the data processing in disaster response situations. However, improvements can be made to increase the number of buildings provided in each of the original datasets.
