Effect of Lost-Foam Casting Process on Properties of Spiral Blade

Abstract: The wear failure mode of a paver spiral blade was simulated by EDEM software. High-manganese steel, medium chromium alloy steel, and high chromium alloy steel were selected as matrix materials; SiC particles and WC particles were selected as surface particle reinforcement materials; and the spiral blade was prepared by the EPC process. The performance and wear mechanism of the spiral blade prepared by EPC were analyzed by microstructure, hardness, impact, pin disk, erosion wear test, and wear morphology. Modeling with EDEM software and applying the discrete element analysis method of particle system could simulate the actual working situation of the spiral blade of the paver well. Through the simulation, it was found that the wear amount of the spiral blade of the paver from the spiral shaft to the outside of the spiral blade was increasing. SiC and WC particle-reinforced wear-resistant coatings were prepared on the surfaces of high-manganese steel, medium chromium alloy steel, and high chromium alloy steel by the EPC method. The wear-resistant coating of high-manganese steel was 5.05 mm, the coating of me

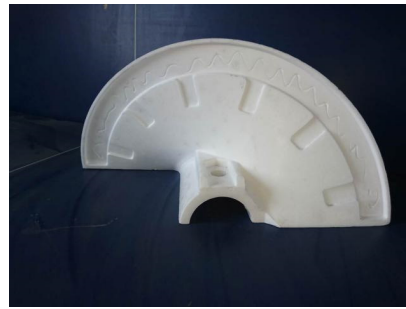
Figure 2. EPS model.

High-manganese steel, medium chromium alloy steel, and high chromium alloy steel were selected as the matrix materials of EPC. The composition is shown in Table 1. SiC particles and WC particles were selected as surface particle reinforcement materials. The preparation process of the spiral blade is shown in Figure 1. Metal powder was prepared by adding 2% of the cosolvent (anhydrous borax powder) into particle-reinforced WC and SiC. The role of the cosolvent was to remove the oxide film in the powder, clean the coating surface, and improve the wettability of molten steel. Meanwhile, the surface-coating part was reserved according to the EPS model. The prepared EPS model is shown in Figure 2. Then, the metal powder was coated on the surface of the EPS model and dried for 1 day. The surface of the EPS model coated with metal powder was evenly dipped with antisticking sand paint, which was left to dry, and then repeatedly dipped twice for 2 days to form a hard shell on the surface of the model. The EPS model was placed in the sand box, filled with quartz sand with uniform particles, and the gate and vacuum were reserved. Vacuum degree was 0.03–0.05 MPa by vacuum pump. High-manganese steel, medium chromium alloy steel, and high chromium alloy steel were fully melted and poured separately. After two hours pouring, the box was discharged for air cooling, as shown in Figure 3.

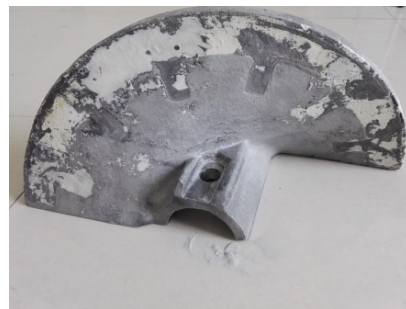
Figure 3. Cast spiral blade.

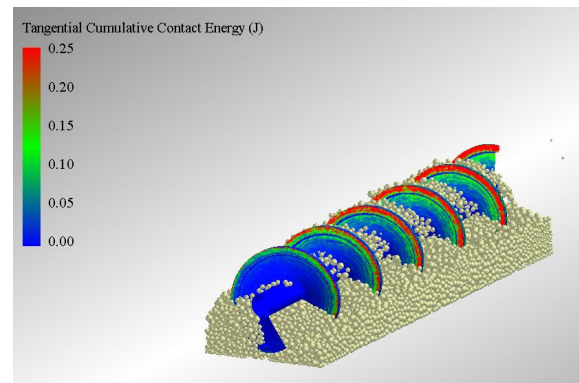
As shown in Figure 5, EDEM software was used for modeling, and the discrete element analysis simulation method of the particle system was used to simulate the actual working condition of the spiral distributor. The wear condition of the spiral blade during material distribution and distribution during the construction of the paver was simulated. The selected abrasive particle size, physical parameters, and interaction coefficient are shown in Tables 2–4.

Figure 5. Working condition simulation of helical blade.

As can be seen from Figures 5 and 6, the wear of the spiral from the spiral shaft to the outside of the spiral blade was increasing. At the same screw speed, the farther away from the screw shaft, the greater the relative speed of the crushed stone aggregate in contact with the screw blade, and the more wear would be produced, accordingly. The spiral near

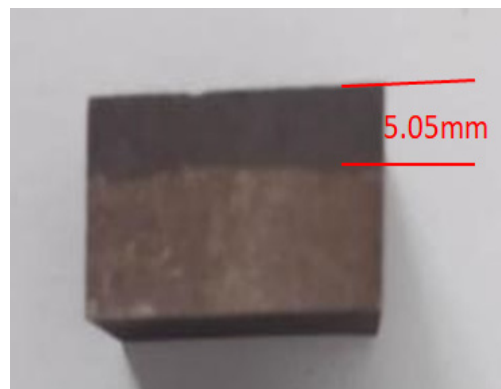
The thickness of the sample coating was measured as shown in the Figure 7. The coating thickness of the first, second, and third was 5.05 mm, 5.98 mm, and 7.02 mm respectively. Figures 8 and 9 showed the metallographic structure of the sample. The core structure of the first sample was austenitic structure, hardened particles were embedded at the grain boundary, and the carbide hardness was 1153HV1. The core of the second sample was acicular martensite, with fine hard particles evenly distributed on the surface, and the hardness of the surface coating could reach 1182HV1. The core of the third sample was coarse acicular martensite, with fine hard particles evenly distributed on the surface [9–11], and the hardness of the surface coating reached 1170HV1.

Figure 7. Coating thickness test.

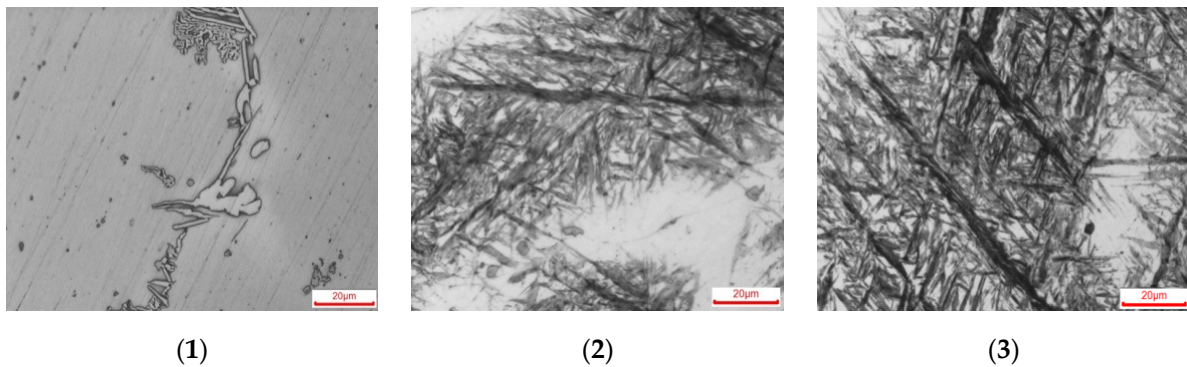
Figure 8. Matrix microstructure, (1) High manganese steel, (2) Medium chromium alloy steel, (3) High chromium alloy steel.

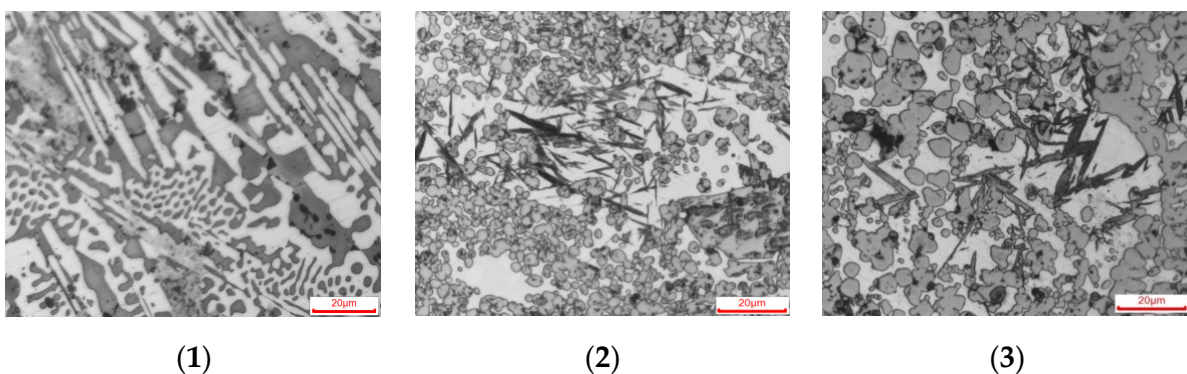
Figure 9. Surface layer microstructure, (1) High manganese steel, (2) Medium chromium alloy steel, (3) High chromium alloy steel.

Figure 9 shows the microstructure of the sample surface, and Figure 10 shows the EDAX analysis results of the second sample surface. The coating structure was SiC, WC particles, and carbides. In the lost-foam casting process, the alloy elements in the matrix would diffuse to the coating. Through EDAX analysis at the red square of Figure 10, it was found that some Cr elements had diffused into the coating, indicating that the migration of alloy elements would occur in the process of EPC.

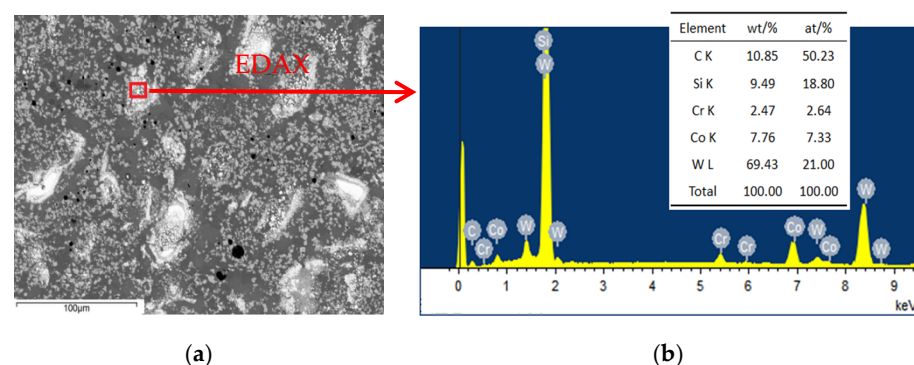
Figure 10. EDAX results of surface layer, (a) Coating scanning, (b) Particle enhanced EDAX results.

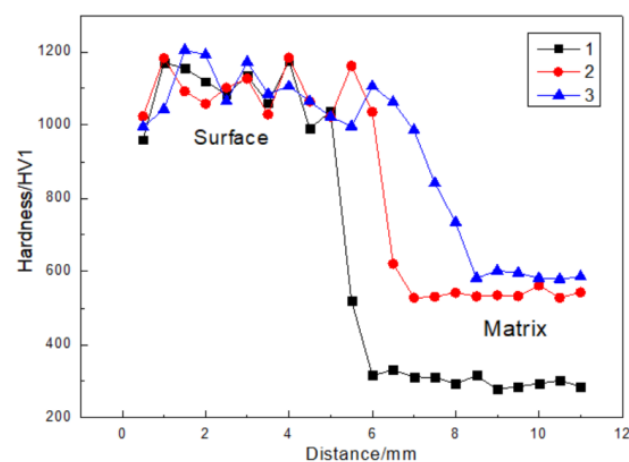
From the micro-Vickers hardness curve, the hardness value was very high at first, and the highest point could reach more than 1200HV1. There was an obvious downward trend. The microstructure of the sample surface was composed of SiC, WC, and carbide, which were all high, hard phases with high hardness, so the surface hardness was high. The first matrix structure was mainly austenite, resulting in low hardness. The matrix structure of the second and third samples was acicular martensite with high hardness.

Figure 11. Vickers hardness curve of sample.

The hardness of the sample was tested by a Rockwell hardness tester and micro-Vickers hardness tester, respectively. The results are shown in Table 5 and Figure 11. It could be seen that the hardness value of the matrix was different due to different matrix materials. The average hardness of the matrix was 28.6HRC, 48.0HRC, and 51.5HRC, respectively. The surface hardness was basically the same due to the use of the same material [12,13].

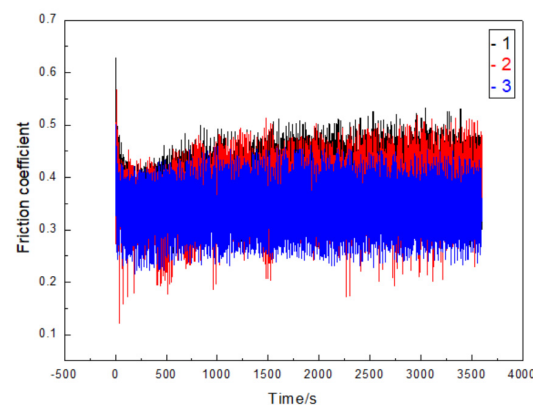
wear performance of the third sample was much better than that of the first and second samples. It can be seen from Figure 12 that the friction coefficient of the first sample was larger, and the friction coefficient of the third sample was the smallest, which corresponded to its wear resistance. After EPC, Cr and Mn elements in the sample would diffuse into the coating, resulting in changes in the hardness of the coating. Mn in the sample diffused into the coating, resulting in relatively low hardness of the coating part and uneven hardness distribution. Therefore, it had a large loss in the wear with the disk, and adhesive wear occurred with the disk. However, when Cr in the sample diffused into the coating, its hardness was high, the hardness in the coating was uniform, and the wear process with the disc was stable, so its friction coefficient was small.

Figure 12. Diagram of friction coefficients.

The pin disc wear results of the three samples are shown in Table 7 and Figure 12. The average wear weight loss of the samples was 0.236 g, 0.194 g, and 0.099 g, respectively. The

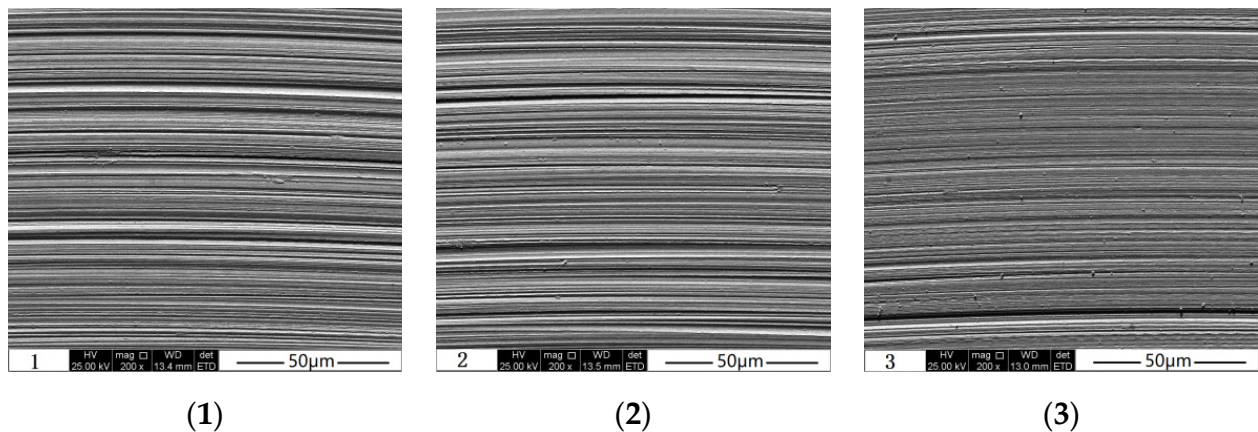
As can be seen from Figure 13, the wear morphology of the pin and disc of the three samples showed a furrow phenomenon. Pin disc friction and wear tester was a kind of dry wear test. The samples could move back and forth in the circumferential direction by pressing the samples tightly on the rotating disc with load. The sample was directly worn with the disc, and there was no medium between them. The furrow of the first sample was deep, with ridges on both sides and a little peeling. The scratch of the second sample was fine and there was no carbide peeling. The third sample had the smallest scratch and no carbide peeling [15,16].

Figure 13. Wear morphology of pin and disc, (1) High manganese steel, (2) Medium chromium alloy steel, (3) High chromium alloy steel.

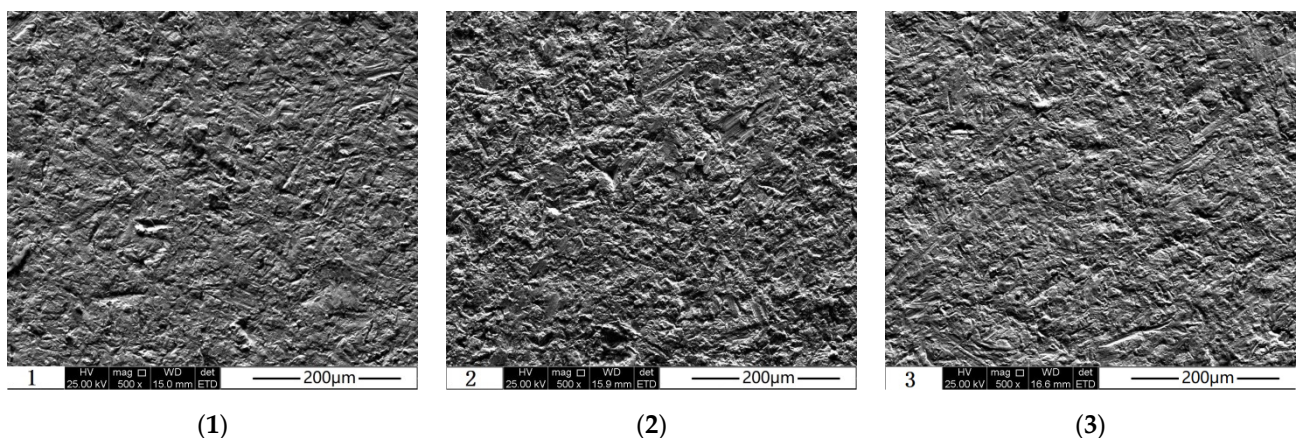
As can be seen from Figure 14, the erosion wear morphology of the three samples showed pits. The samples in erosion wear were in the state of wet friction by colliding with the abrasive material that was freely suspended in the mortar during rotation. Obvious pits could be seen from the first and second samples, and the level drop was large. The third sample block showed a smaller level drop and better erosion wear resistance after erosion.

Figure 14. Erosion wear morphology, (1) High manganese steel, (2) Medium chromium alloy steel, (3) High chromium alloy steel.
