# Research on External Insulation Characteristics of Composite Cross-Arm of 10 kV Distribution Network Based on Multi-Factor Aging

**Abstract:** With the application of the composite cross-arm in power systems, comprehensive anti-aging performance is a key factor to determine whether it can operate safely. In order to study the influence of the operating environment on the external insulation characteristics of composite cross-arms of distribution networks, various aging conditions such as voltage, rain, temperature, humidity, salt fog and ultraviolet light were simulated in a climate chamber based on the real operation conditions of the 10-kV composite cross-arm. A multi-factor aging test of composite cross-arms with two kinds of cross-section shapes (T-shaped and square) was carried out for 5000 h. The change trends of leakage current and flashover voltage of the composite cross-arms before and after aging were analyzed. Finally, the aging mechanism of the silicone rubber sheaths was analyzed to further explain the reasons for the change of external insulation performance of composite cross-arms. The results show that the leakage current rising rate of T-shaped and square compos

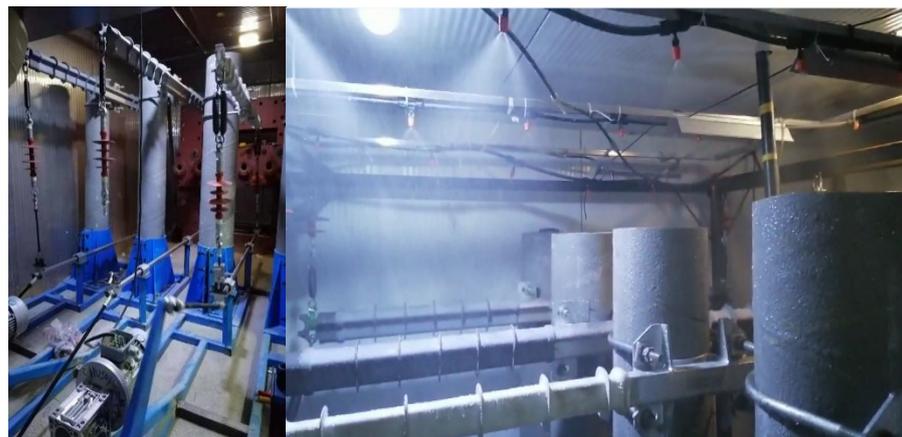
**Figure 2.** The actual effect diagram of the comprehensive aging system.

This paper refers to the IEC/TR 62730-2012 standard. It combines the actual operating environment of the composite cross-arm to build a set of test systems that can simultaneously carry out voltage, rain, temperature, humidity, mechanical force, salt spray and ultraviolet aging [9]. Table 2 shows the multi-factor aging test scheme. For the test, each cycle is comprised of 24 h, and each cycle is divided into 12 stages, each of which is two hours long. “√” in the table indicates that the corresponding aging factors are applied.

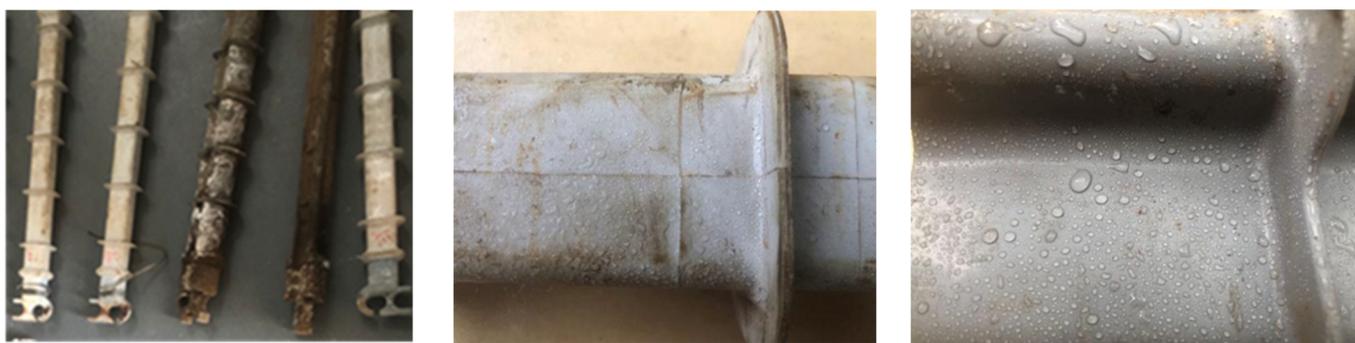
The morphology of the two composite cross-arm samples after 5000 h of multi-factor aging is shown in Figure 3. It can be seen from the figure that the macro appearance of the aged composite cross-arm has changed to a certain extent. Part of the umbrella skirt and sheath of the cross-arm turn yellow after ultraviolet irradiation, but the overall shape of the cross-arm has not changed greatly. After further observation, it was found that all cross-arm samples were aged by salt fog and rain; the contaminated particles mixed with salt, soil and dust were attached to the silicone rubber surface; the metal fittings at the end of the composite cross arm were seriously rusted; and a small amount of sheath near the end metal fittings was damaged. It is considered that this is because a small amount of silicone rubber sheath at the end was damaged and cracked after mechanical force fatigue vibration was applied to the composite cross-arm. In order to explore the changes of the external insulation characteristics of the composite cross-arm after multi-factor aging, it is necessary to carry out artificial pollution electrical experiments on it and analyze the microscopic mechanism of the deteriorated composite cross-arm's silicone rubber sheath to discuss its performance characteristics after aging.

**Figure 3.** Morphology of two kinds of composite cross-arm samples after multi-factor aging.

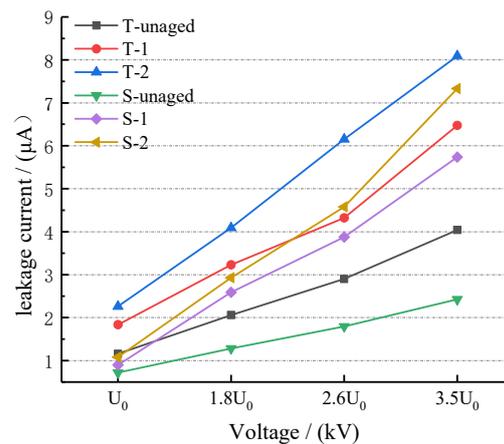
The leakage currents of the square and T-type composite cross-arms at different voltages are shown in Table 6 and Figure 4.

**Figure 4.** Variation of leakage current of composite cross-arms with different aging factors with applied voltage.

With the increase of the test voltage, the rate of the leakage current of the aged composite cross-bar was greater than that of the unaged composite cross-bar. After comparing the composite cross-arms of the different aging types, it was found that the leakage current value of the cross-arm subjected to ultraviolet aging is generally greater than that of the cross-arm without ultraviolet aging ( $T-2 > T-1$ ;  $S-2 > S-1$ ). The reason for this trend is that the hydrophobicity (hydrophobicity is a technical index reflecting the water penetration resistance of materials. The higher the hydrophobicity is, the less water is likely to invade the materials, and vice versa) of the composite cross-arm's silicone rubber sheath is reduced by ultraviolet radiation; the water absorbed by the surface fouling layer increases to form a continuous water film. The leakage current flows along this conductive path; thus, the conductivity of the composite cross-arm surface increases.

After comparing the two composite cross-arms under the same aging factors, it was found that the leakage current value of the T-shaped cross-arm is generally greater than that of the square-shaped composite cross-arm ( $T-1 > S-1$ ;  $T-2 > S-2$ ). The main reason is that the silicone rubber surface area of the T-shaped cross-arm is larger than that of the square-shaped cross-arm, and the surface is more conductive, resulting in a higher leakage current value.

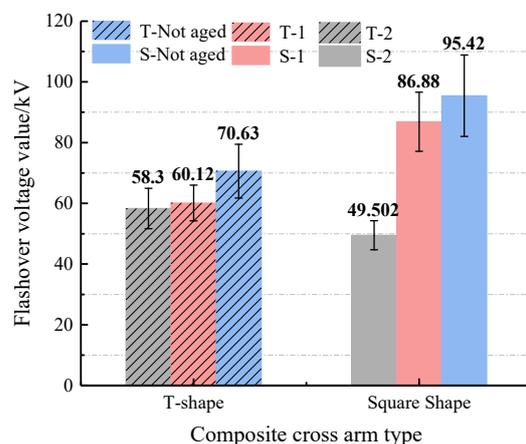
Figure 5 shows the change of the flashover voltage before and after the multi-factor aging of the composite cross-arm's insulation. It can be seen from the trend in the figure that  $T-2 < T-1 < T\text{-unaged}$  and  $S-2 < S-1 < S\text{-unaged}$ , indicating that aging factors such as rain, salt spray, damp heat and ultraviolet rays reduce the composite cross-arm's flashover voltage value. For the T-type cross-arm,  $T-2 < T-1$ , so the flashover voltage will further decrease after the composite cross-arm is irradiated with ultraviolet light. For the square cross-arm:  $S-2 < S-1$ , which shows a similar law to the T cross-arm. However, for the square cross-arm, the S-2 flashover voltage value decreases more; the S-2 flashover voltage value

is only 56% of the S-1 flashover voltage value. Combined with the change law of flashover voltage after aging of the two kinds of composite cross-arms, the reason for analyzing T-2 < T-1 and S-2 < S-1 is because ultraviolet radiation will deteriorate the silicone rubber outer sheath, and the hydrophobicity transference of the outer sheath is weakened. When the soluble substance in the dirt dissolves in water to become electrolytes, and as the wetting reaches saturation, the surface conductance of the outer sheath will be much greater than when it is dry, and this is more likely to cause cross-arm flashover along the surface.

**Figure 5.** Multi-factor aging composite cross-arm flashover voltage.

By comparing the flashover voltage values of the two composite cross-arms, it was found that the flashover voltage value of S-1 is higher than that of T-1. Since the composite cross-arm S-1 and T-1 are not subjected to ultraviolet aging, it shows that the outer sheath of the square cross-arm has better resistance to salt spray and damp heat. However, the flashover voltage S-2 of the square composite cross-arm under ultraviolet irradiation is lower than T-2. At the same time, the flashover voltage value of S-2 is much smaller than that of S-1, while the flashover voltage values of T-2 and T-1 are not much different. This shows that the T-type composite cross-arm silicone rubber outer sheath has better UV resistance.

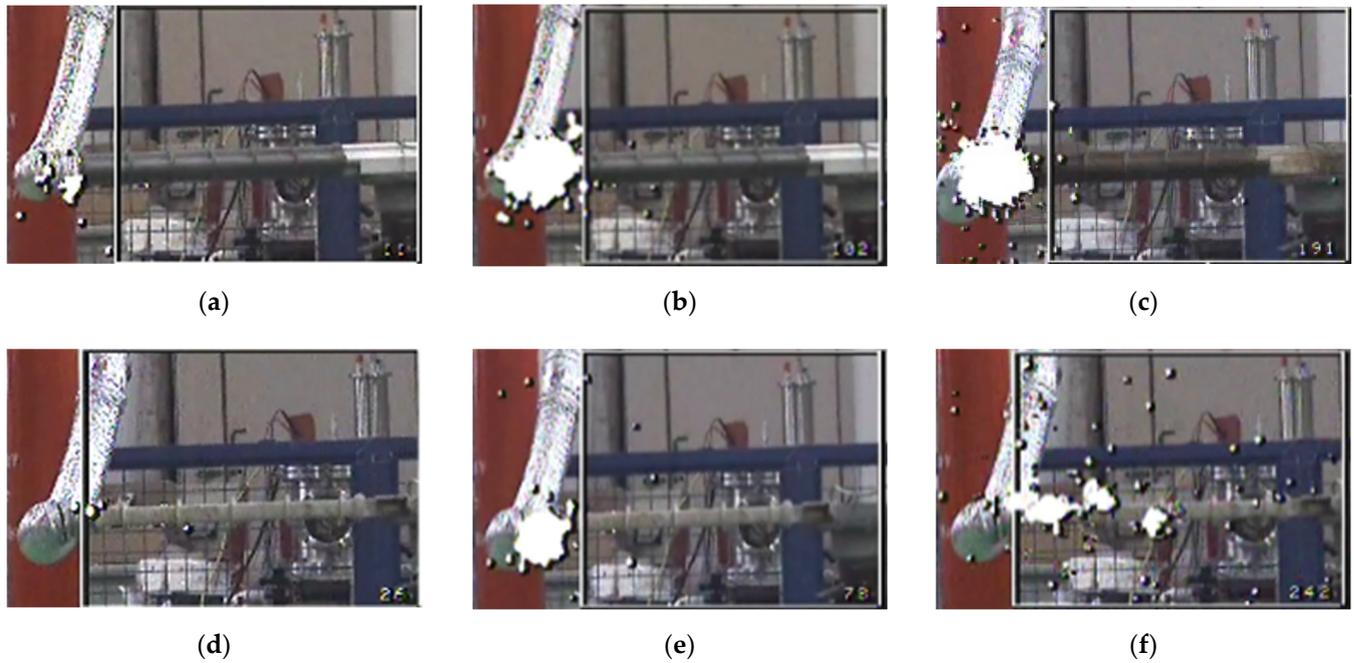
Figure 6 is the UV discharge image of a T-shaped and square composite cross arm at 30 kV voltage.

It can be seen from the figure that the number of discharge spots of the composite cross-arms T-1 and T-2 are significantly higher than that of the unaged cross-arm T-unaged. The higher the number of discharge spots, the stronger the discharge phenomenon on the surface of the cross-arm captured by the UV imager. Compared with the unaged cross-arm, the discharge spots of the aged composite cross-arm are significantly increased under the same voltage, indicating that the surface of the aged composite cross-arm is more prone to discharge, and the external insulation performance is reduced. Comparing T-1 and T-2, it was found that the amount and intensity of discharge spots of the two aging transverse arms are similar. The discharge spots are mainly concentrated at the high voltage end, and no obvious ultraviolet discharge spot was found in other parts of the composite cross arm; this phenomenon is consistent with the change trend of the flashover voltage of the T-type composite cross-arm in Figure 5. In contrast, the number of discharge spots of the square cross-arms S-1 and S-2 are also greater than that of the unaged cross-arm S-unaged, but the range of S-2 discharge spots is wider than S-1, and the discharge is not only concentrated at the high-voltage end. S-2's discharge development is faster and was able to reach the third section of the umbrella skirt position; therefore, it is more prone to flashover. Comparing the composite cross-arm of the same aging type, it was found that the discharge phenomenon of the composite cross-arm T-1 was stronger than that of S-1,

while the discharge phenomenon of T-2 was weaker than that of S-2, indicating that UV irradiation has a significant influence on the external insulation performance of the square composite cross-arm. This phenomenon is consistent with the previous chapter's flashover voltage test results. If the voltage continues to increase, the discharge phenomenon will continue to develop from the high-voltage end to the fixed hardware in the middle of the cross-arm, eventually leading to flashover of the composite cross-arm.

**Figure 6.** Observation diagram of ultraviolet camera for artificial pollution flashover test of composite cross arm: (a) T-unaged; (b) T-1; (c) T-2; (d) S-unaged; (e) S-1; (f) S-2.

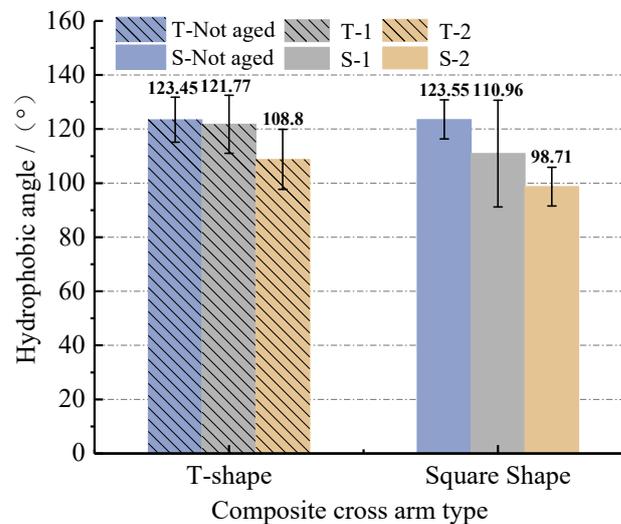
Figure 7 shows the test results of the hydrophobic angle of the silicone rubber on the surface of the composite insulating cross-arm with different aging types.

**Figure 7.** Measurement results of hydrophobic angle of composite cross-arm silicone rubber with different aging types.

Comparing samples S-1 and S-unaged and T-1 and T-unaged, it was found that the hydrophobic angle of S-1 and T-1 decreased, but both remained above  $100^\circ$  and still maintained good hydrophobicity. This shows that aging factors such as rain, salt spray, damp heat and mechanical force have little effect on the hydrophobicity of the silicone rubber outer sheath. Simultaneously observing samples S-2 and S-unaged and T-2 and T-unaged found that the hydrophobic angles of S-2 and T-2 decreased significantly, and the average value dropped to  $98.71^\circ$  and  $108.8^\circ$ , respectively. This shows that the decrease of the hydrophobic angle of the composite cross-arm will further increase after ultraviolet irradiation. UV light has become the most severe aging factor affecting the hydrophobicity of the outer sheath among many other aging factors. This explains the test results in Sections 3.1.1 and 3.1.2 of this paper: that is, that S-2 and T-2 have a larger leakage current and a lower pollution flashover voltage than the rest of the aged composite cross-arms.

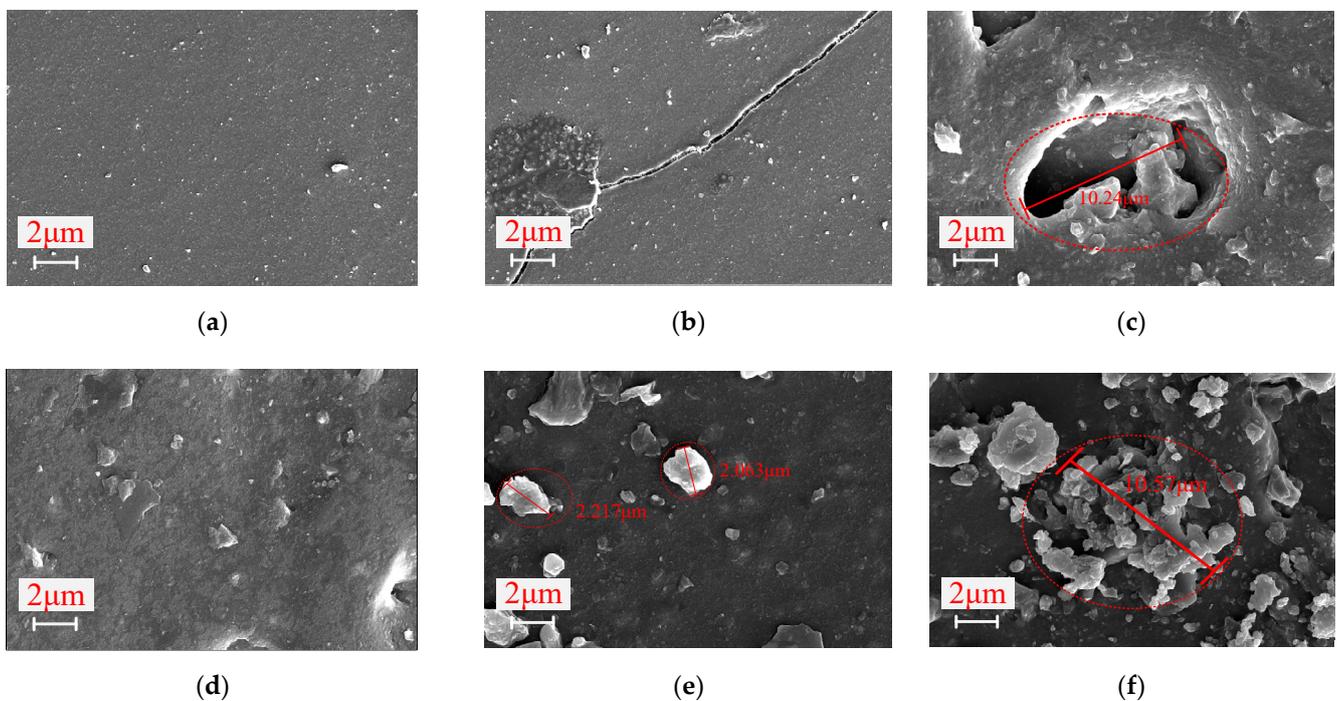
The SEM test results of the composite cross-arm outer sheath with different aging types are shown in Figure 8.

**Figure 8.** Scanning electron microscope results of the outer surface of the silicone rubber sheath: (a) S-unaged; (b) S-1; (c) S-2; (d) T-unaged; (e) T-1; (f) T-2.

It can be seen from Figure 8 that the surface structure of the unaged cross-arm S-unaged and T-unaged samples is smooth and uniform, without any obvious holes or gaps. The surface of the outer sheath of the composite cross-arm S-1 is smooth, and compared with the unaged cross-arm S-unaged, long cracks are present but no obvious precipitates are found. This shows that aging factors such as rain, salt spray, humidity and high temperatures will cause slight cracking of the square cross-arm silicone rubber but will not affect its internal molecular structure. On the other hand, the diameter of small-diameter particles precipitated on the surface of T-1 is about  $2.2 \mu\text{m}$ . Compared with S-1, the T-1 silicone rubber sheath has undergone molecular changes. In contrast, the surface of S-2 is rough, with  $\sim 10.24 \mu\text{m}$  holes in the center. The pores of the composite cross-arm S-2 silicone rubber show a concave shape from the surrounding surface to the inside, and the aging shows a trend of extending to the inside of the material. Particles with a diameter

of about 10.57  $\mu\text{m}$  appeared on the sheath surface of the composite cross-arm T-2, and the density was higher than that of T-1, but no holes or cracks were found.

After the silicone rubber outer sheath is aged by different factors, it shows differences in the microscopic morphology. Among them, the surface of the square cross arm S-2 outer sheath is the most severely aged; there are sunken holes and derivative lines, indicating that the material characteristics of the square cross arm outer sheath have changed after being affected by UV aging. UV irradiation accelerates the deterioration of the sheath material, resulting in a decrease in the overall performance of the material.

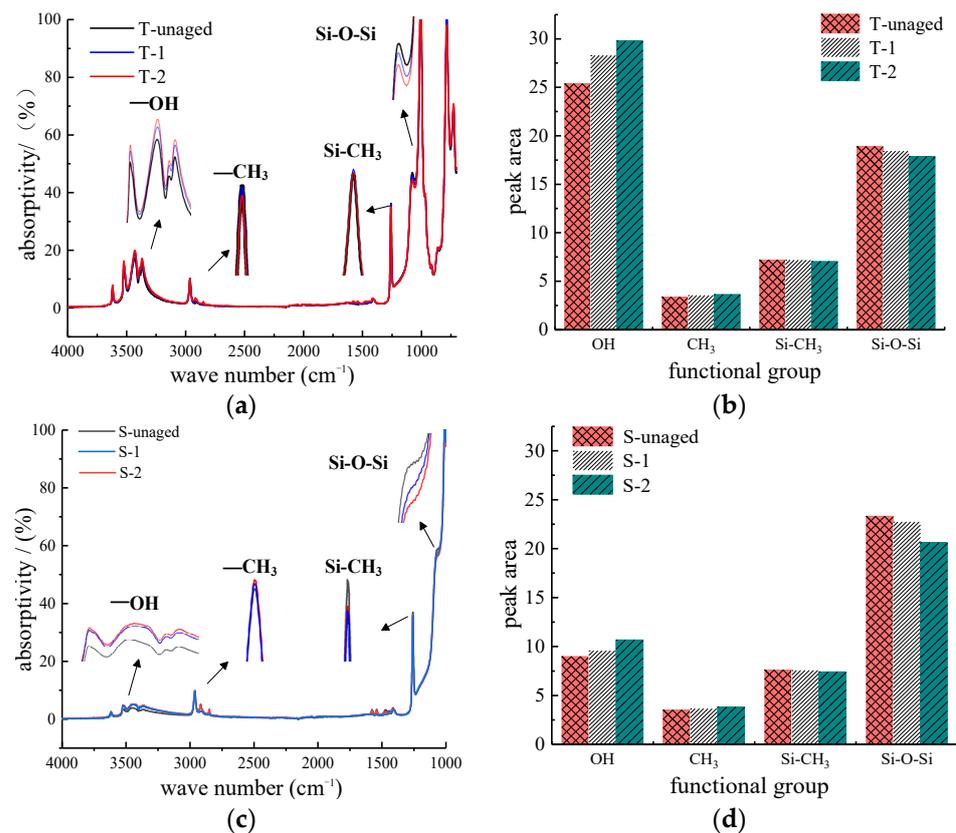
An analysis was conducted of the infrared spectrum of the T-shaped (Figure 9a) and square-shaped (Figure 9c) composite cross-arms. Si-O-Si represents the main chain of silicone rubber; Si-CH<sub>3</sub> represents the side chain methyl group. If the number of main chain and side chain groups are large and complete, then the silicone rubber sheath has good aging resistance. When observing the absorption peak areas of the main chain group Si-O-Si and the hydrophobic functional group Si-CH<sub>3</sub> (Figure 9b,d), it can be seen that the main chain group Si-O-Si and hydrophobic group Si-CH<sub>3</sub> of the composite arms T-2 and S-2 have the smallest absorption peak areas, and T-unaged and S-unaged have the largest absorption peak areas (T-2 < T-1 < T-unaged; S-2 < S-1 < S-unaged). This shows that after multiple factors age the silicone rubber sheath, the molecular structure inside the material is destroyed. However, the absorption peak area of the hydrophilic group (-OH) with a wavenumber of 3200–3700  $\text{cm}^{-1}$  increased after the composite cross-arm was aged, and the -OH absorption peak area of T-2 and S-2 is the largest (T-2 > T-1 > T-unaged; S-2 > S-1 > S-unaged). The increase in the content of hydrophilic groups (-OH) represents the decrease in the hydrophobicity of the outer sheath. This phenomenon occurs because multi-factor aging will break the chemical bond Si-C, under the action of oxygen in the air, the hydrophilic group (-OH) is re-formed. Moreover, Al(OH)<sub>3</sub> will also decompose to form Al<sub>2</sub>O<sub>3</sub> and crystal water, increasing in the content of (-OH) groups. At the same time, the absorption peak of CH<sub>3</sub> located at the wavenumber of 2960  $\text{cm}^{-1}$  has a similar trend to the absorption peak of (-OH). This is because the main bond of the silicone rubber has high energy and is not easy to break. The low side chain bond energy causes some methyl groups to easily fall off after multi-factor aging so that the absorption peak of CH<sub>3</sub> increases. Furthermore, the methyl group, after falling off, undergoes a cross-linking reaction with the main chain, resulting in an increased polarity of the silicone rubber surface; it is more likely to cause flashover of the cross-arm. In addition, UV light caused the most severe deterioration of the outer sheath of the composite cross-arm S-2 and T-2. Ultraviolet light, a high-energy radiation, ionizes the silicone rubber molecules on the surface of the sheath after irradiation, resulting in a higher degree of damage to the silicone rubber. To sum up, after the composite cross-arm is aged by rain, salt spray, ultraviolet, and other factors, the main chain Si-O-Si in the sheath material is broken, the hydrophobic group Si-CH<sub>3</sub> decreases, the hydrophilic group -OH increases and the insulating performance of the silicone rubber sheath decreases.

**Figure 9.** FTIR spectra of T-shaped and square-shaped composite cross-arm silicone rubber sheaths and absorption peak areas of main functional groups: (a) T-type FTIR spectrum; (b) T-type functional group absorption peak area; (c) Square FTIR spectrum; (d) Square functional group absorption peak area.
