Multiple Effects of Intense Meteorological Events in the Benevento Province, Southern Italy

Abstract: In October 2015, two intense rainfall events hit the central and southern regions of Italy and triggered a combination of different and widespread effects, including floods, landslides, and soil erosion. These outcomes devastated about 68 municipalities of the Benevento province (Campania region), killed two people, and caused millions of euros worth of damage to structures, infrastructures, and agriculture. The town of Benevento was one of the sectors most affected by overflow. Extensive areas characterized by flyschoid outcrops experienced widespread occurrences of soil erosion and landslides, and destructive, high-velocity debris flows (about 50) afflicted areas that had experienced heavy rainfall of higher intensity (total rainfall of 415.6 mm). In this study, the characteristics of these rainfall events and related geomorphological processes were determined by (i) analyzing the available rainfall data to identify the spatial pattern, distribution, and statistical characteristics of the two storms and (ii) mapping the storm effects, such as flooded areas, landslide types, and

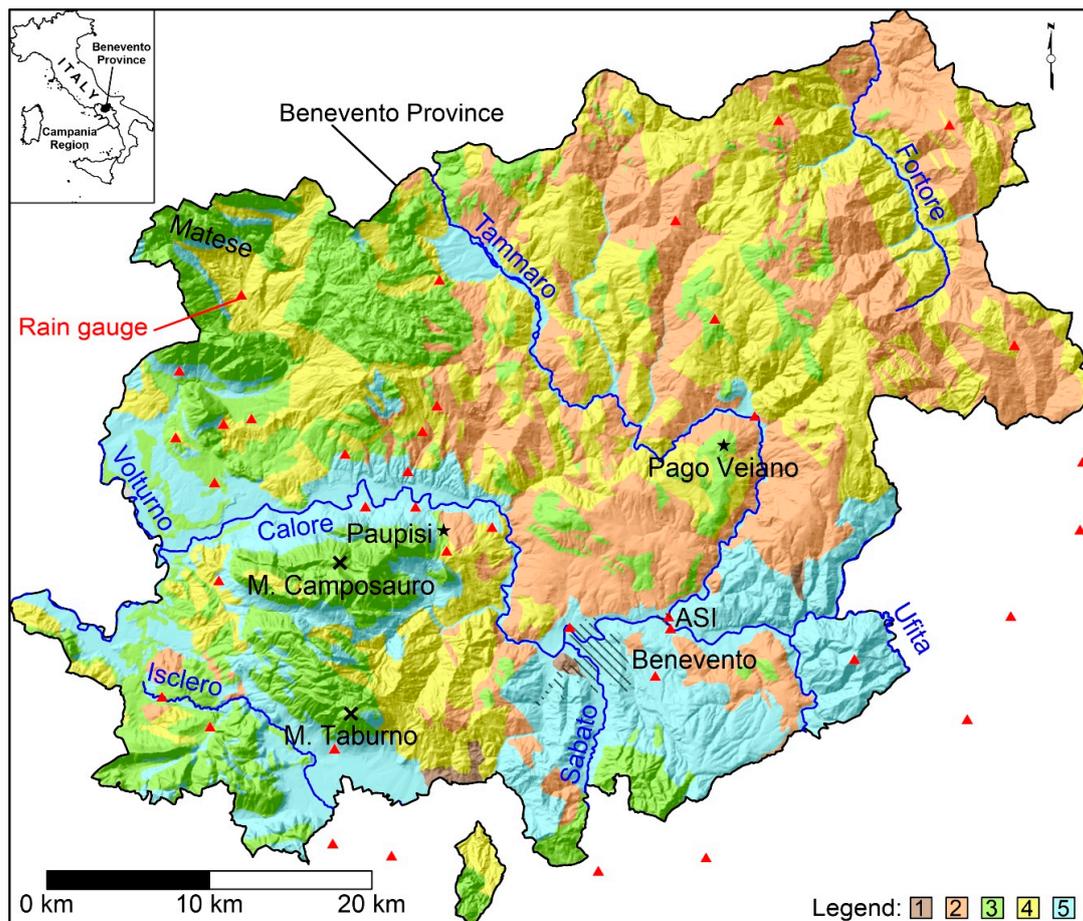
Figure 1. Outcropping of litho-technical sequences in the Benevento province (modified from [18]). Legend: (1) Predominantly pelitic sequences (from low to medium degrees of tectonization); (2) predominantly pelitic sequences (high degree of tectonization); (3) rock sequences (from low to medium degrees of tectonization); (4) rock and complex successions (high degree of tectonization); (5) coarse clastic and/or inhomogeneously lithified sequences. Rain gauges considered for our analysis are reported using red symbols. The industrial area of Benevento (ASI) is labeled.

Geological, geomorphological, and geostructural features have shaped the landscape, resulting in three main geomorphological domains (Figure 1):

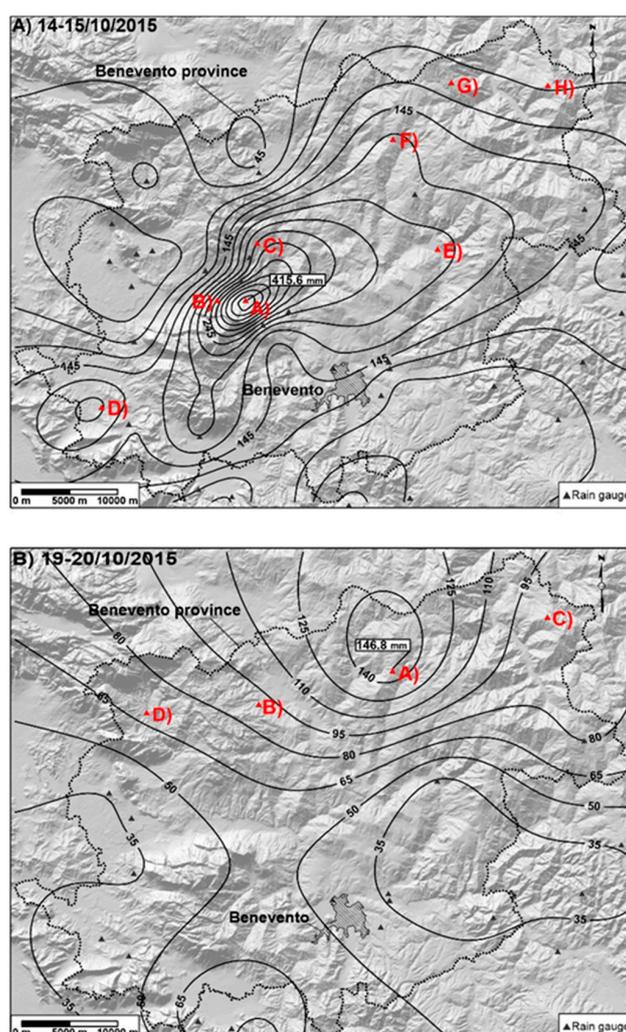
Figure 2. The spatial distribution of cumulative rainfall (black isohyets in mm) for (A) the event of 14–15 October (cumulative rainfall from 8:00 p.m. on 14 October to 3:00 p.m. on 15 October) and (B) the event of 19–20 October (cumulative rainfall from 11:00 a.m. on 19 October to 5:00 p.m. on 20 October). The maps label the registered maximum intensity, and the red triangles are the rain gauges selected for temporal analyses of the storms (Figures 3 and 4). The black triangles are the locations of rain gauges. The base map is a 20 m Digital Elevation Model (DEM, single-sided dimension).

The maps in Figure 2 show the rainfall distribution during the first (Figure 2A) and second (Figure 2B) storm event. The first storm on 14–15 October developed in the NE–SW direction. It principally affected the area surrounding the Taburno-Camposauro massif and the middle Calore river valley, and it elongated toward the upper Tammaro river basin, which was involved in the full extent of the storm. It was characterized by a strong intensity and large extent, covering all of the Benevento province and part of the Avellino province. The center of the maximum cumulative rainfall was located near the Paupisi village, where the total recorded rainfall was 415.6 mm (Figure 2A). The rain gauge located in Vitulano (labeled B in Figure 2A), which is 3.2 km from Paupisi, recorded 270.4 mm, a decrease of 145.2 mm only 3.2 km from the center of the maximum rainfall. The rain gauge in the Benevento town recorded a cumulative value of 156.4 mm. These data highlight that the higher intensities of the storm were spatially concentrated in a limited area (compared with the total affected area).

According to the distribution of rainfall data, a cumulative rainfall value higher than 100 mm occurred in an area of about 2000 km² during the first storm, and it was mostly concentrated in the Benevento province (Figure 2a). In particular, the rainfall on 14–15 October 2015 exceeded 140 mm in 4 h in a wide section of the Tammaro catchment, and it caused the overflow of the Calore river downstream. The rainfall in this catchment was extreme for up to 24 h (Table 1), but it reached the maximum deviation from the mean for a duration of 3 h ($Z = 2.41$) and maintained its intensity for up to 6 h ($Z = 2.29$). After the dam was built in the median sector of the catchment, the hydrological response of the Tammaro river changed, and only 424 km² (of a total catchment area of 694 km²) contributes to river discharge. It is interesting to observe that the 1949 storm occurred before the dam was constructed, and its rainfall had a different temporal distribution: In October 1949, the whole catchment contributed to river discharge, and the flood was induced by the rainfall accumulated

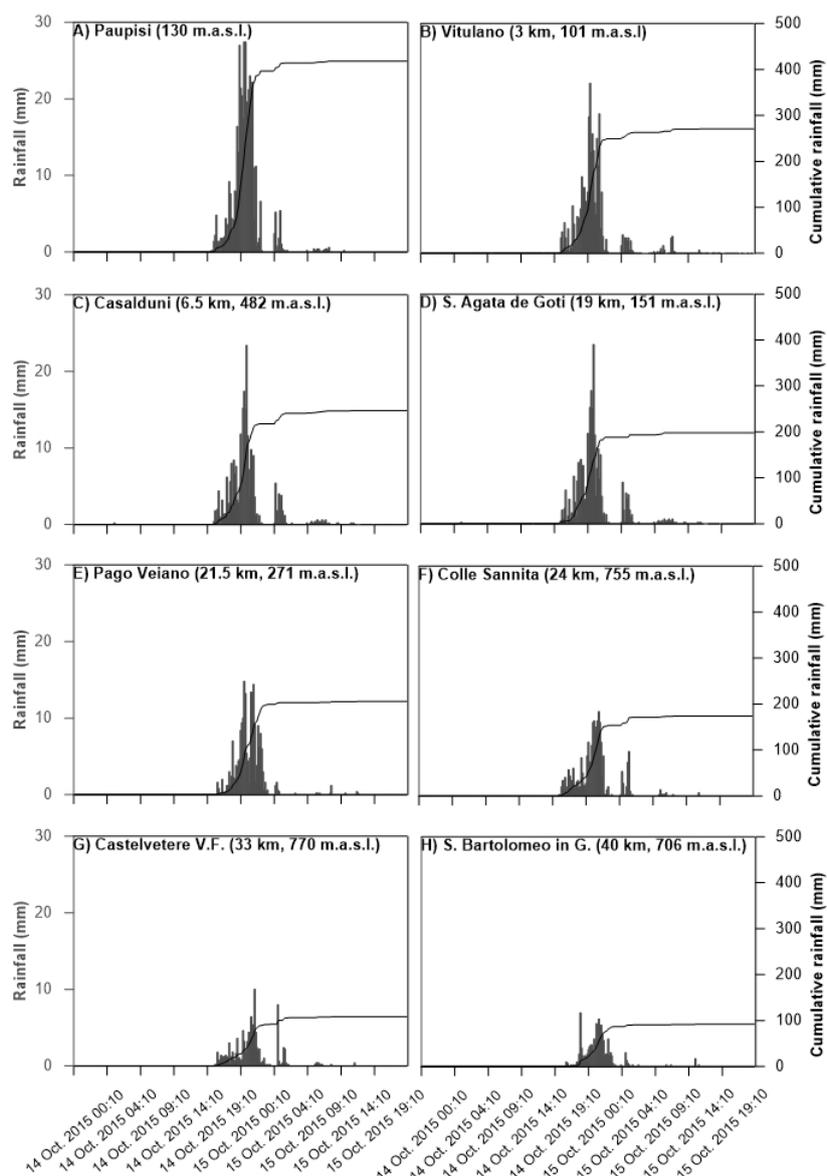
Figure 3. Ten-minute and cumulative rainfall registered during the event on 14–15 October 2015 by some significant stations, starting from the maximum peak of intensity (Paupisi). See Figure 2 for station locations. (A) Paupisi (130 m a.s.l.); (B) Vitulano (3 km, 101 m a.s.l.); (C) Casalduni (6.5 km, 482 m a.s.l.); (D) S. Agata de Goti I. (19 km, 151 m a.s.l.); (E) Pago Veiano (21.5 km, 271 m a.s.l.); (F) Colle Sannita (24 km, 755 m a.s.l.); (G) Castelvetere V.F. (33 km, 770 m a.s.l.); (H) S. Bartolomeo in G. (40 km, 706 m a.s.l.).

During the first storm, rainfall was particularly intense in Paupisi (Figure 3A), but because the available monitoring time series from the Paupisi station covers only the last few years, the data are insufficient for a valid statistical treatment. However, consideration of the entire geometrical and morphological characteristics of the Calore catchment indicates that the flood events in the Benevento city were induced by the rainfall in the Tammaro river catchment. It is very likely that the flooding event downstream of the town was amplified by the huge amounts of rain in the Paupisi area.

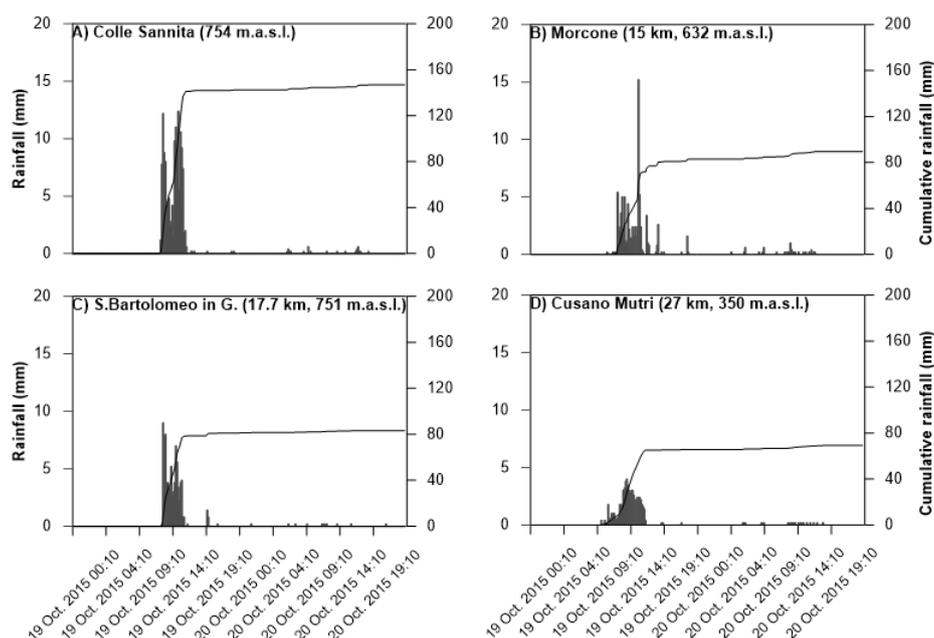
Figure 4. Ten-minute and cumulative rainfall for the event on 19–20 October 2015 recorded by some significant stations, starting from the maximum peak of intensity (Colle Sannita). See Figure 2 for station locations.

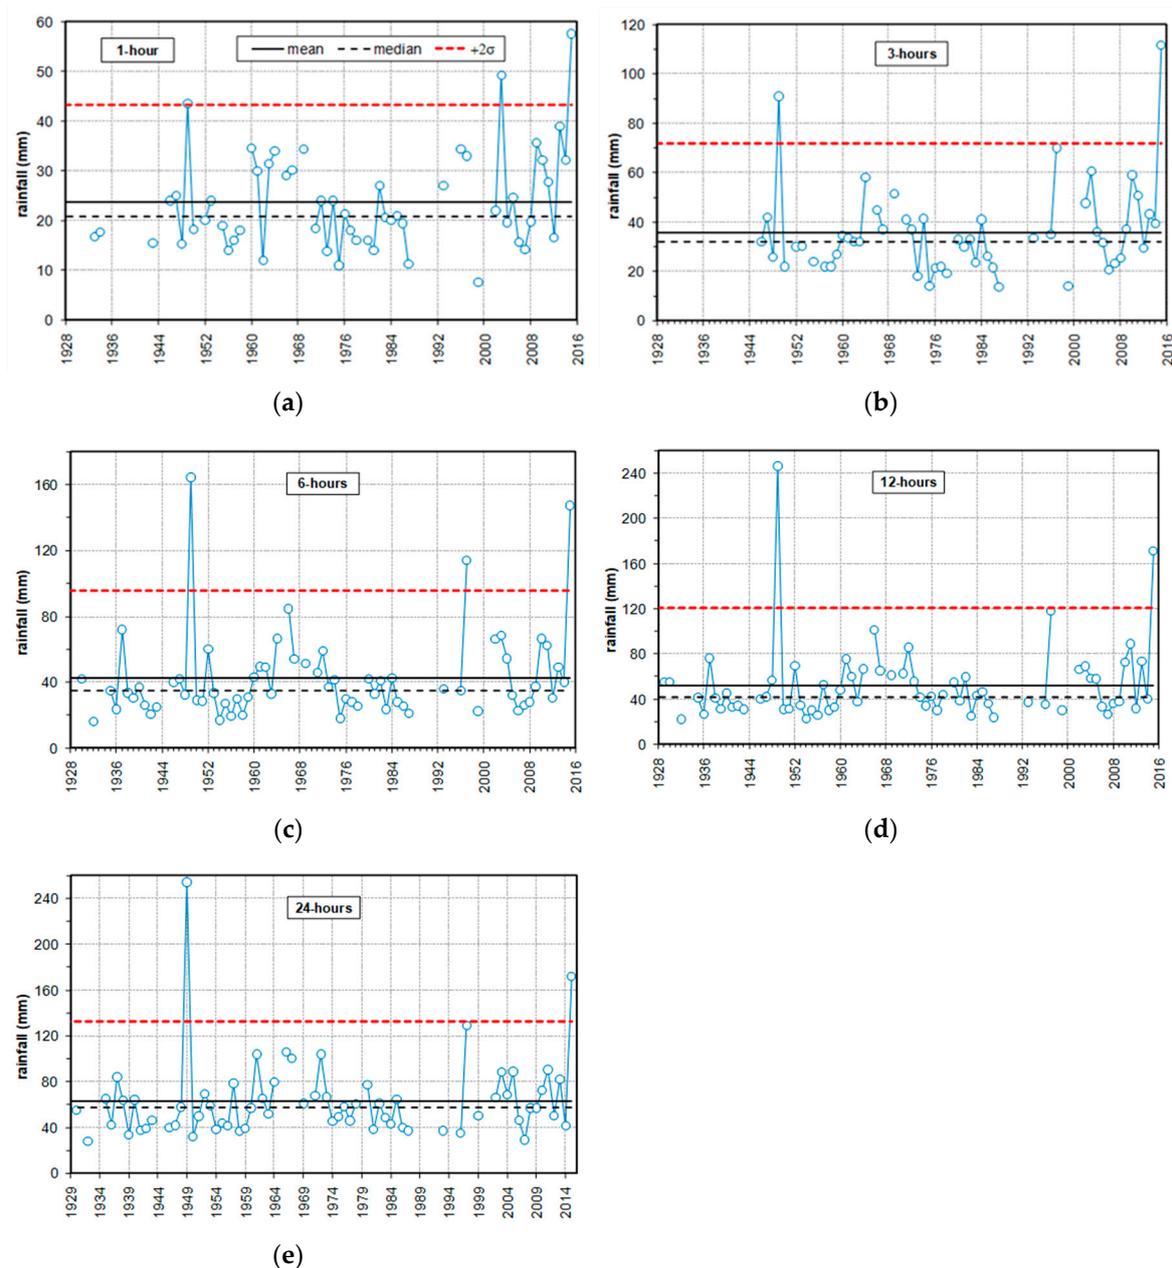
Figure 5. Time series of annual rainfall maxima in 1, 3, 6, 12, and 24 h (a–e) from the S. Croce del Sannio rain gauge (724 m a.s.l., from 1929 to 1999) and the Colle Sannita rain gauge (740 m a.s.l., from 2002 to 2015). The mean, median, and mean +2 standard deviations ($+2\sigma$) are also shown. Some data are missing.

Figure 5 shows the time series of annual maxima of rainfall occurring in 1, 3, 6, 12, and 24 h; the mean, the median, and the mean plus two standard deviations ($+2\sigma$) are also plotted. For maxima in a 3-h period, the storm of 2015 was the most intense in the historical series. For rainfall maxima in longer periods (6, 12, and 24 h), the storm of 1949 was the most intense. Both the 1949 and 2015 storms exceed the $+2\sigma$ value for all of the time series (maximum rainfall in 1, 3, 6, 12, and 24 h). In particular, the storm of 2015 has the maximum deviation from the mean rainfall for the 3-h duration ($>4\sigma$); the deviation is also high for rainfall accumulated in 6 h ($>4\sigma$). The storm of 1949 reaches the maximum deviation from the mean for the rainfall durations between 6 and 24 h; for a rainfall duration of 12 h, it has a deviation of $>5\sigma$.

In the plot of actual data in Figure 5, the deviation from the mean is smaller for the highest values, and it is directly expressed as the Z value. In the transformed series in Figure 6b, values that exceed 2 have a probability of occurrence of less than 0.023. In hydrology, Z values that exceed 2 are typically regarded as extreme events; for example, this classification is used for the drought categories defined by the SPI (Standard Precipitation Index [36]) [31]. The other categories—severe for $1.5 \leq Z < 2$, moderate for $1 \leq Z < 1.5$, and mild for $0 \leq Z < 1$ —are similar to those of the SPI in [36].

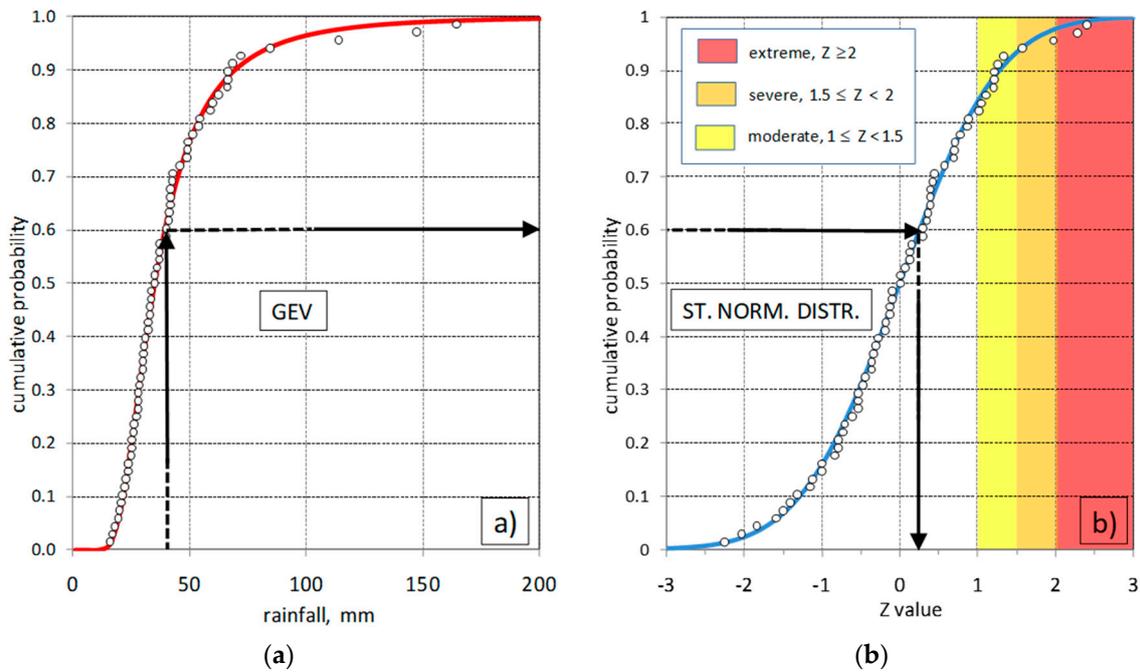
Figure 6. (a) Six-hour rainfall data series plotted by the Weibull formula and fitted by the Generalized Extreme Value (GEV) distribution; (b) cumulative probability transformed into the Z value of the standard normal distribution transformation.

Figure 6a shows the GEV function found by Equation (1) for annual rainfall maxima in 6 h; the actual data are plotted by the Weibull formula (Equation (2)). The cumulative probability calculated by the GEV frequency distribution (Equation (1)) was transformed into the Z value of the standard normal distribution (Figure 6b), resulting in a symmetric series with a zero mean and a standard deviation equal to 1 [31].

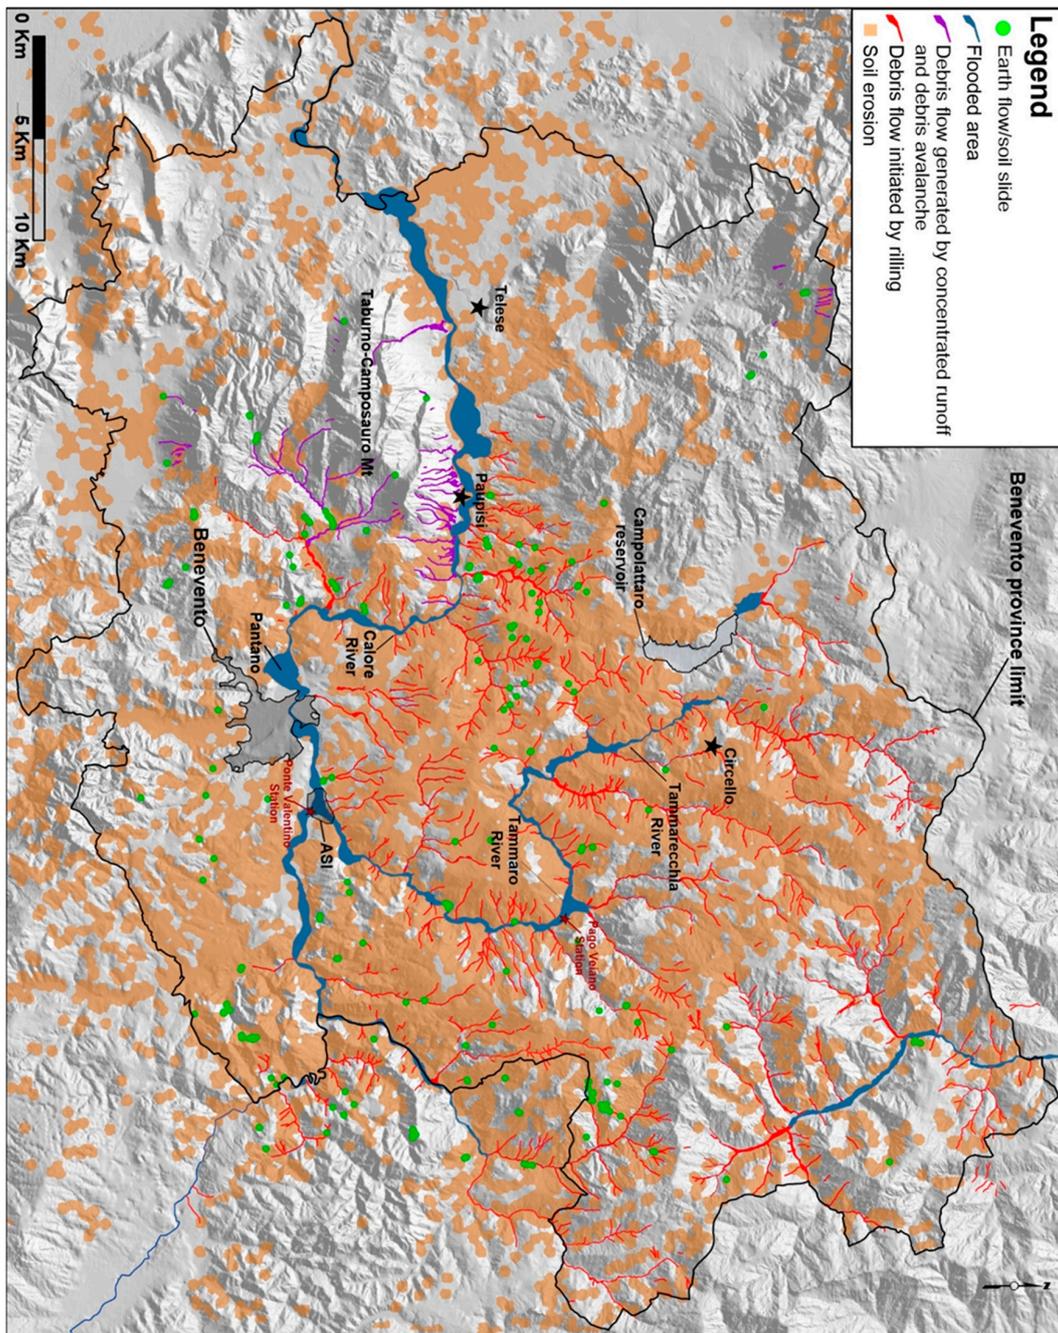
Figure 7. Inventory map of the hydrogeological effects of the storms on 14–15 and 19–20 October 2015 in the Benevento province.

An inventory map of the flooding and hillslope processes produced by the storms was compiled for the whole province (Figure 7) to reconstruct their distribution pattern. Table 2 summarizes the morphometric characteristics and features of the effects that were inventoried in the study region.

As shown in Figure 7, erosional processes occurred extensively throughout the whole province, even though they were concentrated around the NE–SW axis of the storm. Figure 7 is a comprehensive map of both the linear and surface erosion that resulted from the two storms. The soil erosion in the map includes sheet, rill, and gully erosion, resulting in a total affected area of about 930 km². Most of the affected area is devoted to agricultural use, especially for the production of wine, oils, and cereals.

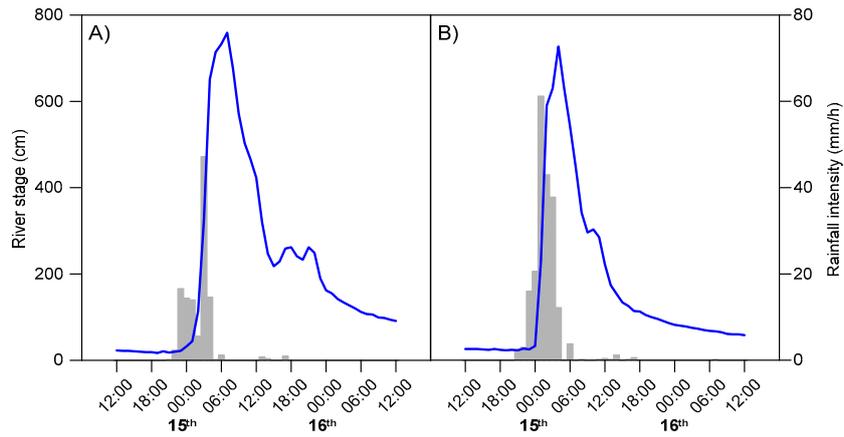
Figure 8. Storm hydrographs of the (A) Ponte Valentino (close to the ASI area) and (B) Pago Veiano stations. Figure 7 shows the station locations.

The first storm caused the overflow of the Calore River and had a sudden peak induced by the water received from the Tammaro River—a right-bank tributary—and by the minor tributaries upstream and downstream of the town of Benevento. Upstream, the overflow started in the middle course of the Tammaro River and propagated along the segment of the Calore River that crosses the city of Benevento. At almost the same time, inundations occurred along the middle-lower course of the Calore before the propagation of the flood wave upstream (Figure 7). The evolution of the process was partly influenced by the lamination effect of the Campolattaro dam. The rivers' responses were very rapid according to a comparison of the rainfall data and water stream levels registered by the Ponte Valentino and Pago Veiano monitoring stations, which are respectively located next to the confluence between the Tammaro and the Calore rivers in the industrial area and along the lower course of the Tammaro river (see Figure 7 for location). The storm did not damage these two stations. The Ponte Valentino storm hydrograph (Calore River) shows a lag time of about 4 h (Figure 8A), while the Pago Veiano storm hydrograph (Tammaro River) indicates a lag time of about 3 h (Figure 8B). From these lag times, the flooding event is defined as a flash flood. Additionally, the graph in Figure 8A indicates that, in the town of Benevento, the maximum stage and therefore the maximum extent of the area affected by the flood were reached at around 7:00 a.m.

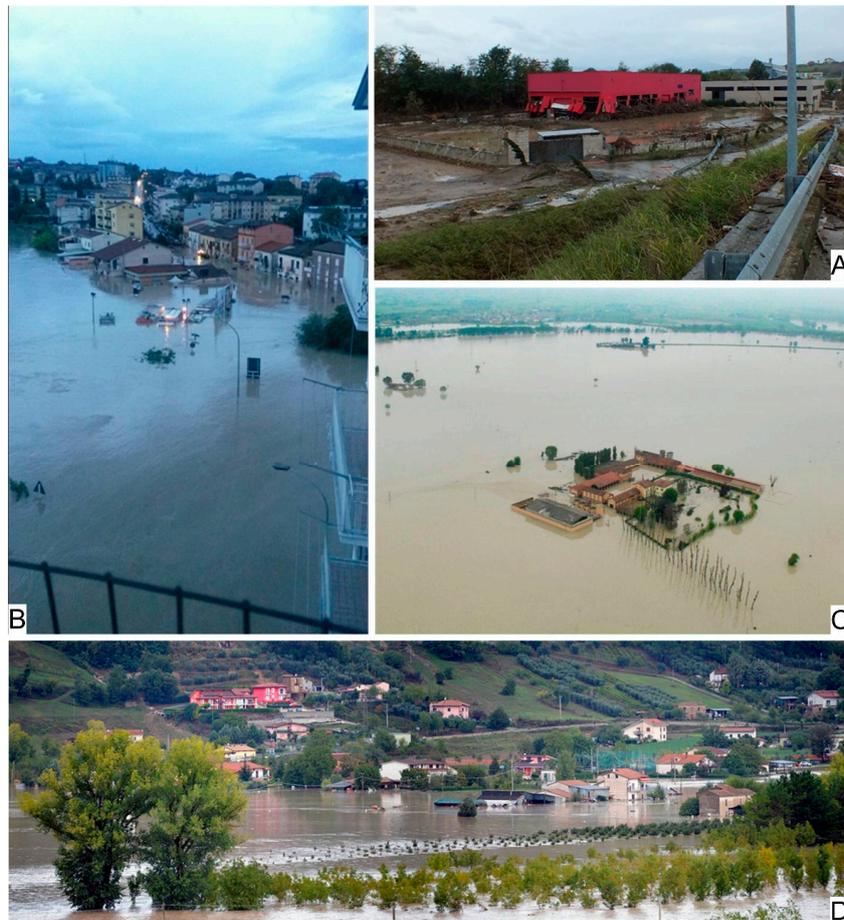
Figure 9. Overflow of the Calore river: (A) Damages in the industrial area of Benevento; (B) flooding at the “Ponticelli” locality, Benevento town; (C) and (D) flooding at the “Pantano” locality, Benevento town.

The overflow of the Tammaro and Calore rivers damaged Benevento’s industrial area, which is downstream and near the confluence of these two rivers. In this area, the water reached an estimated maximum level of 9.5 m [20] and destroyed important local infrastructures and factories (Figure 9A). Further downstream, some of the most damaged zones include a sector of the historical center of Benevento (Figure 9B) and the area named “Pantano” (Figure 9C,D), which means swamp—a clear reflection of its history.

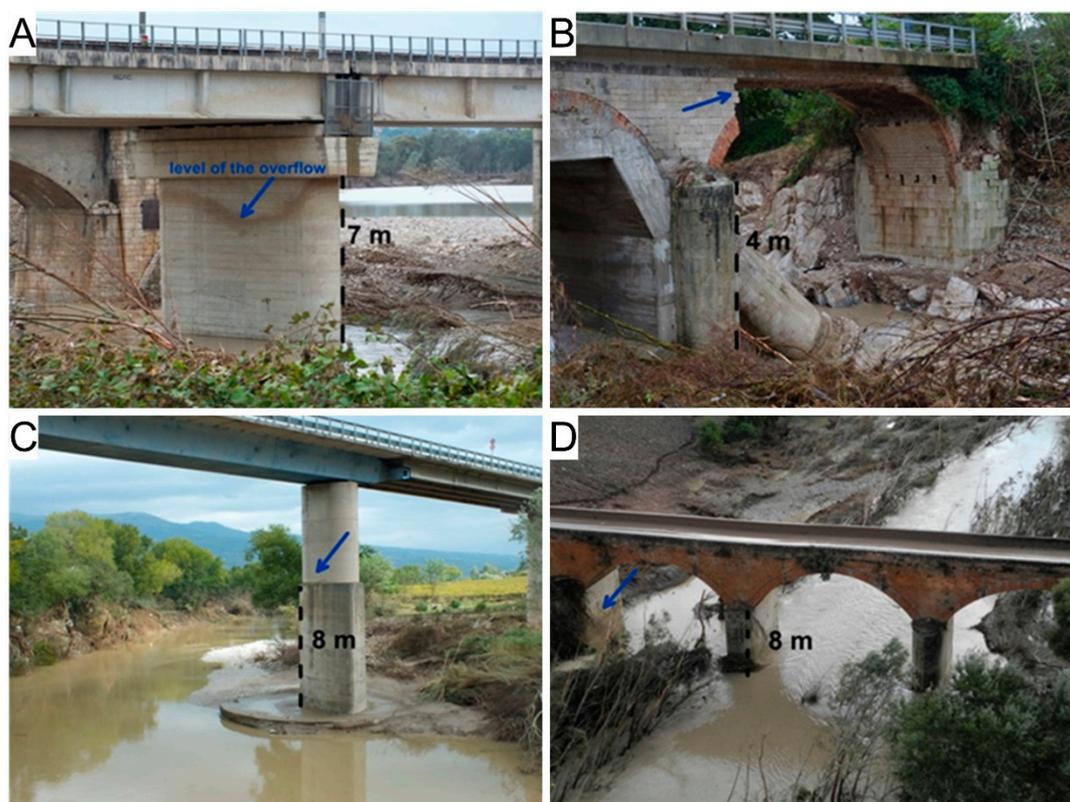
Figure 10. River stage during the overflow of the Tammaro and Calore rivers and Tammarecchia torrent, evidenced by flood marks on bridges, in different places across the Benevento province: (A) The Tammaro river in the industrial area (ASI) of Benevento; (B) the Tammarecchia torrent in Circello; (C) the Calore river in Paupisi; (D) the Tammaro river southwest of Circello.

The flooded area was mapped by comparing satellite images taken a few days after the events of 15 October with available images taken prior to the storm. The highest water level recorded was established using field surveys and measurements, such as the evidence of flood marks on bridges (Figure 10). The highest values (also according to specific morphologies) are over 9 m in the riverbed areas, while, in the flooded areas, the water level reached values higher than 3 m. Overall, the flooded area along the course of the Calore River amounts to about 43 km², of which about 2.0 km² is urbanized.

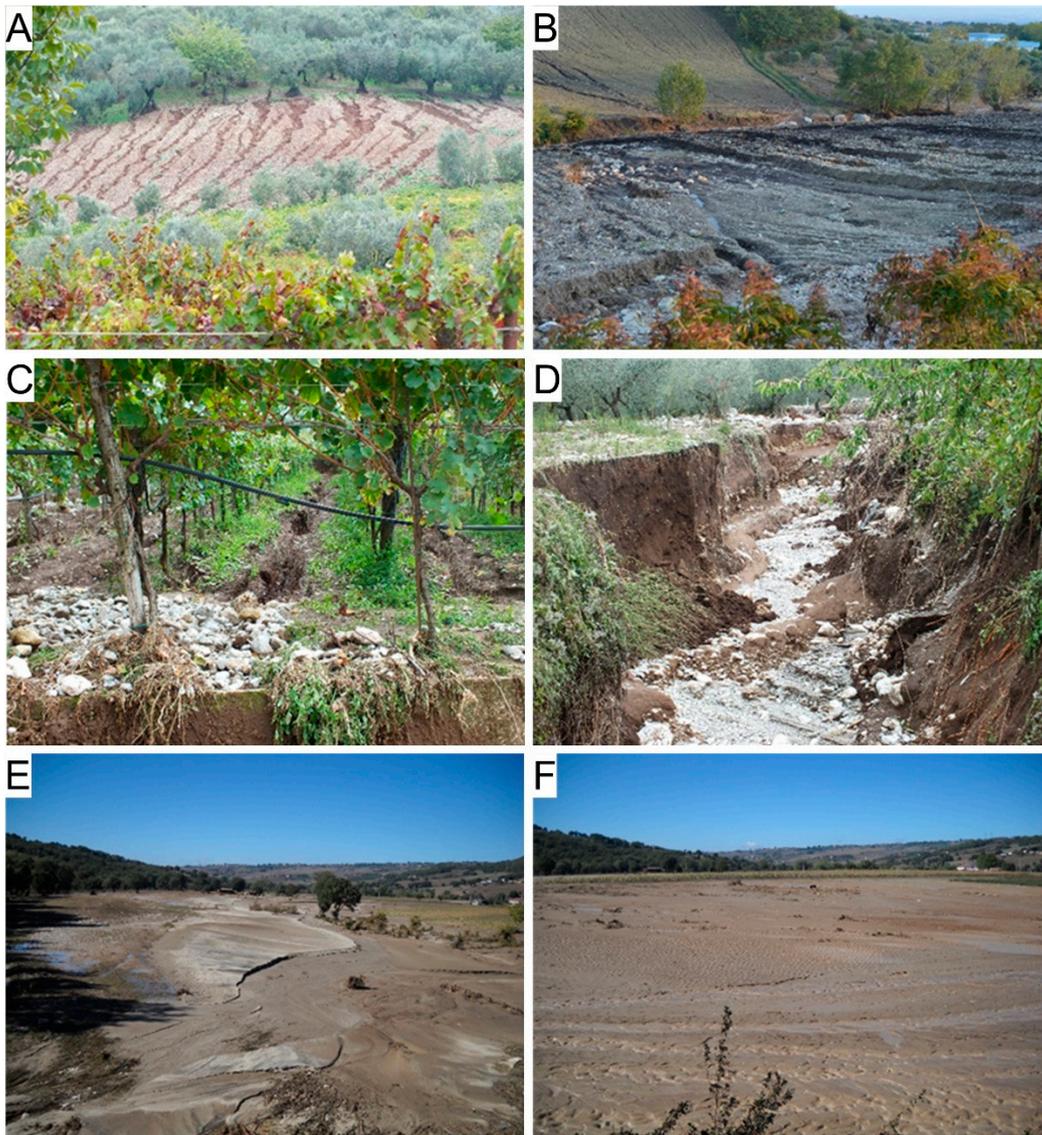
Figure 11. Erosional processes along slopes and floodplains: (A) Concentrated rill erosion; (B) rill and sheet erosion on a cultivated slope; (C) gully erosion in a wine groove; (D) gully erosion along a pre-existing channel; (E) erosive flooding on a floodplain; (F) sediment deposition along the floodplain.

The combination of the two intense rainy events, which occurred during the autumnal plowing of fields (when their susceptibility to erosive phenomena is at a maximum), produced evidence of micro- and macroscale soil erosion, as well as morphological and topographic changes to the ground surface. The erosional processes were more severe where flyschoid and clayey sequences crop out. Field analysis showed that, in many cases, soil erosion removed approximately 20–50 cm of soil as a result of the development of rills (Figure 11A), sheet (Figure 11B), and gullies (Figure 11C). Gully erosion occurred consistently along pre-existing channels, which enlarged and deepened by up to 1.5–2.0 m (Figure 11D). Erosive flooding and sediment deposition on floodplains were also observed along the main river courses that were subjected to floods (Figure 11E,F).

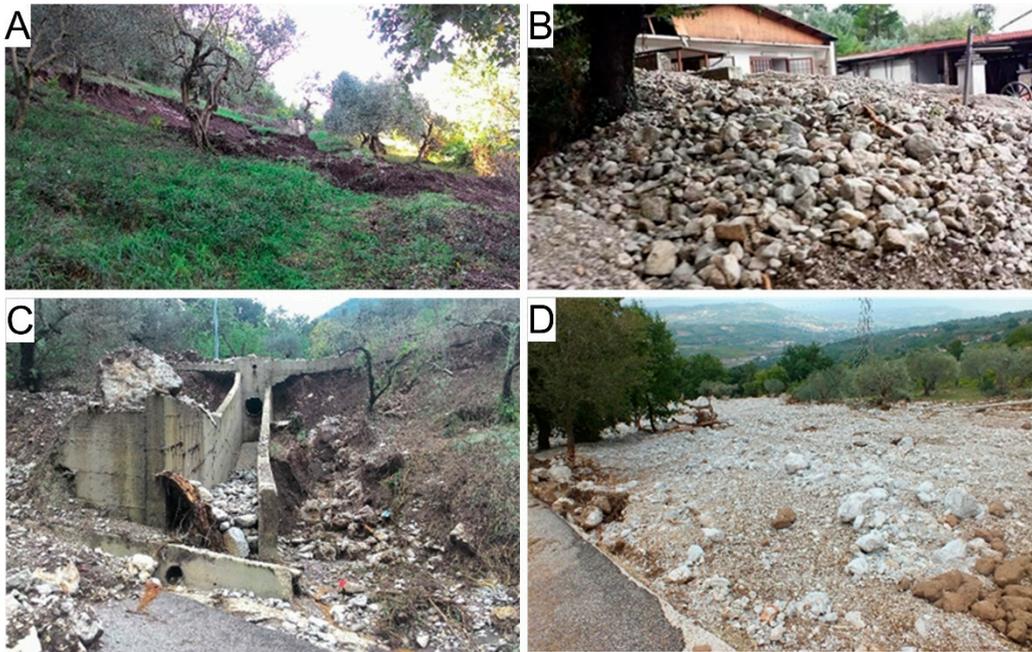
Figure 12. Slope instabilities triggered on slopes: (A) Earth flow; (B) runoff-generated debris flow in the town of Paupisi; (C) poorly sized work in a channel; (D) runoff-generated debris flow deposit.

Earth flows (1) include both first-order and reactivated landslides that were identified by field surveys and a comparison between pre- and post-event Google Earth images (Figure 12A). It should be noted that because of the limited extent of most earth flows and for scaling requirements, the map in Figure 7 shows only their location, and no morphometric parameters or detailed maps of earth

crossings or other linear infrastructures (Figure 12C). In this context, the triggering mechanism was similar to that which occurs in an alpine environment e.g., [40,41]. Segments of the debris flow source channel were located between 350 and 1000 m a.s.l. and had slope angles of 10–40° on the northern slope and around 20° on the southern slope. After entering the gullies, debris flow traveled for hundreds of meters; the travel path length ranged between ~100 and ~7800 m. Some debris flows triggered along the northern side of the Taburno-Camposauro Mt. reached the Calore River and provided readily available sediment for fluvial transport. These debris flows deposited parts of the coarse material in cultivated fields (Figure 12D) that are located at the base of the slope. Other parts reached the SS322 national road.

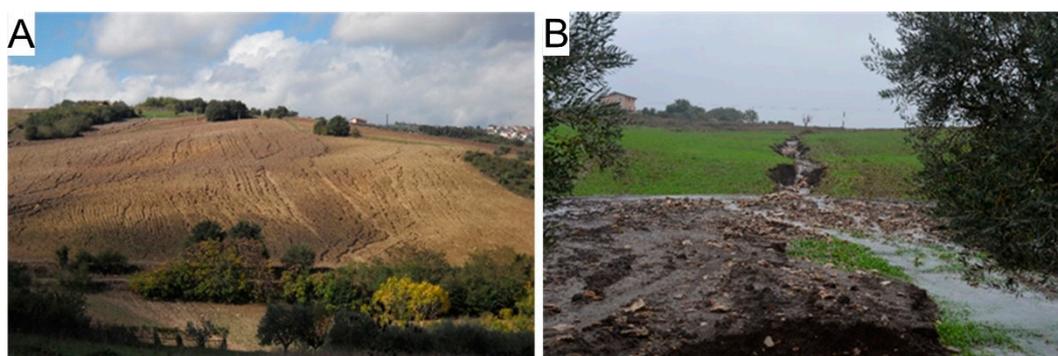
Figure 13. Debris flows initiated by rilling: (A) Coalescing rills; (B) eroded gully and initial part of debris depositional fan area.

Debris flows initiated by rilling (ii) were mainly located in the eastern sector of the study area on clayey and gentle hillslopes. As is well known, rills are typically linear erosional landforms (i.e., microchannels) with a maximum width and depth of a few tens of centimeters [42] generated by the activity of flowing water. Moreover, they are ephemeral features that tend to disappear soon after their formation [39]. Field observations indicated that the source area of each debris flow was characterized by a specific spatial organization of coalescing rills (Figure 13A). Our interpretation of the process is that the coalescence of more rills flowing in a pre-existing or newly formed creek induced erosional processes at the gully head that propagated downstream, leading to the development of the debris flow. Debris flow development reshaped the gullies with drastic changes in geometry that induced sediment transport downstream (Figure 13B) and the formation of very thin and large debris fans (Figure 3B). Field observations indicated that the thickness of the debris fan varied from tens of centimeters to around 1 m. The thickness of the eroded material and gully deepening was greater than 1 m. All mapped debris flows initiated by rilling occurred on clayey and flyschoid slopes characterized by very low slope angles (5–15°), and the runout distances ranged from a few tens of meters to a few kilometers and seem to be related to the availability of erodible material and the slope morphology.

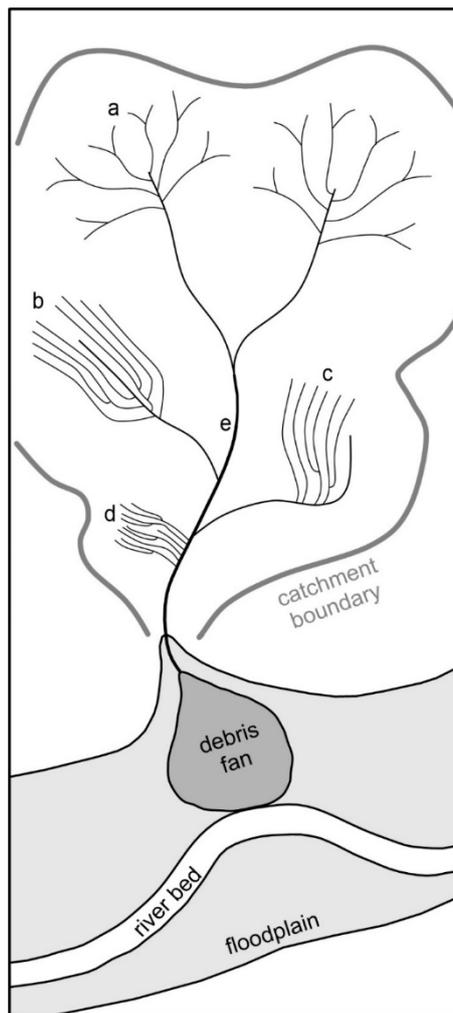
Figure 14. Schematic reconstruction of typical morphological structures of coalescent rills that induce debris flows identified in the study area: (a) Dendritic arrangement; (b) subparallel rill systems, parallel to the direction of the main creek; (c) subparallel rill systems, orthogonal to the main creek; (d) subparallel rill systems, directly flowing into a high-order gully (e).
