# Physical Modeling for Large-Scale Landslide with Chair-Shaped Bedrock Surfaces under Precipitation and Reservoir Water Fluctuation Conditions

**Keywords:** physical modeling; chair-shaped bedrock surface; pore water pressure; rainfall; reservoir water fluctuation conditions

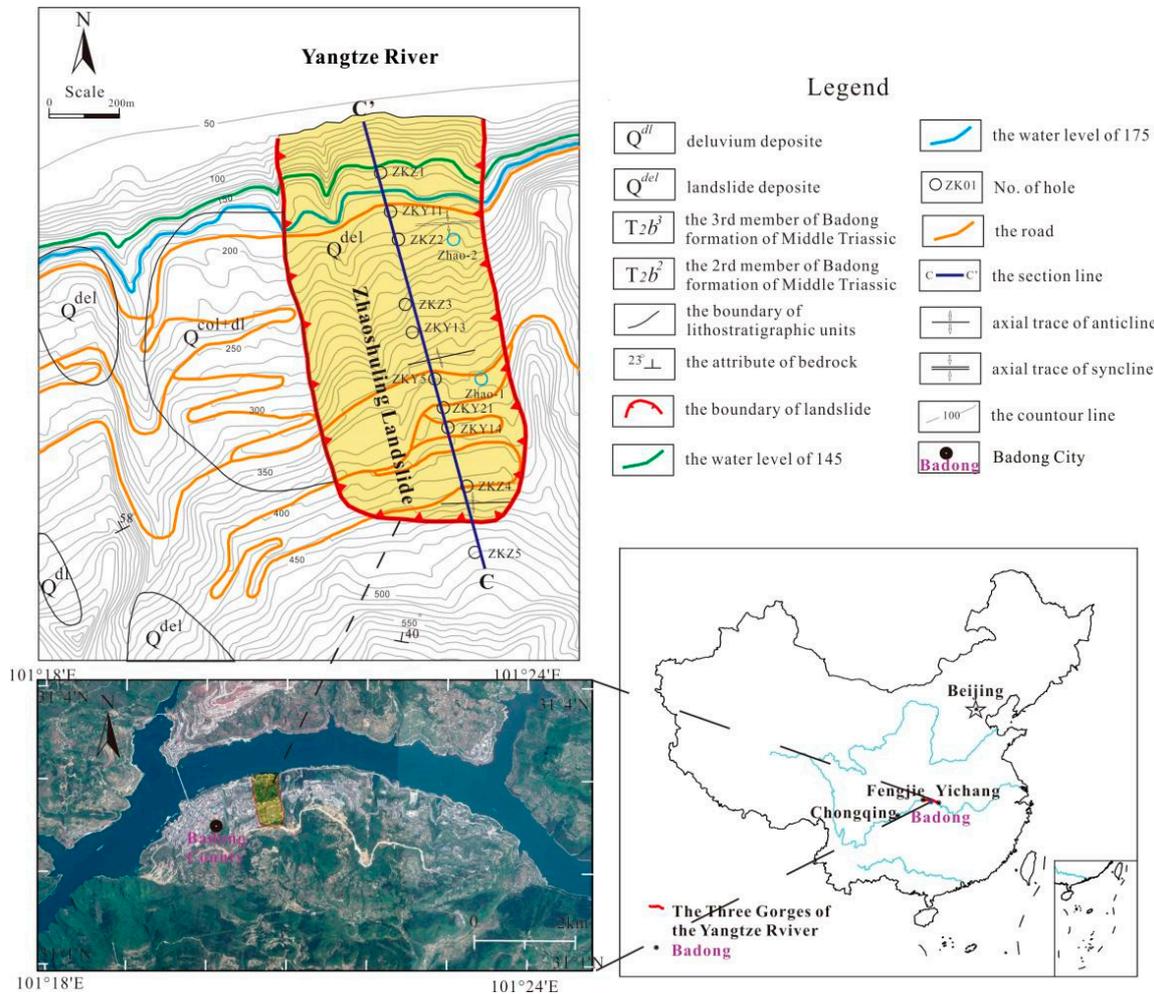
Figure 1. Engineering geological map of the Zhaoshuling Landslide.

China's Three Gorges Region covers 193 km of the middle reaches of the Yangtze River between Fengjie in Chongqing City and Yichang in Hubei Province (as shown in Figure 1). Due to the steep valley-side slopes and long periods of river incision, a large number of landslides have been formed in the Three Gorges Reservoir area, of which more than 90% have been reactivated ancient landslides [1,2]. The Qianjiangping Landslide, which is a famous historical landslide, was reactivated at first by tentative impoundment combined with heavy rainfall and collapsed on July 14th of 2003. This disaster event resulted in major losses of lives and property [3–5]. The Liangshuijing Landslide in Yunyang, which is another ancient landslide, had also displayed intensified deformations in April of 2009, threatening many households located on the sliding body, as well as the shipping processes of the Yangtze River [6–8]. In order to prevent such tragedies and danger risks in the future, examinations of the potential revivals of ancient landslides in reservoir areas have received increasing attention in the field of engineering geology and geotechnical mechanics.

to 425 m, and 475 to 500 m, respectively, can be observed along the longitudinal direction. Figure 1 provides a landscape photograph of the Zhaoshuling Landslide area, as well as the locations of exploratory boreholes. The highest platform is located at the rear of the landslide area with a slope angle of  $10^\circ$  to  $15^\circ$ . The lower platform is located in the front of the landslide with a slope angle of  $10^\circ$  to  $20^\circ$ . Figures 2 and 3 present the plan and sectional views of the Zhaoshuling Landslide engineering geological conditions, respectively.

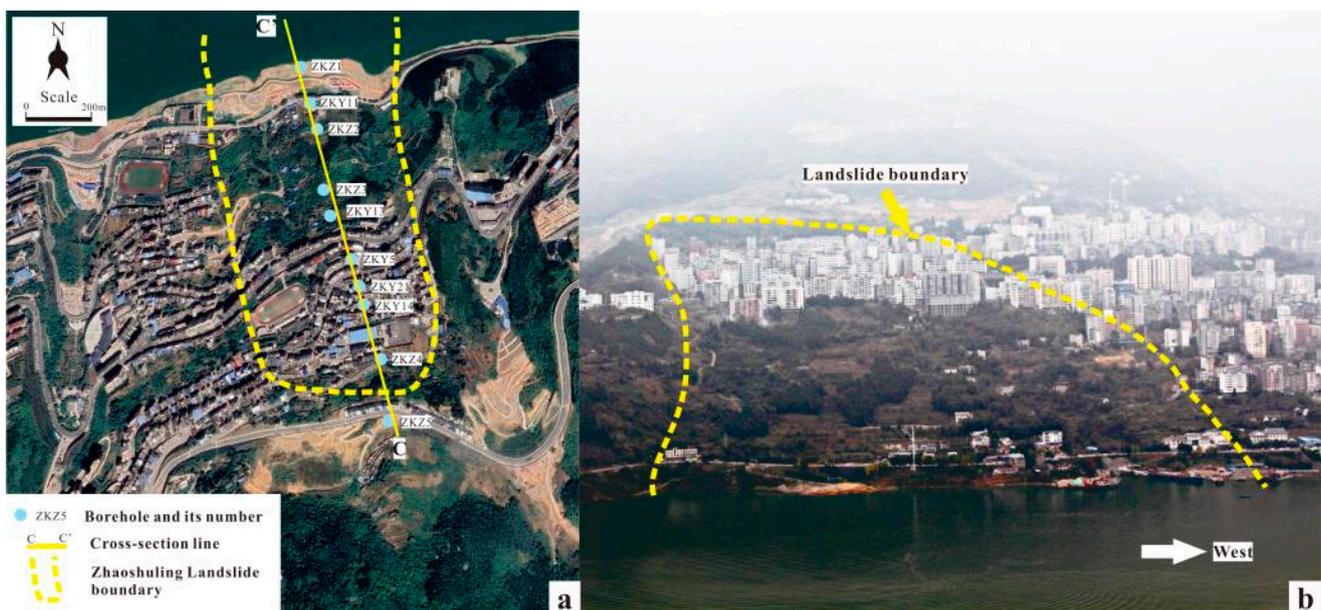
**Figure 2.** Landscape details of the Zhaoshuling Landslide. (a) Satellite image of Zhaoshuling landslide (17 May 2017, from Google Earth); (b) Zhaoshuling landslide photograph (16 November 2016).

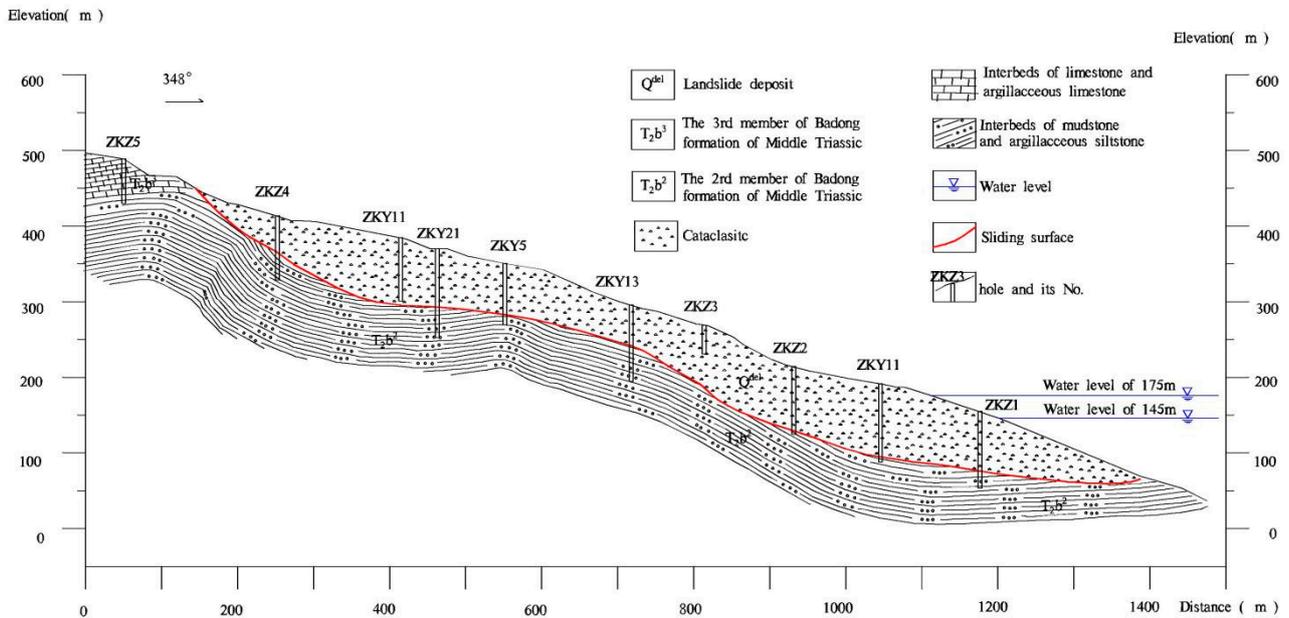
**Figure 3.** Engineering geological cross-section of the Zhaoshuling Landslide (C-C').

The Zhaoshuling Landslide moves along the interfaces of the  $T_2b^2$  and  $T_2b^3$  strata. The material of the sliding mass mainly consists of  $T_2b^3$  strata, with small amounts from the  $T_2b^2$  strata, and can be divided into two layers. The surface layer is mainly a khaki-brown soil-rock mixture, and subsurface mainly consists of quaternary landslide accumulation cataclastic rock masses, with most found to have retained the sequences of the original rock with layered structures. The lithologic characteristics of the bedrock have been determined to consist mainly of  $T_2b^2$  strata with purplish-red interbedded fine-grained argillaceous siltstone and silty mudstone. The sliding surface has been found to be composed of khaki disintegrated rock and gravelly clay, generally with thicknesses ranging between 0.3 and 0.5 m. The surface can be observed to be chair-shaped and is basically consistent with the relief of the local terrain.

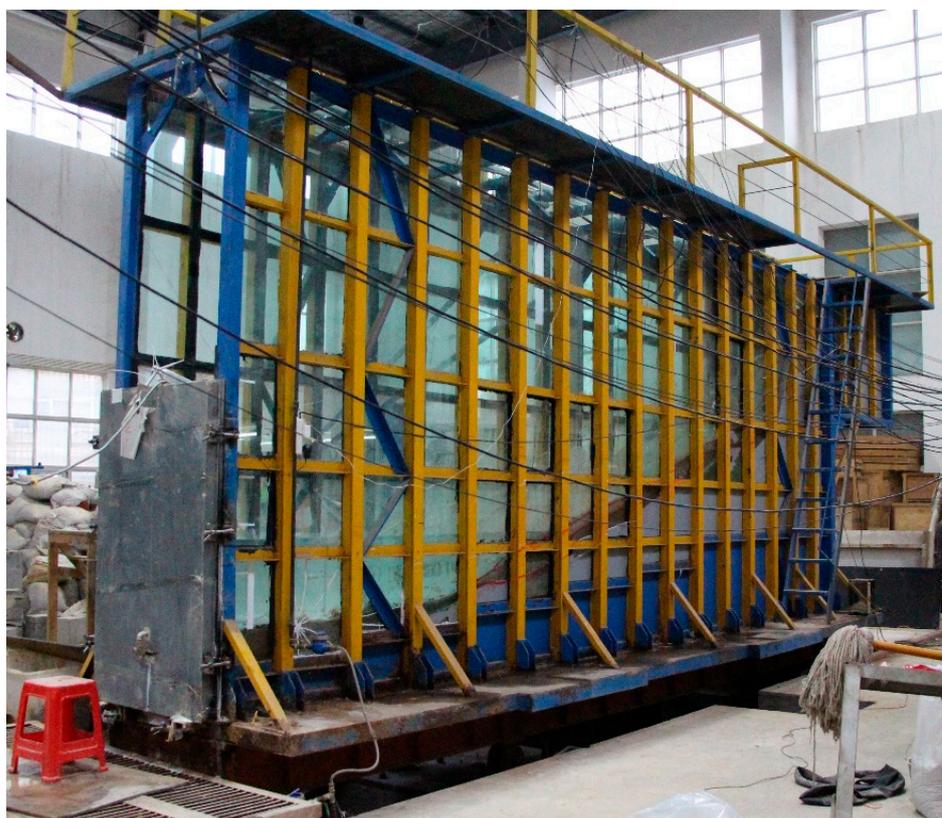
Figure 4. Landslide model test system.

In the present study, a large gravity model test system was constructed, as shown in Figure 4. The test system was manufactured and operated by the China Three Gorges University, Key Laboratory of Geological Hazards on Three Gorges Reservoir Area, and the Ministry of Education, Yichang, China. The test system consisted of a hydraulic control lifting system; reservoir water level control system; fixed-head water supply and drainage system; artificial rainfall system; and an observation and data acquisition system, as detailed in Figure 5.

The model box size measured 8.0 m (length)  $\times$  0.8 m (width)  $\times$  3.5 m (height). The sidewalls were smooth and transparent so that the deformations could be observed and recorded from either side of the model box. In addition, the base and side walls of the model box were reinforced with steel sections. The lifting system included hydraulic pressure jacks connected to the base of the model box. The maximum specified slope angle of the model box to the horizontal was 20°.

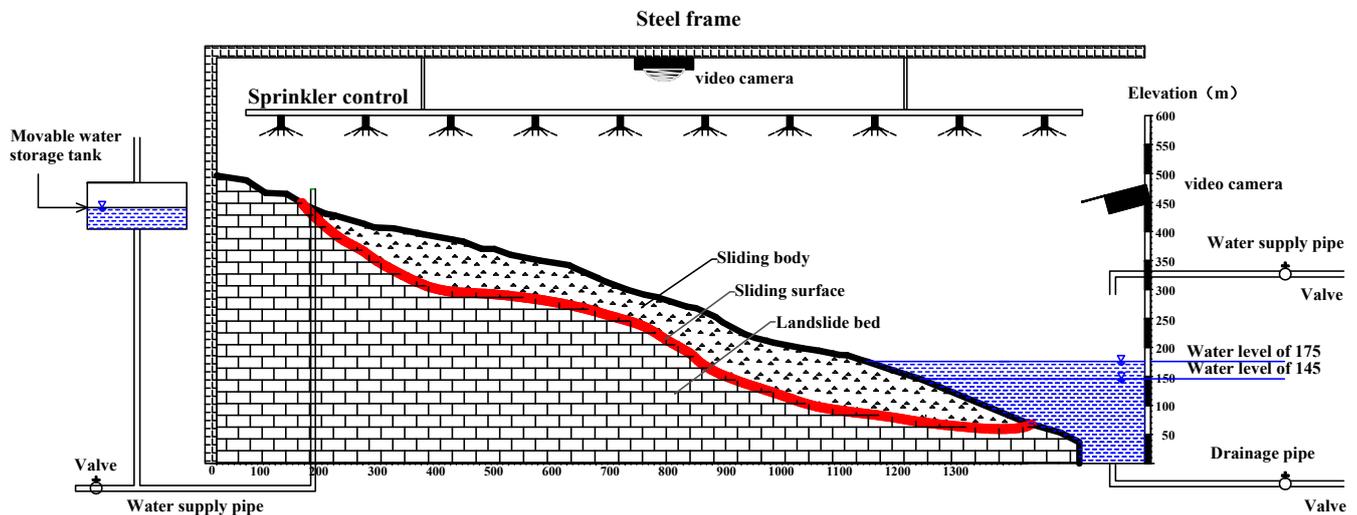
Figure 5. Geological simplified model of the Zhaoshuling Landslide event.

occur; and 2. Whether or not the deformations and failure of the upper sliding body had been affected by the undulating state of the lower sliding surface. It was believed that the answers to the aforementioned questions could be achieved using the monitoring and observational data of the displacements and pore water pressure levels at various locations in this study’s model during different time periods.

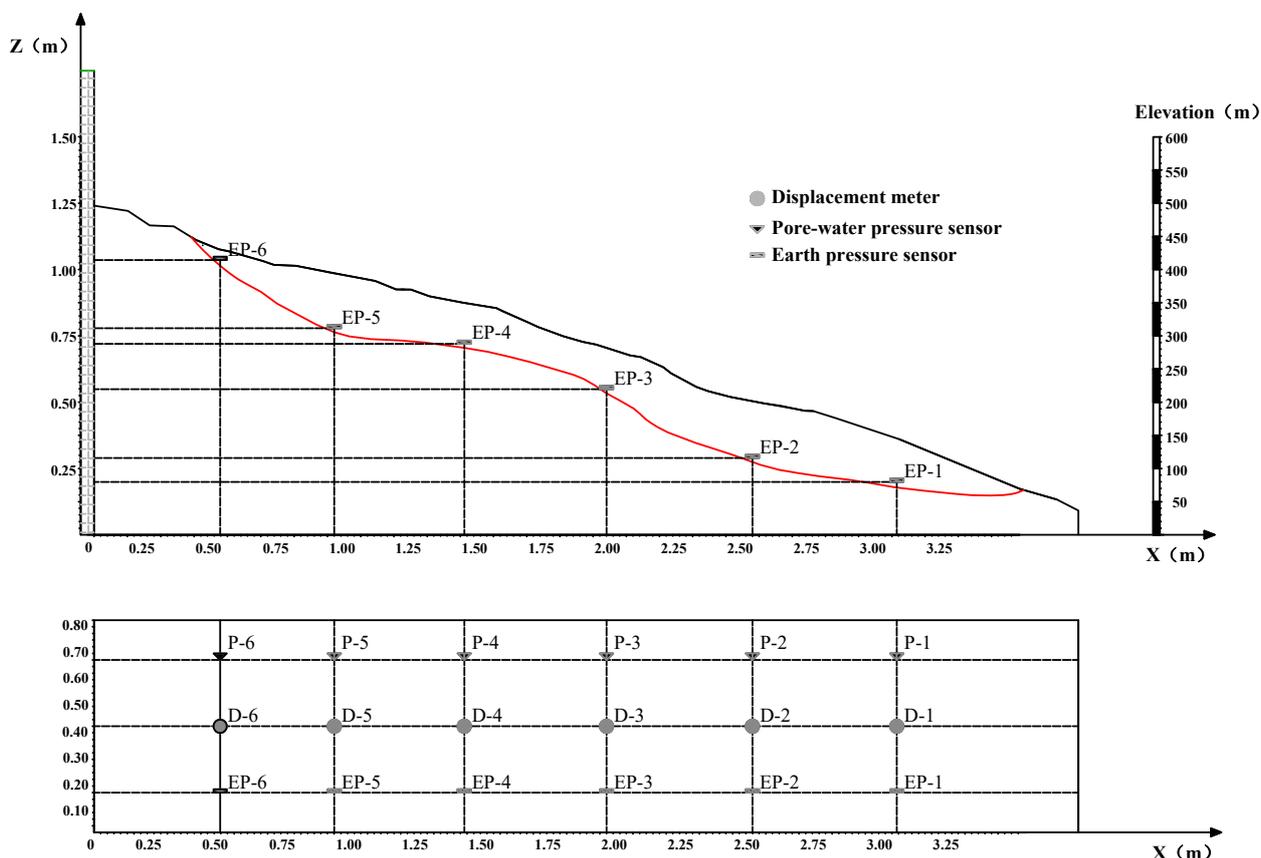
Figure 6. Monitoring layout of the test models.

Throughout this study's testing procedures, displacement meters, pore pressure sensors and soil pressure sensors were set into the large-scaled models, as presented in Figure 6. The details of the instrumentations are summarized in Table 2. All of the sensors were placed uniformly in the toe, middle, and rear zones. However, due to the small thickness of the sliding body in this study's model tests, the sensors were all arranged on the sliding surface, and the sensors in the same section were arranged in the same row. In addition, in

order to record the effects of the sliding surface geometry on the propagation of the landslide, one group of sensors (No. 2) was positioned on the concave part of the chair-shaped surface. Each instrument was calibrated prior to installation. All of the instruments inside the slope model were installed during the placement of the mixed materials. Furthermore, all of the electrical instruments were connected to a data-logger for the convenience of automatic data recording, and each of the entire testing processes were video-taped. Figure 7 illustrates the construction of the physical simulation models.

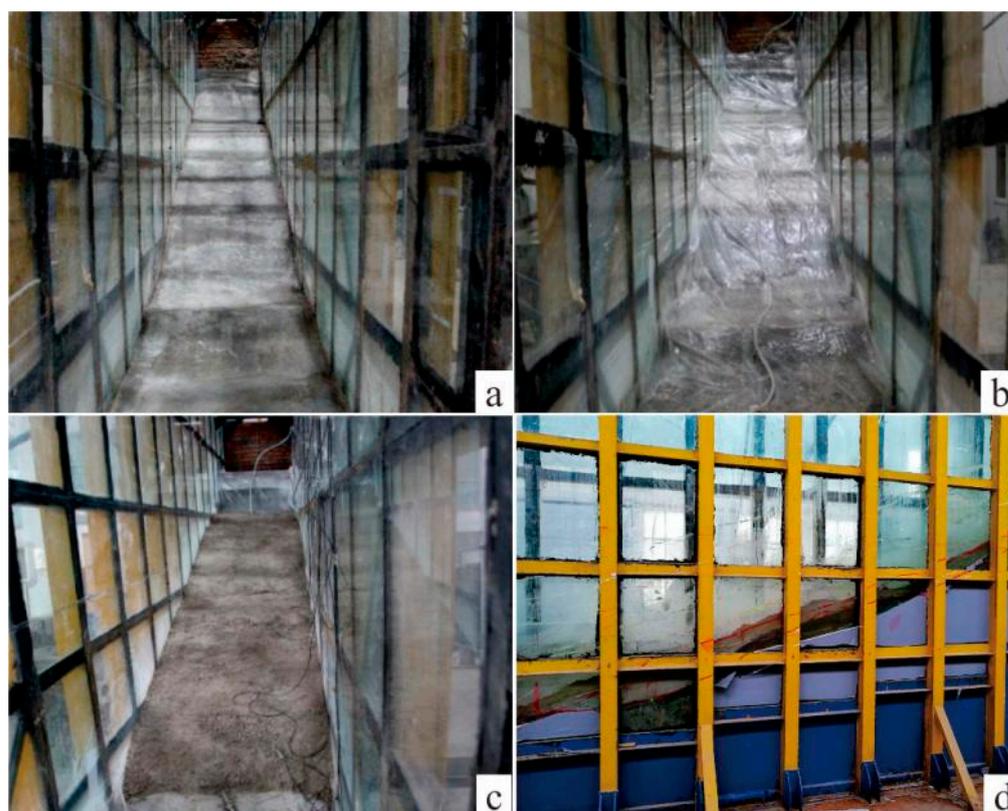
**Figure 7.** Construction of the physical simulation models: (a) Slide bed; (b) Slide surface; (c) Slide mass; (d) Entire model.

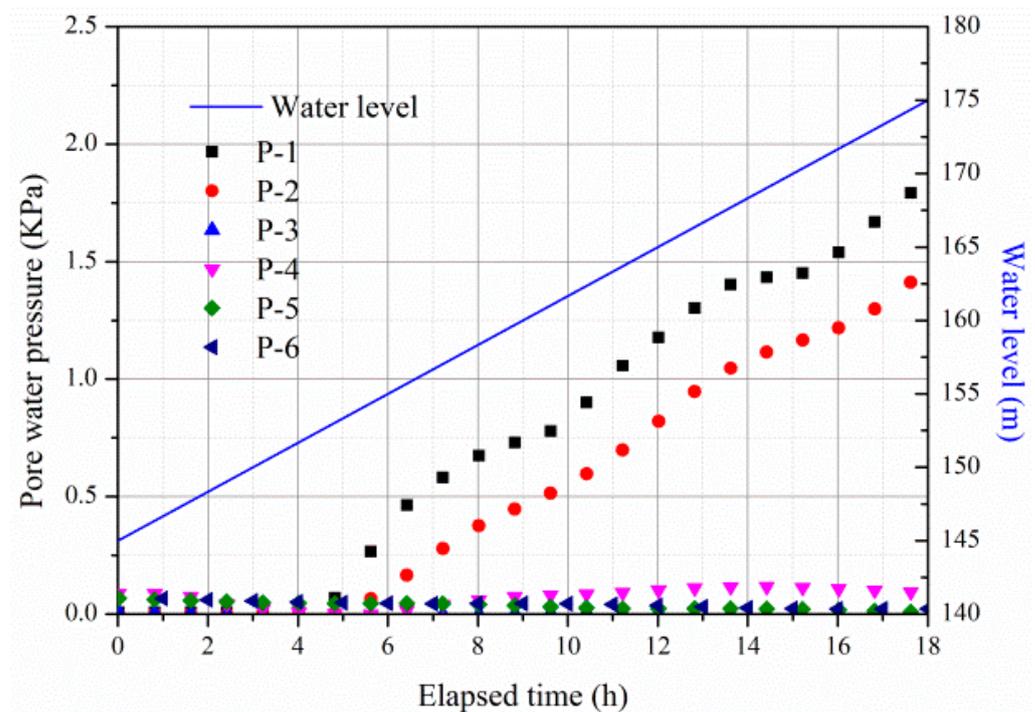
**Figure 8.** Pore water pressures during the rises in the water levels.

The pore water pressure levels measured in this study by the six piezometers are shown in Figure 8. The piezometers (labelled P-1, P-2, P-3, P-4, P-5, and P-6) were installed at the elevations of 0.2 m (80 m), 0.3 m (120 m), 0.55 m (220 m), 0.725 m (290 m), 0.775 m (310 m), and 1.025 m (410 m), respectively. It was observed that the pore water pressure levels measured by the piezometers at the different elevations displayed different results with time in response to the changes in the water levels.

At the beginning of the experimental process, it was observed that all of the pore water pressure sensors had displayed no responses to the rising water levels when the valve was switched on, allowing the water flow into the slope. However, when the reservoir water level had risen to 38.13 cm (corresponding to 152.5 m of real elevation), the P-1 piezometer had displayed a response. Following that, the P-2 piezometer located at an elevation of 30 cm was observed to respond to the reservoir water level changes at approximately five hours after the start of the experiment. However, there were no changes during the rising of the reservoir water levels according to the measurement results of the P-3, P-4, P-5, and P-6 piezometers located in the middle and rear areas of the landslide site. The pore water pressure levels of the P-1 and P-2 piezometers were confirmed to have increased linearly with the rising of the reservoir water levels.

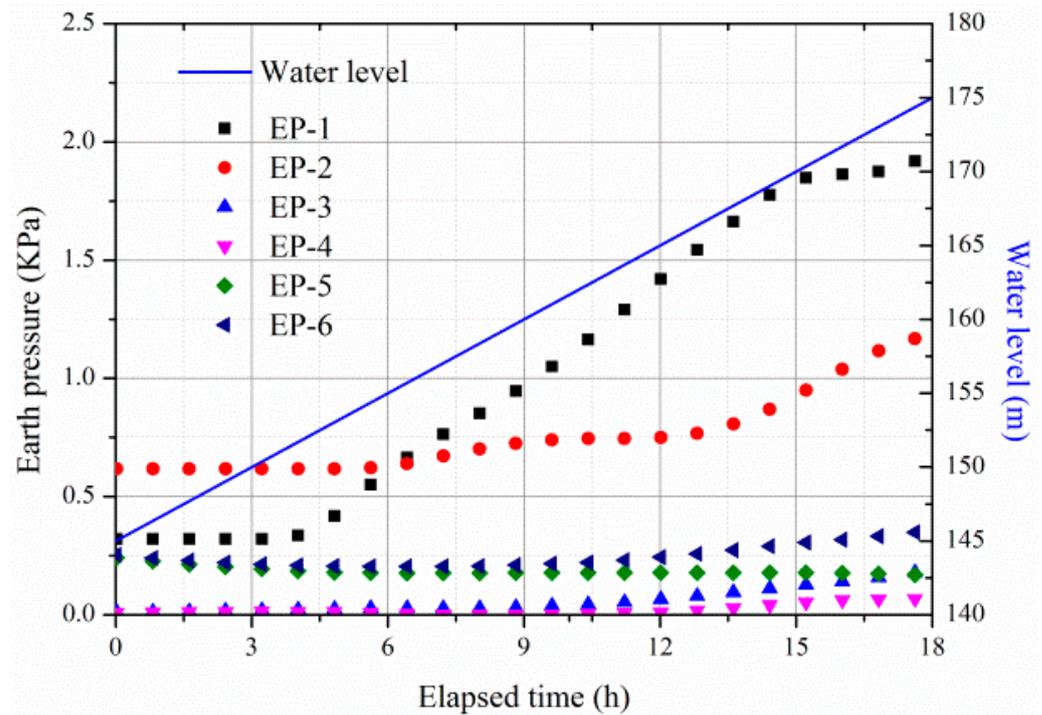
**Figure 9.** Soil pressure levels during the rises in the water levels.

Figure 9 shows the total stress values measured by the six soil pressure sensors installed in the slope model. The changes in total soil pressure levels were in response to the rising water levels. In addition, the slope seemed to have become more uniform as the water levels on the slope rose. Moreover, the total soil pressure seems to have been influenced by the water pressure levels, since the total soil pressure also increased with the rising water levels.

The soil pressure sensors EP-1 and EP-2 presented a similar general trend during the increase in water levels. For example, the total stress recorded by the EP-1 sensor increased from an initial value of 0.32 kPa to a final value of 1.94 kPa. Additionally, there was an incremental change of 1.62 kPa observed within 18 h following the commencement of this study's experiment. The total stress recorded by the EP-2 sensor increased from an initial value of 0.62 kPa to a final value of 1.18 kPa, with an incremental change of 0.56 kPa observed as the water level rose within the aforementioned 18 h period. However, the total stress recorded by the Ep-3, Ep-4, EP-5, and EP-6 sensors, which were located in the middle and rear zones of the slope model, were not found to change.

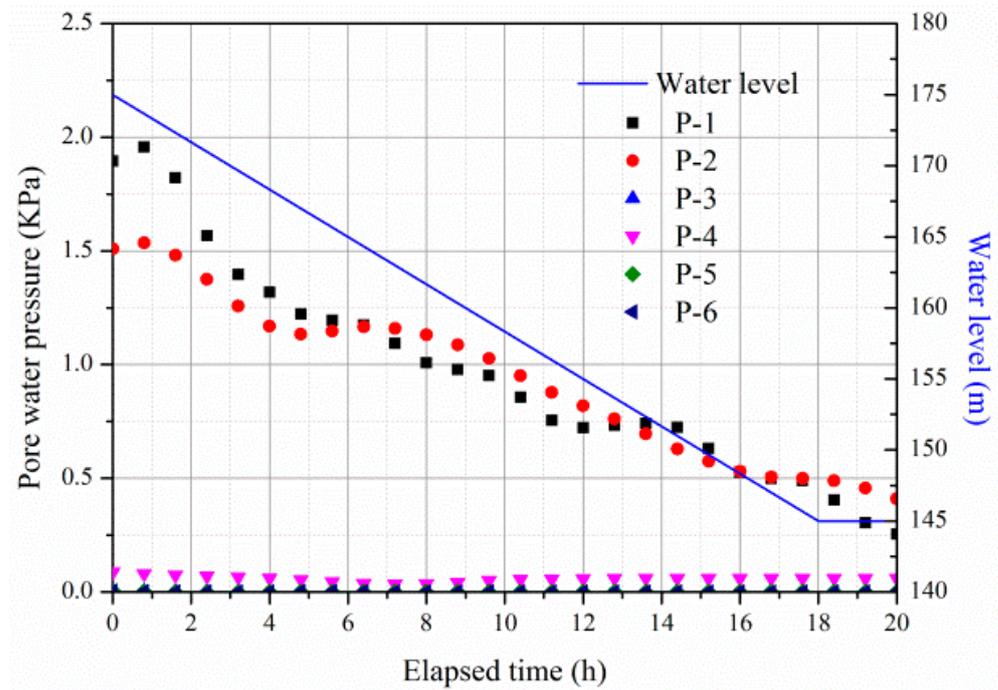
Figure 10. Pore water pressure levels during the water level lowering process.

Figure 10 details the pore water pressure responses with the water level changes recorded by the piezometers at different elevations. It can be seen in the figure that the pore water pressure levels of the P-1 and P-2 piezometers at the elevations of 0.2 m (80 m) and 0.3 m (120 m), respectively, showed a similar general trend during the lowering of the water levels. Furthermore, there was a small delay observed in the pore water pressure relative to the lowered water levels of the model slope. When the water levels of the slope were lowered by 0.075 m, the pore water pressure recorded by the P-1 and P-2 piezometers had decreased by 1.77 kPa and 1.18 kPa, respectively. However, it was found that the pore water pressure levels recorded by the other sensors located at the middle and rear zones of the slopes had displayed little change.

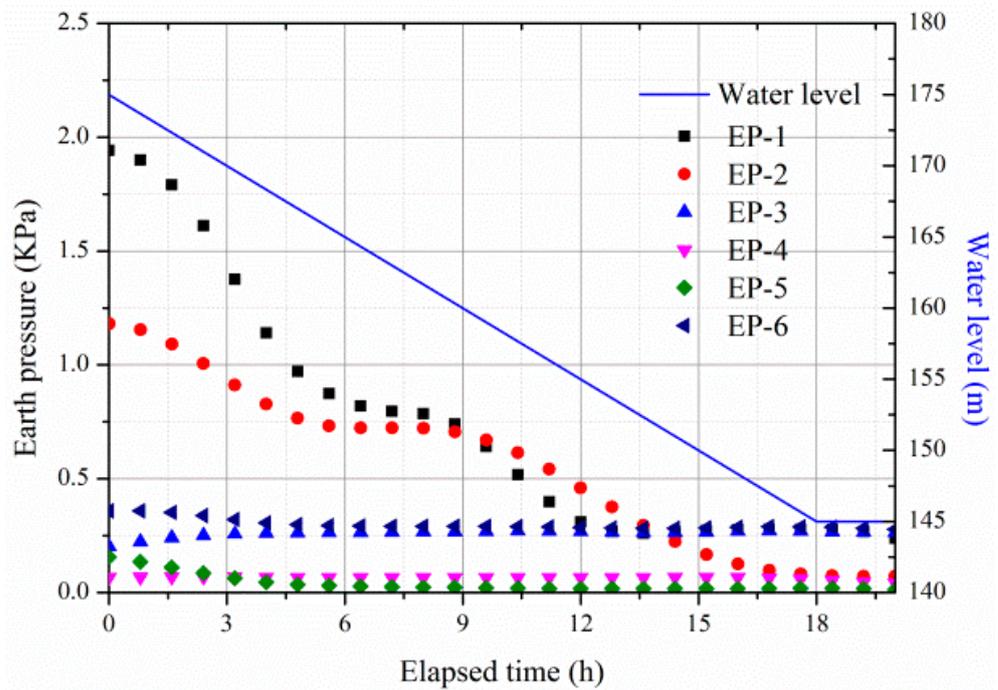
Figure 11. Soil pressure during the water level lowering process.

Figure 11 presents the results of the soil pressure levels measured by the six soil pressure sensors in response to the lowering water levels. The total stress of the soil pressure of the EP-1 sensor, which was located at 0.2 m in the slope, decreased from an initial value of 1.94 kPa to 0.17 kPa. In regard to the EP-2 soil pressure sensor, which was located higher than the EP-1 sensor, it was observed that the pressure had decreased from an initial value of 1.18 kPa to 0.07 kPa. Therefore, the decreasing trend of the total stress was found to be the same as that of the pore water pressure.

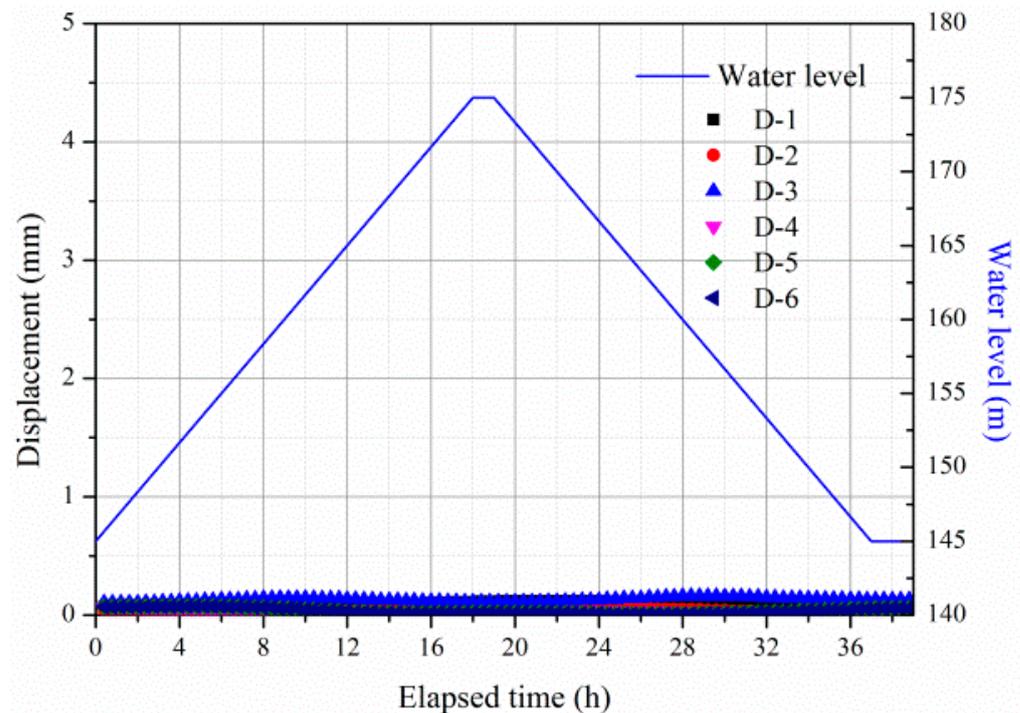
**Figure 12.** Displacements observed during the rising and lowering of the water levels.

In summary, by referring to measurement results of the different displacement sensors, no deformations were observed to have occurred during the aforementioned processes of this study’s model, and no cracks had been observed on the slide surface, as shown in Figure 12.

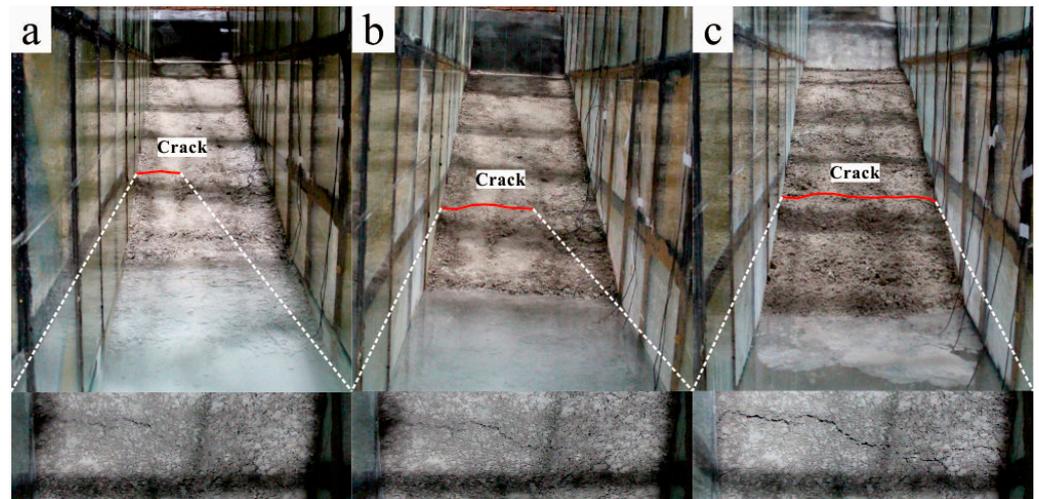
**Figure 13.** Water lowering processes combined with rainfall simulations of the induced landslide process: (a) Cracking occurred in the middle of the landslide with a water elevation of 43.54 cm; (b) Crack propagation with a water elevation of 41.25 cm; (c) Crack penetration with a water elevation of 40.18 cm.

The lowering water level, combined with heavy rainfall, was observed to initiate the formations of a transverse tension crack in the middle of the slope model. The crack occurred in the middle of the slide mass at approximately the 30 min point following the commencement of the water lowering and rainfall simulations, as shown in Figure 13a.

The length and breadth of the tension crack increased with the lowering water levels combined with the rainfall simulations. The length of the tension crack increased as the water levels reached the lower parts of the slopes, as illustrated in Figure 13b,c. Then, obvious sliding deformations were found to have immediately occurred in the middle and toe sections of the slope model. The entire deformation zone of the slope model was bounded at an elevation of approximately 300 m. However, the slope material behind the deformation zone appeared to remain stable. As can be seen in the figures, the obvious deformation region during the model tests was located in the lower zone at an elevation of approximately 300 m.

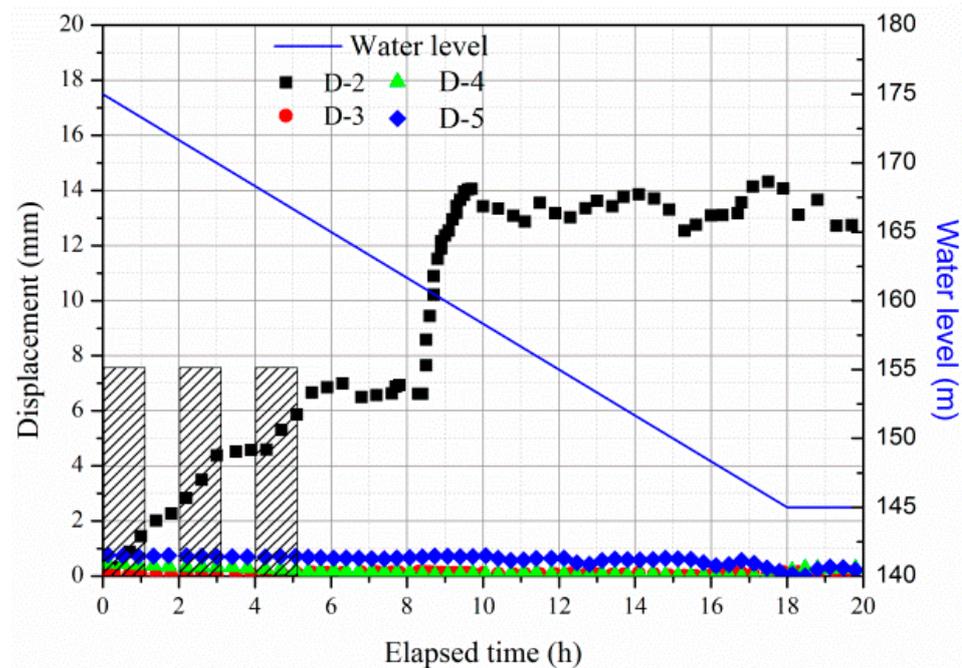
**Figure 14.** Displacements observed during the water lowering process combined with the rainfall simulations.

The displacement data shown in Figure 14 are expressed in millimeters. It should be mentioned that due to sensor failure, sensor readings were not collected by the D-1 and D-6 sensors, and no further results are shown in Figure 14. However, based on the monitoring data recorded by the other four displacement sensors, the deformations were found to be small in the areas of the D-3, D-4, and D-5 sensors, which were located in the middle and rear sections of the model, during the entire experimental process, whereas the deformations at the toe had increased sharply to 14 mm following the rainfall simulations, as shown in Figure 14.

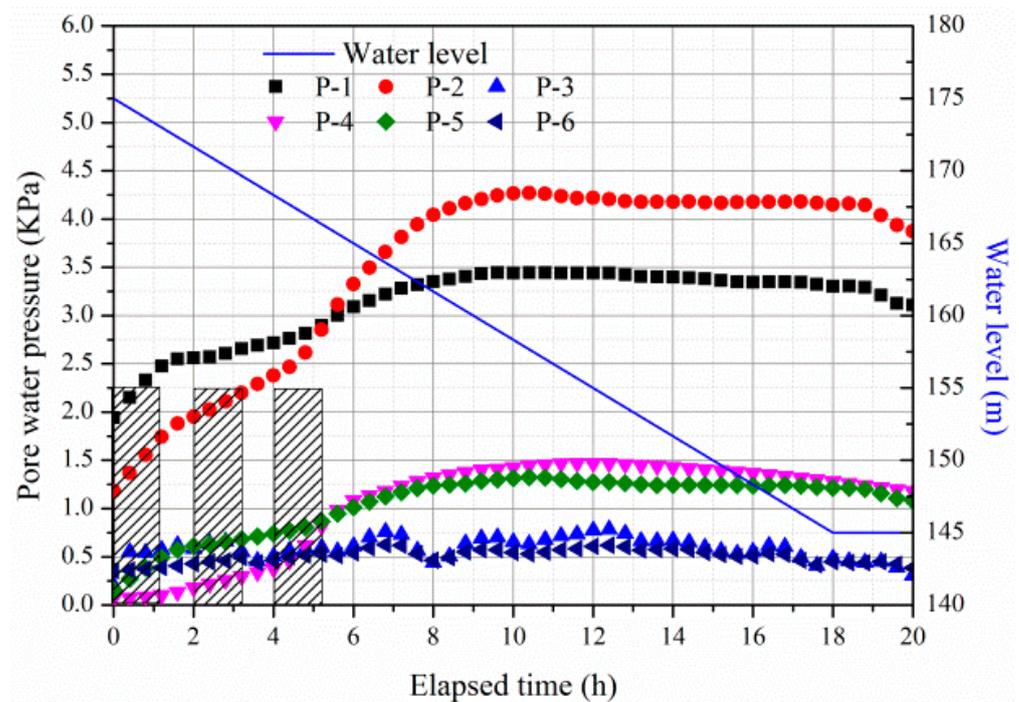
**Figure 15.** Pore water pressure levels recorded during the water lowering process and rainfall simulations.

Figure 15 presents the pore water pressure levels measured by the six pore pressure gauges mounted in the slope model. The changes in pore water pressure were in response to lowering of the water levels combined with the rainfall simulations. The variations in the pore water pressure levels were divided into three types.

The pore water pressure levels recorded by the P-1, P-4, and P-5 piezometers were observed to have gradually increased from initial pore water pressure levels of 1.94 kPa, 0.07 kPa, and 0.16 kPa to 3.44 kPa, 1.47 kPa, and 1.33 kPa, respectively. The incremental changes of 1.50 kPa, 1.40 kPa, and 1.17 kPa occurred within an 18 h timeframe after the initiation of the experiment. The pore water pressure levels recorded by the P-3 and P-6 piezometers were found to have changed little during the entire experimental process, with increases from initial total stress levels of 0.20 kPa and 0.36 kPa to 0.78 kPa and 0.63 kPa, respectively. The incremental changes of 0.58 kPa and 0.27 kPa had occurred within 18 h following the initiation of the experiment. However, the pore water pressure levels recorded by the P-2 piezometer were found to have increased sharply from an initial total stress of 1.18 kPa to 4.27 kPa, an incremental change of 3.09 kPa.

It was observed that, differing from Model-1, the soil and pore pressure levels in all parts of Model-2 displayed a tendency to increase at first and then decrease following the simulated rainfall, as shown in Figures 15 and 16. It was determined that this was due to the fact that the rain had infiltrated into the slope through the pores and cracks of the landslide model, which resulted in increases in the pore water and soil pressure levels, as well as increased weight of the rock and soil. Then, after the rainfall had ceased, the groundwater inside the slope was discharged into the reservoir, resulting in decreased groundwater levels and gradual decreases in the pore water pressure. The rises in the soil pressure levels during the early part of the process also indicated stress concentrations and accumulations of strain energy in the slope. The maximum soil pressure was the result of the coupling of the reservoir water levels and the effects of rainfall. The continuous decreases in the soil pressure during the latter part of the process were determined to be due to the release of strain energy inside the slope and the redistribution of the stress following the deformations of the rock and soil masses within the landslide.

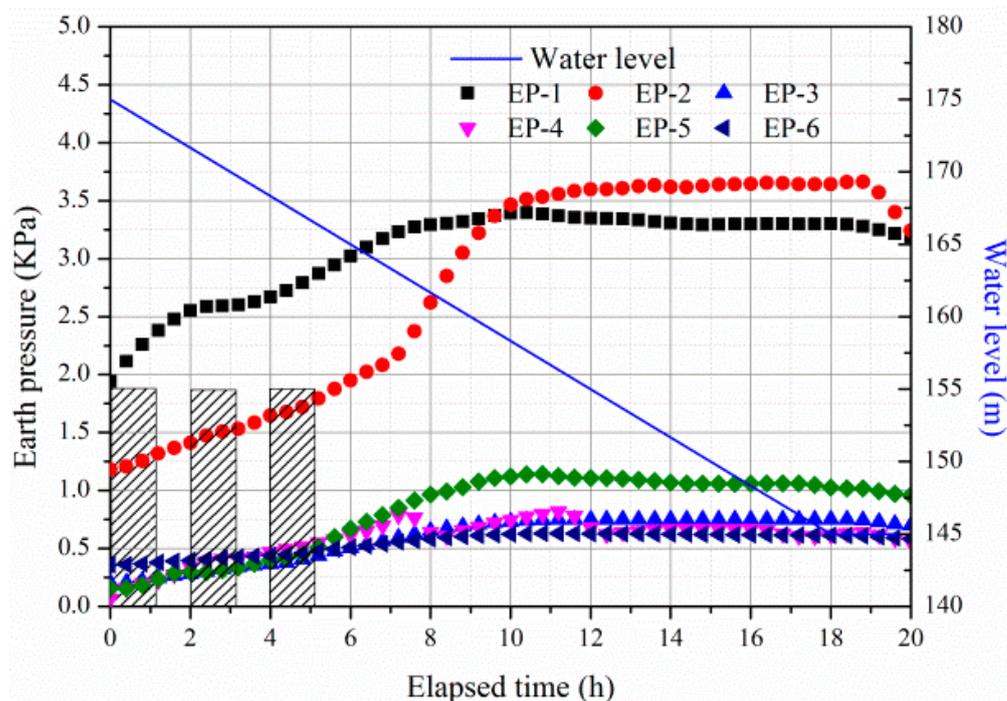
**Figure 16.** Soil pressure levels recorded during the water lowering process and rainfall simulations.

Figure 16 details the soil pressure levels measured by the six soil pressure gauges installed in the slope model. The changes in soil pressure were also in response to lowering water levels combined with the rainfall simulations. The soil pressure levels measured by the P-1 and P-5 piezometers showed similar results within 18 h following the commencement of the experiment, with gradual increases observed from the initial pressure levels of 1.94 kPa and 0.16 kPa to 3.40 kPa and 1.14 kPa, respectively. The soil pressure levels measured by the P-3 and P-6 piezometers were found to display only minimal changes during the entire experimental process, with increases from initial soil pressure levels of 0.20 kPa and 0.36 kPa to 0.75 kPa and 0.63 kPa, respectively. The data range fluctuation characteristics which were recorded by the P-4 piezometer during the final 18 h displayed incremental changes of 0.80 kPa. However, the soil pressure levels recorded by P-2 piezometer were observed to increase sharply from an initial soil pressure of 1.18 kPa to 3.67 kPa. Therefore, an incremental change of 2.48 kPa had occurred.

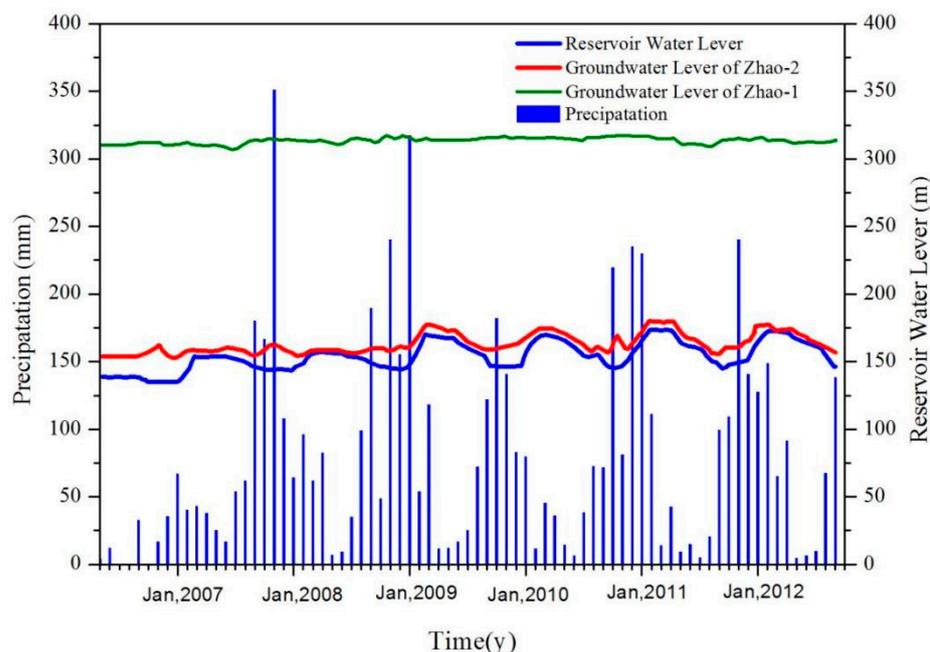
**Figure 17.** Relationships between precipitation, reservoir water levels, and groundwater levels of the Zhao-1 and Zhao-2 borehole sites.

Figure 17 shows the effects of the rainfall and reservoir water fluctuations on the changes in groundwater levels. Borehole Zhao-1 was located in the middle part of the landslide site and had a higher elevation and groundwater level than borehole Zhao-2, which was located at the toe of the landslide site. Therefore, the groundwater at the Zhao-1 borehole was less affected by the reservoir water levels than the Zhao-2 borehole. The changes in groundwater levels in the borehole were dominated by the rainfall effects. However, the amount of surface runoff was larger than that of the infiltration during rainfall events in that area, and the water level fluctuations at borehole Zhao-1 were observed to be small.

Borehole Zhao-2 was located at the toe of the landslide site. During the period of the reservoir water fluctuations and the rainy seasons during the study period (May of 2006 to November of 2012), the changes in groundwater levels of the Zhao-2 corresponded to the variations in the rainfall and reservoir water levels. Figure 17 shows that the fluctuations in the groundwater levels were consistent with that of the reservoir water levels and had also lagged behind that of the reservoir water levels.

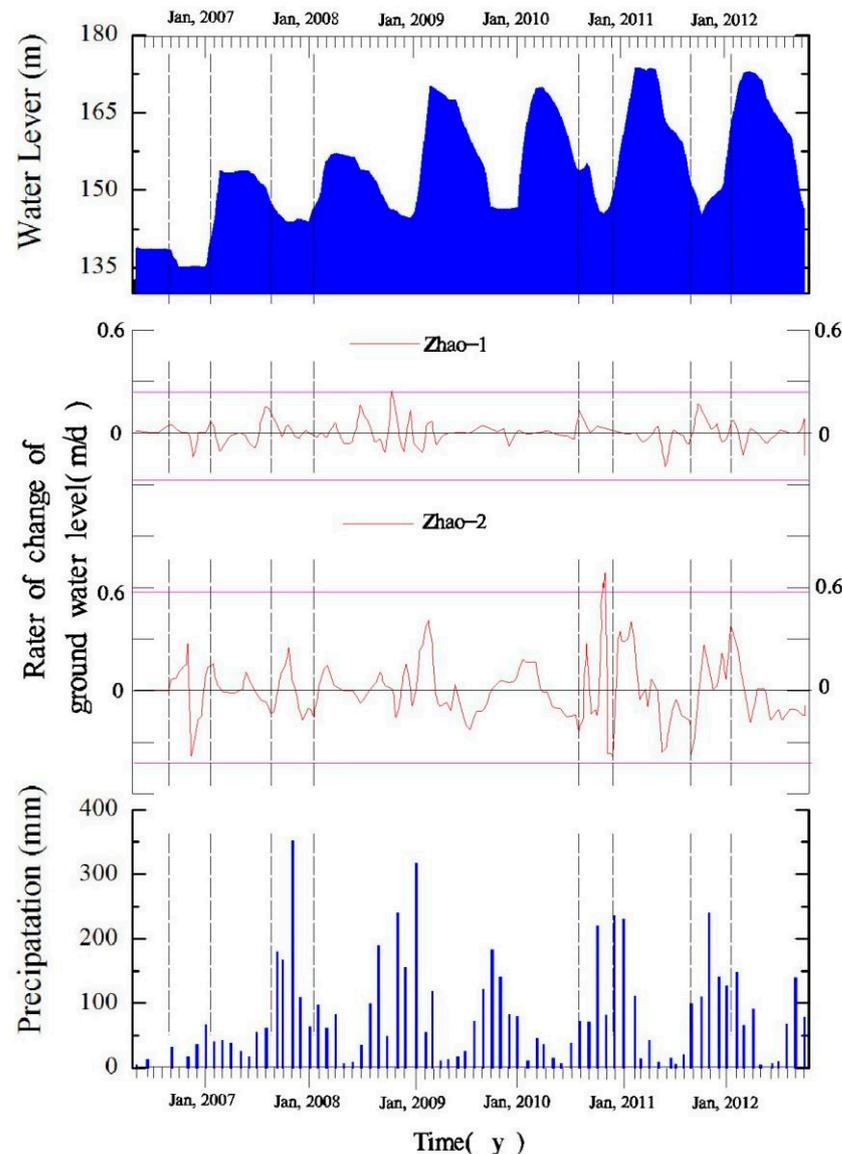
**Figure 18.** Relationships between the precipitation and the changes in the rates of the ground water levels in the Zhao-1 and Zhao-2 boreholes.

Figure 18 presents the effects of the rainfall on the changes in the rates of the groundwater levels. It was found that under the same precipitation conditions, the change rates

of the groundwater levels in the Zhao-2 borehole were greater than that of the Zhao-1 borehole during rainy seasons. These results indicated that the changes in the groundwater levels in the Zhao-2 borehole were more easily affected by rainfall than those of the Zhao-1 borehole. The test results were found to be in accordance with the monitoring data. The higher groundwater level changes in the Zhao-2 borehole, which was in the same position as P-2 in this study's model, indicated that poor drainage conditions existed.

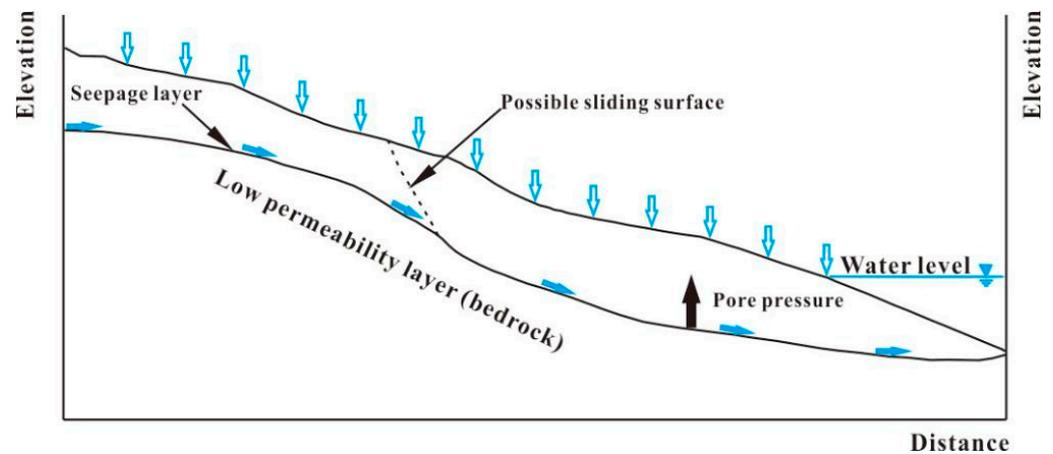
**Figure 19.** Conceptual model of a chair-shaped bedrock landslide under the conditions of lowering water levels and rainfall.

In the current research investigation, a striking feature was observed after examining the cross-sections of the landslide site. That is to say, the rockhead profile was found to be chair shaped. The Guandukou Syncline and Badong Fault were found to strike an E–W control of the tectonic framework and geomorphologic characteristics of the Zhaoshuling Landslide. The Guandukou Syncline was determined to be composed of multiple secondary folds, which are mainly asymmetric, and box folds forming a chair-shaped bedrock surface. The chair-shaped bedrock surface was observed to be generally parallel to the slope surface. However, at the toe of the slope, the interfaces become rather flat or slightly depressed, or even upside down. It was found that the chair-shaped bedrock formation at the toe of the

slope had significant adverse effects on the mechanisms of the slope stability, as detailed in Figure 19.

The significant pressure build-up and the rate of build-up were dependent on the rain intensity, elevation of the recharge zone, different properties of the upper and lower strata, and the rate at which the groundwater could escape from the toe of the slope. With the same conditions of rain intensity and recharge zone elevation, the properties of the strata and groundwater escape conditions were very important to the pore water pressure build-up. For example, if the rainfall on the exposed slope surface occurred at a rate less than the permeability of the slope materials, and the conditions at the toe of the slope were favorable for the ground water to escape, then the water may percolate vertically downwards into the slope without causing large positive pore water pressure level changes.

It was found that the properties between the upper and lower strata were quite different in the Zhaoshuling Landslide site. The bedrock was  $T_2b^2$  strata and had a permeability much lower than that of the slope material. The infiltrating water may have formed a seepage layer on the bedrock surface, which potentially followed the contours of the bedrock. Therefore, any significant change in the inclination of the bedrock may have resulted in localized changes in the hydraulic gradient. However, the bedrock of the Zhaoshuling Landslide was chair-shaped, with a particularly significant change in gradient in the toe region. Therefore, since the bedrock surface was slightly depressed and even upside down at the toe, the seepage flow was not smooth. A localized zone of high transient pore water pressure may have been created within the slope material, which could have potentially reduced the effective stress of the soil body. This was arguably the most critical region of the slope from a stress perspective. Therefore, it was believed that the investigated landslide event may have begun with a local slip under rainfall infiltration and reservoir water level change conditions.
