# Evaluating the Feasibility of Robotic Crawler Deployed Ground Penetrating Radar to Assess Repairs of a Concrete Hydroelectric Dam Spillway in Alabama, USA

**Abstract:** Dams and the water systems they support must be monitored, maintained, and repaired when necessary so they can continue to provide benefits to the communities they serve. This study presents the methods and results from a robotic crawler-based ground penetrating radar (GPR) inspection of rehabilitated concrete from a hydroelectric dam spillway located in Alabama, USA. This spillway, which was recently inspected and repaired, showed evidence of spalling which indicated internal structural deterioration. Standard practice would leave these repairs uninspected or put the wellbeing of people at risk when deploying them on the spillway for manual inspections. GPR data were recorded from recently rehabilitated and resurfaced areas of the site to evaluate the capability of a remotely controlled robotic crawler system to assure repair quality efficiently and effectively. The results indicate that high quality data can be recorded from repairs without the need for manual inspection. The GPR was able to resolve repair leng

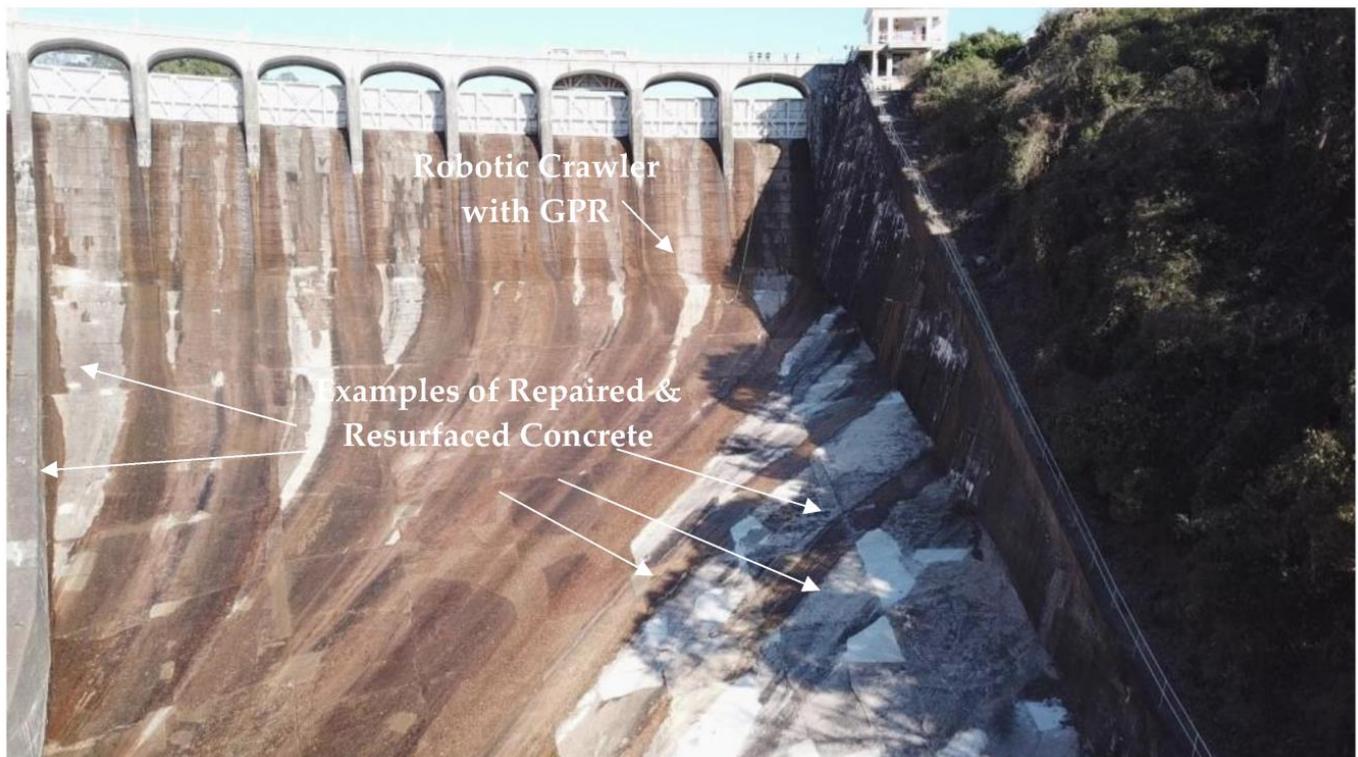
**Figure 1.** Photograph showing crawler with GPR being lowered onto spillway and locations of example resurfaced concrete.

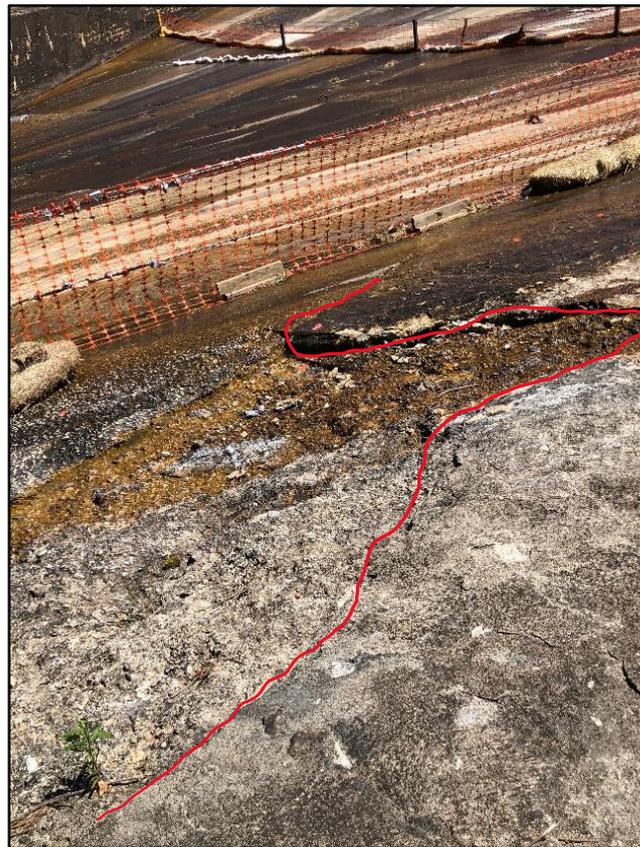
**Figure 2.** Photograph of spillway surface showing significant spalling left of red line.

The dam currently suffers from erosion, delamination, and surface spalling (Figure 2), and was selected as the test site due to concern over structural integrity. Since a refurbishment plan was put in place for this asset, it was deemed an appropriate and timely site to conduct this investigation. A program was previously undertaken to inspect the entirety of the accessible dam spillway and rehabilitate spalled areas [2]. Since this dam was not subject to fire and is not reinforced, spalling is most likely due to freezing/thawing episodes and alkali-silica reactions typical of cement used in construction during the 1920s. The long life this dam has enjoyed also contributed to the current state of deteriorated surface condition. Areas with observable spalling were filled, reinforced, and resurfaced. Inspections also uncovered areas indicative of delamination in the concrete which were subsequently demolished to solid concrete, reinforced, filled, and resurfaced.

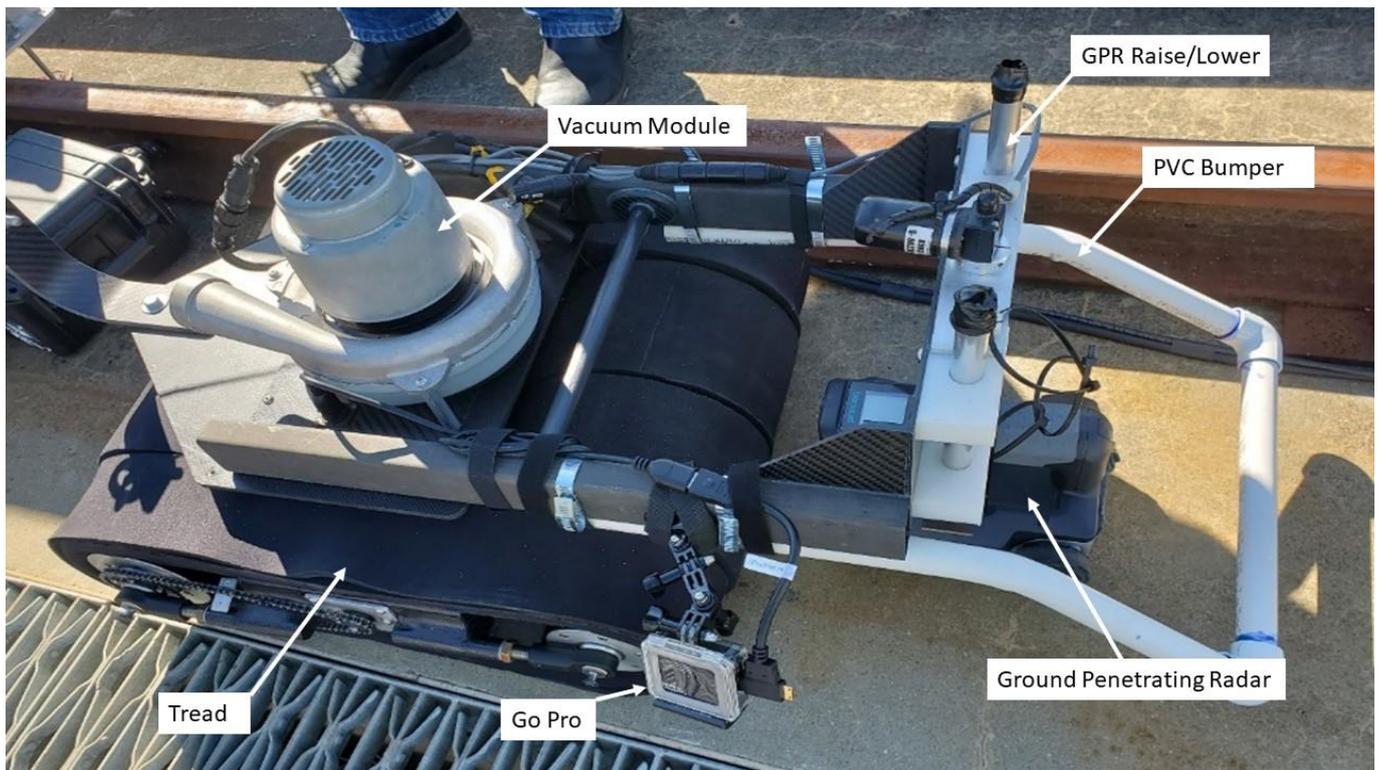
Figure 3. Photograph of crawler with GPR integrated.

This project tested the design and applicability of a remotely controlled robotic crawler to access the spillway and image repaired and resurfaced concrete that suffered from spalling and delamination (Figure 2). While the project considered the use of other robotic options, such as UAV, the concrete condition, and steep slope of the spillway were not amenable to the use of UAV at this time. Over a two-day period, the design and mobility of the crawler itself were tested as well as the ability to remotely collect GPR data. The crawler (Figure 3), designed by ICM (Ithica, NY, USA), uses a vacuum motor and neoprene treads to adhere to and travel on vertical or near vertical surfaces. An attachment was constructed to hold and maneuver the GPR system on the crawler. A mechanism was added to raise and lower the GPR to the surface while on the spillway. This provided the ability to raise the GPR off the ground while preparing to acquire data and then lower the GPR back onto the surface during data acquisition. A GoPro was attached to the crawler to visualize the GPR's mechanical performance in real time. The crawler with attached GPR was lowered with ropes from the top of the dam to the spillway below (Figure 4a). The crawler was then operated remotely through cables running from the crawler to a console. The crawler with GPR was tested by collecting data specifically over patched concrete that was recently refinished (Figure 4b). GPR data acquisition was operated wirelessly from the deck of the dam with an iPad (Figure 4c).

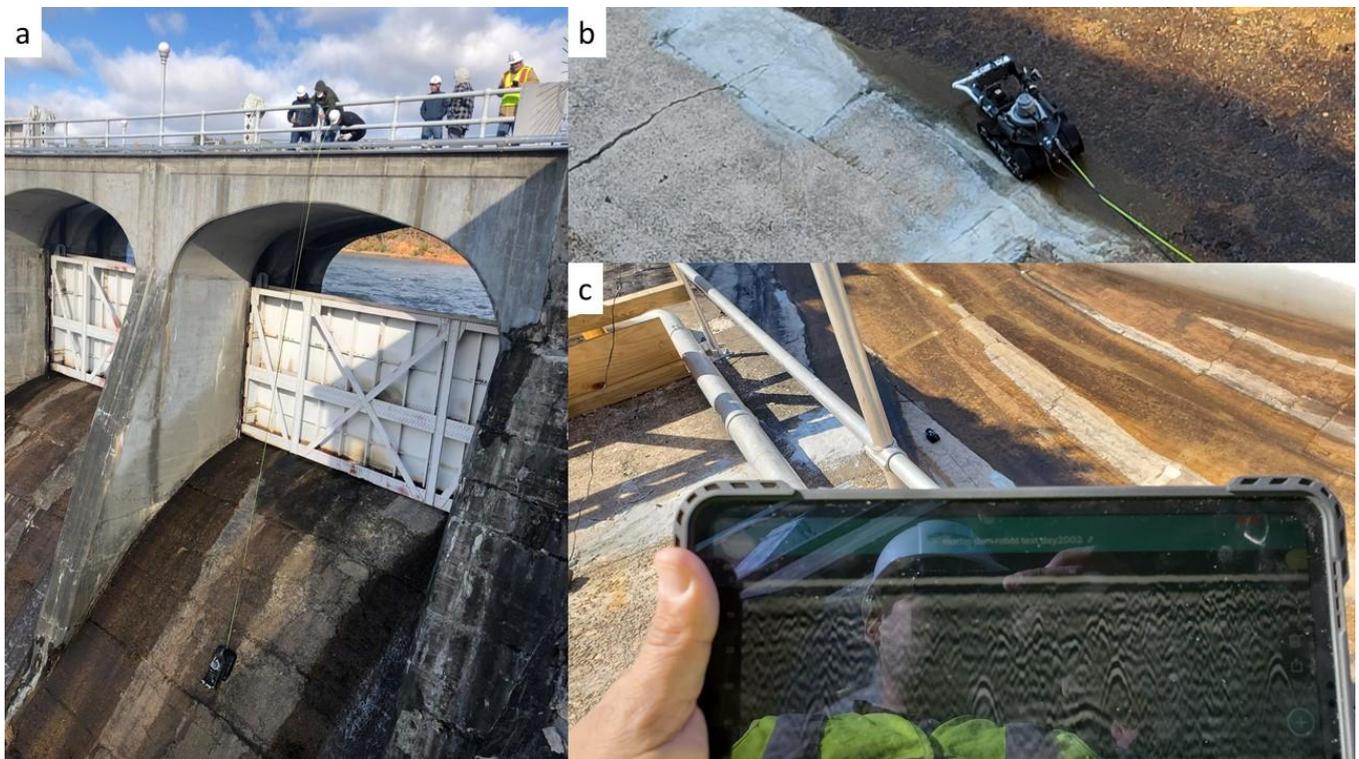
Figure 4. Photographs showing (a) crawler with GPR being lowered onto spillway, (b) crawler with GPR collecting data across repaired concrete surface, and (c) data collection with iPad from top of dam with crawler with GPR in background.

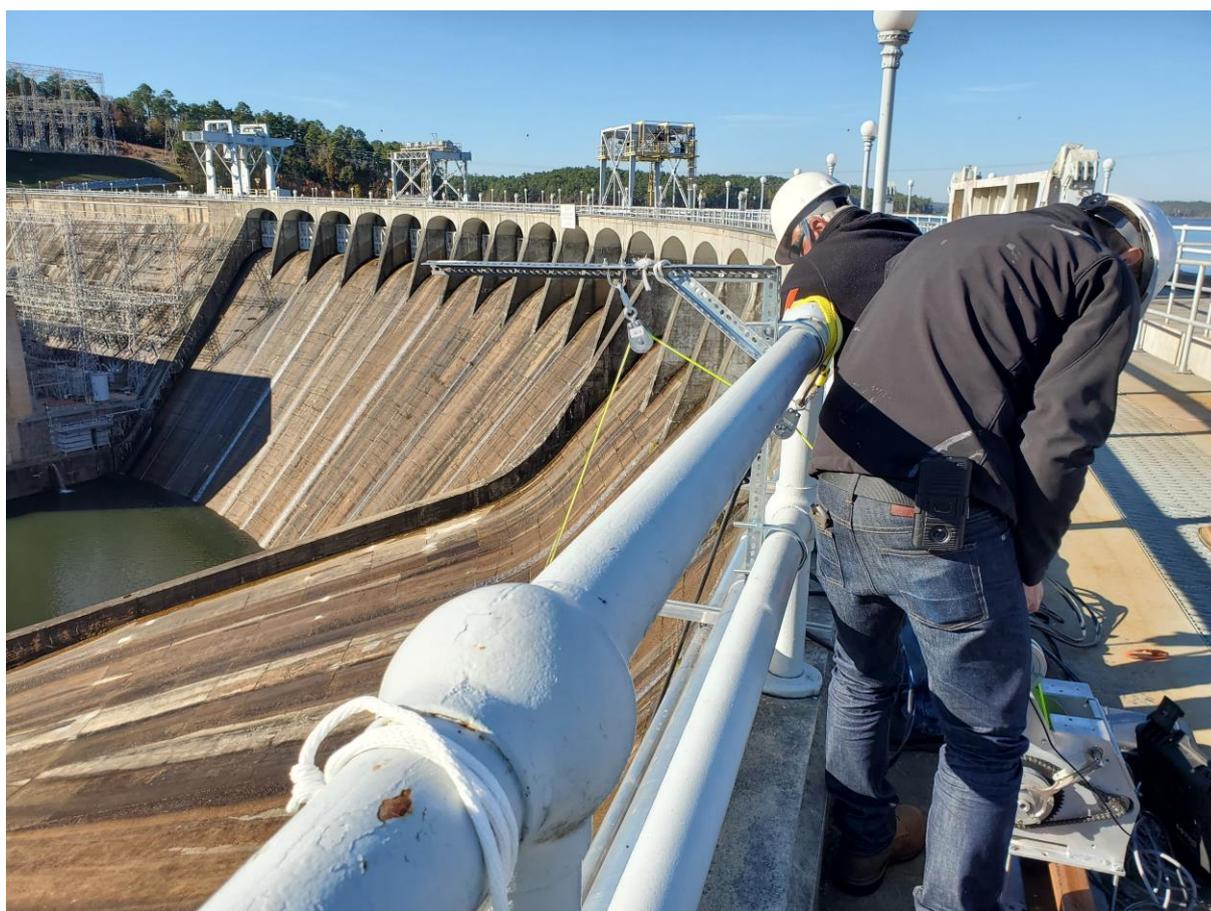
**Figure 5.** Photographs show crawler with GPR being lowered onto spillway after implementation of 1 m boom.

Many of the issues encountered during the first day of testing were resolved prior to the second day of testing. An extended arm boom with a pulley facilitated an easier and more stable lowering of the crawler from the top of the dam (Figure 5). This consisted of an extension approximately 1 m in length from the side of the spillway lip which provided much more control in lowering the crawler down to the spillway. A PVC bumper (see Figure 3) was added to reduce impact stress on the GPR and the crawler's arm. Data collection was greatly improved by positioning the GPR in the rear of the crawler and dragging the sensor rather than pushing it. Wheel contact remained more consistent which allowed for continuous data acquisition and clear results (Figure 6). Streaming video of the GPR in real time with the GoPro was instrumental in identifying wheel skips, contact issues and quickly troubleshooting them. While communication was good overall between the GPR and the tablet, some problems arose when the distance exceeded approximately 100 m. At these distances (sometimes shorter) the wireless connection dropped, and the data ceased to be logged. The crawler had to be driven closer to the tablet to regain connection. This may be fixable with a wireless amplifier to extend the distance of communication between the data logger and GPR. Some noise was present in the GPR data profiles collected with the crawler (Figure 6), but it remains unclear if the source of the noise was the crawler itself or some other external factor.

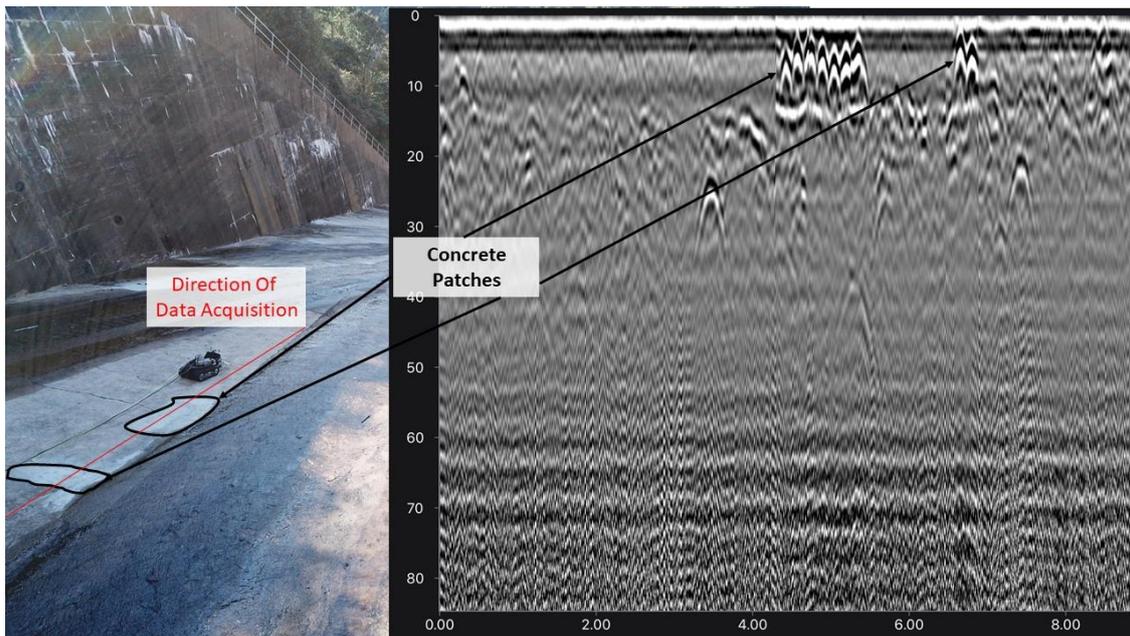
**Figure 6.** GPR profile collected during robotic crawler deployment with (Right) response occurring near the upper central portion of the section shows narrow hyperbolic reflections from steel reinforcements embedded in portion of repaired concrete and (left) concrete patches of repair.

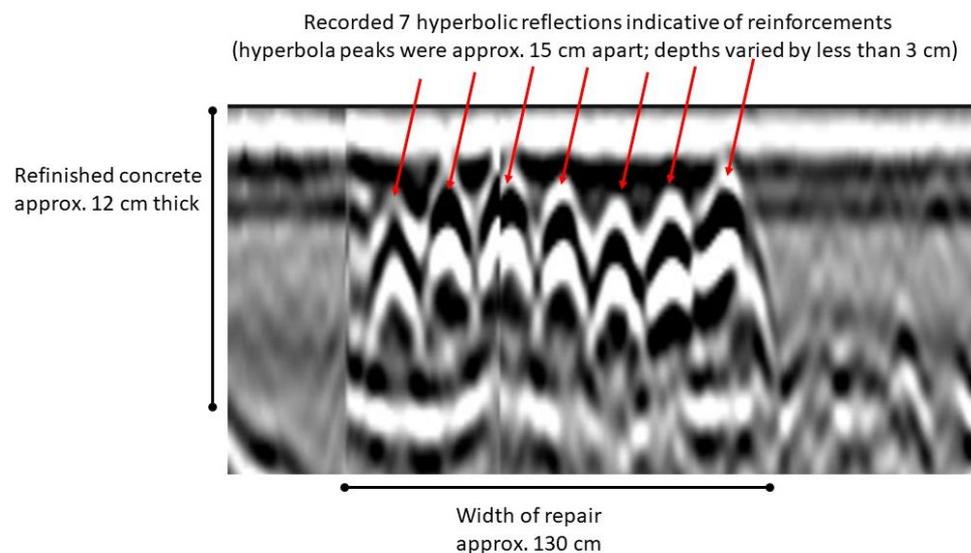
**Figure 7.** GPR profile collected over refinished concrete indicating depth of old/new concrete interface, number of reinforcements, depth of reinforcements, and separation of reinforcements as indicated by hyperbolic reflection responses.

The GPR recorded clear, high-resolution data of the refinished areas on the spillway (Figure 7). Data were of sufficient quality to measure the approximate width and thickness of repair, count the number of hyperbolic reflection responses indicative of steel reinforcements, and evaluate the consistency of reinforcement spacing and depth. Measurements indicate the width of the repair under investigation was approximately 130 cm. The bottom of the repair is indicated by a horizontal reflection event. Using this response, the repair can be measured at 12 cm thick (Figure 7). Seven hyperbolic reflections were recorded with the GPR. These were spaced approximately 15 cm (6 inches) apart with minimal variation. The depths of reflections from reinforcements varied by less than 3 cm with the range of depths between roughly 2 cm and 4 cm deep (Figure 7).

The data collected with the GPR was able to verify that specifications were met for repairs of the concrete surface. According to the scope, saw cuts shall be perpendicular to the concrete surface or tilted inwards between 5 and 10 degrees, and 15 cm × 15 cm wire mesh will be added to the pour area for crack control (size W9 × W9 mesh for pours deeper than 10 cm and W6 × W6 size for pours 10 cm or less). The GPR data indicate a roughly perpendicular shape to the sides of the repair as evidenced by the horizontal reflection event approximately 12 cm below the surface (Figure 7). The reflection trend does not indicate a descending/ascending bottom of repair, suggesting a “pit shape” but rather a squared angle cut both upslope and downslope of the repair. The GPR recorded hyperbolic reflection responses consistent with 15 cm × 15 cm wire mesh as specified for the repair. The depth of concrete was 12 cm and thus the size of the wire mesh should be W9 × W9; however, the data collected in this circumstance were not conducive to making such an estimate. This would be an important upgrade for future research.
