Article

Damage Model and the Influence Factors of Mitigation Engineering against Glacial Debris Flow in the Parlung River Basin, SE Tibetan Plateau

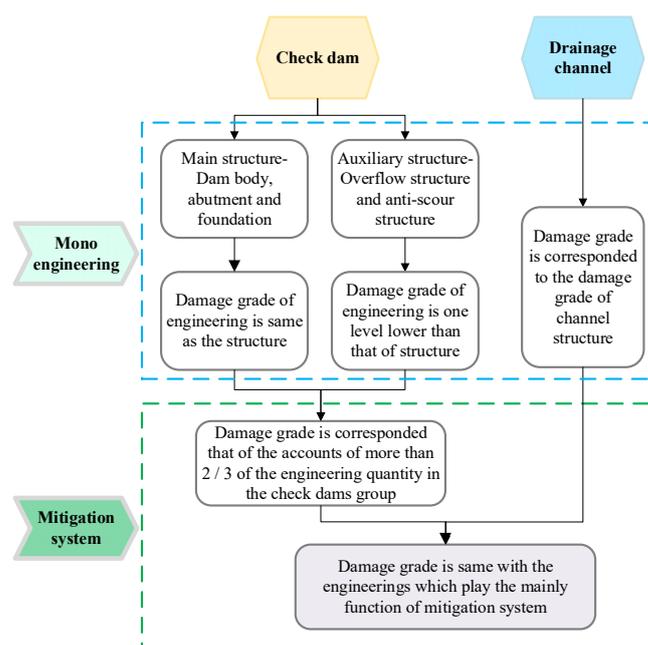
Although the evaluation of hazard mitigation engineering has been a popular topic in recent years, the research has not been carried out systematically. The damage grade of engineering has two criteria: Firstly, the damage to the engineering structure, such as fracture, displacement and erosion of the concrete structure. Second is the damage to future mitigation ability, such as the drainage channel losing its diversion functionality, the check dam losing the function of its reservoir, and the reduction of discharge. This paper refers to the earthquake damage evaluation method [22,35] and builds a new model based on the damage grade of structural reliability and functionality of mono engineering works, as shown in Table 1. In this new model, damage grade is divided into five levels from I to V. Encompassing the association and function combination relationship between mono engineering works and mitigation systems, the classification method is established, as shown in Figure 2.

Figure 2. The classification method of damage grade for debris flow mitigation engineering.

Applying the damage evaluation model established in Table 1 and Figure 2 to the mitigation engineering in PLR, the glacial debris flow drainage channel is statistically analyzed. The results are shown in Figure 5. There are two undamaged engineering works (I grade damage), seven slightly damaged engineering works (II grade damage), three relatively damaged engineering works (III grade damage), five seriously damaged engineering works (IV grade damage), and five totally damaged engineering works (V grade

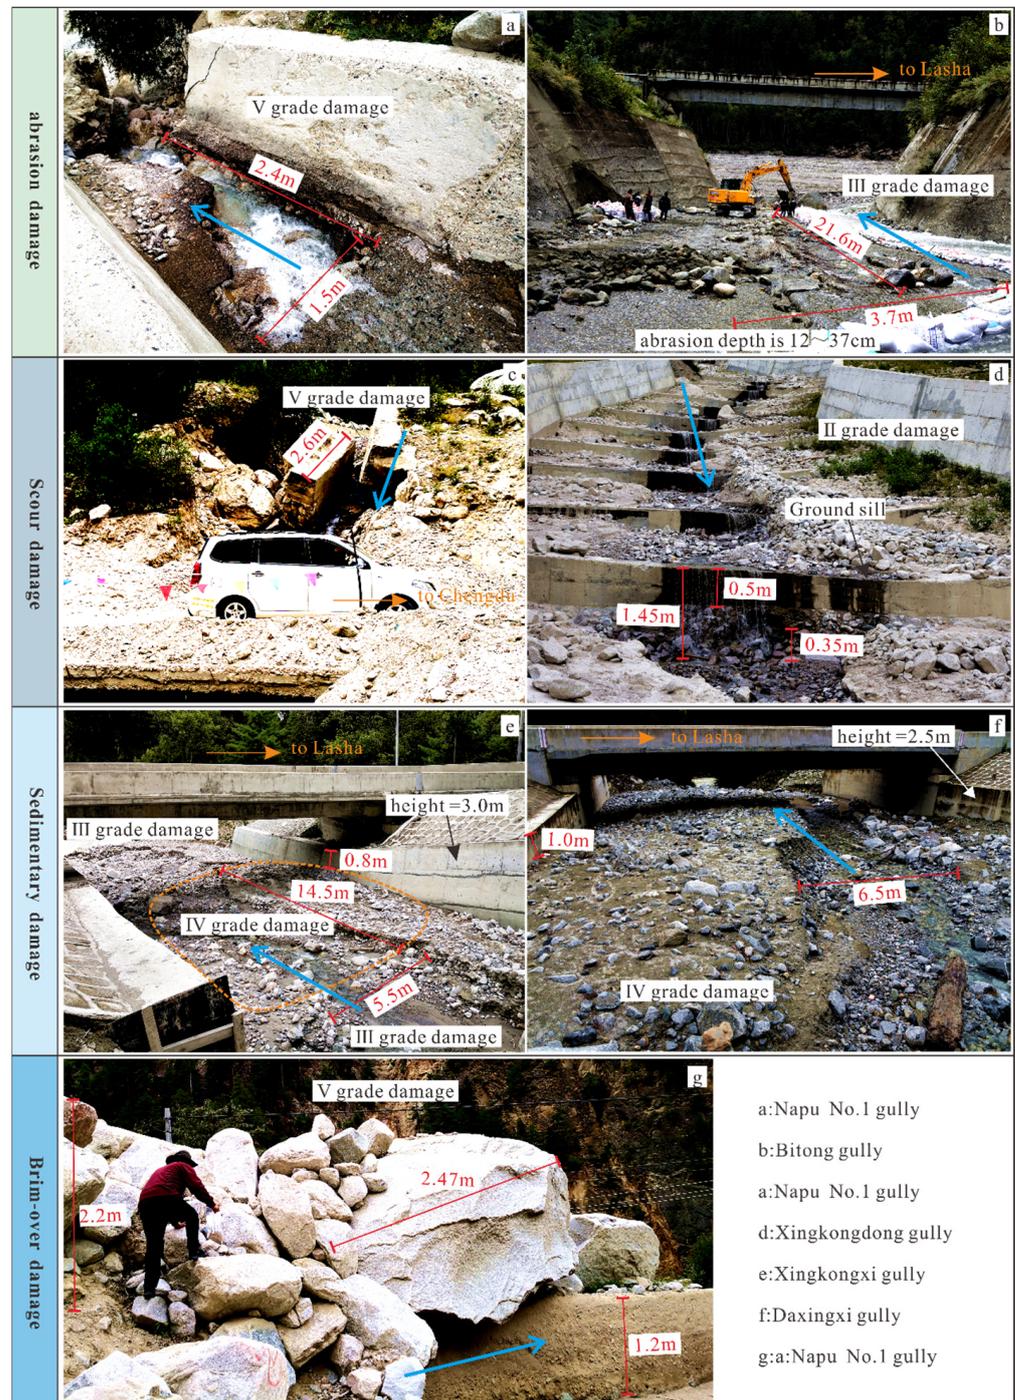
We summarize the engineering damage to drainage channels with four classifications: abrasion damage, scour damage, sedimentary damage, and brim-over damage. Abrasion damage and scour damage are the most common failure forms in the study area, such as erosion of the engineering surface (Figure 3a,b), scour pit in the channel bed (Figure 3d), and side-wall collapse (Figure 3c). Sedimentary damage mainly occurs at the section where the channel gradient changes and most typically occurs in the channel under a bridge (Figure 3e,f). Brim-over damage is mainly caused by design deficiency when the discharge is greater than the drainage capacity, and giant rocks contained in the fluid are the key factor. It usually occurs at the entrance section and bend section of the drainage channel.

Figure 3. Damage types for drainage channels subject to glacial debris flow.

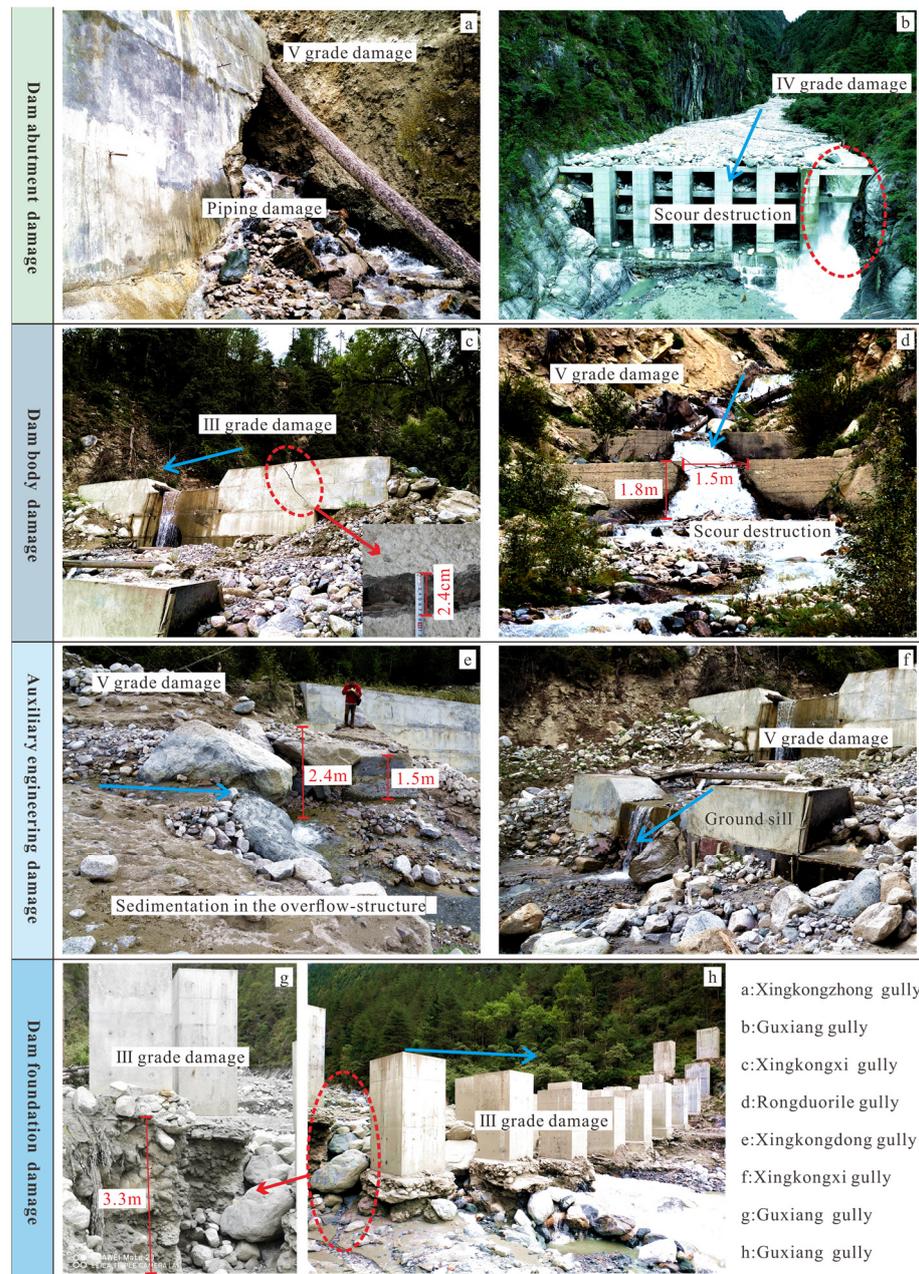
Based on the damage location, as with the drainage channel, the damage of check dams can also be divided into four types: dam abutment damage, dam body damage, dam foundation damage, and auxiliary structure damage, shown in Figure 4.

Dam abutment failure is caused by seepage and scour, which erode the soil and loosen the abutment foundation (Figure 4a,b). Dam body damage is not as common as abutment damage in the study area, which is mainly characterized by cracks caused by impact force (Figure 4c) and notches caused by abrasion (Figure 4d). Dam foundation damage is the most common failure mode. In general, all check dams would be damaged with varying degrees after experiencing debris flow. However, when the scouring depth is less than the foundation depth, its impact on dam stability is limited. Auxiliary structure damage usually includes the erosion and deposition of the overflow structure (Figure 4e), which affects the reliability and function of the check dam. In addition, the damage to the anti-erosion structure is widely distributed (Figure 4f).

Figure 4. Damage types for check dams subject to glacial debris flow.

When it is necessary to build a check dam, it should be designed as a grid-type dam, and there should be an increase in the size of the overflow structure. In the absence of the calculation method of debris flow overflow, the overflow area can be based on the flow area at the entrance of the reservoir to ensure that the overflow area of the dam is larger than that of the channel. The influence of boulders should be considered in the design of auxiliary engineerings, such as anti-scour engineering.

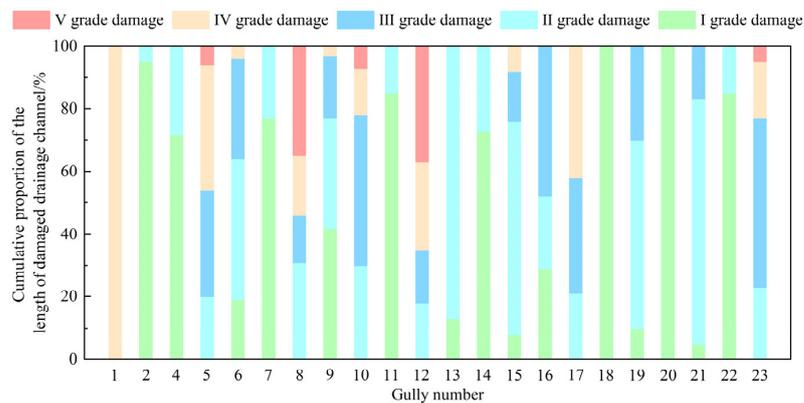
Figure 5. Damage grade division of drainage channels in PLR.

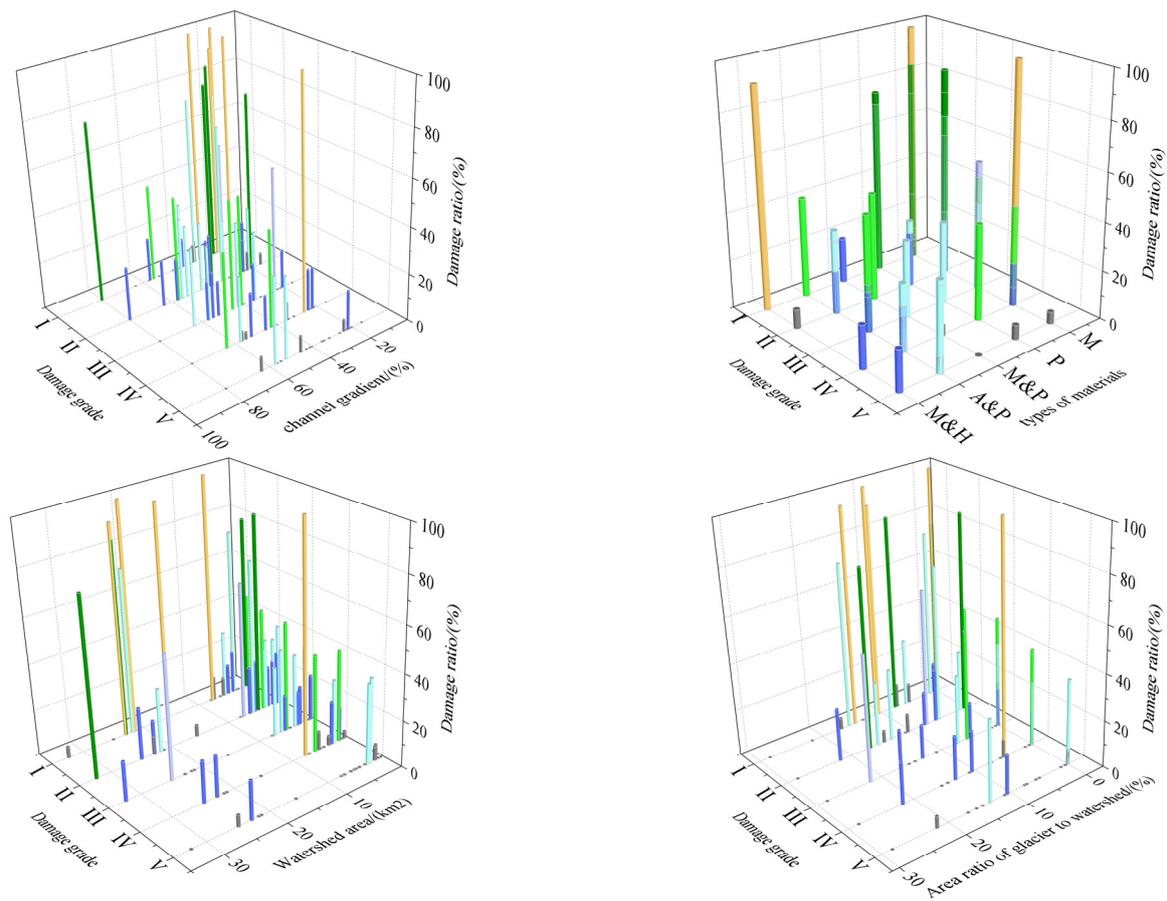
In this paper, we summarize the formation conditions of glacial debris flow into four categories: basin area, channel gradient, glacier area and soil source type. We analyze the relationship between engineering damage and formation conditions, as shown in Figures 6 and 7.

The results show that the channel gradient has a positive correlation with the damage grade and has the biggest impact on sedimentary damage. When the soil sources of debris flow are moraine (M) plus landslide (L) or snow avalanche (A) plus slope erosion (E), it usually results in a seriously damaged grade and a sedimentary damage type. Such types of glacial debris flow should be paid significant attention to when designing and constructing hazard mitigation projects. Broadly speaking, the watershed area has a two-level differentiation effect on the damage grade and damage type. The large area and small area are both closely related to the damage grade, although the exact relationship is unclear. The impact of the glacier area is consistent with the watershed area due to the hydrodynamic conditions of glacial debris flow, mainly rainfall and glacier melt, which are closely related to the area parameter. For the damage type, when the watershed area is larger than 10 km², there is mainly scour damage and abrasion damage, while when less than 10 km², there is mainly brim-over damage and sedimentary damage.

Figure 6. The relationship between debris flow formation conditions and damage grade.

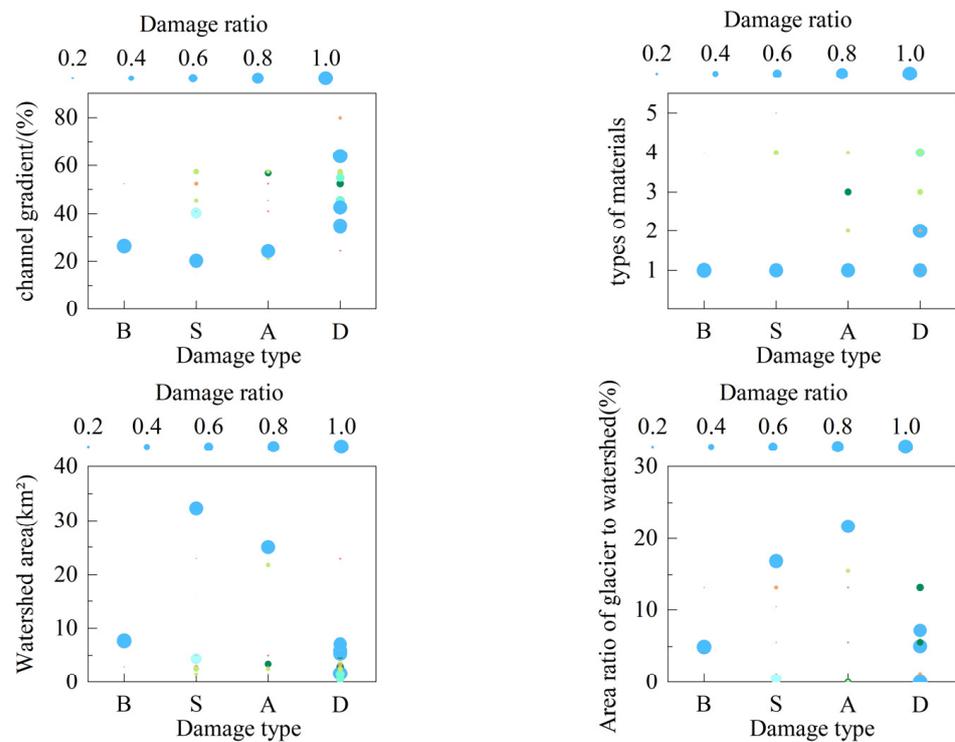
Figure 7. The relationship between debris flow formation conditions and damage type. B: brim-over damage, S: scour damage, A: abrasion damage, D: sedimentary damage.

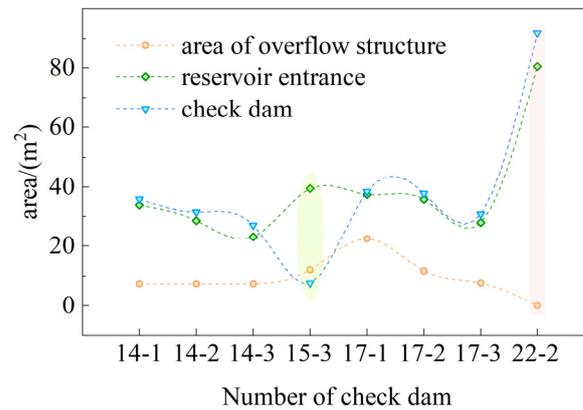
According to previous damage analysis, engineering design defects mainly lead to scour damage of the overflow structure of check dams, caused by a lack of efficiency of flow; it could also cascade by triggering damage to the dam abutment and dam foundation. Through field investigation, the two flow areas of debris flow events, both in the reservoir entrance and the check dam, are compared with the designed area of the overflow structure, as shown in Figure 8. It can be seen from the figure that the most serious abutment damage is to the dam of 22-2 (No.2 dam in Guxiang gully), also shown in Figure 4b and Table 3. However, dam 15-3 (No.3 dam in Xinkongdong gully) experienced no damage because the reservoir of the check dam was empty, and the debris flow was blocked by the reservoir. The check dam greatly reduces the peak discharge so that the overflow structure can meet the hazard requirements. As the reservoir is now full of soil materials, if it experiences a similar debris flow in the future, the overflow capacity will be utterly insufficient. Such an event will trigger damage to the overflow structure when the overflow capacity is less than the size of the debris flow hazard. This kind of issue usually arises from the discharge calculating model of glacial debris flow being inaccurate.

Figure 8. Comparative analysis of overflow area of typical check dam.

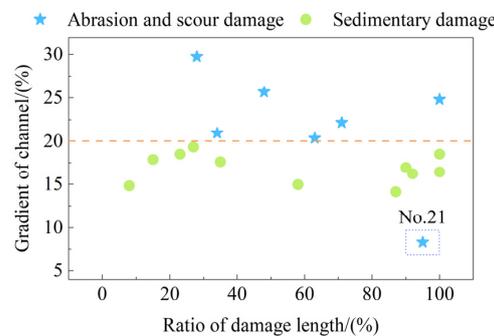
The most common defect of drainage channel design is the channel gradient design, and the engineering work that is built is often designed according to the terrain of the debris flow fan. This leads to several types of damage to the channel engineering work. The drainage channel experiences sedimentary damage when the gradient is less than 200.00‰; otherwise, it experiences abrasion damage and scour damage (Figure 9). There is an outlier in the form of No.21 in Figure 9, which is the drainage channel in Guxiang gully, which experiences abrasion damage when the gradient is less than 200.00‰. The reason for this is that there are two check dams upstream of the drainage channel. After most of the soil materials of debris flow are deposited in the reservoir, the debris flow changes to a torrential flood, which will hardly deposit any material but will produce strong abrasion and scour forces under the higher velocity.

Figure 9. The relationship between the gradient of the drainage channel and damage type.

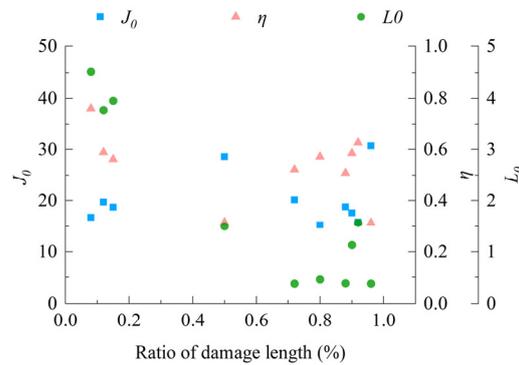
The gradient change of a drainage channel is the most important factor for sedimentary damage. The ratio of damage length is related to the initial gradient of the channel, the amplitude of gradient change, and the length ratio between two sections of the channel with different gradients (Figure 10). On the whole, the length ratio and amplitude of gradient change are inversely proportional to the sedimentary damage grade, while the initial gradient has less effect on the sedimentary damage grade.

Figure 10. Relationship between gradient change and the ratio of sedimentary damage length.

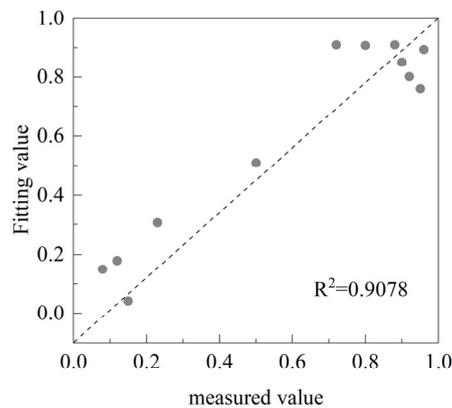
The test of Equation (1) is shown in Figure 11. The test result shows that there is a good correlation between the fitting value of Equation (1) and the measured value, such

that the empirical formula is suitable for the study of drainage channels subject to glacial debris flow in the PLR basin.

Figure 11. Fitting effect test of the Equation (1).

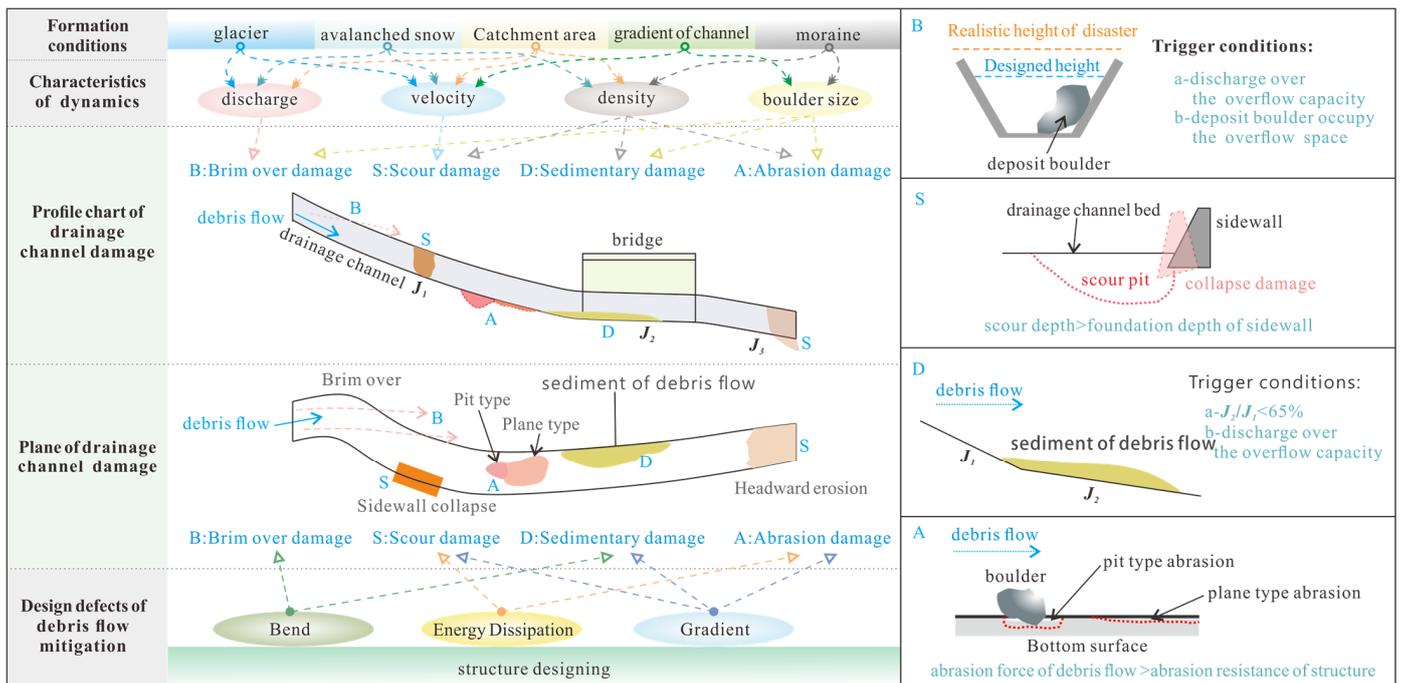
Based on the above analysis, the damage models of the drainage channel and check dam can be established, shown in Figures 12 and 13, respectively.

The four factors of the debris flow formation conditions influence the disaster characteristic of discharge, velocity, density, and boulder content, causing brim-over damage, scour damage, sedimentary damage, and abrasion damage, respectively. In engineering design, the design of horizontal bend and gradient should consider sedimentary damage on the concave bank. The design of energy dissipation engineering should consider the scour and abrasion damage caused by boulders. The damage to the check dam is more complex, such that we cannot obtain the force mechanism based on our investigations. For glacial debris flow hazard mitigation, check dams are commonly used for auxiliary engineering in the mitigation system because of the restraint of the protection object and the terrain of the debris fan. The key factors in check dam damage are the interaction between engineering and debris flow, designing of the overflow structure and designing of the anti-erosion structure (Figure 13). None of these problems are thoroughly studied in the mitigation of rainfall-triggered debris flow.

Figure 12. The damage models of drainage channels under glacial debris flow.

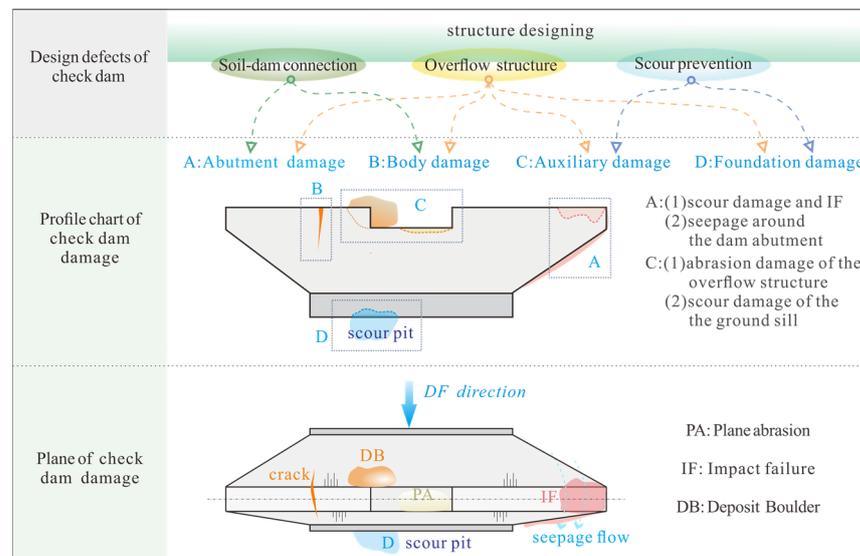
Figure 13. The damage models of a check dam under glacial debris flow.
