Article

Multisource and Multilevel Investigations on a Historical Landslide: The 1907 Servigliano Earth Flow in Montemurro (Basilicata, Southern Italy)

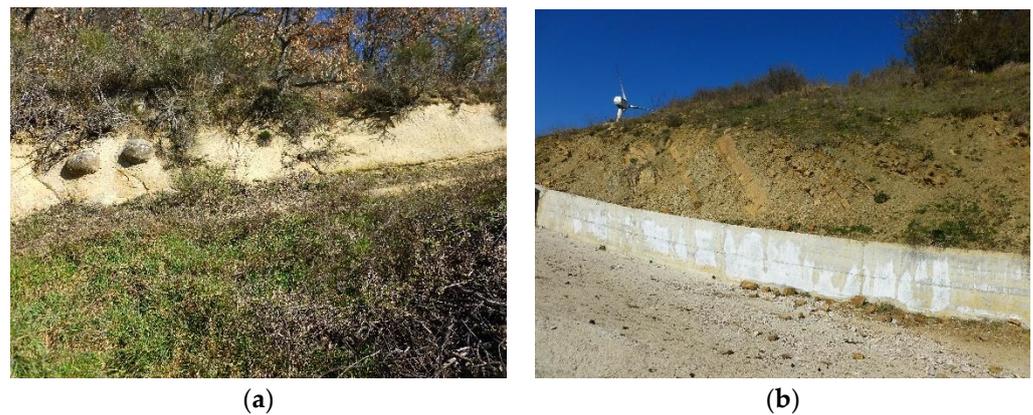
Figure 5. Pre-Quaternary bedrock: (a) outcrop the Gorgoglione Formation; (b) outcrop the Albidona Formation. The site where the photos were taken is reported in Figure 4. (Photos taken by Bentivenga M.)

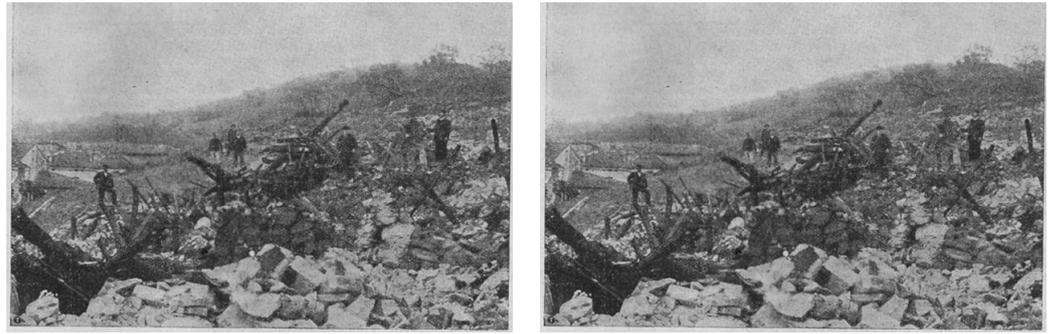
Figure 13. The landslide body (**left, right**) and the damage caused to a retaining wall (**right**) (Source: [67], private archive of Gizzi F.T.).

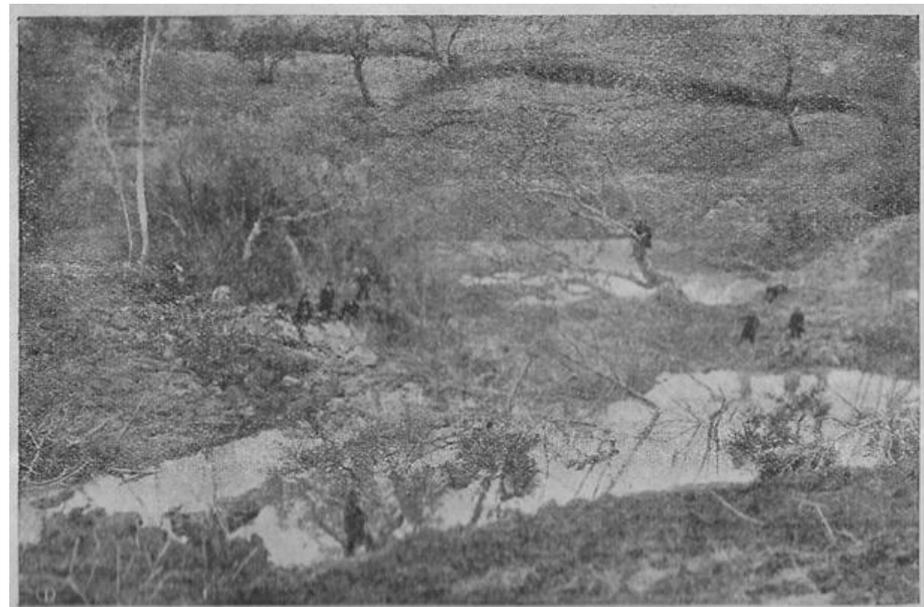
Figure 14. Ponds on the landslide body (Source: [67], private archive of Gizzi F.T.).

The movement of the front of the landslide stopped on 4 March, about a week after its triggering, when the works of clearing the rubble, completed in September 1907, and diversion of the waters also began. In fact, multiple depressions were formed inside the landslide body, which led to the formation of ponds (Figures 14 and 15).
