# Article Coastal Environment Impact on the Construction Materials of Anfushi's Necropolis (Pharos's Island) in Alexandria, Egypt

**Keywords:** Anfushi's Necropolis; Alexandria; building materials; mortar; coastal environment; SLR; stone decay; salt erosion; vector mapping

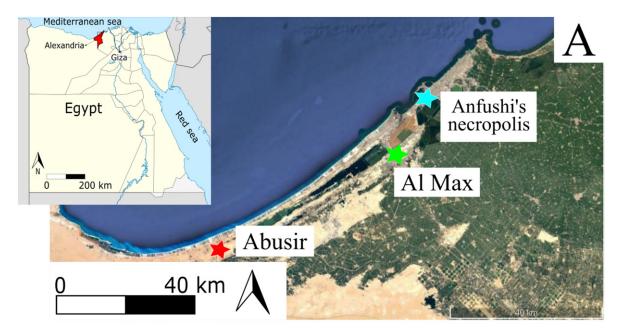
**Figure 5.** (**A**) Ancient quarries in Alexandria (green and red stars) with an example of the light-coloured of limestone outcrop (**B**).

Ancient Egyptians used different kinds of stones (limestone, sandstone, granite, basalt, etc.) from different quarries along Egypt, from south to north and from east to west. The extracted stone blocks were used to build temples and tombs in different periods in Egypt for architectural and ornamental purposes [47–49]. Alexandria was a source of quarried limestone blocks from the Quaternary ages along the Nile delta's Mediterranean coast [50]. Abusir and Al Max west of Alexandria are considered quarries that were used from the Ptolemaic era to the Roman era (Figure 5). The limestone of these quarries is light-coloured, and their deposits belong to the Pleistocene Alexandria Formation. Ancient and recent quarries are observed on the Alexandria-Marsa Matrouh Road in a 21 km area [51,52].
