Article

## Water Impingement Erosion of Deep-Rolled Ti64

**Abstract:** In this work, the Liquid Impingement Erosion (LIE) performances of deep-rolling (DR) treated and non-treated Ti64 were investigated. Various erosion stages, from the incubation to the terminal erosion stages, could be observed. A full factorial design of experiments was used to study the effect of DR process parameters (Feed Rate, Spindle Velocity, Number of Passes, Pressure) on the residual stress distribution, microhardness and surface roughness of the treated Ti64 specimens. The DR-treated Ti64 specimens exhibited improved surface microhardness, surface roughness, and large magnitude of compressive residual stresses, which were attributed to the amount of cold work induced by the DR process. Although DR improved the mechanical properties of the Ti64, the results showed that the treatment has little or no effect on the LIE performance of Ti64 but different damage modes were observed in these two cases. Evolution of the erosion stages was described based on water-hammer pressure, stress waves, radial wall jetting, and hydraulic penetration modes. The initial erosion stages were mainly influenced by water-hamm

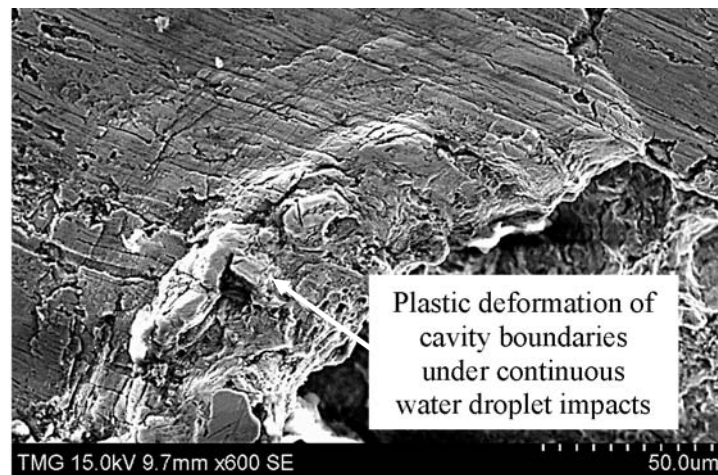
**Figure 22.** SEM micrograph shows plastic deformation of the non-treated Ti64 surface.
