Robotic Nd:YAG Fiber Laser Welding of Ti-6Al-4V Alloy

Abstract: In the present study, Ti6Al4V titanium alloy plates were joined using a robotic fiber laser welding method. The laser welding process was carried out at two different welding speeds. Effects of different heat input conditions on the microstructure and mechanical properties of robotic fiber laser welded joints were investigated. Some grain coarsening was observed in the microstructure of weld metal in samples joined using high heat input, compared to those using low heat input, and volume rates of primary α structures increased in the weld metal. The microstructure of weld metal in samples joined using low heat input was made of basket-weave or acicular α' grains and primary β grains in grain boundaries. Tensile and yield strength of samples joined using low heat input were higher than for those joined using high heat input, but their ductility was lower.

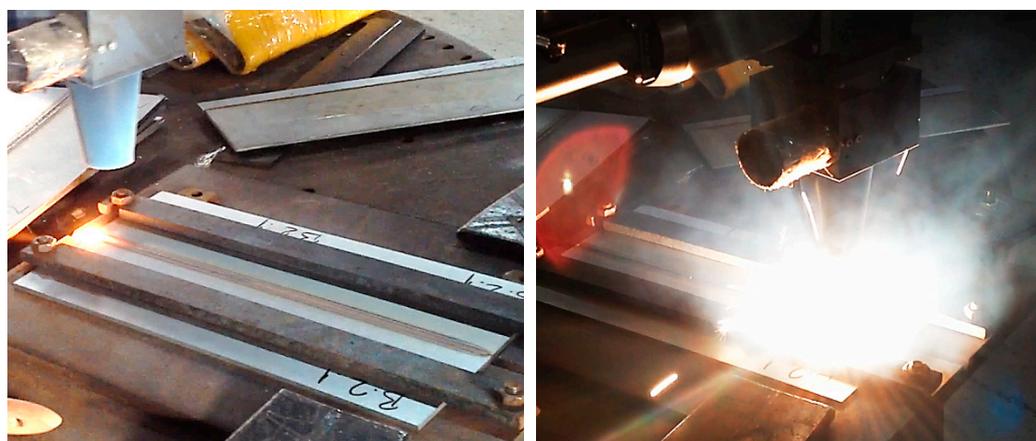
Figure 1. The laser welding process and fixing clamps.

Experimental material was prepared with dimensions of 100 mm × 330 mm × 4 mm for the welding process. Experimental samples were joined in a flat position using a FANUC ROBOT R-2000 iB 210F Nd:YAG fiber laser welding machine with 4 kW power (Fanuc, Yamanashi Prefecture, Japan), without using any additional metal (Figure 1). The welding parameters are given in Table 2.

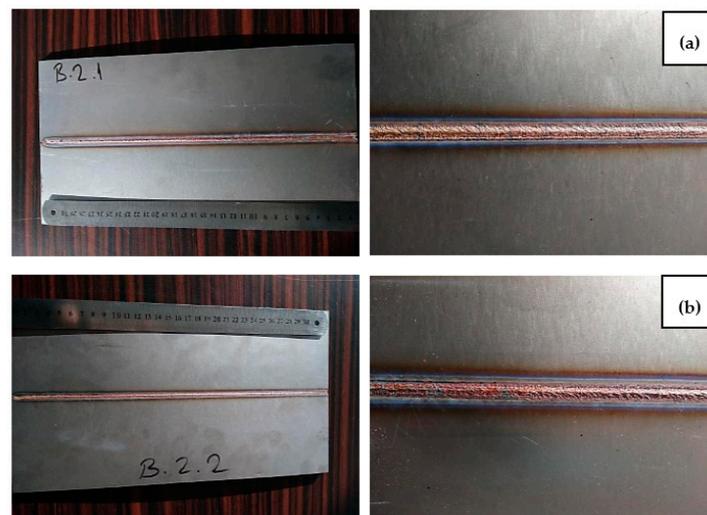
Figure 2. Macro images of laser welded joints, (a) A1 Sample, (b) A2 Sample.

Macro images belonging to A1 and A2 samples are shown in the Figure 2. As can be understood from the macro images, undercut, underfill and cracks were not observed in the welding seam, but cracks were observed in optical microscope image (Figure 5b).

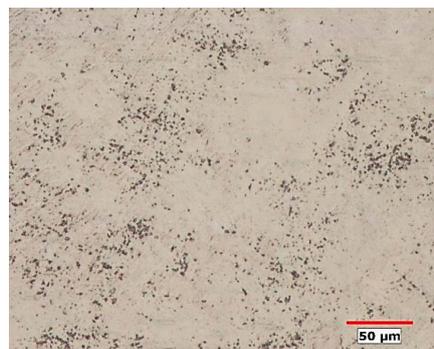
Figure 3. Microstructure image of base metal.

It was observed that the microstructure of the base metal was made of equiaxed α grains (light colored grain, hexagonal close packed) and β grains in grain boundaries (dark colored grain, body centered cubic) (Figure 3).

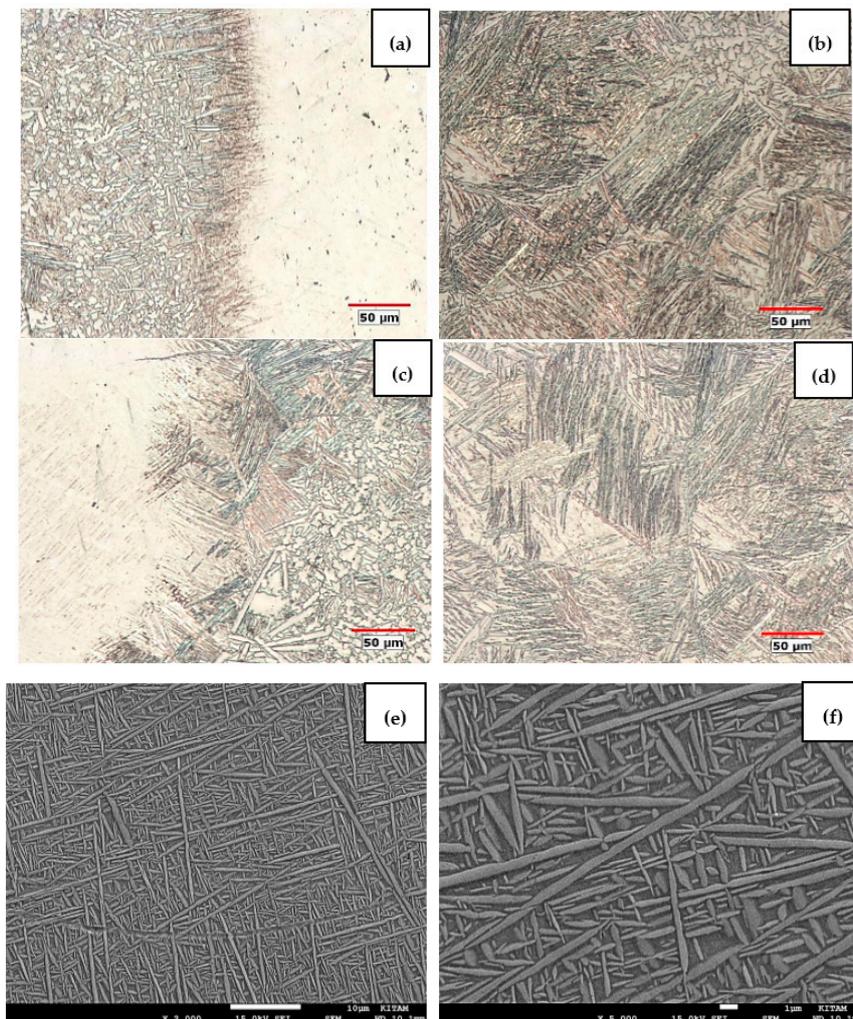
Figure 4. Microstructure images of the welded joint, (a) heat affected zone (HAZ); and (b) weld metal of A1 sample; (c) HAZ; and (d–f) weld metal of A2.

Due to the occurrence of a rapid cooling regime, a dominant martensitic microstructure exists in the weld metal of Ti6Al4V alloy joined by laser welding. In addition, with an increase of heat input, transformed beta grains with acicular alpha grains can form in the weld metal. In the HAZ and weld metal microstructure images for the study (Figure 4), a dominant martensite microstructure, cellular dendrite and columnar dendrite occurred, due to the rapid cooling related to the low heat input that is a characteristic feature of the laser welding method.

When the microstructures of the welded joints were investigated, it was observed that the HAZ arises from fine acicular α' martensite and primary α structures due to fast cooling (Figure 4). These types of microstructures can be observed at cooling temperatures lower than the β transus

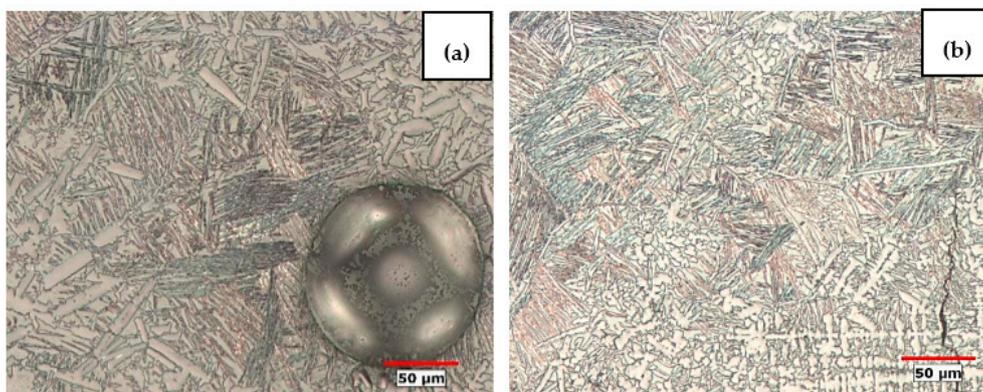
Figure 5. Porosity formation (a) with local crack formation; and (b) in the weld metal of A2 sample.

temperature [20]. It has been reported that cooling rates higher than 410 °C/s should be achieved to obtain a fully martensitic microstructure in Ti6Al4V alloy [3,21]. Studies reported that when the base metal is heated to temperatures over the β transus temperature during welding, martensite phase transformation from the high-temperature β phase takes place, and α' is formed with the basket weave [22]. At cooling rates slower than 410 °C/s, on the other hand, transformed α phase occurs preferentially in the primary β grain boundary. Figure 4 shows that cooling rate as a function of laser welding parameters, i.e., as a function of heat input, affected HAZ width. Because of joining using low heat input, a narrow HAZ developed. Some grain coarsening occurred due to the weld thermal cycle in the HAZ microstructure of samples joined using high heat input. It was observed that the weld metal microstructures of samples especially joined using low heat input was composed of basket-weave, acicular α' grains and primary β grains in the grain boundaries. As a result of the slower cooling rate in laser welding due to the low heat input, a diffusionless transformation of β phase into a martensitic structure takes place. In addition, local microcrack formation was observed in the weld metal of samples joined using low heat input (Figure 5b). Crack formation is always possible in welded joints like laser welding, where cooling is fast [5]. Presence of martensite, a hard and brittle phase, is among the major factors triggering the formation of microcracks in welded joints of titanium alloys and stainless steels. There may always be crack risk in the welding seam under rapid cooling conditions. Especially in laser beam welding, the occurrence of a rapid solidification rate can increase crack risk. To be able to decrease crack risk, it is suggested that samples should be fixed on the ground using clamps during welding [5]. In this study, samples were fixed on the ground using clamps during welding (Figure 1). Titanium alloys are reactive with ambient gases at high temperatures. For this reason, a shielding gas was used to protect the molten weld pool against oxidation until enough cooling had occurred. In spite of these protective conditions, crack and porosity formation were observed in the weld metal of the A2 sample. The crack occurrence in the A2 sample indicates that the molten weld pool was not protected as expected during the welding process. Setting the gas pressure incorrectly could conceivably be the cause of this result. As is well known, titanium alloys are quite resistant to crack risk. Weld cracking, however, can still be caused by contamination cracking, such as hydrogen-delayed cracking or liquation of iron-rich eutectic [3]. In this study, it should also be stated that cracks occurred in the weld metal of the A2 sample carried out locally. Less coarsened columnar β grain structures were observed in weld metal than in the HAZ (Figure 4). The volume rate of primary α structures increased in the weld metal of samples joined using high heat input. Besides, porosity formations were observed in weld metal microstructures (Figure 5a). Porosity formation is frequently encountered in laser welded titanium alloys. Gas type porosities arise especially from hydrogen, which cannot be removed from the weld pool during the solidification of the welding seam [23]. Porosity formation is expected to lower the mechanical strength of welded joints.

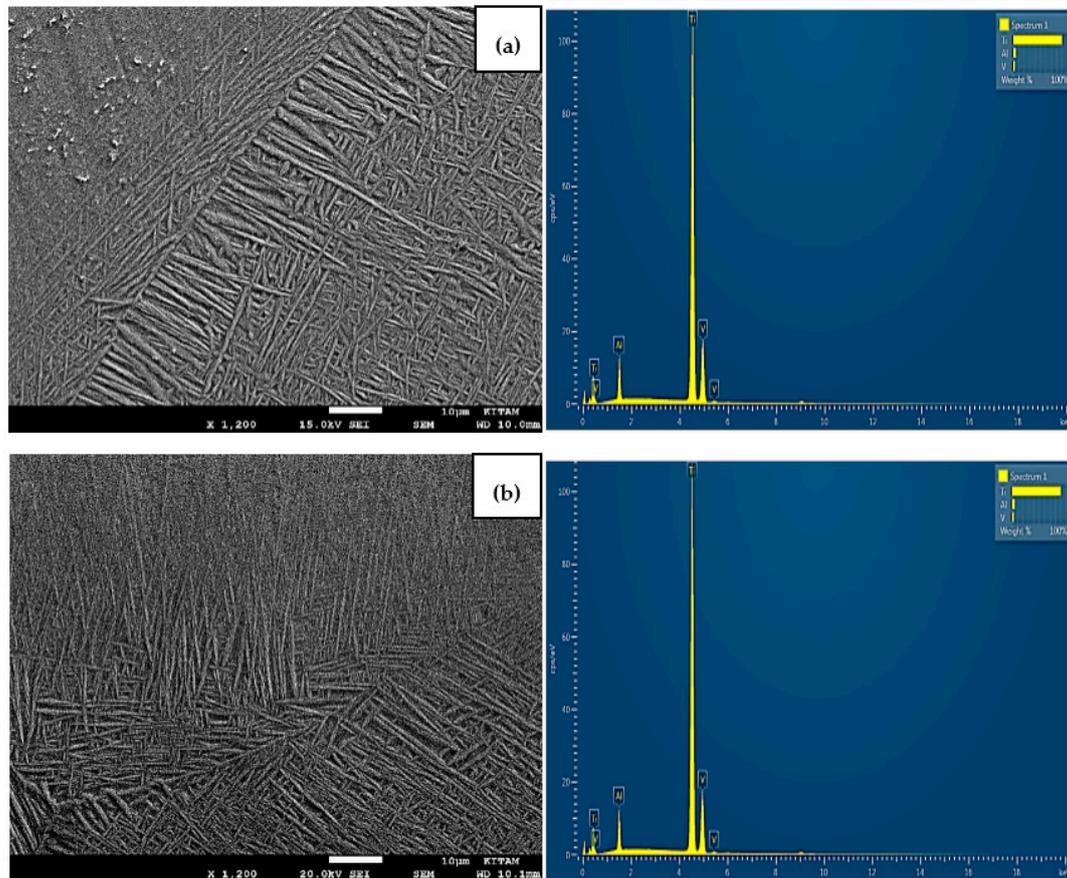
Figure 6. Energy dispersive spectrometer (EDS) analysis of base metal, HAZ and weld metal, respectively. (a) A1 Sample, (b) A2 Sample.

EDS analysis performed on welded samples showed that no major element losses occurred in the base metal, HAZ or weld metal (Figure 6). Based on these findings, it can be stated that heat input did not have any negative effect on laser welded joints.

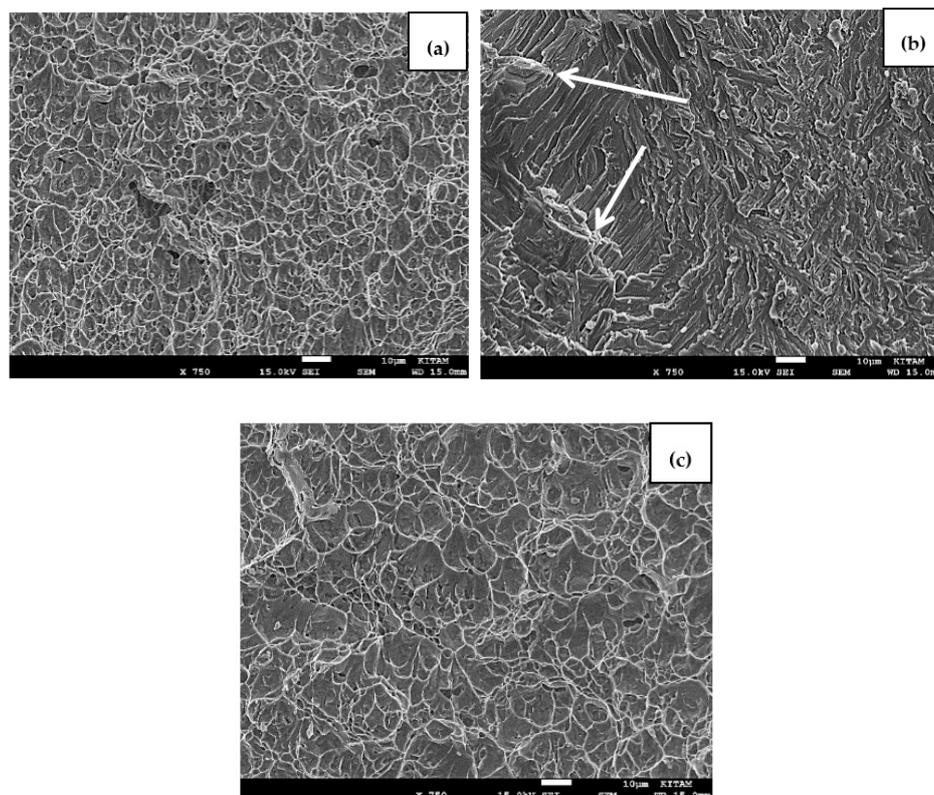
Figure 7. Fracture surface images of base metal and laser welded samples after the tensile test. (a) Base metal, (b) A1 Sample, and (c) A2 Sample, tear ridges indicated by arrows.

When SEM images of fracture surfaces of the base metal and the laser welded samples were examined after tensile testing (Figure 7), it could clearly be seen that ductile fracture, which is a typical fracture mode for titanium, was observable in the base metal and A2 samples by looking at dimples. In addition, for the A1 sample, intragranular fracture occurred with a tear ridges fracture mode. Because welded joints have lower ductility than the base metal after tensile testing, base metal experienced the ductile dimple fracture mode. There were little signs of plastic deformation in the welded A1 sample, with the fracture path appearing to be intergranular along colony boundaries, or cleavage across colonies, which indicates that the fracture mode changed from ductile to cleavage fracture mode [25]. In addition, it is thought that microstructural transformations and loading rates play a significant role in fracture mode changes. The fracture surface morphology of the welds was much rougher than that of the base metal. There were lots of dimples with different sizes and depths in the fracture surfaces of the joints in A1, and obvious tear ridges as well. No inclusion formation was observed in the fracture surface images of welded joints.

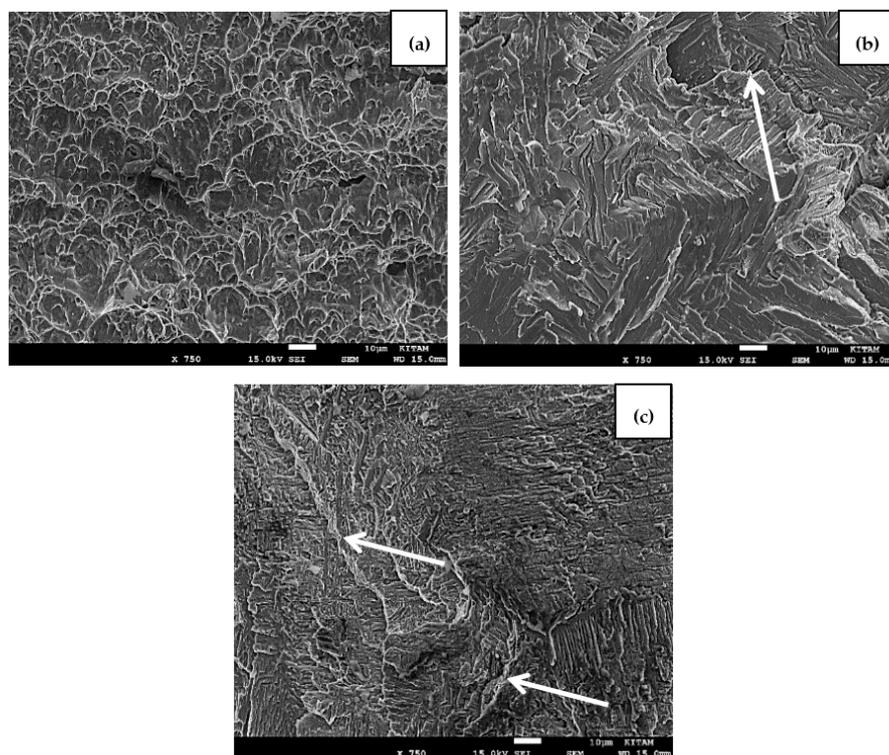
Figure 8. Fracture surface images of base metal and laser welded samples after The Charpy V-notch impact test. (a) Base metal, (b) A1 Sample, (c) A2 Sample, tear ridges indicated by arrows.

Fracture surfaces of the base metal and welded samples after impact testing were examined using SEM (Figure 8). The base metal was broken in ductile fracture mode, while A1 and A2 samples had fractures in the mode of intergranular fractures with either a quasi-cleavage type or tear ridges.

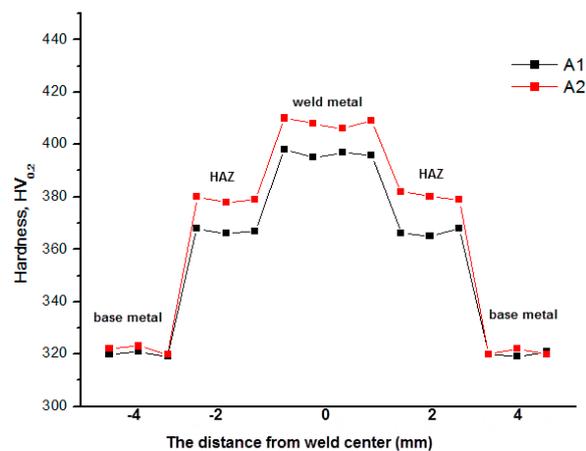
Figure 9. Microhardness distributions in the welded joints.

Due to the higher power intensity of laser welding, when compared to traditional welding methods, it results in low heat input and fast solidification, leading to high hardness levels in the welded joints. Distributions of hardness in welded joints is directly related to microstructure, and martensite in the microstructure is the most important factor for the hardness increase in the HAZ and weld metal of Ti6Al4V alloy. When the average hardness levels of samples joined using different welding speeds—i.e., different heat input, were examined, it was found that the hardness of the weld metal and HAZ was higher than for the base metal (Figure 9).

The reason for this outcome has been reported to be the formation of harder and finer acicular α' martensite structures in the weld metal and HAZ, compared to the structure of the $\alpha + \beta$ base metal [28,29]. Hardness level was observed to decrease as either laser power increased or welding speed decreased; i.e., as heat input increased. Investigators reported that hardness levels decreased as a result of coarsened primary β structure due to higher heat input [29]. With lower heat input, on the other hand, an increase in hardness is expected, owing to the formation of finer-grained α' structures [23]. The reason for the increase of hardness in weld metal compared to base metal was reported to be compact regions of α' with high-density dislocations and phase boundaries [22]. Hardness of the weld metal was determined to be higher than that of the HAZ for both welding speeds. It has been explained by some investigators that the decrease in hardness from weld metal to HAZ was caused by the decreased martensite content and Widmanstätten α structure [30]. When hardness results were examined generally, hardness levels of the HAZ and weld metal were similar. This similarity was linked to the very low heat conduction coefficient ($6.7 \text{ W} \cdot \text{m}^{-1} \cdot \text{K}^{-1}$) of Ti6Al4V alloy [31]. Thermal energy transferred to the weld zone of Ti6Al4V alloy can stay there longer before dispersing [31]. The higher hardness in the HAZ and weld metal compared to the base metal is expected to produce more strength in the joints than in the base metal. A similarity was expected between the hardness and tensile strength results. Nevertheless, such a similarity was not observed in the present study, due to the presence of porosities and microcrack formations in the weld metal and HAZ.
