# Case Study of the Application of an Innovative Guide for the Seismic Vulnerability Evaluation of Schools Located in Sangolquí, Interandean Valley in Ecuador

**Abstract:** The current study is based on the analysis and adaptation of a Federal Emergency Management Agency guide, FEMA P-1000, from the USA to improve school safety against natural hazards by applying the guide to the infrastructure of Ecuadorian schools, focusing primarily on seismic risk. By considering the technical foundations of structuring and managing disasters in buildings for school use, society will be provided with a practical procedure to recognize those aspects that need immediate attention as part of proper risk management. Here, a variety of parameters are involved in the proposed methodology of the given guide from FEMA combined with the national construction standards and regulations. The characteristics of nearby geological faults and structural and nonstructural vulnerability levels, amongst others, were also considered to allow for a detailed evaluation and a subsequent seismic risk categorization. Finally, the global risk is determined for the studied institutions of Sangolquí in the Valley of Los

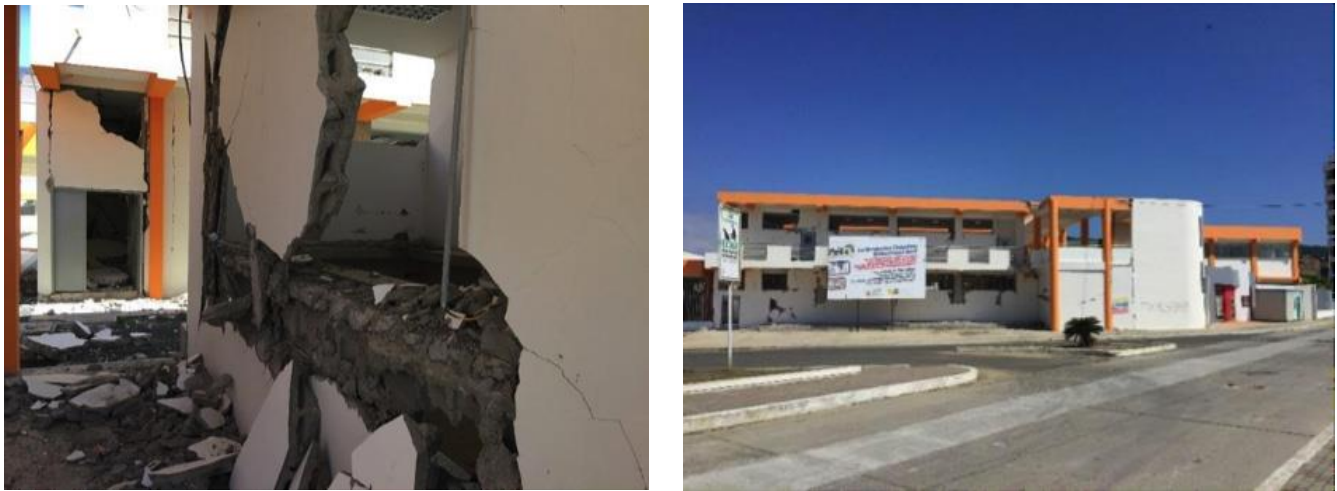
**Figure 2.** Collapsed school building during the earthquake of April 2016.

There were collapsed school buildings or a high degree of deterioration, in which three common characteristics were predominant [88]. These included existing design deficiencies and the lack of professional control during construction processes, as well as poor reinforcement detailing that prevent possible structural damage in the event of severe

earthquakes (Figure 2). As a result, 23% of the 1866 schools and colleges suffered minor (16%), medium (3%), and severe damage (4%).
