# Characterization of Mortar from Casa Barbot (Portugal), a Case Study from the Beginning of the 20th Century

**Abstract:** The popularity of natural cement (Roman cement) in buildings from the late 19th and the beginning of the 20th century and the high diversity of characteristics of natural cement demand research of mortar and binders used in the buildings of this period in Portugal. Understanding the type of binder used in the historic buildings will help the project/intervention team to make the best decisions in terms of the development of compatible mortars for historical conservation purposes. Casa Barbot is one of the Art Nouveau examples of the beginning of the 20th century in Portugal. The garden of this building is characterized by peculiar elements in terms of materials and architecture. Full characterization of the mortars employed in the construction of this building as well as identification of the used binder is the main objective of this study. The study comprises a wide range of laboratory characterization techniques such as X-ray fluorescence (XRF), X-ray diffraction (XRD), petrography, open porosity, density, water absorption by capillarity, and compressive st

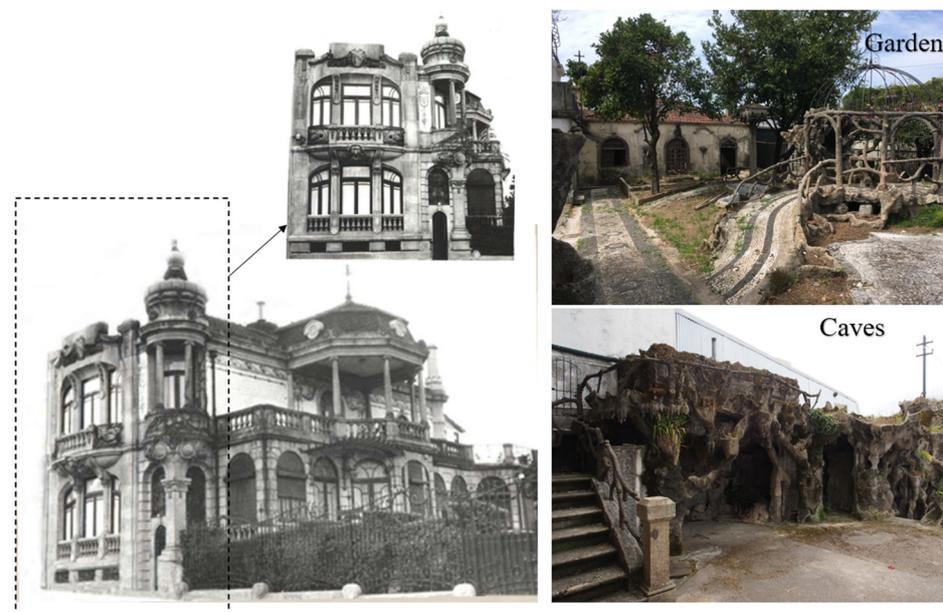
**Figure 1.** The main façade, garden, and caves of the Casa Barbot in Vila Nova de Gaia.

Casa Barbot, representing the only specimen of Art Nouveau in the Municipality of Vila Nova de Gaia, near Oporto (Portugal), was built by Bernardo Pinto Abrunhosa in 1904 and is located in the Avenida da Republica which is nowadays considered as the main artery of the city. The name “Casa Barbot” was given when the house was bought by Ermelinda Vilano Barbot and her family in 1944. The building has all the elements such as wrought iron, glass, and tile combined with stonework and thematic levels that characterize Art Nouveau in terms of materials. The Art Nouveau building is also completed by a typical garden, with greenhouses, a small lake, and caves. Casa Barbot and its gardens constitute a unit impacting the historical, architectural, and artistic profile that needs to be preserved with utmost importance. A general intervention in the garden was performed in 1988. Figure 1 shows the main façade of the building, the garden, and its cave-like structure Casa Barbot.

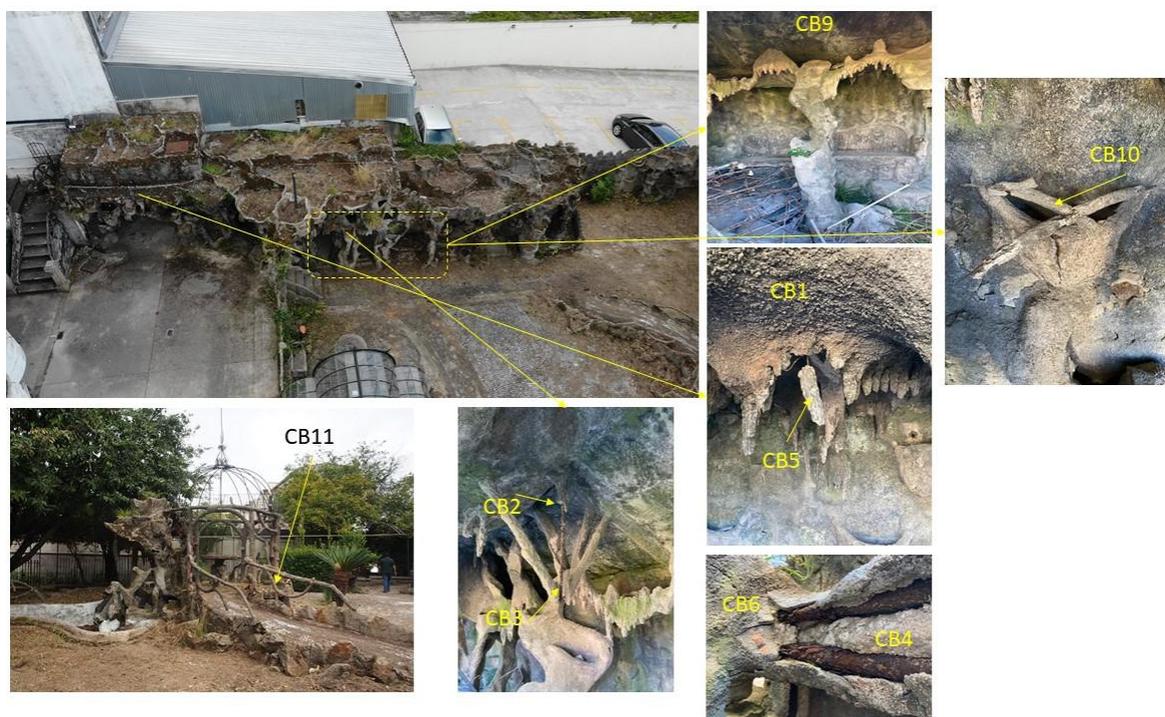
**Figure 2.** Samples identification and location in the garden and caves of the Casa Barbot in Vila Nova de Gaia.

the cracked regions on the cave structure and gazebo in the period garden of this house by means of chisel and hammer, see the location of collected samples in Figure 2.

The visual inspection revealed the existence of several layers, including inner (denoted as Int), outer (denoted as Ex), and interface layer (denoted as Ins). The description of the taken samples and their stratigraphy are presented in Table 1. Biological colonization could be observed in some samples. Efflorescence was observed on the surface of CB1 (taken from the ceiling of the caves). The samples with embedded rebars show weathering degradation and cracks due to the corrosion of reinforcement. All defects observed are related to the water infiltration through the cave's ceiling or corrosion of the reinforcement.

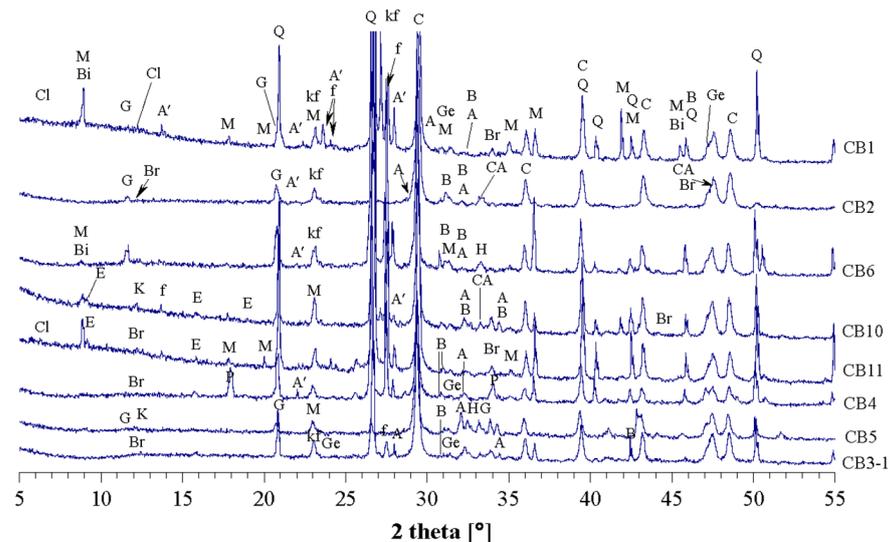
**Figure 3.** XRD diffractograms of the external layer of CB samples (visible peaks that are not labeled with any abbreviation are considered to have the same crystalline compound as the other samples in the same location). Q = quartz, f = feldspar, kf = microcline, A' = albite, E = ettringite, M = muscovite, Bi = biotite, G = gypsum, Br = brownmillerite (C4AF), K = kaolinite, P = portlandite, Ge = gehlenite, B = belite (C2S), A = alite (C3A), H = hematite, Cl = clinochlore, Hc = hydrocalumite, CA = C3A, C = calcite.

Figures 3–5 illustrate the XRD diffractograms of the external, internal, and intersectional layers of mortars (overall fraction), respectively. The main minerals identified are quartz, calcite, and feldspars (k- and Na-). In mortars CB2-Ex and CB5-Ex the quartz peak is lower than in the other samples, which is indicative of a lower content of siliceous sand. On the other hand, portlandite was only observed in CB4-Ex and CB11-Int mortars. It can be due to either the presence of air lime or Portland cement in the binder. Samples CB10 and CB11 contain ettringite, which coincides with the absence of gypsum, probably due to the full consumption of gypsum with free alumina.

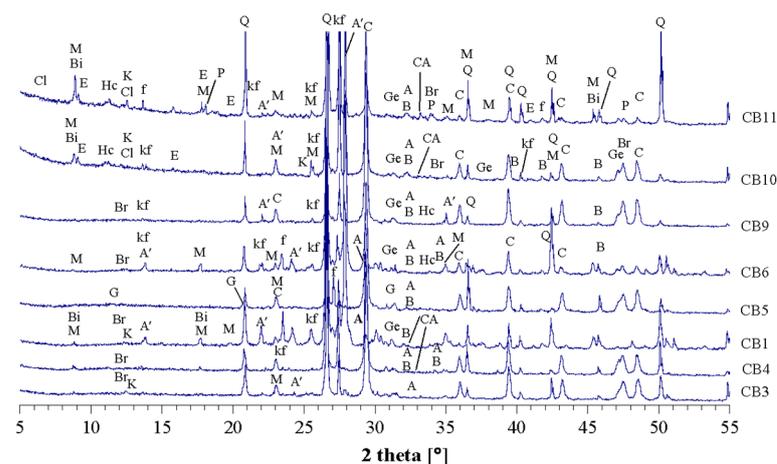
**Figure 4.** XRD diffractograms of the internal layer of CB samples (for the notation see the description in Figure 3).

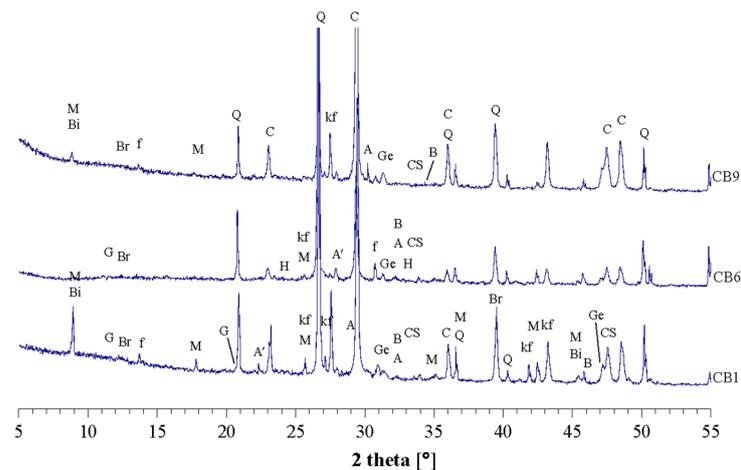
**Figure 5.** XRD diffractograms of intersectional layer of CB samples (for the notation see the description in Figure 3).

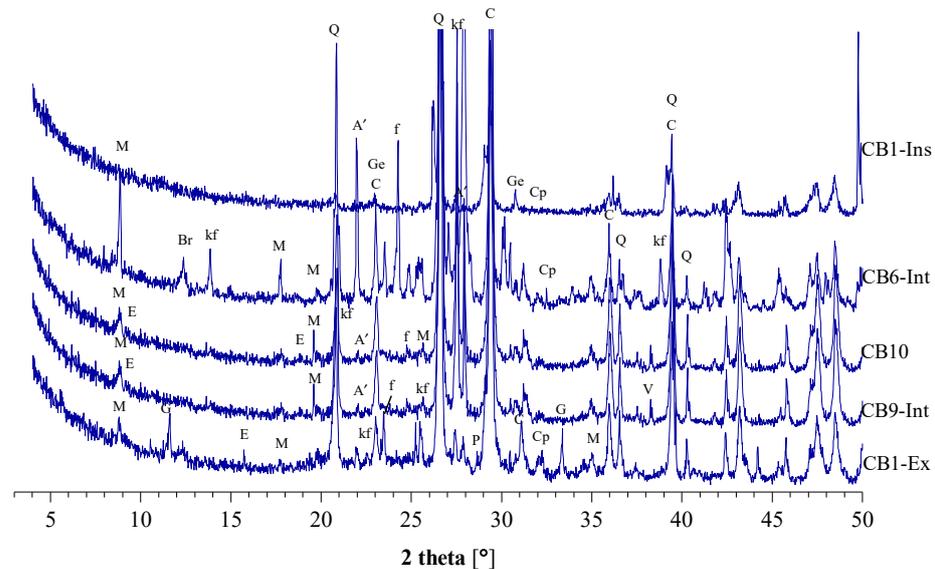
**Figure 6.** XRD diffractograms of binder-rich fraction of CB samples Cp = Portland clinker minerals  $C_3S$  and  $C_2S$  (for the complete notation see the description in Figure 3).

It was only possible to prepare a limited quantity of samples for the analysis of the binder-rich fraction. From the analysis of Figure 6, it is evident that the occurrence of Portland clinker phases ( $C_2S$ ,  $C_3S$ ,  $C_4AF$ ) indicates the use of Portland cement in the binder of CB mortars. In some samples, gehlenite ( $Ca_2Al_2SiO_7$ ), a mineral phase that can be attributed to a natural cement [29] or to the use of slags [48], was also detected.

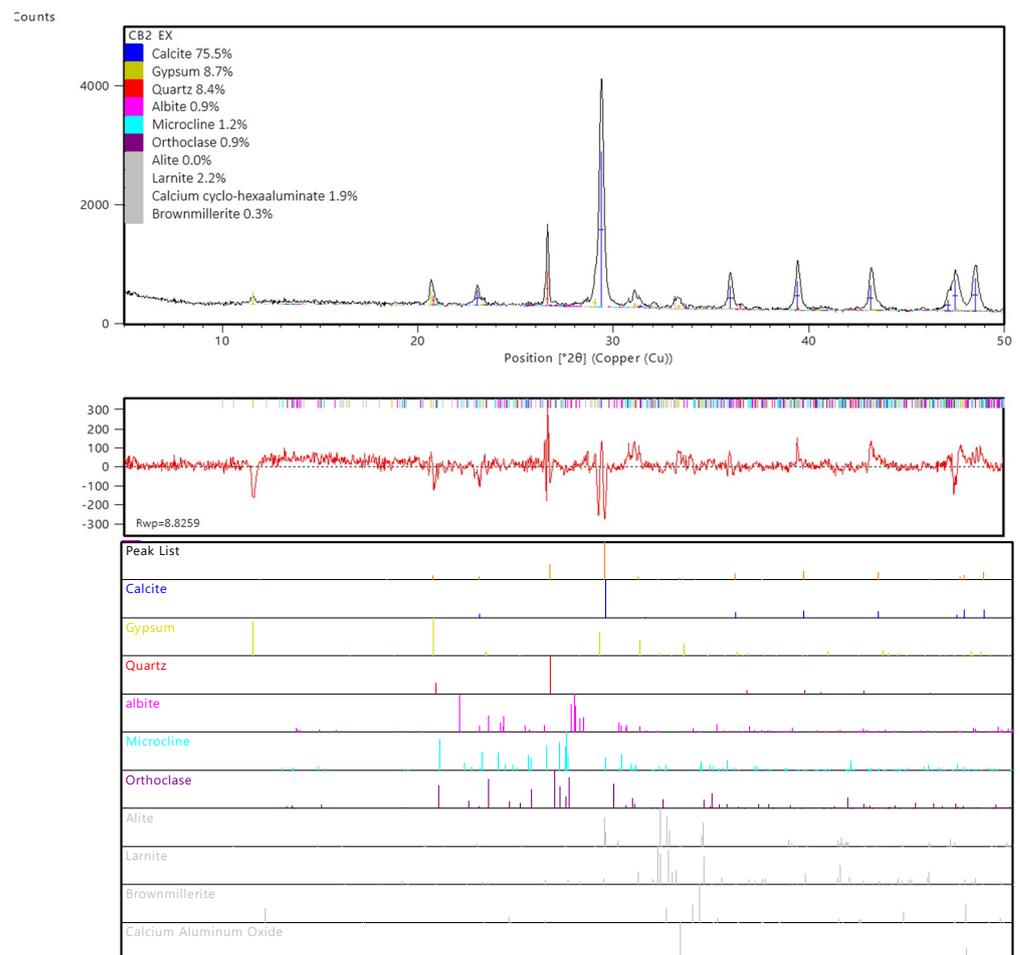
**Figure 7.** XRD diffractogram of sample CB2-Ex showing the fit result obtained by Rietveld refinement.

Table 4 shows the semiquantitative results obtained by Rietveld analysis and in Figure 7 an example of XRD pattern fitting and the value of weight profile R-factor (Rwp) is presented.

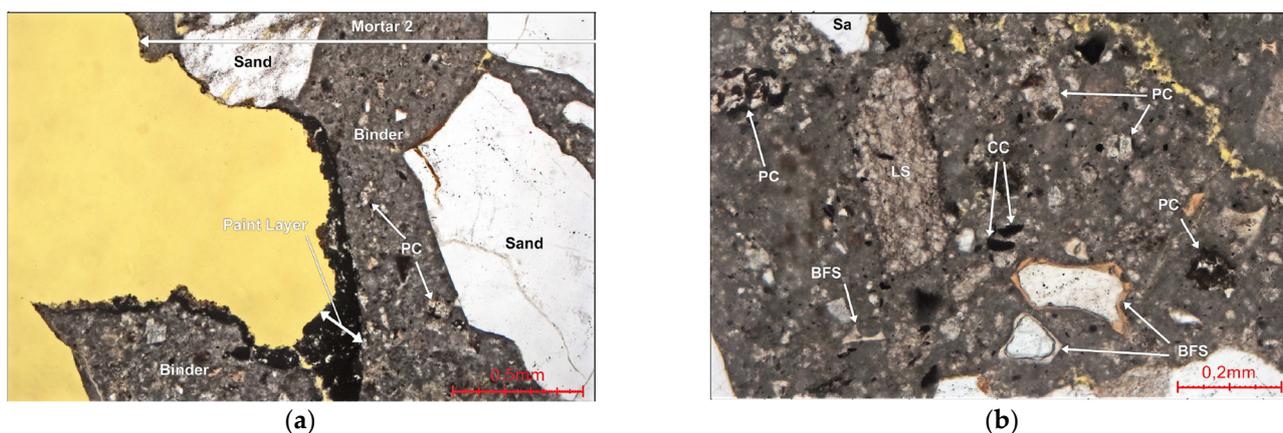
**Figure 8.** Micrographs in polarized light of CB1 sample: (a) external layer which shows remnants of a black paint layer on the surface of the outermost layer of splash render (Mortar 2). The binder of the paint layer consists of a mix of Portland cement and air lime. The mortar contains charcoal (CC-black particles), and the binder presents a high content of Portland clinker grains (PC); (b) interior layer whose binder paste consists of a mixture of Portland cement (PC), grains of limestone (LS), blast furnace slags (BFS) and lime (not seen on the photo). Small fragments of charcoal (CC) give the mortar a rather dark color. Sand aggregates = Sa. The thin section was impregnated with yellow epoxy resin.

This analysis showed a variety of aggregates, confirming the XRD results (see Section 4.2). All studied samples show aggregates mainly consisted of quartz and quartzite with a minor amount of metasiltstone including mica (muscovite) and feldspar, as was confirmed by both XRD and XRF techniques (where a high percentage of potassium was detected). Rounded to sub-angular grains of bituminous sedimentary limestone (Figure 8) were observed in the composition of all samples as a filler, except for the exterior layer of CB5 (labeled as “Mortar 3” in Figure 8). Small black charcoal-like particles with fragments of up to 0.08 and 0.1 mm in size were observed in the composition of all mortars (Figure 8), accounting for less than 1 vol% of the binder.

The binder of an uneven splash render mortar of CB1 (which can be seen all over the ceiling of the cave) appears to be a mix of Portland cement and lime. Several types of air and hydraulic lime lumps are present, namely rounded to sub-angular lumps of microcrystalline lime without any impurities, light brownish to brownish rounded lumps of microcrystalline lime with low content of impurities, and brownish to greyish lumps and grains of lime with high content of impurities.

A black paint layer of carboniferous pigment is also present over the surface of the splash render. The binder is a mix of air lime and Portland cement and is partly transformed into gypsum.

The real density of samples was in the range of 2350–2501 kg/m<sup>3</sup>. However, a large discrepancy can be observed in the samples taken from different parts of Casa Barbot, even in the duplicates, which hinders a decisive conclusion on the mechanical and physical properties of the mortars. This is because each sample is composed of several layers of mortars with different compositional, microstructural, and physical properties. CB2 possesses the highest strength among the others (55.7 MPa), due to the heterogeneous structure of CB2 that consists of different mortars and shapes (i.e., tree knot-like shape), see Table 1. CB2 also shows a relatively low capillary coefficient (0.3 kg/m<sup>2</sup>.min<sup>1/2</sup>) and low open porosity (13%) which corroborates the results of the mechanical test. This can be attributed to the high content of the binder in the composition of CB2, as was observed from XRD and XRF tests. On the other hand, high calcite content ensures the calcination of free lime during the lifetime of the sample and long-term strength gain. It seems that the largest content of gypsum is due to the addition of modern Portland cement during the intervention rather than its formation due to sulfation because the formed gypsum during the sulfation can lead to the loss of strength and adhesion [49]. CB1-Int shows the lowest capillary coefficient (0.04 kg/m<sup>2</sup>.min<sup>1/2</sup>) with a low open porosity of 11.82%. The incorporation of different materials such as Portland cement, blast furnace slag, limestone filler, and lime formed a compact structure (see Figure 8b) with lower capillary pores.

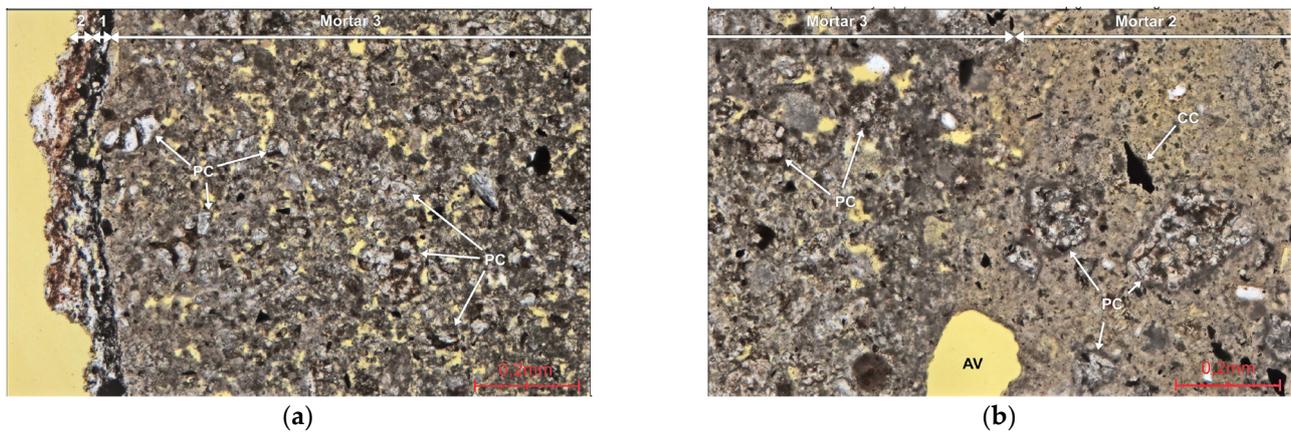
**Figure 9.** Micrographs in polarized light of CB5 sample: (a) the photo shows the paint layers on surface of the CB5-Ext (Mortar 3). The mortar is composed of Portland cement (PC) with a small amount of slaked lime added. The innermost paint layer (1) is of the same type as the carboniferous black paint layer in sample CB1. The outermost paint layer (2) consists of slaked lime and pigment of orange ochre; (b) the photo shows the contact between the CB5-Ext (Mortar3) and CB5-Int (Mortar 2). Compared to Mortar 3, Mortar 2 has a relatively high content of lime. Air voids = AV. Particles of charcoal = CC. The thin section was impregnated with yellow epoxy resin.

Sample CB5 (Figure 9) has two paint layers, an orange air lime paint on the exterior over a black carboniferous layer made with a mix of air lime and Portland cement. The interior mortar layer (CB5-Int) is a mix of Portland cement–air lime–hydraulic lime, with limestone filler and black charcoal particles. The hydraulic lime was attributed to the presence of lumps and grains of lime with high content of impurities in form of amorphous to microcrystalline silicate phases. The intermediate (CB5-Ins) and external (CB5-Ext) layers present the same type of binder, which is composed of a mix of air and hydraulic lime with Portland cement. These mortar layers are fully carbonated.

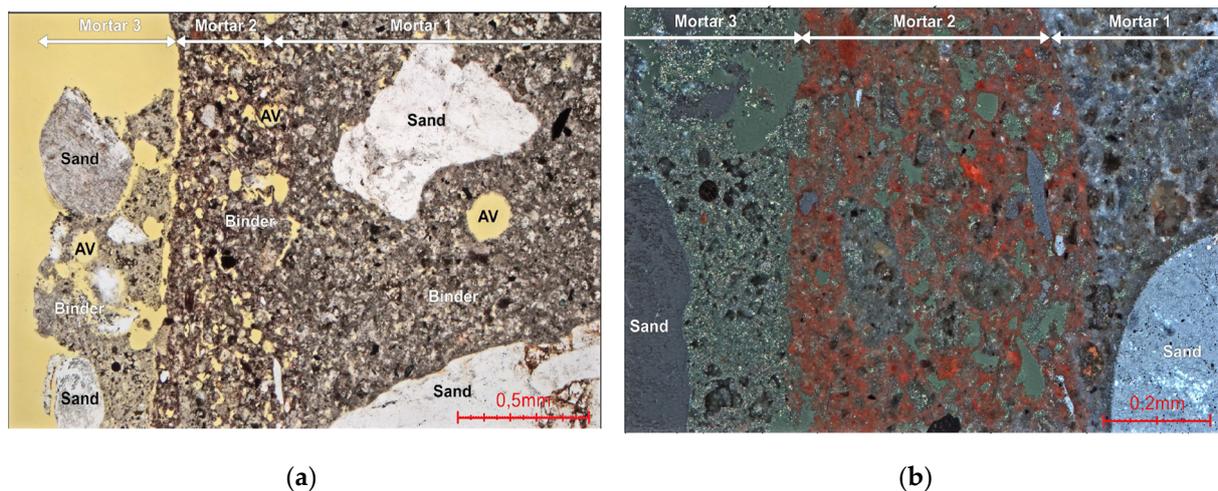
**Figure 10.** Micrographs in polarized light of CB11 sample: (a) the photo shows three mortar layers in the sample: Layer 1 (CB11-Int) is a Portland cement–lime mortar with blast furnace slags; Layer 2 is a reddish pigmented Portland cement–lime paste; Layer 3 (CB11-Ext) is remnants of relatively modern mortar with Portland cement.; (b) the photo shows the three mortar layers at a higher magnification and taken by use of reflected light microscopy. The pigment for Mortar 2 is red iron oxide. Air voids = AV. The thin section was impregnated with yellow epoxy resin.

Sample CB11 is stratigraphically very similar to CB5, although it has no layers of paint (Figure 10). In terms of binder, the splashed layer (CB11-Ext) is a Portland cement mortar. The second layer is a reddish render made by a mix of air and hydraulic lime with Portland cement. The color of this render is due to a red iron oxide pigment. The innermost layer (CB11-Int) is grayish, and the binder is also a mix of Portland cement with lime (air and hydraulic), together with some blast furnace slag grains.

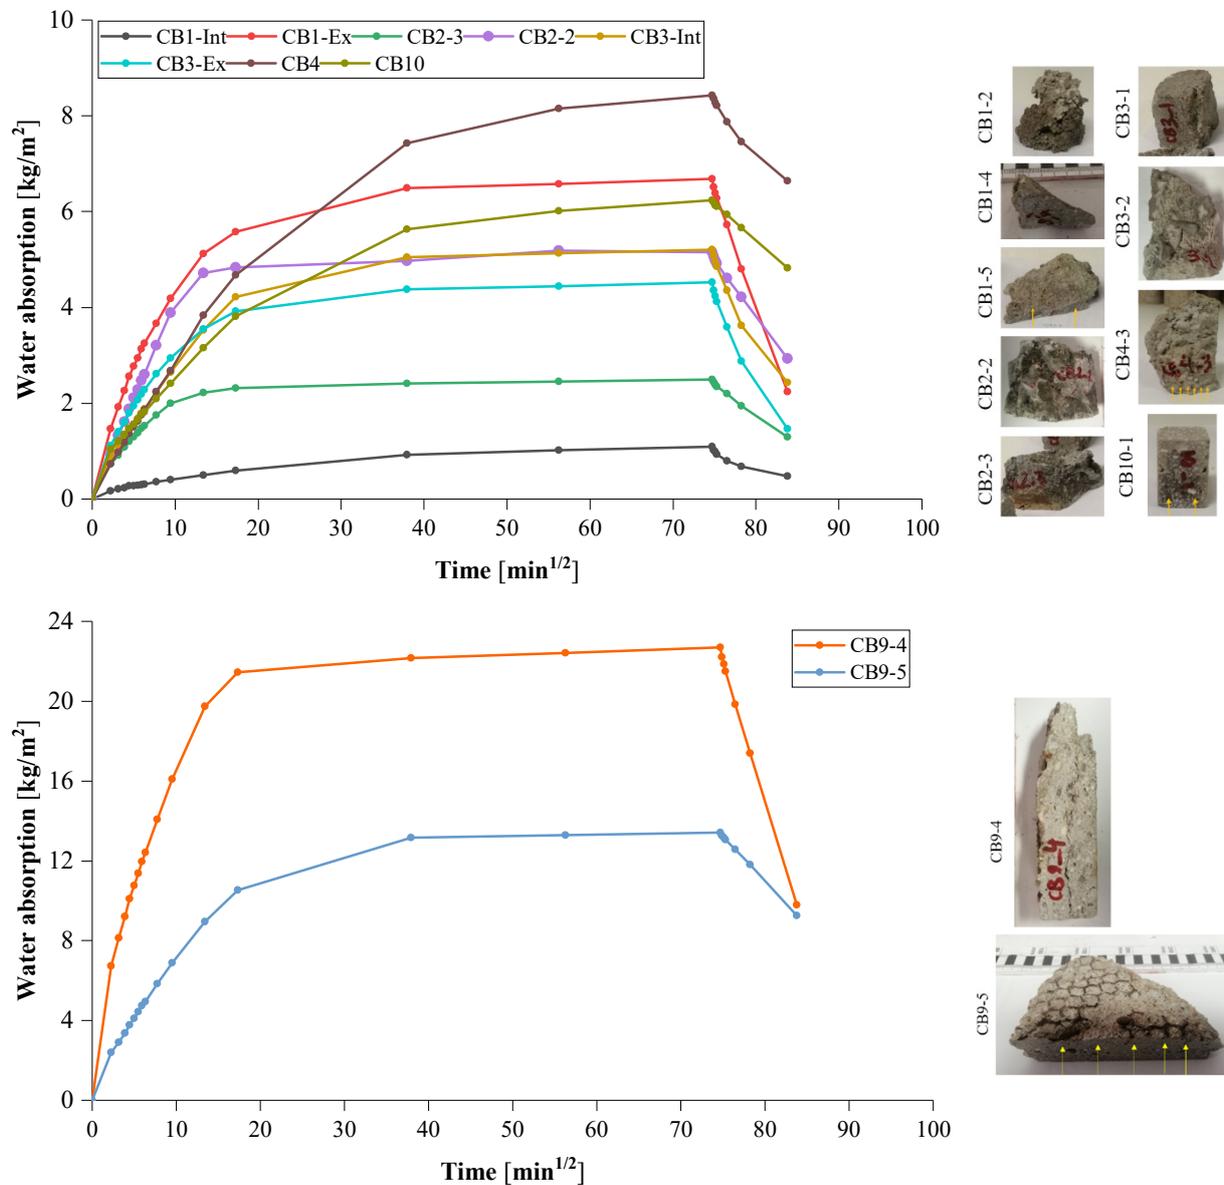
**Figure 11.** The water absorption and drying of mortars.

CB9 shows the highest open porosity among the mortars; however, it shows sensitivity to the test direction in both capillary water absorption and compressive tests. Although two samples of CB9 show high compressive strength (32.94 and 37.5 MPa), one of them registered the lowest value (10.59 MPa). Two distinct water absorption trends (Figure 11) and capillary coefficient (Table 7) were observed in CB9 replicates (1.51 and 0.66 kg/m<sup>2</sup>.min<sup>1/2</sup>). The longitudinal cracks in CB9-4 can be the main reason for the higher capillary coefficient

and lower compressive strength. This also accelerates the drying process in CB9-4, see Figure 11. CB1-Ex and CB9-4 show a very fast initial drying in comparison with the other samples. This can be well attributed to the high open porosity of these mortars (21% and 21.43%, respectively), accelerating the evaporation of absorbed water.
