Article

Experimental Study on the Flexural Performance of Composite Beams with Corrugated Steel Webs under the Coupled Effect of Chloride Ion Erosion and Sustained Load

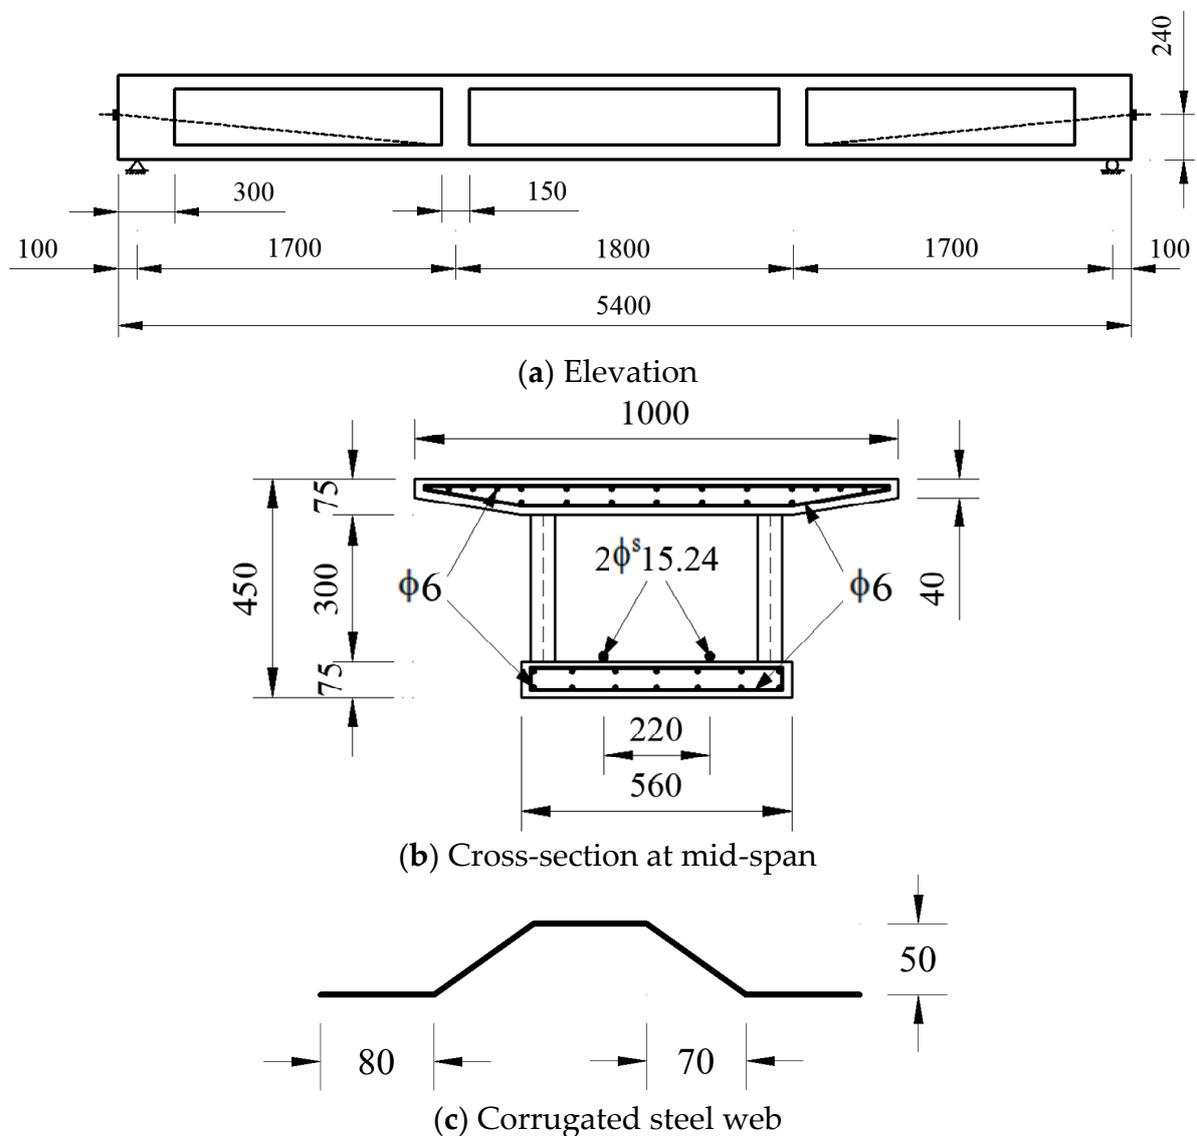
Figure 1. Dimensions and reinforcement diagram of CBCSWs (unit: mm).

Two CBCSWs, labeled as A1 and A2, were designed in the experiment. The two beams had both single-box and single-chamber sections, with a length of 5400 mm, a computed

span of 5200 mm, and a height of 450 mm. The top plate of the beams was 1000 mm wide and 75 mm thick, while the bottom plate was 560 mm wide and 75 mm thick. The corrugated steel webs on each side of the beams had a height of 300 mm and a thickness of 3 mm, a wave height of 50 mm, and a wave length of 300 mm. Each beam was equipped with two middle transverse diaphragms and two end transverse diaphragms. As shown in Figure 1, there was a turning block of externally prestressed tendons in every middle transverse diaphragm. Two steel strands (i.e., P1 and P2) with a diameter of 15.24 mm were arranged along the longitudinal folded line of the beams as externally prestressed tendons (Figure 1). The designed tension control stress of externally prestressed tendons was $0.7 f_{ptk}$ (f_{ptk} is the standard value of the ultimate tensile strength of prestressed tendons), and the graded tension was carried out by jacks. The sensor displayed the tensile force of the externally prestressed tendons in real time. After the prestress loss was approximately completed, the measured prestress values of the externally prestressed tendons were recorded, and they are listed in Table 1.

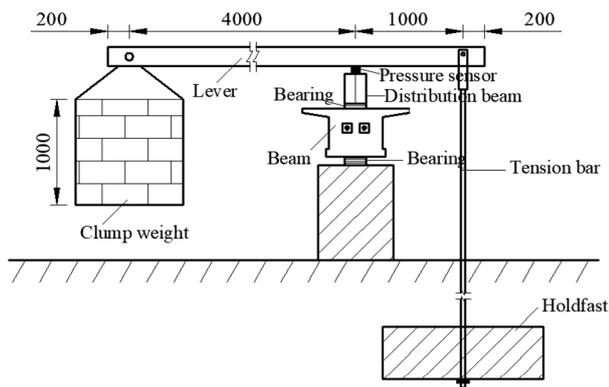
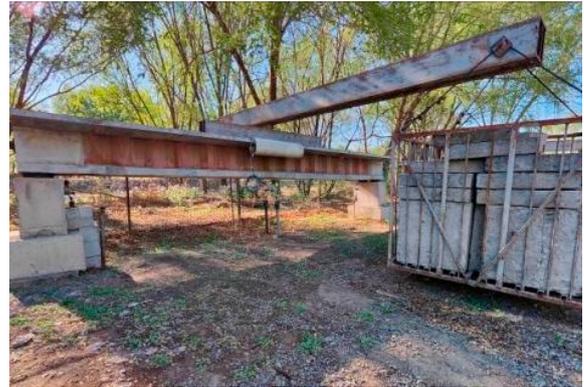
(a) Schematic diagram

(b) Physical picture

Figure 2. Device for applying the sustained load (unit: mm).

In order to make the test conditions more in line with the actual situation, the accelerated corrosion test was carried out on Beam A2 under a sustained load, but the corrosion of externally prestressed tendons was not carried out. Beam A1 was subjected to the same sustained load without an accelerated corrosion test, and for comparison, it was exposed to the natural environment only. The device for applying the sustained load is shown in Figure 2. Based on finite element simulation results, a sustained load of 100 kN was applied to the beams to ensure that the beams remained in the elastic stage during the accelerated corrosion test, and the clump weight as shown in Figure 2a was 20 kN. The value of the sustained load was monitored in real time using a pressure sensor with a maximum range of 200 kN during the accelerated corrosion test. The top and bottom plates of Beam A2 were subjected to a chloride ion drying-wetting cycle and electrochemical corrosion under a sustained load, with a corrosion region of 4500 mm at the mid-span, as shown in Figure 3.

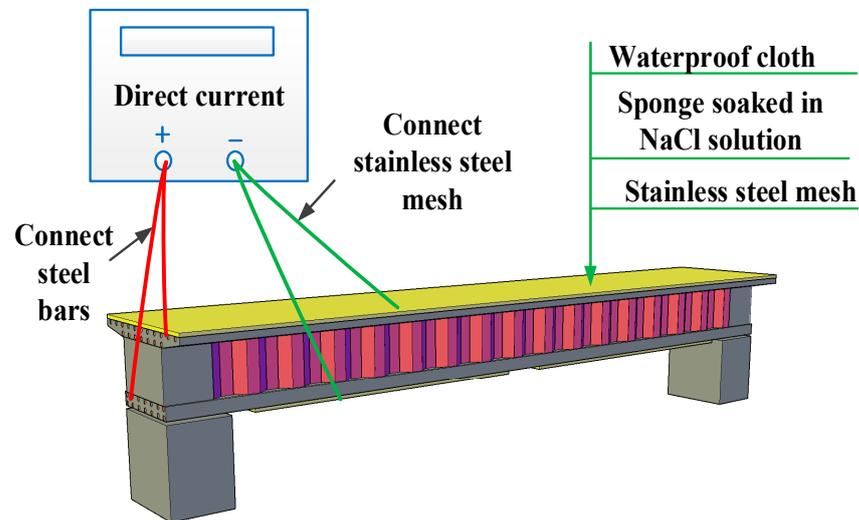
Figure 3. Schematic diagram of accelerated corrosion test.

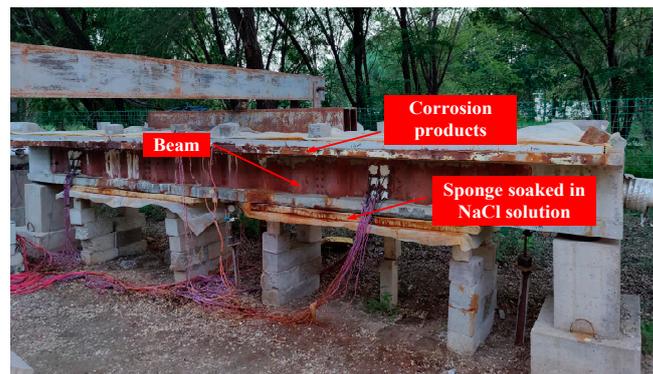
Figure 4. Arrangement of accelerated corrosion test.

One drying–wetting cycle of chloride ion solution was 14 days, with 7 days in the drying state and 7 days in the wetting state, for a total of 10 cycles, amounting to 140 days. During the wetting stage, the sponge was immersed in 5% NaCl solution and placed tightly against the surface of the beam, as shown in Figure 4. In addition, 5% NaCl solution was regularly replenished to the sponge every day to keep it saturated. The steel bars in the top and bottom plates were connected to the positive pole of the DC power supply with an output voltage of 0–120 V and an output current of 0–3 A, while eight pieces of stainless-steel mesh (Figure 3), of which six were on the top plate and two were on the bottom plate, were connected to the negative pole. The current density was taken as $200 \mu\text{A}/\text{cm}^2$ during the corrosion process. During the drying stage, the beam was exposed to the natural environment after the sponge was removed.

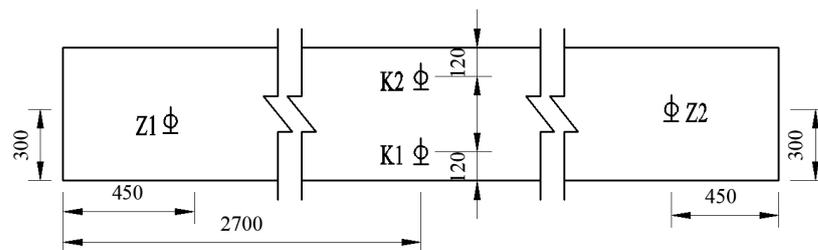
Figure 5. Arrangement of dial gauges (unit: mm).

During the corrosion process, the deflections at the supports and mid-span of each beam were measured, and the layout of dial gauges is illustrated in Figure 5. Moreover, the changes in prestress were monitored by using the pre-arranged JMZX-3006 comprehensive tester and pressure sensors. In order to eliminate the influence of temperature on the deflection and prestress, the monitored data were collected at 8:00, 11:30, 14:30, and 17:30 each day.

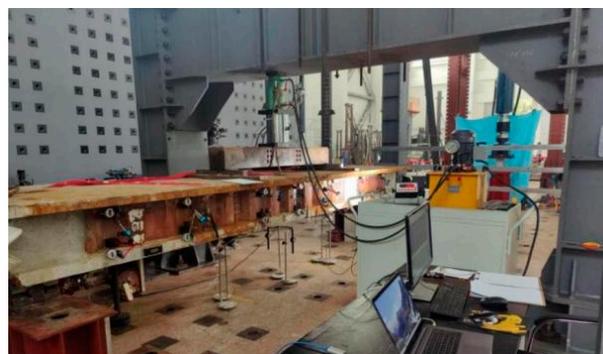
Figure 6. On-site loading picture.

After the accelerated corrosion test, a manual hydraulic jack with a measuring range of 600 kN was used to apply three-point symmetrical loading to the two beams, as shown in Figure 6. To ensure the free horizontal movement of the beams, a roller bearing with a diameter of 40 mm was provided at one end of the beams.

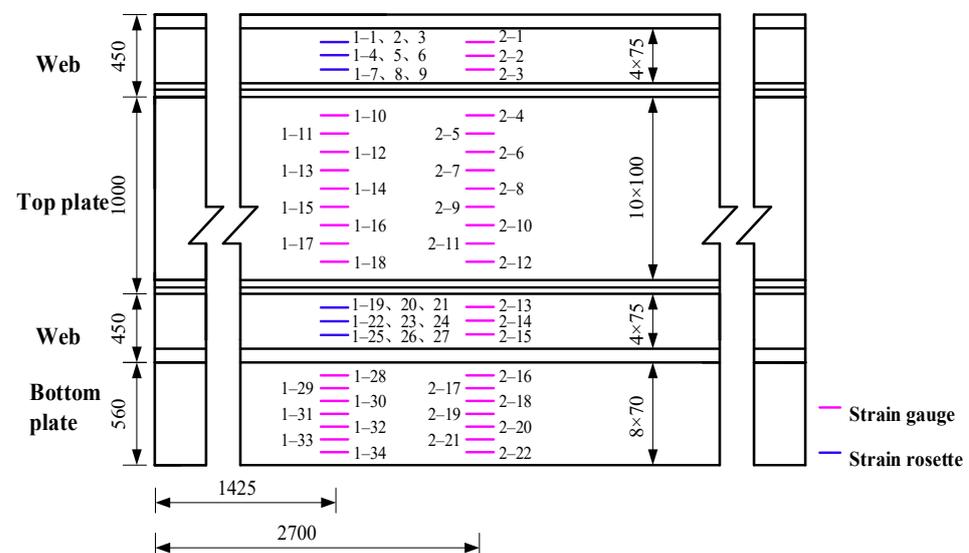
Figure 8. Arrangement of strain gauges (unit: mm).

To study the changes in prestress of externally prestressed tendons with increasing loads, the prestress was measured using a JMZX-3006 comprehensive tester during loading. Moreover, the strain gauges and triaxial strain rosettes were arranged at the 1/4 section, mid-span, 3/4 section of the top plate, the bottom plate, and the web, which aimed to study the distribution of longitudinal strains along the height and width of the beam, verifying whether the longitudinal strains satisfied the quasi-plane section assumption and measuring the changes in strain of the corrugated steel webs during the loading process, as depicted in Figure 8.

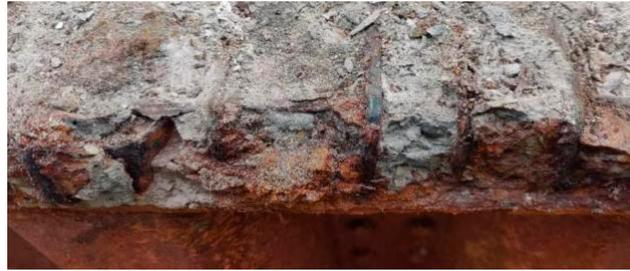
Figure 9. Corrosion of steel bars embedded in Beam A2.

To measure the mass loss of the steel bars in Beam A2, the top and bottom plates were broken with an electric chisel after the bending failure test, and the steel bars were exposed to the outside, as shown in Figure 9. It is clear that the steel bars were significantly corroded.

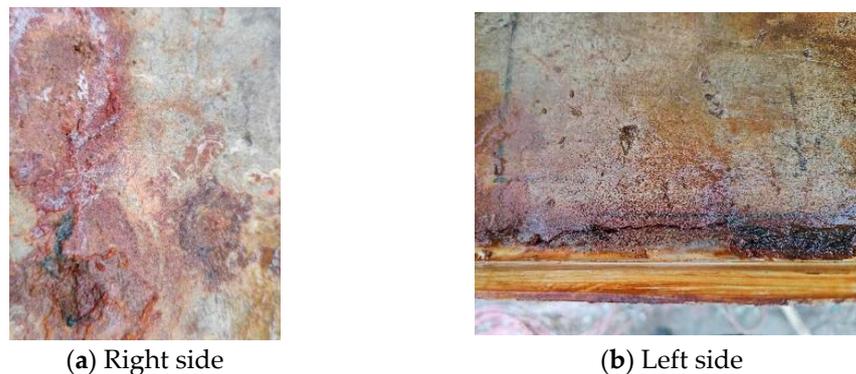
Figure 10. Corrosion of the top plate of Beam A2 on the 30th day of the accelerated corrosion test.

On the 30th day of the accelerated corrosion test, visible reddish-brown corrosion products were found at the edge of the top plate of Beam A2, and corrosion-induced cracks could also be observed, as shown in Figure 10. This is because there was sufficient oxygen at the edge, resulting in more severe corrosion of the steel bars compared to those in the middle position. Longitudinal corrosion-induced cracks appeared on the side surfaces of the beam, with reddish-brown and yellow corrosion products precipitating from the corrosion-induced cracks, as depicted in Figure 11. Figure 12 shows that the corrosion of the bottom plate is relatively light, with dotted reddish-brown corrosion products observed, compared to the top plate.

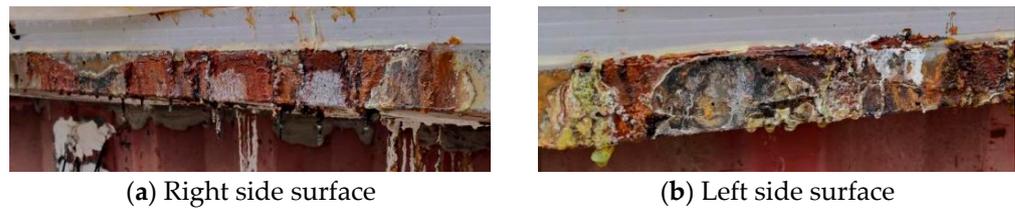
Figure 11. Corrosion products on the side surfaces of Beam A2 on the 30th day of the accelerated corrosion test.

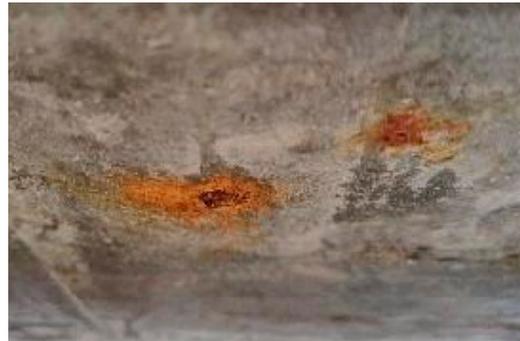
Figure 12. Corrosion of the bottom plate of Beam A2 on the 30th day of the accelerated corrosion test.

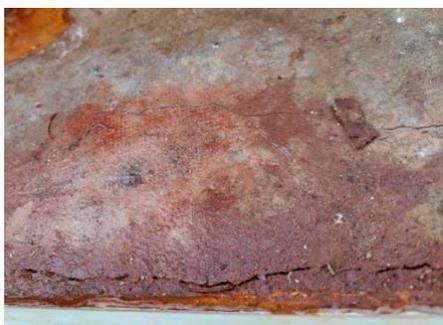
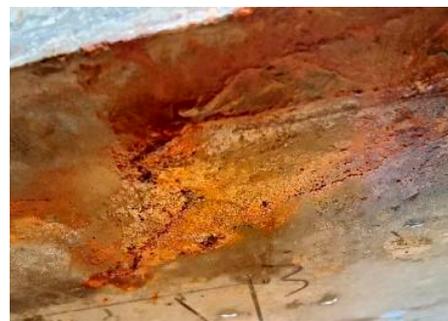
(a) Corrosion-induced cracks on the top plate

(b) Corrosion products on the bottom plate

Figure 13. Corrosion of Beam A2 on the 50th day of the accelerated corrosion test.

After 50 days of the corrosion test, the width of corrosion-induced cracks on the top plate gradually increased, and new corrosion-induced cracks appeared, as illustrated in Figure 13a. The corrosion products on the bottom plate also gradually increased and exhibited a flake distribution, as shown in Figure 13b.

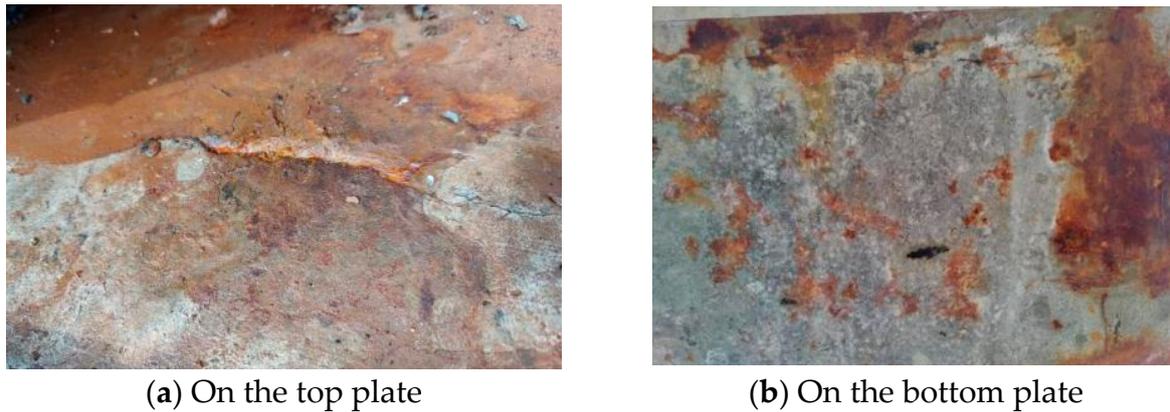
Figure 14. Corrosion-induced cracks of Beam A2 on the 80th day of the accelerated corrosion test.

Figure 14 shows the corrosion of Beam A2 on the 80th day of the accelerated corrosion test. The corrosion-induced cracks on the top plate continue to extend and widen. However, there are relatively fewer new cracks. There are multiple transverse corrosion-induced cracks and discontinuous longitudinal ones on the bottom plate, which means the corrosion on the bottom plate progressed significantly.

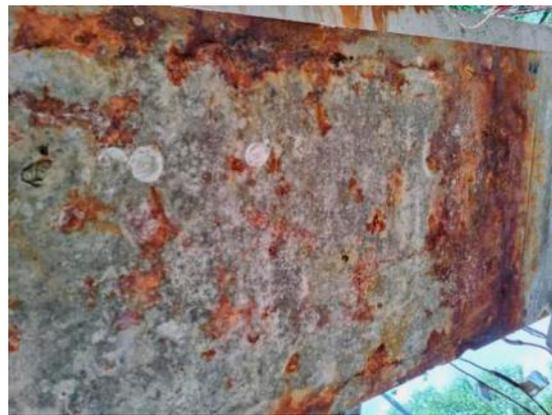
Figure 15. Corrosion-induced cracks on the bottom plate of Beam A2 on the 100th day of the accelerated corrosion test.

When the corrosion test reached the 100th day, the longitudinal corrosion-induced cracks on the bottom plate connected into a single one, and the width of the cracks continued to expand, as shown in Figure 15. He et al. [40] also found that, under the coupling of sustained load and chloride corrosion, the width of the corrosion-induced cracks of RC beams increased with corrosion time during the entirety of the experiment, which is consistent with the results of this paper.

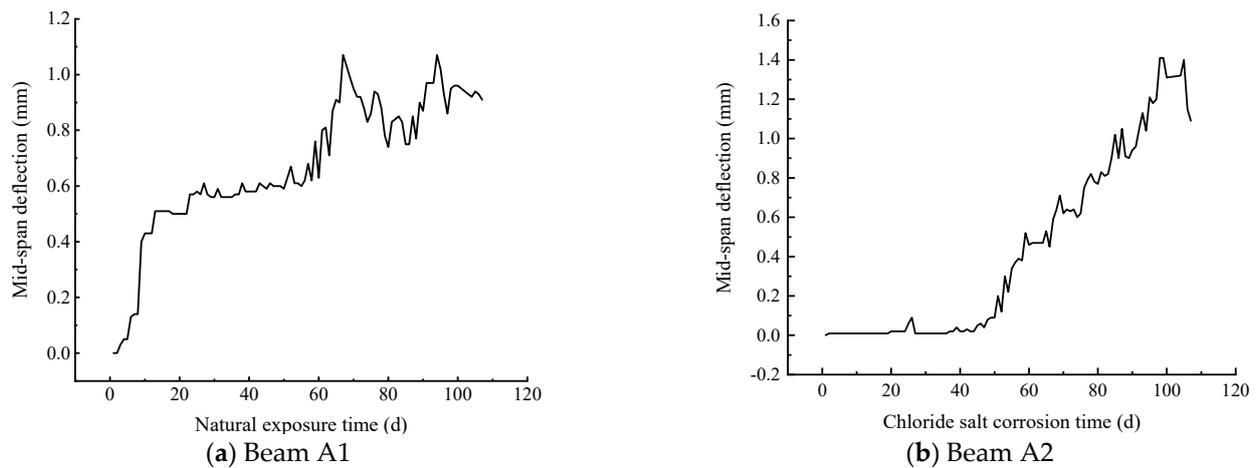
Figure 16. Changes in deflection at mid-span of the beams during natural exposure and chloride ion accelerated corrosion.

The deflection at the mid-span of the two beams during the accelerated corrosion test is shown in Figure 16. From the figure, it can be found that the mid-span deflection of both beams increases with corrosion time, while the increase in deflection at the mid-span of Beam A2 is greater and the growth rate is faster. This is because the steel bars in Beam A2 are corroded, reducing the stiffness of the beam, which makes Beam A2 exhibit larger deflection under the same conditions. Du et al. [41] also found that, due to the corrosion of steel bars, the time-dependent deflection of a corroded beam under loads increases more rapidly than that of a non-corroded beam, which is in line with the results of this paper.

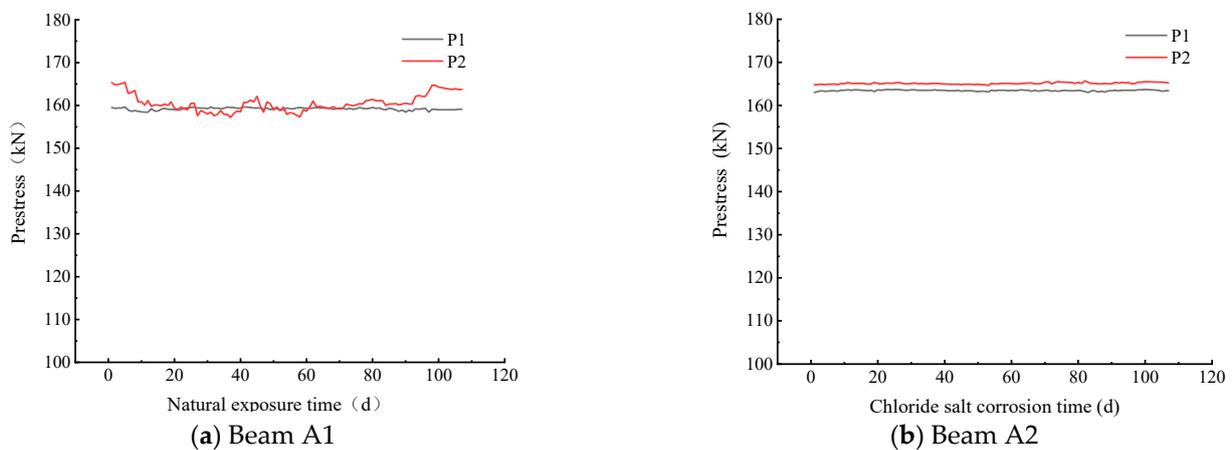
Figure 17. Stress variations in externally prestressed tendons during natural exposure and chloride salt corrosion.

Figure 17 depicts the stress variations in the externally prestressed tendons in two beams during the accelerated corrosion test. It can be seen that, except for P2 of Beam A1, the stress change in the externally prestressed tendons is not significant. Although the stress fluctuation of P2 is relatively larger compared to others, the stress difference before and after the test is only 1.6 kN (0.96%), indicating a small change. This may be due to the short corrosion period of the two beams and the fact that the externally prestressed tendons are independent of the chloride salt corrosion. Moreover, during the accelerated corrosion test, the deflection at the mid-span of the beams is relatively low (less than 1.4 mm), and the beams are in the elastic stage, and the effect of externally prestressed tendons is not obvious, so the stress change is not significant.

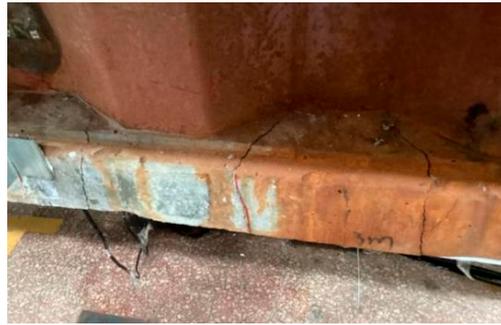
Figure 18. Development of cracks of Beam A2 when the load is 200 kN.

When the load is 200 kN, a squeaking sound is heard from Beam A2, and the maximum width of cracks is 0.72 mm. At the junction of the bottom plate and the corrugated steel webs, the cracks extend inward from 30° to 45° with the inclined web, as shown in Figure 18. Meanwhile, the prestresses of P1 and P2 increase linearly with increments of 14.1 kN and 17.8 kN, respectively. The relative slip between the bottom plate and the web at the 2/3 section is the largest, which is 0.27 mm.

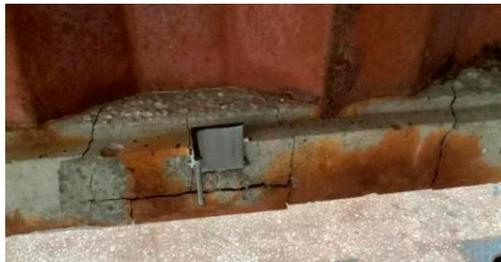
Figure 19. Development of cracks on Beam A2 when the load is 235 kN.

When Beam A2 is loaded to 235 kN, noticeable movement occurs on both sides of cracks on the bottom plate, and the maximum width of cracks is 1.00 mm. Obvious gaps are observed along the corrugations at the junction of the bottom plate and the web, and the stress cracks intersect with the longitudinal corrosion-induced cracks, as shown in Figure 19.

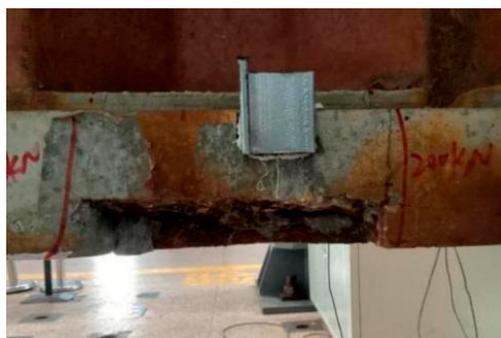
Figure 20. Concrete spalling of Beam A2 during loading process.

A snap is heard when the Beam A2 is loaded to 248 kN, then the load begins to decrease, and the concrete starts to spalling at the intersection of stress cracks and longitudinal corrosion-induced cracks, the corroded steel bars are exposed, which indicates that damage occurs to Beam A2, as shown in Figure 20.

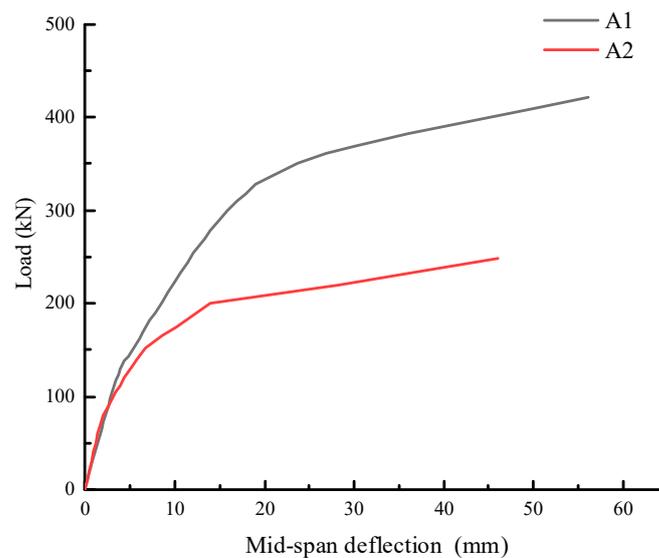
Figure 21. Load–deflection curves at mid-span.

The load–deflection curves at the mid-span of Beams A1 and A2 are shown in Figure 21. It can be seen from Figure 21 that the bearing capacity of Beam A2 is obviously degraded due to the coupled effect of the steel corrosion and sustained load, which is in agreement with the results of Li et al. [44], who studied the behavior of RC beams under simultaneous loading and reinforcement corrosion. Before cracking, the deflection at the mid-span of Beams A1 and A2 approximately increases linearly with the increasing load, and the stiffness of Beam A2 is slightly greater than that of Beam A1. Hu [6] also confirmed that the deflection of the CBCSWs had a linear relationship with the load growth in the range of the elastic stage. As the load increases, the bottom plate of Beam A2 cracks, resulting in a decrease in stiffness; thus, Beam A2 has a lower stiffness. When the load reaches 143 kN, Beam A1 cracks, where a distinct turning point can be observed on the load–deflection curve at the mid-span of Beam A1.

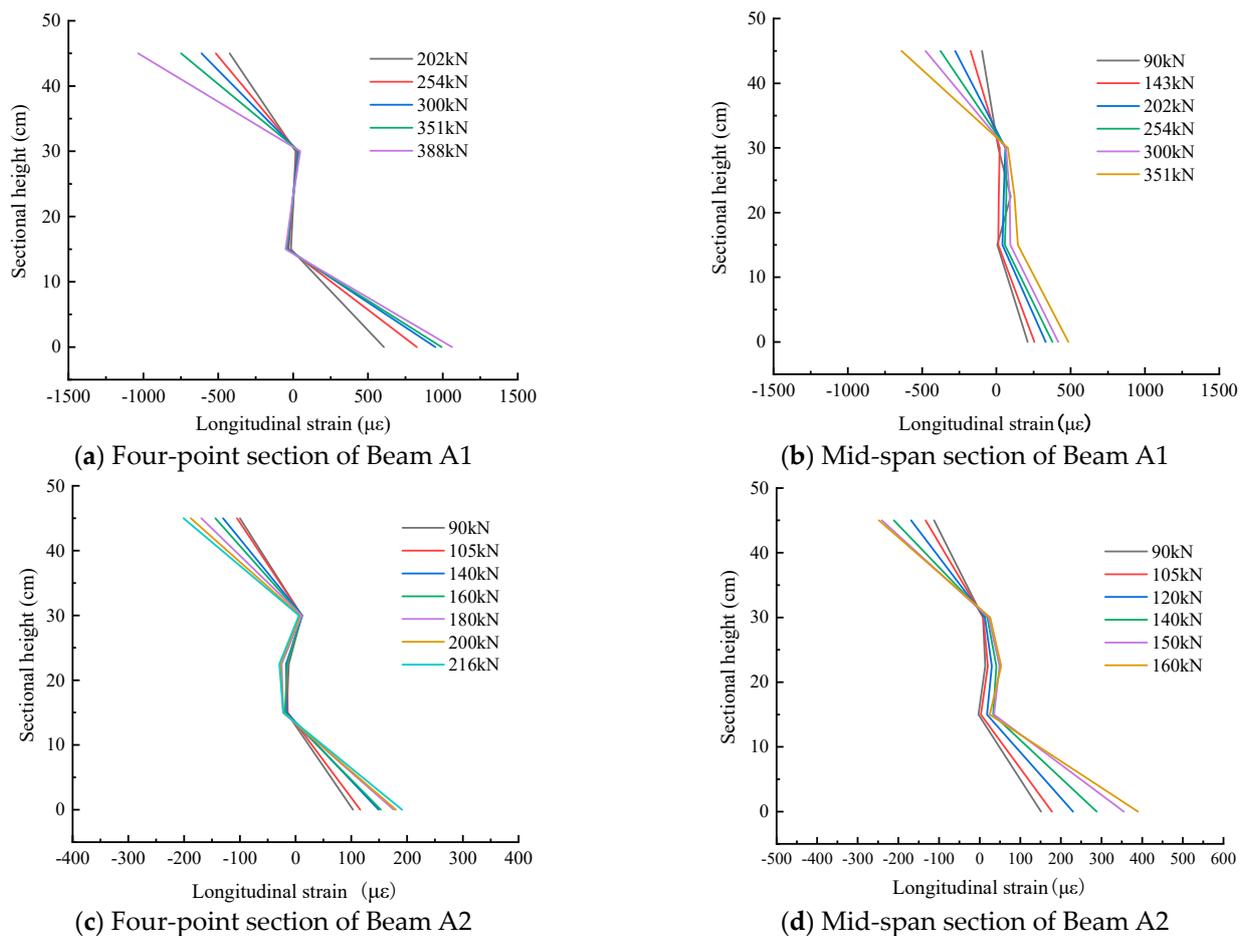
Figure 22. Distribution of longitudinal strains along the height direction.

The distribution of longitudinal strains along the height direction of Beams A1 and A2, including the four-point section and mid-span, is shown in Figure 22. Chen [5] proved that the strain distribution of the top and bottom plates of uncorroded CBCSWs conformed to the quasi-plane section assumption through both experimental research and theoretical analysis. Yuan et al. [45] found that the strain distribution of uncorroded CBCSWs was basically consistent with the quasi-plane section assumption when it was subjected to bending load. It can be seen from Figure 22 that the quasi-plane section assumption is still approximately applicable to the corroded CBCSWs. Due to the longitudinal folding effect of corrugated steel webs, the strain within the height range of the web is close to zero, indicating that the corrugated steel webs hardly bear bending moments [45,46]. Therefore, it is feasible to adopt quasi-plane section assumption in engineering calculations that only considers the influence of top and bottom plates on the bending performance of corroded CBCSWs, ignoring the corrugated steel webs.

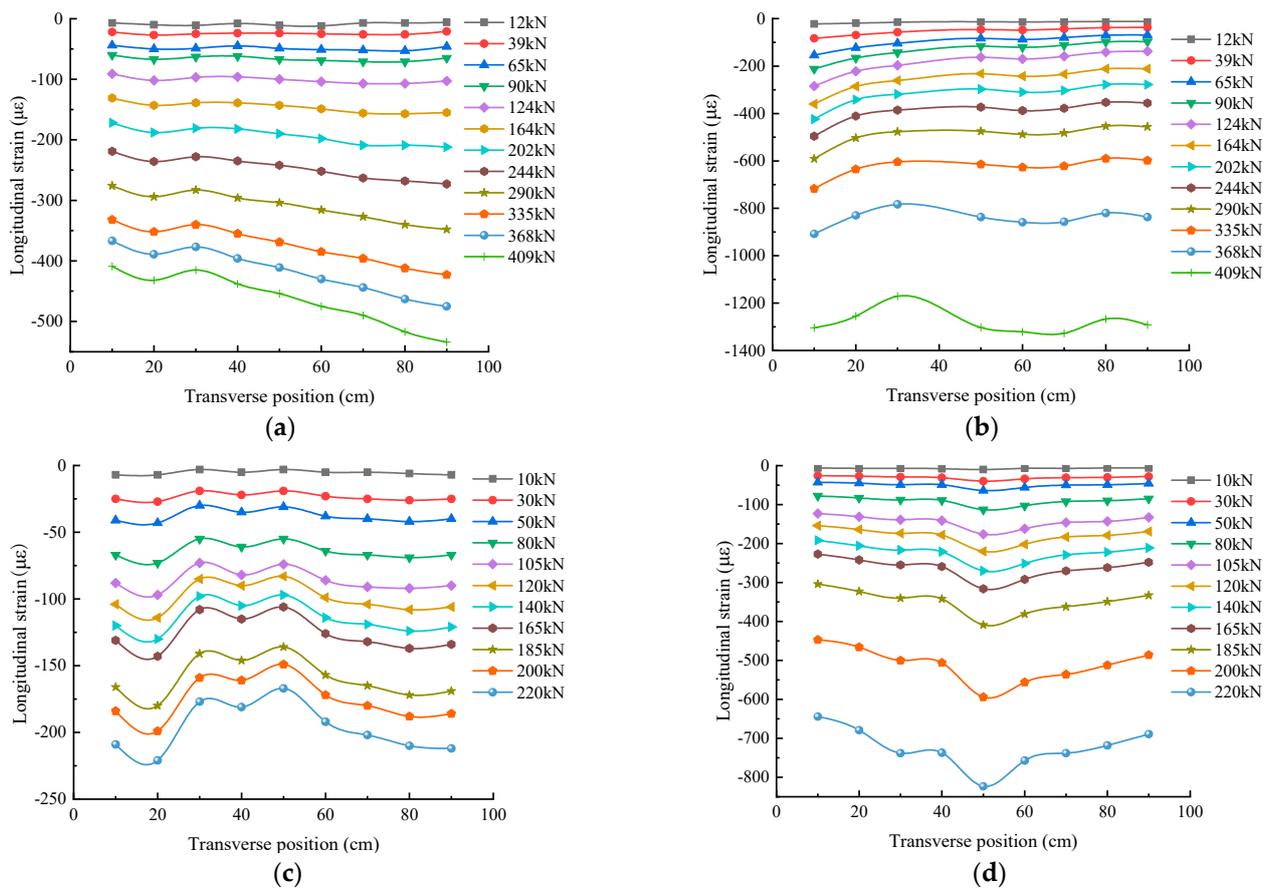
Figure 23. Distribution of longitudinal strains along the width direction of the top plate. (a) Distribution of longitudinal strains along the width direction of the top plate at the four-point section of Beam A1. (b) Distribution of longitudinal strains along the width direction of the top plate at the mid-span section of Beam A1. (c) Distribution of longitudinal strains along the width direction of the top plate at the four-point section of Beam A2. (d) Distribution of longitudinal strains along the width direction of the top plate at the mid-span section of Beam A2.

The shear lag effect is mainly manifested in the uneven distribution of longitudinal compressive stresses along the width direction of flange plates under a load. The distribution of longitudinal strains along the width direction of the top plate of Beams A1 and A2 are depicted in Figure 23.

As shown in Figure 23, for Beam A1, when the load is relatively small, the distribution of longitudinal strains is relatively uniform. After the beam cracks, the longitudinal strains at 20 cm of the four-point section are greater than those at 10 cm and 30 cm, and the longitudinal strains gradually increase from 30 cm to 90 cm at this section. The longitudinal strains at 30 cm and 80 cm of the mid-span section are significantly smaller than those at other positions, and as the load increases, this difference becomes more obvious.

As depicted in Figure 23, for Beam A2, when the load is relatively small, the distribution of longitudinal strains is relatively uniform as well. After the concrete cracks, the longitudinal strains at 20 cm and 80 cm of the four-point section, which is in the web position, are greater than those at other positions, while the longitudinal strains at the middle position of the mid-span section are significantly larger than those at other positions.

Thus, the distribution of longitudinal strains along the width direction of the top plate of Beams A1 and A2 is uneven, indicating the presence of the shear lag effect, which is consistent with the findings of Ma et al. [26], Chen et al. [27], and Ji et al. [28]. Compared with Figure 23a,c, as well as Figure 23b,d, it can also be observed that the load is within the range of 220 kN, and the distribution of longitudinal strains along the width direction of the top plate of corroded CBCSWs is more uneven, that is, the shear lag effect of the top plate of corroded CBCSWs is more obvious.

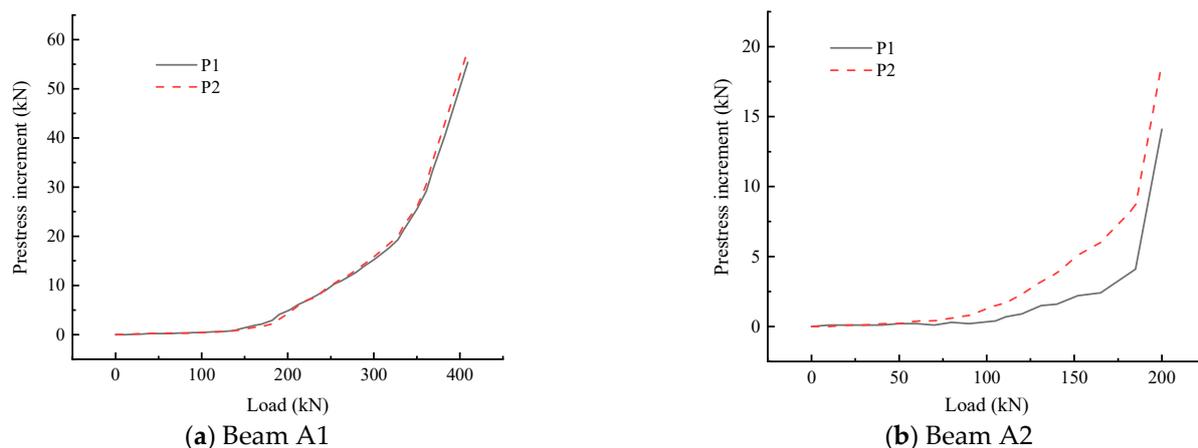
Figure 24. Stress changes in externally prestressed tendons during the loading failure process.

The stress increments of the externally prestressed tendons of Beams A1 and A2 are shown in Figure 24. For Beam A1, the prestress increments of the two externally prestressed tendons are basically consistent, as shown in Figure 24. The change in prestress increment can be divided into three stages with the increase in load. In the first stage, before the plates crack, the curve is almost horizontal, that is, the growth rate of prestress is slow, and its increment is small. Li [42] reached the same conclusion. When the beam is loaded to 143 kN, the stress increments of P1 and P2 are only 1.1 kN and 0.9 kN, respectively. In the second stage, after cracking, the slope of the curve increases, the growth rate of prestress accelerates, and the increment increases. When the beam is loaded to 350 kN, the prestress increments of P1 and P2 are 25.5 kN and 26.0 kN, respectively. After the load reaches 350 kN, which is the third stage, the slope of the curve increases significantly, illustrating a significant increment in prestress. In the research of Li [42], he obtained a similar conclusion. When Beam A1 fails, the prestress increments of P1 and P2 are 55.4 kN and 57.8 kN, respectively, accounting for 35.09% and 35.35% of the initial prestress, respectively, and it can be seen that the externally prestressed tendons are fully utilized when Beam A1 fails.

For Beam A2, the stress increments of the externally prestressed tendons can also be divided into three stages, but there is an obvious difference in the stress increment between the two tendons. In the first stage, before cracking, the curve is almost horizontal with a small prestress increment and a slow increase in increment. When Beam A2 is loaded to 110 kN, the prestress increments of P1 and P2 are only 0.7 kN and 1.7 kN, respectively. Entering the second stage after the plates crack, the slope of the curve increases, which indicates an accelerated increase in prestress. When the load is 185 kN, the prestress increments of P1 and P2 are 4.1 kN and 8.6 kN, respectively. When the load is beyond 185 kN, the slope of the curve increases significantly, demonstrating that the increase in prestress increment speeds up again. While the beam is damaged, the prestress increments of P1 and P2 are 14.1 kN and 18.8 kN, respectively, which are 8.44% and 11.24% of the initial prestress, respectively. It can be found that, compared with Beam A1, Beam A2 fails to fully utilize the performance of externally prestressed tendons when it is damaged.
