Experimental Investigations and Seismic Assessment of a Historical Stone Minaret in Mostar

Abstract: Minarets, tall structures, connected or not to the mosque attract attention due to their specific architectural features. Vulnerability to seismic damage has been witnessed throughout history on tall and slender structures after earthquake ground motions. In that respect, it is of the utmost importance to investigate the dynamic characteristics and resilience of historical stone minarets. This paper aims to provide the results of an on-site dynamic investigation of a stone minaret in Mostar and deliver its seismic assessment. The minaret is part of the Tabačica mosque built at the turn of the 16th and 17th century in the City of Mostar, Bosnia and Herzegovina. The on-site investigation comprised dynamic identification of the minaret by ambient vibration testing and qualitative estimation of the masonry wall by sonic pulse velocity testing. Besides the modal analysis a time-history analysis was performed by using the Applied Element Method (AEM), considered an appropriate tool for assessing the behavior of historic masonry structures. A good match is found between the first natural

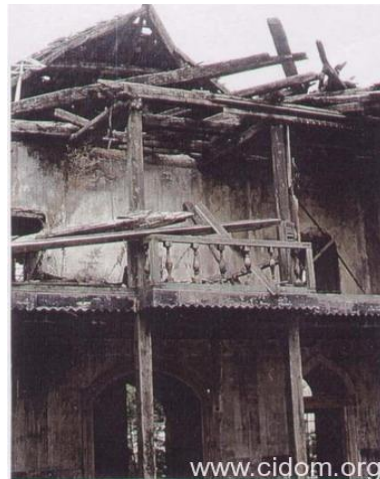
Figure 2. Demolished roof structure after a war [56]. Reproduced with permission from CIDOM, 2022.

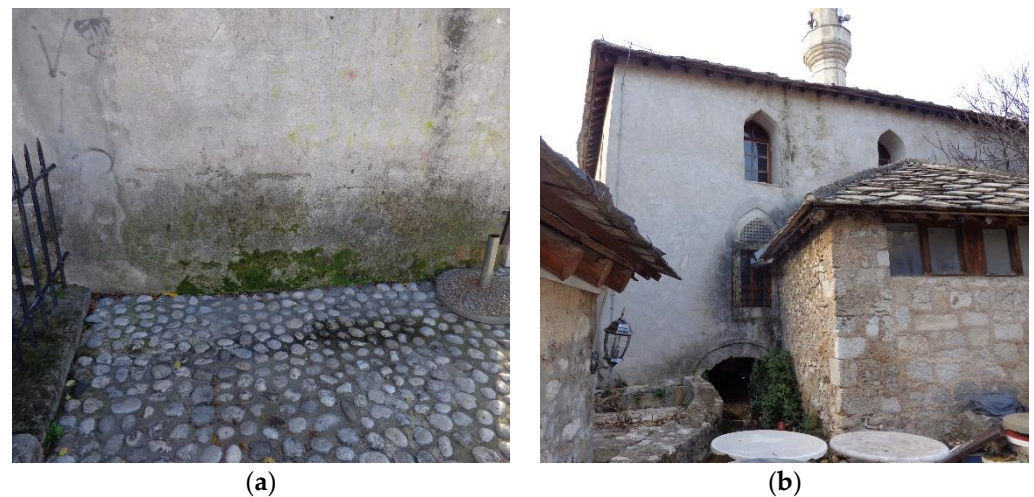
Figure 4. (a) Ascending moisture and biological attack (author's photo, 2023). (b) Descending moisture (author's photo, 2023).

During the visual inspection of the minaret, damage due to ascending and descending moisture has been noted as illustrated in Figure 4a,b respectively. Several dead pigeons were noted in the staircase of the minaret as once they entered the staircase, they were not able to exit. The birds did not cause any damage to the structure and no threats by insects were noted.

There are smaller damage impacts visible on the mosque building due to moisture (Figure 4a) and biological attack (Figure 4b). There is damage to the stone roof slabs at the eaves (Figure 8), and a vertical crack can be seen on the western façade of the attached shop building (Figure 9).

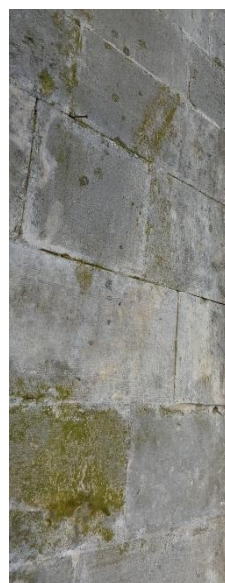
Figure 5. Biological attack at the base of the minaret (author's photo, 2023).

There are no signs of damage on the minaret itself after the reconstruction except for a minor biological attack at the bottom of the base (Figure 5). However, plaster spalling on the side of the mosque building is visible along the vertical joint between the minaret and the mosque building (Figure 6), which was not present shortly after the reconstruction (Figure 7). The metal grounding rod runs vertically along the joint, which might have been generating this damage over a period of 20 years.

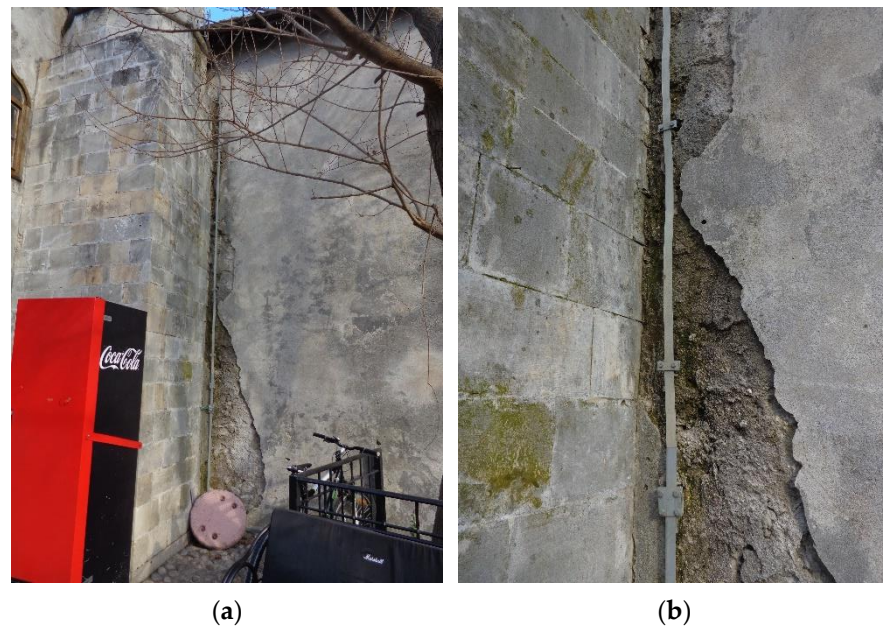
Figure 6. Plaster spalling along the vertical joint between the minaret and the mosque building (a) view (author's photo, 2023). (b) detail, (author's photo, 2023).

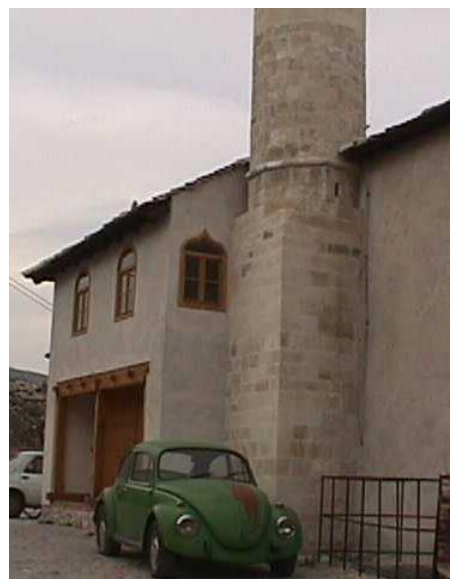
Figure 7. Vertical joint between the minaret and the mosque building, no plaster spalling visible shortly after reconstruction (author's photo, 2020).

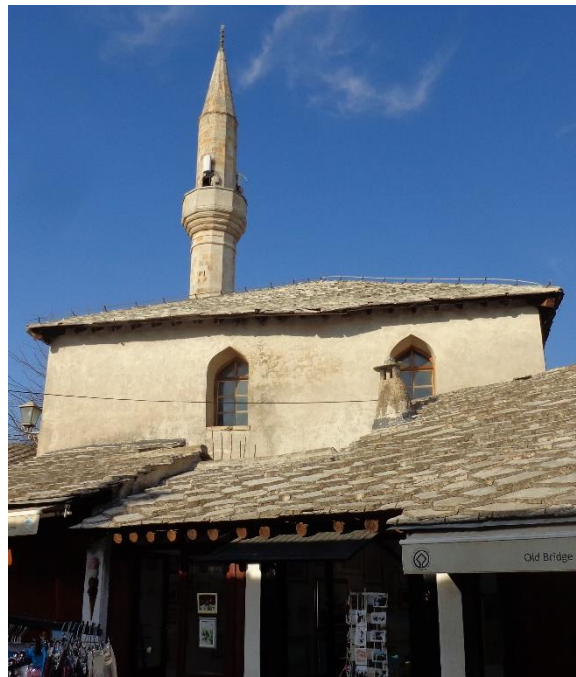
Figure 8. Damaged stone roof tiles at the southern eaves (author's photo, 2023).

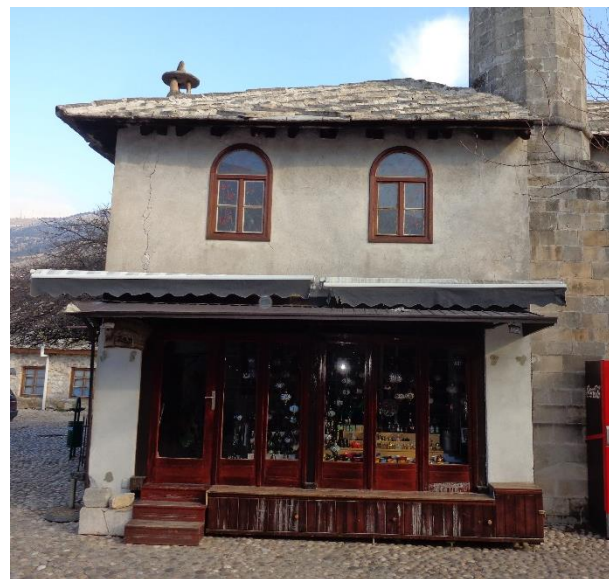
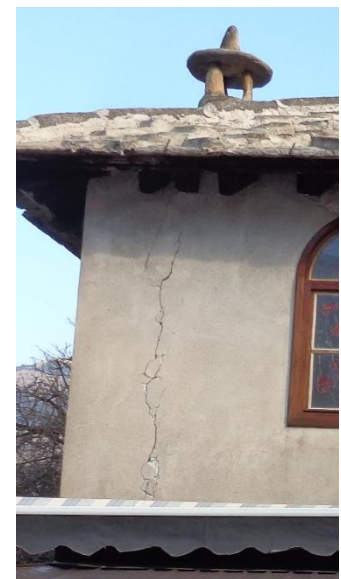
Figure 9. Vertical crack at the western façade of the attached shop building: (a) view (author's photo, 2023); (b) detail (author's photo, 2023).

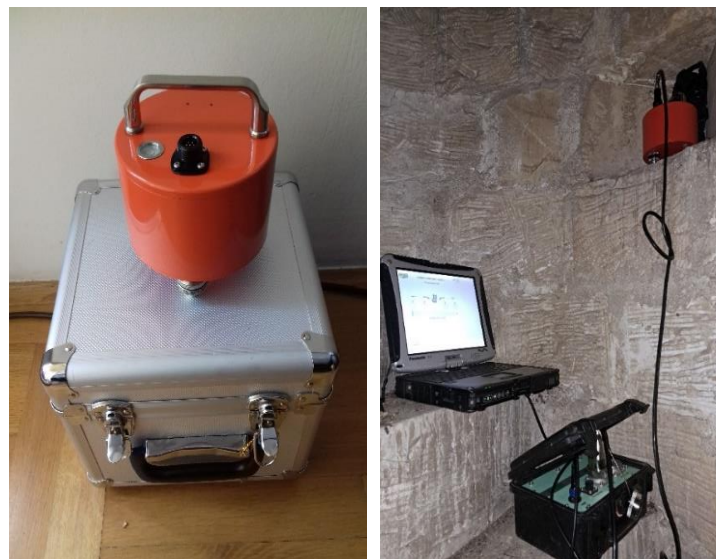
Figure 12. Geophysical equipment for seismic surveys (author's photo).

The measurements were performed with the equipment shown in Figure 12. The Seismograph GEA24 16077, compact-sized with 24 channels, was used. It is suitable for all applications and is very reliable. GEA24 can acquire data using geophones with any resonance frequency (even 1 Hz). In this specific case, a three-component geophone with a resonant frequency of 2 Hz was used.

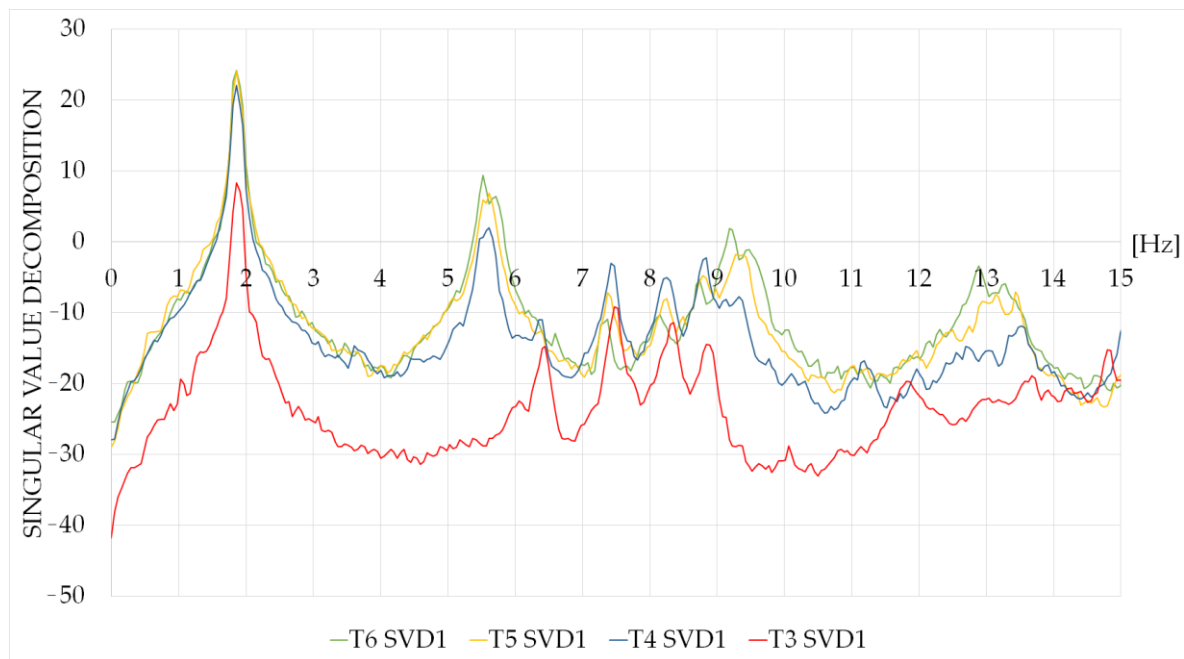
Figure 14. Singular value decomposition of the acquired data in positions T3 to T6.

Data were also elaborated by employing an OMA-specific analysis software [81], relying both on time domain—UPC SSI—and frequency—sEFDD—based identification methods. From the analyses carried out, there emerges a strict coupling of the bending modes of the minaret. The first frequency of the minaret using the OMA method test results was 1.85 Hz in all test setups (bending in the Y direction), very close to the second identified frequency, equal to 1.91 Hz (bending in the X direction), while the second bendings were found, respectively, at about 5.53 and 5.67 Hz. A supposed torsional mode was located at 7.40 Hz, and the successive coupled bending modes were identified at 9.20 (Y) and 9.40 (X) Hz, and again at 12.90 (Y) and 13.40 (X) Hz. Since no reference sensors were employed, it is not possible to present the graphical depiction of the identified modes. Results are reported as a graph in the frequency domain (Singular Value Decomposition—Figure 14) and numerically in Table 2. The average damping values for F1 to F4 are consistent with the level of vibration and are within the reported ranges under operational conditions as defined in manuals for civil engineering and seismic design [82,83]. A significant value of damping has been detected for the torsional mode indicating that it may be affected by biases, as reported by Karatzetou et al. [84].

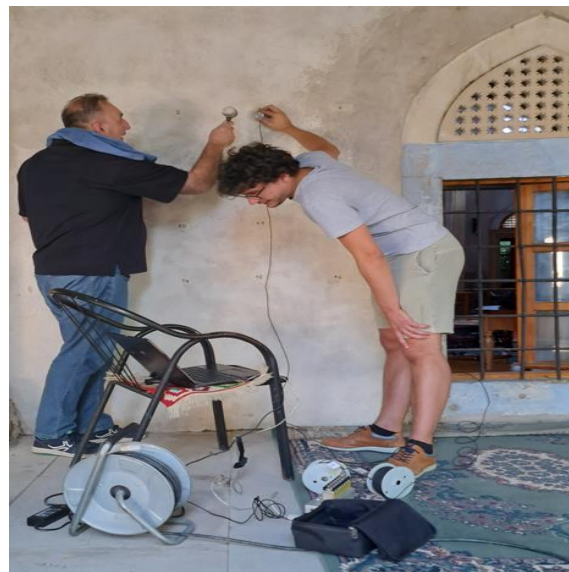
Figure 16. The emission of acoustic waves with a rubber hammer (outside) (author's photo, 2022).

The emission of acoustic waves was done with a rubber hammer. The hammer applies an impulse on the surface of the wall and generates a sonic wave. The arrival times of the P-waves were recorded on an accelerometer which is connected to the instrument on the opposite side of the wall (Figures 16 and 17). This enables the transformation of the mechanical energy into acoustic-vibration energy and enables the wave to propagate through the material. A receiving sensor (monoaxial accelerometer) is responsible for recording and transmitting to the acquisition system the response of the material to the propagation of the signal in the section.

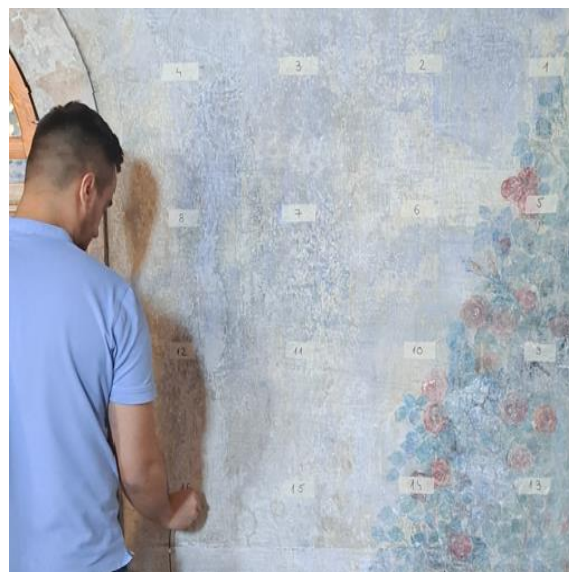
Figure 17. Receiving waves using an accelerometer (inside) (author's photo, 2022).
