Article

Experimental Study on Seismic Behavior of Damaged Beam-Column Joints Retrofitted by Viscoelastic Steel-Enveloped Elements

Abstract: In order to improve the seismic performance of damaged reinforced concrete joints, a new retrofitting method using viscoelastic materials and steel plates is proposed. A reversal cyclic loading test was carried out on four T-shaped RC joints to investigate the reliability of this method. Seismic performance, including the strength, stiffness, ductility, and energy dissipation capacity of the original non-damaged joint and different repaired and retrofitted joints are then compared. The results show that this new method can significantly improve the strength of the retrofitted joints, and the joints can be loaded to a larger displacement value. After retrofitting, the energy dissipation of the joints increases, and the stiffness degradation decreases. The test results indicate that the retrofitting method is effective in repairing seismically damaged RC joints.

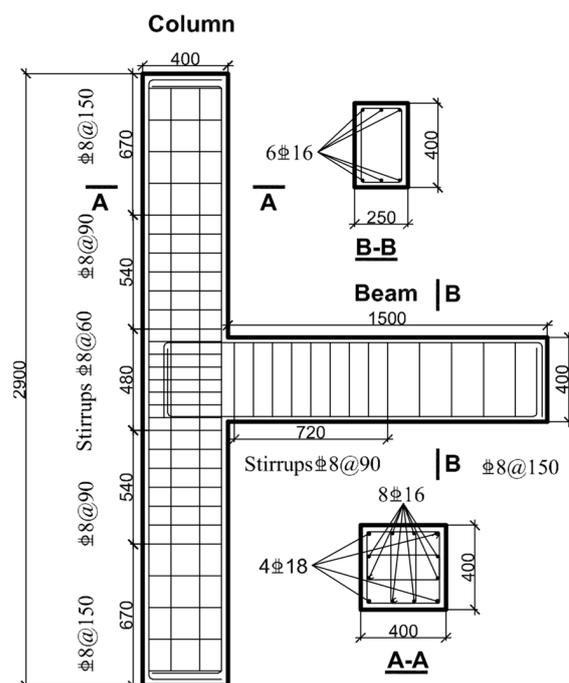
Figure 1. Dimensions and reinforcement details of specimen (unit: mm).

A total of 4 full-scale reinforced concrete T-shaped joint specimens are designed and constructed in this experiment, labeled as J0, JR1, JR2, and JR3, respectively. J0 is a non-damaged joint specimen used for comparison. The design of J0 takes into account both the maximum output power of the testing machine and the reinforced concrete structures design code. During the test, it is directly loaded with rapid cyclic loading until it fails; JR1, JR2, and JR3 are pre-damaged RC joints, retrofitted by different viscoelastic steel-enveloped elements. The retrofitted elements of the three specimens are similar, except for the absence of viscoelastic material in the retrofitting of JR1. In the JR2 specimen, 10 mm thick viscoelastic pads are pasted between the inner surface of the U-shaped steel sleeve and the upper and lower surfaces of the beam, while in the JR3 specimen, 18 mm thick viscoelastic pads are pasted at the same position. The different parameters of the specimens are shown in Table 1. The concrete designed strength grade of the specimens is C40, and the steel grade is HRB400. C40 concrete has a mix ratio of 1:1.5:3, and its concrete strength is 40 Mega Pascal. The mechanical properties of the materials used in the test are listed in Table 2. The section size of the column and beam is 200 mm × 200 mm, and 150 mm × 300 mm, respectively. The length of the beam and column is 1500 mm and 2900 mm, respectively. The details of the specimens are shown in Figure 1. Before the test, JR1, JR2, and JR3 specimens are subjected to pre-damage tests with cyclic loading, and then the method proposed is used for retrofitting.

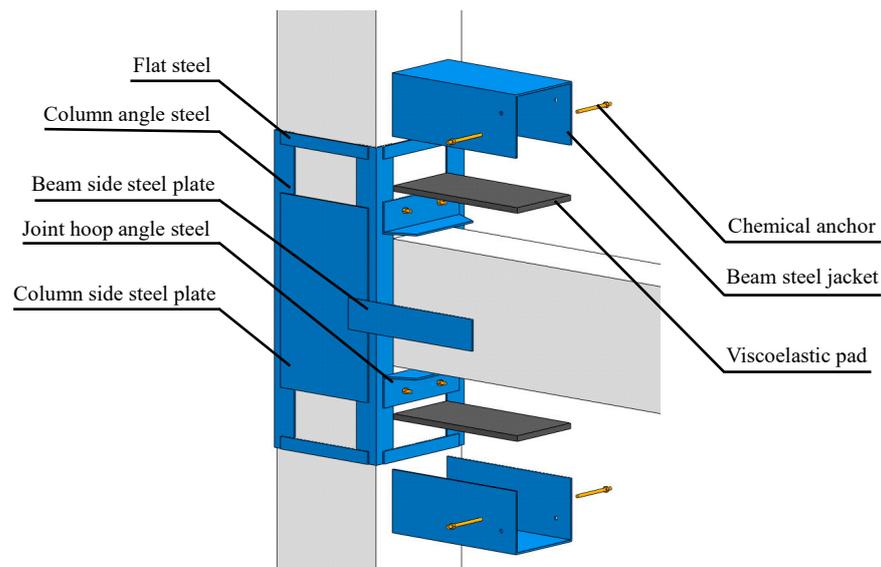
Figure 2. Schematic view of retrofitted concrete specimens.

The steel grade used is Q335, and the thickness of steel plate and angle steel are both 6 mm. In order to efficiently connect steel plates and RC joints, M12 type chemical anchor bolts were utilized in this study. In structural engineering, a chemical anchor bolt is a composite component that fixes a threaded rod in a drilled hole of concrete by using a special chemical adhesive to provide anchorage for the fixed part. The M12 type chemical anchor bolts are commonly used for efficiently connecting steel plates and RC joints. In general, the M12 type chemical anchor bolts have a maximum tested force 15 kN, and they are typically used between 12 and 13 kN. The chemical anchor bolts used in this study are composed of 5.8 grade carbon steel.

The viscoelastic material used is a nitrile rubber-based viscoelastic material, specially made by the research group. Specifically, this material is made up of a high polymer, with a nitrile butadiene rubber matrix that has been vulcanized at a high temperature and pressure with a range of additives, such as vulcanizing agents, accelerators, anti-aging agents, reinforcing agents, plasticizers, etc. The dynamic mechanical performance tests were evaluated through tests at varying environment temperatures, displacement amplitudes, and loading frequencies. The results indicate that the viscoelastic damper shows outstanding stiffness and energy dissipation capacity under different loading cases [20,21]. The storage modulus of the material is 1.47 MPa, and the loss factor is 1.26 at an excitation force of 1 Hz and a temperature of 15.2 °C. The three-dimensional schematic diagram of the viscoelastic steel-enveloped retrofitting method is shown in Figure 2.

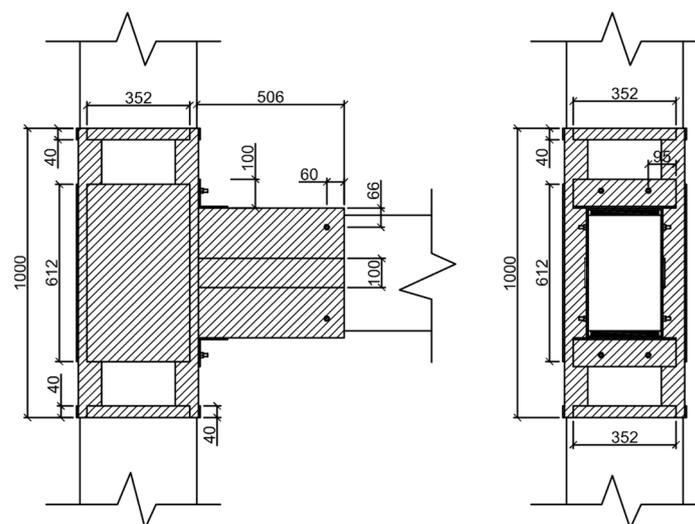
Figure 3. Details of retrofitted concrete specimens.

The range of the retrofitted column is 500 mm above and below the center of the joint, so the total length of the column reinforcement is 1000 mm, as shown in Figure 3. The enveloped steel elements mainly include: L80 angle steel in the column foot, flat steel, and large steel plates on the three sides of the column. The angle steel is wrapped at the four corners of the column, and the remaining steel plates are distributed on the four sides of the column, with a certain length of overlap with the angle steel. All the steel plates are welded together to form a single entity. All steel plates on the columns of the reinforced specimens are firmly bonded with the concrete using structural glue, enabling them to work as a cohesive unit. The density of the adhesive material is 1.6 g/cm^3 . After the application of the adhesive, the steel plate bonding material exhibits an adhesive failure strength of 3.4 MPa. Meanwhile, the adhesion failure strength between the viscoelastic pad and the concrete side colloid is 0.396 MPa, and that between the viscoelastic pad and the steel plate side colloid is 0.581 MPa.

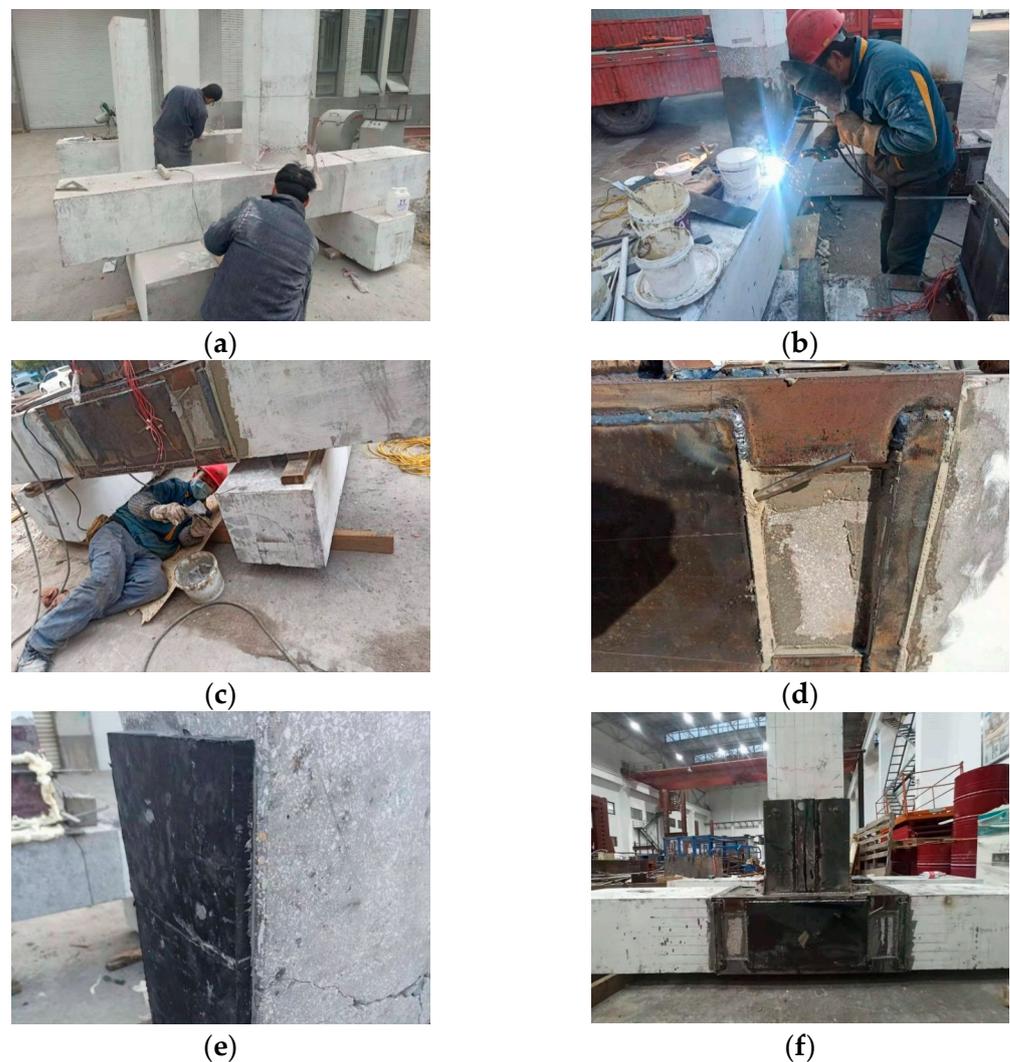
Figure 4. Main retrofitting processes on the pre-damage specimens: (a) grinding and cleaning; (b) positioning and welding of steel sleeves; (c) seam sealing; (d) injection of adhesive; (e) glued viscoelastic pads; (f) retrofitted specimens.

The retrofitted steel around beam extends from the surface of the column and spans 500 mm along the direction of the beam. The steel plates used for reinforcement mainly include the upper and lower U-shaped steel sleeves and the long steel plates on both sides. The upper and lower U-shaped steel sleeves are cold-formed from a single piece of steel

plate cut into appropriate sizes. Two bolt holes are drilled on the side head of the U-shaped steel sleeve for the passage of the chemical anchor bolt. The inner space between the two wing plates of the steel sleeve should be slightly larger than the size of the beam section to facilitate the injection of adhesive into the gap between the steel plate and the concrete. The two U-shaped steel sleeves do not touch the edges of the side of the beam, which allows for convenient adjustment of errors during the retrofitting process. Two long steel plates are arranged at the center of the beam side and welded with two U-shaped steel sleeves. A certain length of L100 angle steel hoop is set at the right angle between the upper and lower beams and the column. The angle steel hoop is welded to the angle steel of the column, and is simultaneously anchored using chemical anchor bolts. The angle steel hoop is also outside the U-shaped steel sleeve on the beam side. The surface is tightly welded. The main reinforcement construction processes on the pre-damage specimens are shown in Figure 4.

JR1 adopts the pure-enveloped steel reinforcement method to strengthen the joints after an earthquake. The beam steel sleeve of the test specimen is firmly bonded to the beam concrete using structural adhesive, and no chemical anchor bolts are used to anchor the side of the beam steel sleeve. Viscoelastic pads are placed between the concrete and

the steel sleeve on the upper and lower surfaces of the beam in the JR2 and JR3 specimens. The upper and lower surfaces, respectively, of the viscoelastic pad are bonded to the steel plate and the concrete. The specimens are only filled with structural adhesive between the column steel sleeve and the column surface. The beam steel sleeve is anchored to the beam concrete using chemical anchor bolts, and no structural glue was injected between the beam steel sleeve and the beam concrete. A viscoelastic pad is attached to the center of the beam surface, with a length of 500 mm, which is the same as the length of the beam steel sleeve. The width of the pad is 230 mm, which is 20 mm less than the width of the beam, and there are 10 mm gaps between the left and right sides and the U-shaped steel sleeve wing plates. The thickness of the viscoelastic pad of the JR2 specimen is 10 mm, and the thickness of the viscoelastic pad of JR3 is 18 mm.

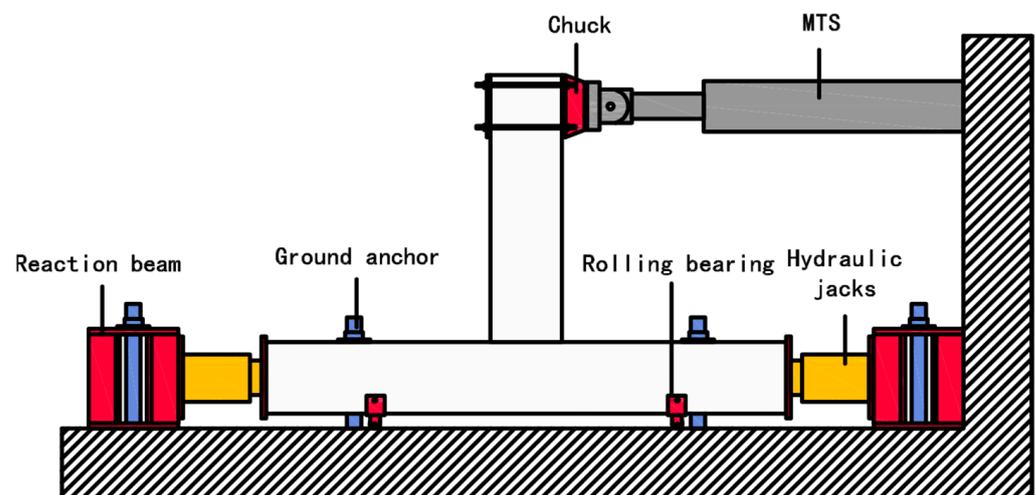
Figure 5. Schematic diagram of test setup.

Considering the existing conditions of the laboratory and referring to the test methods, the loading position is set at the end of the beam [22], and the test setup shown in Figure 5 is used.

Due to the constraints of the test loading equipment, the lateral loading method was adopted in the test. This means that the joint column was placed horizontally on the ground, while the beam ends were loaded laterally. In other words, the test model of the beam-column joint was oriented at 90 degrees, with the column in the horizontal direction and the beam in the vertical direction. The loading device is mainly composed of MTS actuators fixed on the wall, beam end chucks, hydraulic jacks at both ends of the column, reaction beams, and hinged supports under the column. The primary function of the hinged support is to facilitate the free rotation of the column end during the loading process, thereby simulating the rotational displacement at the position of the column's reverse bending point in the actual structure. The photograph of actual loading is shown in Figure 6.

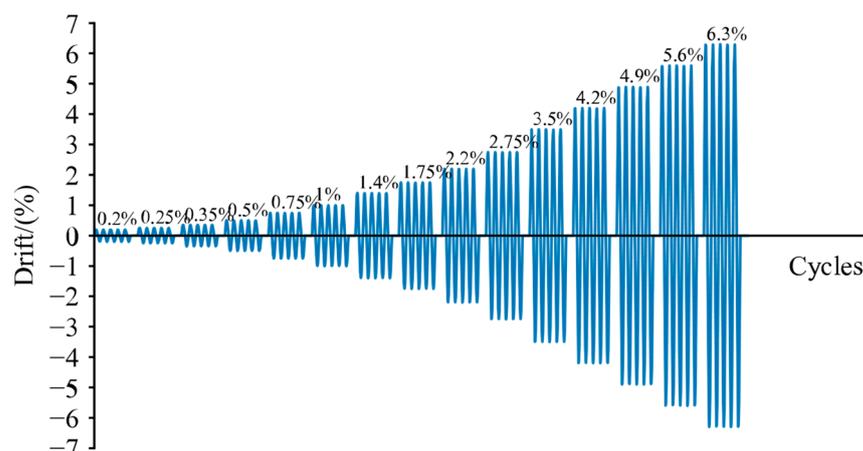
Figure 7. The lateral displacement history.

This test is conducted following the recommended practices for the American Concrete Association Test [23], wherein the displacement angle is directly used to control the loading. Different from the pseudo-static loading test, this test uses a fast cyclic loading method. Based on the performance of the viscoelastic material, the loading frequency that can best exhibit the properties of the material was determined. The test method of Wu [24] is also taken into consideration, and a loading frequency of 2 Hz was selected for this test. To better evaluate the hysteretic performance of the joint with the viscoelastic pad under the fast loading rate, each drift level is loaded with five cycles [25]. The specific parameters of the test loading control are shown in Table 3, and the loading history is shown in Figure 7.

The pre-damage test applies a fast loading method similar to the loading process in the above paragraph, but with simplified displacement levels, requiring loading displacement amplitudes of 0.5%, 1%, and 2%. In addition, the number of cycles for each level of loading is reduced to three times.

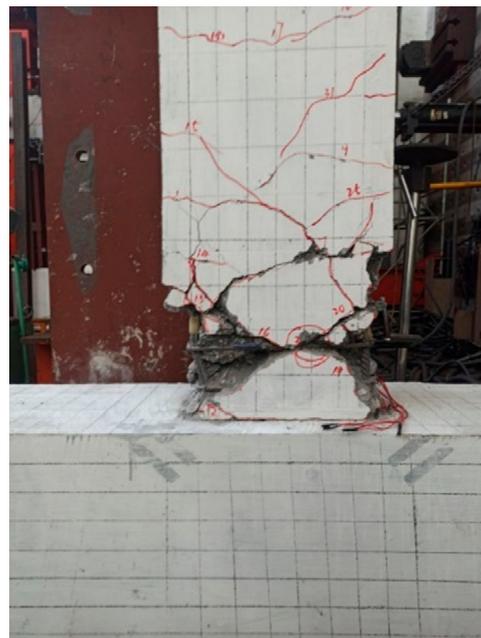
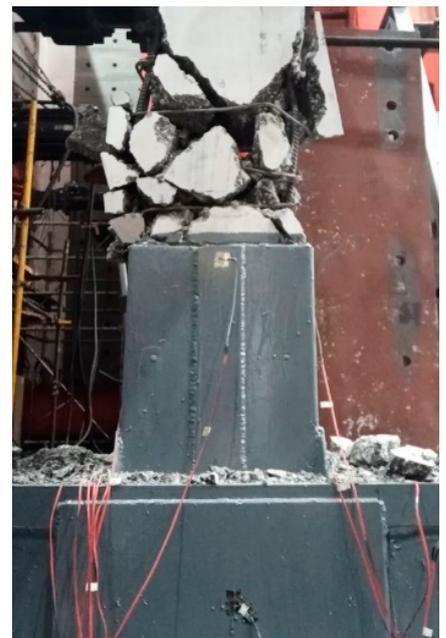
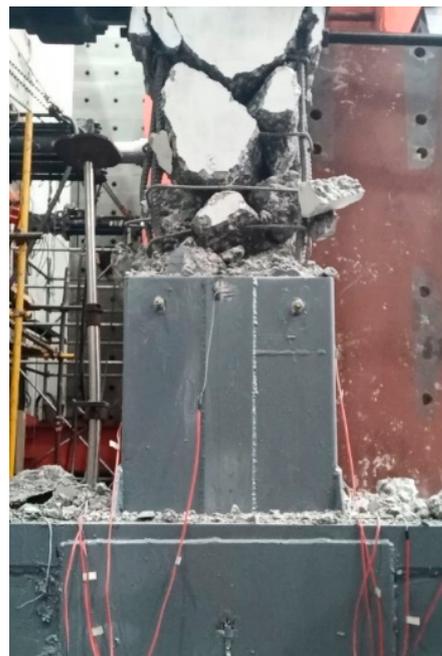
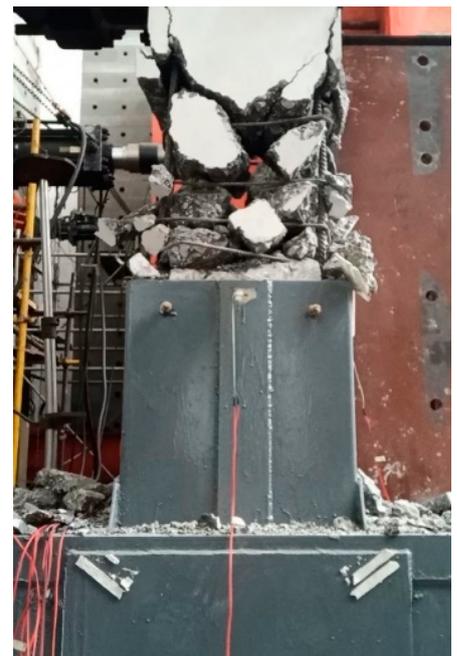
Figure 8. Failure modes of different specimens. (a) J0; (b) JR1; (c) JR2; (d) JR3.

In specimen J0, no significant cracks were observed on the surface of the beam and column during the non-destructive test at the first three drift levels. At 0.5% drift, cracks appeared at the joint between the root of the beam and the cylinder surface, and numerous cracks started to emerge on the beam. At 1.4% drift, wide cracks appeared, with a width of up to 2 mm. The center, at 20 mm from the cylindrical surface, expanded obliquely, and X-shaped cross-distributed cracks appeared at multiple positions on the front of the beam. At 1.75% drift, an obvious plastic hinge was formed on the front of the beam. At 2.75% drift, the right side of the beam continued to crack, and new cracks appeared. At the end of the right beam, a large concrete block peeled off, and concrete block peeling also occurred at the plastic hinge on the front side. Subsequently, the concrete continued to peel off, and the bearing capacity continued to decrease. At 4.2% drift, the capacity dropped to 61.4 kN, and the loading was stopped.

In specimen JR1, no rubber pads were used for the retrofitting. During the loading process from the fifth to the eighth level, small cracks continued to appear on the front and side of the beam, as well as on the upper side of the outer steel. At a drift of 2.2%, an evident cracking sound was heard, and small pieces of concrete continuously detached

from the front side of the beam. At a drift of 2.75%, the concrete continued to spall at the intersection of the cracks, and new transverse cracks continued to develop in the upper portion. At a drift of 3.5%, the concrete on the upper side of the outer steel at the front of the beam spalled in multiple places, while the concrete on the left and right sides was crushed into blocks. At a drift of 4.2%, large concrete blocks detached from the left, right, and central portions of the beam, resulting in the exposure of the longitudinal reinforcement and stirrup inside the beam, and the maximum load dropped below 60 kN.

In the destruction process of specimen JR2, no obvious damage was observed for the first four drift levels of loading. Small cracks appeared out of the steel during the fifth and sixth levels of loading. At drift 1.75%, large cracks appeared on the left side of the beam, and more micro-cracks appeared on the front side. At a drift of 2.2%, X-shaped crack intersections appeared in the bottom, parallel to the edge of the outer steel. The crack was wider, with a width of about 2 mm. At a drift of 2.75%, the cracks on the front side of the concrete beam continued to expand and widen, with concrete fragments continuously falling during the loading process. At a drift of 4.2%, the concrete on the front side of the beam near the edge of the outer steel was continuously crushed, and the maximum crack reached 10 mm. New and wider X-shaped cross cracks continued to appear on the side, with the cracks extending to the end of the beam. At a drift of 4.9%, the concrete near the steel plate at the center of the X-shaped cross cracks on the left and right sides of the beam was severely damaged, resulting in a large amount of concrete spalling on the surface. The concrete on both sides was also broken into large pieces. At a drift of 5.6%, the outer concrete of the steel bar within 500 mm outside the outer steel range of the front and side of the beam was almost completely peeled off, and the internal main reinforcement was obviously bent. In the fifth lap, the maximum load dropped to about 70 kN, and the test was stopped. Finally, a large bulge of the steel plate at the end of the outer steel coated with rubber pads was observed. The failure modes of all specimens are shown in Figure 8.

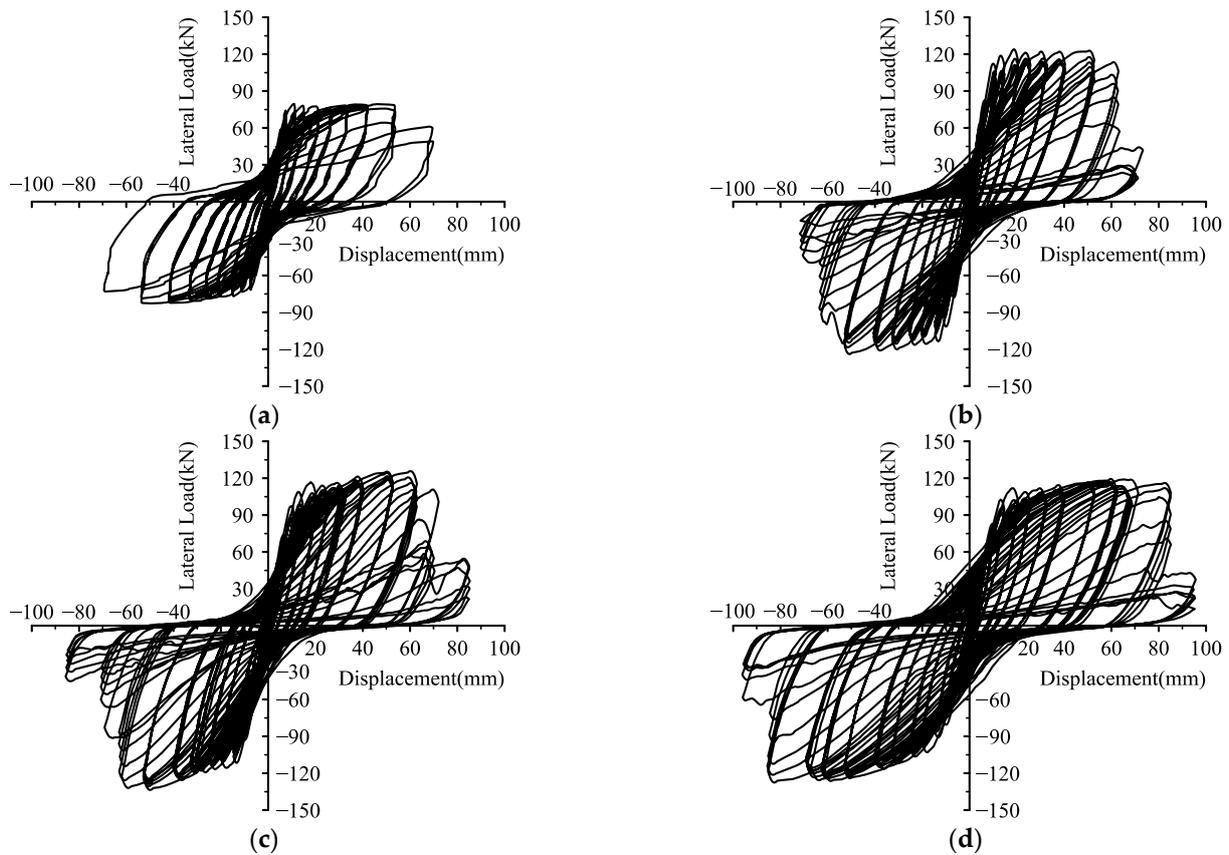
Figure 9. Hysteresis curves of different beam column joints. (a) J0; (b) JR1; (c) JR2; (d) JR3.

The hysteresis curves of different beam column joints, J0, JR1, JR2 and JR3, are shown in Figure 9. The height of the hysteresis curve of the specimen J0 is lower, reflecting the lower strength after the test piece yields. In contrast, the height of the hysteresis curve of the JR1-JR3 test piece is higher. It can be seen that the ultimate strength is close to 120 kN at the highest points for JR1~JR3, which is much higher than the ultimate strength of about 80 kN of the comparative specimen J0. It can be shown that the strength of the seismically damaged joint after retrofitting can be significantly improved. In particular, it should be noted that the JR2 and JR3 specimens are retrofitted with viscoelastic pads, and the beam steel sleeve is not bonded to the surface of the beam concrete, while the JR1 specimen beam steel sleeve is tightly bonded to the outer surface of the beam concrete. The ultimate strength of the joints retrofitted using the viscoelastic steel-enveloped method is comparable to that of the joints strengthened solely by the steel-enveloped method. Upon comparison, it was observed that the J0, JR1, and JR2 specimens reached the same displacement at the point of complete destruction, approximately 60 mm. However, the JR2 specimen exhibited a maximum displacement slightly greater than 60 mm, while the JR3 specimen was able to reach a maximum displacement of nearly 80 mm. It can be seen that no matter whether the viscoelastic pad is used or not, the retrofitting method can ensure that the ultimate displacement of the retrofitted seismically damage specimens can reach that of the non-damaged specimen. When the viscoelastic pads are used, their ultimate displacement will increase. The use of the 18 mm viscoelastic pad reinforcement method will increase the ultimate displacement more than will the use of the 10 mm viscoelastic pad reinforcement method.

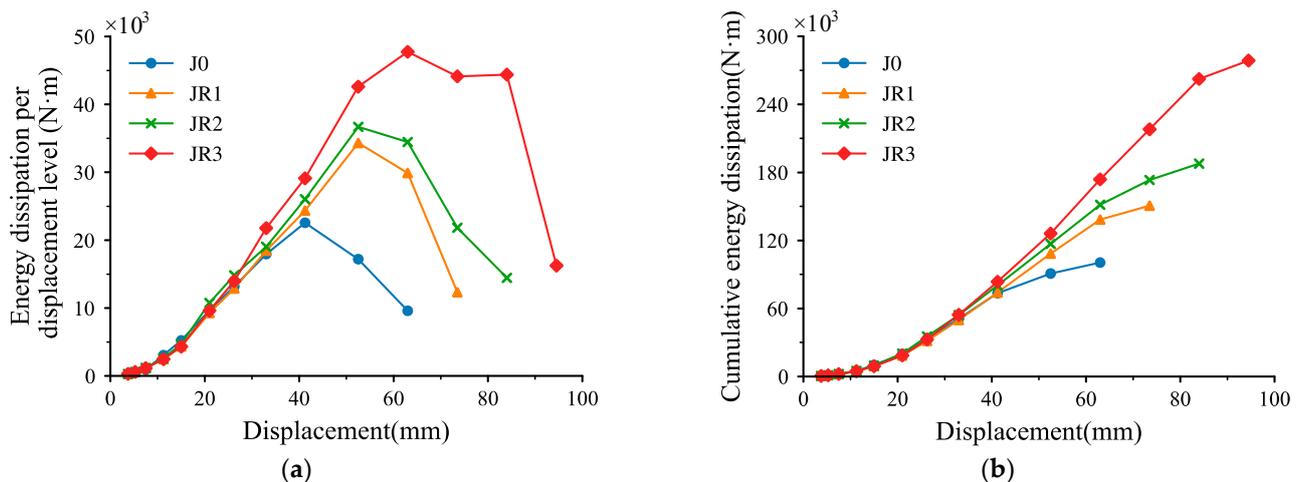
Figure 10. Energy dissipation of specimens: (a) energy dissipation per displacement level; (b) cumulative energy dissipation.

In this test, the energy dissipation of each specimen during the loading process of each displacement level is shown in Figure 10a, and the total cumulative energy dissipation of the joints during the entire loading process is shown in Figure 10b.

It can be seen that when the displacement amplitude of the load is small, the energy dissipation of each specimen is similar. In the early stage, the energy dissipation of the non-damaged specimens is slightly larger. At about a 20 mm displacement amplitude, the JR2 joint dissipates slightly more energy. When the load displacement amplitude is 33 mm,

the energy dissipation of JR3 is the largest. With the displacement amplitude increasing, the energy dissipation of each specimen gradually shows a certain regularity: the energy dissipation of the JR3 specimen is the largest; followed by the energy consumption of JR2, the energy dissipation of JR1, and the energy dissipation of the J0 specimen, which is the smallest. It should be noted that the energy consumption of joint J0 is small before the displacement amplitude reaches 52.5 mm. The experimental results indicate that the joints retrofitted using viscoelastic methods exhibit a greater energy dissipation capacity under larger displacement amplitudes. From the perspective of the accumulated energy consumption of the joint, the same conclusion can be obtained. In the later stage of loading, it is observed that the energy consumption of the JR3 specimen is significantly greater than that of the other joints, indicating that the viscoelastic material has more effectively exerted its energy consumption effect.

The results demonstrate that increasing the thickness of the viscoelastic pad has a significant impact on enhancing the strength of the joint in the later stages of loading. Compared to JR0, the energy consumption of the JR1, JR2, and JR3 specimens increased due to the effect of the steel plates. In comparison to JR1, the presence of the viscoelastic pad in JR2 significantly improves the later-stage stiffness of the joint, thereby increasing the energy dissipation capacity in the later stages. As viscoelastic materials exhibit large deformation capacity, they can dissipate more energy, which endows the JR3 joint with the best energy dissipation performance.

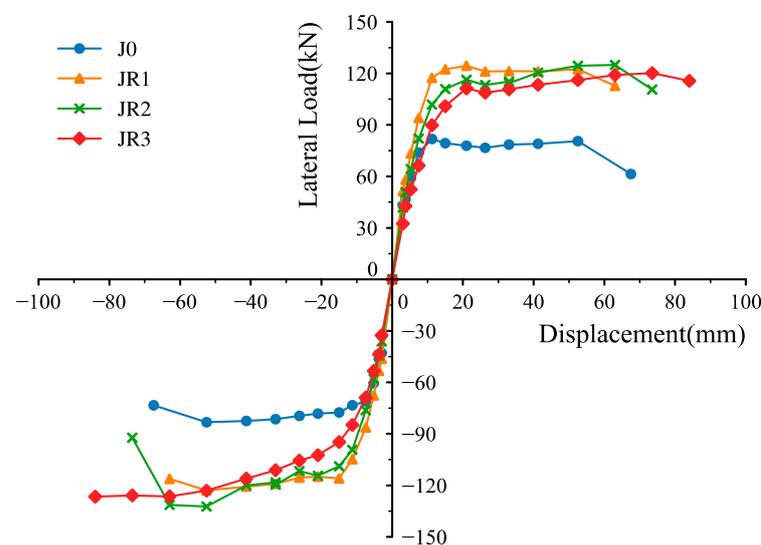
Figure 11. Skeleton curves comparison of different specimens in the test.

The skeleton curve is the connection point of the maximum peak load data points extracted during each level of loading. The envelope of the entire hysteresis curve can provide important characteristics of the RC joint. The skeleton curve comparison of all specimens in this test is shown in Figure 11.

In terms of strength, the non-destructive concrete specimen exhibits significantly lower strength than the seismically damaged joint specimen after retrofitting. The strength of different reinforced retrofitted samples is also slightly different. The strength of the JR1 specimens retrofitted only with the steel is greater than the strength of the joints retrofitted with viscoelastic and steel shortly after yielding. As the loading progresses, the strength of the JR1 specimen decreases slightly, while the strength of the JR2 and JR3 specimens increases slightly, surpassing the strength of the JR1 specimen in the final stage of loading. This behavior may be attributed to the low stiffness of the viscoelastic material under small displacement amplitudes, which results in a slower increase in the initial strength. This

characteristic also helps to prevent excessive damage to the joint in the early loading stage. In the later stage, the viscoelastic pad was squeezed almost to its limit of deformation, the rigidity of the retrofitted area was improved, and the strength increased. The results show that the addition of viscoelastic pads has a significant effect on the enhancement of the strength of the joints at the later stage of loading.

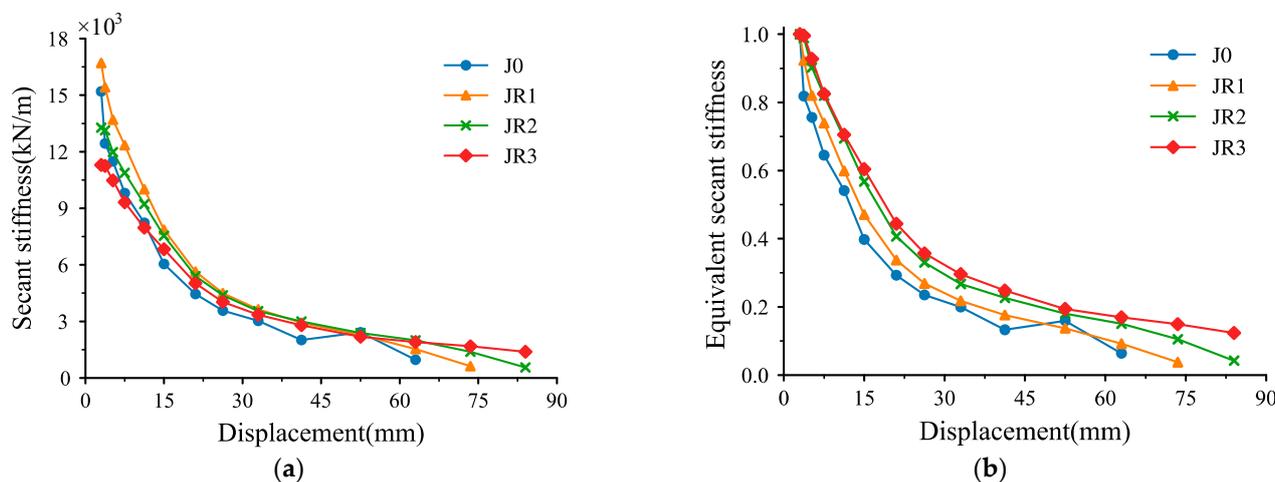
Figure 12. Stiffness degradation comparison of secant stiffness and equivalent secant stiffness of different specimens in the test: (a) secant stiffness; (b) equivalent secant stiffness.

In order to facilitate the comparison of the stiffness of each specimen, the secant stiffness of the specimens during the first cycle of loading at each drift level is extracted and plotted in Figure 12a. To evaluate the degree of stiffness deterioration in the specimens, the stiffness of the first cyclic loading at each displacement level was normalized by dividing it by the stiffness of the specimen during its first cyclic loading at the initial displacement level, as shown in Figure 12b. The resulting stiffness value is calculated as the equivalent secant stiffness and is used to determine the degree of stiffness deterioration in the specimens. The comparison between the secant stiffness and the equivalent secant stiffness of each test piece is shown in Figure 12.

Based on the comparison shown in Figure 12a, it is apparent that the JR1 joint exhibits the highest initial stiffness, followed by the J0 joint, with the JR2 joint being a close third, and the JR3 joint exhibiting the lowest initial stiffness. The reason for this trend may be that the initial stiffness of the viscoelastic material is small. As the loading displacement increases, its stiffness will increase accordingly. Therefore, the stiffness of the seismically damaged joint after retrofitting with viscoelastic materials will also increase with the loading. As

the loading progresses, the stiffness of the J0 joint decreases rapidly. When the loading displacement reaches 15 mm, the stiffness of the J0 joint is smaller than that of the retrofitted joint, as it was at a lower level. The stiffness of the JR1-3 joints tends to remain at the same level during the loading process until the displacement amplitude reaches 52.5 mm. During the loading process, after 52.5 mm, the secant stiffness of the JR1 specimen decreases faster than that of the JR2 and JR3 specimens.

Through the comparison of Figure 12b, we can see the stiffness degradation level of each specimen. The figure illustrates that the stiffness degradation of the JR3 joints is comparatively milder, followed by that of the JR2 joints, while the stiffness degradation of the JR1 and J0 joints is more pronounced. Nonetheless, the JR1 joints exhibit better performance than do the J0 joints. One contributing factor is the damage sustained by the joints, resulting in reduced initial stiffness. However, this may also lead to a milder degree of stiffness degradation over time. It can still be inferred that the steel-enveloped retrofitting method can alleviate the stiffness degradation of the joint. Furthermore, the results suggest that the viscoelastic steel-enveloped retrofitting method exhibits superior performance in terms of reducing stiffness degradation compared to the pure steel-enveloped retrofitting method.

In summary, of the pure steel-enveloped retrofitting method effectively improved the initial and later stiffness of the seismically damaged joints, while the viscoelastic steel-enveloped method also enhanced the stiffness. However, the latter cannot restore the initial stiffness of the joints to the level of the non-damaged joints. Nevertheless, the performance of the retrofitted joints in the later stages is good. After retrofitting, the stiffness of the joints degrades more smoothly, and the stiffness degradation of the joints retrofitted with viscoelastic pads is lower than that of the joints without viscoelastic pads.
