# Seismic Performance of Reinforced Concrete Buildings with Joist and Wide-Beam Floors during the 26 November 2019 Albania Earthquake

**Abstract:** Beams with width greater than their depth and depth equal to the depth of the slab (concealed wide beams) are widespread in Reinforced Concrete (RC) buildings in Albania. A large number of RC buildings with wide beams were hit by a strong  $M_w$  6.4 earthquake on 26 November 2019. The earthquake hit two of the most densely populated areas in Albania and caused widespread damage to these buildings. This paper aims to provide an updated view on the seismic performance of buildings with wide beams in light of the new field data following the 26 November 2019 Albania earthquake. To this end, a thorough literature review including experimental and field observations from past earthquakes is presented and data from field visits in Albania are described. It was found that damage to the joists and wide beams themselves was limited, even when the buildings suffered significant non-structural or structural damage in other elements as a result of the earthquake. A discussion on the behavior of wide beam–column frames based on nonlinear structura

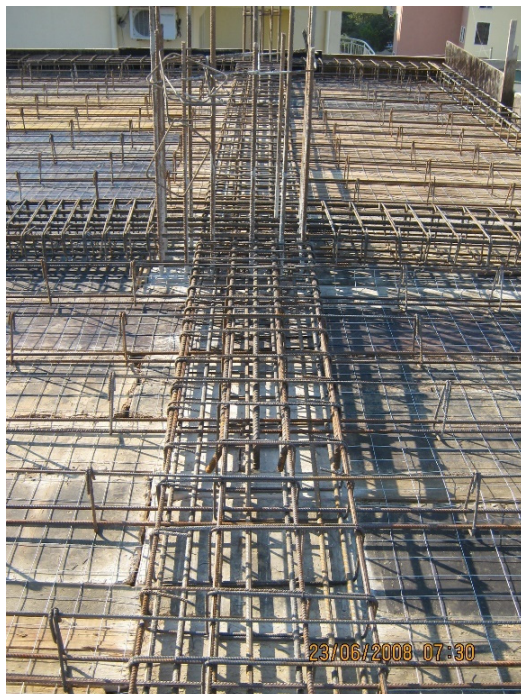
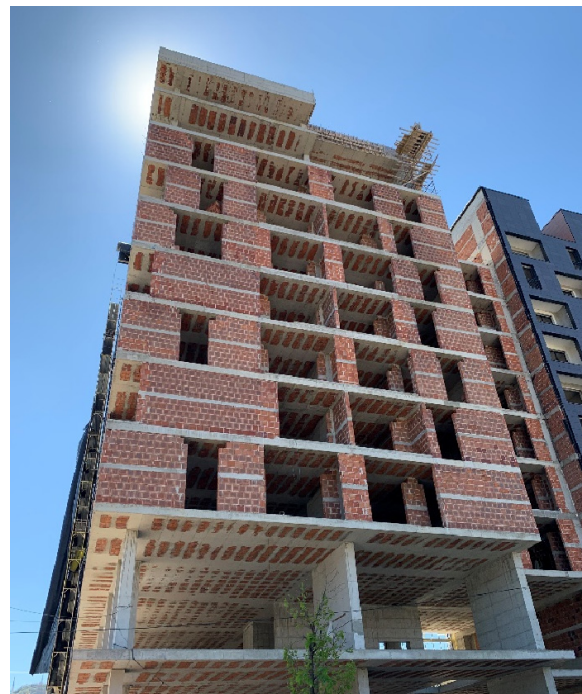
Photos of the wide beam–joisted slab system are shown in Figure 2. Figure 2a shows a slab under construction, with wide beams in two directions and a one-way joisted slab. Notice the flat formwork in Figure 2a (one of the main advantages of this system) and the dense shear reinforcement in the beams. It is common to have situations in which the width of the beam is greater than the dimension of the supporting column, which is sometimes not in accordance with the national seismic code requirements [4] regarding width and eccentricity:  $b_w \leq 2b_c$  and eccentricity  $e \leq b_c/4$ . In many cases, wide beam–column frames are the only lateral load resisting system in RC buildings in Albania, although newer buildings typically have shear walls and/or perimeter moment-resisting frames. An example of a building under construction in Tirana with shear walls and wide beams is shown in Figure 2b.

**Figure 2.** Wide beams in Albania: (a) photo during construction; (b) wide beams in a building with columns and shear walls under construction in Tirana.

The slab system shown in Figure 2 became popular in Albania after 1990. A large number of RC buildings employing this wide beam–joisted slab system were subjected

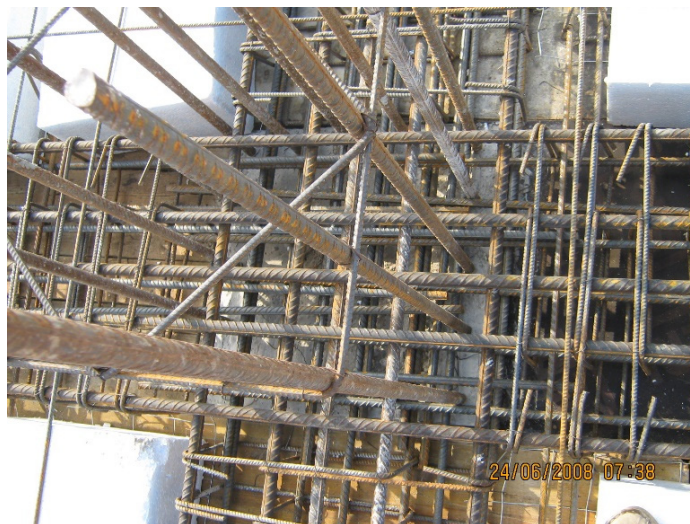
**Figure 5.** Congestion of reinforcement near the beam–column joint in a building in Durrës.

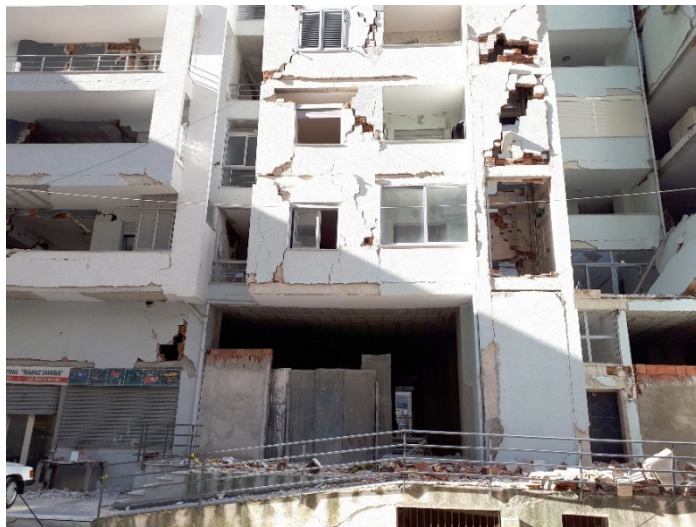
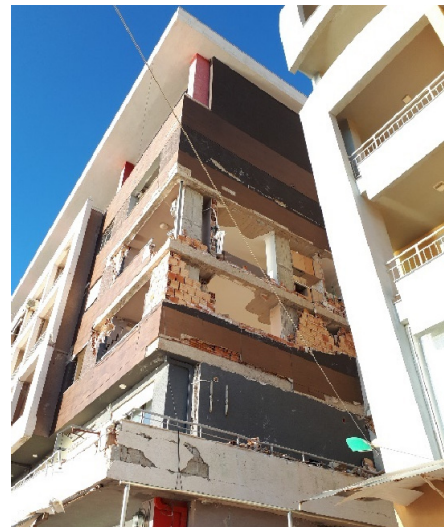
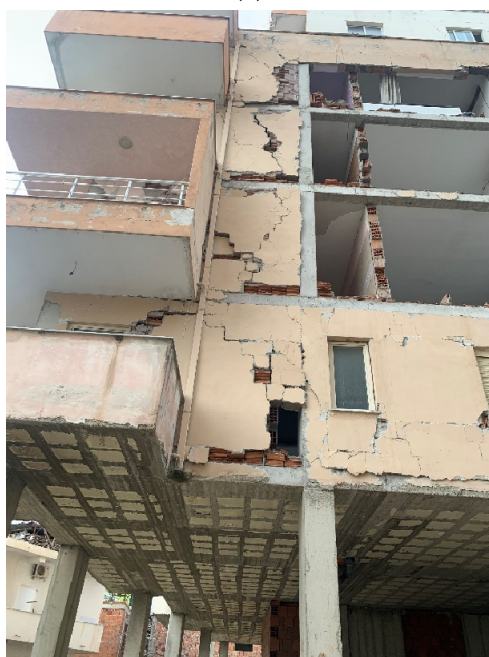
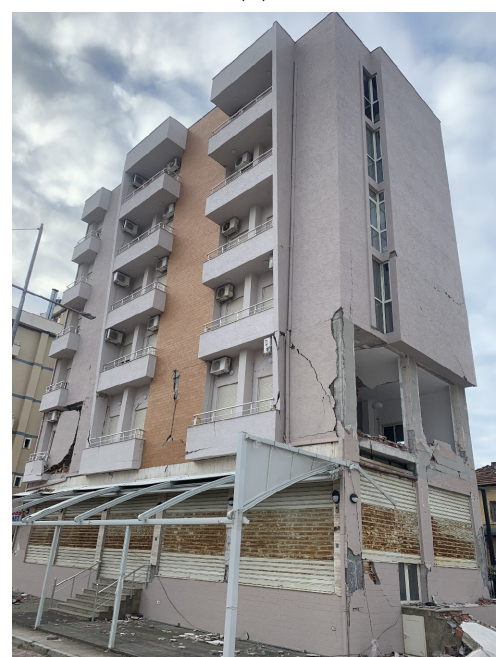
Examples of buildings with wide beams that suffered significant non-structural damage are given in Figure 9. In the building with wide beam–column frames shown in Figure 9a, damage was excessive, with in-plane and out-of-plane failures of the infill and partition walls. The building in Figure 9b also suffered damage to infills up to the fifth floor. Due to failure of the brick walls, it is possible to see in Figure 9b the exposed, apparently undamaged, exterior wide beam–column connections. The building shown in Figure 9c had an open ground floor (with very few infills compared to the upper stories). The structural system consisted mainly of wide beam–column frames, although a shear wall with small dimensions compared to the floor area was provided. Excessive damage to infills occurred

in this building in the lower five stories. Moreso, the building shown in Figure 9d had an open ground floor and suffered light-to-moderate structural damage on the ground floor and extensive non-structural damage on the first floor (infill and partition walls fell down). Only light damage occurred to the upper floors.

**Figure 9.** Examples of buildings with wide beams that suffered significant non-structural damage during the 26 November 2019, earthquake: (a) a twelve-story building in Durrës city; (b,d) a six-story building in Durrës seaside; and (c) a ten-story building with open ground floor in Durrës beach area (photo: Rikard Luka).

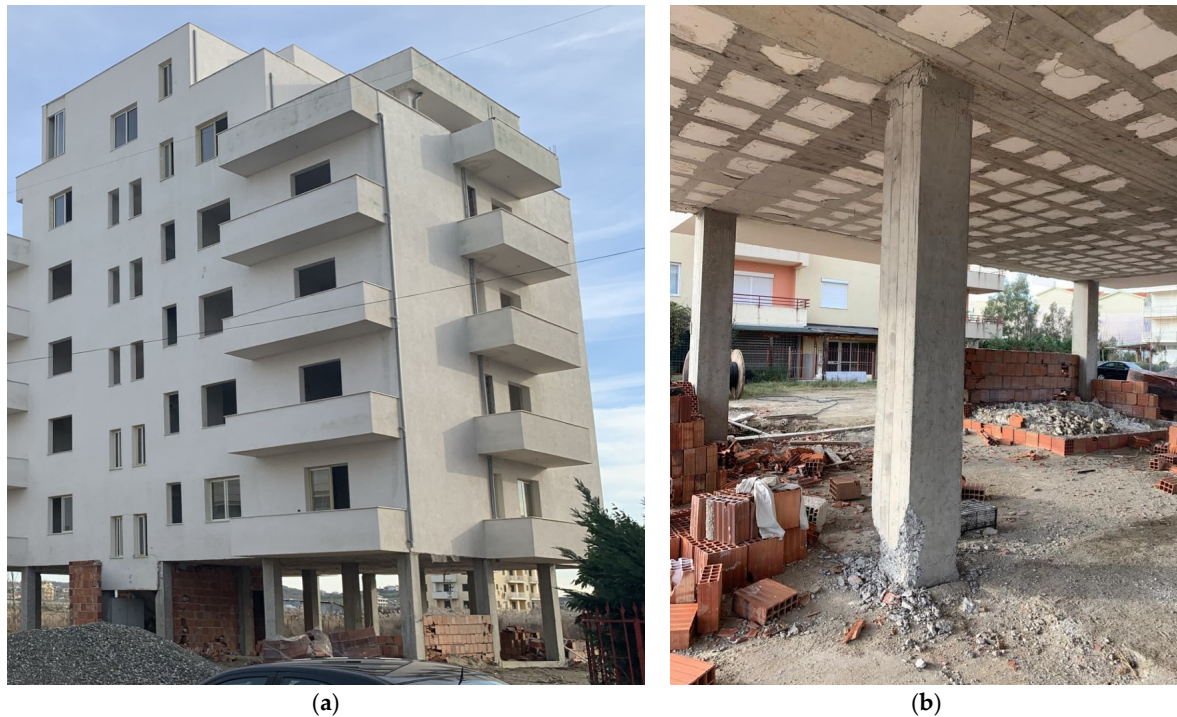
Another building, in which the influence of wide beams in the global response is easier to identify, is shown in Figure 11. This building was unfinished (Figure 11a), and the ground floor was open, with very few infill walls constructed at the time of the earthquake. In this building, no significant signs of distress were detected in the wide beams, but the column bases suffered damage which was mainly expressed by concrete crushing (Figure 11b). This response (i.e., with essentially elastic and undamaged beams and damaged column bases) is likely a result of the excessive flexibility of wide beams and the elevated value of yield drift for these beams. This issue is discussed in more detail in the following Section 5.

**Figure 11.** Seven story building in Durrës: (a) building view; (b) damaged column bases.

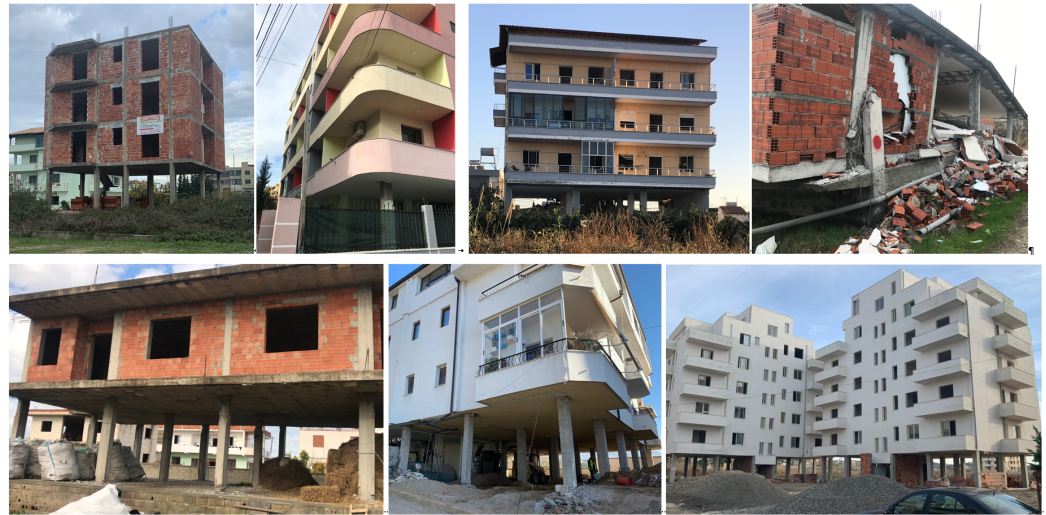
A four-story RC building located in Durrës is analyzed in this section. The building is representative of older (around 1990–2000) RC buildings in Albania, in which wide-shallow beams were used in combination with relatively thin columns. This building typology continues to be widespread in suburban areas near Durrës (Figure 12) and it was one of the most severely affected by the November 2019 earthquake.

**Figure 12.** RC Buildings with wide beams and an open ground floor.
