# A BIM-Based Model for Structural Health Monitoring of the Central Body of the Monserrate Palace: A First Approach

**Citation:** Machete, R.; Neves, M.; Ponte, M.; Falcão, A.P.; Bento, R. A BIM-Based Model for Structural Health Monitoring of the Central Body of the Monserrate Palace: A First Approach. *Buildings* **2023**, *13*, 1532. <https://doi.org/10.3390/buildings13061532>

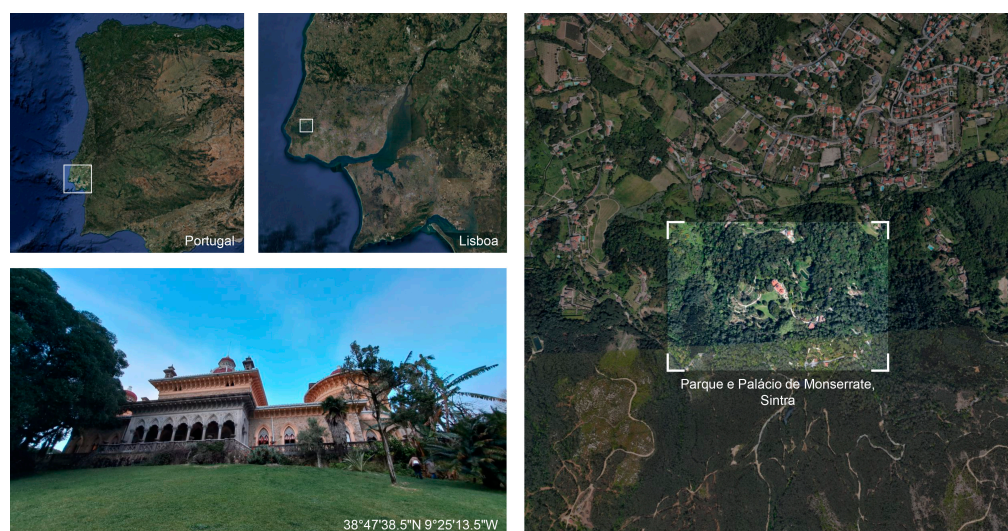
**Figure 1.** Location of the case study: Portugal (left up), Lisbon (center up), Monserrate Park and palace (right), Monserrate Palace (left down).

The Monserrate Palace belongs to the Cultural Landscape of Sintra (Figure 1), classified as a World Heritage Site by UNESCO since 1995, and is characterized by its unique identity and the progress of architecture and technology in landscape and project planning. These topics alone are an indication of its heritage value, emblematic identity and consequent relevance for the research and preservation of the palace and its surroundings.

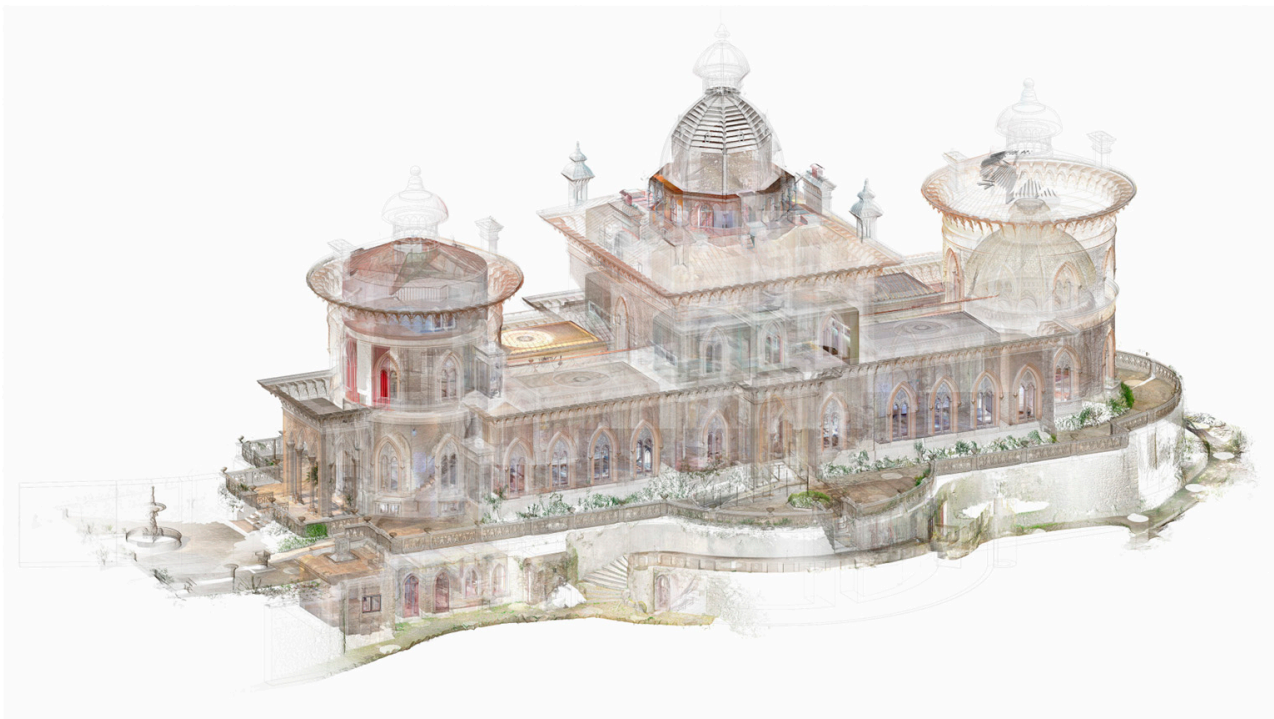
**Figure 3.** Point cloud perspective view.

Regarding the geometric data acquisition, 336 scans were carried out with TLS to obtain geometric information about the Monserrate Palace. Of this total, 205 scans corresponded to the rooms of the central body and side wings, which were the object of the study. These scans were acquired with a Faro Focus S70 laser scanner starting in April 2021. For each scan, a combination of parameters was selected, considering the amount of information that was needed from each room of the palace and finding a balance between collected information and the duration of its acquisition. The detailed point cloud was processed in Autodesk ReCap® [37], and was the basis of the geometric model (Figure 3). To geo-reference the model, a topographic survey was carried out with a GNSS receiver and total station with the support of topographical targets located at strategic points (Figure 4). The coordinates (M, P) are relative to the PTM06/ETRS89 system, and the H coordinate, orthometric altitude, is in relation to the Cascais tide gauge.

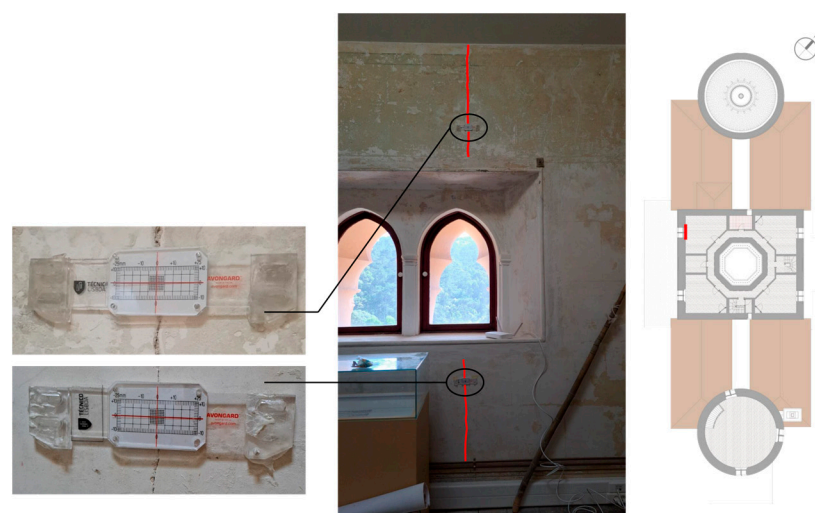
**Figure 6.** Location of the cracks in the west workroom over and below the window on the third floor: view of crack meters (left); photo of the cracks in relation to the wall (middle); location in plan view (right).

Due to the good conservation of the Monserrate Palace, no cracking state was generally acknowledged. Only one major crack was identified indoors in the west workroom over the window on the third floor of the central body of the palace (Figure 6). As no other cracks or inclinations in the walls were surveyed, it was decided to only place crack meters along this crack to periodically monitor and control any movement that occurred instead of displacement transducers.
