# The Diagnostics of the Condition and Management of Large-Panel Buildings Using Point Clouds and Building Information Modelling (BIM)

**Abstract:** Technological developments involving the implementation of modern measuring equipment and the digitalisation of civil engineering can contribute to extending the service life of buildings. Large-panel buildings constitute a large housing stock throughout Europe. This paper presents the possibility of using laser scanning to identify typical assembly defects in large-panel buildings. Based on point cloud data, numerical models were created to assess the impact of improper assembly on the elements' performance. It was indicated that using scanning to identify and monitor the displacement of structural elements does not relieve experts of the need to perform other tests. Analyses related to the possibility of using Building Information Modeling technology to manage large-panel buildings were also conducted. A parametric model was made, from which a number of possibilities of its use at every stage of the building's life were presented in an example. It was highlighted that parametric models of large-panel buildings, due to their repeatab

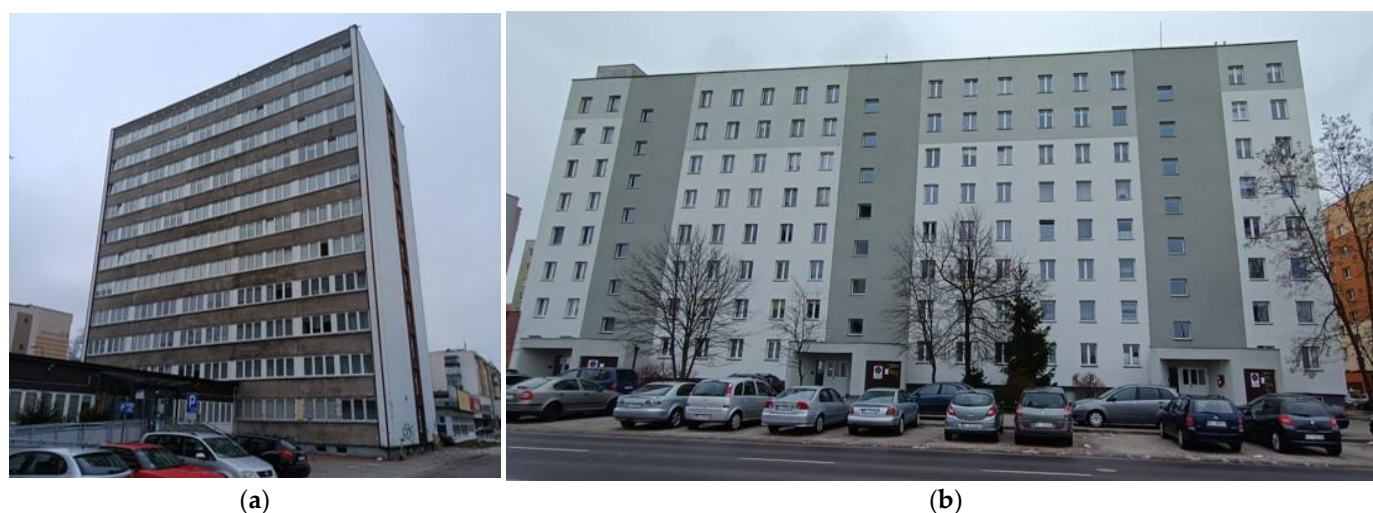
**Figure 1.** Examples of large-panel buildings: (a) building before thermomodernisation of the front elevation; (b) building after thermomodernisation.

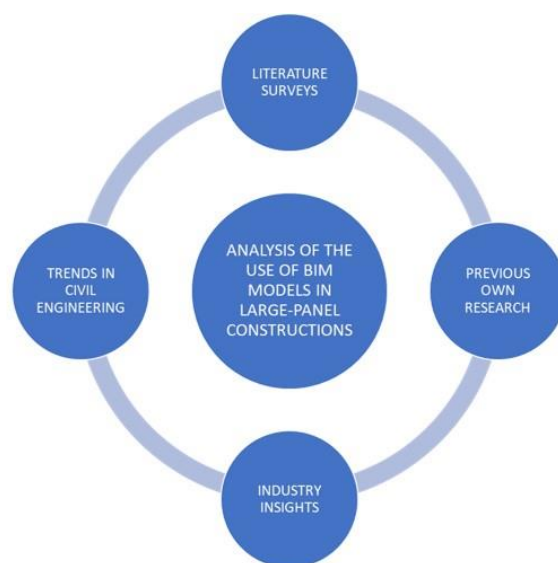
current trends in the civil engineering sector, industry insights from construction experts and a large amount of our own research on systemic prefabricated buildings [4,5,9,10]. The authors verified the results of their research carried out using various methods. The verification was carried out on the example of detailed condition analyses of more than 100 buildings located across the country in 6 out of 16 provinces in Poland. For example, in the province of Mazovia, more than 100 buildings were examined [3,12]. The subsequent research presented in this article contributes to the development of a research methodology for large-panel buildings. A research methodology related to the feasibility of using BIM technology in large-panel facilities is presented in Figure 7.

**Figure 7.** Methodology of the research carried out to identify the feasibility of using BIM models in large-panel buildings.

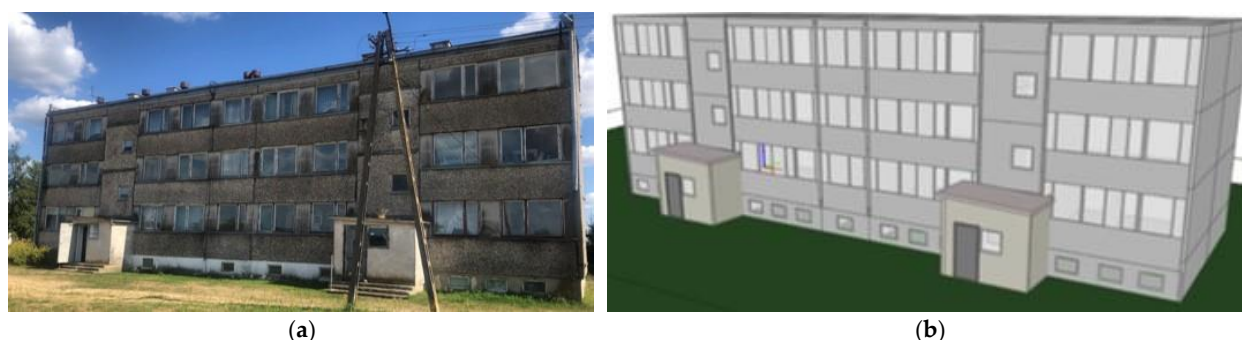
The analyses carried out indicated a significant interest in BIM technology among engineers, as well as investors and facility owners. Drawing knowledge from the aforementioned sources, including from cases where BIM technology for facilities management has already been implemented [82,83], the authors have identified opportunities for the application of parametric models in large-panel buildings. The paper presents benefits that are not limited to individual facilities but can be implemented to manage entire housing estates. This is due to the very repetitive architecture of buildings located within the same housing estates. This makes the work of digitising the documentation easier. The copying of geometry significantly reduces the labour intensity associated with modelling. The conducted analyses were carried out using a sample parametric model made by the authors. The partially decommissioned large-panel building surveyed, together with the parametric model, is shown in Figure 8.

**Figure 8.** Digital version of existing large-panel building: (a) existing building; (b) BIM model.
