# Experimental Study on Seismic Performance of Partially Corroded Squat RC Shear Walls in Coastal Environment

**Abstract:** In coastal environments, squat reinforced concrete (RC) shear walls are susceptible to local accumulation of moisture and chloride salts, causing local corrosion in the shear walls, which in turn affects their seismic performance. Four squat RC shear wall specimens were designed considering the corrosion locations and the heights of the corroded area. The seismic performance of partially corroded squat RC shear wall specimens was analyzed through a quasi-static test. The results show that as the height of the corroded area increases from 15% to 25% of the total height, the area of the hysteresis loop of the shear walls obviously decreases. As the height of the corroded area increases from 0 to 15% and 25% of the total height, the peak and ultimate displacements of shear walls are, respectively, reduced by 6.7% and 19.2% in the positive loading direction, and are, respectively, reduced by 22.3% and 18.3% in the negative loading direction. Compared with the unilateral corroded shear wall, the area of the hysteresis loop and the stiffness of the bilateral corrod

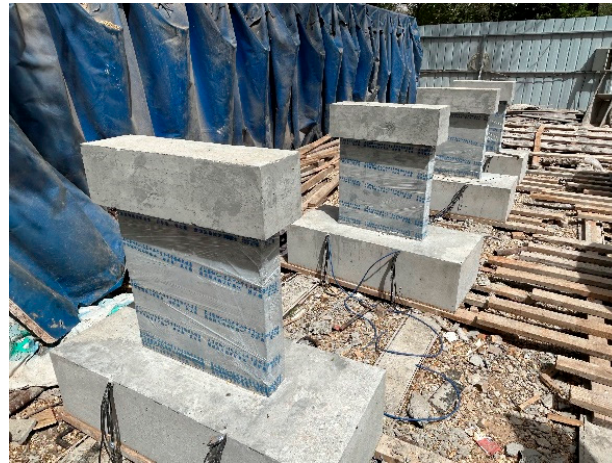
**Figure 3.** Shear wall specimens after curing.

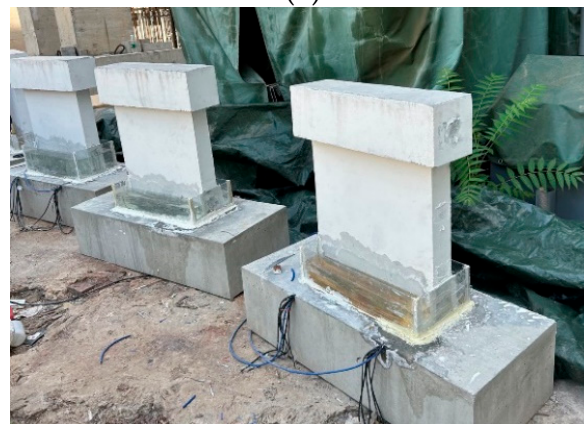
**(a)**

**(b)****Figure 4.** Shear wall specimens with different corrosion conditions. (a) Schematic drawing; (b) physical picture.

The different corrosion conditions of shear wall specimens are shown in Figure 4 and Table 2. A water tank containing 5% NaCl solution by mass fraction was pre-set in the target corroded position of specimens, as shown in Figure 5.
