Article

Building Surface Defect Detection Using Machine Learning and 3D Scanning Techniques in the Construction Domain

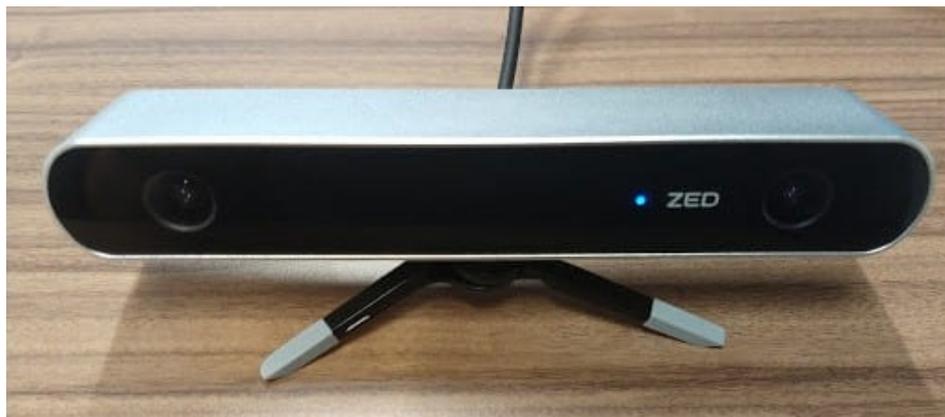
Figure 1. ZED camera system.

Another sensory system used was the ZED camera system, which consists of a dual depth-sensing camera with resolutions ranging from 1344×376 pixels at 100 frames per second up to 4416×1242 pixels, reaching a refresh rate of up to 15 frames per second at this high resolution. This range of resolutions and refresh rates makes the system adaptable to various scanning methods [14]. Jose Eleazar Peralta Lopez et al. have also demonstrated that the ZED camera is rugged enough to withstand real-life conditions by being mounted on the front of an SUV while collecting images on the streets of a real-life city [15]. For example, if the research team decides to scan buildings from a fixed point, then it is better to use a high resolution to capture as much detail as possible. If the decision is to use a drone in the future, then the team must sacrifice resolution for more frames, to match the speed of a drone and keep the flow of data constant. Otherwise, in the case of an automated terrestrial vehicle, there can be a balance between quality and speed, making it the right choice if you need to capture fine details at a faster rate than can be achieved with manual labor. The system's small size and portability also make it suitable for use in combination with a drone or an automatically guided vehicle.

Other sensory systems used by the research team in previous work were Microsoft Kinect, which is like the ZED camera system (Figure 1) and the DJI Guidance system, which was made specifically for drone guidance [16]. The most advanced sensor used was the Velodyne VLP-16 Puck LiDAR, with a 360-degree scan range. It was calculated that it needs at least 6 scans to make a full 360-degree simulation of a building interior [17]. With good calibration, a LiDAR sensor is able to scan and produce 3D maps in a very short timeframe, with an accuracy of 1 mm [18].

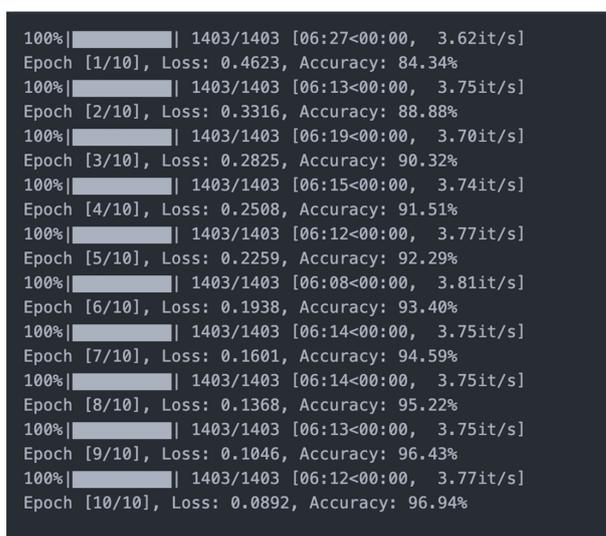
Figure 2. Accuracy of the ResNet50 model improvement at each step of training.

Using the ResNet50 training model, the team ran the training for 10 steps of training for the entire set of pictures, which added up to a total of approximately 140 min. During each step of training, the training accuracy can be seen to improve, as shown in Figure 2.

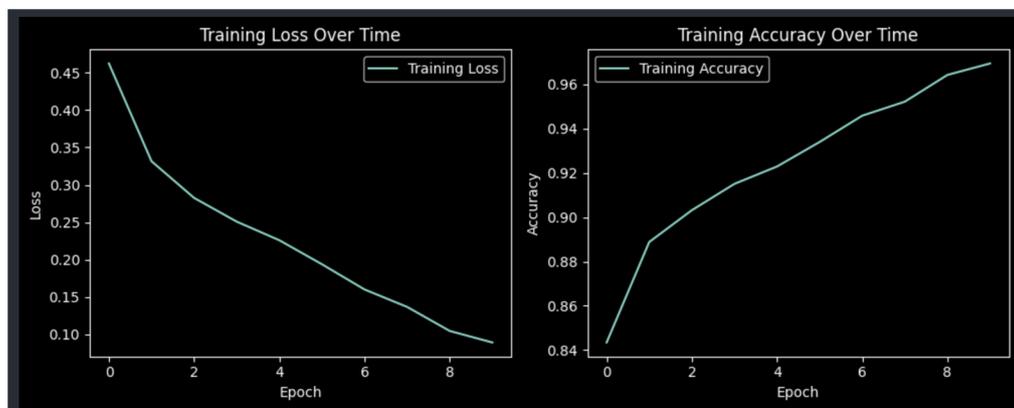
Figure 3. Training loss and training accuracy using ResNet50 on an online image library.

The goal is to train the model until the point where the training loss is minimal and the training accuracy is as high as possible, as shown in Figure 3. The values of the hyperparameter configuration (learning rate, batch size, etc.) are based on the used hardware; in this case, Apple Neural Engine from the M1 Pro was used.

By comparing the graph of the training loss and training accuracy shown in Figure 3 with the graph shown in Figure 5, it can be observed that the graphs follow the same general behavior, but in the case of the ResNet101 model, the training loss decreases faster

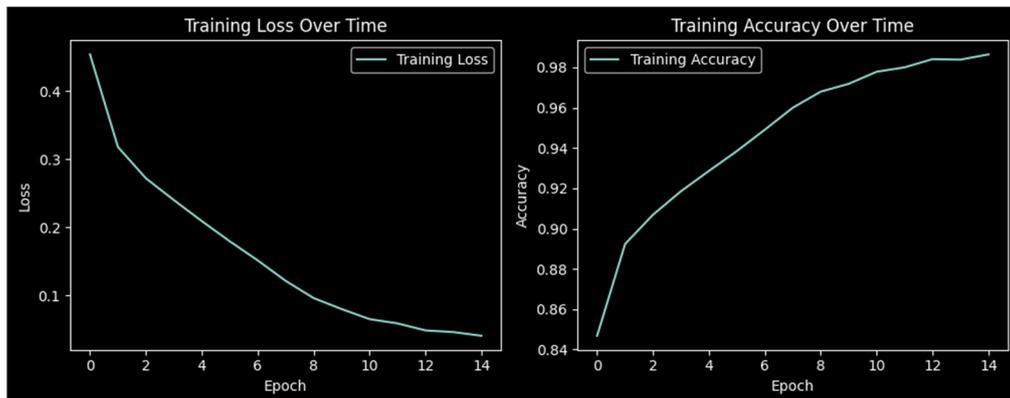
Figure 5. Training loss and training accuracy using ResNet101 on an online image library.

(0.3316 loss for ResNet50 vs. 0.3182 loss for ResNet101 at step 2), and the training accuracy improves in a shorter time right from the beginning (88.88% training accuracy for Resnet50 vs. 89.24% training accuracy for ResNet101 at step 2).

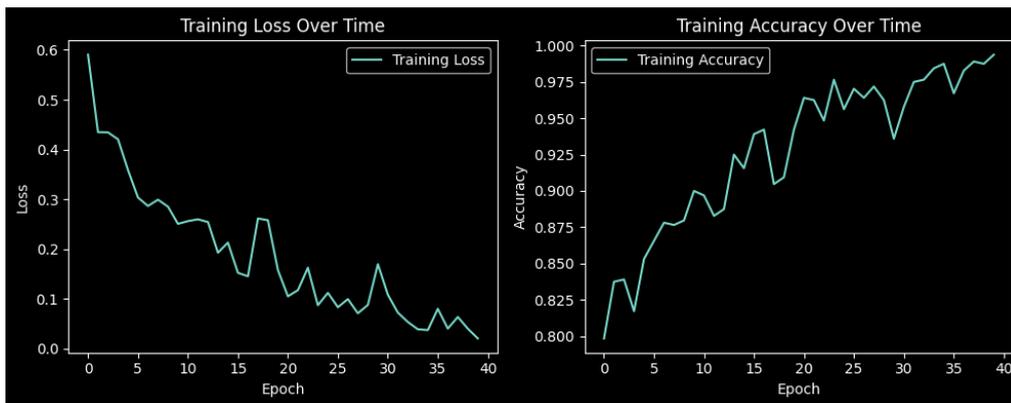
Figure 9. Training loss and training accuracy using ResNet101 model on real images captured by the research team.

In this case, the graphs of the training loss and training accuracy do not follow a smooth path like that in the previous cases. As can be seen in Figure 9, both graphs vary slightly during the training period, but both tend towards a general path of improvement over time. The fluctuation may be caused by the quality of the images captured by the team, showing the importance of the quality and reliability of the pictures being captured and the need to take into account natural factors, such as lighting, haze, shadows, etc., as mentioned by Hongpan Lin et al. in their paper [32].

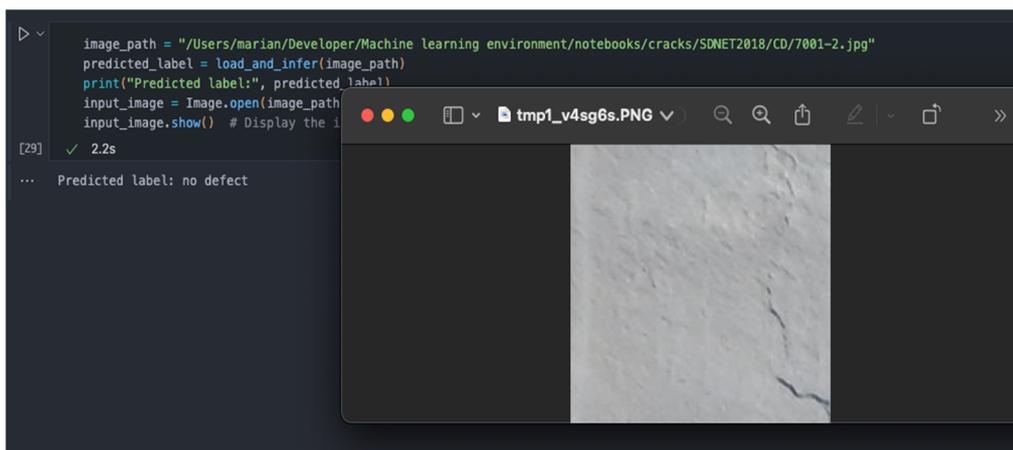
Figure 11. Differentiation between a shadow and a crack.

Some tests were made with the final trained model using real images captured by the research team on real construction sites. The results can be seen in Figures 11–14, where the application correctly identifies an image with or without any cracks/defects and knows how to detect the difference between a crack and a shadow.

The difference between a simple image-processing algorithm and the machine learning solution used in our paper can be observed in Figures 11 and 12. A simple image-processing algorithm mainly uses edge detection to detect cracks; therefore, such an approach could be deceived by features that are similar to cracks (i.e., shadows or stains), and this could lead to fake positives. Our model uses a set of labelled crack images, with which it learns to differentiate between similar features; therefore, as it can be observed being highlighted in

the red box, it correctly predicts that the stain and the shadow do not represent a structural defect (i.e., a crack).

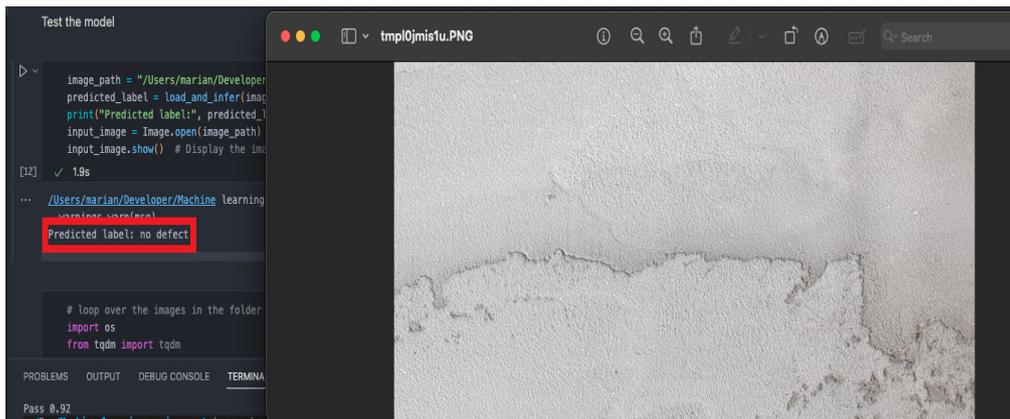
Figure 12. Differentiation between a stain and a crack.

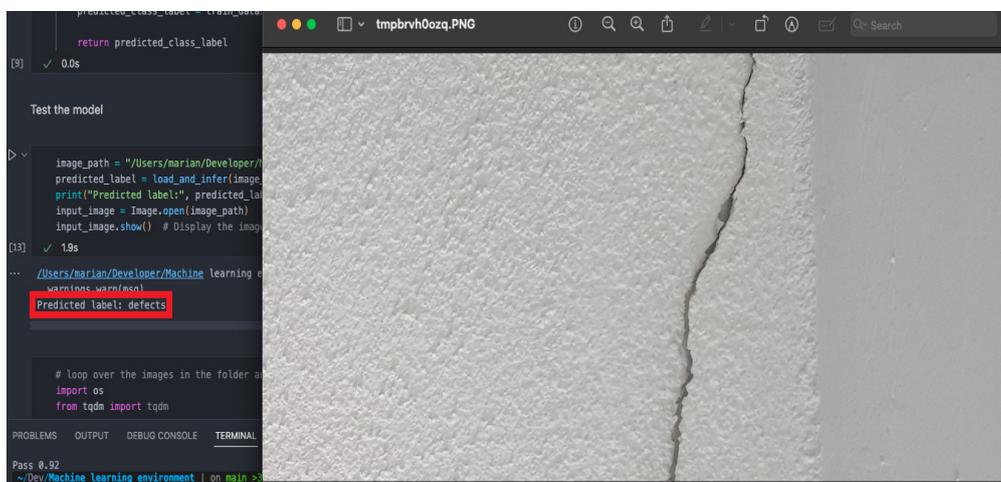
Figure 13. Crack detection using ResNet101 on a real image captured by the research team.

Shown above in Figures 13 and 14 and highlighted in the red boxes are the results of the approach chosen by the research team. The solution (i.e., the ResNet101 training model) can correctly predict structural defects with high accuracy (i.e., 92%) on real images, and as shown earlier, its accuracy does not decrease when confronted with naturally occurring factors on a construction site, such as stains or shadows, which proves that it can be used for future work in this domain.

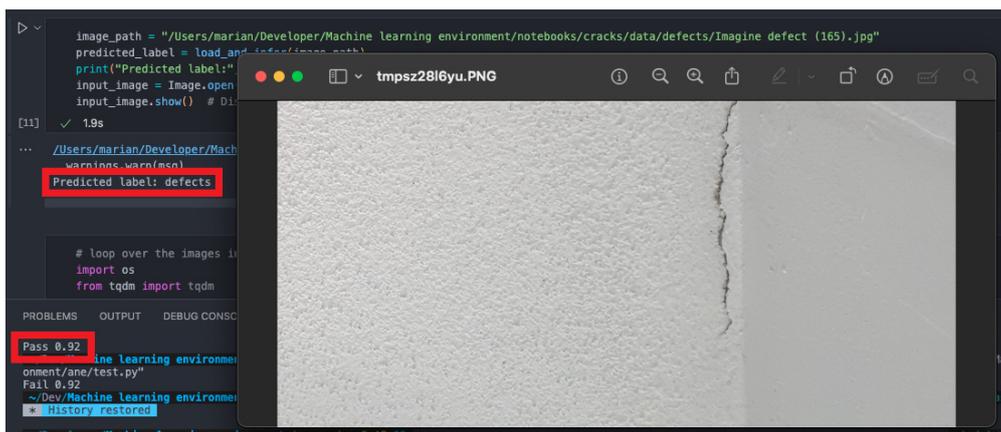
Figure 14. The accuracy of detection reaches 92% in real conditions using ResNet101.

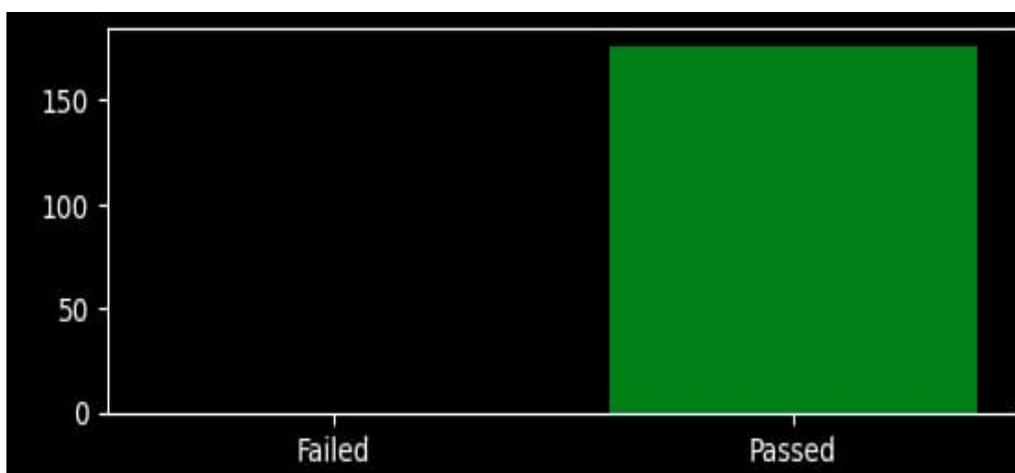
Figure 15. Tests run on the images of walls with no defects.

For the first step, just as predicted, the model passed all 176 images with no defects, as shown in Figure 15. Based on these positive results, the team is confident that the model is able to identify a picture of a wall with no cracks or defects.

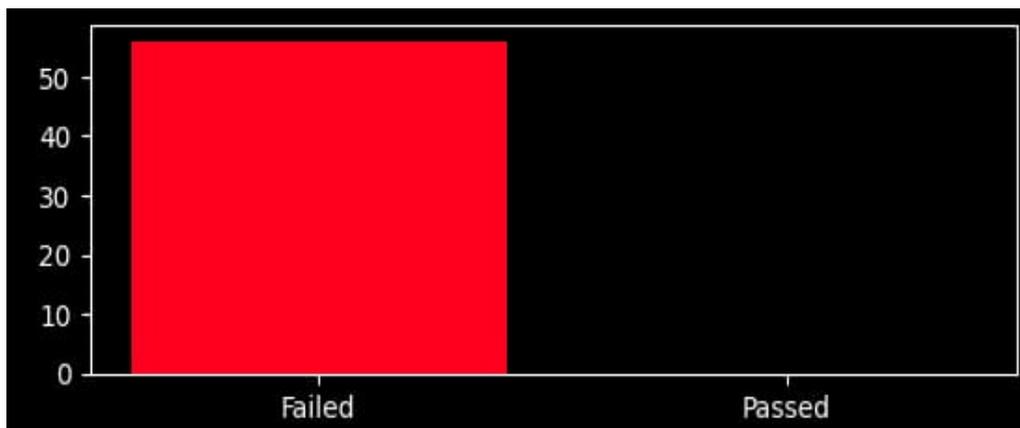
Figure 16. Tests run on the images of walls with surface defects.

For the second step, the model failed all 56 images that presented surface defects, as can be observed in Figure 16. Therefore, we can state that in these controlled conditions, the model can correctly identify an image with a wall that presents faults such as cracks, holes, or other similar surface defects.

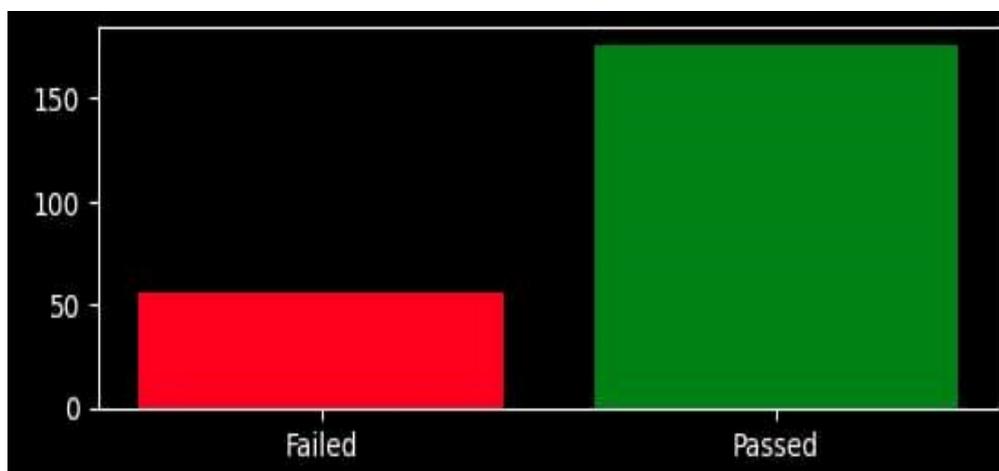
Figure 17. Tests run on both sets of images simultaneously.

For the last step, the model correctly identified both types of images (with and without defects) with high accuracy, as shown in Figure 17. The research team is confident that in laboratory conditions, where the images are captured in good lighting conditions and without noise, that the model is capable of correctly differentiating between a wall with no defects and a wall that presents cracks, holes, paint chips, etc.
