Article

Performance and Durability of Paints for the Conservation of Historic Façades

Abstract: This paper analyzes the performance of various types of paints available in the Brazilian market, including PVA, matte acrylic, silicate, and lime paints within the context of their applicability to the conservation of historic building facades. Considering distinct suppliers and application methods, this study highlights the importance of tailoring paint selection to the preservation requirements of historic edifices, taking into account local preservation norms and the material characteristics of the buildings' original construction. The paints were evaluated based on water vapor permeability, washability, and adhesion. Furthermore, the paints' color variation with exposure to accelerated artificial aging was assessed. For testing purposes, specimens produced from cellular concrete slabs were used as substrates, which were coated with the paints under study. Based on the results, it was observed that, regarding the diffusion of water vapor, the silicate and lime paints presented the highest permeability values, and the acrylic and PVA paints had the lowest. Concerning washability, th

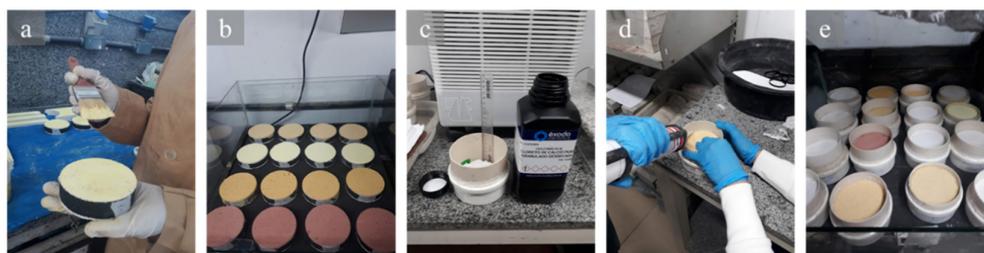
By regulatory requirements, the specimens were positioned on polyvinyl chloride (PVC) supports containing calcium chloride (CaCl_2) desiccant to initiate the test. The relative humidity in the chambers was maintained at $50 \pm 5\%$ using a saline solution of magnesium nitrate ($\text{Mg}(\text{NO}_3)_2$), and the temperature was kept at $21 \pm 1^\circ\text{C}$. Figure 1 illustrates the test preparation and execution.

Figure 1. (a) Painting the substrates; (b) specimens with sealed sides arranged in the glass chamber; (c) PVC support with calcium chloride desiccant (CaCl_2); (d) sealing the sides of the support with silicone; (e) supports with specimens in the chamber with relative humidity of $50 \pm 5\%$.

The water vapor permeability test followed the guidelines of the ASTM E96/E96M standard [31] using the desiccant method. A total of 32 specimens 10 cm in diameter and 2.5 cm thick were tested, 4 specimens for each paint formulation and 4 for the unpainted substrate. After painting, the specimens had their sides sealed with rubberized paint and were placed in chambers with a relative humidity of 50%.

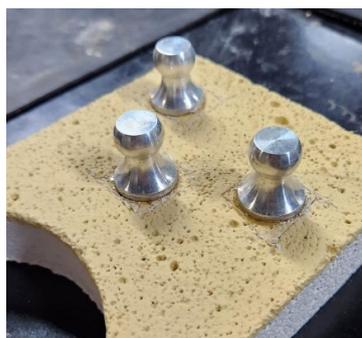
The adhesion of the paints to the substrate was evaluated following the guidelines of the ASTM D4541 standard [33] for conducting the pull-off adhesion test using a DeFelsko PosiTest AT-A tester, which assesses the adhesion strength of a coating system. A total of 3 studs were affixed, with a two-component epoxy and cyanoacrylate glue being utilized, to the previously cleaned surface of each specimen (Figure 2). This adhesive does not affect the coating properties, penetrate through the coating, or degrade the coating. This approach aligns with the recommendations set forth in ASTM D4541 [33]. Subsequently, the test apparatus was connected to the aligned loading device to apply perpendicular stress to the test surface with a gradual and uniform increase of 1.0 MPa/s, and the behavior was observed until the loading device detached.

Figure 2. Specimen submitted to the adhesion test D4541 [33].

The properties of both the glue and the substrate play critical roles in influencing the type of failure and the strength of the bond in adhesion tests, such as those described by ASTM D4541 [33] for evaluating the pull-off strength of coatings. The chemical composition of the adhesive determines its curing mechanism, bond strength, flexibility, and resistance to environmental factors. An adhesive with high bond strength and appropriate flexibility for the substrate material can distribute stresses more evenly, potentially reducing the likelihood of adhesive failure (where the bond between the adhesive and the substrate or coating fails) and cohesive failure (where the material itself fails internally). As for the substrate properties, the porosity, surface roughness, and chemical composition affect how the adhesive bonds to it. A porous substrate may allow for better mechanical interlocking, improving adhesion strength, but it might also absorb part of the adhesive, reducing its effectiveness. Surface roughness can increase the effective bonding area but requires an adhesive capable of adequately wetting the surface. Additionally, the chemical compatibility between the substrate and the adhesive is crucial to prevent degradation of the bond over time [33].

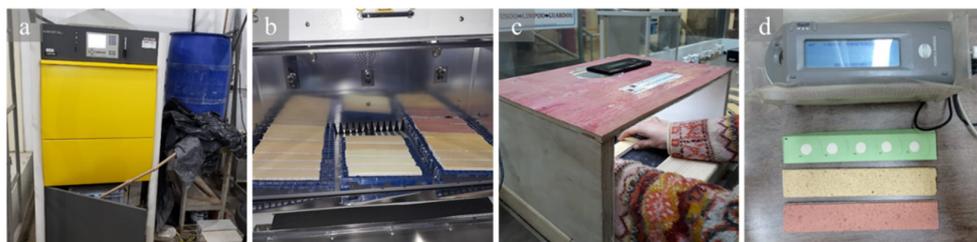
For the durability study, 21 samples were tested, 3 for each paint formulation, each measuring 3.5 cm in width and 20 cm in length. Figure 3 illustrates the test methods regarding weathering and color monitoring.

Figure 3. (a) Weathering chamber; (b) disposal of specimens inside the weathering chamber; (c) photograph capture; (d) colorimetric analysis using a spectrophotometer.

The specimens with different paint formulations were subjected to accelerated aging following Cycle 1 of the ASTM D6695 standard [34], which consists of 102 min of continuous exposure to light at a relative humidity of $50 \pm 5\%$ and a black panel temperature of $63 \pm 2^\circ\text{C}$, followed by 18 min of precipitation using a deionized water spray. Thus, each cycle lasted 2 h. The weathering chamber was the Suntest XXL+ model from Atlas Material Testing Technology, equipped with 3 1700 W xenon lamps. The typical irradiance applied during the test was $0.35 \pm 0.02 \text{ W}/(\text{m}^2\text{-nm})$ at 340 nm [33].

Throughout the aging process, the properties of the specimens were continuously monitored using photographic records and colorimetric analysis, which involved chromatic coordinates obtained with a portable Konica Minolta CM-2500D spectrophotometer. A specialized camera with controlled lighting conditions was used to capture the photographs, ensuring uniformity. Chromatic coordinates were acquired for each specimen at 5 fixed

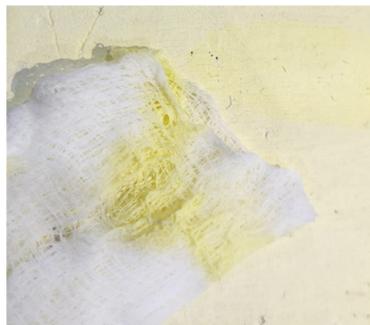
The washability test of the paints revealed that the PVA, MA_1, and MA_2 formulations exhibited no change or material loss after 200 rubs with wet surgical gauze. In contrast, the remaining configurations, YS, YS_3, BS, and L, had signs of wear after being rubbed from 10 to 20 times with the gauze (Figure 4), possibly suggesting a diminished washability performance. It is important to note that this analysis can be considered simplified and should be supplemented with the results of accelerated aging and durability tests.

Figure 4. Washability of paint specimen with lime + yellow dye formulation.

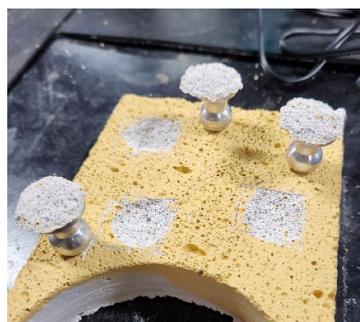
For six of the seven paint formulations, except for the lime paint, there was adhesion failure within the substrate. This hindered a direct assessment of the adhesion between the coating and the substrate because, due to the low mechanical strength of cellular concrete, along with its porosity and uneven texture, the coating did not detach from the paint film (Figure 5).

Figure 5. Pulling out of the substrate during the test.

However, in the case of the lime paint, the paint layer stood out due to its greater thickness and density compared to the other coatings. The adhesion strength value was low, at 0.08 MPa, but it still allowed for an effective assessment, as outlined in the ASTM D4541 standard [33]. It is worth noting that, despite the challenges faced during this test, the results obtained can offer valuable insights for the planning of future projects in historic environments with similar substrates.

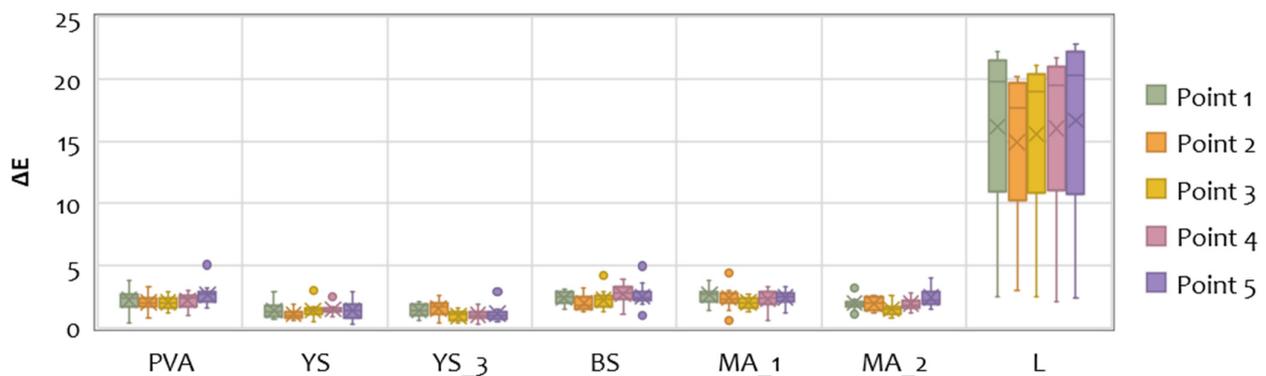
Figure 6 depicts the color variations of the paint formulations at the measurement points after the exposure period. The lime paint exhibited the most significant color variation, followed by the matte acrylic paints (MA_2 and MA_1). When evaluating the durability of paints and coatings, the assessment of fading becomes particularly crucial. As per NBR 13749 [39], pigments are expected to withstand the UV radiation to which they are exposed.

Figure 6. Color variation.

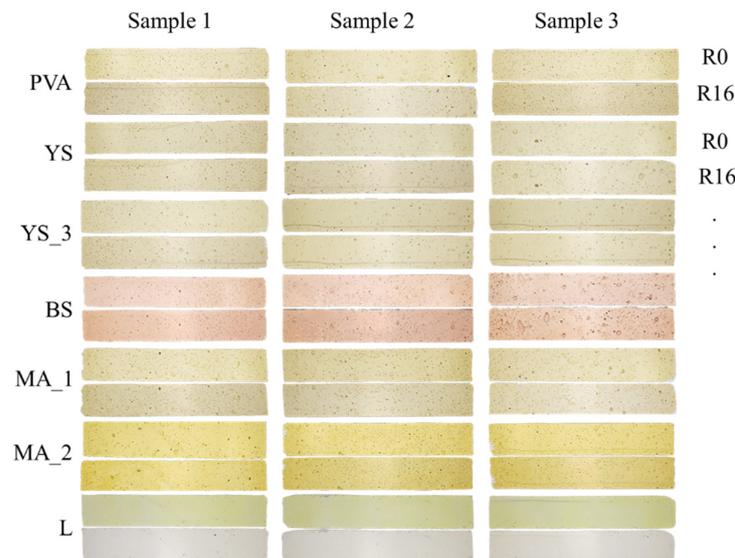
Figure 7 presents a photographic comparison of the specimens between monitoring time 16 and reading “0” (before exposure to the test). The visual analysis aligns with the colorimetric analysis, clearly illustrating the significant pigment loss in the lime paint. Similar findings were also reported by Brito [20], who observed pronounced fading and staining in lime-based paints. In contrast, samples with silicate-based paint, primarily reddish in color, exhibited better performance, despite showing some changes in color and white spots, resembling the results obtained in this study for brown silicate paint (BS).

Figure 7. Color variation by image analysis (R: reading).

Most notable differences become apparent when comparing the lime paint with the others. Furthermore, the matte acrylic paint MA_1 exhibits a statistically significant difference compared to the yellow silicate paint applied with two coats (YS) and three coats (YS_3). It is worth noting that when comparing the YS and YS_3 samples, no significant change is observed after 16 cycles. In other words, the application of two coats of paint was enough to create a durable film regarding the chosen accelerated aging cycle.
