Color of Tenement Houses Built in the 19th and Early 20th Centuries in Wrocław (Poland)—Research, Restoration and Conservation

Przemysław Nowakowski

Faculty of Architecture, Wrocław University of Science and Technology, 50-317 Wrocław, Poland;
przemyslaw.nowakowski@pwr.edu.pl

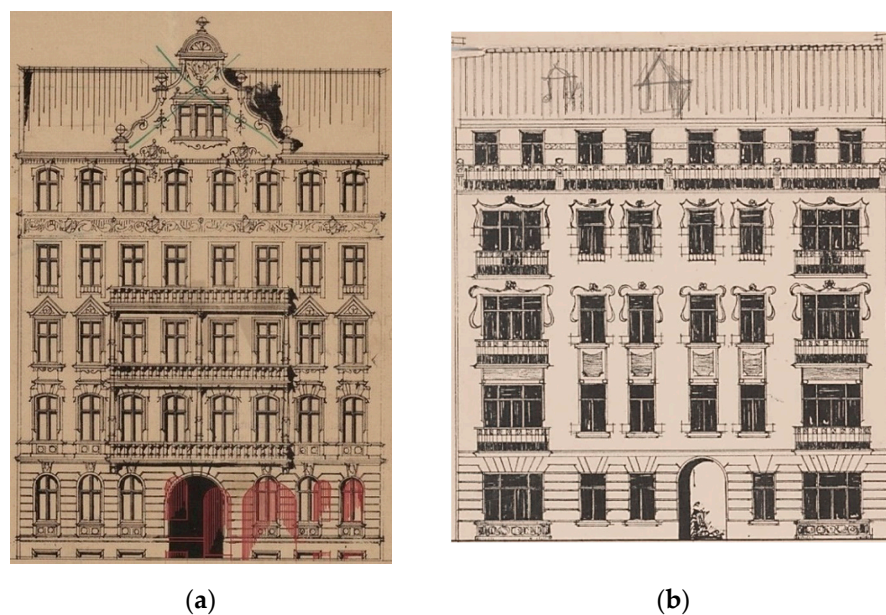
Figure 2. Archival façade projects of tenement houses in Wrocław in the Neo-Renaissance (a) and Art Nouveau (b) styles (Collection of the Building Archive of the City of Wrocław).

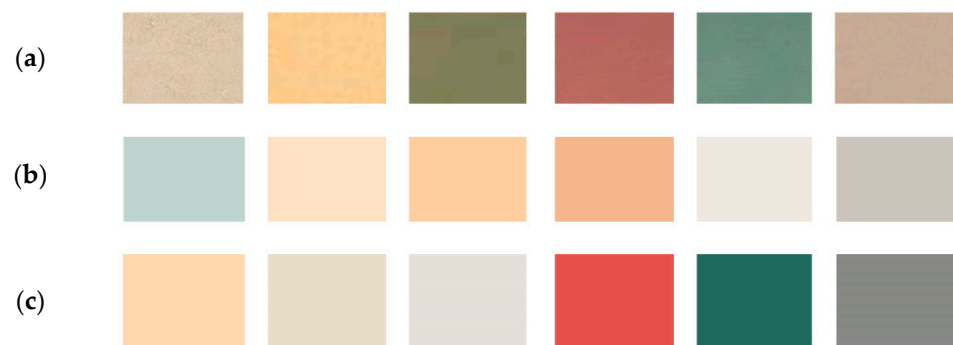
Figure 4. Examples of intensive (a) and bright (b) colors in the style of Historicism and Art Nouveau (c). Inspiration (Donauer and Reusch 2007).

From the middle of the 19th century, the façade colors were less saturated and less expressive (Figure 4b) (Donauer and Reusch 2007). The surfaces of the walls, the tectonic divisions, and the details were more often of homogeneous color. This convention is represented, that is, by the renovation project of the tenement house on Podwale St. 61 (2014).

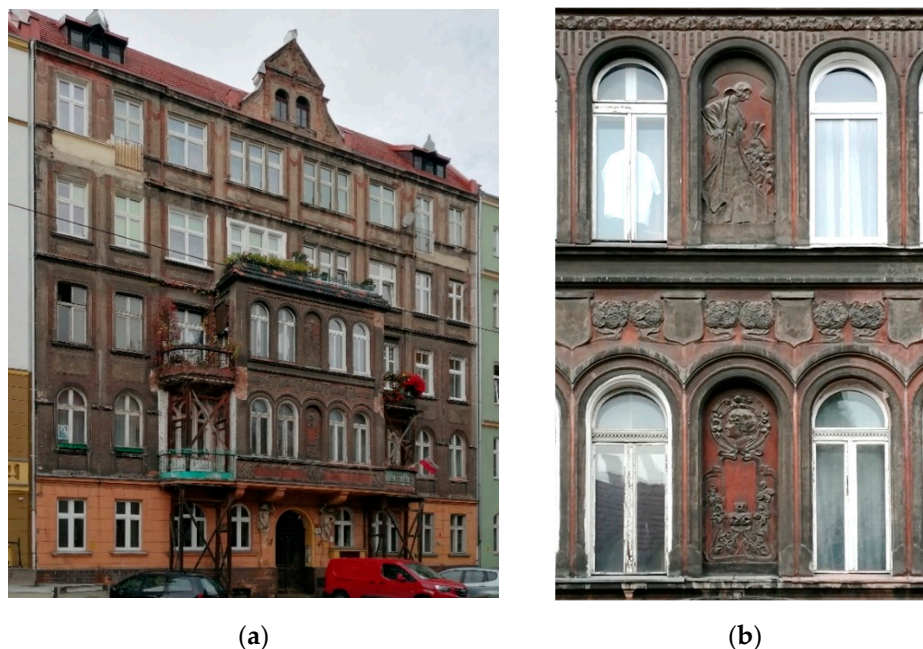
Figure 5. A tenement house in the Art Nouveau style on Rozbrat St. 12 (a). Dark red and gray colors and stucco (b).

The bold color propositions of the old elevations are represented, for example, by a tenement house in its original state in the Art Nouveau style on Rozbrat St. 12. It has not been revitalized so far. The combination of dark red and gray colors, tectonic divisions, varied plastering structures and beautiful stucco is impressive (Figure 5).

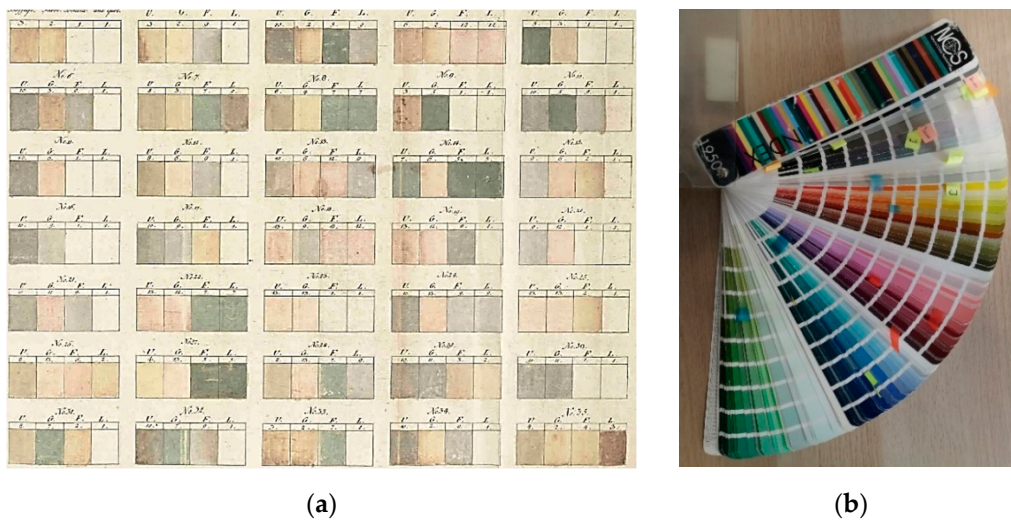
Figure 6. The façade color pattern made by F. Ch. Schmidt in *Der bürgerliche Baumeister*, 1790 (Wojtysiak 2003) (a). The modern color template, NCS-System (b).

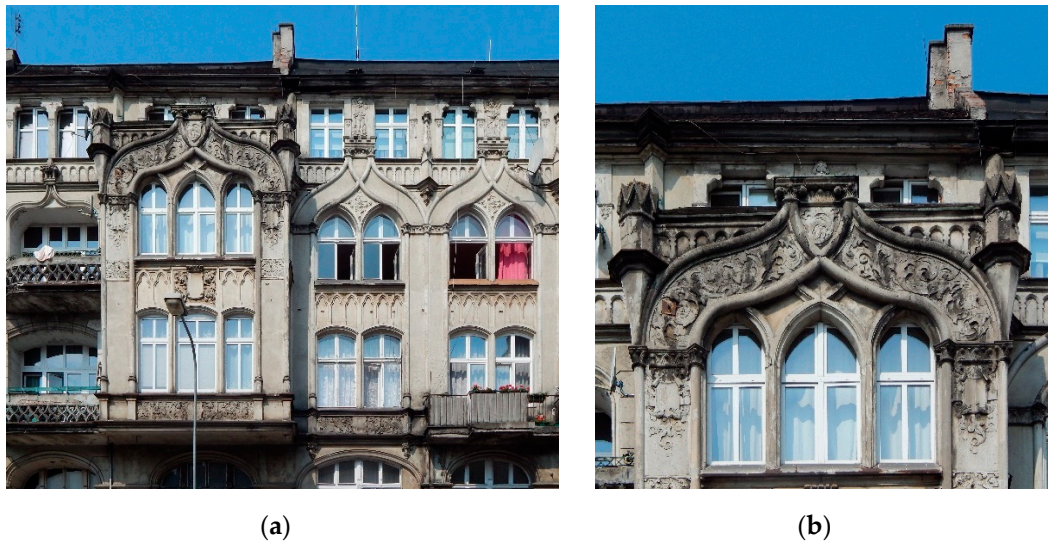
Figure 7. Tenement house, Krasinskiego St. 21–23, Wrocław. Elevation before renovation work (a). Architectural details were missing on the terrace balustrade (b).

On-site research showed different states of preservation of the elevation (Figure 7). They were included in the inventory plan. The plan was useful in determining the scope and costs of the renovation work.

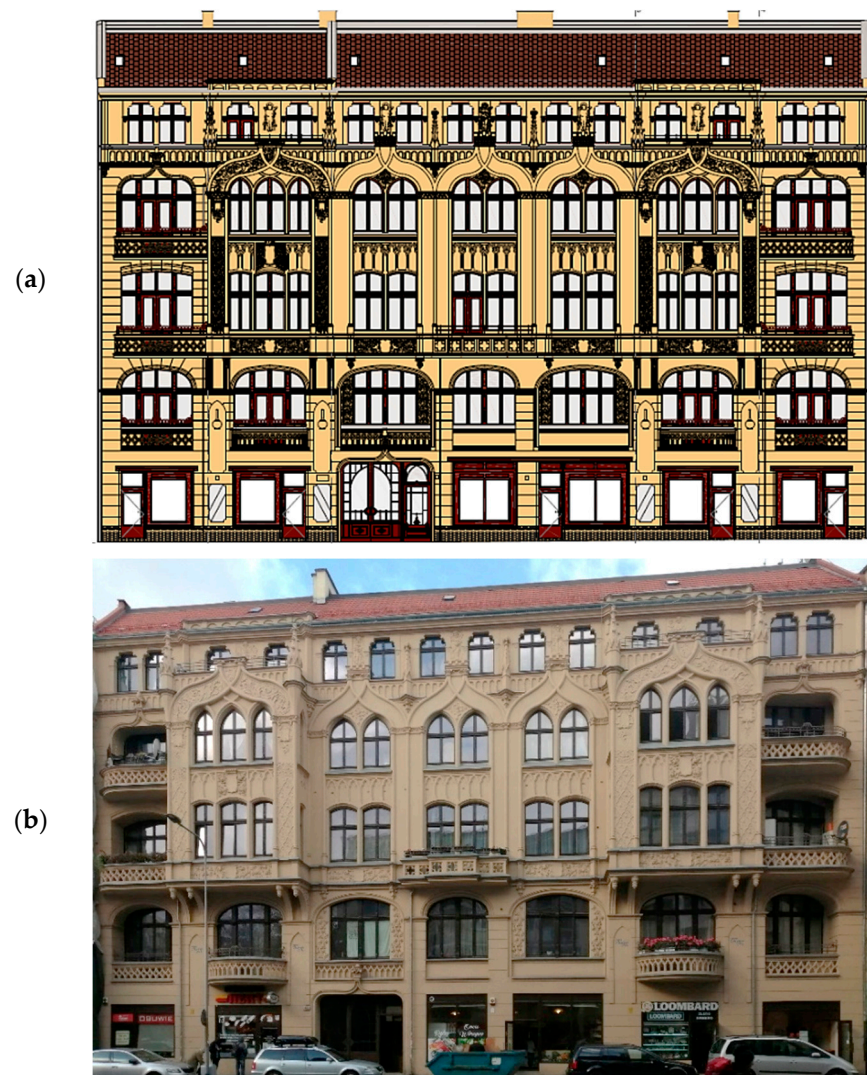
Figure 8. Tenement house, Krasinskiego St. 21–23, Wrocław. Design of the colors of the front elevation (a) and the elevation after renovation (b) (Nowakowski 2015a).

The stratigraphic studies showed the existence of the original paint coating on the walls and the stucco details. The façade color was compared with the color palette in the “NCS” system: “S1515-Y20R” or “S1010-Y20R” (Witkowska 2015a). A slightly cooler color tone, “S1510-Y30R” or “1515-Y30R”, was also allowed. Finally, the architect chose the beige color of the façade according to the “NCS S1010-Y20R” system. He also used the brown color of the steel balustrades and the aforementioned windows, doors, and shop windows, “RAL 8015” (Nowakowski 2015a). The renovation work was carried out by a renovation company according to the conservation recommendations, as well as the construction and detailed project (Figure 8).

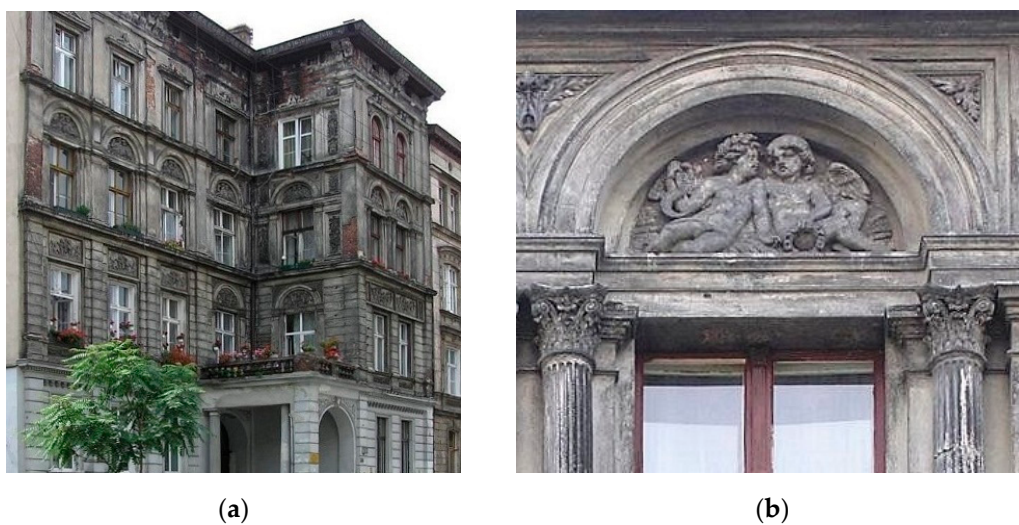
Figure 9. Tenement house, Kniaziewicz St. 17, Wrocław. Elevation before renovation work (a), Preserved stucco details, cornices, columns and pilasters with peeled paint (b).

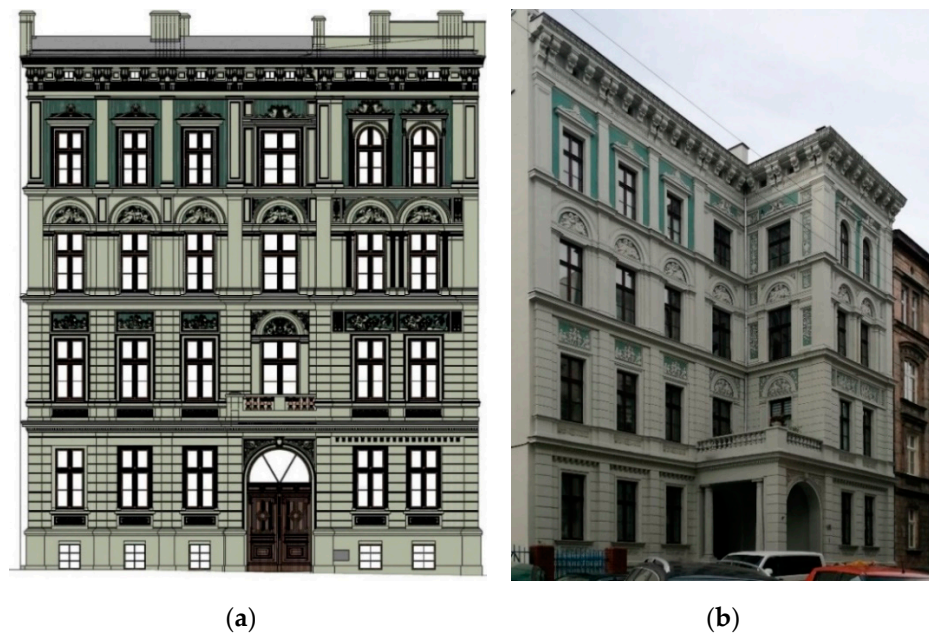
Figure 10. Tenement house, Kniaziewicz St. 17, Wrocław. Design of the front elevation colors (a) and the front elevation after renovation (b) (Nowakowski 2017).

The stratigraphic study showed the existence of a primary layer of stucco decoration and elevation painting. They were made within the flat surfaces of the walls, on some sculptural plaques, cornices and pilasters. The colors were compared with the “Caparol 3Dplus” pattern (Nowakowski 2017; Witkowska 2017). Finally, the architect proposed façade colors in cool green shades, according to “Caparol 3Dplus”—“Moos 50”, “Patina 70” as a renovation paint system, and the brown color of the woodwork “RAL 8024” (Figure 10).

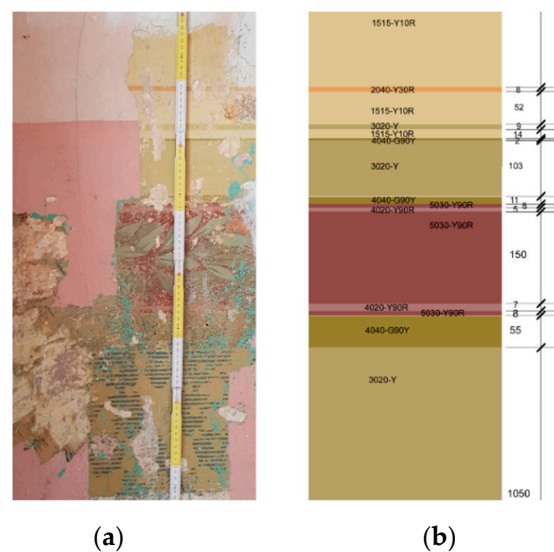
Figure 12. Exposure of the fragment of the original staircase painting and pattern (a) and a simplified reconstruction project (b) (Nowakowski 2017).

The stratigraphic research showed a very decorative painting of the walls of the staircase (Figure 12a). The outcrop has revealed a relatively good condition of a fragment of the original painting. There were four painting conventions used:

- painting covering large surfaces of walls with a wide brush in earthy, green, and maroon colors;
- painting a few stripes with a narrow brush in intense earthy colors;
- painting the ribbed decoration in blue-green with a roller;
- template painting with floral decoration in a lighter blue-green color.

However, the walls of the staircase were later repainted in a pink shape. Oil and emulsion paints were used at that time (Figure 12a).

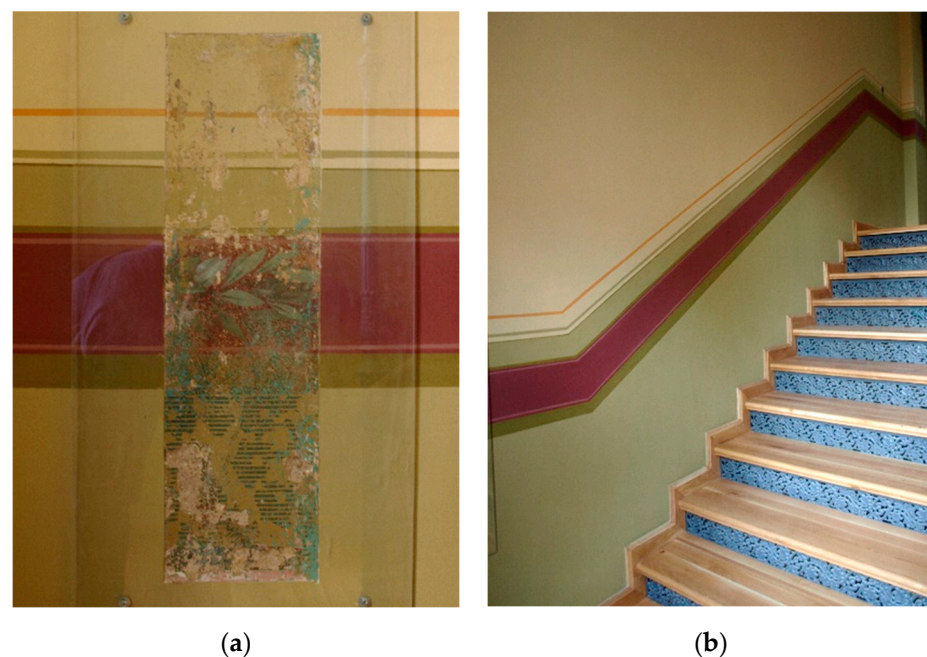
Figure 13. Securing the original fragment behind a glass pane (a). Reconstruction of the wall painting of the staircase after the renovation (b).

Reconstruction of the original look of the staircase turned out to be too expensive for the renovation budget. The application for co-financing was submitted before the stratigraphic study. The architect designed a simplified color scheme in agreement with the Wrocław Municipal Monuments Conservator Office (Figure 12b). He also decided to protect the uncovered fragment of the original pattern (Figure 13a). The new, controversial concept included the design of general divisions with colored stripes, parallel to the stairs. “Caparol” colors in earthy shades (including ochre and olive green) and burgundy were used, according to the NCS system (Figure 13b).

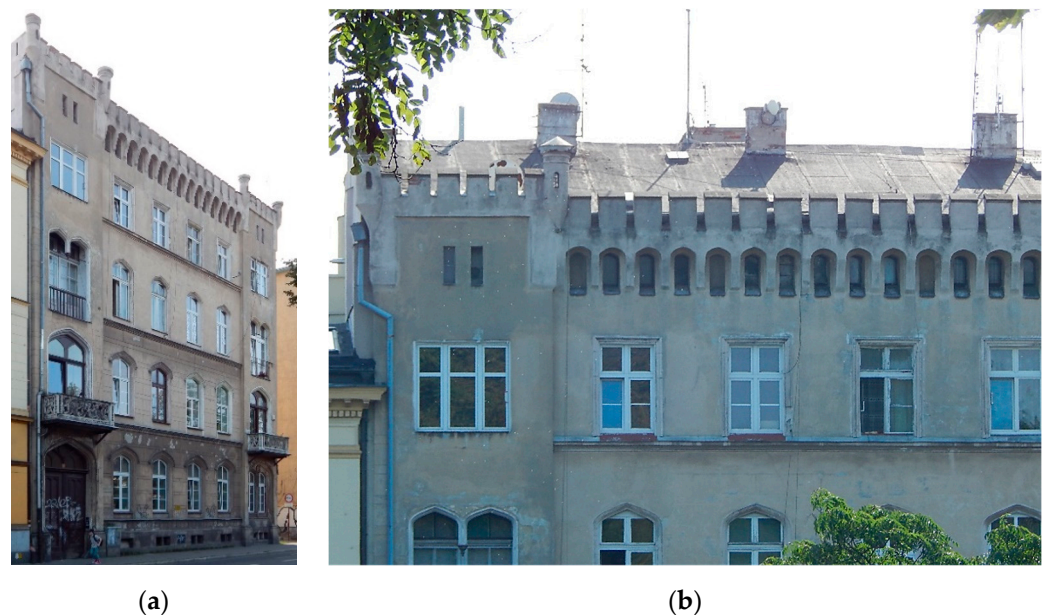
Figure 14. The tenement house, Podwale St. 61, Wrocław. Dirty elevation with peeling paint. There were no balconies on the third floor (a). Characteristic battlement with peeled paint. Details of the turrets were missing (b).

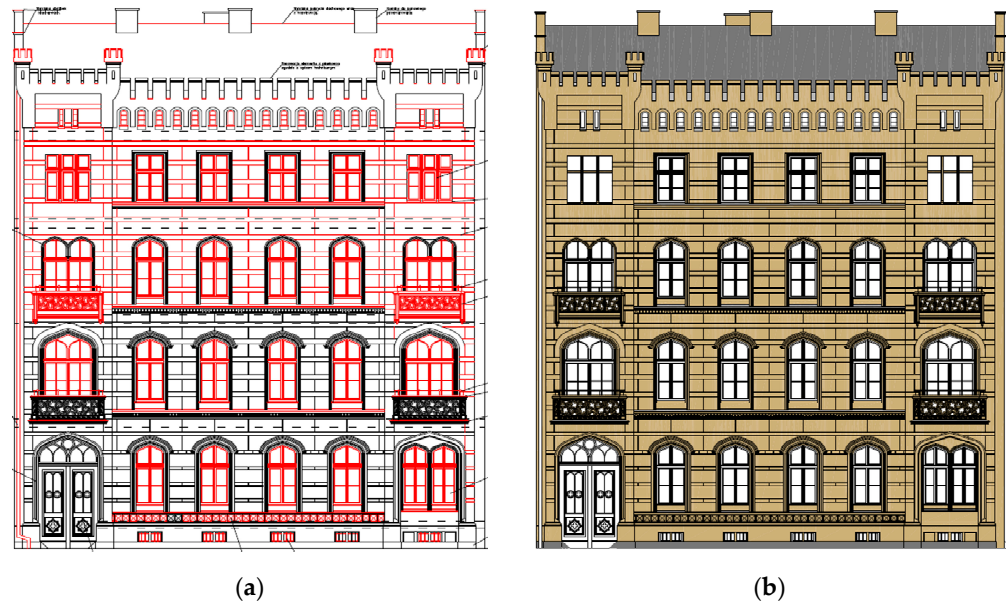
Figure 15. The tenement house, Podwale St. 61, Wrocław. The graphical scope of the renovation, marked in red (a) and the color concept of the front elevation (b) (Nowakowski 2014b).

Stratigraphic studies showed the existence of the primal paint layer in an earthy hue (referring to the natural building material) (Wandrychowska 2014). The original color was similar to “Caparol Histolith Dunkler Ocker 20”. As a result of stratigraphic studies, comprehensive conservation work was recommended on the surfaces of flat walls, plaster and sandstone, architectural details, door and window joinery, and metal details (Figure 15a) (Nowakowski 2014b; Wandrychowska 2014). The ocher color was proposed on the elevation according to the “Caparol Histolith System, Dunkler Ocker 20” (Figure 15b).

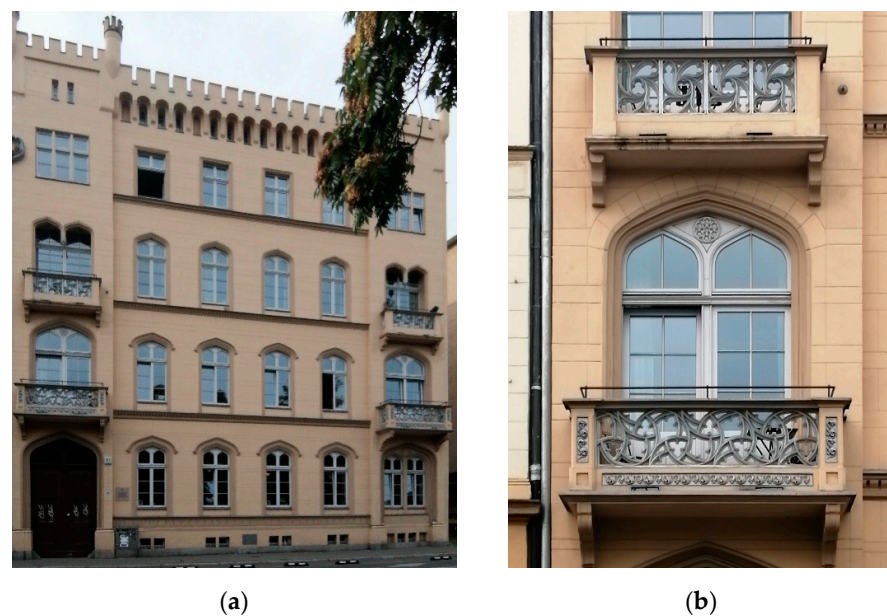
Figure 16. Front elevation colors after renovation (a). Reconstructed zincal balcony balustrade details with Gothic motifs and replaced windows (b).

The balconies on the second floor were made of zincal segments joined with rivets. They were placed on a brick balustrade. The third-floor balconies were completely reconstructed with similar technology.

The preservation work was carried out according to conservation recommendations, as well as the construction and detailed project (Figure 16).

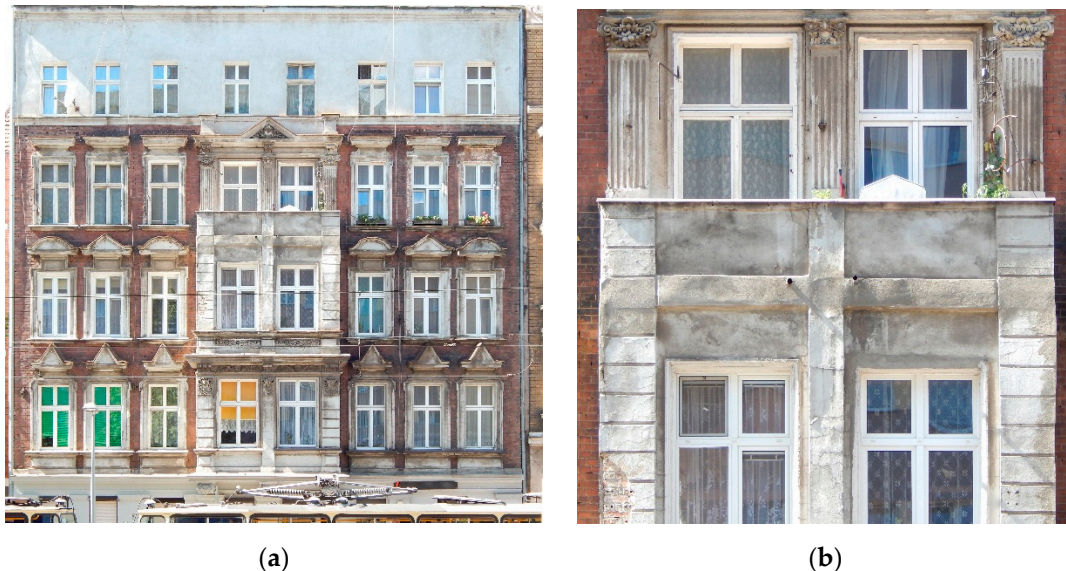
Figure 17. The tenement house, Grabiszynska St. 101, Wroclaw. Dirty elevation with damaged plaster and peeling paint (a). The oriel with damaged and uneven plaster and peeled paint. Architectural details in the Neo-Renaissance style were missing (b).

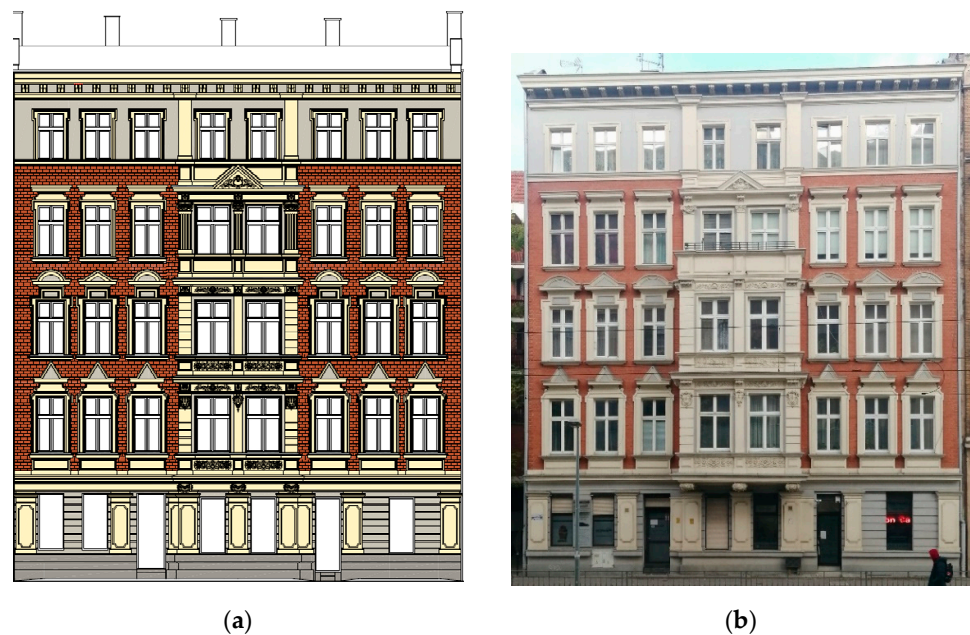
Figure 18. The tenement house, Grabiszynska St. 101, Wrocław. Design of the front elevation colors (a) and the front elevation after renovation (b) (Nowakowski 2014a).

The architect proposed the beige color on the plastered surfaces, according to the “Caparol Histolith Heller Ocker 20” system, and the gray color, the “Caparol Histolith Azurit 30” system. The brick surfaces have been cleaned and impregnated (Figure 18) ([Nowakowski 2014a](#)).

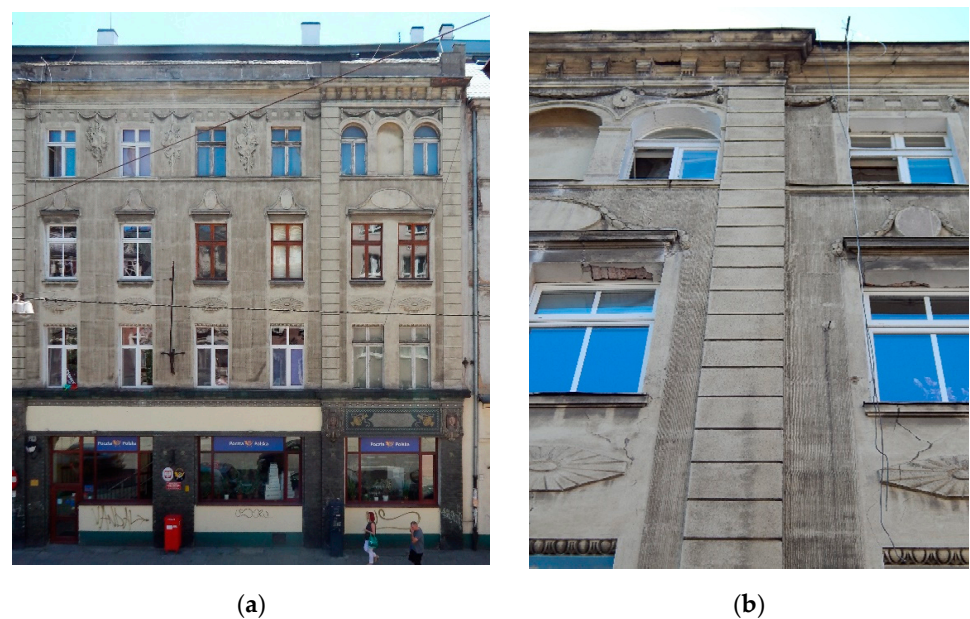
Figure 19. The tenement house, Kosciuszki St. 37, Wrocław. Ceramic plates with a mosaic were covered with lime plaster (a). Dirty and damaged façade plaster and crooked grooved profiles (b).

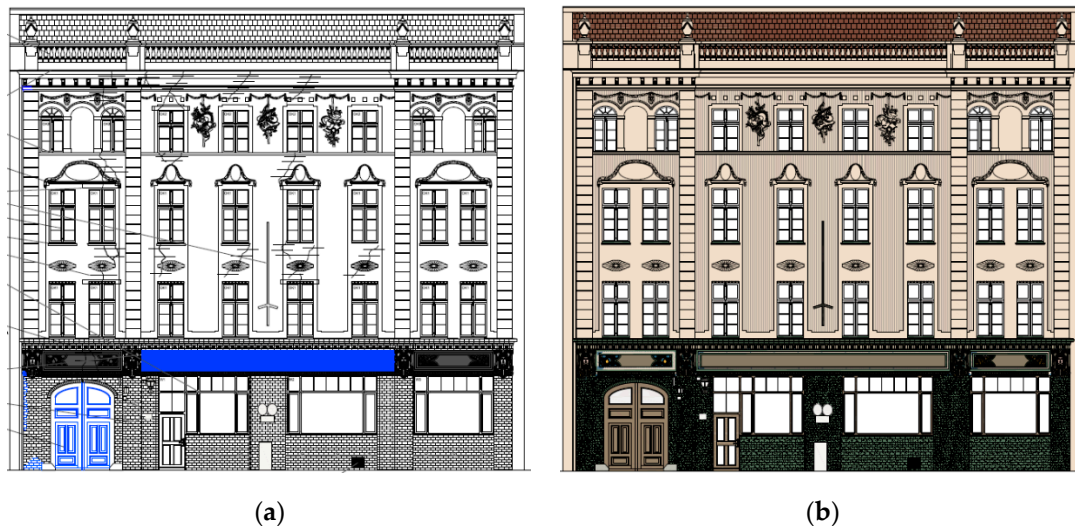
Figure 20. The tenement house, Kosciuszki St. 37, Wrocław. Graphical concept of the renovation of the front façade (a) and the color proposal (b) (Nowakowski 2015b).

Stratigraphic studies showed the existence of the original stucco decoration layer and the painting of the façade after its reconstruction at the beginning of the 20th century. The colors were compared to the “Caparol 3Dplus” pattern. There were two shades of “Onyx 50” and “Marill 55”. The later repaints made during the general renovation after World War II were extensive. The color of the windows was white. However, all windows were replaced at various times (Figure 20).

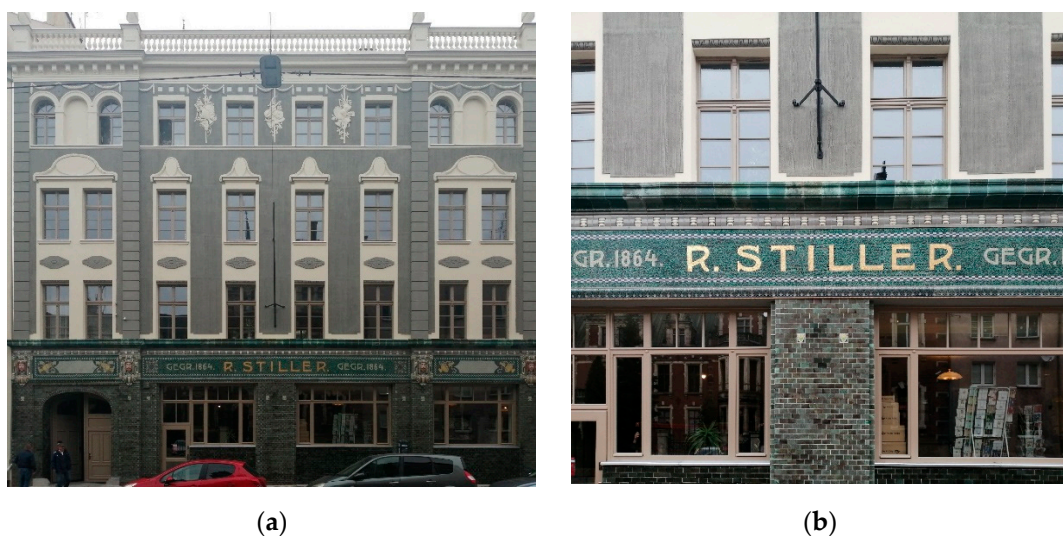
Figure 21. Colors of the front elevation after renovation (a), exposed mosaics and repaired ceramic cladding of the ground floor, replaced windows and doors (b).

The scope of the project included a comprehensive renovation of the elevation of the front house (Nowakowski 2015b; Witkowska 2015b). Designers suggested façade colors in shades of gray-green according to the “Caparol 3Dplus”—“Onyx 50” and “Marill 55” renovation paints and the “RAL 1019” woodwork color. The colors of the rusticated avant-corps pilasters were changed to “Marill 55”. The work was carried out according to the conservation recommendations, as well as the construction and details project documentation (Figure 21).
