Architectural History and Painting Art at Ajanta: Some Salient Features

Manager Singh ^{1,*} and Babasaheb Ramrao Arbad ²

¹ Archaeological Survey of India, Science Branch, Western Zone, Aurangabad-431004, India;
E-Mail: m_singh_asi@yahoo.com

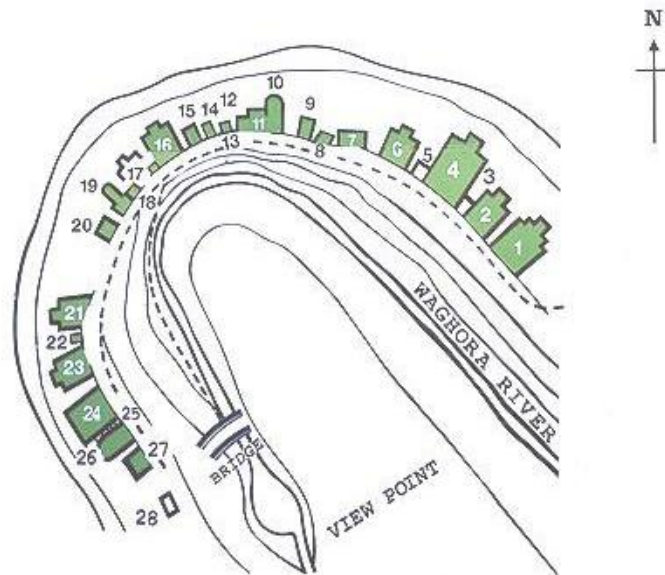
Figure 1. The plan and location of various caves of Ajanta.

The emperor Harisena, obviously approving the vast project, apparently did not get directly involved himself until work at the site had already been underway for four or five years. As a consequence, his ‘regal’ cave 1 had to be cut in less than ideal location at the eastern extremity of the site, since the central area of the scrap had already been taken during the first few years of excavation. However, in compensation, Harisena’s splendid cave benefited greatly from the experiences that the excavators have already gained by this time. Therefore, compared to relatively clumsy cave 16 started by the Chief Minister, the highly elaborate and dignified cave 1 is truly a monument “fit for a King”. Figure 1 shows the plan and location of various caves of Ajanta.

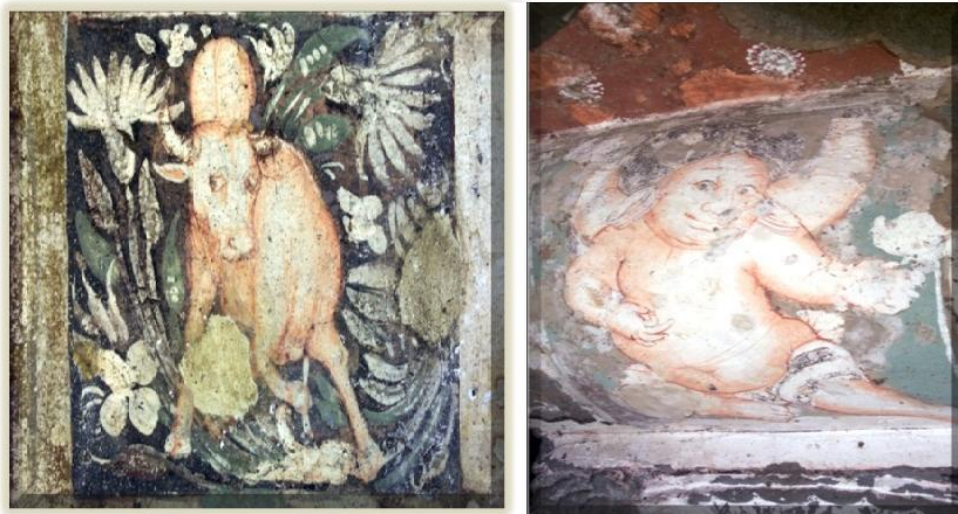
Figure 2. Showing Three Dimensional Paintings from cave 1 and 26, Ajanta.

Ajanta painters were guided by a highly developed sense of blending of colors with a view to produce total impression with three dimensional effects giving true perspective to line and plane. Besides, the technique of giving three dimensional effects to the painting was first introduced in India in the cave paintings of Ajanta in 3-4 century A.D. Figure 2 shows some of the paintings of Ajanta showing three dimensional effects. This technique was later copied by the other artist in the Asian region.

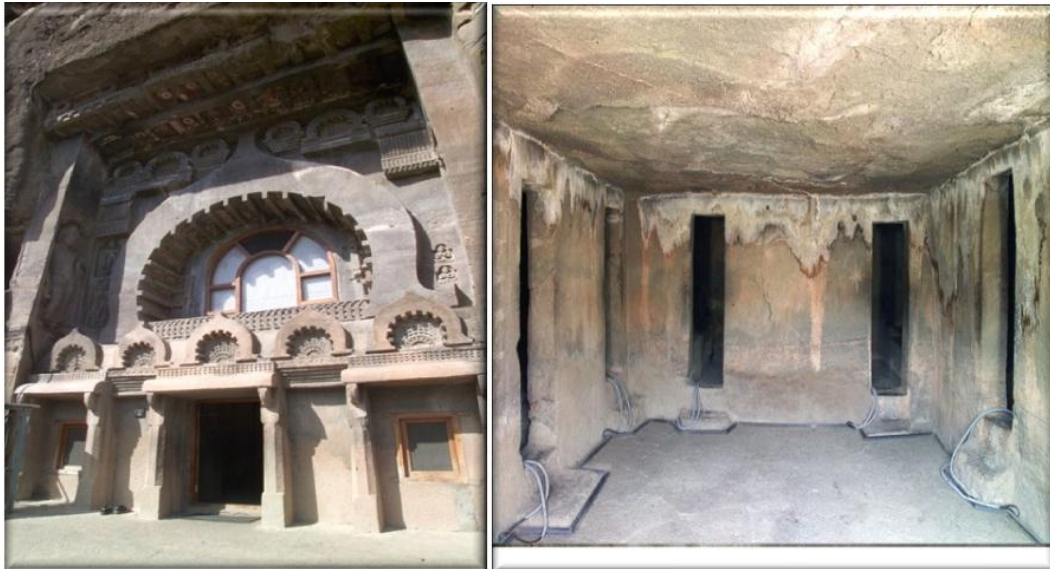
Figure 3. Showing View of Hinayana Caves 9 & inner view of Cave 13.

The first of Ajanta caves were started in about the first century B.C. (Figure 3) that included the impressive chaitya hall, cave 10 and simple associated vihara cave 12 all done by true community effort [18]. The repainting in old Hinayana cave no 9 & 10 was made in 3-4 A.D but the plan was never realized except by painting some more areas of the cave [19, 20].

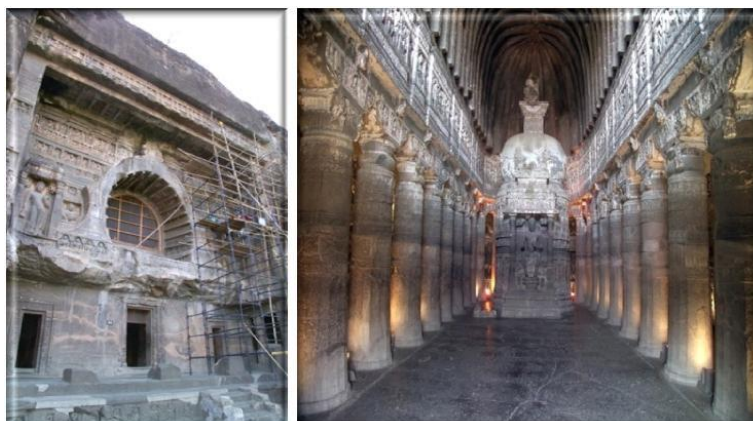
Figure 5. The outer and inner view of cave 26, Ajanta. The stupa was aligned for summer solstice and is not in the center of cave.

To implement the order in cave 26, the excavators were able to locate the stupa by adjusting forward almost two feet from its normal position (Figure 5). In fact, this is the only chaitya hall in India where the space around the stupa is not equidistant at left, rear and right. Then, at the same time by adjusting the frame of the great inner arch under the outer vault rightward in relation to outer facade arch, the planners were able to achieve the desired solstice alignment through the “sun-window” to the stupa.

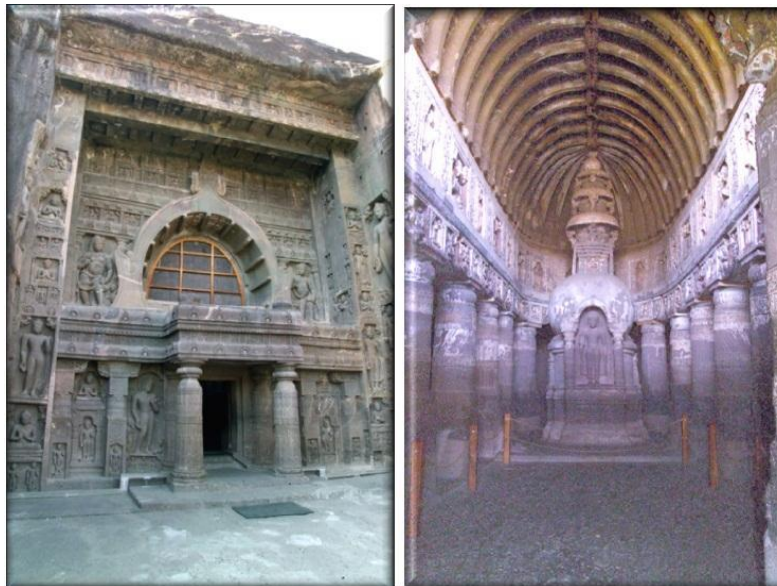
Figure 6. Outer and Inner view of cave 19, Ajanta: for its alignment to winter solstices external part was little curved and inner part also altered.

Cave no.19 presented much greater difficulties (Figure 6). Fortunately, the interior pillars and stupa had already been roughed up by the time the order came and hence cannot be re-positioned. However, the carvers did what they could do to surge the stupa to the left, its upper elements were shifted leftward and even Buddha image stands slightly to the left, while the whole stupa base is wrenched into a leftward asymmetry. The pillars towards the cave left rear were squeezed a few inches left ward and pillar 1 and 7 just to the left of stupa were slightly reduced in size. The exterior of the cave 19 was also angled in the solstitial direction to a significant degree, through it does not reach the proper solstitial alignment, as it has already been roughed up and could not be twisted more than at present.

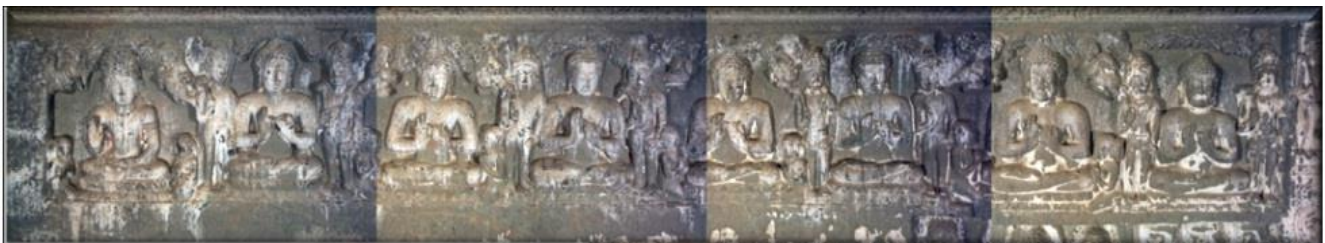
Figure 7. The last eighth Buddha from right to left in different Mudra due to flaws in the stone.

Some alignments were also made due to flaws or faults in the rock being cut. One fine example is cave 26: R.H.S Buddha on upper portion of wall wherein one Buddha has been positioned differently due to flaw in the stone. Figure 7 shows this deviation.

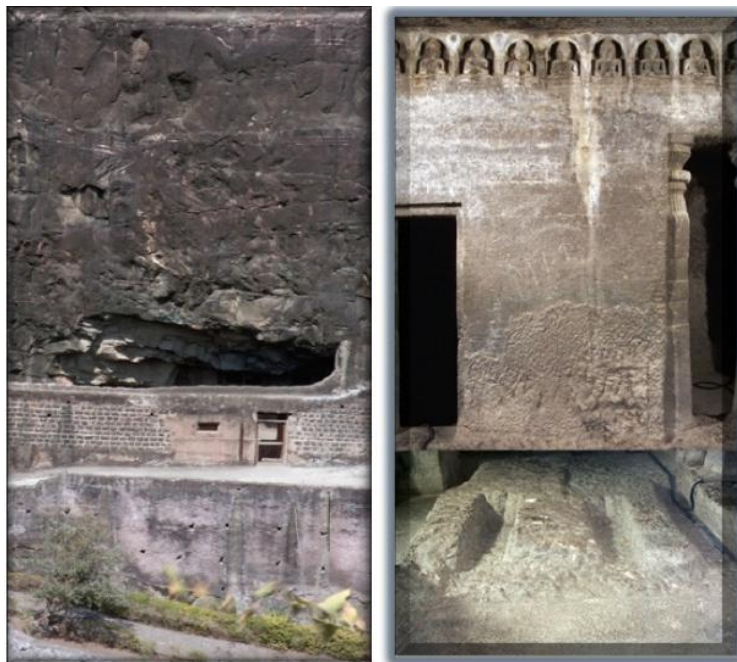
Figure 8. Cave 8 with weak rock causing problem to its stability and various excavators working on the same pillar of cave upper 6.

Geological factors were yet another feature that imposed restraints, although at first the planners seemed less concerned or less aware than was the case later when excavators more and more adjusted the positioning of their cave in accordance with the problematic flaws in the rock. The positioning of early cave 8 is the case in point. Planners thought this location, lower than any of the adjacent caves and easy to access from the old river path, were quite ideal but it surely reflects inexperience of early Vakataka undertaking. There is a thick horizontal deposit of red bole, a very weak clayey rock running through the basalt at a descriptive height and presenting problem that would have warned to abandon any excavation. As we see, work went on with dire consequences (Figure 8).

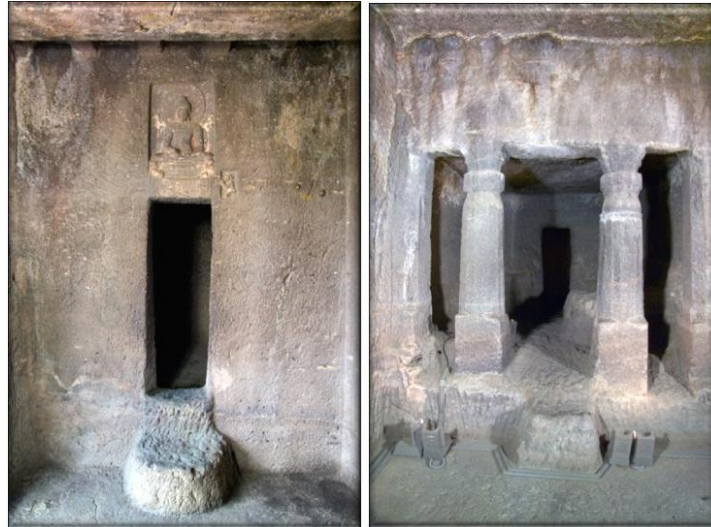
Figure 9. Simple and complex outer cells at Ajanta.

more complex forms by cutting new pillared fronts out of their front wall. Figure 9 shows both the simple and complex outer cells at Ajanta.

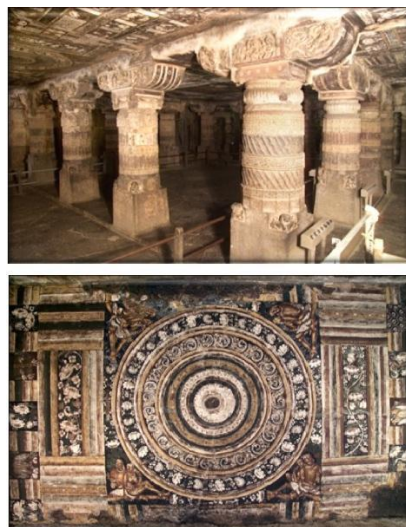
Figure 10. Inner view of cave 2 and its beautiful medallion.

These development at Bagh revolutionized Ajanta as well (Figure 10).

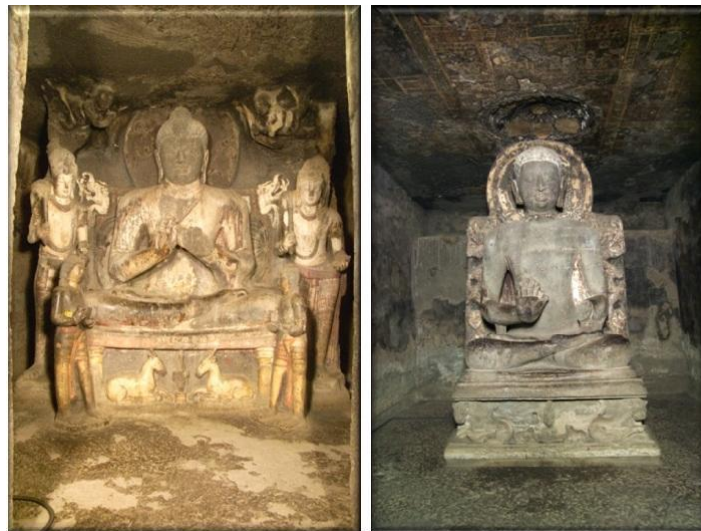
Figure 11. Addition of attendants in later cave 17's Buddha whereas cave 6's Buddha was cut from a proposed stupa with adjustment

This is because the great cave 1 was probably the very first vihara at Ajanta to have been planned from the start with a shrine, and although cave 1's shrine today contains a fine Buddha image, it is almost certainly originally intended to house a stupa. Although stupa rapidly yielded to the Buddha image, an abandoned stupa in cave 11 backs the completed image, while the image in cave lower 6 may have been cut from a block originally shaped to hold stupa. Cave 11's stupa was clearly its original focus. In fact, it was abandoned in favors of an image carved from the same matrix. This seems to represent the moment of transition from stupa to image (Figure 11).

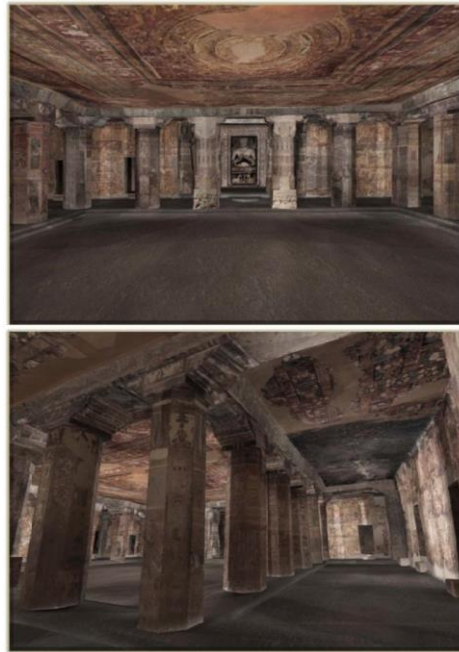
Figure 12. A 3D view of cave 17's ceiling (Flying Carpet) and aisle.

However, the situation was different in case of ceiling of cave 17. It was also exposed quite early and was subjected to similar error. However, it seems that the excavators kept correcting their errors as work proceeded. Thus, when ceiling level angled upward, they soon brought it down when it angled upwards again they brought it down again. The result of these continuous corrections was waviness of surface, which is now explained as attempt to create the effect of flying carpet or shamiana (Figure 12).

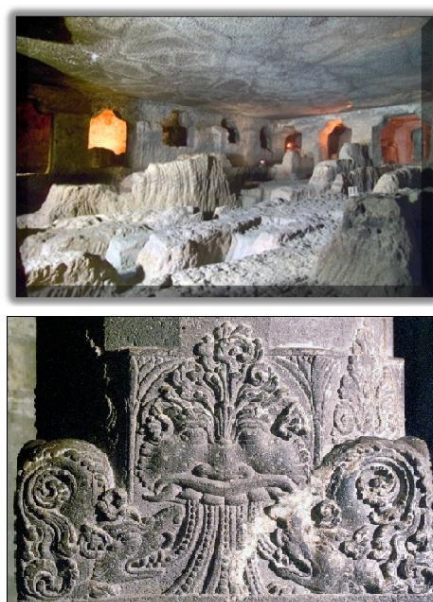
Figure 13. General view of unfinished cave 24 and later ornamentation of Ajanta Pillars based on Bagh caves design.

Some unfinished caves like 5 and 24, gives an idea about cutting the rock with long chisel and hammer, without any need of scaffolding (Figure13). Probably, the excavators used intermittent left over part of the rock to climb and finish the work before its actual removal from cave interiors. As we can also see from still incomplete interiors of cave 24, a considerable amount of matrix was left enclosing the projected pillars. Thus, later adjustment was possible for the pillars, which could be slightly repositioned to achieve a more balanced spacing.

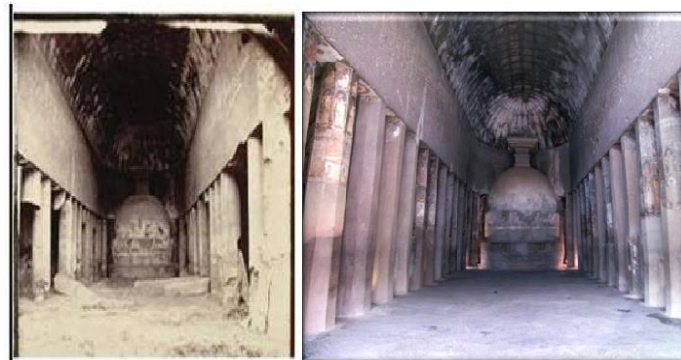
Figure 14. Before and after structural conservation measures for the cave 10, Ajanta.

Ever since the Ajanta Caves were abandoned by the Buddhist monks in around 6th century A.D., the facade of almost all the caves have fallen, the pillars, support and walls in many caves also fell and in some caves the rain water along with mud, supposed to flow in the ravine of Waghura River, entered inside the caves with deposition of slit up to a height of 3-5 feet. Structural conservation measures in the form of removing the filth from the cave interior and making new support pillars as per conservation needs were extensively carried out. The finest example is 2nd B.C. cave 10 at Ajanta and figure 14 shows view of before and after structural conservation measures for the cave.

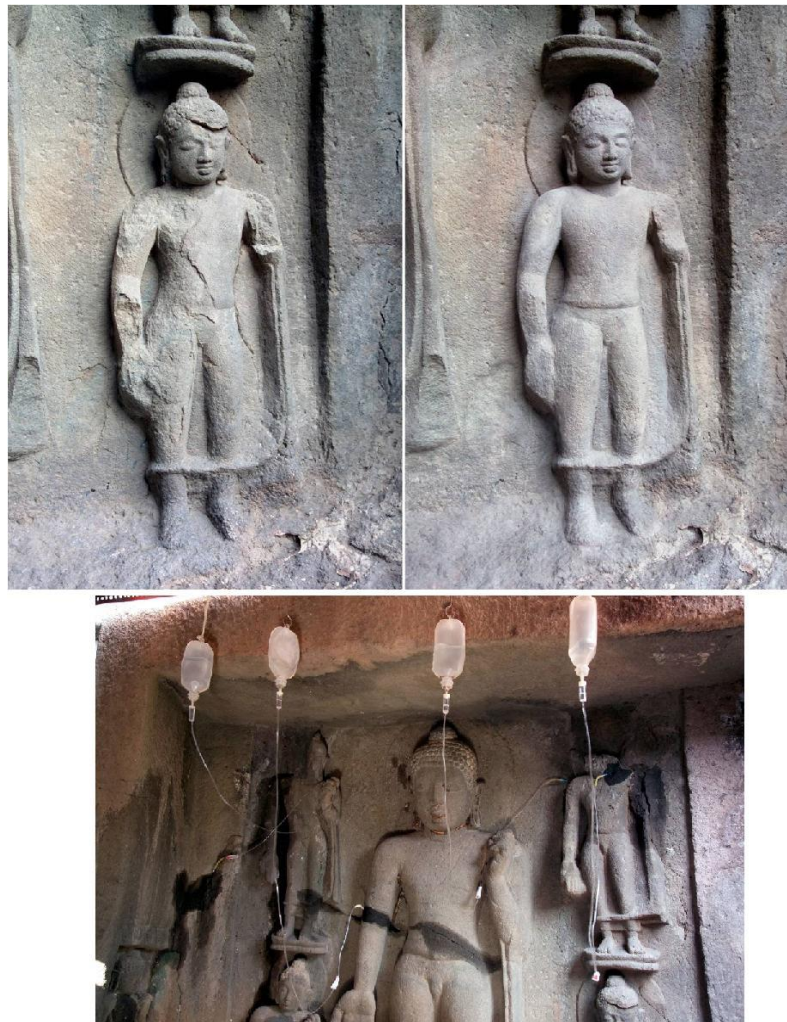
Figure 15. Consolidation of sculptures of Ajanta using ethyl silicate.

Ajanta is also known for its beautiful sculptures of Buddha hewed out of basaltic rock. However, due to environmental impact and flaw in the original basaltic stone, many of the sculptures were in bad condition showing loss of parts, exfoliation and weathering to different extent. Extensive consolidation and mending works of all outside sculptures were carried from 2003 onwards at Ajanta with Ethyl silicate introduced through saline technique into the cracks, crevices of weathered sculptures. Subsequently, as per archaeological norms and condition the lost part of the sculptures were mended with basaltic stone powder and ethyl silicate as per requirement. Most of the sculptures of Ajanta have now been consolidated by this process and figure 15 shows ethyl silicate mending of the sculptures of Ajanta. The work was executed after creating proper atmospheric condition for execution of mending work.

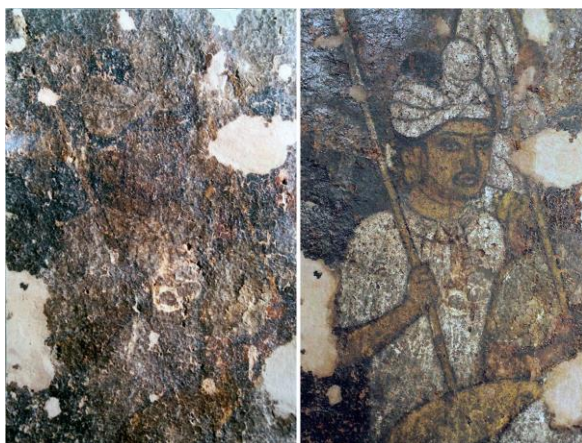
Figure 16. Scientific conservation of murals of cave 10, Ajanta.

As the Ajanta paintings have been executed by tempera technique with animal glue as binding media, use of any water based solvent mixture for cleaning is totally ruled out. Many of the painted surfaces of Ajanta were cleaned by first consolidating the fragile surface with the help of a lime and caseins mixture and allowing it to dry properly. After complete drying, the varnishes layers along with soot and grime were removed using mixture of organic solvents such as morpholine, butyl lactate, n-butyl amine, butyl lactate, butanol, ethanol, and dimethyl formamide in various ratios with dexterity and patience [26]. No attempt was made to remove last traces of accretions as precautionary measures. The main intention of chemical cleaning measures was to make the surface to breathe. Figure 16 shows before/after treatment photograph of recently executed chemical cleaning of painted surface of Ajanta. Around 10–15 % of the surface accretions were left as such during cleaning operation as safety layer.
