Multi-Methodological Investigation of the Biersdorf Hillslope Debris Flow (Rheinland-Pfalz, Germany) Associated to the Torrential Rainfall Event of 14 July 2021

Abstract: The investigation of mass movements is of major interest in mountain regions as these events represent a significant hazard for people and cause severe damage to crucial infrastructure. The torrential rainfall event that mainly occurred on the 14 July 2021 in western Central Europe not only led to severe flooding catastrophes (e.g., Meuse, Ahr and Erft rivers) but also triggered hundreds of mass movements in the low mountain range. Here, we investigate a hillslope debris flow that occurred in Biersdorf in the Eifel area (Rhenish Massif, Rheinland-Pfalz) using a comprehensive geomorphological–geophysical approach in order to better understand the triggering mechanisms and process dynamics. We combined field studies by means of Electrical Resistivity Tomography (ERT), Direct Push Hydraulic Profiling (HPT) and sediment coring with UAV-generated photogrammetry, as well as debris flow runout modelling. Our results show that for the Biersdorf hillslope debris flow, the geomorphological and geotectonic position played a

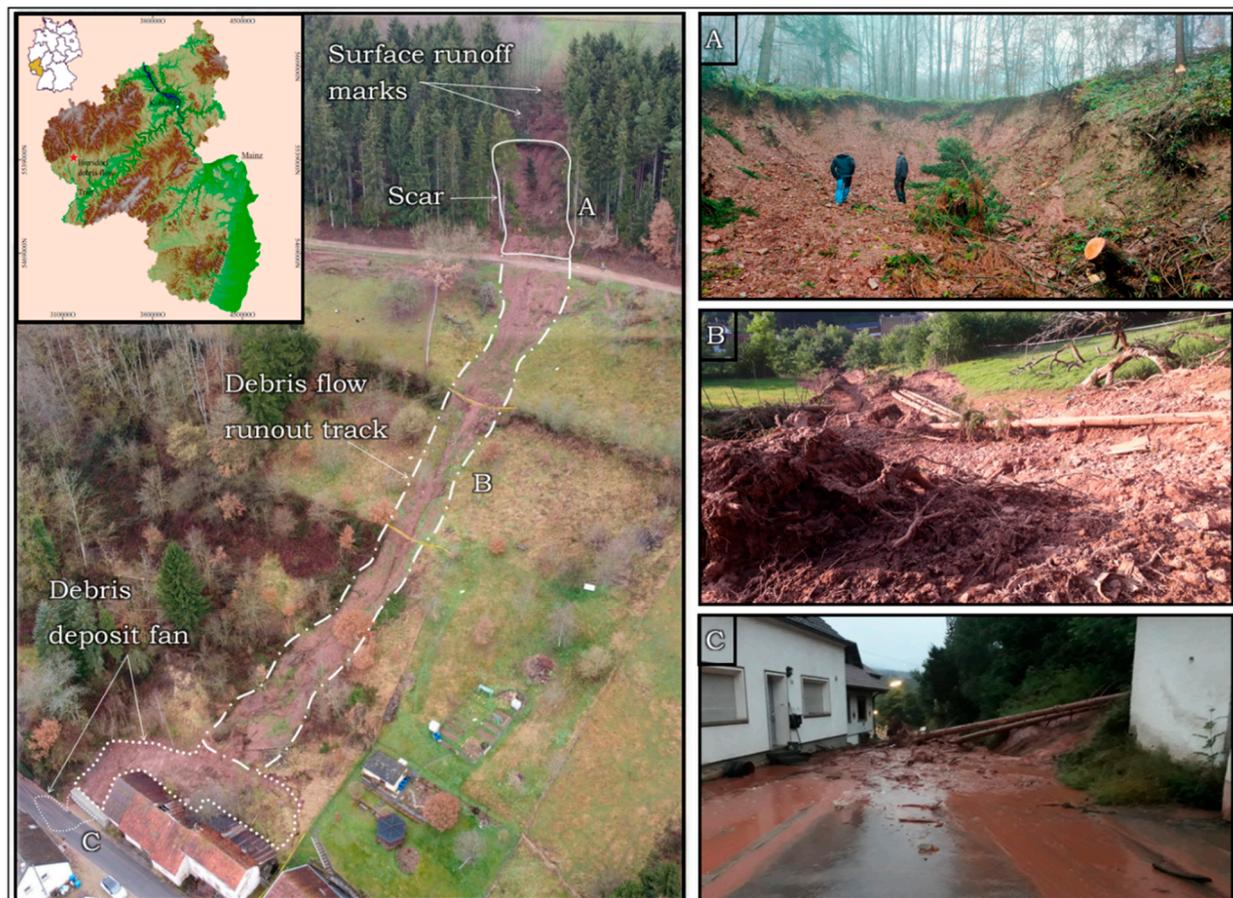
Figure 1. Aerial view of the hillslope debris flow of Biersdorf that occurred on 14 July 2021 with the associated location in Rheinland-Pfalz (Photo taken on 2 February 2022). (A) View into the scar. (B) Downhill view of the runout track. (C) Debris deposits on the municipal road (Photos taken on 15 July 2021).

Several hours of torrential rainfall during the evening from 14 to 15 July 2021 caused the Biersdorf hillslope debris flow producing a scar of about 6 m in depth and 15 m in width. The incipient muddy debris flow moved 150 m down the slope into a small valley, overflowing a fortunately abandoned house and the local road with depositing fan sediments up to 3 m thick (Figure 1).

In the transitional and depositional area, large grain size differences, ranging from fine granular soil material to large mobilized blocks and wooden material, occur. Based on the field traces and depositional characteristics, the investigated event could also be classified as a muddy debris avalanche [8]. The traces of the event are still visible today, indicating long-lasting effects on the slope morphology. Although abandoned, the property is uninhabitable and in danger of collapsing, and the road had to be secured, reflecting noticeable economic damage.

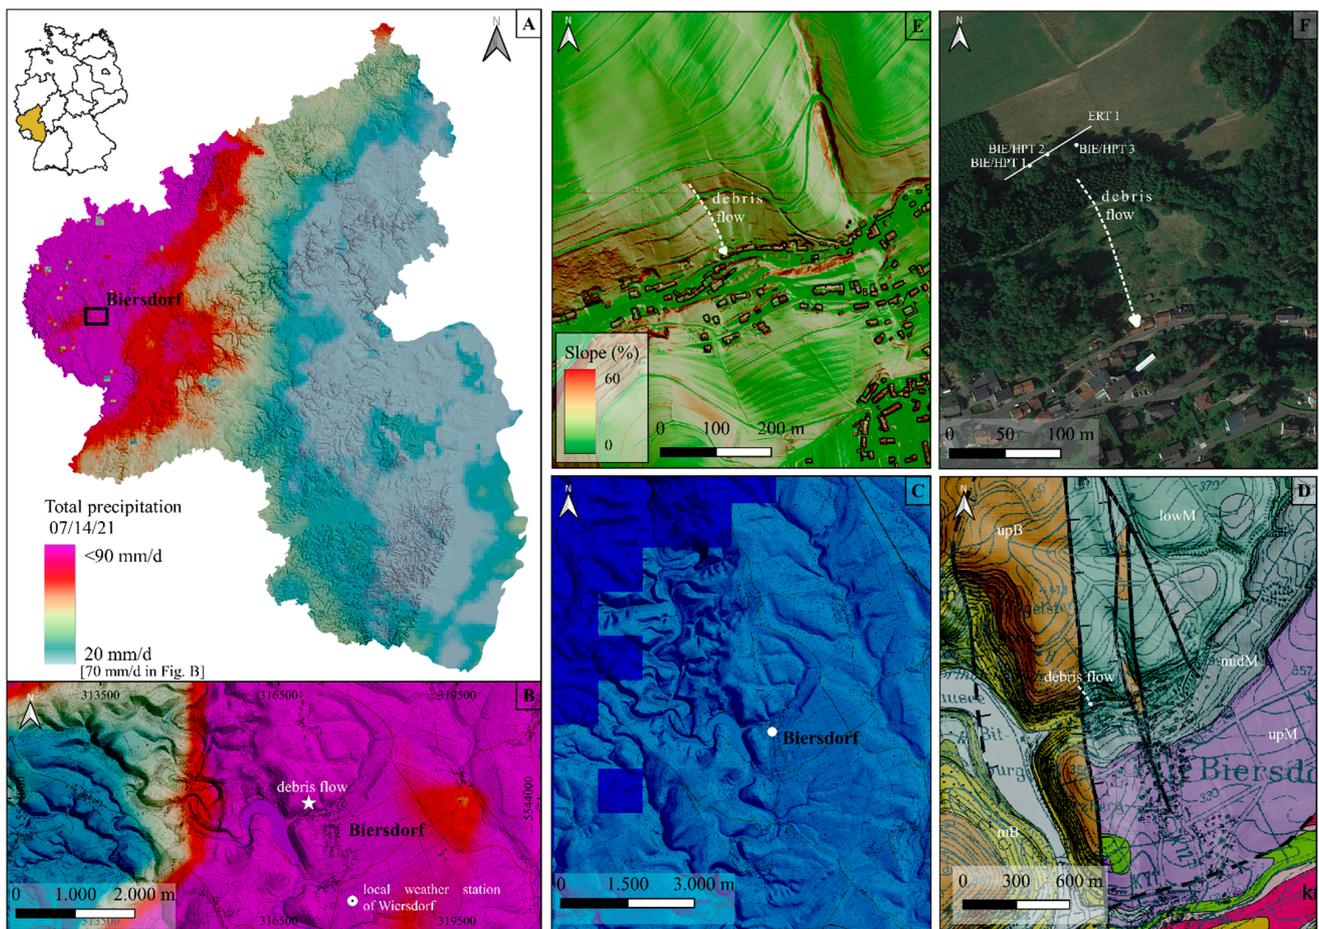
Figure 2. (A) Precipitation distribution in Rheinland-Pfalz from 14 July 2021. Derived from the RADOLAN weather data of the DWD [23]. (B) Section of the precipitation distribution around Biersdorf with the unit of measurement changed for visualization. (C) DWD soil saturation model around Biersdorf from 13 July 2021 with the following units: dark blue = oversaturated ($\geq 100\%$ usable field capacity), blue = saturated, at the beginning of oversaturation ($80 < 100\%$; DWD 2022, [24]). (D) Geological structure and lithologic distribution in the study area (upB = Upper Buntsandstein, lowM = Lower Muschelkalk, midM = Middle Muschelkalk, upM = Upper Muschelkalk). (E) Slope of the study area including downhill track of the debris flow. (F) Aerial view of the study area with the realized geomorphological prospects marked.

The small village of Biersdorf is located in the western Eifel region (Rheinland-Pfalz, Germany). It is divided into two districts, one is located on the hillslope plateau and the second one in the Kannenbach stream valley (Figure 2E). The stream flows into a reservoir lake, which dams the river Prüm, the local erosional base for the Kannenbach stream. The area around Biersdorf consists of moderately steep hills under agricultural use and steep and deeply incised valleys. The geomorphological situation is typical of this region, characterized by valley deepening throughout the Quaternary [22]. The hillslope debris flow occurred on a steep (28% inclination in average), extensively used, south exposed slope that is located directly behind a few houses near the Kannenbach stream (Figure 2E). The study area contains the slope section with the associated catchment area upslope. Three pathways cross parallel to the slope in its upper third and mark anthropogenic impacts on the hillslope morphology (Figure 2E). Right underneath the second pathway, the initial scar edge is located.

As well as the described potential trigger mechanisms, one has to assume that the forest path just upslope of the scar also played an important role (Figure 2e). Compaction in the course of such infrastructural measures reduces the infiltration capacities and rates. In addition, the morphological change between the path and slope leads to the formation of an artificial convex embankment in a downslope direction. The risk of hillslope debris flows increases if the surface runoff concentrates on these embankments with significantly steep artificial slopes [49].

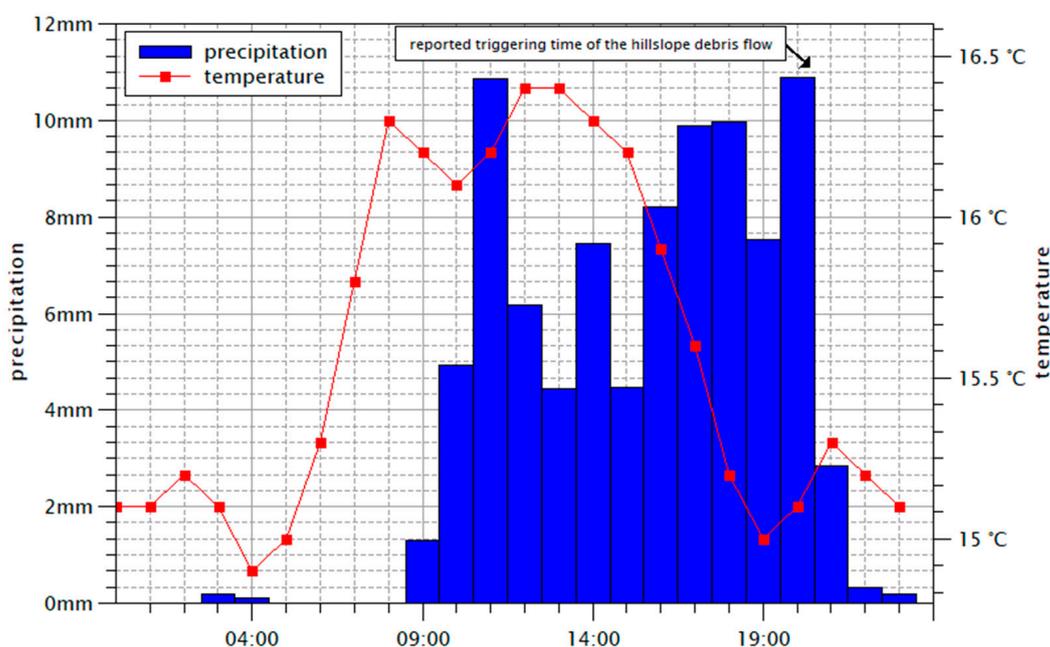
Figure 3. Hourly precipitation distribution for the torrential rainfall event from 14 July 2021 derived from the weather station of Wiersdorf with the approximately reported triggering time of the hillslope debris flow [27].

Low air pressure dominated the weather conditions on the days from 12 to 14 July 2021 over central Europe. In association with a high-level depression slowly approaching from France, the tropospheric situation was stratified with increasing instability. Warm and very humid air masses reached western Germany from the Mediterranean region in a rotary motion around a distinctive low-pressure zone. Due to forced uplift (orographic and dynamic) and slight damming effects in the western low mountain ranges (e.g., Sauerland, Westerwald, Eifel, Ardennes), recurrent or persistent heavy rainfall first occurred regionally and later extensively [26]. On the 14 July, the focus of heavy rainfall extended in an area from southern Nordrhein-Westfalen to the southern Eifel region (Figure 2A) with more than 100 L/m² precipitation. Regionally, more than 150 L/m² was recorded in this period. The local weather station in Wiersdorf (approximately 4 km southwest of Biersdorf) recorded 90 L/m² on that day, by far the highest value of the year and the highest daily precipitation value in the station's 20-year history [27]. Figure 3 show the hourly precipitation distribution for the 14 July 2021.

Recurring precipitation events throughout Germany and in the Eifel region occurred over three weeks before 14 July, already saturating the soil in some regions [26]. According to the published saturation model of the German Weather Service (DWD), the soils around Biersdorf were already heavily pre-saturated by the failure day (Figure 2C) [28]. Further rainfall under these pre-conditions lead to a strong increase in pore water pressure and forced surface runoff [29,30].

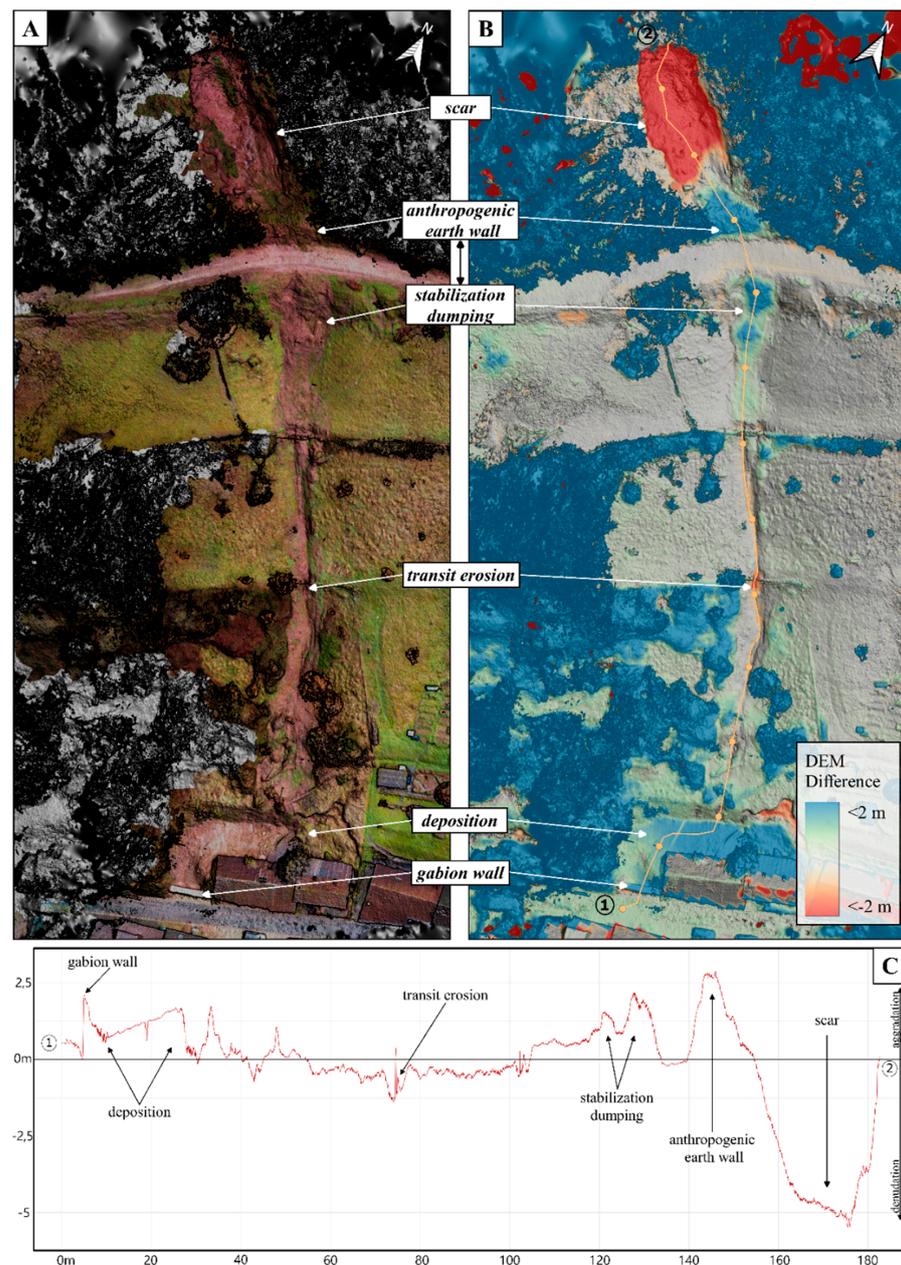
Figure 4. (A) Photogrammetrically-calculated model of the hillslope debris flow with overlying true-color mesh; densely vegetated areas marked in grey. (B) Elevation difference between the photogrammetrically-generated DEM from 2 February 2022 and an ALS-generated DEM from 2018. (C) Elevation change in the drawn transect (yellow line in B) with distinct morphological markers shown as 2D graph.

The photogrammetrically calculated model of the hillslope debris flow is shown in Figure 3. The model allows measuring the precise runout and displaced masses (Figure 4b). Since photogrammetrically-created DEM cannot be effectively filtered for vegetation, densely vegetated areas were discarded in order to solely compare real ground points (Figure 4a; vegetation marked in grey). Security measures and clean-up work were carried out at various locations compared to the in situ photos immediately taken after the debris flow (Figure 1). Nevertheless, the fissure, runout and deposits were mostly unaltered and are clearly recognizable in the model, showing a lasting effect on slope morphology.

The total length of the hillslope debris flow from the initiation point to the outermost deposition layer is 184 m. The resulting scar in the initiation area is 15 m wide on average with a maximum depth of 6 m. This widely exceeds the assumed depth for unconsolidated parent material (or sediment cover) at this location. Such underestimated sediment covers are a typical feature that was observed to be associated with numerous mass movements triggered by the torrential rainfall event of 14 July 2021 in the Eifel region [2].

Based on a comparison with the airborne LiDAR Survey (ALS) from 2018, we can show that approximately 1350 m³ of material moved downslope in the scar. In order to stabilize the forest path, an earth wall with a height of 2.50 m was built at the end of the scar, partially using debris flow material. Below the path, material was re-dumped into the erosion channel on an area of 87 m².

The runout track is 130 m long with a maximum incision of 1.5 m (Figure 4C; cf Figure 1B). For an event of this magnitude, this incision throughout the runout track is relatively low and could be attributed to a moderate flow velocity. The deposition area behind the affected house is 238 m² in size. In the course of shoring works, it was leveled up to 2 m above the original ground surface. In total, the mass balance of the whole debris flow runout suggests that 1090 m³ of material was relocated during the event, including post-event anthropogenic measures.

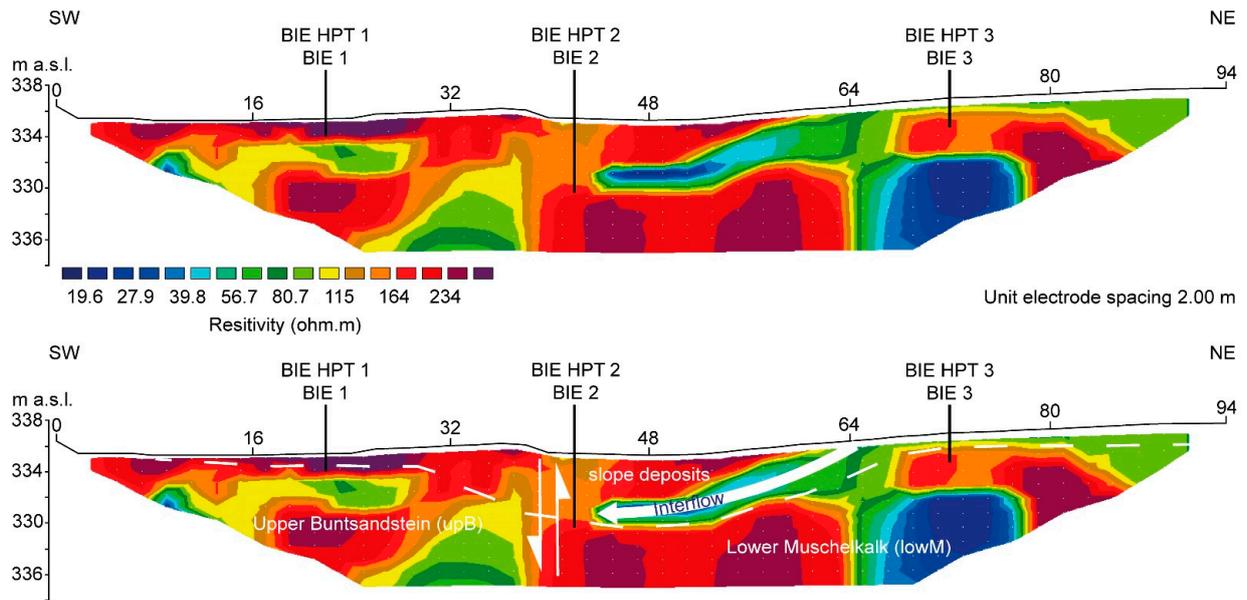
Figure 5. Upper: depth section of ERT transect BIE ERT 1 (iteration 6, absolute error 1.4%) and position of DP HPT logs and sediment cores retrieved from right above the scarp ridge (cp. Figure 1). Lower: depth section with interpretation according to field observation and geological data (see discussion in Section 5).

To gain detailed information on the stratigraphic composition of the shallow subsurface, we conducted ERT measurements followed by DP HPT logging. To finally calibrate the geophysical and DP results and to receive stratigraphical sequences, we retrieved sediment cores at the DP positions. ERT transect BIE ERT 1 (Figure 5) was conducted 25 m above the scar of the hillslope debris flow on a total length of 94 m in a southwest–northeast direction. Overall, apparent resistivity values range from 18 to 364 ohm.m. The inversion model shows a tripartite structure. The first part ranges from 0 to c. 40 m with high resistivities at the top followed by generally lower values and a further high resistivity unit below log location BIE HPT 1. A second part is visible until 64 m, characterised by higher values reaching the greatest thickness at DP site BIE HPT 2, intercalated by a unit of significantly lower resistivity emerging upward towards the northeast. The third part from 64 m until the end of the transect is characterised by high resistivities at the top followed by low values towards the base.

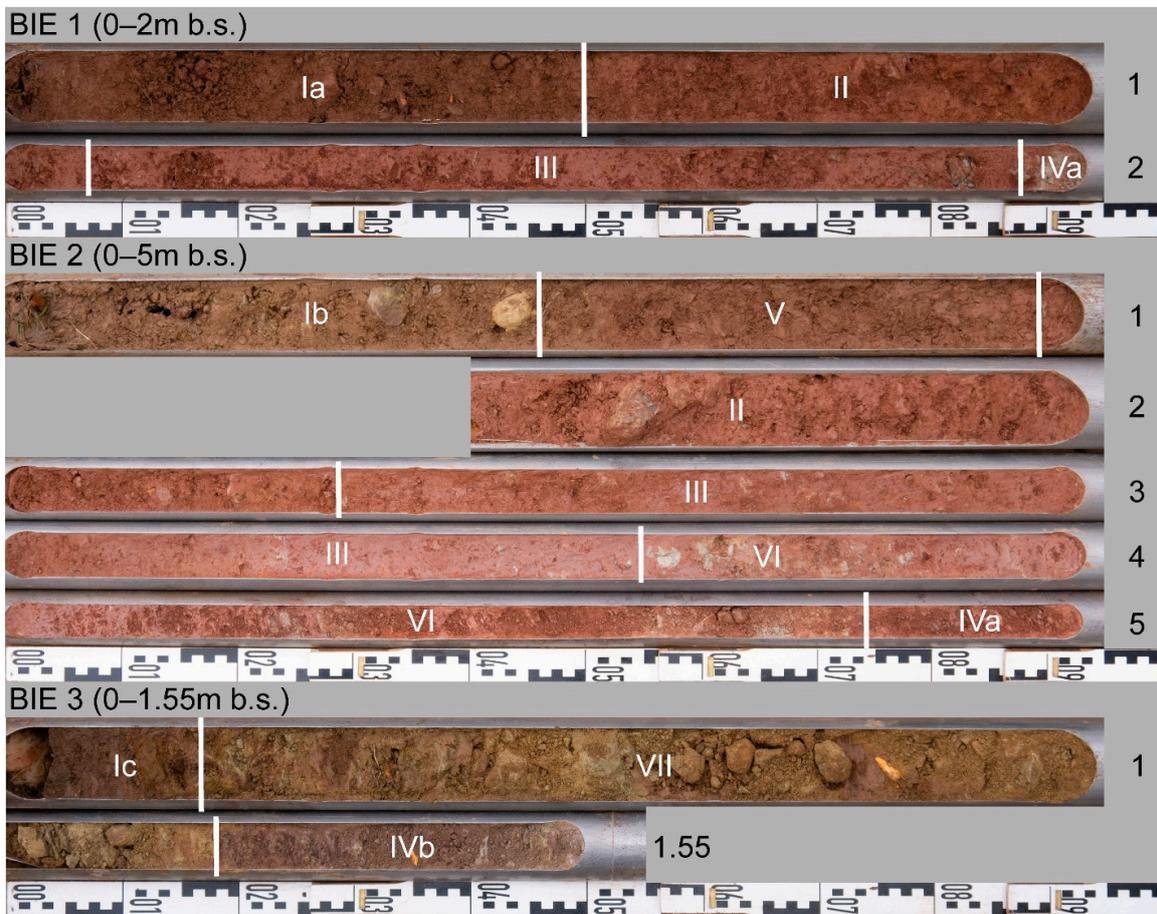
Figure 6. Photo of sediment cores BIE 1 (upper), BIE 2 (middle) and BIE 3 (lower). Ground surface upper left, coring base lower right of each core. Sediment units are described in Table 3.

All the DP HPT logs and sediment cores were drilled as deep as possible (Figures 6 and 7). Overall, 10 sediment units (SU) were described (Table 3). All cores show colluvial and/or periglacial slope deposits of different characteristics below the topsoil and above strongly weathered bedrock material. While reworked and weathered clay and sandstones dominate BIE 1 and BIE 2, BIE 3 contains reworked and weathered limestone material.

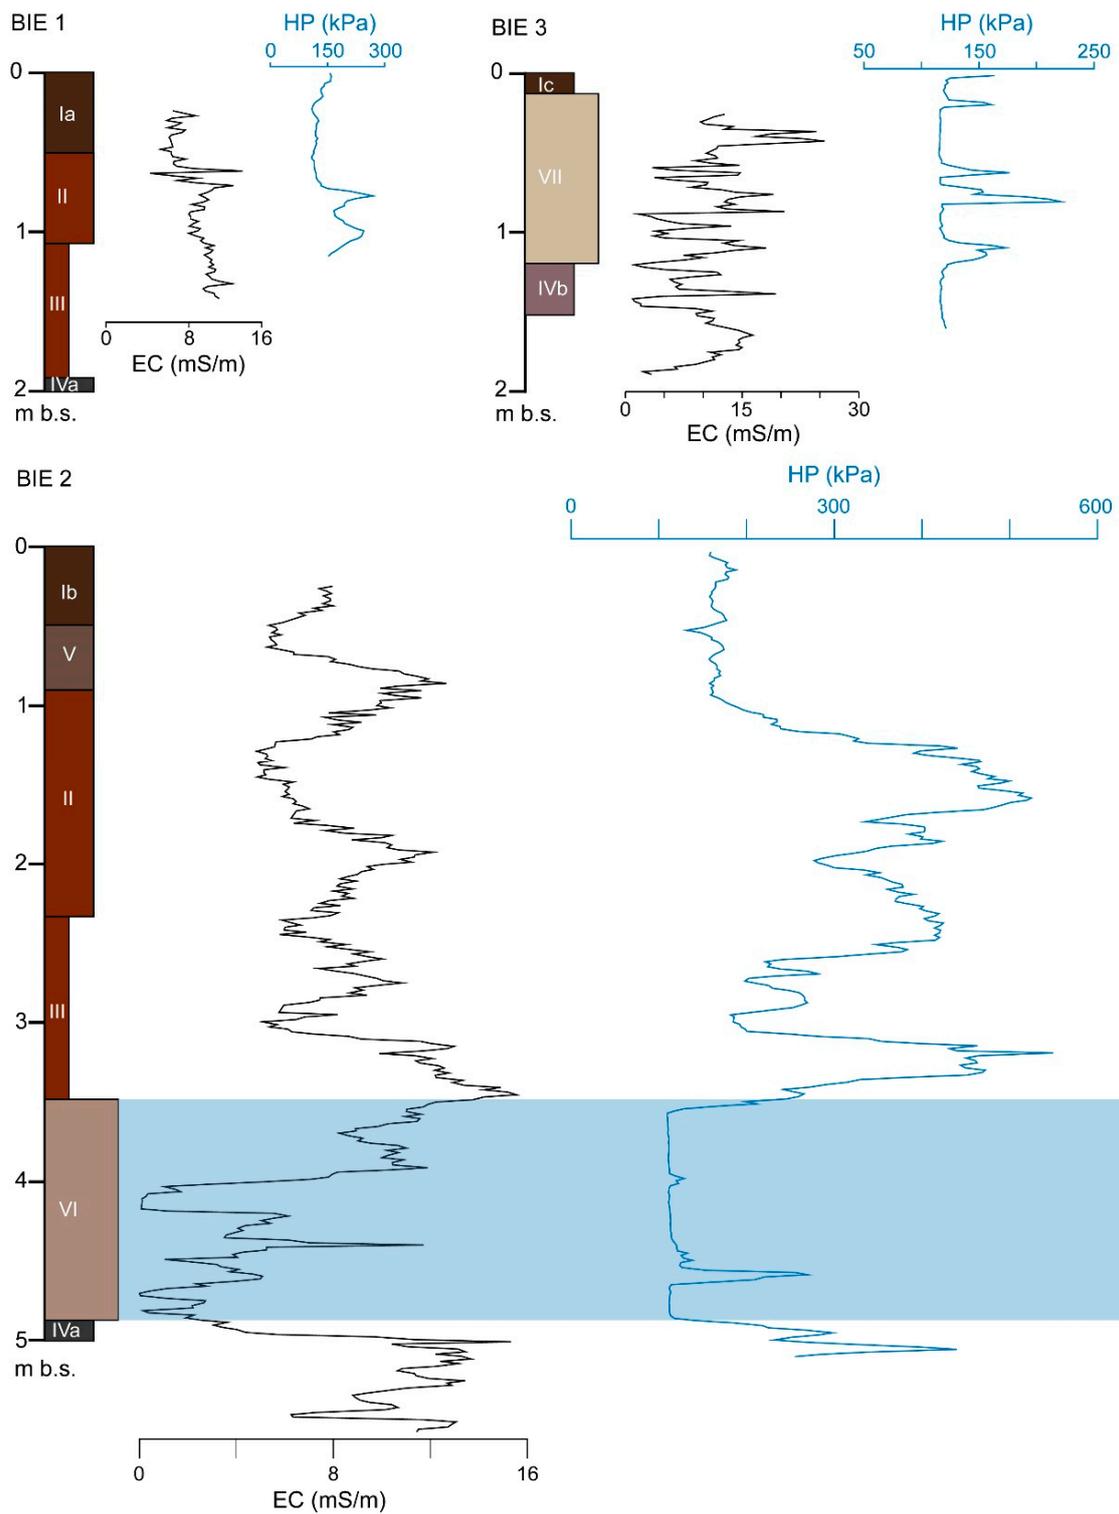
Figure 7. Sediment cores BIE 1 to 3 with DP HPT data (electrical conductivity, EC and hydraulic pressure (HP)). Sediment units Ia–VII refer to description in Table 3 (see also Figure 5).

DP log BIE HPT 1 is characterised by very low EC values in SU Ia and II, which slightly increase towards SU III. The weathered bedrock of SU IVa, which we reached by sediment coring, could not be penetrated with the HPT probe. HPT values show a distinct increase from SU II to SU III. In BIE HPT 2 and BIE 2 we reached the greatest depth with 5.58 m and 5.00 m, respectively. Both EC and HPT data trace coarser or more porous layers in the sedimentary sequence by low EC and low HPT values. The most significant decrease in EC occurs in SU VI, which is accompanied by the lowest HPT values of all three DP HPT logs. In sediment core BIE 2, SU VI is characterised by a dominance of sand and sandstone debris in a silty matrix. Towards the base, EC and HPT increase again. Compared to BIE HPT 1 and BIE HPT 2, BIE HPT 3 shows significantly differing characteristics. EC values show intensive fluctuations between 0 and 30 mS/min; HPT values are constantly low apart from some clayey layers in SU VII.

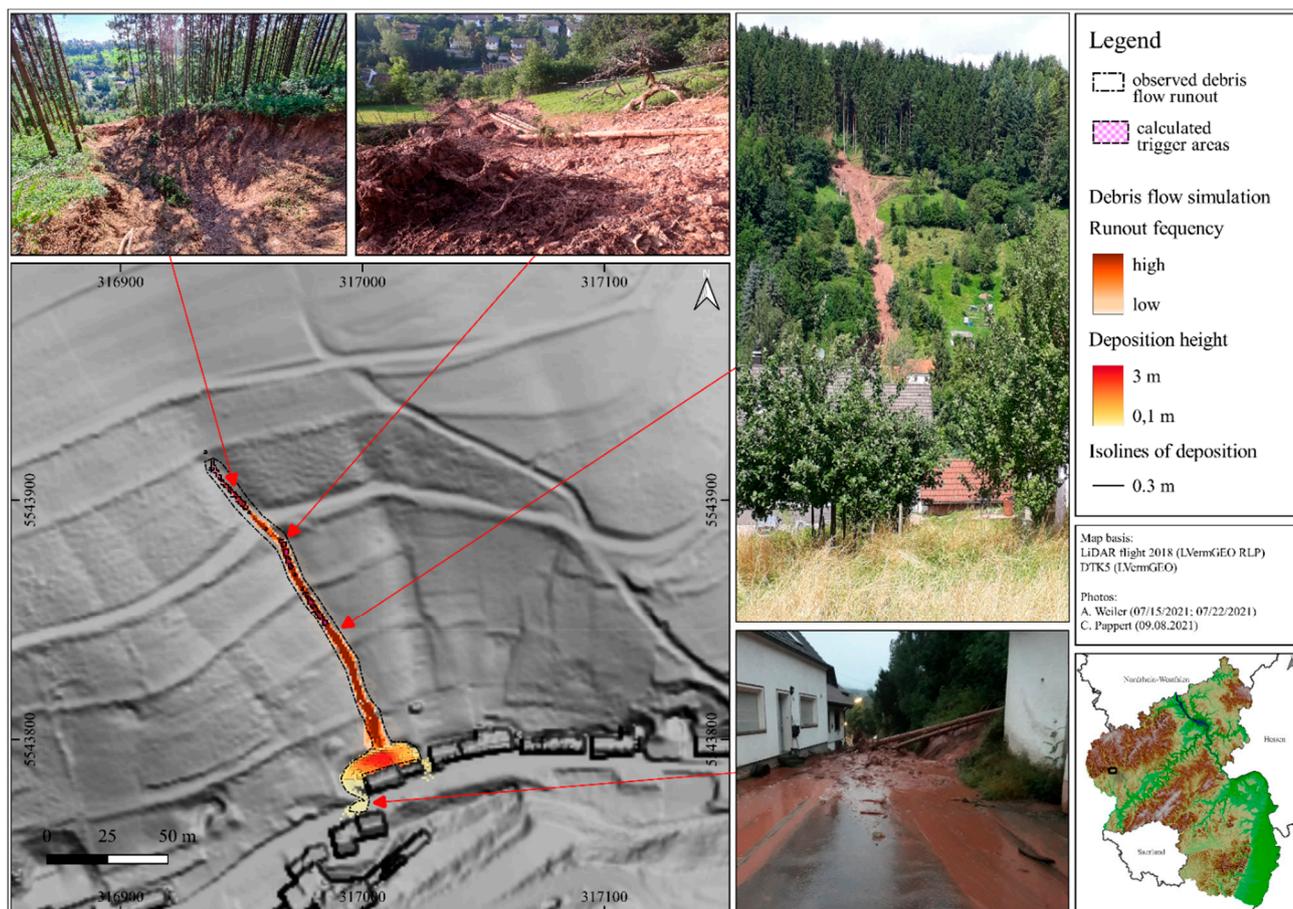
Figure 8. Modeled runout and deposition behavior of the debris flow with calculated trigger areas and photographic comparison to the in situ situation.

The modelled hillslope debris flow runout and deposition behavior are shown in Figure 8. We use photos taken by local residents immediately after the event and our terrain surveys as reference to compare the simulation results with real conditions. The initial source areas in the upslope position, determined by the hillslope debris flow disposition index, represent plausible locations with nearly identical dimensions compared to the actual scar. For the modelling framework we estimated the mass to drag ratio (m/d) based on a combination of field observations. We integrated the relatively large mobilized mass ($\sim 1350 \text{ m}^3$) calculated by the mass balance of the DEM difference, the high amount of fine material as observed in the scar and, based on stratigraphical evidence derived from sediment coring, the relatively low incision rate in the runout track as an indication of a moderate flow rate as well as the measured flow length. The sliding friction coefficient μ is highly dependent on the land cover, and therefore we used spatially distributed friction values based on the land cover type in comparison with the literature values [42,43,45,46]. The downstream flow calculated from these input parameters (c.f. Table 2) is largely consistent with the real runout behavior (Figure 8).

The accordance between the generated model and the observed runout is about 97%. In agreement with the real event, the model shows moderate erosion along the slope and high deposition rates (up to 3 m, anthropogenically leveled after the event) at the foot slope, where the house functions as a barrier. In addition, the accumulation of material on the road coincides with the real event as documented (Figure 8).

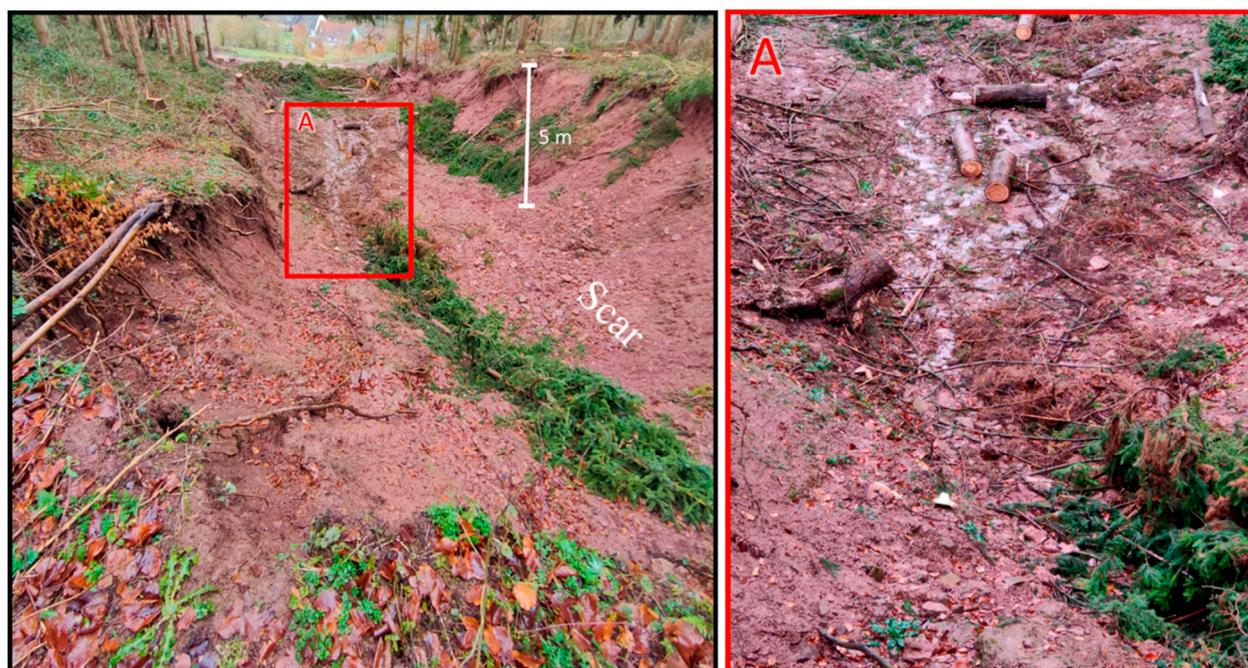
Figure 9. Spring water discharge in the scar of the hillslope debris flow at the depth and assumed location of the observed interflow lens.

ERT measurements in combination with DP HPT logging and sediment coring have provided detailed insights of subsurface structures upslope of the fissure zone. We assume that the potential interflow lens at a 3 m depth below the surface that is characterized by significantly low resistivity values (Figure 5, lower) plays a crucial role for the trigger mechanism of the event. At a comparable depth, DP log BIE HPT 2 shows the lowest HPT values of all the logs, indicating high permeability in sand-dominated SU VI (blue shading in Figure 6) framed by significantly higher pressure values, indicating dense, clayey (impermeable) periglacial slope deposits (base of SU III) and weathered bedrock (SU IVa), respectively. In addition, slope deposits reach their greatest thickness of 4.9 m within the investigated transect. In comparison to DP log BIE HPT 1, where permeability significantly decreases in 0.8 m b.s., DP log BIE HPT 3 shows an overall higher permeability related to loose limestone debris in SU VII. These observations are in accordance with reports from the late evening of 14 July by local residents who observed disappearing water masses in the field upslope to the northeast of the scar and a concentration of surface runoff in the depth line where site BIE HPT 2/BIE 2 is located. In addition, during sediment coring in February 2022, we observed continuous water discharge within the scar at a depth that corresponds to the position of the assumed interflow (Figure 9).

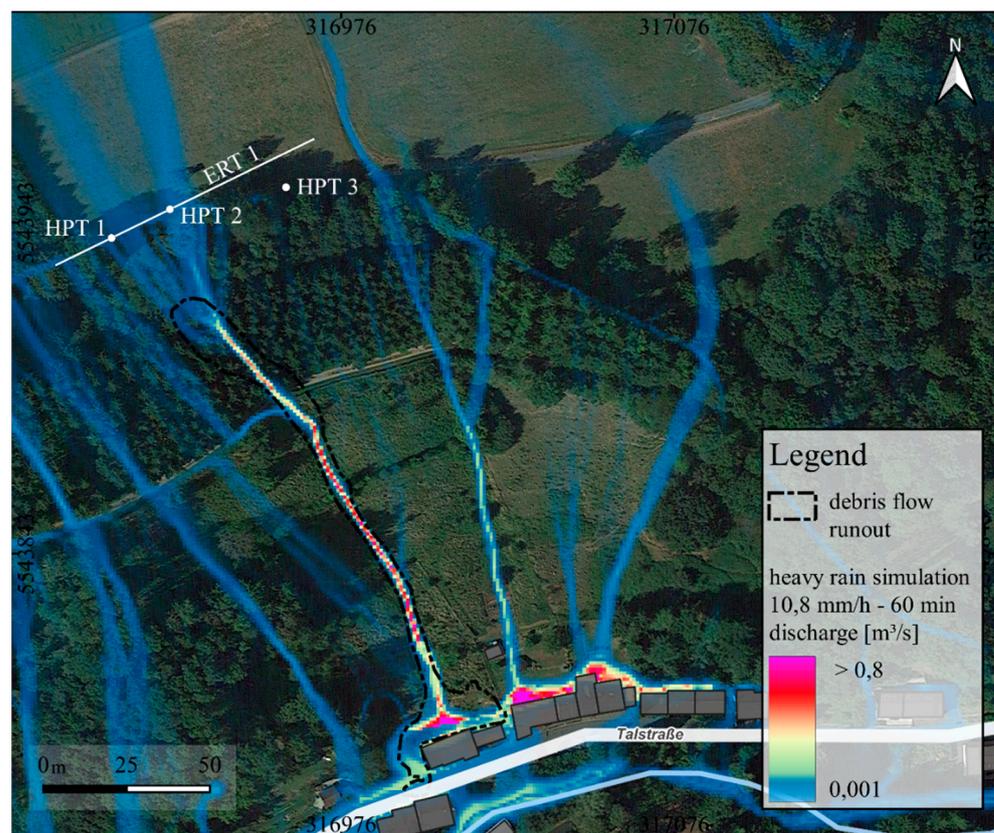
Figure 10. Comparison of the observed debris flow runout with the results of surface runoff modeling for the study area. The heavy rain simulation is based on weather data from the Wiersdorf station [27] during the hour before the mass movement occurred. The time of the triggering was assumed by local residents' reports.

metry. This allows for the quick (one to two days of fieldwork) and accurate acquisition of subsurface and morphometric slope composition. Our model correctly identified the sliding area along the slope, while correctly disregarding the numerous others in the area as possible source and hazard zones. This is probably due to the accuracy of the surface runoff simulations and the corresponding identification of the initial debris flow starting points. The simulation of the runout and deposition behavior by the GPP enables simple and fast modeling for different scenarios. The consistent modelling results are strongly related to the high resolution of the input DEM. The success of the deposition modeling also depends on the appropriate determination of the initial thickness of the unconsolidated material incorporated into the mass movement.
