GIS and BIM as Integrated Digital Environments for Modeling and Monitoring of Historic Buildings

Abstract: Multidisciplinary data integration within an information system is considered a key point for rehabilitation projects. Information regarding the state of preservation and/or decision making, for sustainable restoration is prerequisite. In addition, achieving structural integrity of a historic building, especially one that has undergone many construction phases and restoration interventions, is a very elaborate task and should, therefore, involve the study of multidisciplinary information regarding historical, architectural, building material and geometric data. In this paper the elaboration of such data within 2D and 3D information systems is described. Through the process described herein, a methodology, including the acquisition, classification and management of various multisensory data, is displayed and applied within a geographic information system (GIS). Moreover, the multidisciplinary documentation process, aggregated with the surveying products, generates 3D heritage building information modeling (HBIM), including information regarding construction phases, pathology a

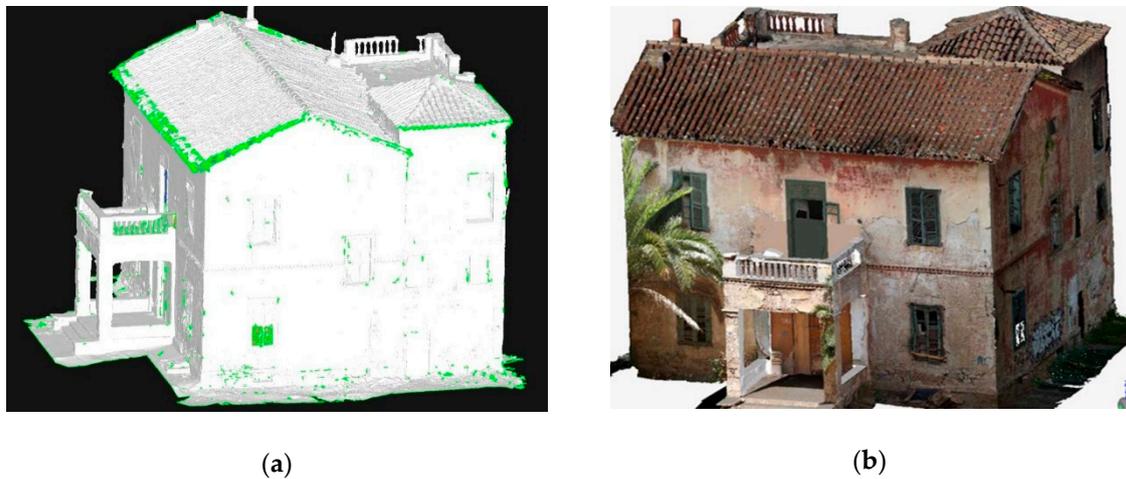
Figure 3. 3D model of Villa Klonaridi: (a) 3d mesh; (b) 3d textured model (northeast orientation).

The first step was the creation of a 3D model of the historic building, using the data provided from the geometric documentation, in order to acquire the volumetric information of the building. The computational tools used for the 3D modeling were the Cyclone 3D Point Cloud Processing software (Cyclone 9.0, Leica, Hexagon Geosystems AB, Heerbrugg, Canton St. Gallen, Switzerland, 2014), the Metashape Agisoft, the Geomagic Studio (Geomagic Studio, 3D Systems, Morrisville, NC, USA, 2013) and the AutoCAD Map 3D 2013 software. The processed point clouds describe the surface of the historic building in detail and, thus, the elements that comprise it. However, apart from the geometry that they represent, the point clouds do not contain additional information about the building structure such as masonry type, decay patterns and other default areas. The creation of a mesh was accomplished, by forming triangulated surfaces and turning them into a 3D model (Figure 3). A high-resolution three dimensional model of Villa Klonaridi was produced, including information related to deformations, discontinuities and cracks and additionally, artistic details that were encountered in the historic building. A high-quality textured model and additional products were obtained in order to assess the current state of preservation of the building.

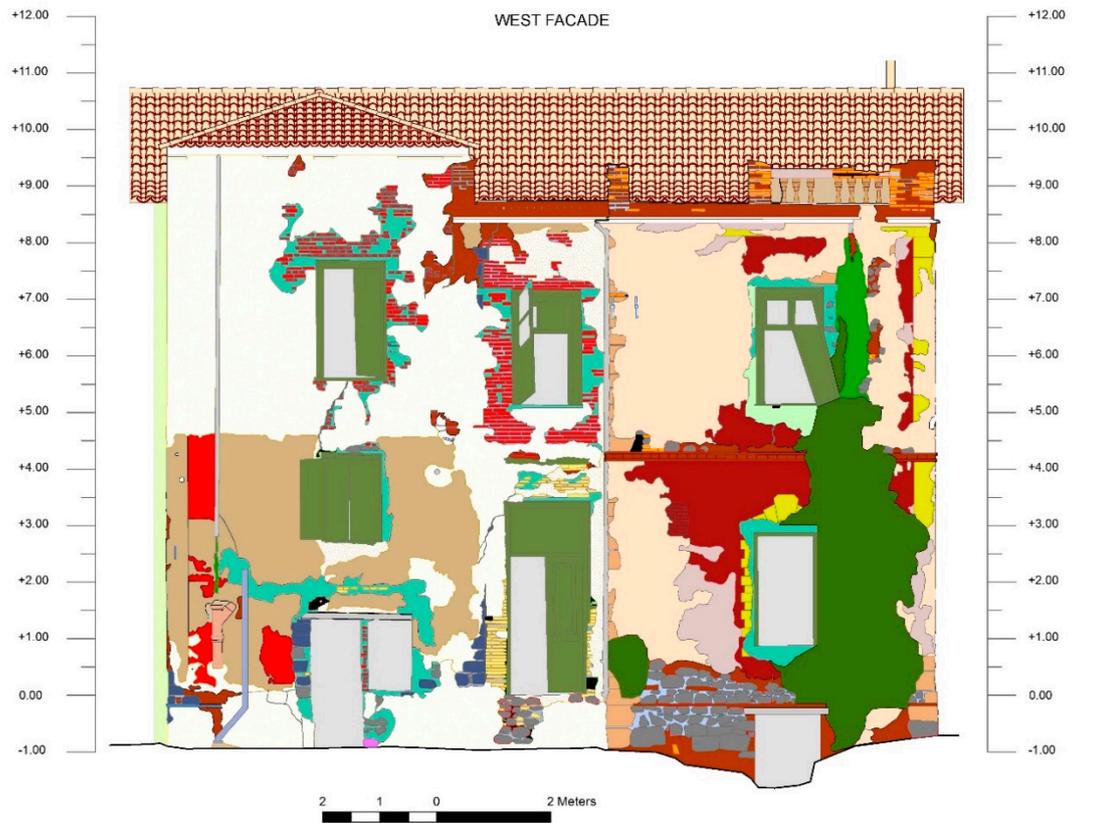
Figure 9. Thematic map of building materials and decay of the west façade.

The integration of the collected multidisciplinary data was performed within a GIS environment. Spatial interrelation was acquired and geospatial attributes were developed thus accomplishing a connection between qualitative and quantitative data. The logical data structure of the GIS platform was developed in such a manner that all the level of information were included, incorporating information from general data down to specific data: building as a whole, façade, parts of the historic building, type of documentation data and spatial features, depicting the recording type of information. The classification of the multidisciplinary data (including building materials, decay, etc.) within the information system was performed via a CAD environment, through a detailed digitization, using orthophotos of each facade as blueprints, while all the qualitative and numeric information were imported in an attribute database. GIS operations are utilized for the documentation of the building materials, as well as for the modelling and analysis of the decay extent and patterns. Relational and Boolean operations were used as well as geoprocessing analysis for the development of thematic maps of the historic building. The thematic maps of the facades of the historic building demonstrate the variation of the building materials and the structural system which alters according to the construction phases, thus providing valuable information related to the masonries and their interconnection on a structural level (Figures 8–11).

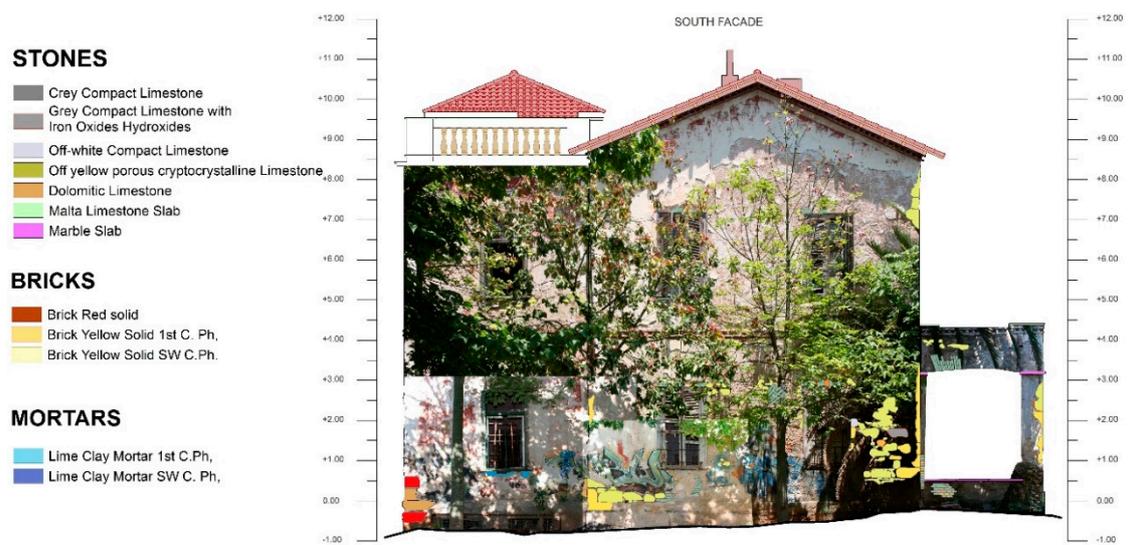
Figure 10. Thematic map of building materials of the south façade.

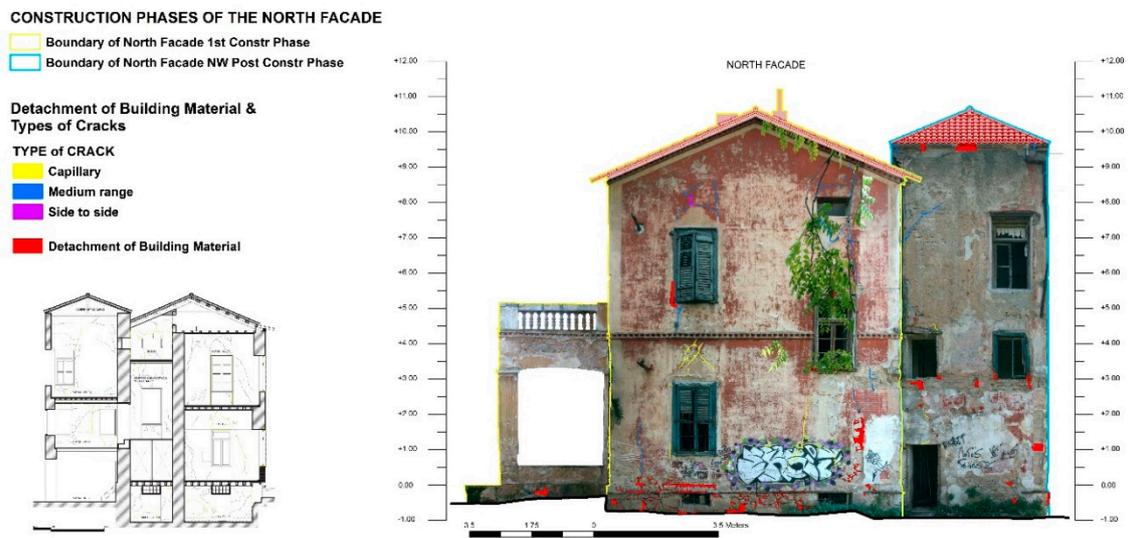
Figure 13. Thematic map of cracks and detachment of building materials depicted on the north façade of the building.

In the north façade of the building (Figure 13), excessive amount of building material detachment is concentrated in the area where the third construction phase is located (northwest), while a side to side crack, located above the first floor window of the first construction phase, can be also noticed in the architectural drawing. In addition, detachment of building material located in the lower part of the façade, indicates phenomena of rising damp, nevertheless, severe cracking in the structure of the first construction phase is not noticed.

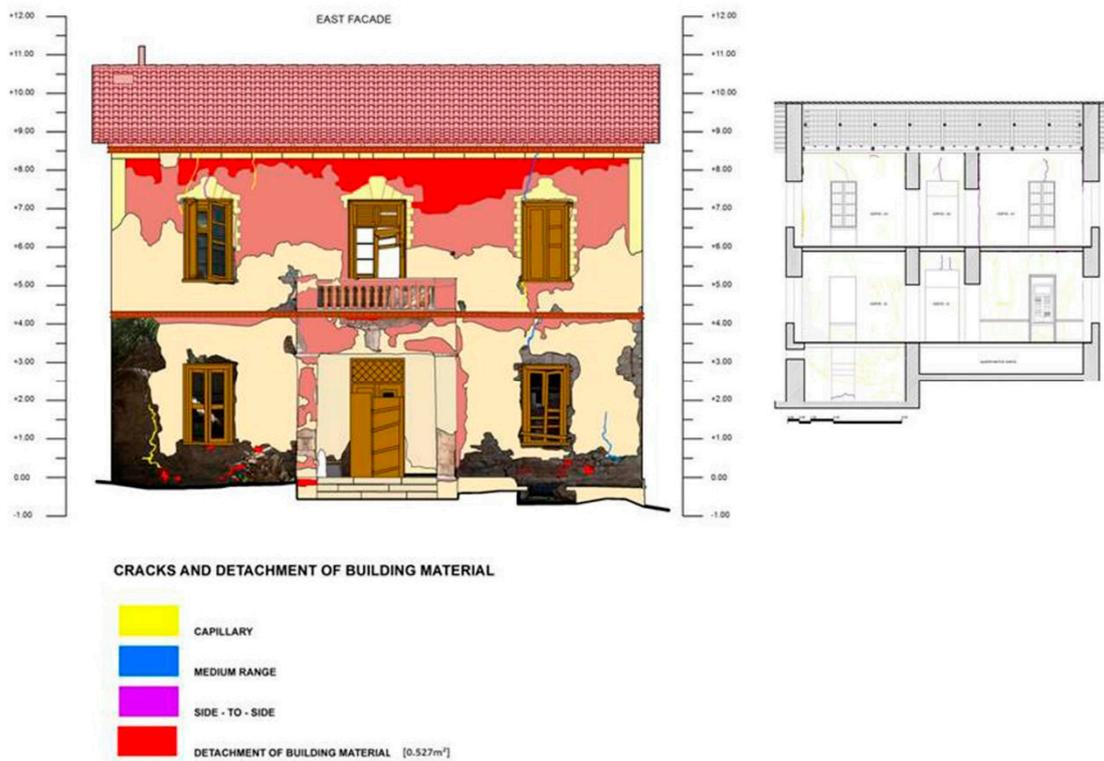
Figure 14. Thematic map of cracks and detachment of building materials depicted on the east façade of the building.

Regarding the thematic map of the east facade (Figure 14), which belongs to the first construction phase structure, various capillary cracks are present, the detachment of the exterior plaster (reaching the 1/3 of the total area of the façade) indicates humidity issues, however deformations and side-to side cracks, are nearly absent, apart from a crack located in the southeast first floor window, as indicated on the architectural section.

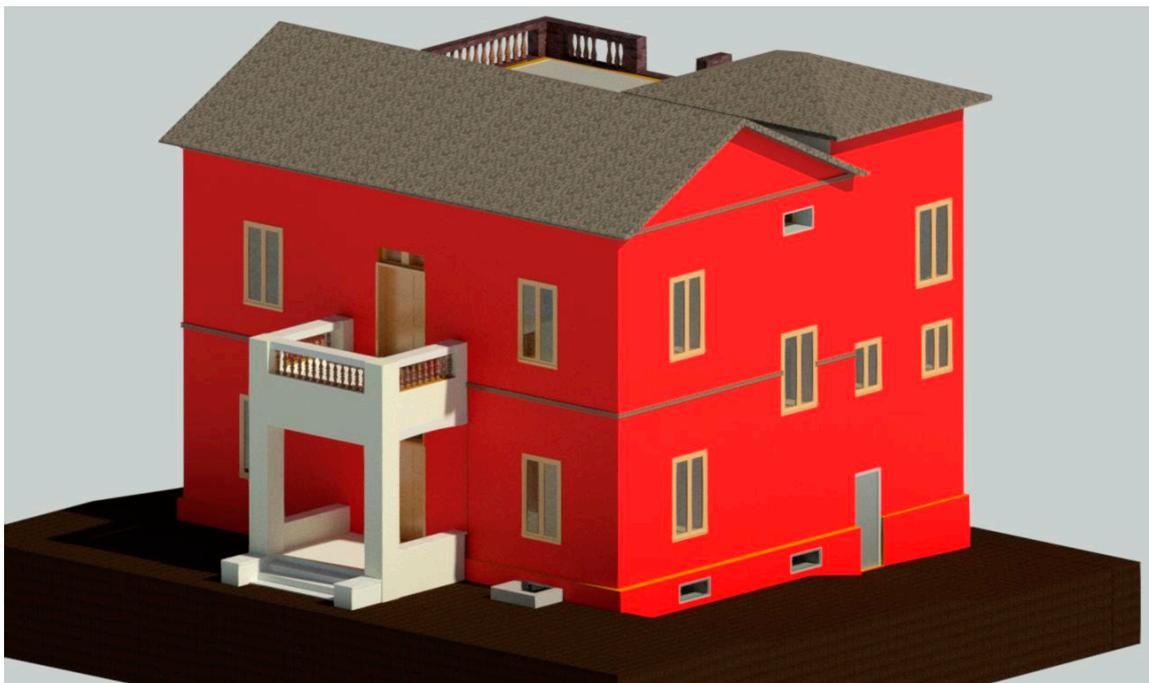
Figure 17. HBIM of the historic building of Villa Klonaridi.

The stratigraphic information of this structural element of a wall of the 1st construction phase, presented herein, includes information regarding its composition, type of building material, width of the construction wall and masonry's layers. This information regarding the width and the masonry, derives from the in situ NDT results of the GPR prospection, while the building material selection from the in lab analytical testing. This process was applied for every element that was developed within the HBIM environment, resulting to a semantically enriched 3D HBIM of the historic building (Figure 17).

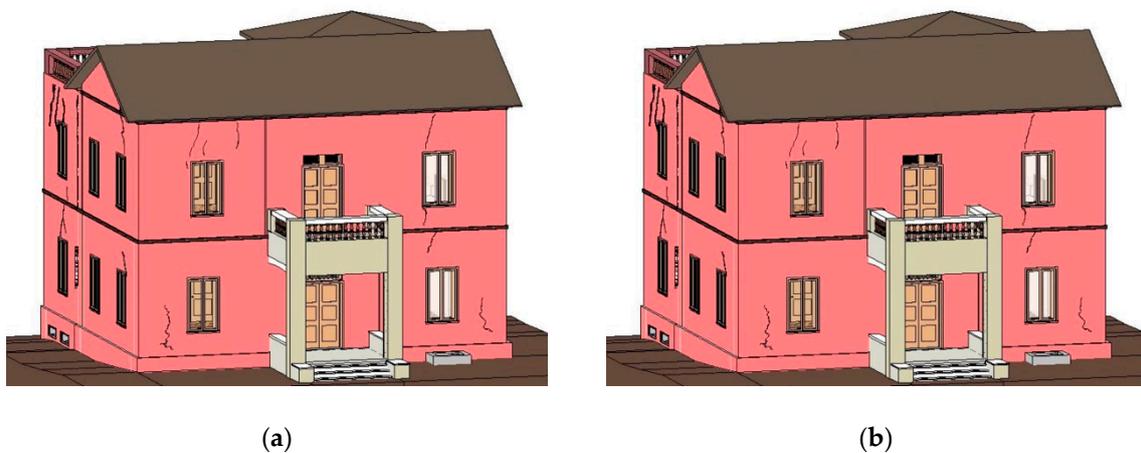
Figure 18. Elements of cracks (all types) embedded within the HBIM of the building: (a) southeast of the historic building; (b) southwest of the historic building.

The elements of the cracks as a result of decay mechanisms were incorporated in the HBIM as voids. Information regarding geographical data as well as which wall element is cut, can be obtained. However, this type of information, embedded within a BIM system, can be altered and quantitative information can derive from such elements, only if the void is transformed in a solid element. Once the crack obtains a solid element character, building material type can be imported. Within this framework, restoration plans, described only in studies and reports and implemented only on-site, can be incorporated within the HBIM system, including information regarding the compatible restoration material, selected per structural construction phase, as well as the prevailing degradation mechanisms. In Figure 19, a lime clay filling mortar of 1MPa compressive strength is created (as a material type in HBIM), including all the morphological and physical-chemical characteristics, as the study indicates [49]; thus providing qualitative and quantitative information for the restoration process, ensuring compatible and performing restoration actions, as well as adequate documentation of restoration works.
