# Non-Invasive Identification of Vulnerability Elements in Existing Buildings and Their Visualization in the BIM Model for Better Project Management: The Case Study of Cuccagna Farmhouse

**Featured Application:** The procedure could be applied, on a municipal or territorial scale, in order to proceed with a rapid assessment of the vulnerability of the existing historical heritage.

The proposed procedure has been applied to safeguard Cascina Cuccagna, a historic farmhouse in the urban fabric of Milan city. The safety works have been partially financed by Fondazione Cariplo in the framework of the calls for proposals Art and Culture-Cultural Heritage at risk.

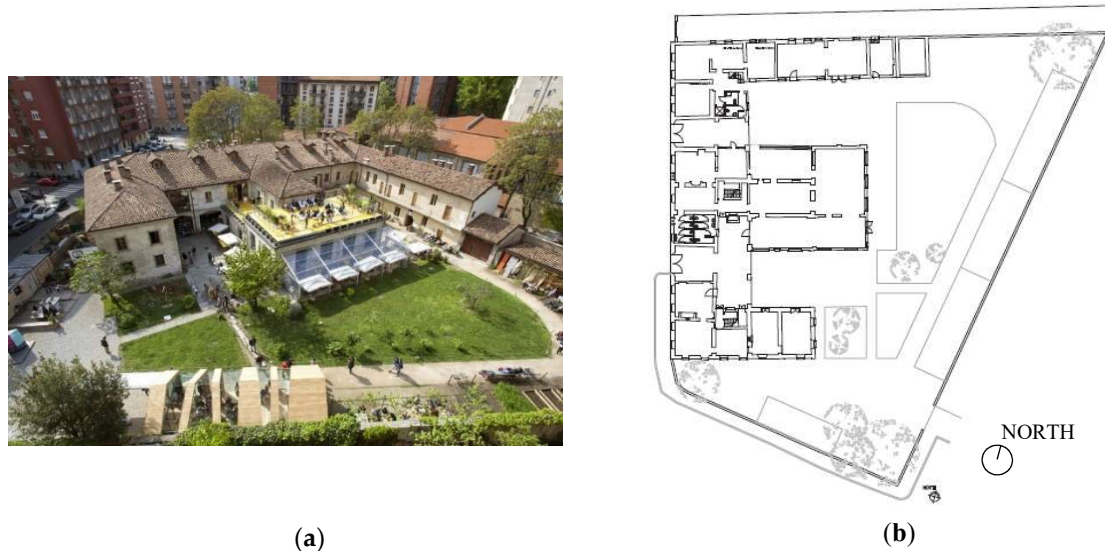
**Figure 3.** Cascina Cuccagna, (a) overall view and (b) ground floor plan.

of the rural buildings still existing in the city of Milan (Figure 3). Until about the middle of the 20th century, farmsteads represented the place of life and productivity for most of the inhabitants of the Lombard plain. Still today, they are a remarkable architectural resource and often, as in the case of Cascina Cuccagna, they are used with different functions from the original ones.

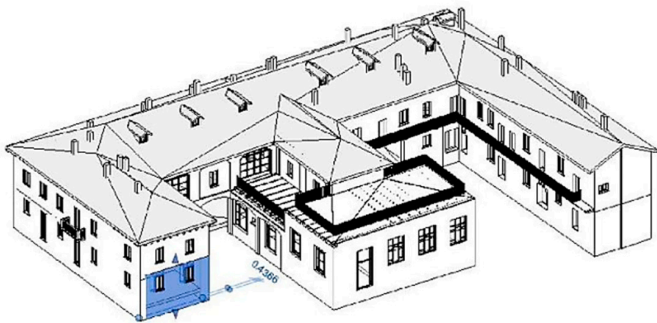
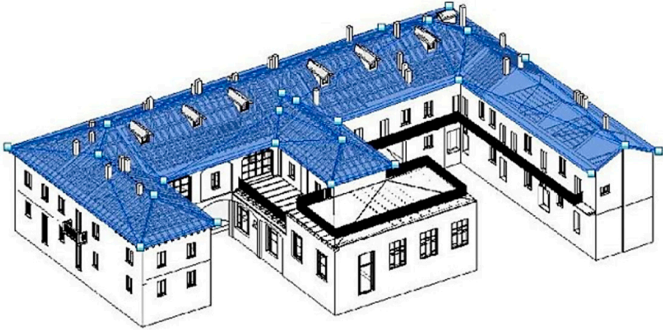
Masonry Wall Thickness 63 cm.	
		Damage level
quality of supports and binders		2.0000
masonry adhesion and/or cohesion		2.0000
related to the masonry section: positioning of the outer leaf		
related to the architectural-structural elements: slenderness		
masonry adhesion and/or cohesion		
presence of chimneys		
interruptions due to plants ducts		
eaves/rain pipes within the masonry section

Roof Cover Roof tile	
		Damage level
	lack of binder in the joints	
	masonry de-cohesion	
	presence of water	
	decay of stone elements	
	masonry adhesion and/or cohesion	
	heads rotting	
	decay of secondary elements and/or of the tables	
	general decay	1.0000
	exposed outer leaf	1.0000
	plaster efficiency	
	conditions of the covering layer	
	inefficient eaves and pipes	1.0000

**Figure 9.** Example of coupling between structural element, specific vulnerability, and associated weights: (a) masonry wall thickness; (b) roof cover.

From the rapid evaluations and the experimental tests carried out, each vertical and horizontal structural element and all the non-structural elements could be classified as indicated in Table 4. Each type of specific vulnerability found on individual elements was assigned a weight, according to the damage level obtained in the previous investigations: absent damage (0), scarcely influential (1), averagely influential (2), significantly influential (3). The result of this operation is presented in a matrix with a correspondence between structural elements and specific vulnerabilities, useful to characterize the elements in a BIM environment. In the commercial software that was used, in addition to the geometric, mechanical, and material characteristics, each structural element could be associated with the table of specific vulnerabilities and weights assigned to each item referred to that element. (Figure 9).

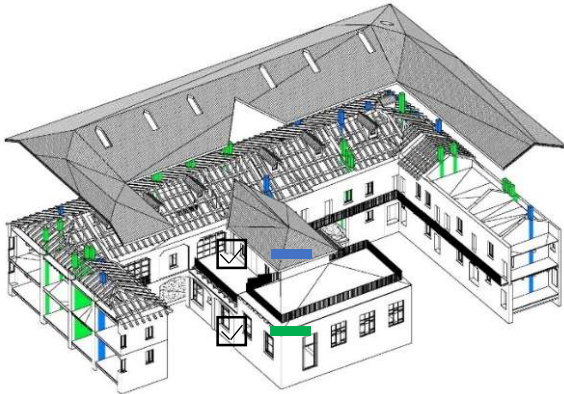
**Figure 10.** Simple query: presence of flue pipes and their degree of incidence on the vulnerability of the wall panel.
