Article

Feasibility of a Thermography Nondestructive Technique for Determining the Quality of Historical Frescoed Masonries: Applications on the Templar Church of San Bevignate

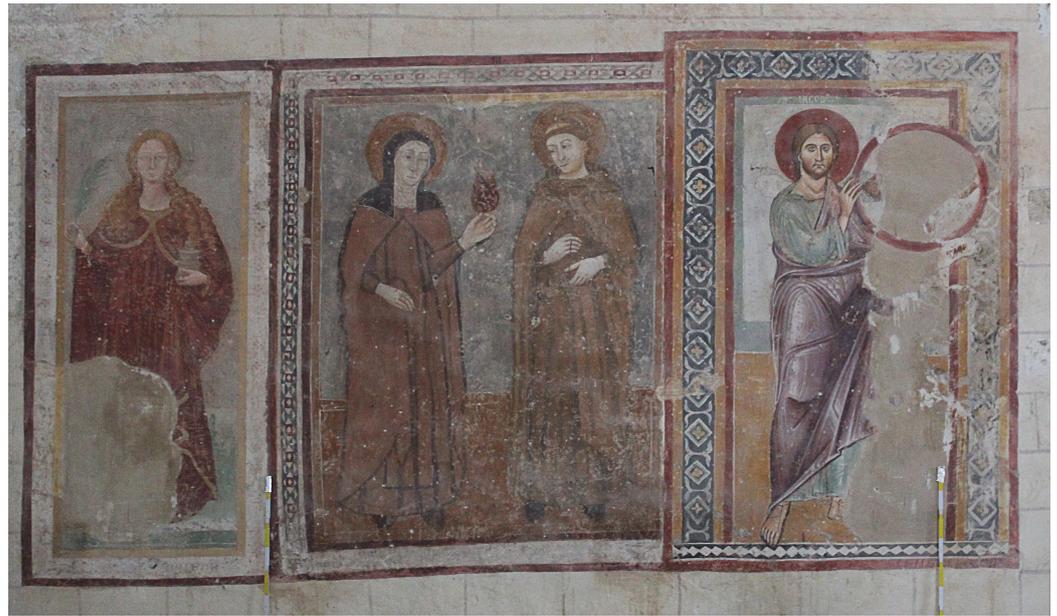
Figure 8. One of the frescoes under investigation, in particular the one composed by an apostle preceded by three Saints Maddalena, Stefano and Lorenzo. In the pic are visible the reflective meter-sticks located as reference points for the subsequent post-processing (see the cone of vision 4 in Figure 2).

With regard to the frescoes that decorate the examined wall, rows of overlapping ashlar are reproduced to imitate an austere wall face made of stone, a typical decoration of the Templar churches to recall the poverty of the holy land and of the holy sepulchre. Moreover, the series of the 12 apostles stand out, distributed also on the other side wall, on the façade and the back walls of the apse; such pictorial cycle was superimposed on the original decoration during a second phase between 1283 and 1285. In particular, the first tranche of thermographic investigation covered the mural painting composed by an apostle preceded by three Saints Maddalena, Stefano e Lorenzo, positioned according to the votive rites required by the ancient order, Figure 8.

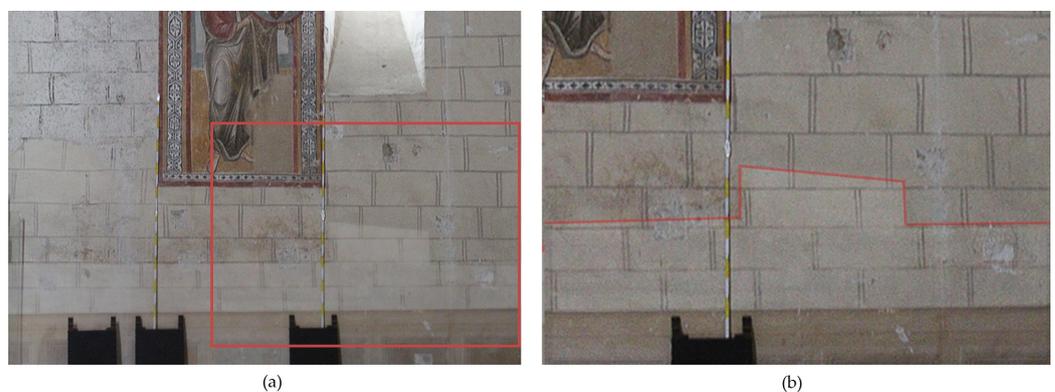
Figure 12. (a) Portion of the fresco under investigation, (b) highlighting of colours of different gradation, (c) thermal image with improved contrast, (d) final binary image (see the cones of visions 6 and C in Figure 2).
