Article

# Fatigue Characteristics of Double Damage Reinforced Prestressed Hollow Slab Beams under Freeze-Thaw Cycle Erosion

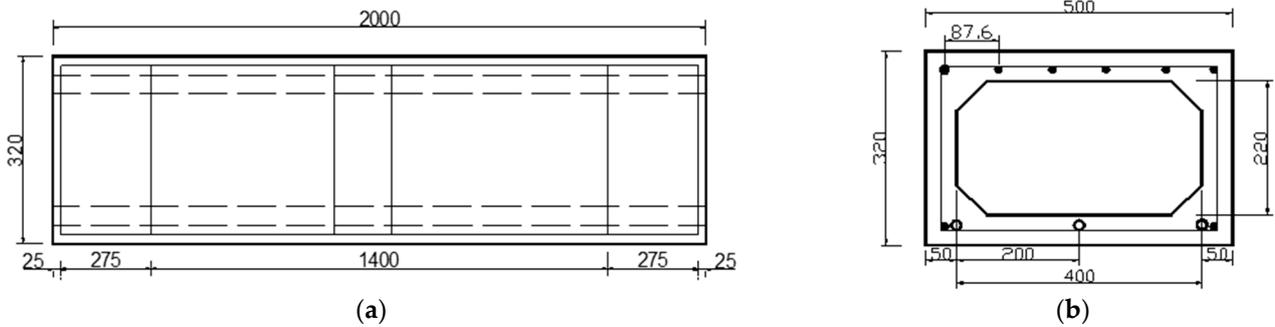
**Figure 1.** Longitudinal section, cross-section, and distributed steel of the prestressed hollow slab girder (mm): (a) Longitudinal section and; (b) Cross-section and distributed steel.

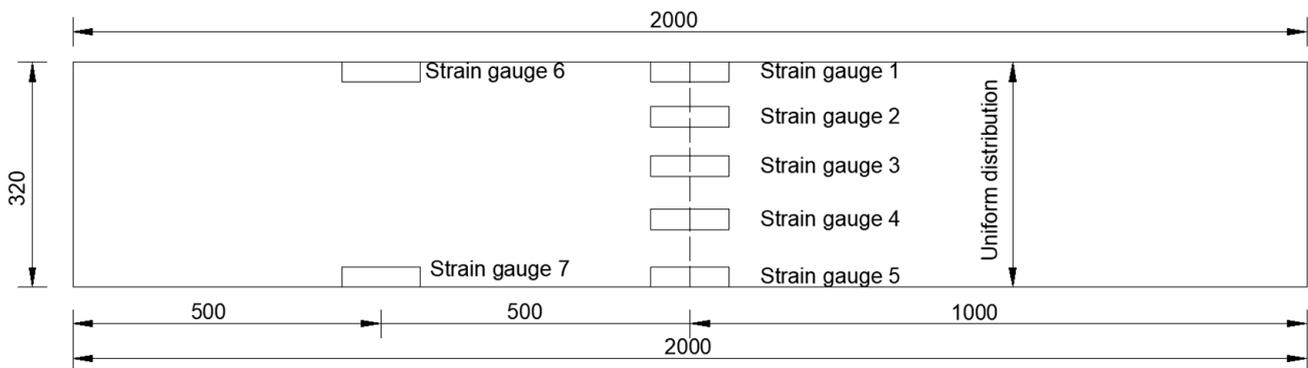
**Figure 2.** Elevation of test beam layout of electronic strain gauges (mm).

Strain test: The strains at 1/4 length and at the midspan of the test beam were measured. As shown in Figure 2, two electronic strain gauges were placed on the test plate at a quarter of the length of the test beam. Five electronic strain gauges were placed on

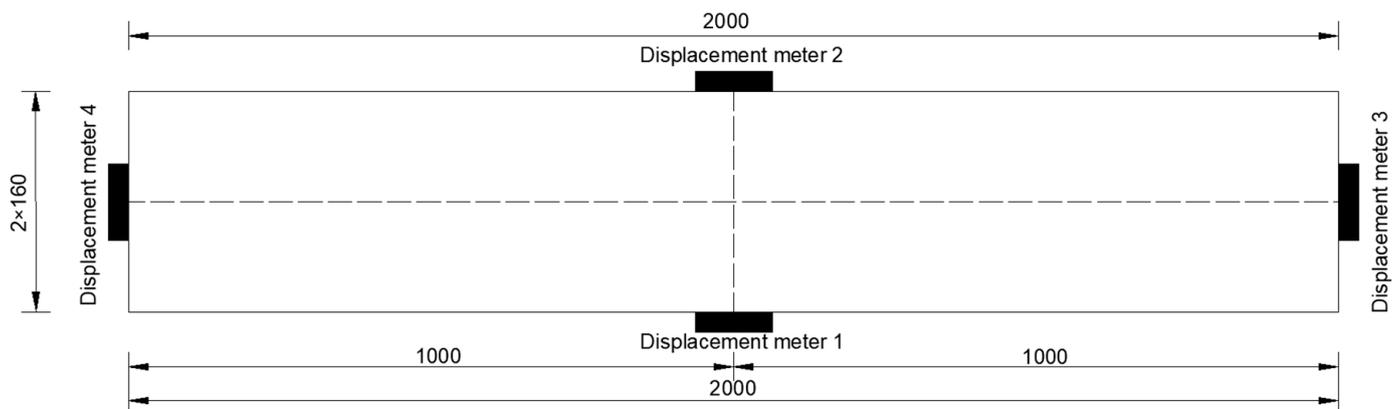
**Figure 3.** Layout of digital displacement meters in elevation on the test beam (mm).

Displacement test (dynamic and static displacement): The dynamic and static displacements at both ends and at the midspan of the test beam under static and fatigue loads were measured. One displacement meter was placed at each end of the test beam, and one was placed at each side of the transverse bridge in the midspan, totaling 4 displacement meters. Figure 3 shows the specific layout. The measurement range of the resistance displacement sensor is 0–50 mm, and the accuracy is  $\pm 0.1\%$  F.S.

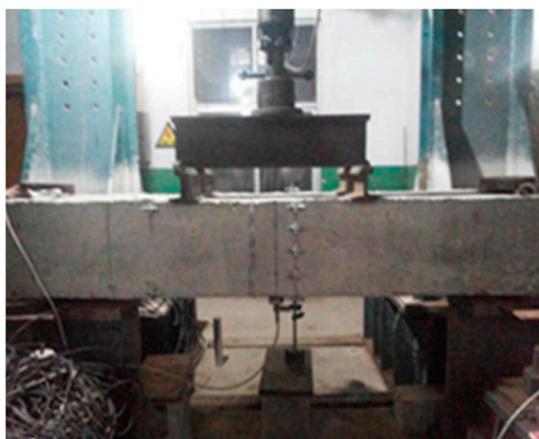
**Figure 4.** The static loading test.

The primary objective of static loading of the prestressed hollow slab beam was to obtain the ultimate capacity of the test plate, for determining the fatigue test stress ratio and the fatigue amplitude of the prestressed concrete test beam. As shown in Figure 4, a trisection loading method was used to align the longitudinal and transverse axes of the test beam, and subsequently, two I-beams of the same length were arranged at the third point of the test beam in a direction perpendicular to the axial direction of the beam. After the trisection loading had been achieved, a larger I-beam was placed at the upper center of the two I-beams along the same direction, and several rubber pads were placed on the upper region.

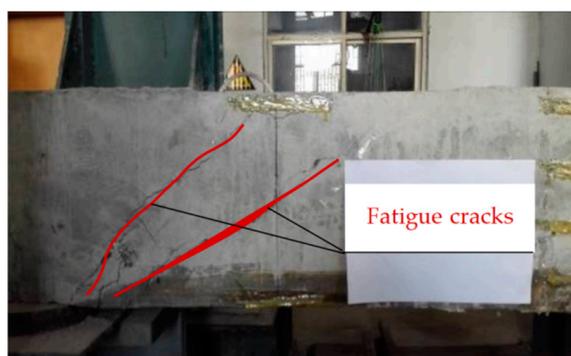
**Figure 5.** Fatigue load crack diagram of the test plate.

The maximum and minimum fatigue loads were  $F_{max} = 160$  kN, and  $F_{min} = 60$  kN, respectively, and the frequency was 5 Hz. After every  $5.0 \times 10^5$  cycles of fatigue loading, static loading was performed on the test beam, and the loading level was 5 kN for each level, which was accumulated in turn. For every  $5.0 \times 10^5$  cycles of fatigue loading, the fundamental frequency, dynamic displacement loading, crack, width, and development law were recorded. The fatigue test was stopped immediately when the width of the fatigue crack on the test plate was observed to reach 0.2 mm (Shown in Figure 5).

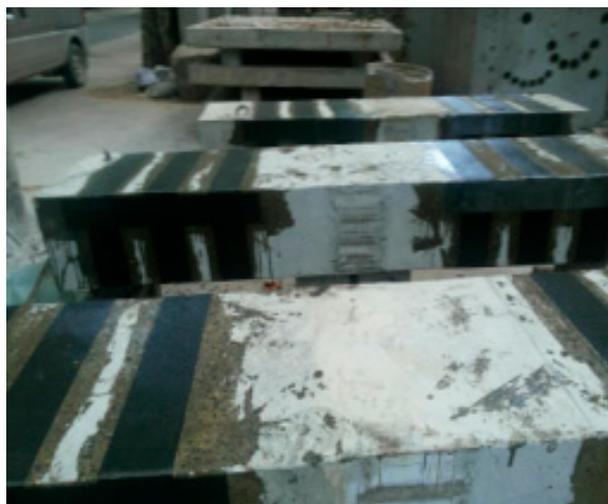
**Figure 6.** Construction drawing of the test beam reinforced with carbon fiber sheets.

The prestressed hollow slab reinforced with carbon fiber cloths was constructed as follows: ① Surface treatment: the surface reinforcement area of the test slab was ground, the laitance on the surface was cleaned, the structural layer of the test slab was exposed, the surface of the test slab was cleaned, and the test slab was kept dry after grinding. ② Brushing primer: the base adhesive was deployed according to the designed mix proportion of the adhesive; the base adhesive was uniformly spread onto the surface of the concrete, and the next step was initiated after drying the surface of the base adhesive. ③ Carbon fiber sheets of calculated sizes were cut and pasted onto the reinforcing region, they were rolled along the direction of the carbon fiber cloth several times with a roller, bubbles between the carbon fiber cloth and the concrete sticking interface were extruded, and the structural adhesive was made to fully saturate the carbon fiber cloth, which was subsequently pasted. The construction drawing of the test beam reinforced with carbon fiber sheets is shown in Figure 6.

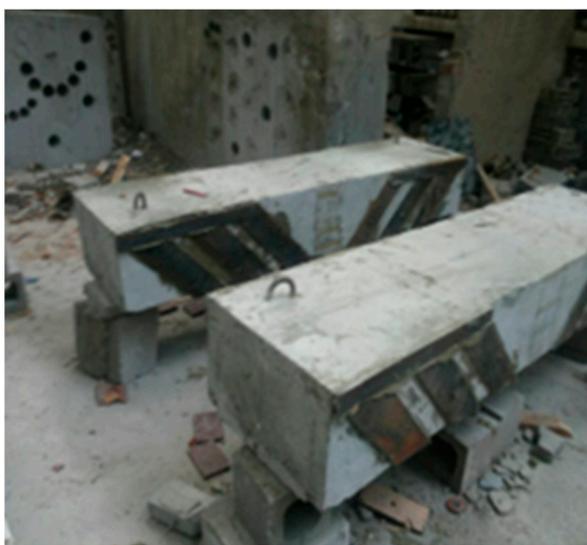
**Figure 7.** Construction drawing of the test beam strengthened by pasting steel plates.

The construction process of the prestressed hollow slab beam strengthened by pasting steel plates was as follows: ① Surface grinding: the surface of the test plate was ground with a grinding wheel, the dust on the surface of the test plate was washed with clean water, and the surface was wiped with absorbent cotton dipped in acetone after the surface of the test plate was dry. ② Configuration of the structural adhesive: the structural adhesive was configured on-site, and the raw materials of the structural adhesive were poured into clean iron barrels in proportion and subsequently mechanically stirred in one direction until the color was uniform. ③ Pasting the steel plate: the prepared adhesive was smeared onto the bonding surface of the steel plate with a spatula, the steel plate was pasted at a fixed position, and a steel nail was subsequently driven into the concrete from the surface of the steel plate with an air nail gun to ensure a better paste quality. ④ Solidification of the reinforced components: the reinforced test plate was solidified at 20 °C, and the test specimen could be stressed within a three-day curing period. The construction drawing of the test beam strengthened by pasting steel plates is shown in Figure 7.

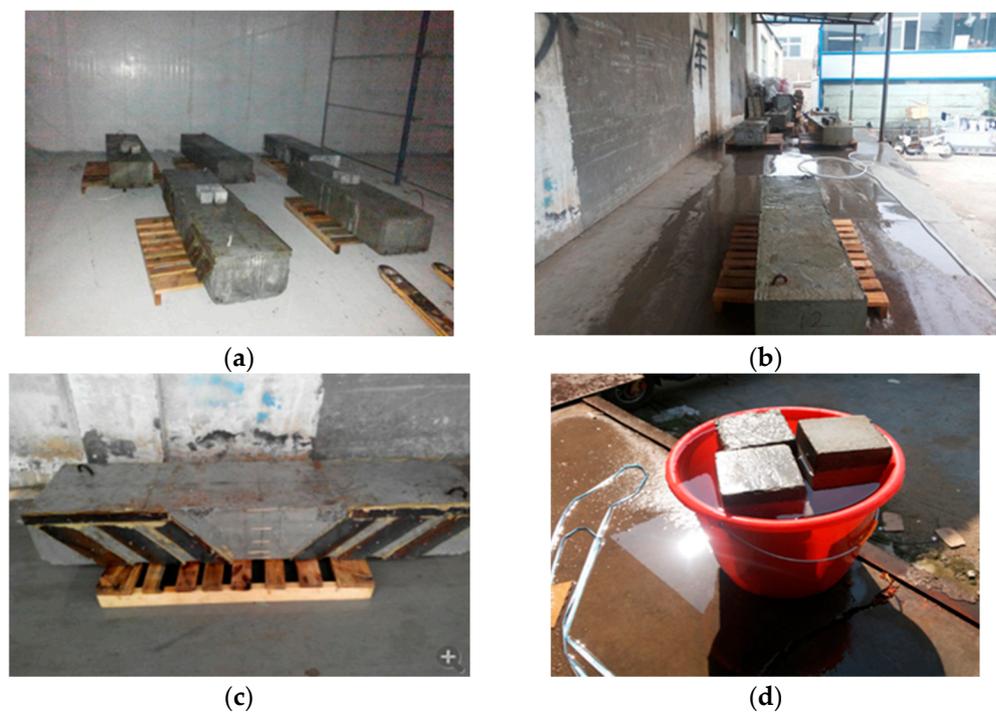
**Figure 8.** Freeze–thaw test process for the reinforced test plate and corresponding test blocks: (a) freezing of the reinforced test plate; (b) water melting of the test plate; (c) melted test plate; (d) simultaneous immersion melting of the test blocks.

Along with durability specifications [39], 50 freeze–thaw cycle erosion tests were conducted on test plates and corresponding test blocks reinforced by bonded steel plates and carbon fiber cloths by the air-freeze water-thaw method. The temperature in the freezing stage was maintained at  $-18\text{ }^{\circ}\text{C}$ . A set of prestressed hollow slabs strengthened using steel and carbon fiber sheets and the corresponding test blocks were soaked in a pool for four days and subsequently removed. The moisture on the surface was wiped and 50 freeze–thaw cycles were initiated. Once the test plate and the test block were simultaneously frozen and thawed, this was regarded as a single freezing and thawing cycle, and the process was repeated until 50 freeze–thaw cycles were completed. The freeze–thaw test process for the reinforced test plate and corresponding test blocks are shown in Figure 8.

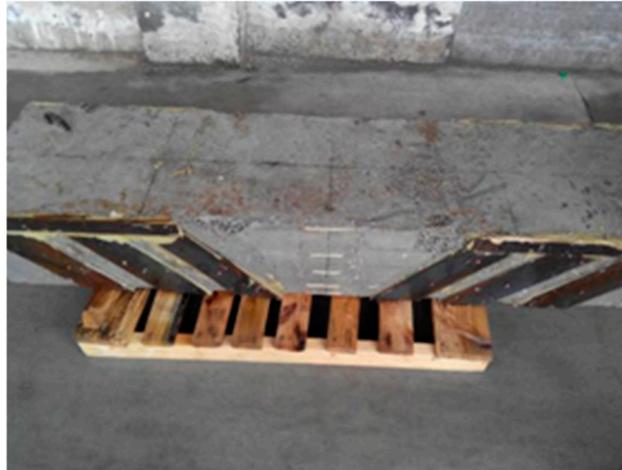
**Figure 9.** Pasting a carbon fiber cloth reinforced component interface after freeze–thaw erosion.

A set of test panels was subjected to freeze–thaw cycles, and minor cracks developed on the surface of the test panels. In the latter half of the freeze–thaw cycles, it was evident that water was immersed in the test plate in the microcracks and that the microcracks on the test plate might have been expanded by the freeze–thaw cycles. After observing the corrosion of the reinforced specimens by the freeze–thaw cycles, it was found that the strengthened specimens bonded with the carbon fiber sheets. The local cracking on the reinforced interface and the local peeling of the carbon fiber sheet and the concrete are shown in Figure 9. The rust on the steel plate surface is shown in Figure 10.

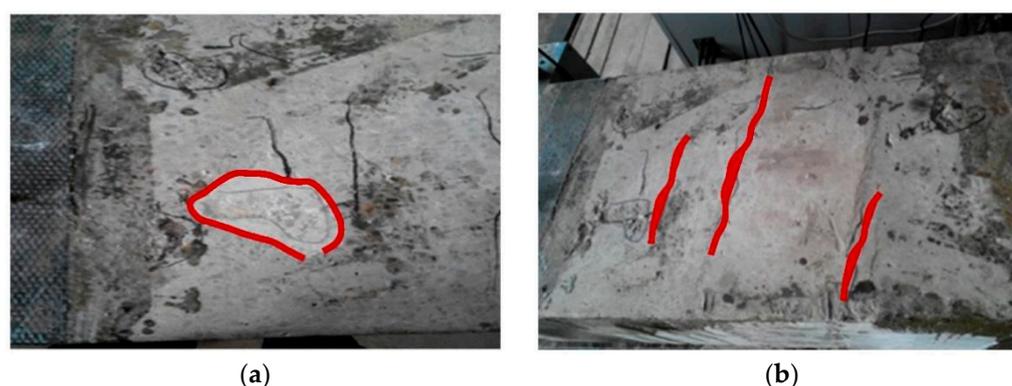
**Figure 11.** Damage diagram of test plate reinforced by carbon fiber cloth during fatigue testing: (a) local crushing after 2 million fatigue cycles at the roof; (b) damage map of roof concrete.

As shown in Figure 11, the damage cracks that appeared in the early stage of the fatigue test plate were covered after grinding and strengthening with carbon fiber cloths, and the occurrence of the original crack was unclear in the fatigue process. However, in the fatigue test, after the freeze–thaw cycle of the plate reinforced with carbon fiber cloths, several cracks appeared on its top plate. A transverse through the crack was gradually generated. After 2 million cycles of fatigue loading, several pits appeared on the concrete roof, and local peeling between the carbon fiber cloths and the concrete occurred.

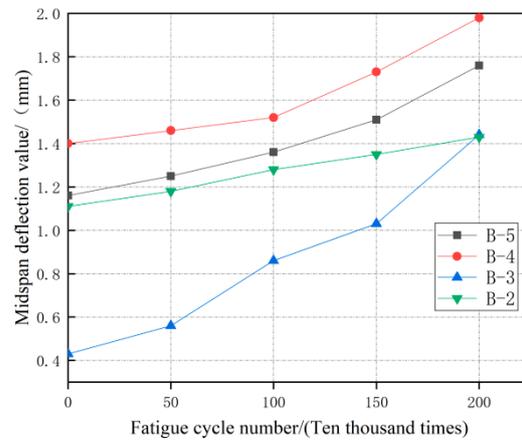
**Figure 12.** Deflection trend diagram of fatigue process by freeze–thaw erosion of strengthened test plate.

Figures 12 and 13 show the deflection and strain of the freeze–thaw reinforced specimens with the increasing number of fatigue cycles. The analysis showed that the deflection in the carbon fiber cloth strengthened specimens after freeze–thaw damage increased gradually in the first  $5.0 \times 10^5$  fatigue cycles and also relatively quickly in the first  $5.0 \times 10^5$  to  $20.0 \times 10^5$  fatigue cycles. After the freezing and thawing damage, the deflection in the steel plate reinforced specimen gradually increased in the initial  $5.0 \times 10^5$  fatigue cycles and rapidly increased during the  $15.0 \times 10^5$ – $20.0 \times 10^5$  fatigue cycles. The flexure of the pasted steel reinforced components gradually increased in the first  $15.0 \times 10^5$  fatigue cycles and increased rapidly during the  $15.0 \times 10^5$ – $20.0 \times 10^5$  fatigue cycles. At a constant fatigue time, the flexure of the bonded carbon-fiber reinforced specimen was greater than the deflection in the bonded steel reinforced specimen. The compressive strain in the carbon-fiber reinforced specimen and steel reinforced specimen increased linearly during fatigue, and the compressive strain in the carbon-fiber reinforced component was larger than that of the steel reinforced component. The tensile strain of the carbon-fiber reinforced component, which increased smoothly during the initial  $15.0 \times 10^5$  cycles of fatigue loading, was lower than that of the steel reinforced component. This tensile strength rapidly increased in the last  $5.0 \times 10^5$  cycles of fatigue loading and became larger than that of the steel reinforced component. The strains in the bonded steel plate strengthened specimens increased linearly during fatigue.

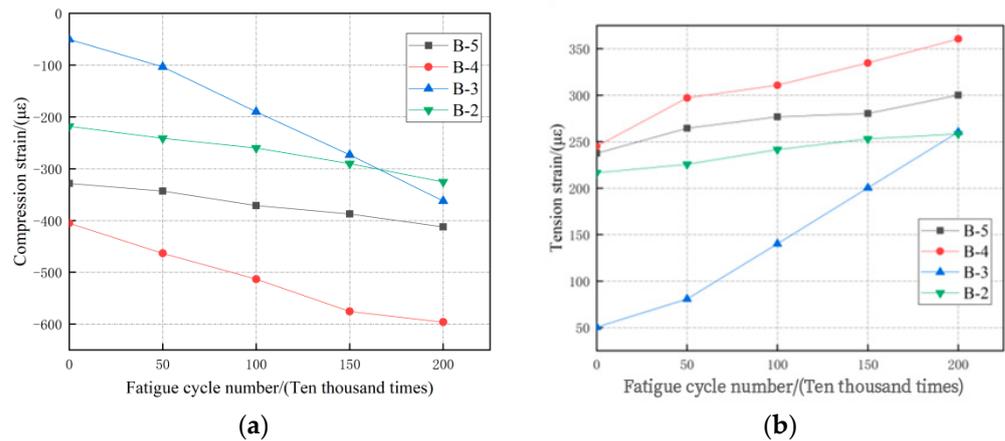
**Figure 13.** Figures of tensile strain and compressive strain of strengthened test plate during freeze–thaw fatigue process: (a) tensile strain; (b) compressive strain.

The stress and deformation of the reinforced components increased with the fatigue time. After  $20.0 \times 10^5$  fatigue loading, the deflection and the tensile and compressive strains in the intermediate portion of the steel-reinforced specimen were lower than those of the carbon fiber cloth reinforced specimen. The midspan deflection and the tensile and compressive strains in the steel plate reinforced components were 1.88 mm,  $308.2 \mu\epsilon$  and  $-352.2 \mu\epsilon$ , respectively, with increases of 72.4%, 21.1%, and 31.1%, respectively. The midspan deflection and the tensile and compressive strains in the carbon-fiber-reinforced components were 1.72 mm,  $360.6 \mu\epsilon$ , and  $-596.2 \mu\epsilon$ , respectively, with increases of 68.8%, 48.3%, and 44.2%, respectively. Consequently, it was found that the increase in the flexure of the carbon fiber reinforced component was slightly lower than that of the steel reinforced component, and the increases in the tensile and compressive strains in the carbon fiber cloth reinforced specimens were larger than those of the steel-reinforced specimens. Com-

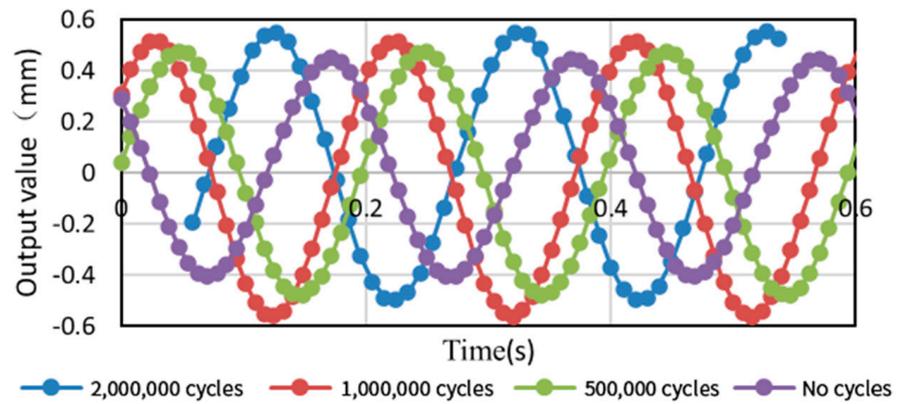
Figure 14. Dynamic displacement diagram of fatigue test process of steel plate strengthened component.

The dynamic displacement of a test plate subjected to sinusoidal fatigue loading by freeze–thaw erosion reflected the impact resistance of the test plate after freeze–thaw cycling. After the reinforced prestressed concrete hollow test plate was subjected to freeze–thaw erosion, its dynamic data during fatigue loading changed owing to the changes in its fatigue characteristics. The dynamic displacement diagram of the reinforced component bonded with steel plates under freeze–thaw erosion is shown in Figure 14 and Table 10.

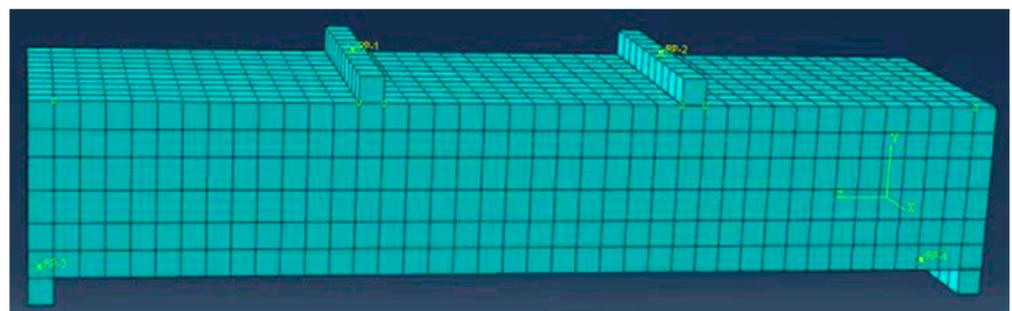
Figure 15. Finite element model of the prestressed hollow slab.

Based on the actual structural size of the prestressed hollow slab, the ABAQUS finite element analysis software was used to establish a finite element model for a prestressed hollow slab beam (Figure 15).

The finite element model has a total of 1971 units. The concrete unit adopted a 3D solid unit, the elastic modulus was  $3.0 \times 10^4$  MPa, and the Poisson's ratio was 0.2. Other material parameters were set according to the material parameter properties described in the experimental section of the text. ABAQUS provides three models to simulate the nonlinearity of concrete: a concrete dispersion cracking model, concrete plastic damage model, and concrete brittle cracking model. According to the main forms and causes of damage of the prestressed hollow slab beams, the main choice of concrete material in this paper was the plastic damage model, which could simulate the forms of damage of the concrete materials.

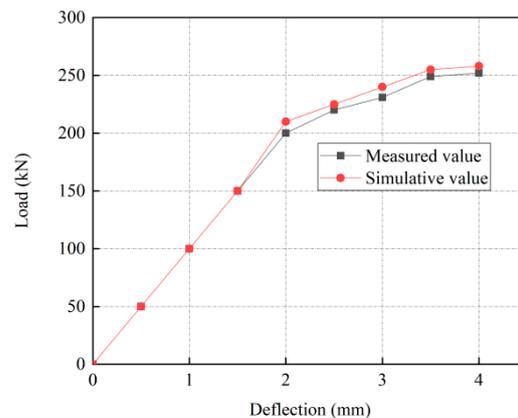
**Figure 16.** Comparison of measured and simulated load-displacement curves of test plate.

By comparing the simulated values obtained using the ABAQUS software with the measured values obtained during the test, it was found that the changing trends in the midspan load–displacement curves of the two values were quite similar (shown in Figure 16). However, in the software simulation processing, the bond-slip between the steel bars, prestressed bars, and concrete was neglected; therefore, the load value obtained during the test was larger for a constant deflection. The load–displacement curves of the measured and simulated values underwent three stages: The first stage was the elastic stage, wherein the load and deflection increased proportionally. The second stage was the yield stage, wherein the cracking load of the prestressed hollow slab was 200 kN, and the slope of the load–displacement curve decreased owing to the decrease in stiffness caused by the cracking of the test plate. The third stage was the strengthening stage, wherein the load increased gradually, but the deflection decreased rapidly. The ultimate load was determined as the longitudinal reinforcement yield. In addition, the finite element simulation of the concrete damage can be seen in Figure 17. When a static load was applied to the prestressed hollow slab finite element model, the damage cracks mainly occurred at both ends of the bearing, which was consistent with the results of the actual static load tests. Therefore, the accuracy of the prestressed hollow slab finite element model was verified.

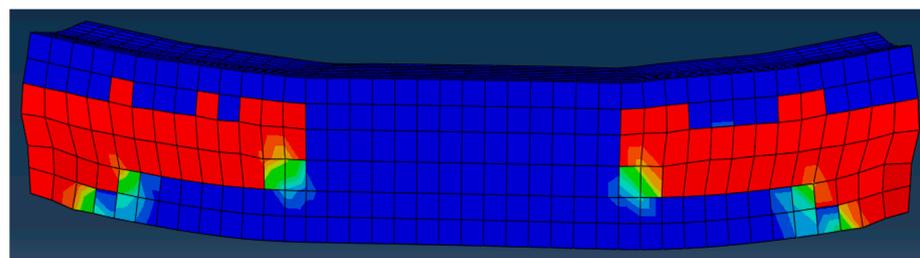
**Figure 17.** Damage diagram of prestressed hollow slab concrete.

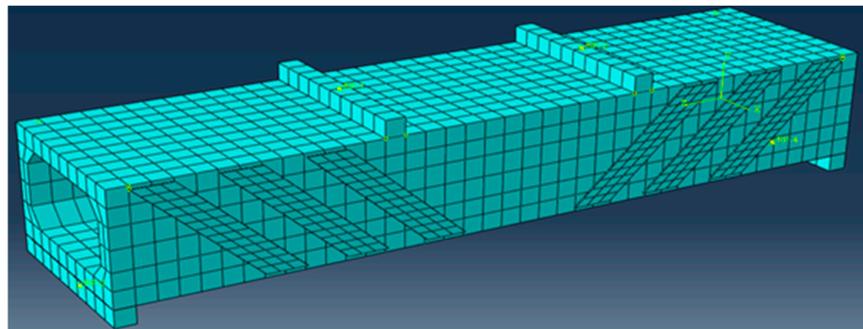
**Figure 18.** Finite element model of the prestressed hollow slab reinforced component.

As shown in Figure 18, the relevant structural dimensions and material parameters in the finite element model were set according to the prestressed hollow slab reinforced component model constructed for the experiments mentioned earlier. The bonded steel plate used was Q235, the elastic modulus was  $2.1 \times 10^{11}$  Pa, and the steel plate was placed obliquely at  $45^\circ$  and bilaterally bound to the prestressed hollow plate.

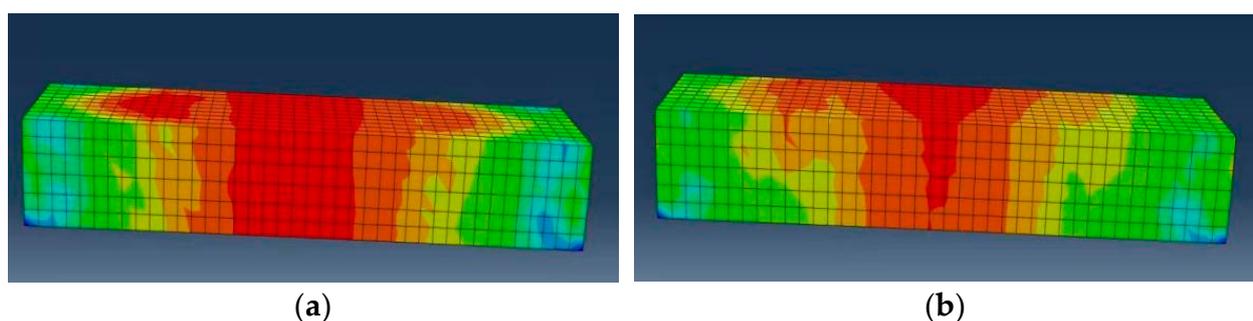
**Figure 19.** Vertical displacement program of reinforced components with different freeze–thaw cycles: (a) 100 freeze–thaw cycles; (b) 150 freeze–thaw cycles.

In addition, the material degradation in the steel bars under the action of freeze–thaw cycles was minute; therefore, the effects of freezing and thawing on the mechanical properties of the steel bars were not considered. In the fatigue cyclic loading simulation,  $5.0 \times 10^5$  cycles of fatigue loading were applied for different freeze–thaw cycles at a 0.8 stress level. The vertical displacement program of the reinforced components is shown in Figure 19.

Figure 19 shows that the reinforced specimens primarily produced large displacement deformations in the middle of the span under the double effects of freeze–thaw cycles and fatigue loads. Thus, the midspan node 576 was selected as the reference node, and the deflection values at this reference node for different freeze–thaw cycles and  $20.0 \times 10^5$  fatigue cycles of loading were extracted, as shown in Figure 20. It was shown that the midspan deflection in the reinforced component that had not undergone freeze–thaw cycle corrosion was 1.12 mm after  $20.0 \times 10^5$  cycles of fatigue loading. The deflection values of the reinforced components after 50, 100, 150, and 200 freeze–thaw cycles and fatigue loading

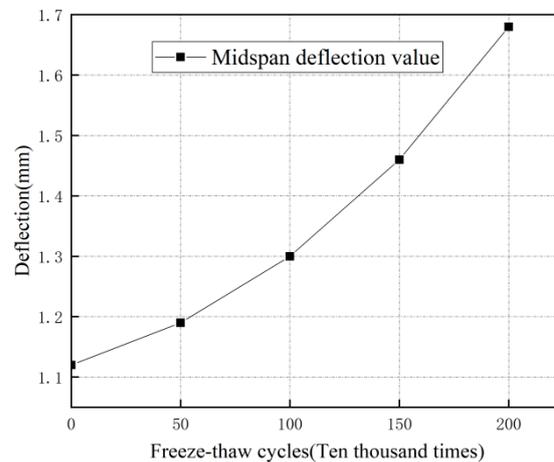
**Figure 20.** Midspan deflection of reinforced components under different freeze–thaw cycles.

were 1.19 mm, 1.3 mm, 1.46 mm, and 1.68 mm, respectively, which were increased by 6%, 16%, 30%, and 50%, respectively. As described above, the flexure of the intermediate portion of the reinforced component increased continuously with the increasing number of freeze–thaw cycles. The rate of increase in the midspan deflection also increased, namely the downward deflection of the reinforced component became increasingly rapid.

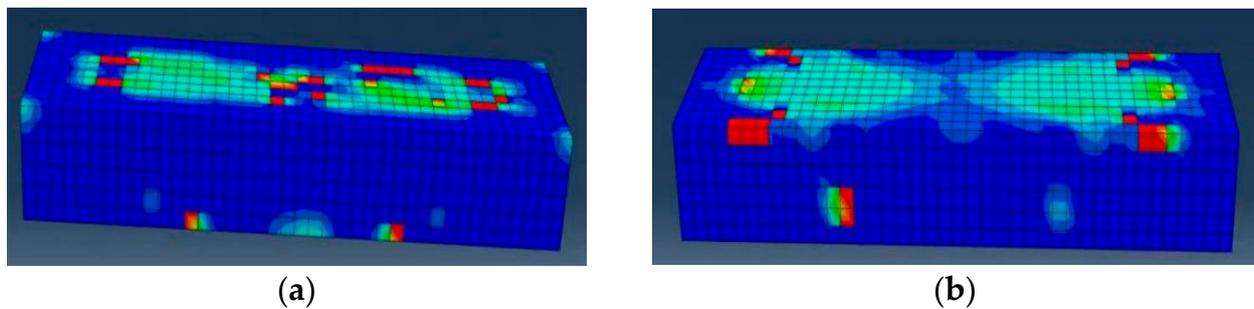
**Figure 21.** Fatigue life map of reinforced components under different freeze–thaw cycles: (a) 50 freeze–thaw cycles; (b) 100 freeze–thaw cycles.

Figure 21 shows that the freeze–thaw cycle corrosion mainly caused damage to the concrete and reduced its fatigue life, and the regions with relatively weak fatigue lives were primarily concentrated on the damaged concrete bottom surface. Figure 22 shows that the fatigue life of the prestressed hollow slab reinforced component exceeded 2 million cycles under the action of 0, 50, 100, and 150 freeze–thaw cycles. Therefore, the prestressed hollow slab reinforced components bonded with steel plates exhibited certain anti-fatigue characteristics. However, as the number of freezing and thawing cycles increased, the fatigue lives of the prestressed reinforced hollow slabs continuously decreased and the decay of the fatigue life tended to increase. The fatigue life of the prestressed hollow slab

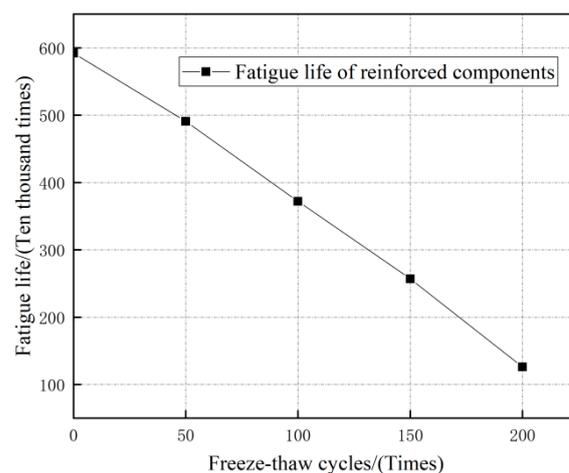
**Figure 22.** Fatigue life of reinforced components under different freeze–thaw cycles.

reinforced component that had not undergone freeze–thaw cycle corrosion was 5.92 million cycles. After 50, 100, 150, and 200 freeze–thaw cycles, the fatigue life of the reinforced components was reduced to 4.91 million, 3.72 million, 2.57 million, and 1.26 million cycles, respectively. Under the effect of corrosion by the freezing and thawing cycles, the fatigue life of reinforced components was reduced by 17–78% relative to the fatigue life obtained in the cases without corrosion. The freeze–thaw cycle corrosion greatly affected the fatigue life of the prestressed hollow slab reinforced with bonded steel plates.
