# Experimental Study on the Deformation and Mechanical Properties of Bamboo Forest Slopes

**Abstract:** In this paper, model tests on a plain soil slope and a bamboo-rooted slope under slope top loading were carried out to analyze the slope surface displacement, the change in earth pressure, and the failure mode of the slope. Furthermore, the influence of rainfall on the deformation and mechanical properties of bamboo-rooted slope sliding was studied. The results show that: (1) the failure mode of the plain soil slope was block sliding failure, while the failure mode of the bamboo-rooted slope was progressive backward failure. (2) Under the slope top load, the slope displacement shows the rule that the top of the slope was large and the foot of the slope was small. The presence of bamboo rhizomes had a negligible effect on the slope displacement, but it significantly contributed to the sliding area's increase. (3) Compared with the plain soil slope, the earth pressure in the area of the foot of the slope under the same level of the load was elevated more obviously by the bamboo-rooted slope, which indicates that bamboo rhizomes could play a specific role in reinforcing the slope.

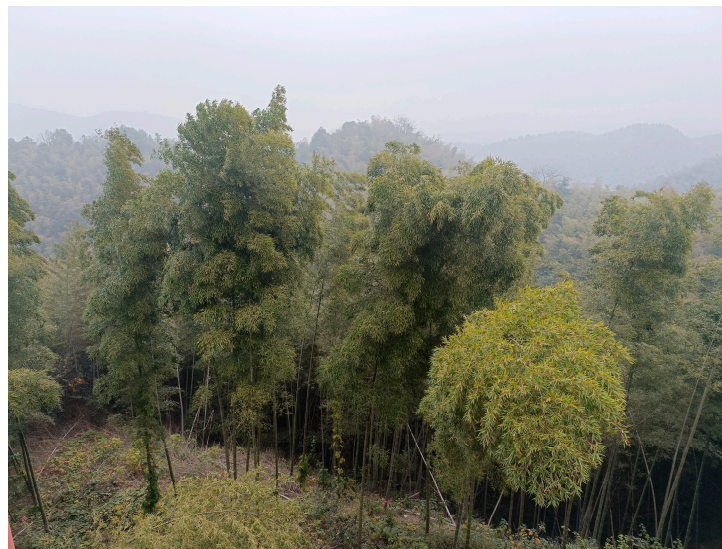
**Figure 1.** Jinpen Mountain bamboo forest.

The theoretical foundation of model tests is similarity theory. To design a landslide model test, certain similarity conditions should be selected according to the actual soil conditions, which generally include geometric similarity, physical-mechanical similarity, and boundary condition similarity [19]. In general, landslides are more likely to occur on steeper mountains [7] and choosing a larger similarity ratio is conducive to accurately reflecting the sliding properties of the prototype slopes. Considering the boundary size effects of the model box and the slope model, a bamboo forest slope satisfying the test requirements was selected in Jinpen Mountain, Taojiang County, Yiyang City, Hunan Province, China. Finally, the similarity ratio of the slope model is determined to be 1:7, and the slope angle of the model is 45°. In order to simplify the test process and highlight the research subject of the test, the model slope was divided into two parts: an upper layer of clayey soil and a lower layer of bedrock. There is a section of platform at the top and foot of the slope. The test prototype slope is shown in Figure 1. The similarity of the physical quantities for each model test is shown in Table 1.

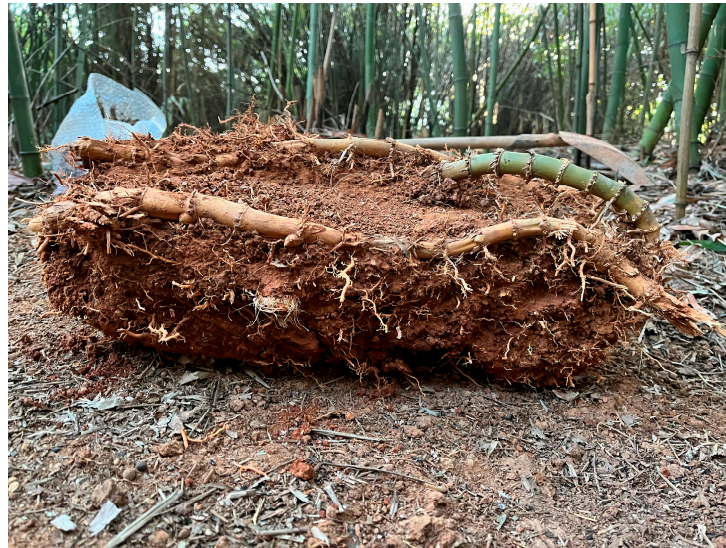
The well-developed underground root system of bamboo consists of rhizomes and stumps. Bamboo stumps have bamboo poles at the top and bamboo rhizomes at the bottom. Bamboo rhizomes grow horizontally in the soil, forming a web-like structure that is an essential component of the bamboo roots. Typically, a bamboo forest is connected as a whole by its complex underground root system, so the main factor affecting slope stability is the leading underground part of the bamboo, the bamboo rhizomes. On the prototype slope of Jinpen Mountain, three areas of 1 m<sup>2</sup> were selected to be excavated to a depth of 25 cm. After removing the soil containing the bamboo rhizomes, the two were separated to obtain complete bamboo rhizomes. The mass ratio of root to dry soil was defined as root content [20], and the average root content in these three areas was calculated to be 0.53%. In the model tests, appropriate lengths and weights of bamboo rhizomes were selected and buried into the model slopes, where the root content was controlled to be around 0.53%. The morphology of the bamboo rhizomes is shown in Figure 2. The parameters of the bamboo rhizomes are shown in Table 3.

**Figure 2.** Morphology of the bamboo rhizomes.

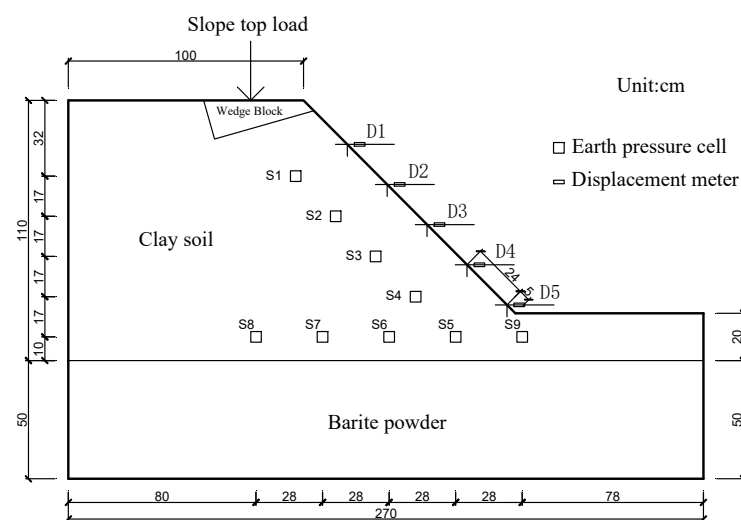
Test G1 was a plain soil slope. A total of nine earth pressure cells numbered S1–S9 were buried in the model slope, five of which were arranged along the direction parallel to the slope surface, 25 cm away from the slope surface, and 24 cm apart from each other. The other five measurement points were arranged at the bottom of the slope at a distance of 10 cm from the barite powder layer, with a distance of 28 cm between them. Two rows of measurement points shared the same earth pressure cell S5 at the foot of the slope. Five displacement measurement points were laid on the slope surface, from the top to the foot of the slope in the order of D1–D5. D5 was 5 cm away from the foot of the slope, and then a displacement measurement point was arranged at every 24 cm along the slope side up. To ensure that more effective data variations could be measured, all earth pressure cells and displacement meters were placed on the central axis of the model slope. The test G1–G3 sensor arrangement is shown in Figure 3.

**Figure 3.** Test G1–G3 sensor arrangement.

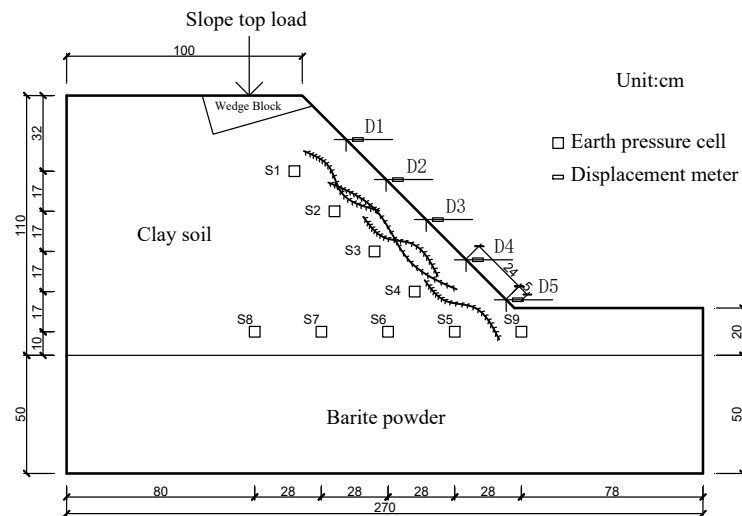
Test G2 was a bamboo-rooted slope. According to the preset root content of 0.53%, six bamboo rhizomes of about 75 cm in length and six of about 40 cm in length were selected, stacked on top of each other, and buried parallel to the slope to a depth of 15 cm. The soil

was covered with bamboo rhizomes, and the slope was compacted and then chipped. The sensor arrangement in the model slope was the same as in test G1. The embedment of bamboo rhizomes is shown in Figure 4.

**Figure 4.** Schematic diagram of bamboo rhizomes' embedment.

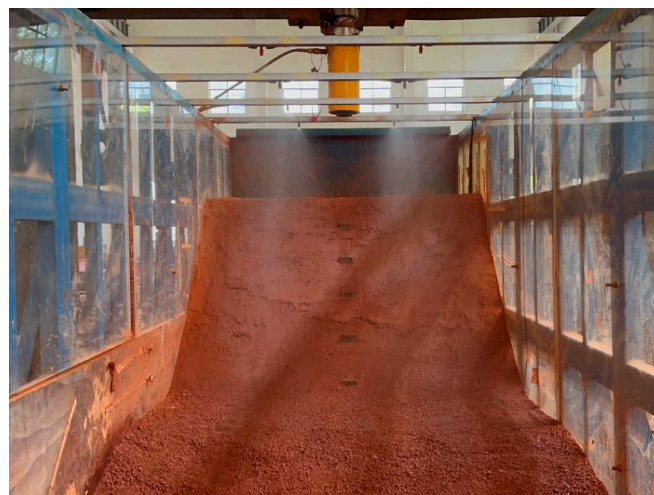
Test G3 was a rainfall bamboo-rooted slope. A rainfall simulation system was used at the beginning of the test to apply rainfall conditions to the slope top, slope face, and slope toe locations. The rainfall intensity was 20 mm/h, and the duration was one hour. After rainfall, it was left for four hours to allow the water to penetrate completely before being loaded. This rainfall intensity and duration could ensure the infiltration of rainwater to the location of the soil layer where the bamboo rhizomes were located. The arrangement of sensors within the slope and the embedment of bamboo rhizomes were the same as in test G2. The rainfall simulation system is shown in Figure 5.

**Figure 5.** Rainfall simulation system.

- (3) Rainfall simulation system. This included angle steels, a water supply piping system, rainfall nozzles, and a flowmeter. The spraying diameter of each rainfall nozzle was 1 m, and the spraying flow rate was 0.8 L/h. There were eight nozzles in total, which were connected through the water supply pipeline. Two rainfall nozzles were fixed on each angle steel, and the angle steels were spaced 60 cm apart and evenly arranged above the model box. A flowmeter was connected to the delivery pipe and was able to measure the amount of liquid passing at a rate of 1–40 L/min. The rainfall system was able to simulate an effective rainfall area of 5 m<sup>2</sup>, the rainfall intensity could be controlled at 0–20 mm/h, and the average rainfall uniformity was 82%.

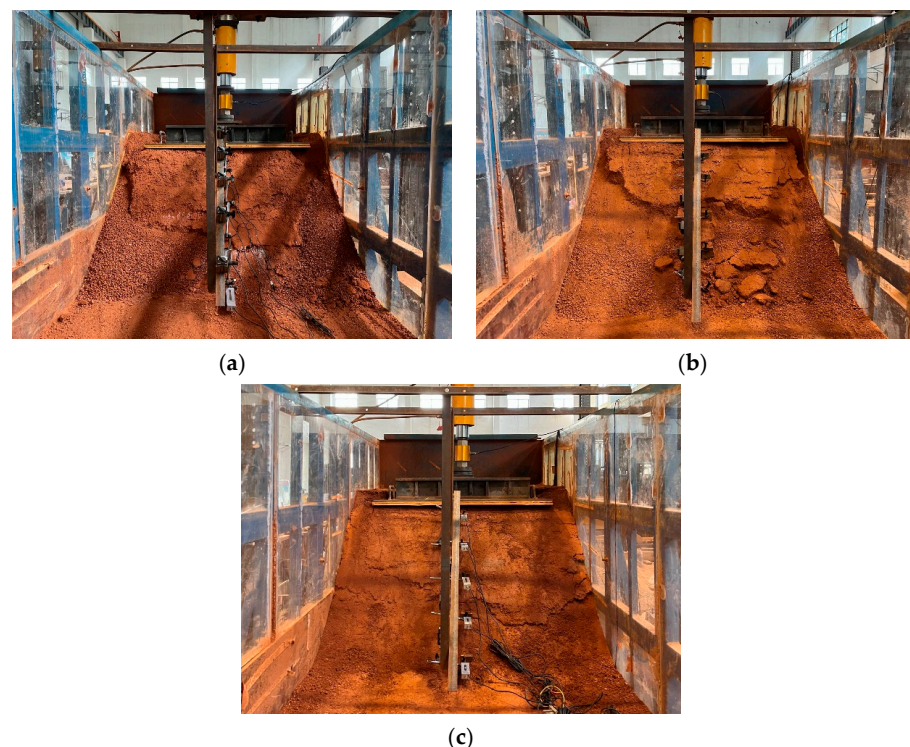
Figure 6 shows the failure of the slope after each group of test loading. In the initial stage of the slope top load applied to test G1, the soil deformation mainly occurred at the top position of the slope. With the load increase, the top of the slope produced a large settlement, and the soil was gradually compacted. The soil on the left edge of G1 started to slip from the foot of the slope area when 75 kN was applied, and then the soil on the right edge began to slip from the foot of the slope area when the load was 110 kN. The soil at the top of the slope gradually collapsed from both sides to the middle under the action of the higher load, and the soil in the middle sliding part continued to bulge in the direction of the outer side of the slope until the loading was complete. In test G2, the critical load at which sliding occurred was increased. Sliding occurred on the left and right edges of the soil when the slope was loaded to 85 kN and 90 kN in a similar form to G1, respectively, but the area where sliding occurred was increased. The multi-stage sliding failure occurred in the soil near the foot of the slope when it was loaded to 105 kN, followed by a slight local sliding failure in the lower right part of the side slope at 110 kN. The sliding body showed a trend of backward sliding failure. As can be seen from Figure 6c, the extent of slippage in the soil of test G3 was not as evident as in the first two sets of tests. In the process of increasing load, the soil did not show the phenomenon of the slipping of fine soil particles. However, it is noteworthy that when the top load of the slope was applied to 95 kN, the slider slid suddenly and formed a penetration crack from left to right in the middle and lower part of the slope and expanded rapidly with the increase in the load. In summary, under the action of the load on the top of the slope, block sliding failure occurred in test G1, and progressive backward failure occurred in test G2. After rainfall, test G3 soil slid without obvious signs and protruded in the direction of the outward slope as a whole.

**Figure 6.** Slope failure after loading in each group of tests. (a) Test G1 plain soil slope. (b) Test G2 bamboo-rooted slope. (c) Test G3 rainfall bamboo-rooted slope.

It is noteworthy that block sliding failure of slope G1 and progressive backward failure of slope G2 were observed in this paper. In contrast, R. Sonnenberg et al. [14] found that the failure mode of fallow slopes was progressive blockwise failure, and the failure mode of planted slopes was block sliding failure. The reason for the different results may be related to the root morphology of the vegetation. The root morphology of bamboo rhizomes is intertwined and grows parallel to the slope, while a single willow plant has independent roots and grows vertically. In the slope's sliding process, the already deformed bamboo rhizomes below will drive the soil above to slide down, and then the progressive backward failure will occur.

- (1) The bamboo rhizomes could change the failure mode of the slope and make the slope change from block sliding failure to progressive backward failure. Their intertwined root system forms a net-like structure, which will drive more surface soil to slide down during the sliding process of the slope.

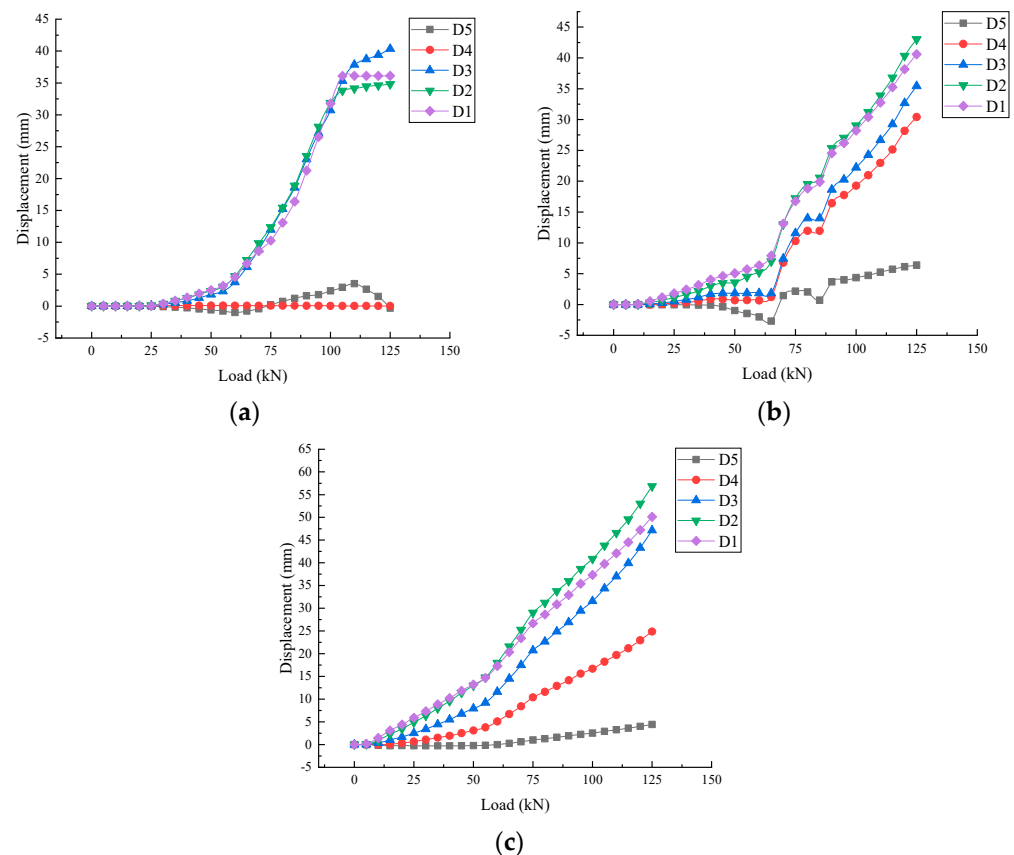
Figure 7 shows the variation in the horizontal displacement of the slope with the load on the top of the slope. As seen in Figure 7a, the critical load in test G1 that made the displacement of the five measurement points start to alter significantly was 30 kN. With increasing load, the displacements at D1, D2, and D3 all significantly increased. The displacement increase rate at these three measurement points was significantly increased when the load was loaded to 60 kN, and the maximum displacement occurred at D3 for about 40 mm. Combined with the failure to the slope, it is not difficult to find that the sliding surface of this set of slopes was located between measurement points D3 and D4. The soil on either side of the sliding surface suffered from shear failure, which made the soil above the sliding surface more prone to slip. As a result, D4 and D5, which were closer to the foot of the slope, did not shift significantly during loading. As seen in Figure 7b, the critical load in test G2 that made the displacement of the five measurement points start to alter was 20 kN. With the increase in load, the displacement at the foot of the slope increased for all measurement points except D5. When loaded to 65 kN, there was a more significant growth in the rate of displacement increase at each measurement point. The maximum displacement occurred at D2 around 43 mm. As seen in Figure 7c, the critical load in test G3 that made the displacement of five measurement points start to shift was 15 kN, and the displacement of each measurement point showed a roughly linear increase in the process of step-by-step loading. When the load was increased to 60 kN, the growth rate of displacement at each measurement point was raised, and the maximum displacement occurred at D2 of about 57 mm. Compared with test G2, the maximum displacement increase was about 32%.

**Figure 7.** Variation of horizontal displacement in the slope with a slope top load. (a) Test G1 plain soil slope. (b) Test G2 bamboo-rooted slope. (c) Test G3 rainfall bamboo-rooted slope.

The above test results show that the slope displacement presented the rule that the top of the slope was large and the foot of the slope was little under the action of the load on the top of the slope. The addition of bamboo rhizomes had a slight effect on the maximum displacement of the slope, but it had a significant contribution to the increase in the sliding region. The displacement of the rainfall bamboo root slope showed an approximately linear increasing trend in the process of step-by-step loading. It produced the largest displacement among the three groups of slopes, which was less stable.

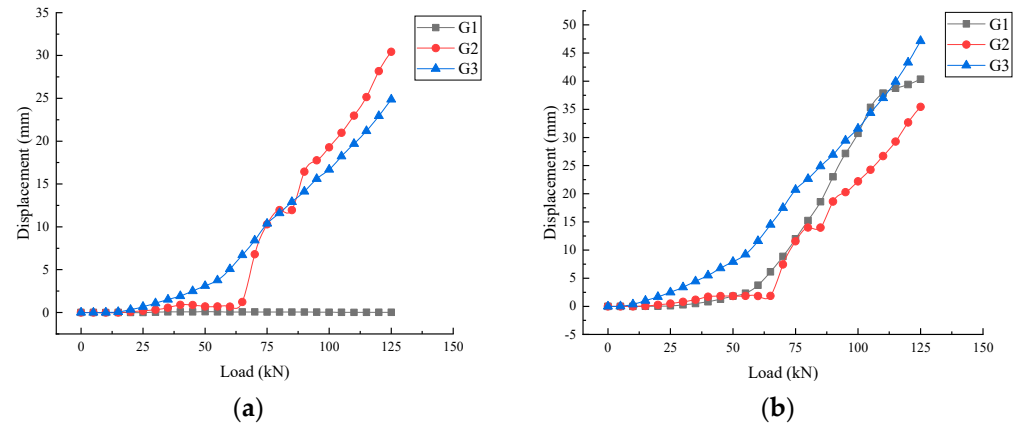
Figure 8a compares the displacement variation of measurement point D4 in each group of tests. Compared with test G1, the displacement increase in measurement point D4 in

test G2 was more apparent, and the sliding area of the slope increased significantly. This phenomenon was mainly caused by the intricate underground growth of bamboo rhizomes, with roots intertwining to form a web-like structure. Bamboo rhizomes drove additional soil to slide in the process of slope sliding

**Figure 8.** Displacement of representative measurement points in each group of tests. (a) Measurement point D4. (b) Measurement point D3.

Figure 8b compares the displacement variation of measurement point D3 in each group of tests. It can be found that the presence of bamboo rhizomes played a specific limiting role in the horizontal displacement of the slope and the stability of slope G2 was improved compared to slope G1. Due to the effect of rainfall, the displacements of measured point D3 on the slope of G3 were higher than those of G2 at all loading levels. This suggests that the stability of this slope was significantly reduced compared with that of slope G2

In Figure 8b, the displacement of measuring point D3 in test G3 is the result of the interaction between the restraining effect of bamboo rhizomes on soil and the weakening effect of rainfall on soil. At the initial loading stage, the displacement of slope G3 at measurement point D3 increased faster with the load. When the load reached 60 kN, the displacement growth rate of measurement point D3 in slope G1 exceeded that of slope G3. During the subsequent loading process, the deformation of slope G1 increased significantly. When the load at the top of the slope was close to 100 kN, the displacements of the two groups of slopes at this point were already relatively close. The above test results show that the weakening effect of rainfall on the soil body accounts for the main effect when the slope does not produce large deformation. After the slope was deformed, the restraining effect of the bamboo rhizomes gradually appeared, and it was more evident at the middle and lower positions of the slope. However, it is worth noting that the displacement of slope G3 exceeded that of slope G1 under higher load, which indicates that the restraining ability of bamboo rhizomes to soil is limited. Comparing the variation of soil pressure in the vicinity of this displacement measurement point, under the action of the top load, the soil pressure rise of slope G3 was smaller than that of slope G1, which also confirmed the displacement variation.

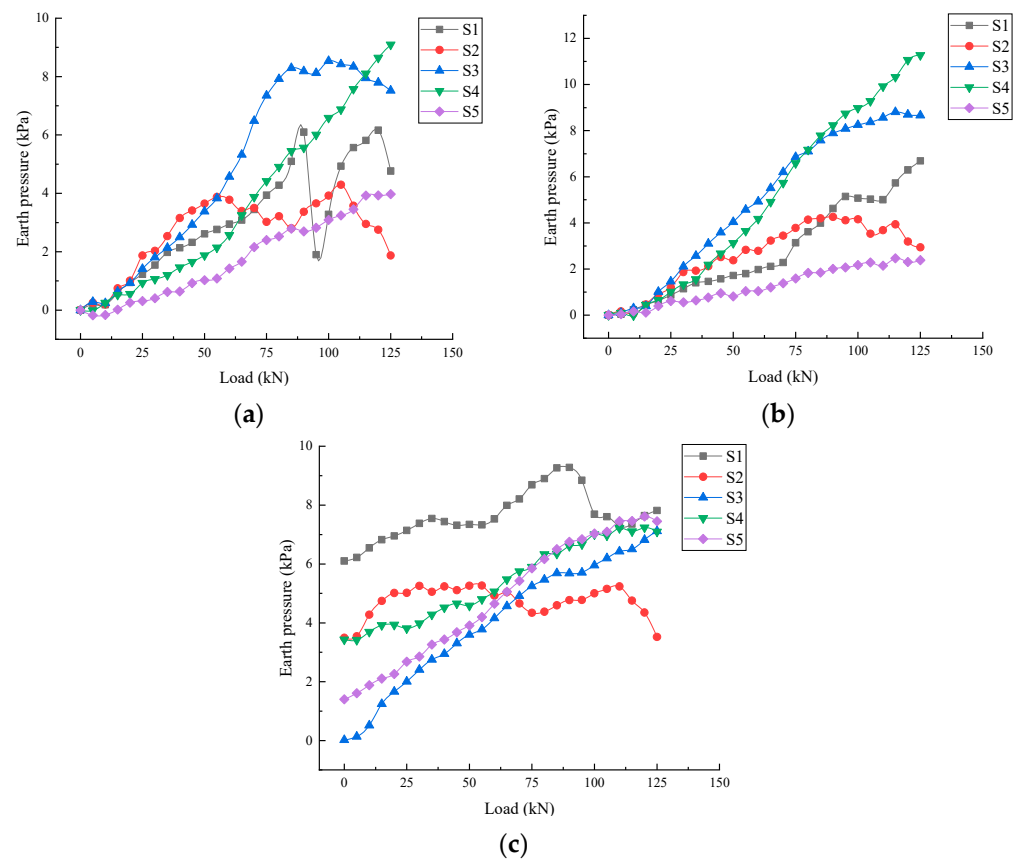
Figure 9 shows the variation of horizontal earth pressure with the slope top load at measured points along the slope direction. It can be seen from Figure 9a that in the initial loading stage of test G1, the earth pressure response at the measuring points S1 and S2, which were closest to the loading position, was more rapid and the amplitude increased more evidently. However, with the increase in load, S1 dropped at 95 kN and then continued to rise. This means that the soil near the measurement point had reached a new equilibrium state after the failure occurred under this load level, and the earth pressure rose again. The same unloading trend also occurred at measurement points S2 and S3. By analyzing the test data of these three measurement points, it was found that the soil above measurement point S3 was damaged during loading at the top of the slope. The

sliding surface of the slope was between measurement points S3 and S4, corresponding to a shift of the slope G1. Compared with test G1, the number of measurement points where unloading occurred in test G2 was significantly reduced. Only a minor amount of unloading occurred at measurement point S2, which was closer to the loading area at the top of the slope. During the initial loading process, there was no obvious pattern in the magnitude of earth pressure shift at each measurement point along the slope in the direction of test G1. However, in test G2, the earth pressure of S1 and S2, which were close to the loading position of the slope top, was invariably smaller than that of S3 and S4, which were located in the middle of the slope. This suggests that bamboo rhizomes may be more effective in limiting the deformation of the soil located in the lower and middle parts of the slope, resulting in less displacement and higher earth pressure under the same load. Under rainfall conditions, the soil capacity of the slope increased due to the infiltration of rainwater, which created a substantial initial earth pressure at the beginning of loading. The rainfall boundary was applied at the slope's top, surface, and foot, so rainwater infiltration was more at the top and less at the foot of the slope. Therefore, the initial earth pressure of measurement points S1 and S2, located at the top of the slope, was larger than that of other measurement points. The incremental magnitude of earth pressure at each measurement point during step-by-step loading was considerably smaller than in the first two sets of tests. This shows that due to the infiltration of rainwater, the effective stress between soil particles and particles decreased, and the slope had a greater displacement under the same load, which reduced the compactness of the soil at each measuring point significantly. The absence of a stable support surface for the earth pressure cell resulted in a significant reduction of the earth pressure in this set of working conditions compared to slope G2.

**Figure 9.** Variation of horizontal earth pressure at measured points along the slope with the slope top load (a) Test G1 plain soil slope. (b) Test G2 bamboo-rooted slope. (c) Test G3 rainfall bamboo-rooted slope.

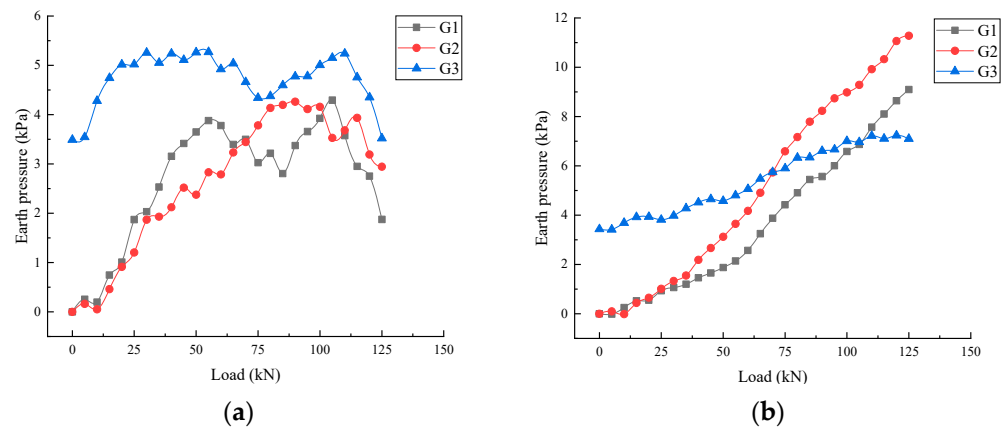
Figure 10a compares the variation of earth pressure measurement point S2 with the slope top load in each group of tests. Since the measurement point S2 was close to the location of the top load, the earth pressure at this measurement point in each group of tests produced different degrees of unloading phenomenon during the step-by-step loading process. Through comparison, it can be found that the soil of slope G3 in the three groups of tests could not continue to bear higher loads at first, and the earth pressure at the measuring point S2 did not evidently increase, only when loaded to 20 kN. The second was slope G1; the unloading load level was 55 kN. The highest load level that can be supported was slope G2, and the load level for unloading was 90 kN. Under rainfall conditions, there was a significant decrease in the amplitude of earth pressure at measurement point S2 with the rise in load. The variation amplitude of earth pressure at measuring point S2 in test G3 was 1.78 kPa, which was 58% lower than that of 4.26 kPa in test G2. Observing the shift in displacement measurement point D2 near test earth pressure measurement point S2 in both groups, it was found that the maximum displacement of test G3 at D2 was 56.85 mm, which was improved by about 32% compared with the maximum displacement of test G2 at D2 of 43.03 mm. This further indicates that the soil deformation released the earth pressure inside the slope, and the two data can be corroborated with each other.

**Figure 10.** Earth pressure of representative measurement points in each group of tests. (a) Measurement point S2. (b) Measurement point S4.

Figure 10b compares the variation of earth pressure measurement point S4 with the slope top load in each group of tests. It can be seen that the earth pressure at measurement point S4 in test G2 was greater than that in test G1 under all levels of loading. The maximum earth pressure at measurement point S4 in test G2 was 11.28 kPa, which was approximately 24% higher than the maximum earth pressure of 9.1 kPa at measurement point S4 in test G1 under the same level of loading. In contrast, the value-added earth pressure at measurement point S4 in test G3 was only 3.81 kPa, which was only 34% of the same measurement point in G2. This suggests that the bamboo rhizomes had a favorable reinforcement effect at the location near the foot of the slope. Still, the reinforcement effect of the bamboo rhizomes was fragile under the rainfall condition and could not limit the deformation of the soil. The above test results suggest that the bamboo rhizomes could play a specific restraining effect on the rear soil. They could increase the bearing capacity of the soil, reduce the occurrence of unloading, and improve the earth pressure at the foot of the slope under the same load. Rainfall significantly reduced the stability of the slope, and the earth pressure uplift value was inferior in the process of increasing load at the top of the slope. This indicates that the soil was uncompacted during the loading process and was more prone to landslides.

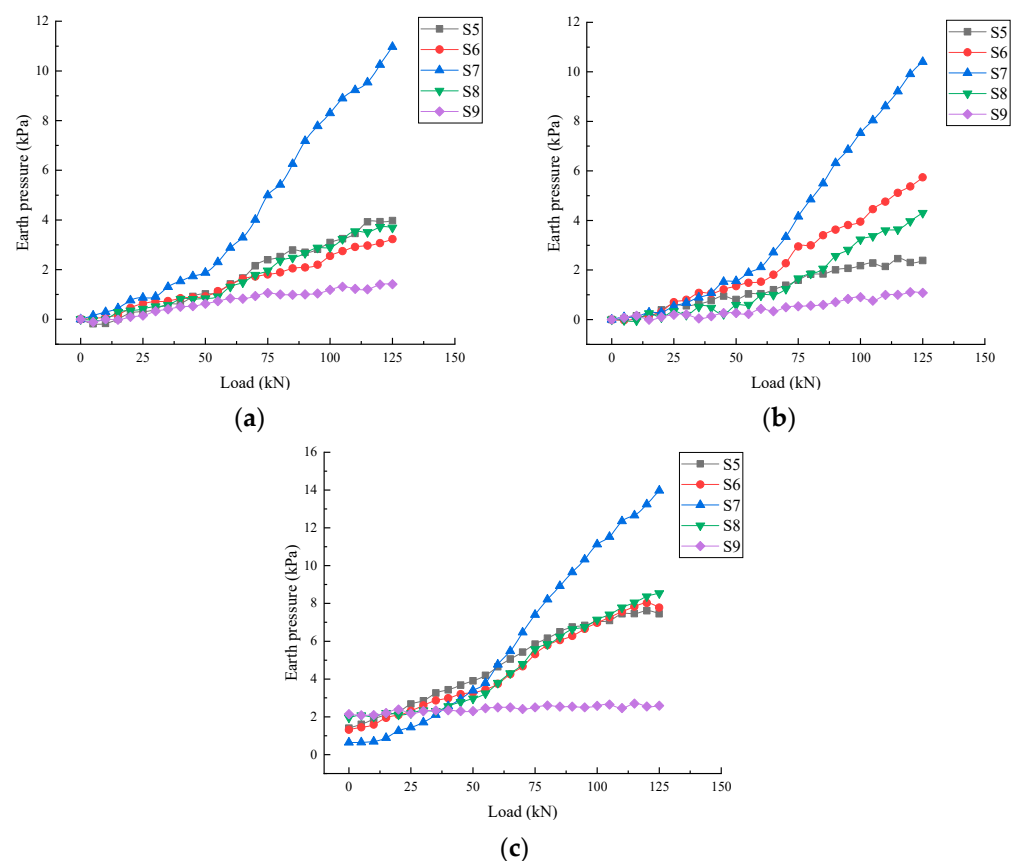
Figure 11 shows the variation of horizontal earth pressure with the slope top load at the measured points along the bottom direction of the slope. From Figure 11a, it can be seen that the slope of earth pressure rise at S7 started to exceed the remaining four

measurement points significantly when the load was applied to 30 kN, and the horizontal soil pressure at this point reached 10.97 kPa when the load was applied to 125 kN. This is mainly because the top of the slope is loaded with a wedge block. During the step-by-step loading process, the most direct-action area of the load at the bottom of the slope was located near the measuring point S7. The same pattern was present in the data of test G2 and test G3. As seen in Figure 11b, there was a tendency for the earth pressure in the direction of the bottom of the slope under the top load of test G2 to gradually decay from the center of measurement point S7 to both sides. Under the higher-level load, the earth pressure at each measurement point was S7, S6, S8, S5, and S9 from high to low. The difference in earth pressure at each measurement point was prominent, while the earth pressure at measurement points S5, S6, and S8 in test G1 was similar in magnitude. This indicates that the existence of bamboo rhizomes limited the displacement of the soil at the bottom of the slope, and there was an essential condition for the increase in earth pressure during the step-by-step loading process. As seen in Figure 11c, there was initial earth pressure at each measuring point at the beginning of the test due to the rainfall in test G3. Still, since the measurement points were located at the bottom of the slope, they were less affected by the rain than the measurements along the slope surface direction. The earth pressure at measurement points S5, S6, and S8 in this group of tests had a similar trend of shift during the process of step-by-step loading, and the phenomenon of the gradual decay of load from S7 to both sides in the direction of the slope bottom was not evident.

**Figure 11.** Variation of horizontal earth pressure at measured points along the bottom of the slope with the slope top load (a) Test G1 plain soil slope. (b) Test G2 bamboo-rooted slope. (c) Test G3 rainfall bamboo-rooted slope.

The above test results show that the horizontal earth pressure in the bottom direction of the slope decreased from the center of the measuring point S7 to both sides under the top load of the slope. The bamboo rhizomes strongly influenced the stability of the shallow soil, and the measurement points closer to the bamboo rhizomes had higher earth pressure under the same load level. The influence of rainfall on the horizontal earth pressure of the soil at the bottom of the slope was mainly concentrated in part nearer to the slope, while the effect on the horizontal earth pressure of the soil deep inside the slope was minor.

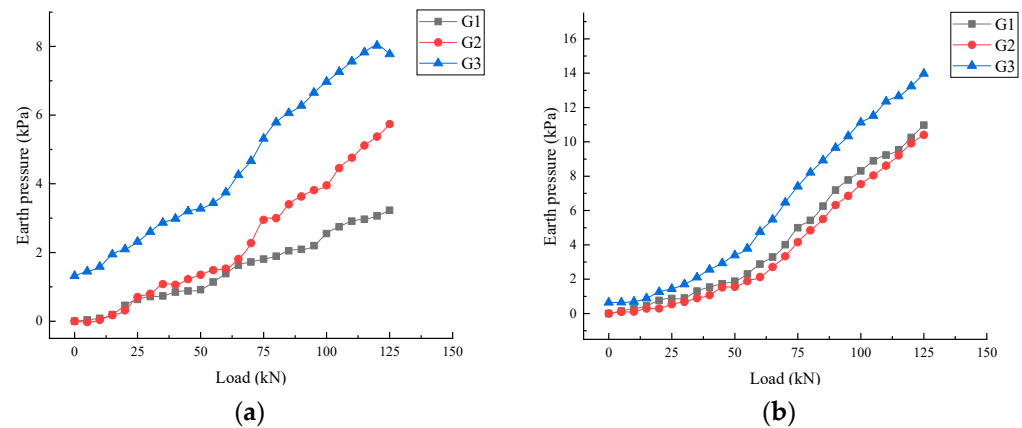
Figure 12a compares the variation of earth pressure measurement point S6 with the slope top load in each group of tests. When the load was less than 65 kN, the magnitude of earth pressure at measurement point S6 was relatively consistent in tests G1 and G2. In contrast, when the load exceeded 65 kN, it was evident that the earth pressure at

measurement point S6 in test G2 had a relatively significant increase. This suggests that the bamboo rhizomes could also play a relatively good role in enhancing the slope in the bottom direction of the slope under high-grade loads. The trend of earth pressure change with the slope top load at measurement point S6 in test G3 was roughly the same as in test G2, indicating that the influence of rainfall boundary on earth pressure at this measurement point was dominated by changes in the initial earth pressure.

**Figure 12.** Earth pressure at representative measurement points in each group of tests. (a) Measurement point S6. (b) Measurement point S7.

Figure 12b compares the variation of earth pressure measurement point S7 with the slope top load in each group of tests. Comparing the data, it can be seen that the magnitude of earth pressure at measurement point S7 was generally consistent with the load increase in tests G1 and G2, indicating that the bamboo rhizomes had a negligible effect on the earth pressure at measurement point S7. Combined with the location of the measurement points in the slope, it can be found that the influence of the bamboo rhizomes on the back soil ranged between measurement points S6 and S7.

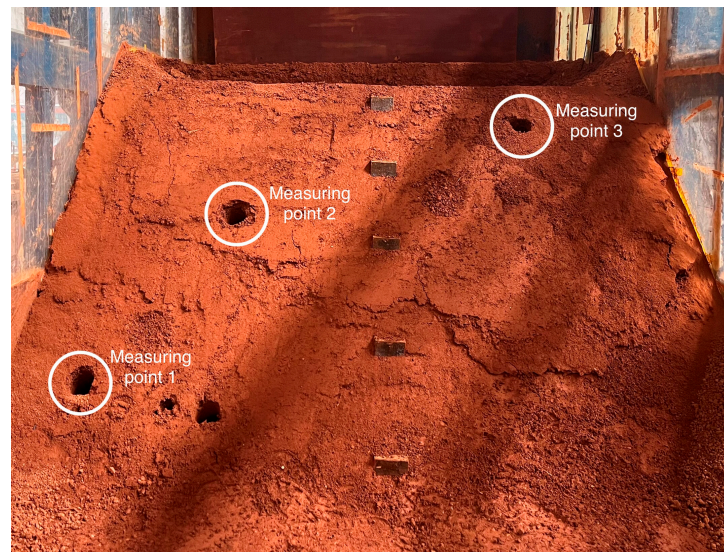
The above study analyzed the effects of single variables of bamboo rhizomes and rainfall on the deformation and mechanical properties present during the sliding of slopes. However, the impact on the soil in the case of mutual coupling between the two still requires additional exploration. The coupling effect can be reflected in the superposition of the values of a certain characteristic of the slope. Therefore, it is valid to compare the displacement and earth pressure in test G3 with that in test G1 to derive the coupling effect of bamboo rhizomes and rainfall. Then, ensuring that the bamboo rhizomes and rainwater are in a coupled state is a prerequisite for the test results to be usable and relevant. At the end of test G3, soil samples at the depths of 5 cm, 10 cm, 15 cm, 20 cm, and 25 cm were selected from three measuring points at the slope's lower, middle, and upper parts, and the samples were tested for water content. The distribution of measurement points is shown in Figure 13. The water content at different depths of each measurement point is shown in Table 4.

**Figure 13.** Distribution of water content measuring points.

Combined with the water content of the soil at the beginning of the test (about 13%), the water content of the soil increased significantly at a depth of 15 cm with bamboo rhizomes. This indicates that during the infiltration of rainfall; the infiltration peak had reached and passed where the bamboo rhizomes were situated. Therefore, the results of test G3 were produced with coupled bamboo rhizomes and rainfall
