Influence of Composite Thickness on Ultrasonic Guided Wave Propagation for Damage Detection Using Embedded PZT Transducers

Abstract: This paper describes a study that focuses on assessing the influence of composites with different thicknesses (2 mm, 4 mm, and 9 mm) on embedded ultrasonic guided waves (UGWs) under varying temperatures. The study also demonstrates the effectiveness of these embedded sensors in identifying damage. A novel cut-out method that included an embedded diagnostic layer and phased-array lead zirconate titanate (PZT) transducers, created using the ink-jet printing technique in the manufacturing process was employed. The research then focused on studying the behavior of UGWs under varying temperatures for each composite panel. This analysis aimed to understand how temperature variations affected the propagation of guided waves in thick composites. Finally, artificial damage on the surface and impact damage were introduced, both embedded and surface-mounted PZT transducers were used to detect and locate these damages in different thickness composite panels. The results of damage localization indicated that the embedded PZT transducers were more sensitive than t

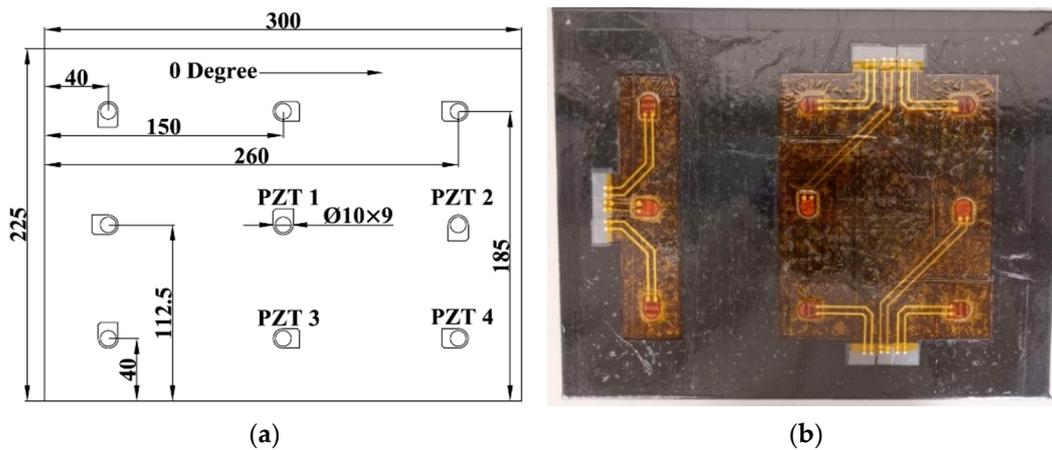
Figure 1. (a) Drawing of the composite panel; (b) schematic of embedded PZT transducers during lay-up.

In the experiments conducted for this study, three composite panels were fabricated to investigate the effects of thickness on Lamb wave propagation in composites utilizing embedded PZT transducers. Unidirectional carbon fiber pre-pregs, specifically Hexply[®] IM7/8852 (Hexcel, Duxford, UK), were used for the lay-up process. The stacking sequences employed were quasi-isotropic, $[(0^\circ/+45^\circ/-45^\circ/+90^\circ)_n]_s$, with n representing the number of plies. The panel thicknesses manufactured are 2 mm, 4 mm, and 9 mm. The dimensions of the specimens were 300 mm \times 225 mm, and the average cured thicknesses for each composite panel were approximately 2 mm, 4 mm, and 9 mm, respectively. The embedding of PZT transducers was accomplished using DuraAct[™] (PI Ceramic GmbH, Lederhose, Germany) (P-876.K025) PZT transducers. Figure 1a illustrates the drawing of each composite panel, depicting the configuration of the PZT transducers. Additionally, Figure 1b provides a schematic representation of the diagnostic layers with embedded PZT transducers during the embedding process. These composite panels, along with the embedded PZT transducers, were specifically designed to investigate the thickness effects on Lamb wave propagation and enable a comparative analysis with the results obtained from surface-mounted PZT transducers in the author's previous work. The choice of material, lay-up configuration, and PZT transducers facilitates a systematic examination of the influence of thickness on Lamb wave behavior in composite laminates.

To generate the actuation signal, a National Instrument (NI) PXI-5412 arbitrary signal generator was used, while a NI PXI-5105 digitizer was employed to record the measured UGW signals. The actuation signals utilized were five-cycle Hanning-windowed toneburst signals [37] with an input amplitude of 6 V. The sampling frequency was set to 100 MHz, with actuation frequencies of 50 kHz and 250 kHz for different experiments. Path 1–2 of the embedded PZT transducer pair, as shown in Figure 1a, was chosen for all three panels.

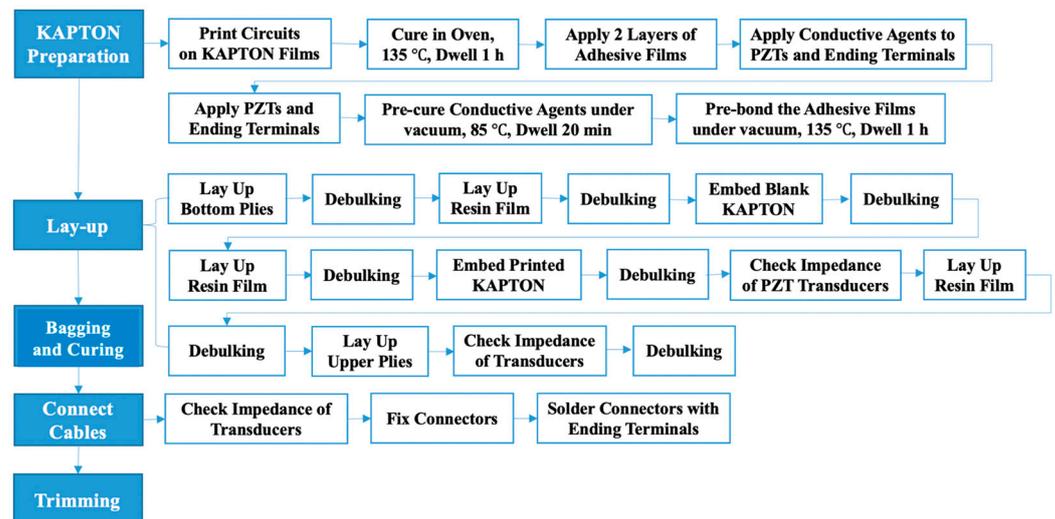
Figure 2. Flow chart of the manufacturing procedure.

Figure 2 shows the flow chart of the embedding technique for the composite manufacturing. To prepare the diagnostic layers with printed circuits, a Dimatix materials printer (DMP-2580) was utilized along with a silver-based ink containing nanoparticles at a concentration of 30–35 wt.%. The circuits were printed on Kapton® films (DuPont, Stevenage, UK), which had a thickness of 25.4 μm and a melting temperature of up to 400 °C. The piezo voltage for printing was set to 20 V, and a jetting frequency of 5 kHz ensured stable drop formation during the printing process. To achieve optimal printing quality, the substrate temperature was maintained at 55 °C, and a drop spacing of 35 μm was employed. To enhance the conductivity of the circuits and increase signal amplitudes, the circuits were printed three times with a width of 1.4 mm. After printing, the Kapton® films with the printed circuits were placed in a laboratory oven at 135 °C for 1 h to ensure the particles in the ink became conductive.

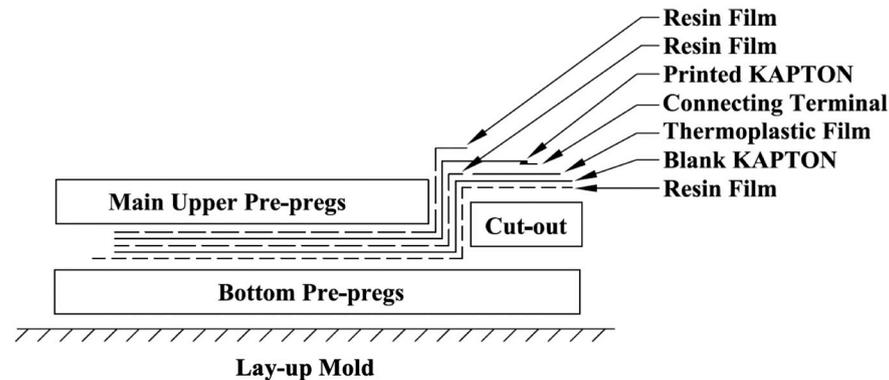
Figure 3. Schematic of cross-sectional part at cut-out position.

making connections. To address these challenges, high-temperature connecting terminals (Techni Measure Ltd., Doncaster, UK) (TML Co. TPF-2MS) were used. The terminals enabled soldering and ensured more stable connection quality when joining the circuits and connectors. Figure 3 provides an illustration of the high-temperature connecting terminals and their application in connecting the circuits and connectors.

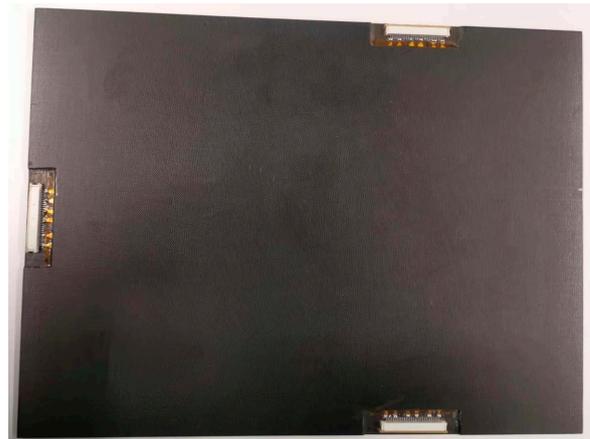
Figure 4. Photo of the panel with embedded PZT transducers after trimming.

Following the inspection, the edges of the composite panels were trimmed. Connectors (RS 514–4408) were then mounted on the designated edges and bonded using superglue (RS 473–445). Finally, soldering was employed to establish the connection between the circuits and connectors. Figure 4 illustrates an example of a composite panel with embedded PZT transducers after the trimming process. The panel depicted in the figure has a thickness of 2 mm. The introduction of the cut-out method allowed for the precise trimming of composite edges while preserving the integrity of the embedded circuits. This approach facilitated the subsequent mounting of connectors and the establishment of reliable connections through soldering. The resulting composite panel with embedded PZT transducers exhibited a streamlined and functional design, as demonstrated in Figure 4.

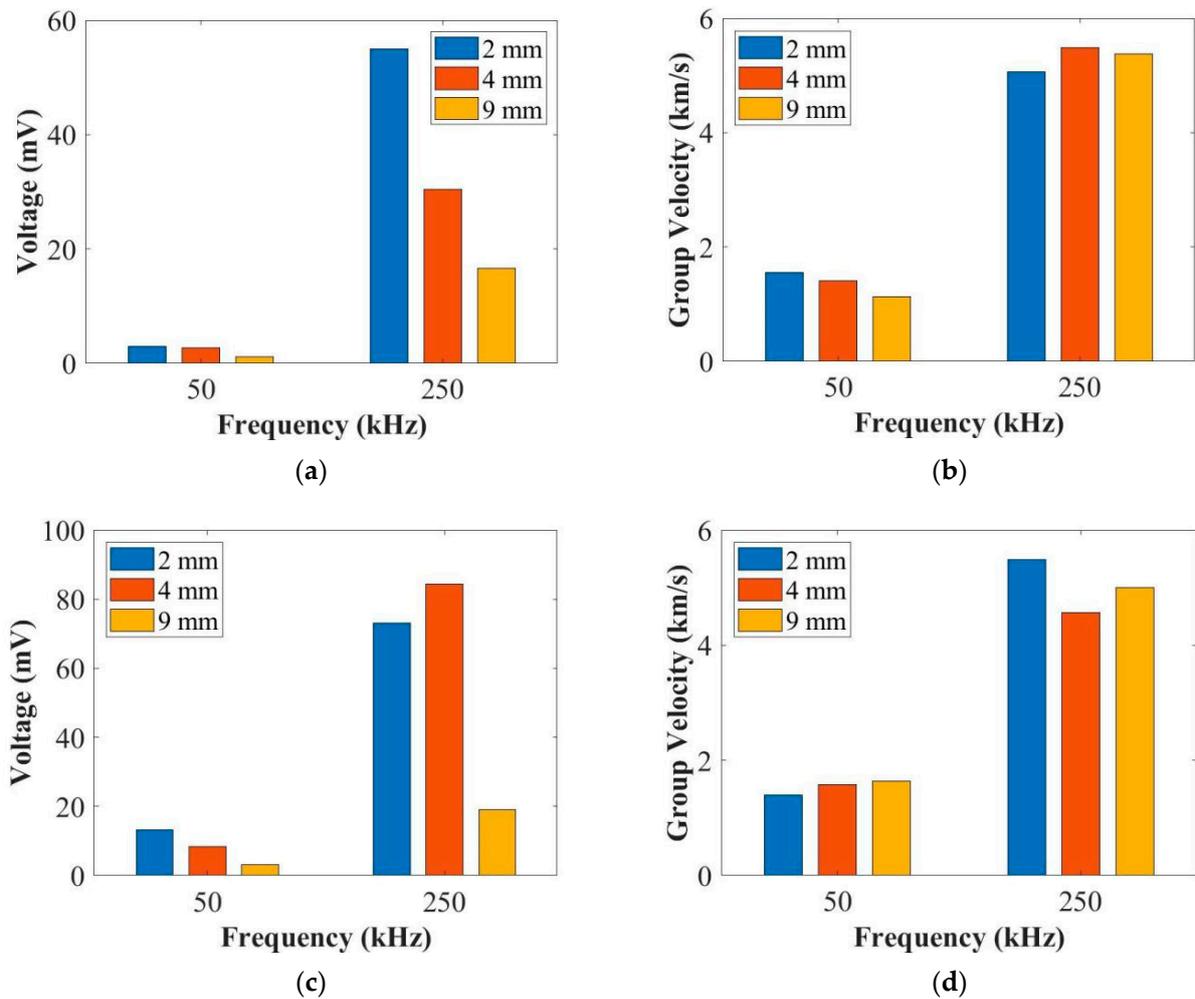
Figure 5. The summary of (a) the amplitude and (b) the group velocity of the embedded UGW and (c) the amplitude and (d) the group velocity of the surface-mounted UGW for the thickness of 2 mm, 4 mm, and 9 mm panels at 50 kHz and 250 kHz.

Figure 5a,b presents the extracted features of the peak amplitude and group velocity, respectively, for the first wave packet of embedded UGWs at 50 kHz and 250 kHz. The corresponding surface-mounted results are also included for comparison in Figure 5c,d. The peak amplitude was determined by selecting the peak of the envelope signals, while the group velocity was calculated by dividing the distance of the embedded PZT transducer pair path 1–2 by the time-of-arrival of the envelope signals. From Figure 5a, it can be observed that the peak amplitudes of both the A_0 and S_0 modes decrease with increasing thickness. In Figure 5b, it is evident that the group velocity of the A_0 mode decreases with increasing thickness at 50 kHz. On the other hand, the group velocity of the S_0 mode for the 9 mm thick panel is faster than that of the 2 mm thick panel but slower than that of the 4 mm thick panel at 250 kHz.

In summary, the thickness of the plate has an impact on the amplitudes of both the A_0 and S_0 modes of embedded UGWs. Additionally, the group velocity of the A_0 mode is influenced by the thickness, whereas the group velocity of the S_0 mode does not exhibit a significant dependence on thickness. These findings provide valuable insights into the behavior of UGWs and the influence of thickness when utilizing embedded PZT transducers. They contribute to the understanding of how to optimize excitation parameters for damage detection and localization in composite structures with different thicknesses, thereby enhancing the effectiveness of SHM applications.

Comparing the results obtained from embedded PZT transducers in Figure 5a,b with the surface-mounted PZT transducers in Figure 5c,d [21], some notable differences can be observed. In particular, the amplitude of the S_0 mode for the embedded signals exhibited a dependence on thickness at 250 kHz, whereas the amplitude of the surface-mounted signals did not show a similar trend. Additionally, the group velocity of the A_0 mode showed contrasting behaviors between the embedded and surface-mounted signals at 50 kHz. The group velocity decreased for the embedded signals as the thickness increased, while it increased for the surface-mounted signals. The reason behind these opposite relationships in the group velocity between the embedded and surface-mounted UGWs lies in the different bonding materials used. The embedded PZT transducers were bonded using resin films to comply with composite manufacturing specifications. On the other hand,

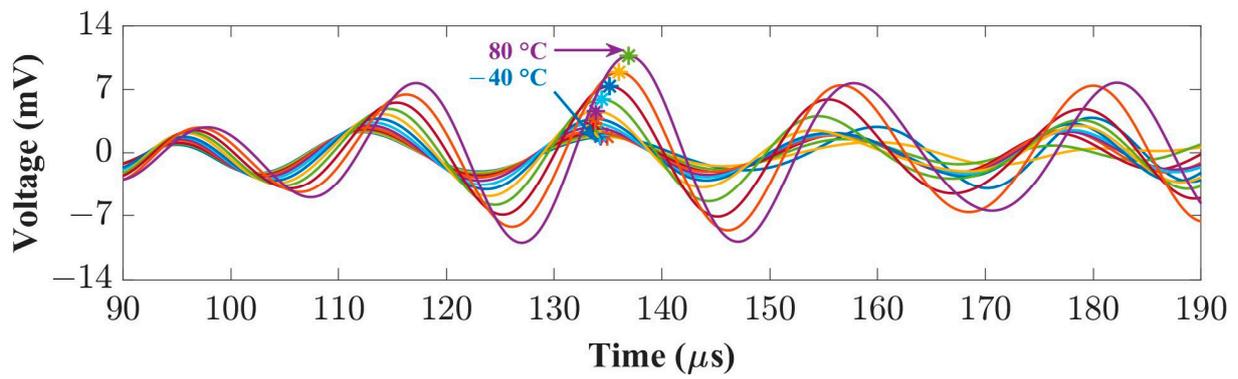
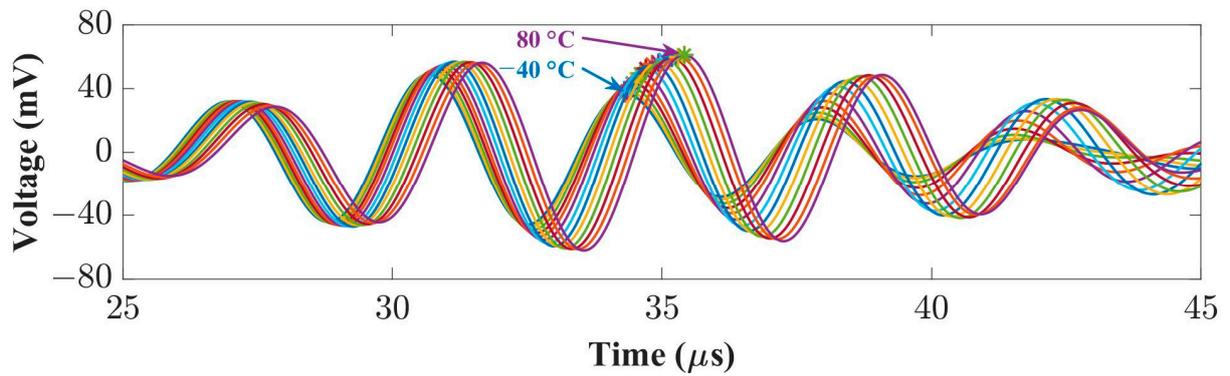
Figure 6. Examples of embedded UGWs under different temperatures at (a) 50 kHz and (b) 250 kHz.

Figure 6 presents an example of the embedded signals at 50 kHz and 250 kHz for a 2 mm thick panel under different temperatures. The peak amplitude of each first wave packet of the embedded signals was automatically computed to measure amplitude reduction and phase shift. The analysis of the peak amplitude and time-of-flight of the embedded signals under varying temperatures provides insights into the temperature effects on UGW propagation and helps determine appropriate compensation algorithms. By quantifying the amplitude reduction and phase shift, the researchers can develop temperature compensation techniques that ensure accurate and reliable diagnosis in the presence of temperature variations.

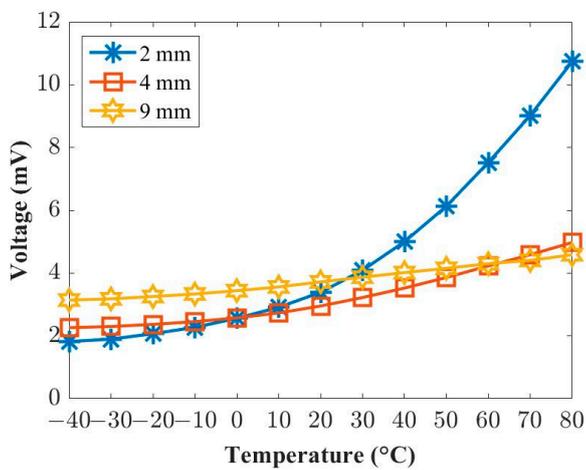
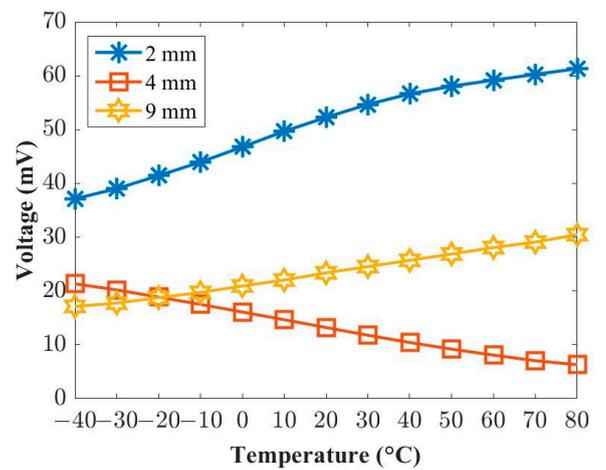
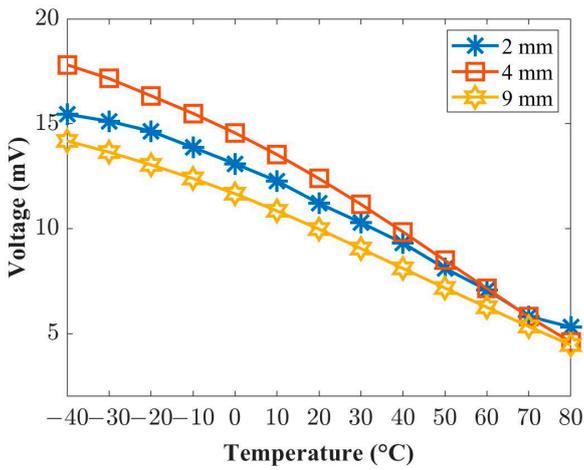
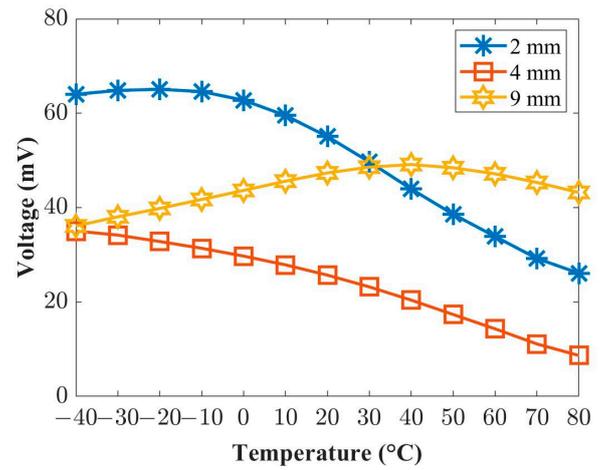
Figure 7. Relationships of the temperature with the peak amplitude at (a) 50 kHz and (b) 250 kHz for embedded UGW and at (c) 50 kHz and (d) 250 kHz for surface-mounted UGW.

Figures 7 and 8 present the relationships between temperature and the peak amplitude, as well as the time-of-flight (ToF) of the first wave packet of the embedded signals at 50 kHz (A_0 mode) and 250 kHz (S_0 mode) for the 2 mm, 4 mm, and 9 mm thick panels. These figures also include the surface-mounted results for comparison. In Figure 7a, the peak amplitude of the A_0 mode exhibits an increasing trend with temperature for all panel thicknesses at 50 kHz. However, the slopes of the amplitude increase vary for different thicknesses. Similarly, in Figure 7b, the peak amplitude of the S_0 mode shows temperature dependence at 250 kHz. For the 2 mm and 9 mm thick panels, the amplitude increases with temperature, while for the 4 mm thick panel, the amplitude decreases as temperature increases.

Comparing the embedded temperature results to the surface-mounted temperature results in Figure 7c,d, some differences can be observed. For the peak amplitude of the A_0 mode (50 kHz), it decreased for the surface-mounted signals but increased for the embedded signals with increasing temperature for all panel thicknesses. Similarly, for the peak amplitude of the S_0 mode (250 kHz), the surface-mounted signals initially increased and then decreased with temperature, while the embedded signals consistently increased, but only for the 2 mm thick panel. Additionally, the ToF of the A_0 mode (50 kHz) increased for the surface-mounted signals but showed a decrease followed by an increase for the embedded signals in the 2 mm thick panel.

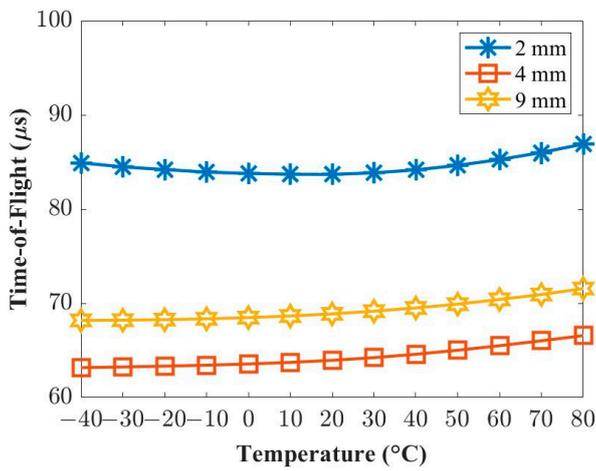
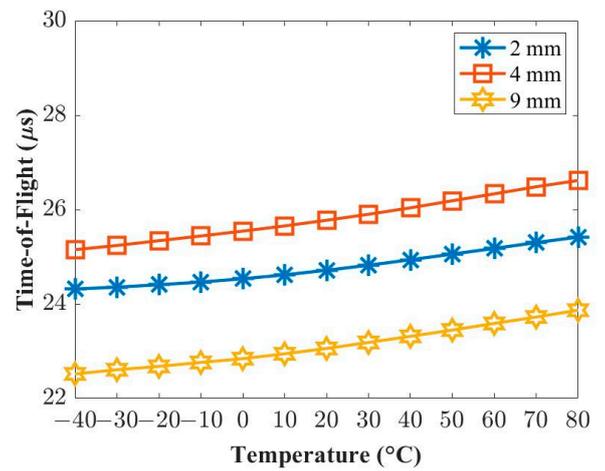
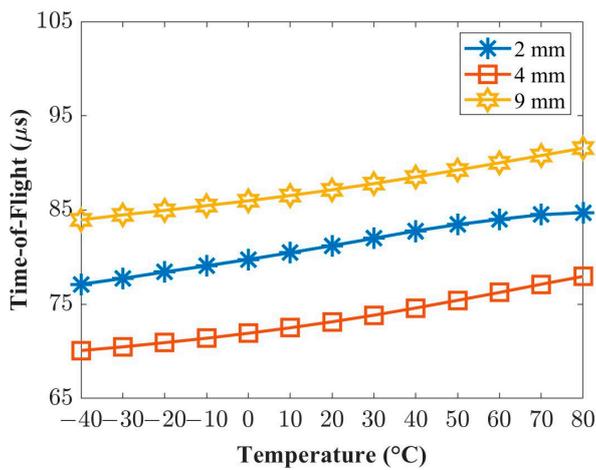
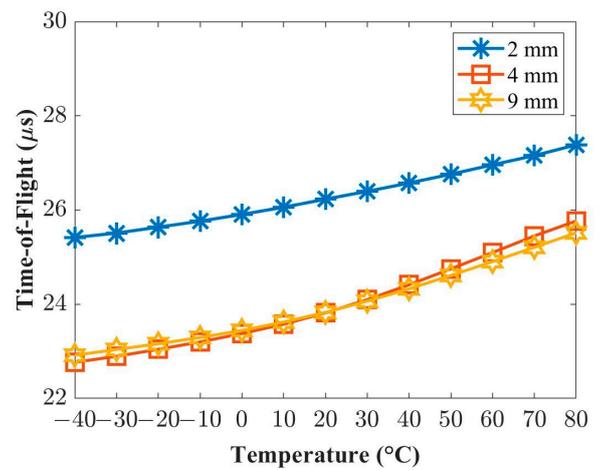
Figure 8. Relationships of the temperature with the time-of-flight at (a) 50 kHz and (b) 250 kHz for embedded UGW and at (c) 50 kHz and (d) 250 kHz for surface-mounted UGW.

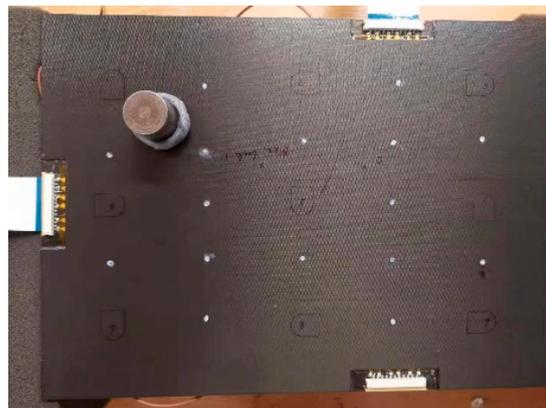
Figure 9. Photo of a weighted Blu Tack placed on the surface of the 2 mm thick panel.

Figure 9 illustrates the placement of the weighted Blu Tack, which simulates surface-mounted artificial damage, on the surface of the 2 mm thick panel. The weighted Blu Tack is positioned in a designated location, typically off-center, to mimic the presence of localized damage on the composite surface. This configuration allows for the investigation of damage detection and localization using the correlation coefficient and the delay-and-sum (DAS) algorithm for panels with different thicknesses, including 2 mm, 4 mm, and 9 mm.

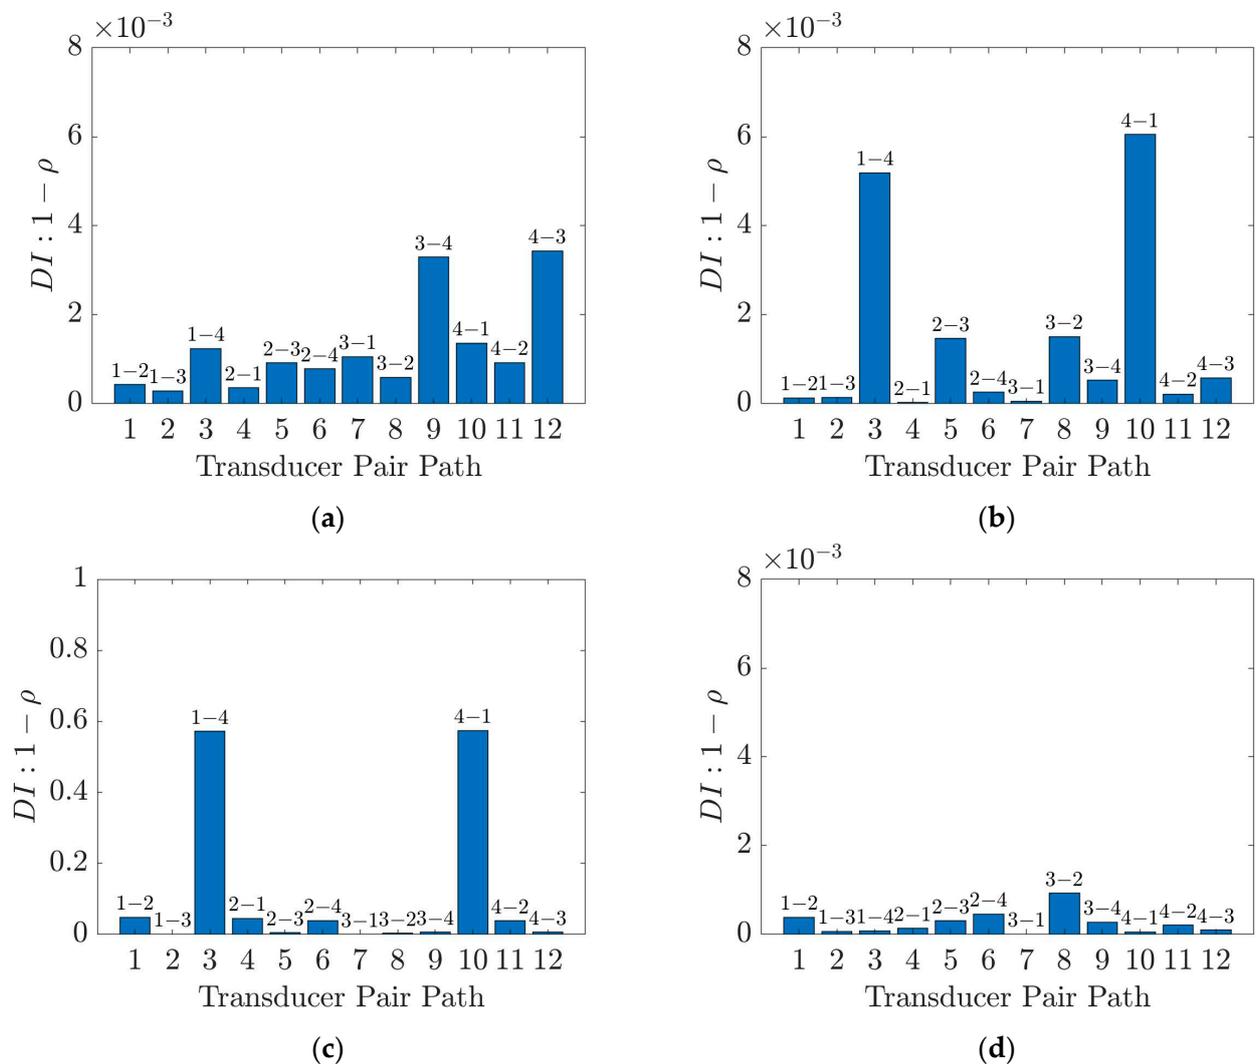
Figure 10. Detections of surface-mounted artificial damage for the 2 mm thick panel at (a) 50 kHz and (b) 250 kHz using embedded PZT transducers and at (c) 50 kHz and (d) 250 kHz using surface-mounted PZT transducers.

Figures 10–15 present the results of damage detections and localizations for the panel thicknesses of 2 mm, 4 mm, and 9 mm at 50 kHz and 250 kHz, respectively. These figures also include the surface-mounted results for comparison. For the 4 mm panel, it is important to note that the embedded circuits of PZT transducer 1 shown in Figure 1 became disconnected during the manufacturing process. As a result, only three embedded PZT transducers were available for damage detection and localizations in this panel. Regarding the 9 mm panel, the much higher amplitude of crosstalk introduced interference in the first wave packet of the measured signal for pair paths 1–3/3–1 and 2–4/4–2 shown in Figure 1 at 50 kHz. This interference made it difficult to accurately identify the time-of-arrival of the measured signals for the aforementioned pair paths. Consequently, the correlation coefficient and DAS algorithm based on the time-of-arrival information could not be effectively used for damage detection and localization at 50 kHz.

The DI values for the S_0 mode are generally higher than those for the A_0 mode, indicating that the S_0 mode is more suitable for surface-related damage detection. The DI values decrease with increased thickness at both 50 kHz and 250 kHz, indicating that the DI values of the S_0 and A_0 modes of embedded UGWs are thickness-dependent. Compared to surface-mounted results, the DI values for the A_0 mode of embedded UGWs are lower, while those for the S_0 mode of embedded UGWs are higher. This is because the A_0 mode is out-of-plane dominant, while the S_0 mode is in-plane dominant.

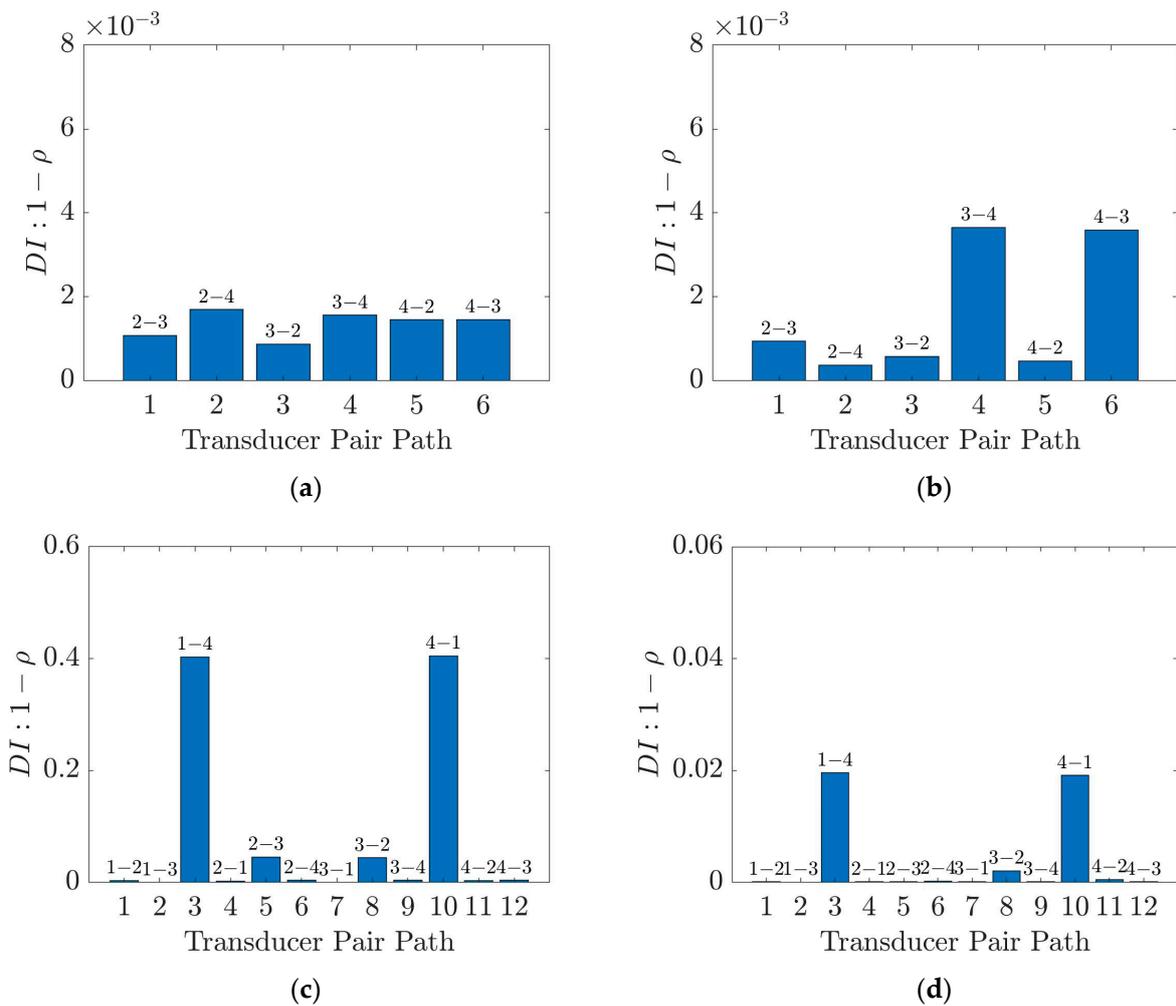
Figure 11. Detections of surface-mounted artificial damage for the 4 mm thick panel at (a) 50 kHz and (b) 250 kHz using embedded PZT transducers and at (c) 50 kHz and (d) 250 kHz using surface-mounted PZT transducers.

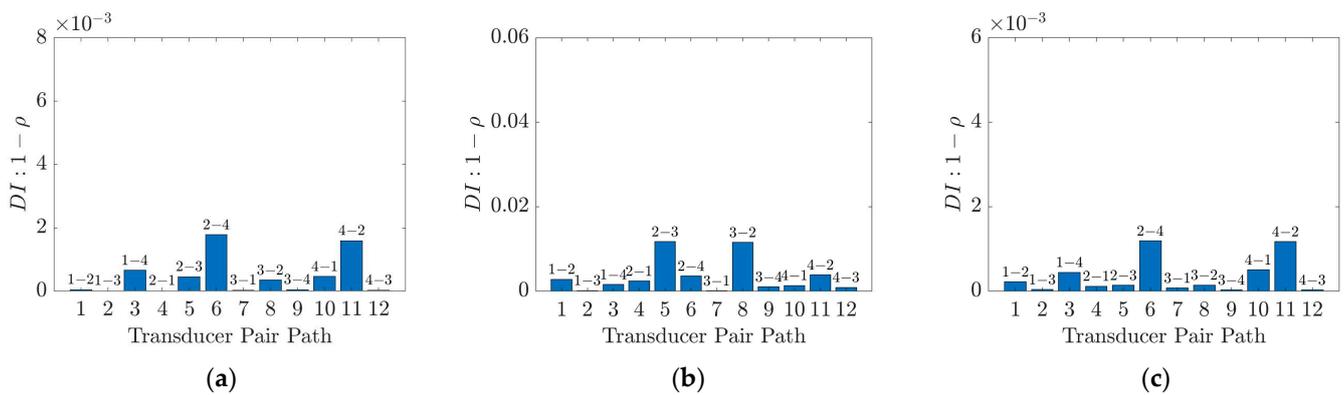
Figure 12. Detections of surface-mounted artificial damage for the 9 mm thick panel at (a) 250 kHz using embedded PZT transducers and at (b) 50 kHz and (c) 250 kHz using surface-mounted PZT transducers.

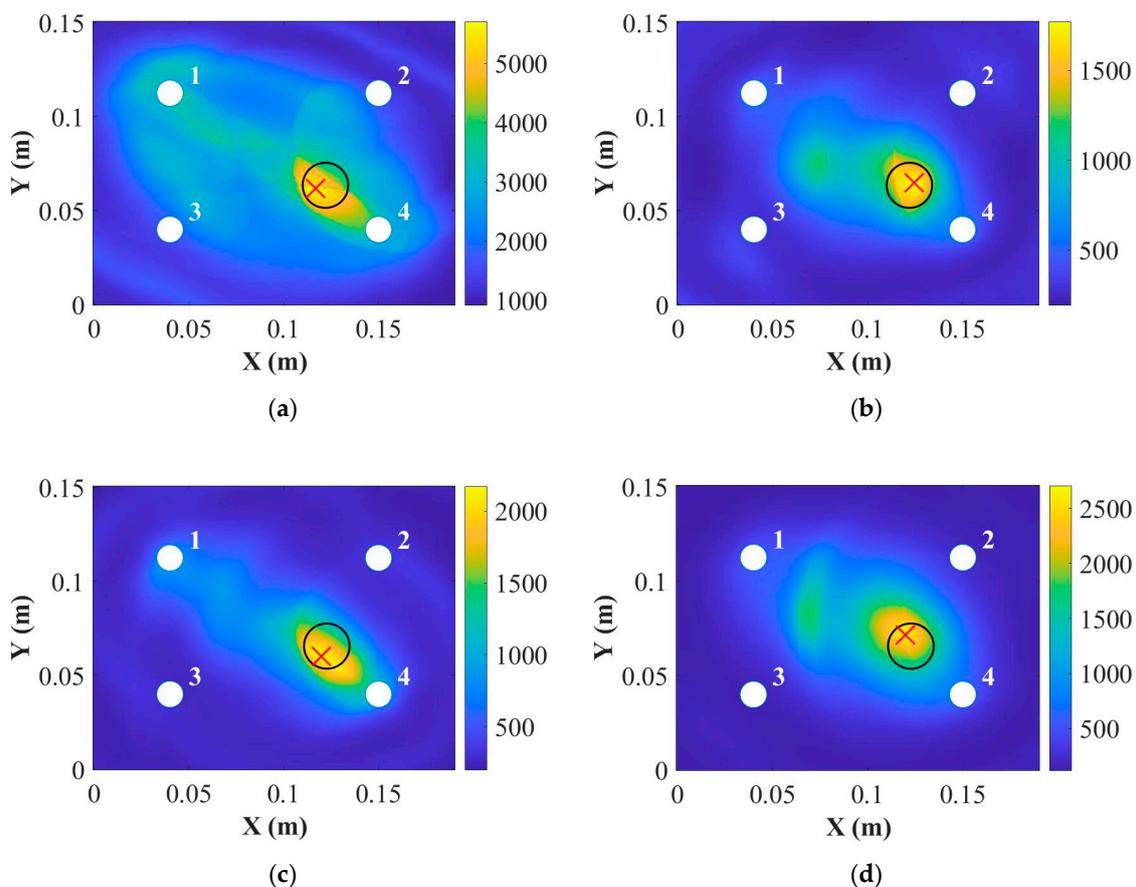
Figure 13. Localizations of surface-mounted artificial damage for the 2 mm thick panel at (a) 50 kHz and (b) 250 kHz using embedded PZT transducers and at (c) 50 kHz and (d) 250 kHz using surface-mounted PZT transducers (where the “○” is the position for real damage and the “×” is the position for predicted damage).

The surface-mounted artificial damage can be accurately located using embedded PZT transducers, even for thick composite panels (e.g., 9 mm). The embedded PZT transducers demonstrate better sensitivity in locating surface-mounted artificial damage in thick composite laminates compared to surface-mounted PZT transducers, as shown in Figure 15. These findings highlight the advantages of using embedded PZT transducers for damage detection and localization in thick composite laminates. The embedded transducers exhibit higher sensitivity and accuracy in locating surface-mounted artificial damage compared to surface-mounted transducers. Additionally, the choice of the appropriate UGW mode (S_0 or A_0) depends on the nature of the damage and the specific requirements of the application.

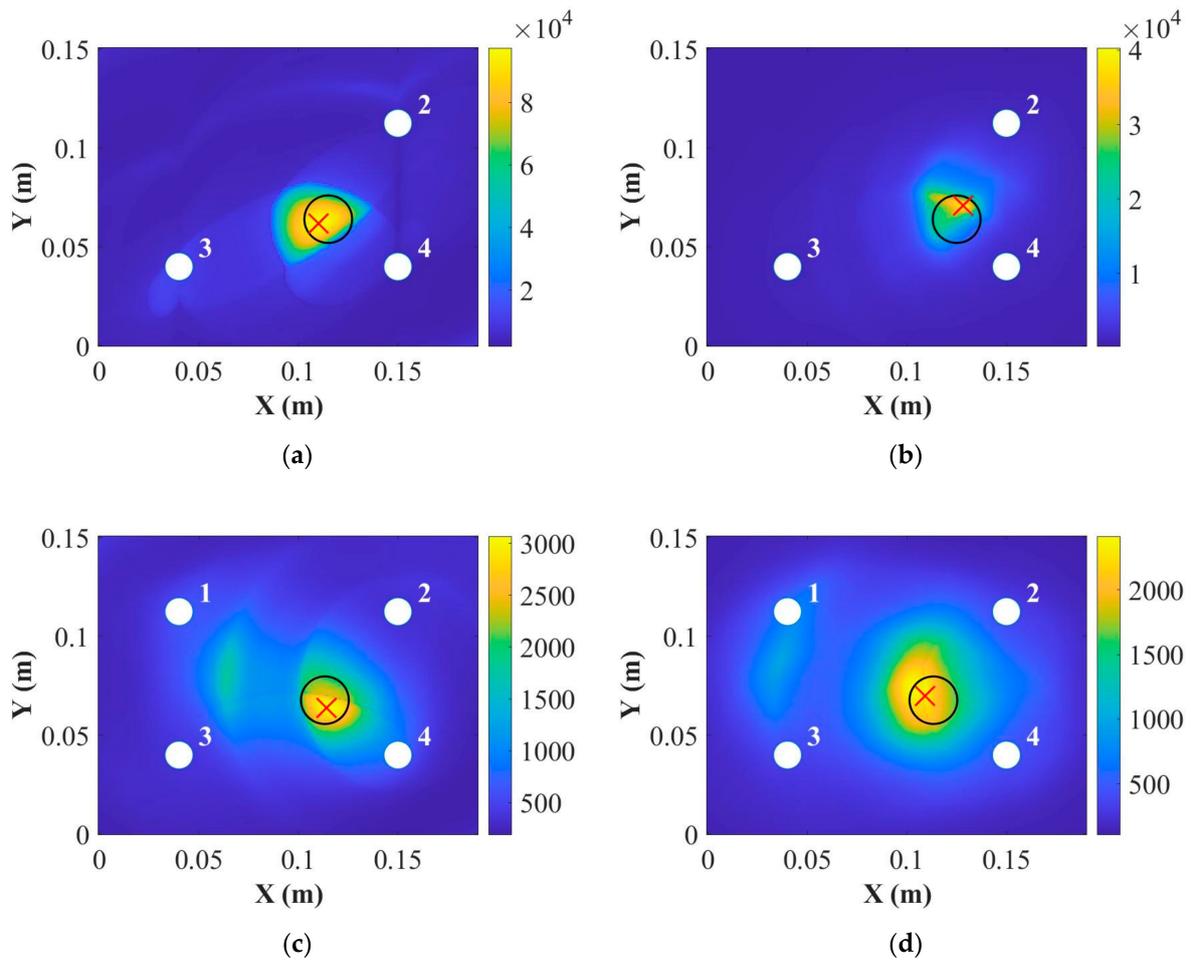
Figure 14. Localizations of surface-mounted artificial damage for the 4 mm thick panel at (a) 50 kHz and (b) 250 kHz using embedded PZT transducers and at (c) 50 kHz and (d) 250 kHz using surface-mounted PZT transducers (where the “○” is the position for real damage and the “×” is the position for predicted damage).

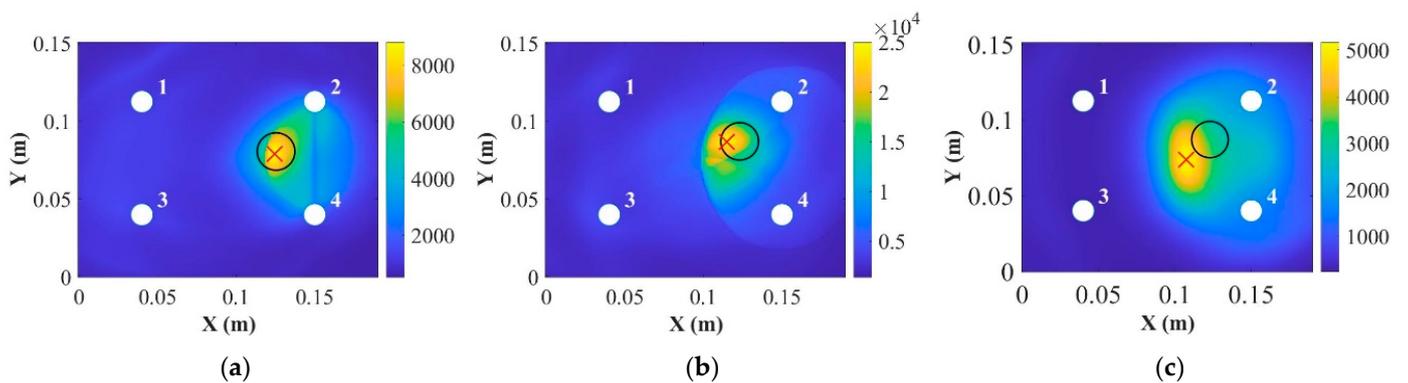
Figure 15. Localizations of surface-mounted artificial damage for the 9 mm thick panel at (a) 250 kHz using embedded PZT transducers and at (b) 50 kHz and (c) 250 kHz using surface-mounted PZT transducers (where the “○” is the position for real damage and the “×” is the position for predicted damage).

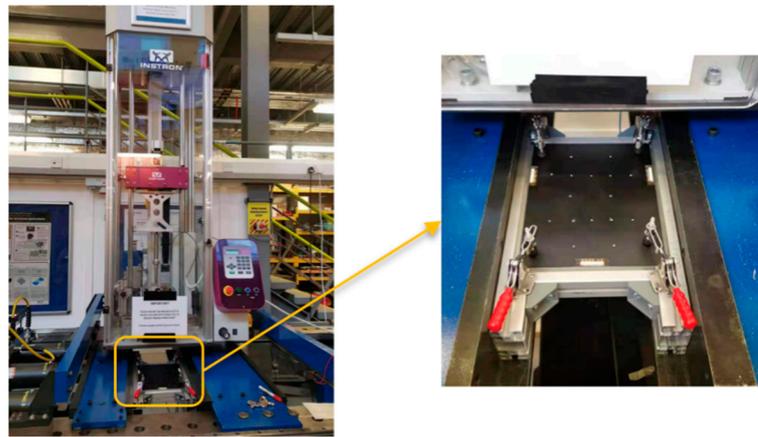
Figure 16. INSTRON CEAST 9350 drop tower for the impact test.

The impact tests were performed using a drop tower, specifically the INSTRON CEAST 9350, as shown in Figure 16. The impact position for each panel was the same as that used for the surface-mounted artificial damage in Section 5.1. The impact energy was initially set at a relatively low level and increased incrementally by 2 J for each impact test. After each impact, the impact area was inspected using a DolphiCam C-scan (CF08) to identify the resulting damage. The impact energy was increased until a suitable damage area was detected and captured by the C-scan.

The impactor used in the tests was a hemisphere with a diameter of 20 mm. The load cell used for the 2 mm thick panel was a 22 kN load cell with an additional 3 kg mass, while a 90 kN load cell with the same additional mass was used for the 4 mm and 9 mm thick panels. The impact energy and velocity values used for each panel were as follows: 15 J and 3.53 m/s for the 2 mm thick panel, 20 J and 2.72 m/s for the 4 mm thick panel, and 57 J and 4.59 m/s for the 9 mm thick panel, respectively. These impact tests provide the basis for evaluating the detection and characterization of real BVID in composite panels of different thicknesses using embedded UGWs. The impact parameters were carefully chosen to achieve suitable damage areas for subsequent analysis and assessment.

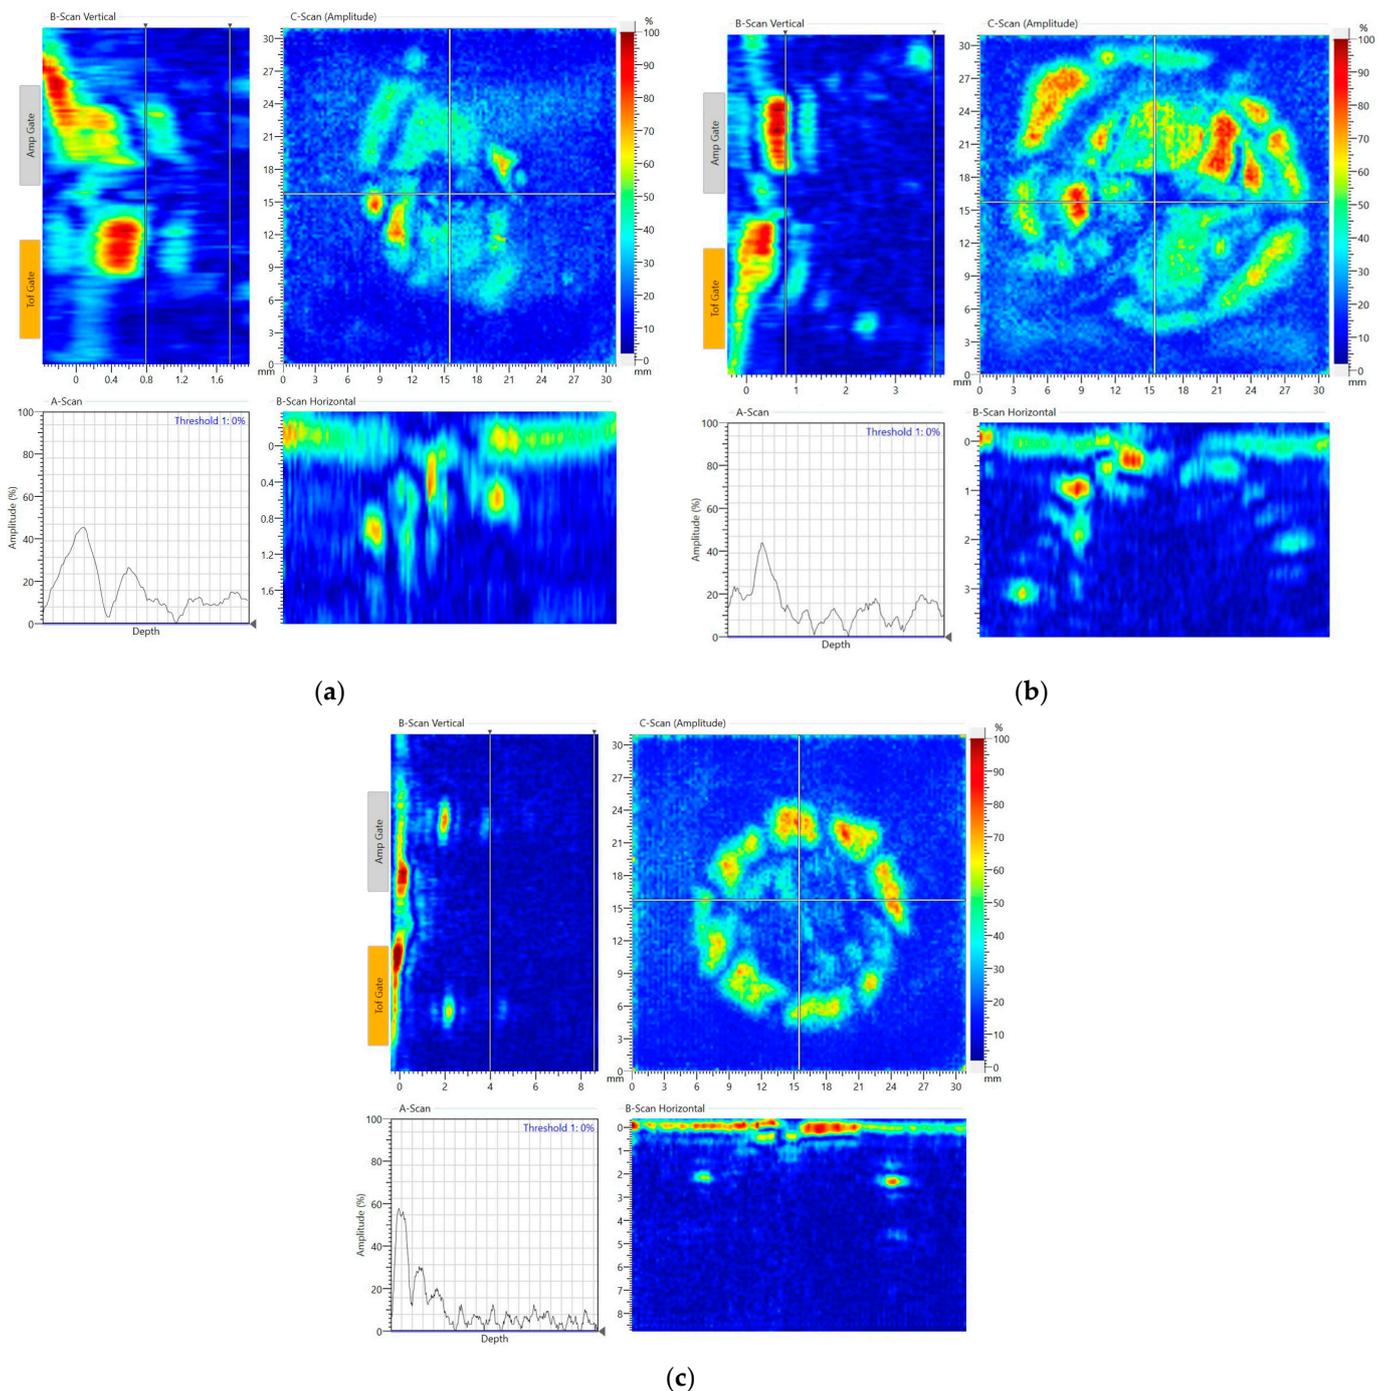
Figure 17. C-scan results of the impact damage at (a) 15 J for the 2 mm panel, (b) 20 J for the 4 mm panel, and (c) 57 J for the 9 mm panel.

Figure 17 illustrates the results of the non-destructive inspection (NDI) using the DolphiCam C-scan (CF08) for the impact damage on each composite panel. The following observations can be made based on the figure:

- (a) For the 2 mm thick panel (Figure 17a), the detected damage area was approximately 176 mm², and the damage thickness was measured to be around 1.2 mm from the impact surface. Additionally, surface cracks were visible on the panel after the impact test.
- (b) In the case of the 4 mm thick panel (Figure 17b), the detected damage area was approximately 452 mm². The horizontal and vertical B-scans indicated a damage thickness of approximately 3 mm from the impact surface. Similar to the 2 mm thick panel, surface cracks were also observed.
- (c) For the 9 mm thick panel (Figure 17c), the detected area of the impact damage was around 254 mm². The horizontal and vertical B-scans revealed a damage thickness of approximately 2 mm from the impact surface. Surface cracks were also visible on this panel following the impact test.

These NDI results provide visual evidence of the impact damage inflicted on each composite panel. The DolphiCam C-scan successfully captured the extent and location of the damage, as well as the presence of surface cracks. These findings will serve as a basis for further analysis and comparison with the results obtained from the embedded UGW measurements for damage detection and localization.

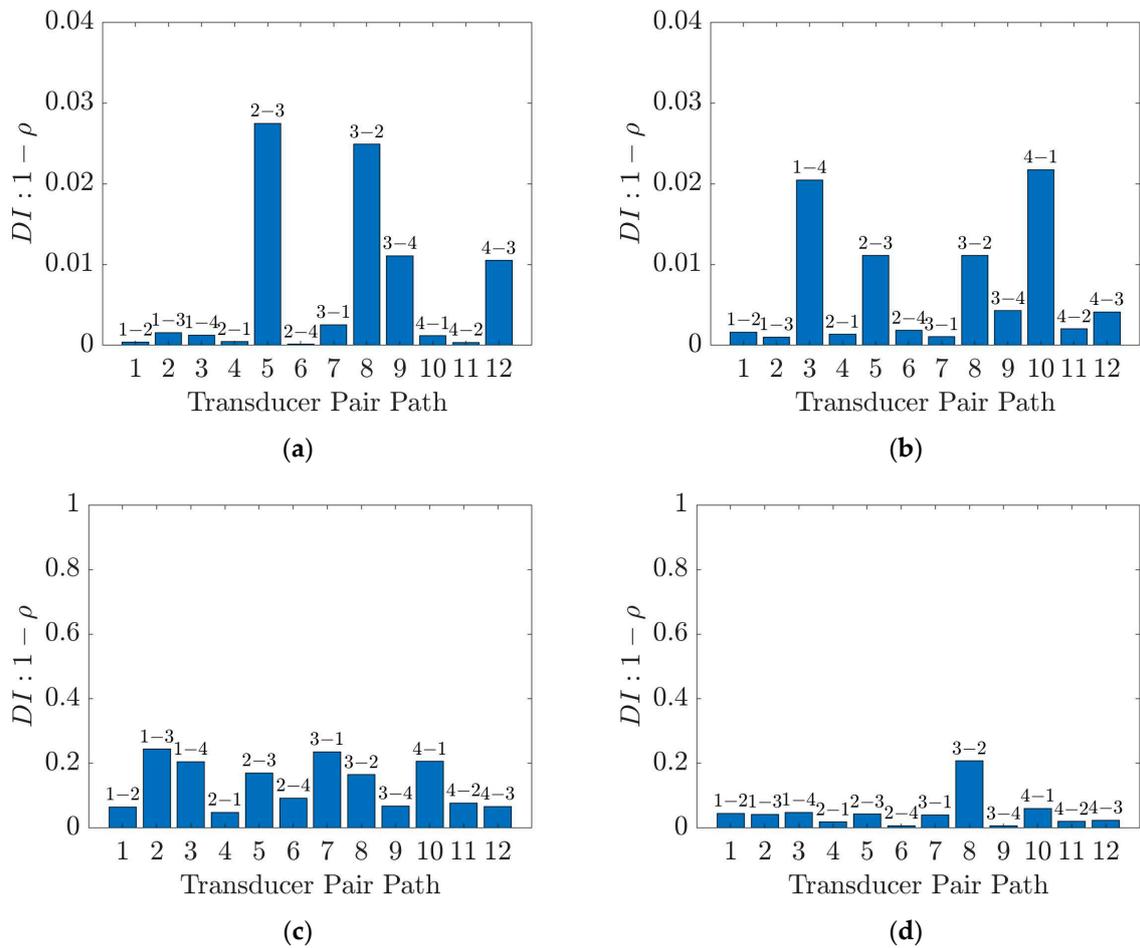
Figure 18. Detections of impact damage for the 2 mm thick panel at (a) 50 kHz and (b) 250 kHz using embedded PZT transducers and at (c) 50 kHz and (d) 250 kHz using surface-mounted PZT transducers.

and 250 kHz, respectively. In Figures 18–20, the damage index (DI) values of embedded results for the A_0 and S_0 modes were lower than those of surface-mounted results for each thickness panels. However, it should be noted that the DI values will not be compared among the thickness of 2 mm, 4 mm, and 9 mm panels due to the different impact energies of each panel. In addition, the results also demonstrate that the damage index is capable of detecting the presence of impact damage for all three panel thicknesses.

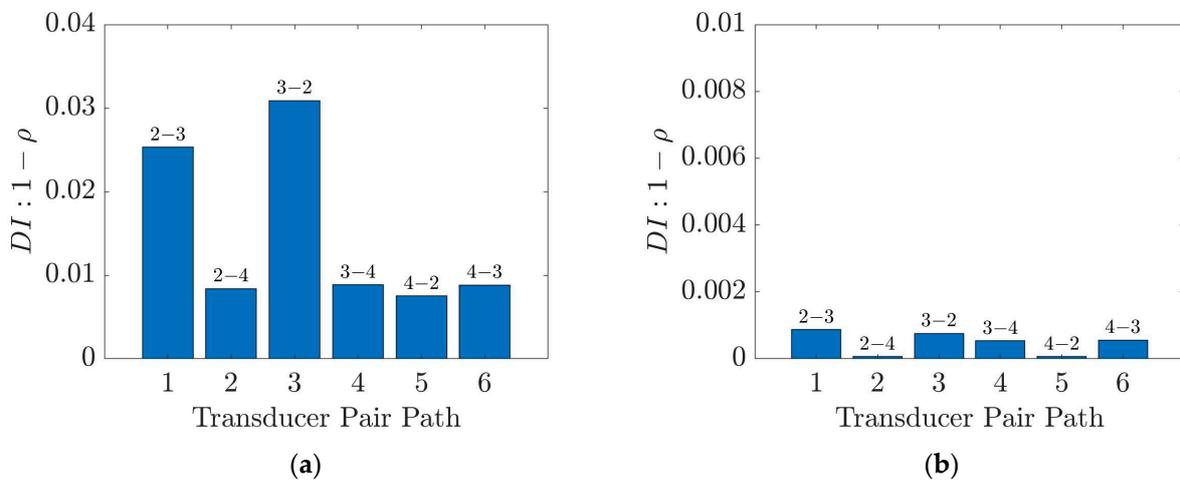
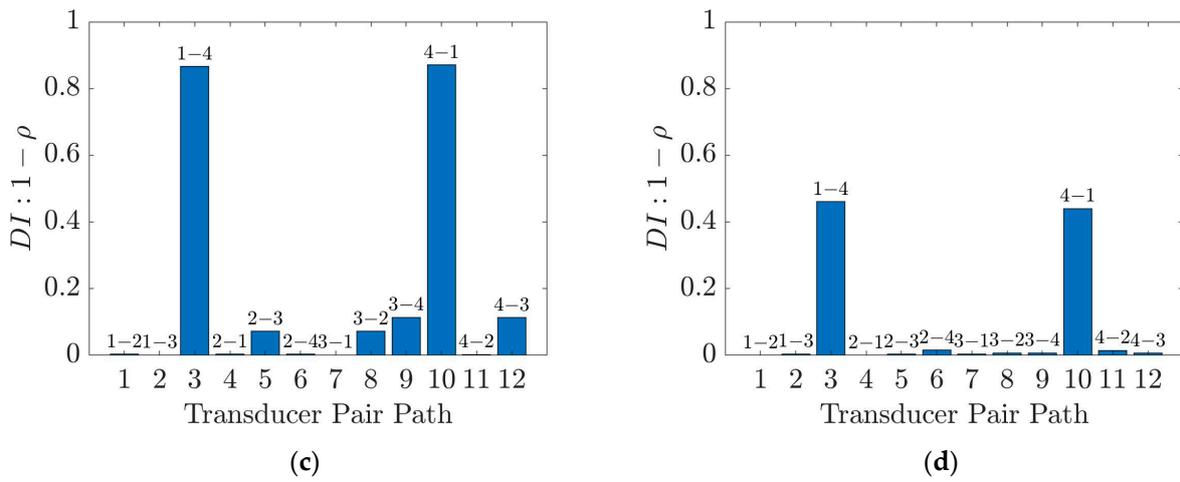
Figure 19. Detections of impact damage for the 4 mm thick panel at (a) 50 kHz and (b) 250 kHz using embedded PZT transducers and at (c) 50 kHz and (d) 250 kHz using surface-mounted PZT transducers.

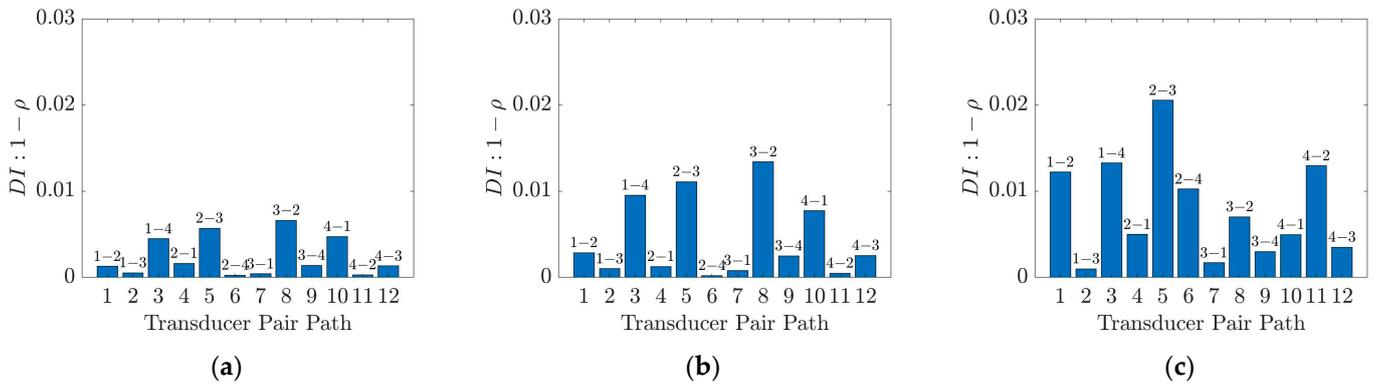
Figure 20. Detections of impact damage for the 9 mm thick panel at (a) 50 kHz using embedded PZT transducers and at (b) 50 kHz and (c) 250 kHz using surface-mounted PZT transducers.
