Influence of Composite Thickness on Ultrasonic Guided Wave Propagation for Damage Detection Using Embedded PZT Transducers

Abstract: This paper describes a study that focuses on assessing the influence of composites with different thicknesses (2 mm, 4 mm, and 9 mm) on embedded ultrasonic guided waves (UGWs) under varying temperatures. The study also demonstrates the effectiveness of these embedded sensors in identifying damage. A novel cut-out method that included an embedded diagnostic layer and phased-array lead zirconate titanate (PZT) transducers, created using the ink-jet printing technique in the manufacturing process was employed. The research then focused on studying the behavior of UGWs under varying temperatures for each composite panel. This analysis aimed to understand how temperature variations affected the propagation of guided waves in thick composites. Finally, artificial damage on the surface and impact damage were introduced, both embedded and surface-mounted PZT transducers were used to detect and locate these damages in different thickness composite panels. The results of damage localization indicated that the embedded PZT transducers were more sensitive than t

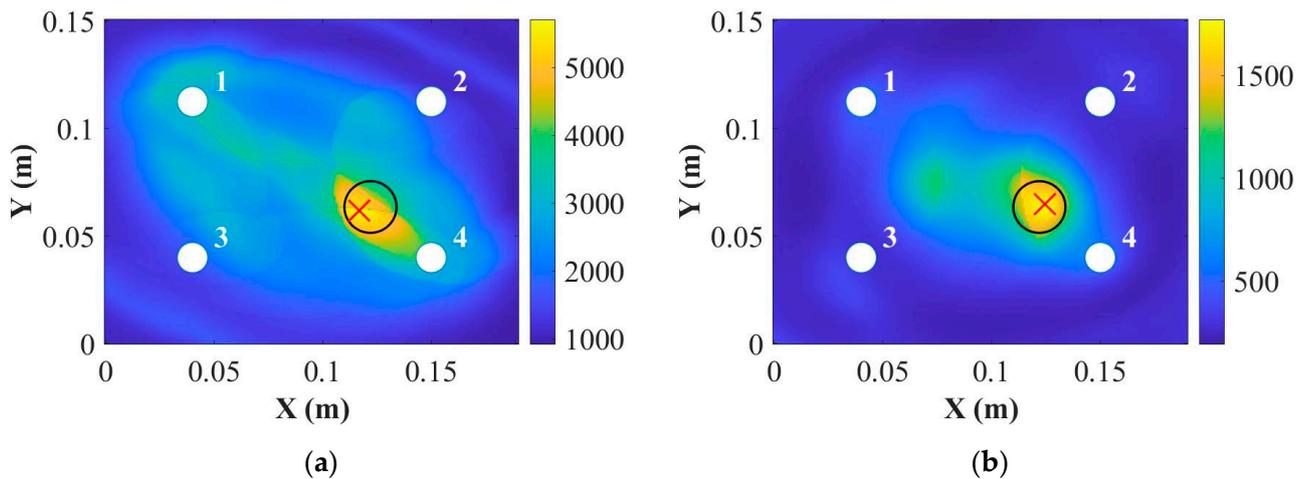
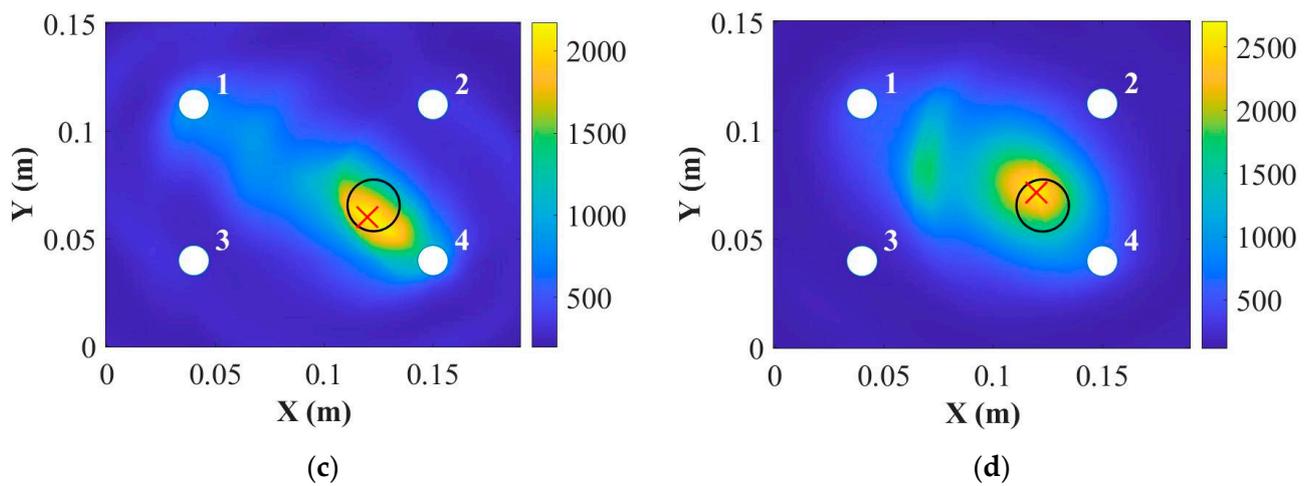
Figure 21. Localization of impact damage for the 2 mm thick panel at (a) 50 kHz and (b) 250 kHz using embedded PZT transducers and at (c) 50 kHz and (d) 250 kHz using surface-mounted PZT transducers (where the “○” is the position for real damage and the “×” is the position for predicted damage).

Additionally, in Figures 21–23, the DAS algorithm is effective in accurately locating the damage position for the 2 mm and 4 mm thick panels at 50 kHz. However, the DAS algorithm is unable to accurately locate the impact damage for all three panel thicknesses at 250 kHz. Overall, the findings indicate that the A_0 mode at 50 kHz is more suitable for accurately locating the impact damage. This conclusion is consistent with previous experimental results utilizing surface-mounted PZT transducers [28]. It is worth noting that the DAS algorithm using embedded PZT transducers in the A_0 mode demonstrates greater sensitivity for impact damage detection compared to surface-mounted PZT transducers at 50 kHz.

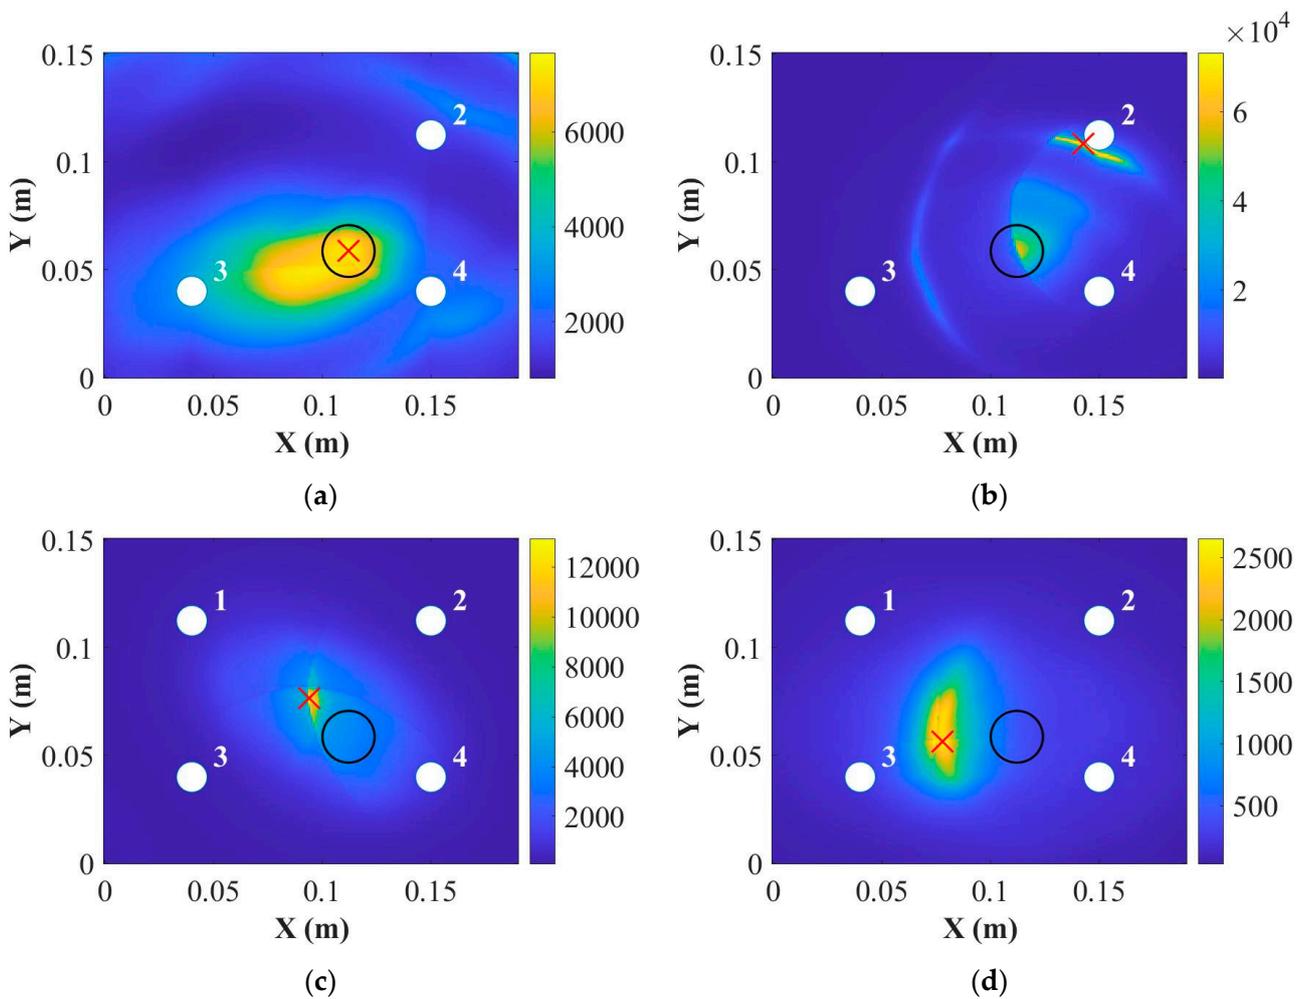
Figure 22. Localization of impact damage for the 4 mm thick panel at (a) 50 kHz and (b) 250 kHz using embedded PZT transducers and at (c) 50 kHz and (d) 250 kHz using surface-mounted PZT transducers (where the “○” is the position for real damage and the “×” is the position for predicted damage).

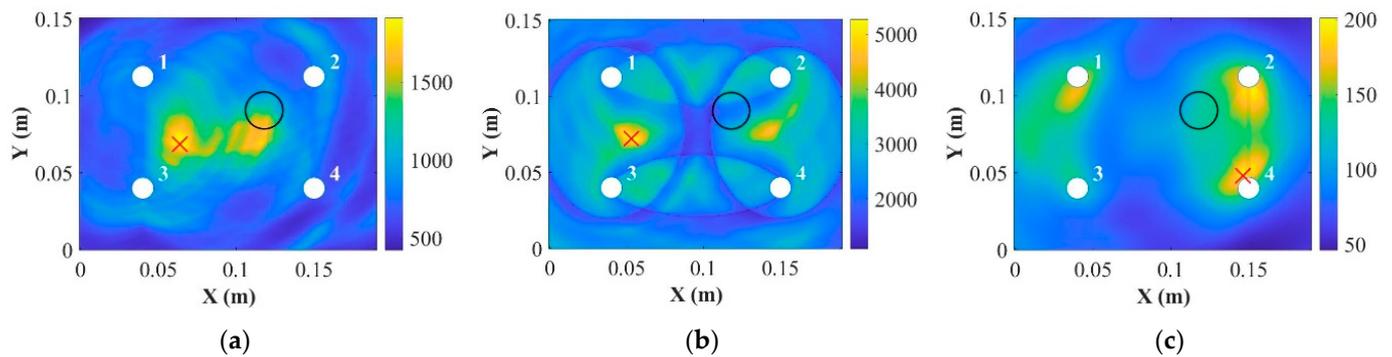
Figure 23. Localization of impact damage for the 9 mm thick panel at (a) 250 kHz using embedded PZT transducers and at (b) 50 kHz and (c) 250 kHz using surface-mounted PZT transducers (where the “○” is the position for real damage and the “×” is the position for predicted damage).
