Mechanism and Application of Layered Grouting Reinforcement for Fractured Coal and Rock Roadway

Abstract: This paper takes the ZF3806 working face of Shuiliandong Coal Mine in Binxian County, Shaanxi Province as the engineering background. Aiming at the problems of the development of surrounding rock cracks and roof breakage encountered in the process of roadway excavation and support and based on the composite beam theory, the method of layered grouting reinforcement of roadways is proposed according to the deformation and failure of the roadway roof and the internal drilling conditions. At the same time, combined with the splitting grouting mechanism, the roadway is strengthened and supported by layered grouting of “shallow bolt grouting + deep cable grouting”. The “shallow” and “deep” form a complete and stable composite beam support structure. After grouting, the bending moments of “shallow” and “deep” support beams decrease by 20.78×10^6 N·m and 26.50×10^6 N·m, respectively. The support scheme is applied to the field test, and the grouting effect is analyzed and monitored. The research results show the layered grouting support scheme of “shallow bolt grouting + deep cable gro

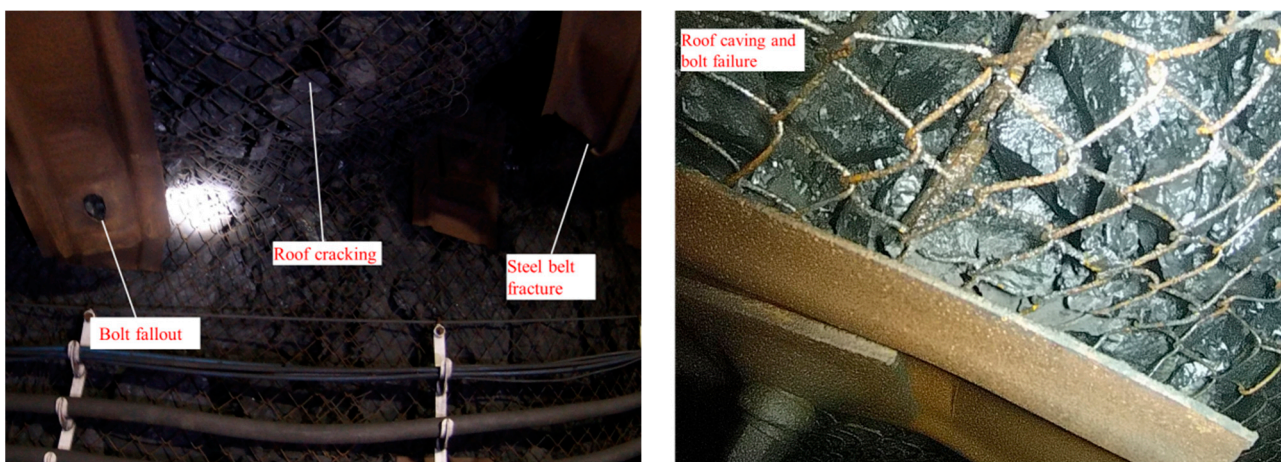
According to the field investigation and analysis, the roadway under the original support scheme was seriously deformed and damaged. As shown in Figure 2, the deformation and damage mainly occurred in the roof, characterized by the broken roof, falling off and failure of bolts, uneven deformation of the roof, bending and fracture of the steel belt, roof leakage, and severe roof subsidence. Cracks and local bulges were visible on both sides of the roadway, and the displacement on both sides changed significantly. The workload of roadway maintenance in the later stage was significant, and there were certain safety risks. The main reasons were as follows: the surrounding rock of the roadway was weak, fissures were developed, the degree of fragmentation was high, the support strength was insufficient, and the integrity was poor.

Figure 2. Deformation and failure conditions of the roadways.

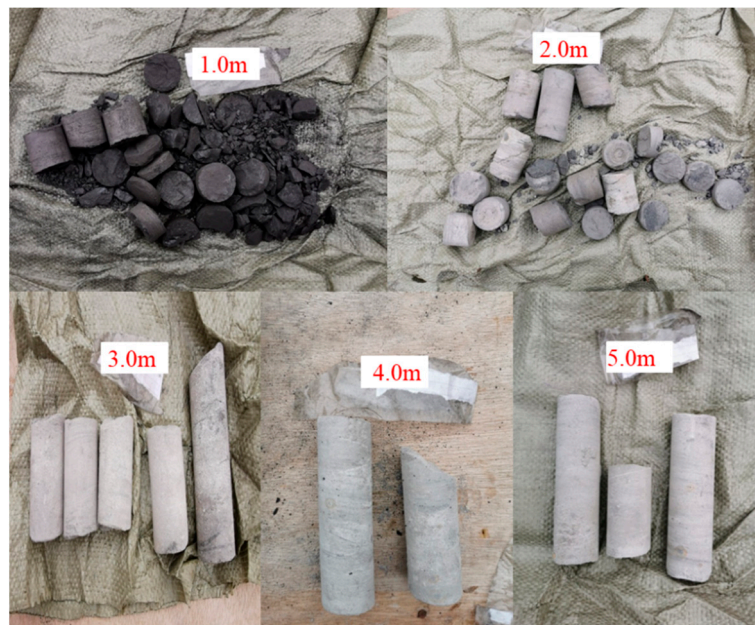
The mining roadway roof of the ZF3806 working face was drilled and cored for 5 m. Due to the fragmentation of the coal body on the roof surface, drilling began 1 m above the roof surface. As shown in Figure 3, the roadway top coal was broken, and the rock core was loose. The mudstone layer 1 m above the coal seam was also relatively broken, while the sandstone layer upward was more and more complete, and there was no obvious fracture in the rock core. Therefore, the crushing range of the roadway was mainly concentrated in the first 3 m of the roof, the sandstone layer behind was relatively complete, and no obvious fracture was found in the rock core.

Figure 3. Characteristics of rock core.

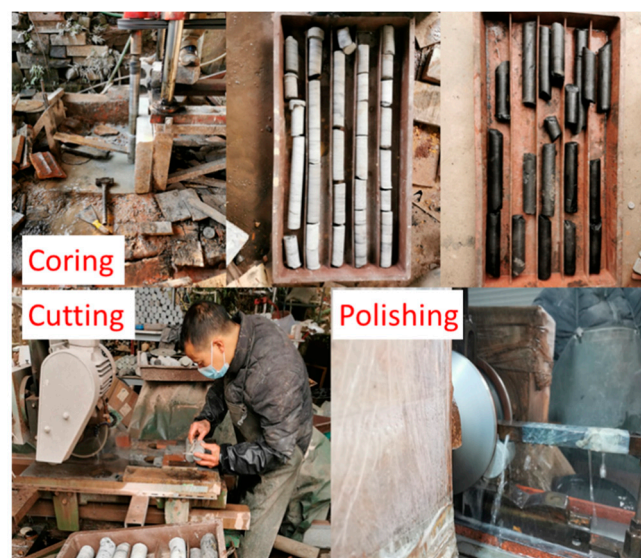
According to the research content, the test rock sample was taken from the ZF3806 working face of Shuiliandong Coal Mine in Bin County, Shanxi Province. The rock samples were roof coal, mudstone, silty fine sandstone, and siltstone. Through on-site sampling, the rock samples were transported from the underground to the ground, and coal cores and rock cores were drilled in the laboratory with a coring machine [35–38]. Then, the end was cut and polished with an end grinder. All standard specimens prepared were $\Phi 50 \text{ mm} \times 100 \text{ mm}$; the standard specimen processing equipment and process are shown in the Figure 4. Rock specimens were processed into standard specimens, and uniaxial compression tests were carried out. Because the mudstone layer was thin and fractured, no good rock specimens were obtained. It was processed into coal rock combination test pieces with some coal specimens to explore the collective failure of mudstone and coal.

Figure 4. Processing of standard specimens.

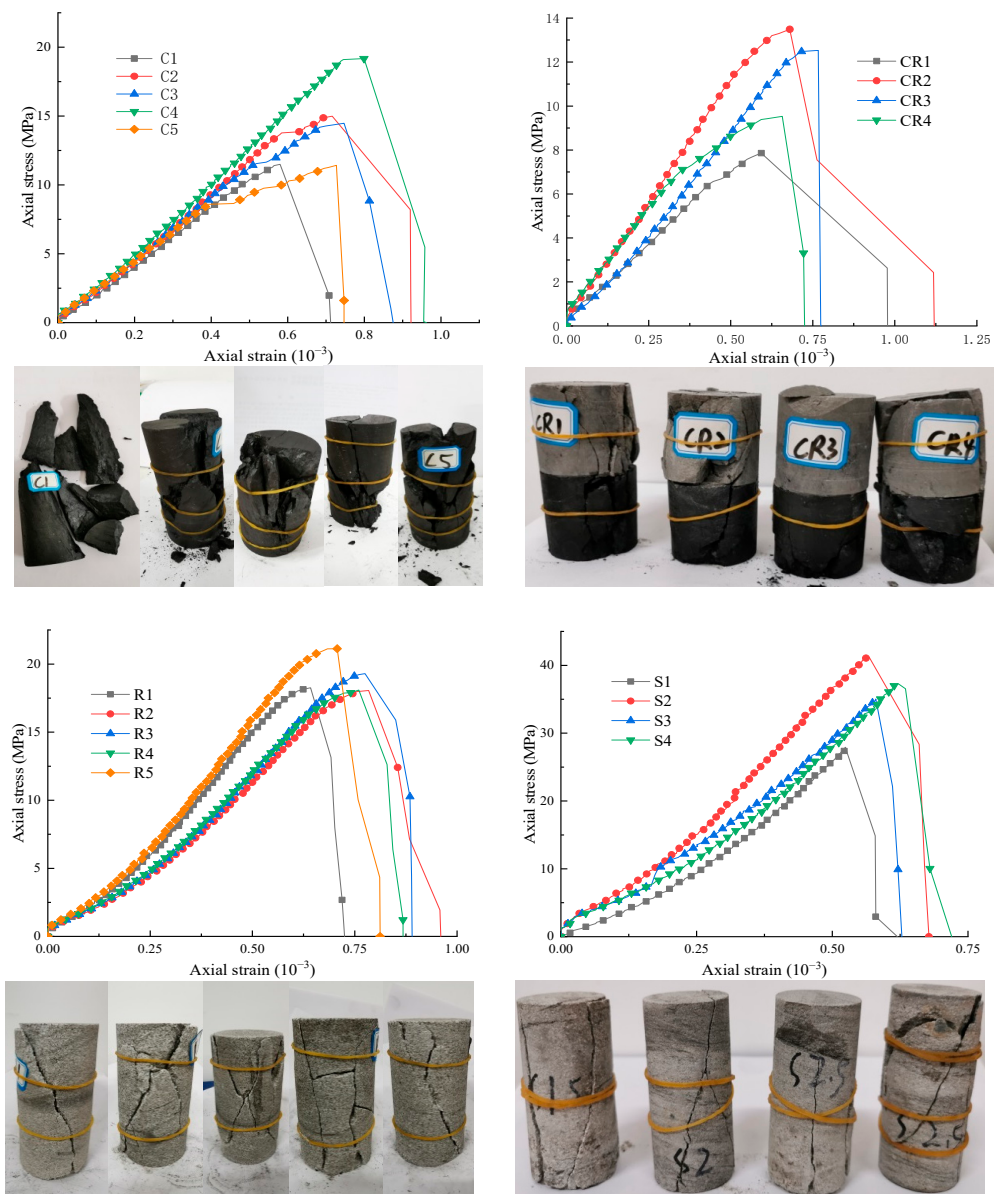
The stress–strain curve and failure of rock specimens after the uniaxial compression test are shown in Figure 5. The stress–strain curves of all specimens had evident stages of compaction, elasticity, yield, and failure. The failure stage of the coal sample was mainly brittle shear failure. The coal rock assemblage was distinguished by symbiotic double shear failure and numerous fracturing failures. The analysis showed the reason is that there were many microfissures in mudstone and coal. At the same time, the coal sample and coal rock combination exhibited expansion, indicating the roof is subject to obvious crushing and bulking deformation. Sandstone mainly showed shear and double shear failure. The uniaxial compressive strength of the coal sample was 11.42–19.17 Mpa with an average of 14.31 MPa. The uniaxial compressive strength of the coal-rock combination was 7.86–13.49 Mpa with an average of 10.85 MPa. The uniaxial compressive strength of the fine siltstone sample was 18.06–21.13 Mpa with an average of 18.97 MPa. The uniaxial compressive strength of the siltstone sample was 27.92–41.20 Mpa with an average of 35.36 MPa. The strength of the coal rock combination was the lowest and that of siltstone was the highest.

Figure 5. Stress–strain curve and failure mode of rock uniaxial compression experiment.

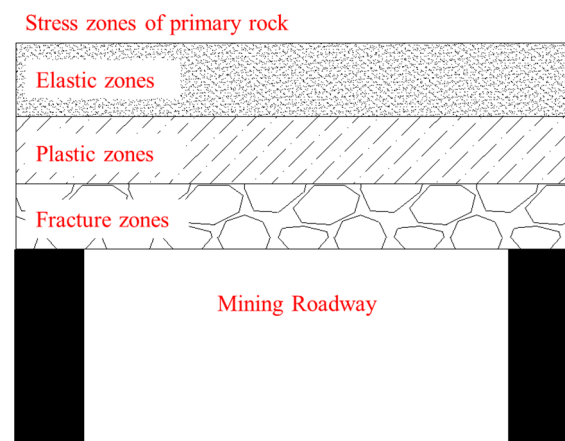
where σ_{ij} is the stress tensor, and x_k is the length of the k direction. The stress gradient's absolute value is the stress change speed in this direction—the more significant the stress gradient, the faster the stress change. The area with a significant stress gradient is stress concentration, and the rock mass is more likely to be damaged. When the stress gradient is zero, the stress in this direction does not change.

Figure 6. Distribution of roadway surrounding rock state.

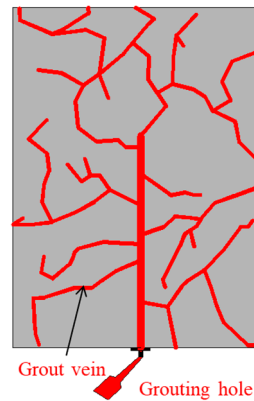
by using anchor bolts and cables combined with layered grouting to reduce the stress gradient of the roof by layered grouting and improve the self-strength of the rock mass at the same time. The bolt and cable provide active support, and the preload is expanded to increase the vertical stress of the rock stratum. After layered grouting, the stress on the rock stratum is uniform, the stress in the layer is homogeneous, and the stress gradient between layers is reduced so no stress concentration occurs on the roof. At the same time, grouting also increases the cohesion and internal friction angle of the rock mass, reducing its destructive capacity.

Figure 7. Grouting diagram.

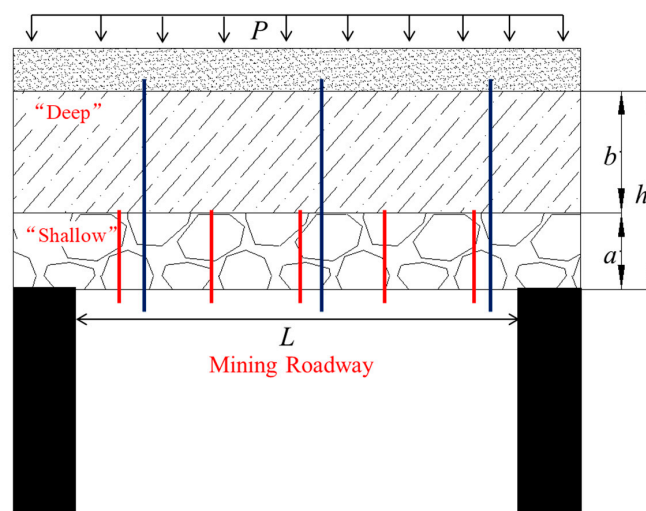
As shown in Figure 8, after the roadway excavation, the early setting and early strength grouting fluid is used to support the “shallow” part of the roadway roof so the “shallow” broken coal body can quickly form a rock stratum with a particular strength. At the same time, the internal stress environment is changed by a specific preload, and the stress gradient between rock layers is reduced. Then, the “deep” grouting cable grouting is carried out, and the superfine cement grouting material uses its good fluidity and permeability to make the “deep” fissure-developed coal. Rock masses form a complete rock stratum with long-term stability. After grouting, the roof forms a relatively complete rock stratification, and the “shallow” and “deep” grouting layers are penetrated by cables to form a complete combination. The combination layers squeeze each other, which increases the friction resistance and reduces the rock deflection. The bending strength of the combination increases, and the overall bearing capacity of the surrounding rock mass of the roadway is improved.

Figure 8. Layered grouting support structure.

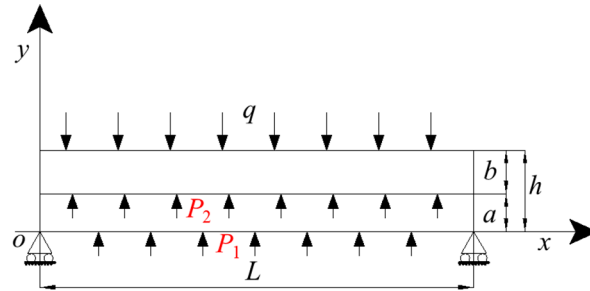
Figure 9 shows the mechanical model of the roof after layered grouting is established. The roof is simplified as a composite beam, and the grouting area is generally considered elastic. After grouting, the grouting layer will produce support resistance. The support resistance of the “shallow” grouting body is P_1 and that of the “deep” is P_2 . L is the roadway width, a and b are the thicknesses of the “shallow” and “deep” grouting support layers, respectively, and h is the thickness of the composite beam of the grouting layer.

Figure 9. Simply supported beam model of roof.

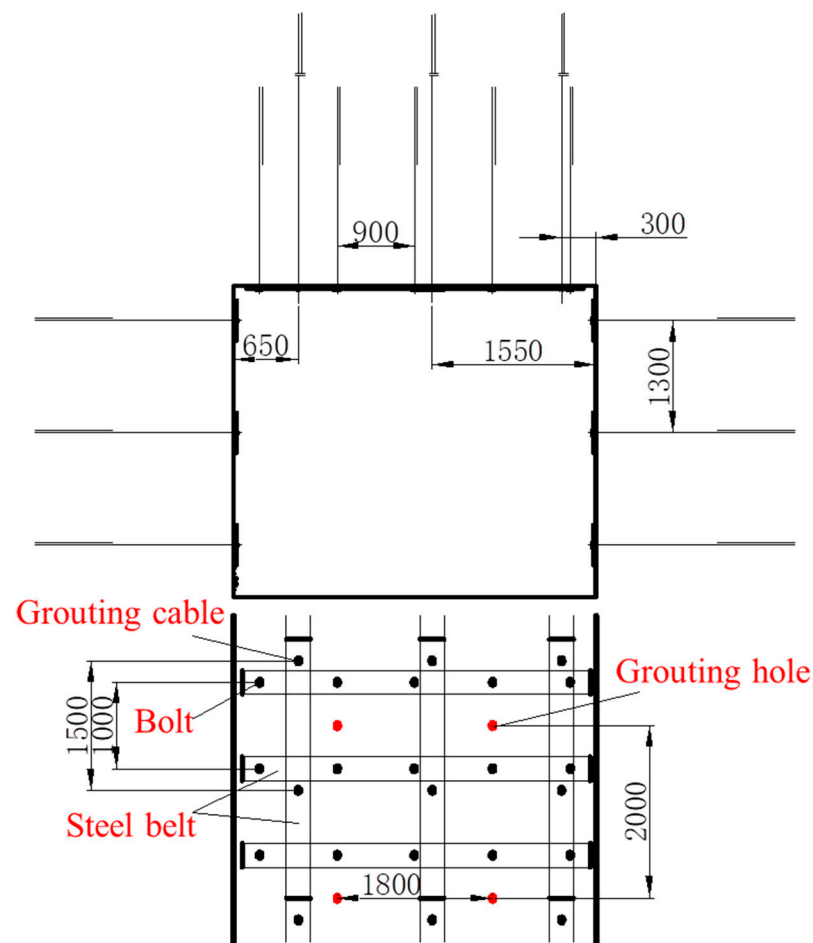
1. Bolt support parameters: As shown in Figure 10, the roadway roof adopts a $\varnothing 20 \text{ mm} \times 2200 \text{ mm}$ equal strength threaded steel resin bolt and the row spacing of $0.9 \text{ m} \times 1 \text{ m}$. The arch-type high-strength pallet is adopted, and the specification is $150 \text{ mm} \times 150 \text{ mm} \times 10 \text{ mm}$. The extended anchoring method is adopted, and the anchoring length of the bolt is 1050 mm. A W-shaped steel belt support is combined, and a diamond-shaped metal mesh is hung on the whole section with a mesh size of $50 \text{ mm} \times 50 \text{ mm}$. The two sides are arranged with a $\varnothing 20 \text{ mm} \times 2200 \text{ mm}$ bolt with a row spacing of $1.3 \text{ m} \times 1 \text{ m}$.

2. Cable support parameters: As shown in Figure 10, the roadway roof adopts a $\varnothing 22 \text{ mm} \times 6300 \text{ mm}$ hollow grouting cable arranged in a “well type” form with anchor support. The row spacing of the cable is 1.5 m, and the cable is perpendicular to the roof. The distance between the upper side cable of the roof and the upper side is 0.3 m, the distance between the middle cable and the upper side is 1.55 m, and the distance between the lower side cable and the lower side is 0.65 m. The anchoring length of the cable is 1300 mm. The cable is supported by a three-hole steel belt, and the stubble is arranged between steel belts.

3. Layered grouting reinforcement support: A layered grouting reinforcement support design is implemented for the roadway roof. The “shallow bolt grouting” is based on the original bolt support. The hole depth is 2 m, the grouting holes are located between every two rows of anchor bolts, and the row spacing between grouting holes is $1.8 \text{ m} \times 2 \text{ m}$. When grouting, the borehole shall be used with the grout stop sleeve to make the borehole pass through the fracture zone vertically as far as possible and maximize the diffusion of grouting fluid. The “deep cable grouting” adopts continuous downward grouting carried out in sequence along the roadway. When the design grouting pressure is 10 MPa, the pressure is stabilized for more than 10 min so the grout can spread to the maximum range and the roof rock cracks can be filled as much as possible. The “deep anchor cable grouting” material is superfine cement, and the “shallow anchor bolt grouting” material is GRPC-1 early setting and early strength new material. The “shallow” grouting shall be carried out first and then the “deep” grouting. In the process of “shallow” grouting when there are abnormal phenomena, such as slurry channeling on the surrounding coal wall, the grouting pump shall be stopped in time.

Figure 10. Roadway support scheme.

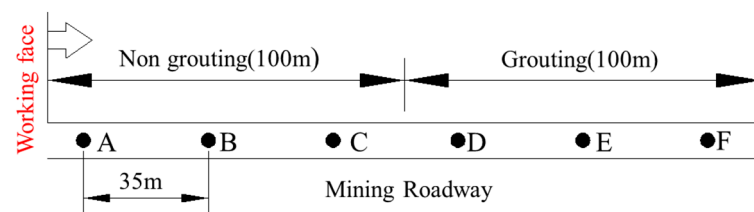
As shown in Figure 11, six displacement monitoring points are designed in the grouting section and the non-grouting section, which are ABCDEF in turn, with a distance of 35 m between points. The section of the grouting reinforcement support scheme is 100 m long, including DEF points, and ABC points are arranged in 100 m of the original support scheme section for a total of 200 m in the test section. The specific arrangement is shown in Figure 11. The “cross” point distribution method is adopted to measure the displacement and deformation of the roadway, and the measurement is conducted every other day.

Figure 11. Layout of monitoring points.

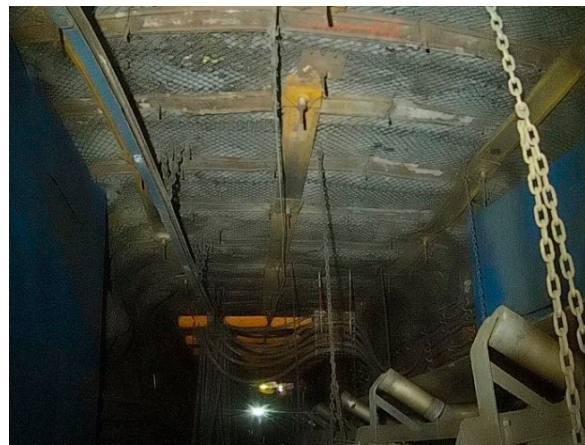
As shown in Figure 14, the roadway is stable after the layered grouting method with the core of “shallow bolt grouting + deep cable grouting” is adopted. The roadway surface displacement is reduced, and the maximum roof displacement is 0.12 m. The roof’s overall integrity is good, and no roof leakage or bolt is falling off; bolt failure no longer occurs. The later maintenance cost of the roadway is significantly reduced, ensuring the safe and efficient mining of the working face. After layered grouting, the surrounding rock of the roadway can release the bearing stress and maintain the stability of the surrounding rock.

Figure 14. Effect of grouting support.
