Article

Large-Scale Experimental Static Testing on 50-Year-Old Prestressed Concrete Bridge Girders

Keywords: prestressed concrete; existing bridges; deck girders; large-scale tests; structural capacity

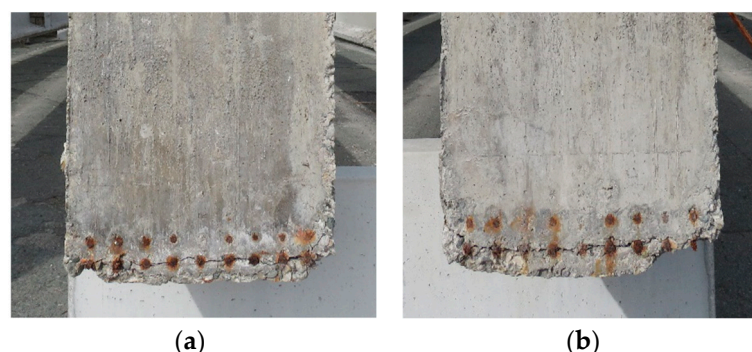
The B3-P47/46 and B4-P47/46 girders showed 5 mm wide horizontal cracks at the edges caused by corrosion activity that transversally crossed the strands (Figure 6). The visual inspections revealed no other corrosion-induced damages. The presence of such kind of damage can be ascribed to the presence of structural joints.

Figure 6. Cracks on the end of the (a) B3-P47/46 and (b) B4-P47/46 beams.

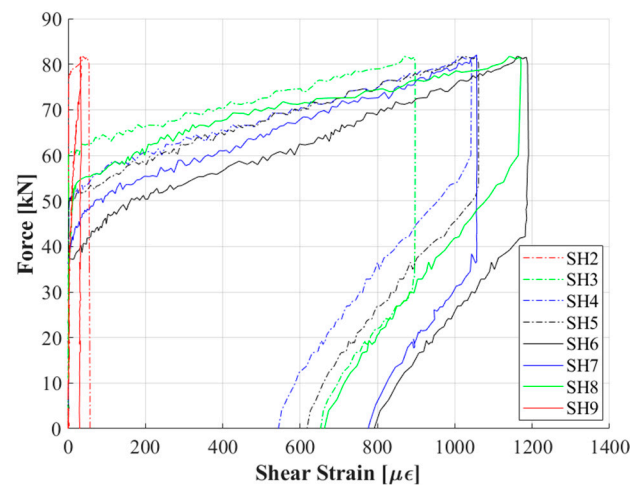
One of the aims of the experimental research is to study the structural behavior up to failure, paying particular attention to the bending and shear resistance mechanism. In the first group of specimens reported in the present paper, a flexural failure was expected, with a mechanical test designed accordingly. Nevertheless, multiple schemes of devices were designed and installed to record shear strains in relevant positions. Figure 19 shows the measurements recorded by the transducers' reading tensile effect belonging to the B8-P47/46 beam. The dashed–dotted lines refer to the sensors installed on the left side of the beam (position A in Figure 9); the solid lines represent the strain recorded on the right side (position B in Figure 9). A correspondence between the dashed and solid lines can be observed, with the exception of SH6 and SH8, which show a slight increase on the right side compared to the left one. Furthermore, a reduction in strain is recorded by moving from the midspan to the support zone.

Figure 19. Tensile shear strain of the B8-P47/46 beam.
