Review

Retrofitting of Bridge Slabs for Safety Railing Refurbishment in Italy: A State-of-the-Art Review

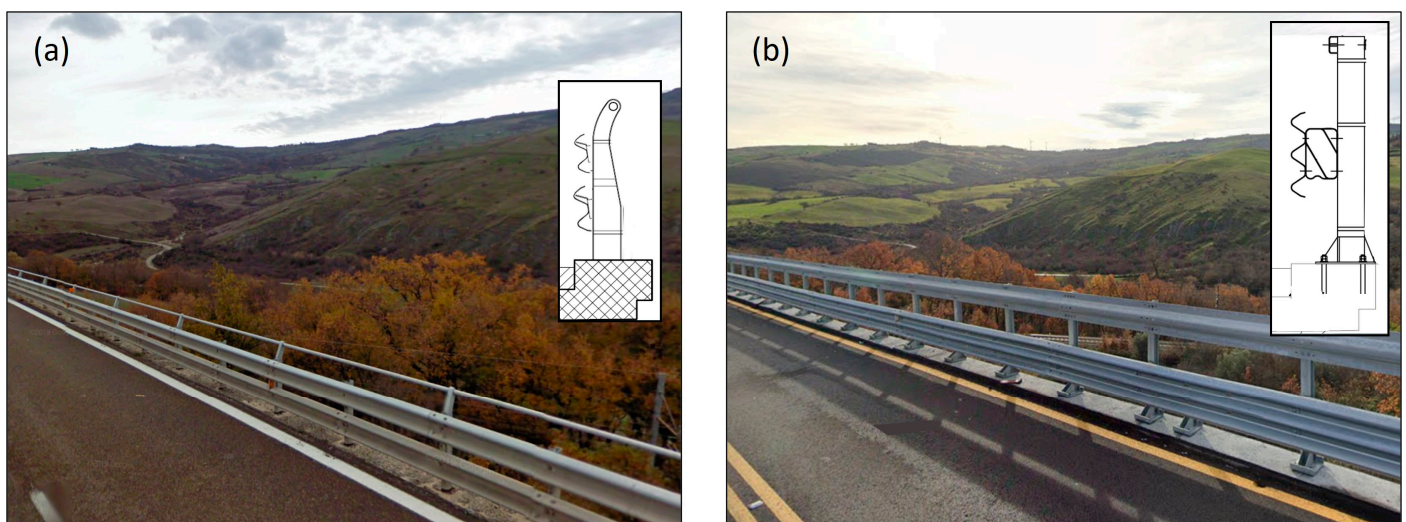
Figure 1. Photo and scheme of pre- (a) and post- (b) railing refurbishment intervention on a reinforced concrete bridge.

Several Italian road management bodies have started the requalification of road railings (e.g., Figure 1), even though the extension of the national road network requires huge investments that should be allocated considering precise criteria for prioritization, based on the risk generated by the traffic volume (average daily traffic, representing the exposure) and the adequacy level of installed railings, which represents the vulnerability.

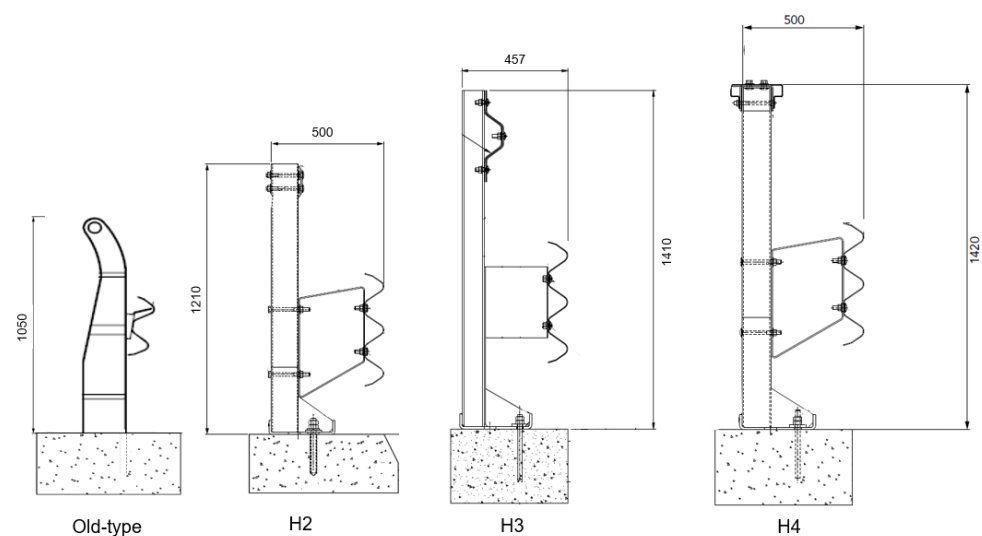
Figure 2. Typical old type and new H2, H3, and H4 bridge railings (dimensions in mm).

According to [5], in case a railing is replaced, an H2, H3, or H4 class new railing must be installed depending on the type of road (motorways, extra-urban roads, and urban roads) and traffic volume (also as a percentage of commercial vehicles with mass higher than 3.5 tons). H2, H3, and H4 barriers have increasing containing capacity and are usually installed on bridge edge curbs through chemical anchors. Figure 2 compares old bridge barriers and new ones [17]. These latter (shown only as illustrative models among the wide variety of commercially available devices) are taller than the old ones and are equipped with a 3-wave profile instead of a 2-wave profile. Moreover, connecting elements placed at the top of the barrier are more robust allowing a better collaboration between consecutive posts, thus increasing the containing capacity of the device.

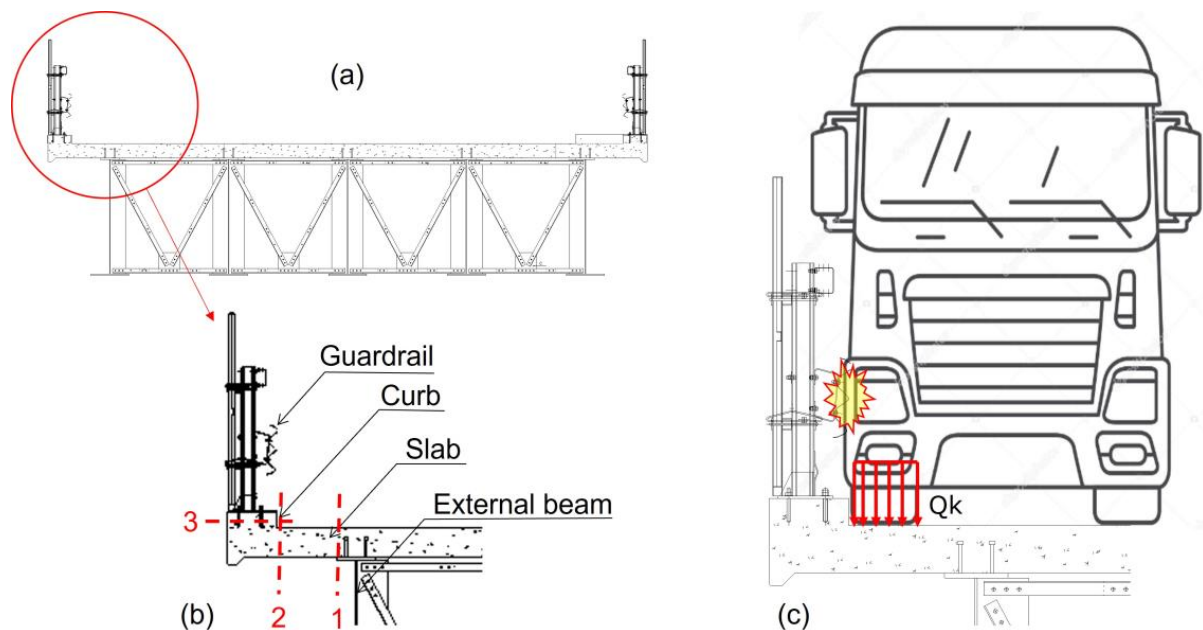
Figure 4. (a) Bridge deck section with reinforced concrete slab, (b) guardrail supporting elements and critical sections, and (c) truck impact position.

When installing a new railing (Figure 4a), checking the needed geometric requirements is necessary. In particular, the dimensions of the edge curb should fit the barrier base plate dimensions. If this check gives a positive result, the effect of the barrier failure in case of a crash must be evaluated. In this case, it can be assumed that the railing posts are subjected to plastic deformation as happens in crash tests performed to approve a safety device. Therefore, the plastic bending moment of the post must be evaluated as a consequence of the truck crash (Figure 4c). Given that they are made of ordinary steel, simple structural engineering methods may be adopted. Based on the post actions, sections 1, 2, and 3 in Figure 5a must be checked. Sections 1 and 2 are subjected to shear, bending moment and axial load, while Section 3 is subjected to shear and overturning moment.

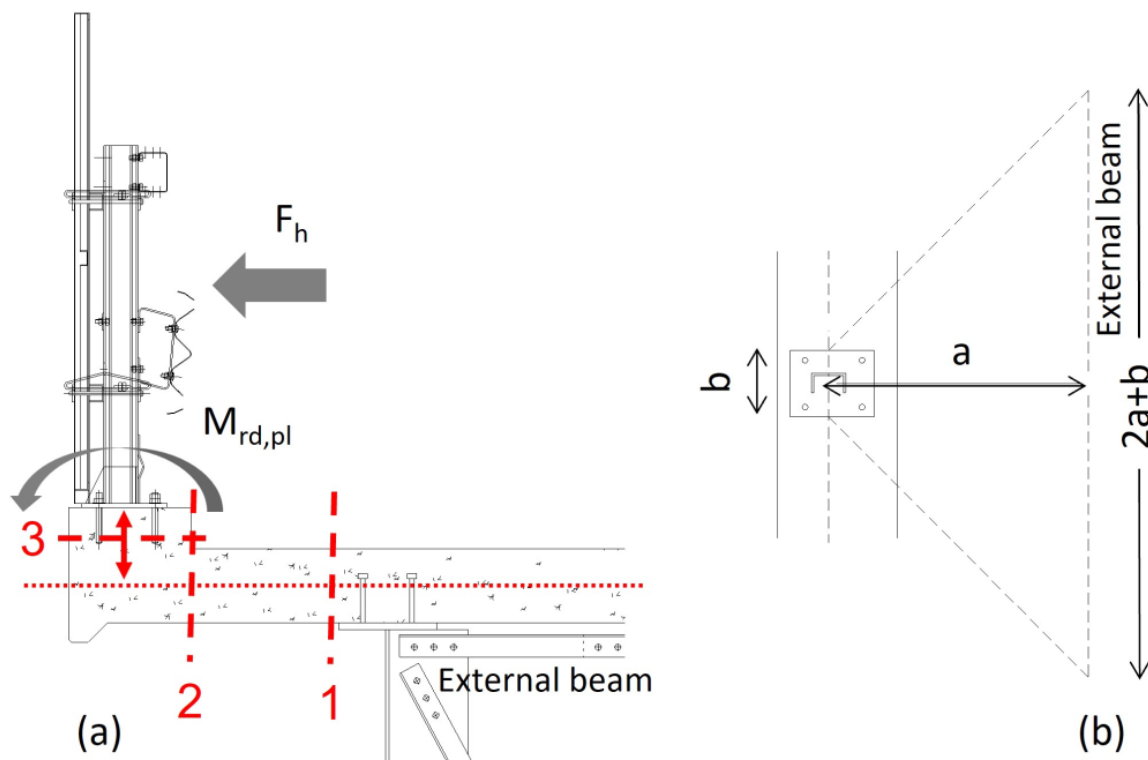
Figure 5. (a) Crash actions on the railing and (b) plan view of the effective slab sections.

Once the post plastic moment $M_{rd,pl}$ is calculated, the horizontal crash force F_h should be derived taking into account a height of 1.00 m from the road pavement, as reported by the Italian and European codes [29–31]. It is worth noting that F_h represents the tensile axial load acting on slab sections 1 and 2 (Figure 5a). Section 1 has a width equal to $2a + b$, where b is the barrier plate width, and a is the slab cantilever length (Figure 5b). This assumption is based on the commonly adopted 45° stress diffusion, even though more refined methods can be used (e.g., finite-element analyses). Once the crash loads are computed, they must be increased by a factor of 1.5 according to the Italian code and combined with other live and dead loads. Among the live loads, the weight of the truck wheel applied near the curb (Q_k in Figure 4c) must be considered (200 kN according to the Italian code [29]). The load combination must be applied to a simple structural scheme represented by the bridge slab cantilever extending from the external beam.

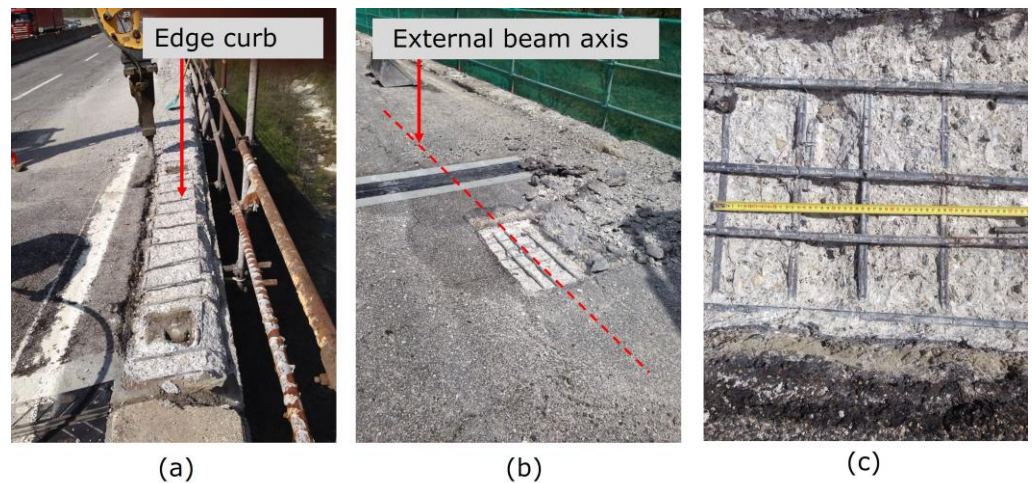
Figure 6. Example of in situ investigations for (a) edge curb detailing, (b) slab reinforcement across the external beam, and (c) detailed survey of reinforcement reported in (b).

Figure 6 shows investigations for the design of a safety railing refurbishment of an RC bridge. Note that the parapet in Figure 6a,b is made of provisional elements installed only for the safety of workers, while the type of guardrail to be installed is similar to that shown in Figure 2 (H2, H3, or H4). In particular, the investigations of Figure 6 are devoted to detecting the type and number of rebars placed in correspondence with the external beam axis, which is the most stressed section of the slab. This must be performed by removing road pavement and concrete cover until reaching the reinforcement. Moreover, further investigation is necessary on the edge curb (Figure 6a). The number of these investigations should be set based on the availability of bridge design documents as well as its total extension. It is worth noting that most bridges built in the period 1950–1970 have no design documents, and, in those cases, the in situ investigations should be more accurate since the structural knowledge must be obtained starting from scratch.

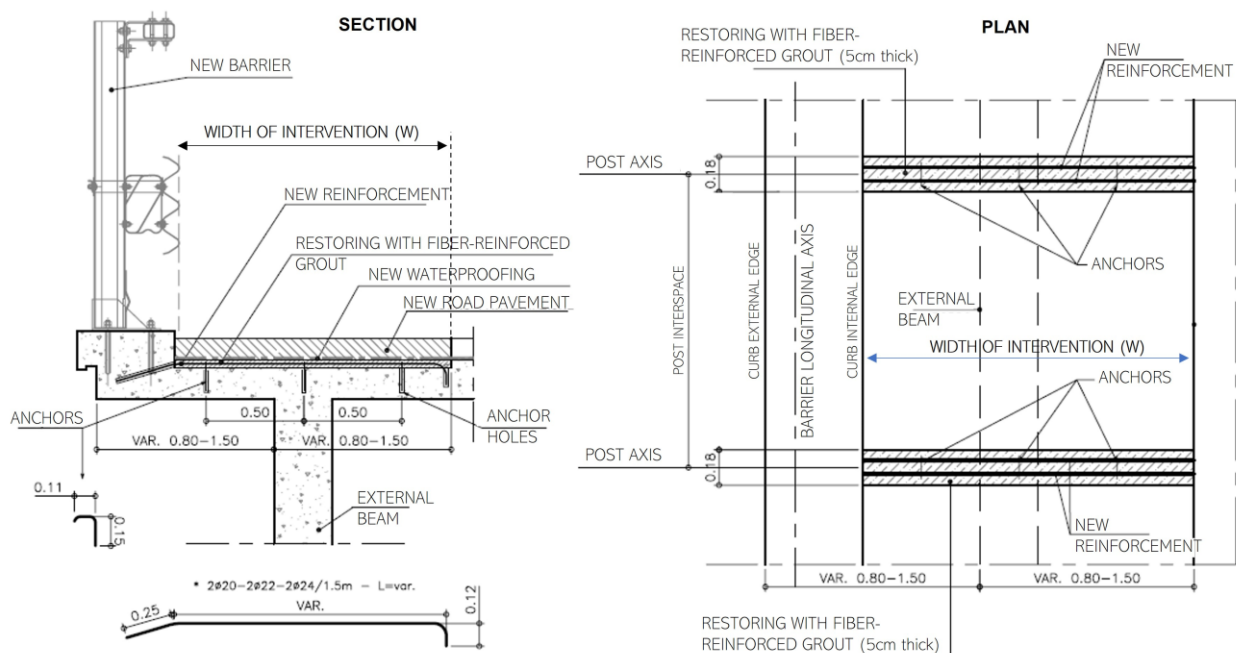
Figure 7. Slab strengthening through additional rebars.

As can be seen from Figure 7 (showing the section and plan views of the intervention details), the additional reinforcement in terms of rebars is placed across the external beam to provide the necessary development length, obtaining a total width of intervention equal to W . New rebars are installed only in correspondence with the new barrier post axis to limit the invasiveness of works. This requires a precise cut in the slab concrete cover and the hydrodemolition commonly of about 5 cm or until finding the existing rebars. New rebars are anchored in the curb through an inclined branch. Once the main rebars are installed, vertical anchors are realized through vertical holes and epoxy resin. The concrete cuttings are finally filled with high-strength fiber-reinforced grout and a waterproofing layer. Thus, the road pavement is restored to complete the intervention.

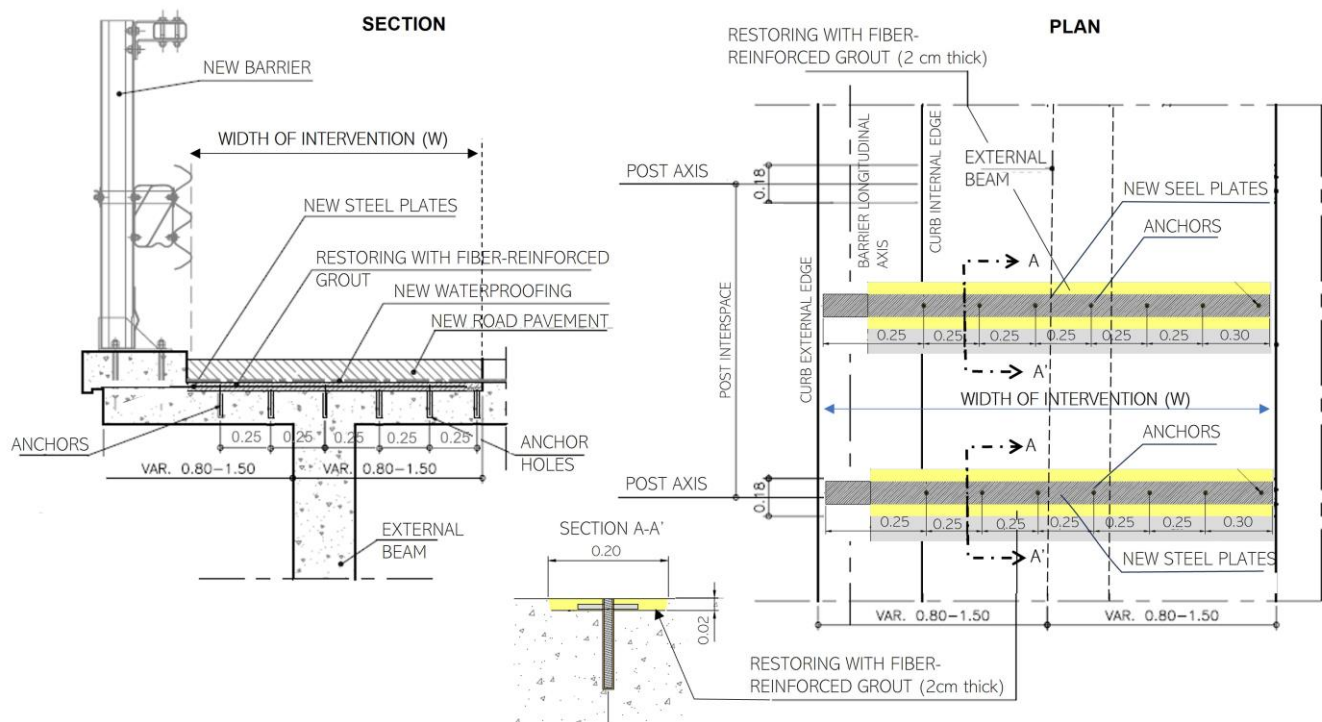
Figure 8. Slab strengthening through NSM steel plates.

Technique no. 3 is based on the use of steel plates provided with holes that can be coupled with chemical anchors made of threaded rods (Figure 8). This is necessary to make the plates collaborate with the existing concrete. In fact, due to ordinary steel's smoothness, the steel–concrete bond is not effective. Concrete cover cutting has a lower depth (usually 2 instead of 5 cm related to techniques 1 and 2). It requires the complete curb demolition in order to allow the plates to properly extend.

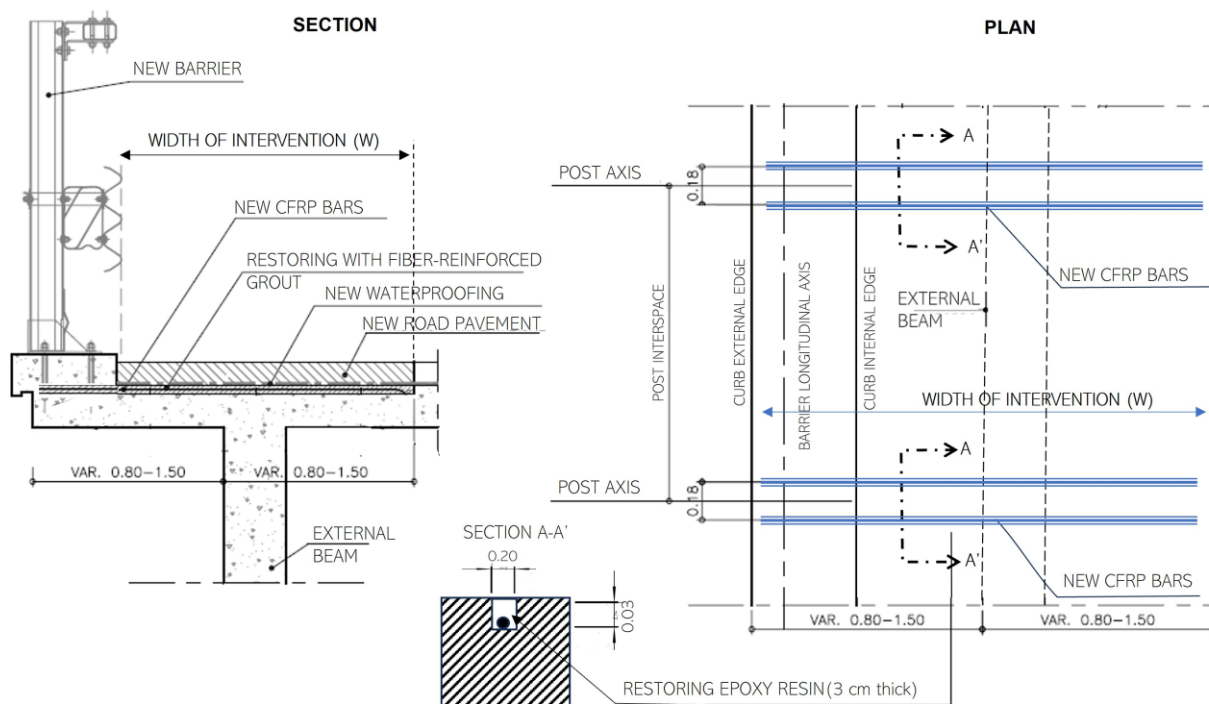
Figure 9. Slab strengthening through NSM composite bars.

A typical application of NSM composites is depicted in Figure 9. As can be seen, no anchors are needed due to the epoxy resin connection. A small cut (obtained by milling) in the slab transverse direction is sufficient to install the carbon (or other material) fiber bars after a bed of epoxy resin is created. To strengthen the interface between the curb and slab, in this case, the curb should be demolished and subsequently reconstructed. It is worth noting that concrete members reinforced with composites usually fail by delamination (i.e., concrete failure at the interface with composites) resulting in fragile structural behavior. However, works for this type of intervention are less invasive on the existing slab structure. On the other hand, they are more expensive due to the use of composite bars and a significant amount of epoxy resin, also needing more skilled workmanship.

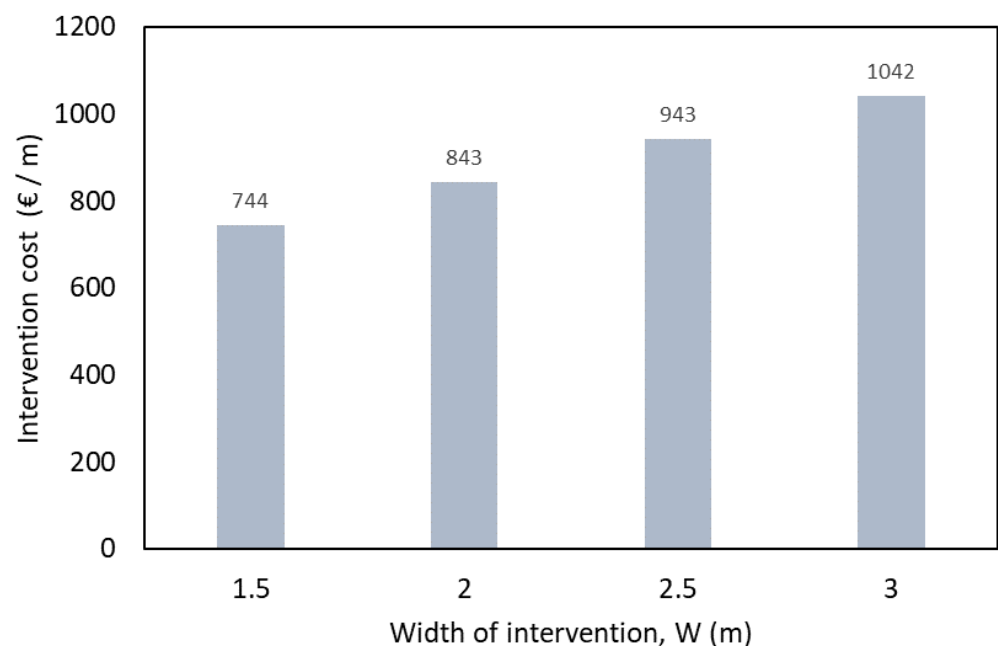
**Figure 10.** Unit length cost of strengthening solution no. 1.

As can be seen from Figure 10, the intervention cost is proportional to the intervention width. Based on inspected design documents of real bridges, the most frequent W value is 2 m corresponding to an intervention cost of EUR 843/m including the cost of new railings and all the works needed for the slab retrofit. These data are strongly susceptible to increase in the near future given the current inflation rates across the EU. Therefore, it should be treated as a temporary estimate.

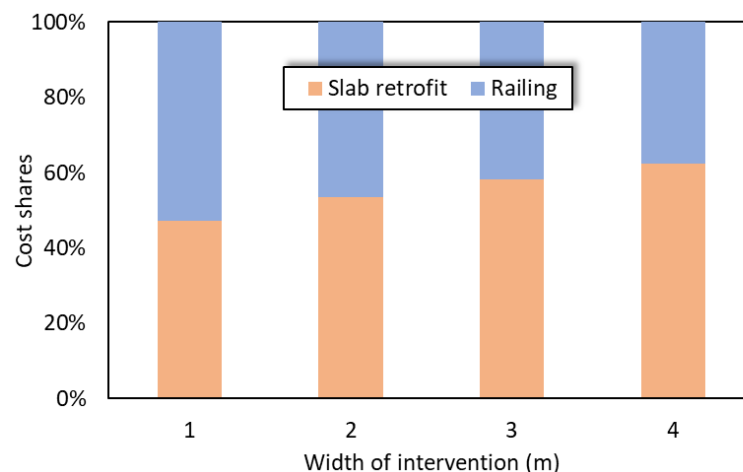
Figure 11. Relative cost of new barrier and slab retrofit for solution no. 1.

Looking at Figure 11, the cost of the slab retrofit varies between 50 and 60% of the total intervention cost, being in most cases higher than the new railing cost. This means that low-impact and cheap slab retrofit solutions can greatly reduce the overall cost of interventions of the wide national bridge asset.
