# A Case Study of Pavement Foundation Support and Drainage Evaluations of Damaged Urban Cement Concrete Roads

**Abstract:** Surface cracks and joint deteriorations are typical premature failures of urban cement concrete pavement. However, traffic loads on the urban pavement are much lower than those on highways. Limited research has been conducted to investigate the causes of accelerated damage in urban cement concrete roads. To investigate the foundation issues that may cause the accelerated damage of urban cement concrete pavements, in this study, field evaluations were conducted to assess pavement foundation support and drainage conditions. Field visual inspections, Ground Penetrating Radar (GPR) survey, Dynamic Cone Penetrometer (DCP) test, and the Core-Hole Permeameter (CHP) test were performed. In urban residential areas with inadequate subgrade bearing capacity, cement concrete pavements are prone to early damage. Foundations with a higher content of coarse particles exhibit a higher CBR value, which can extend the service life of the pavement. The compaction of foundation materials near sewer pipelines and manholes is insufficient, leading to non-uniform support conditions

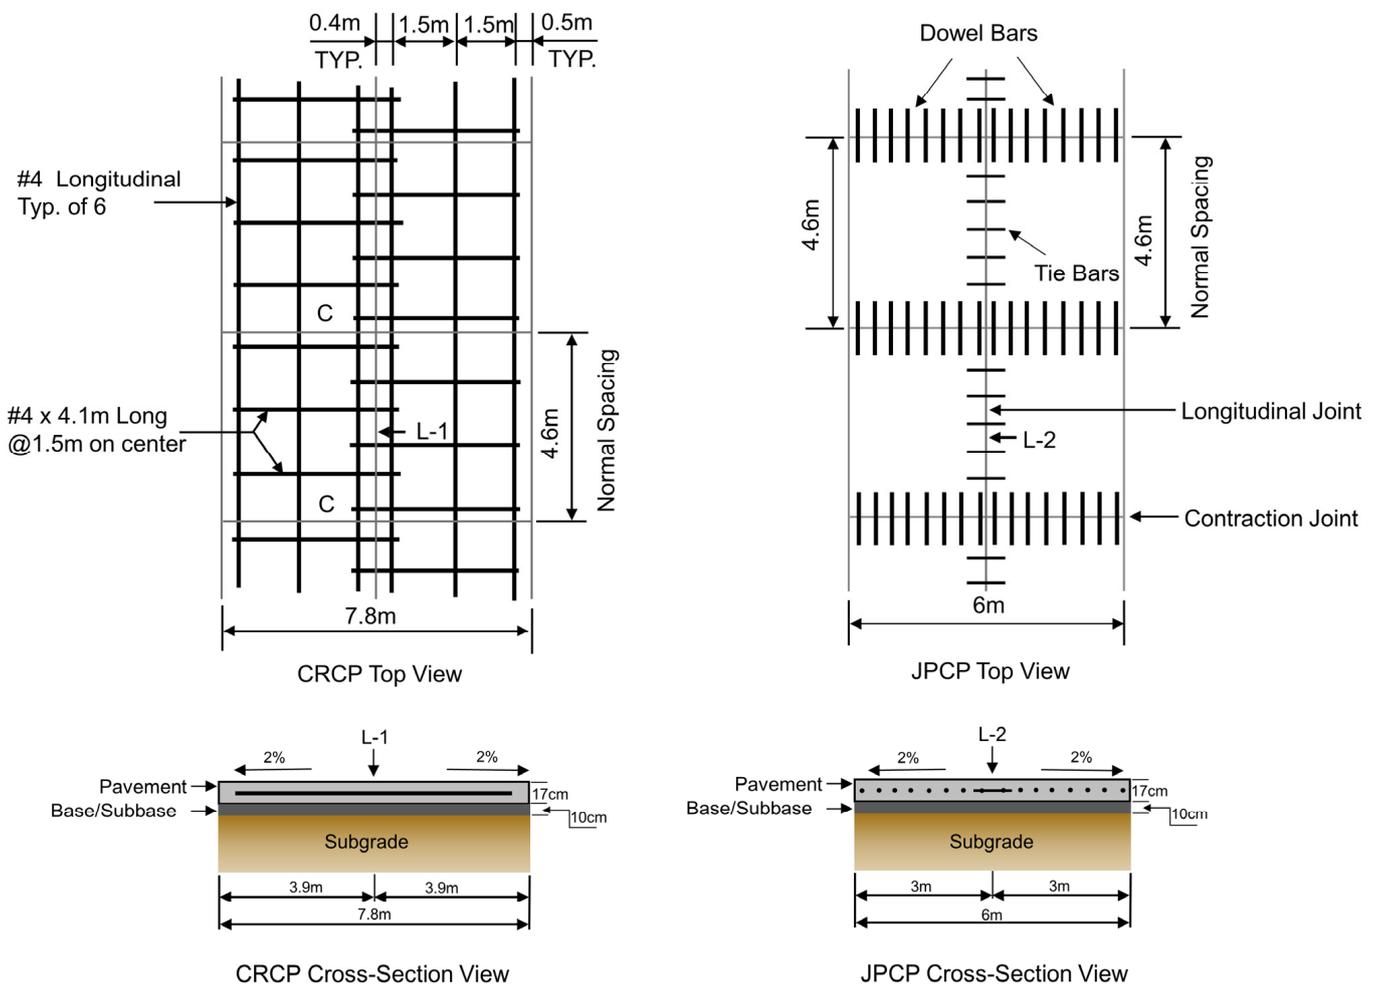
Figure 1. The design schematic of the two pavement types.

In this study, a total of six test sites selected for investigation were in one city located in a seasonal frost region, the area where the city is located experiences four distinct seasonal changes, with hot summers, averaging around 30 °C, and cold winters, with an average temperature of about −6 °C. These sections are typical of those observed to be suffering accelerated in the form of surface cracks, joint deterioration, and D-cracking. For the six test sites, two types of pavement surface design were followed: Continuous Reinforced Concrete Pavement (CRCP) and Jointed Plain Concrete Pavement (JPCP) typically as shown in Figure 1. The steel bars were embedded at the mid-depth of the slab at 1.5 m spacing in both transverse and longitudinal directions, with overlap at the longitudinal joints. The other locations were unreinforced but did contain dowels across the transverse joints.

Sites JPCP-4-A and JPCP-4-B were constructed using the JPCP design as shown in Figure 1. The service life of both sites is four years. Site JPCP-4-A exhibited good pavement conditions without any visible surface damage. Site JPCP-4-B had one slab yielding a transverse crack, with no evidence of joint deterioration.

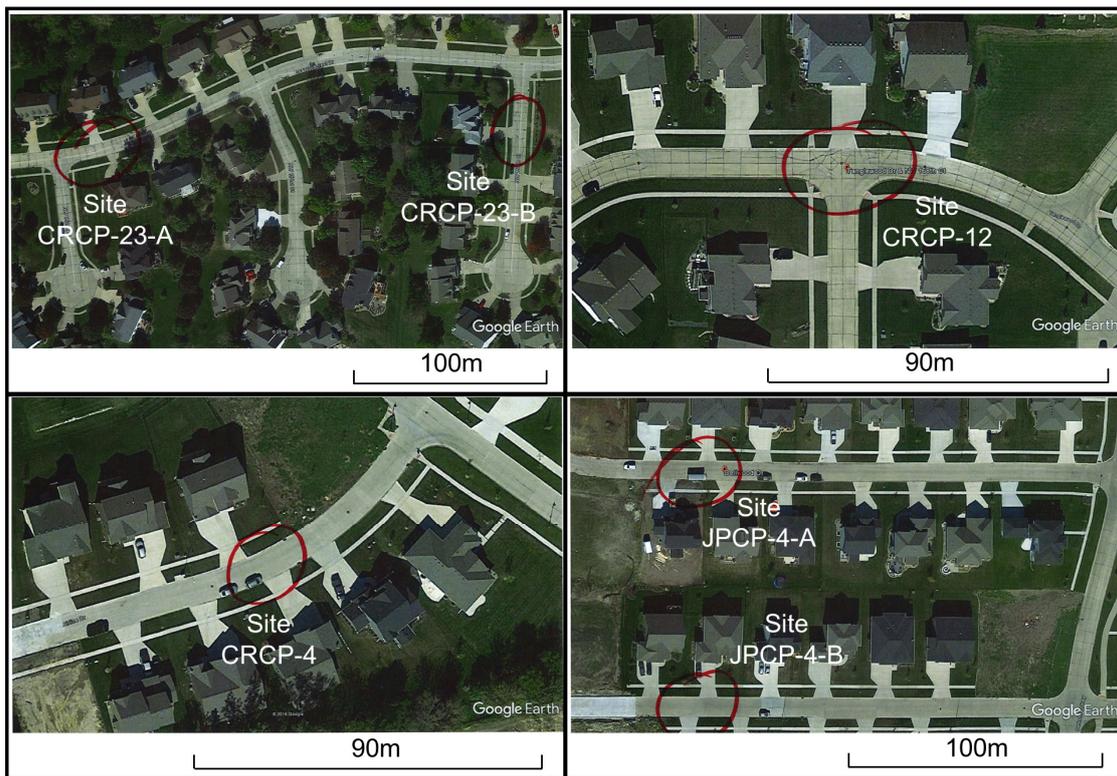
**Figure 2.** Aerial images of six selected testing sections (The parts marked with red circles are the specific test sites).

Figure 2 provides photos of the locations of the six test sites. The test site ID is named after the surface design type, service age, and site number. The diagram indicates that all test sites are within residential areas, subjected to traffic loads considerably lower than those on highways, with a load limit of 36 tons. Located on a secondary road, Site CRCP-23-B likely experiences even lighter vehicle traffic in comparison to the other sites, which are on the main roads of the residential area. Furthermore, Site CRCP-12 is positioned at the intersection of two roads and the Site CRCP-12 is close to a manhole and sewer pipelines.

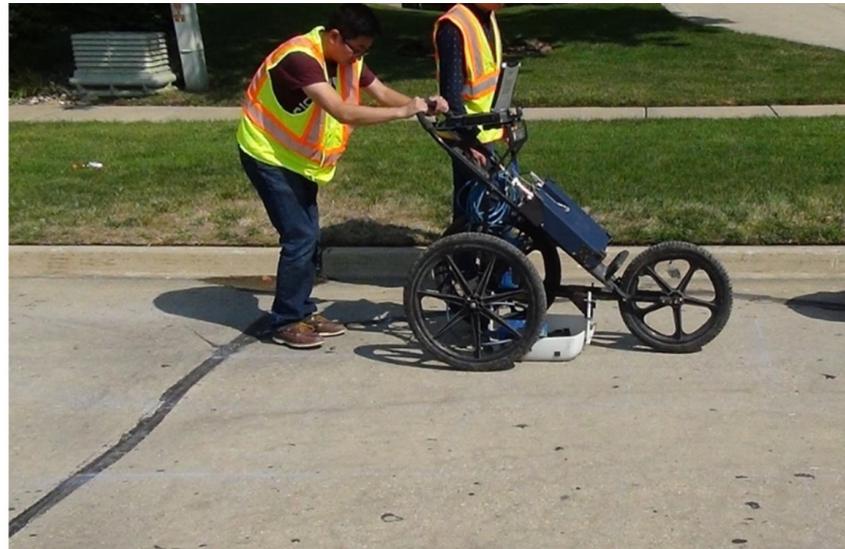
**Figure 3.** GPR survey conducted on a test site.

the pavement surface. In this study, a ground-coupled 1600 MHz antenna (model SIR-20, manufactured by GSSI) installed on a survey cart was used to collect three-dimensional (3D) information for the top 46 cm of the selected test sections, as shown in Figure 3.

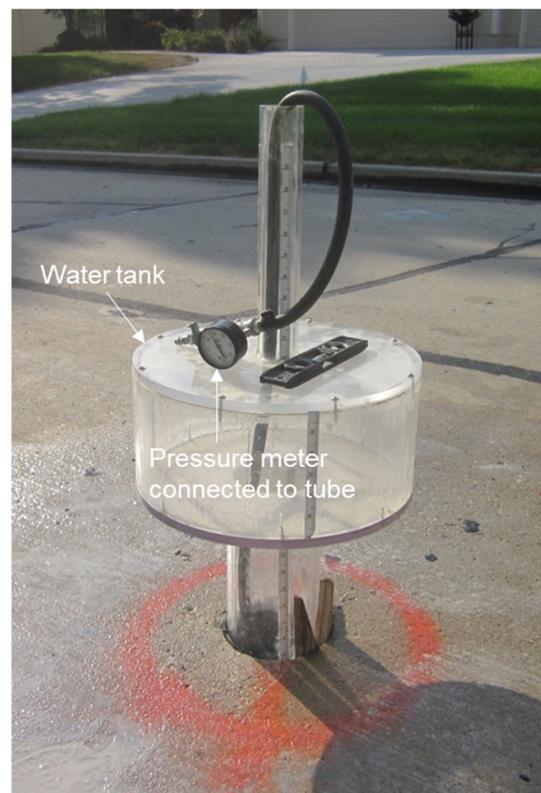
**Figure 4.** The CHP device was installed in a concrete core hole.

The CHP test was performed to evaluate the drainage performance of the foundation materials. The test uses the falling head method to measure the in-situ permeability of the foundation layers after drilling cores, the corresponding test device as shown in Figure 4.

In this testing methodology, a core hole with a diameter of 15 cm is bored through the pavement surface down to the underlying support layer. Subsequently, the testing apparatus is inserted into the borehole. To ensure an airtight seal within the interior of the core hole, an inflatable rubber tube is employed, inflated to an air pressure between 20 to 25 psi. The procedure includes the systematic recording of the water head loss rate from the apparatus, observed continuously over a period ranging from 20 to 60 min. The hydraulic conductivity ( $K_{\text{CHP}}$ ) of the tested layer is calculated using Equation (4) following the approach described in ASTM D6391 [44].

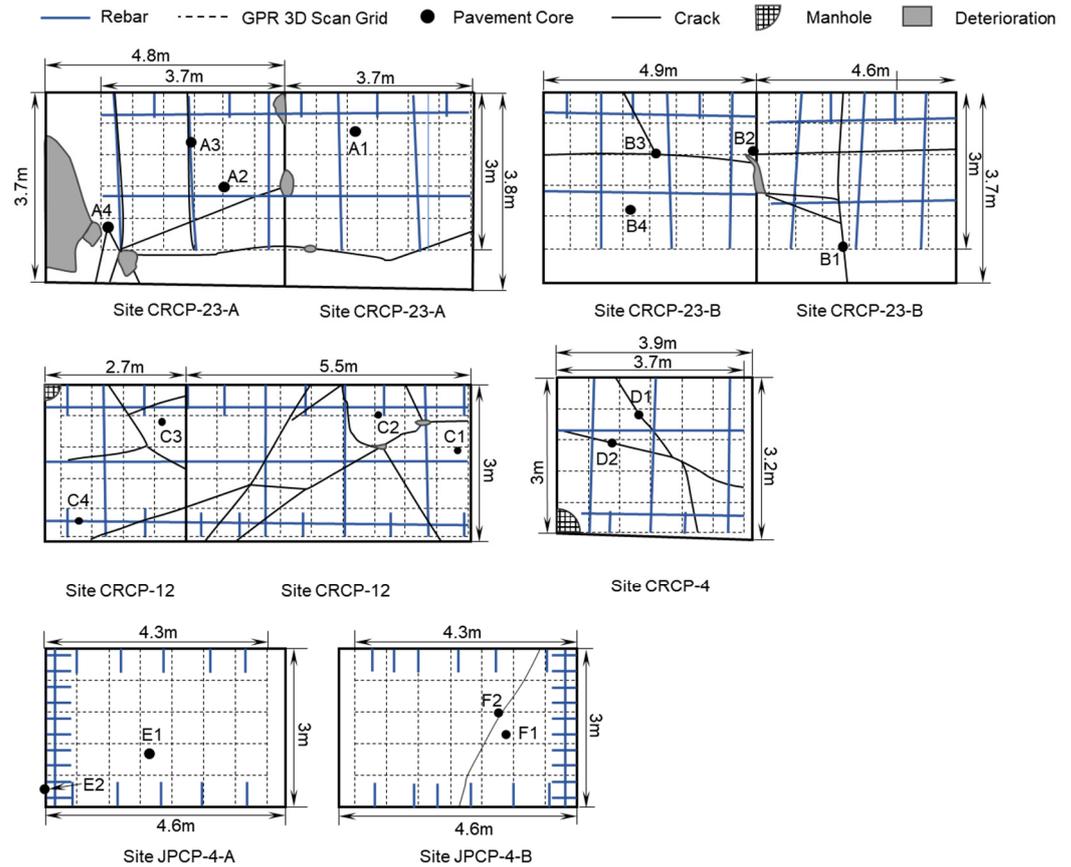
**Figure 5.** The schematics of the locations of rebar, testing grid, pavement cores, cracks, manholes, and deterioration of the selected slabs at all sites.

Based on the visual inspections and GPR test results, locations of surface cracks, rebars, and cavities in base layers can be determined, as shown in Figure 5 thus determining the coring locations for further material laboratory tests. At least two 15 cm cores were extracted from each test slab, including a non-cracked full core. After drilling cores, DCP and CHP tests were performed in the core holes to evaluate the in-situ bearing capacity and drainage performance of the foundation materials, respectively.

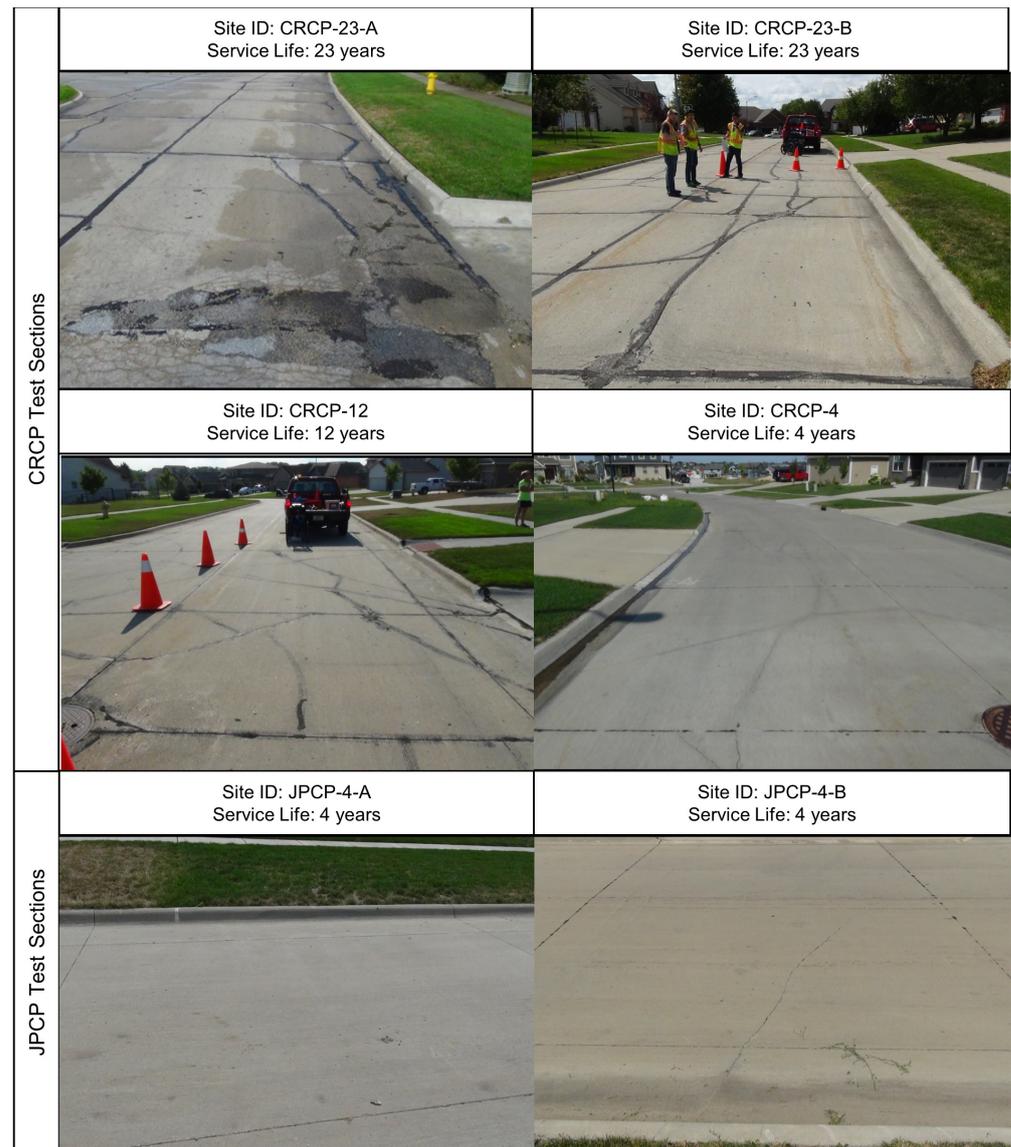
Figure 6 provides photos of the typical surface conditions of the six test sites. In general, all sites with JPCP pavement designs exhibited similar distress patterns, consisting of longitudinal and transverse cracking with varying degrees of joint deterioration. The sites with younger JPCP pavement appeared to exhibit less distress.

**Figure 6.** Typical pavement conditions of the six test sites.

Sites CRCP-23-A and B were constructed at the same time with the same design. The service life of the two sites was 23 years at testing time, and both yielded similar surface damage including significant longitudinal cracking. However, CRCP-23-A showed more joint deterioration and D-cracking.

The surface thickness and reinforcement design of the Sites CRCP-12 and CRCP-4 were the same as those of CRCP-23-A and B. However, even though the service life of the two sites was much shorter, similar surface damage can be observed. Both yielded some random surface cracking and joint damage.

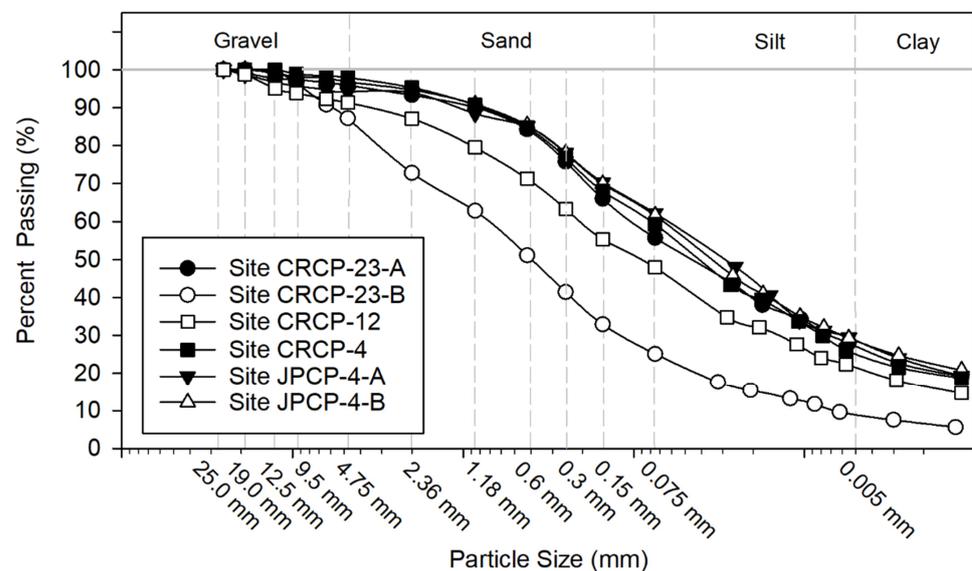
The particle size distribution curves of the foundation materials of the six test sites are shown in Figure 7. The foundation materials at Sites CRCP-23-A, CRCP-4, JPCP-4-A, and JPCP-4-B were similar. The foundation material at Sites CRCP-23-B and CRCP-12 contained more sand and fewer fine materials. Relevant research [49–51] indicates that a higher content of coarse aggregates can enhance the stability and drainage performance of the subgrade. Following this, DCP and CHP tests will be conducted at all test sites to measure the bearing capacity and drainage performance of the foundation.

**Figure 7.** Sieve analysis results of the foundation surface materials of the six test sites.

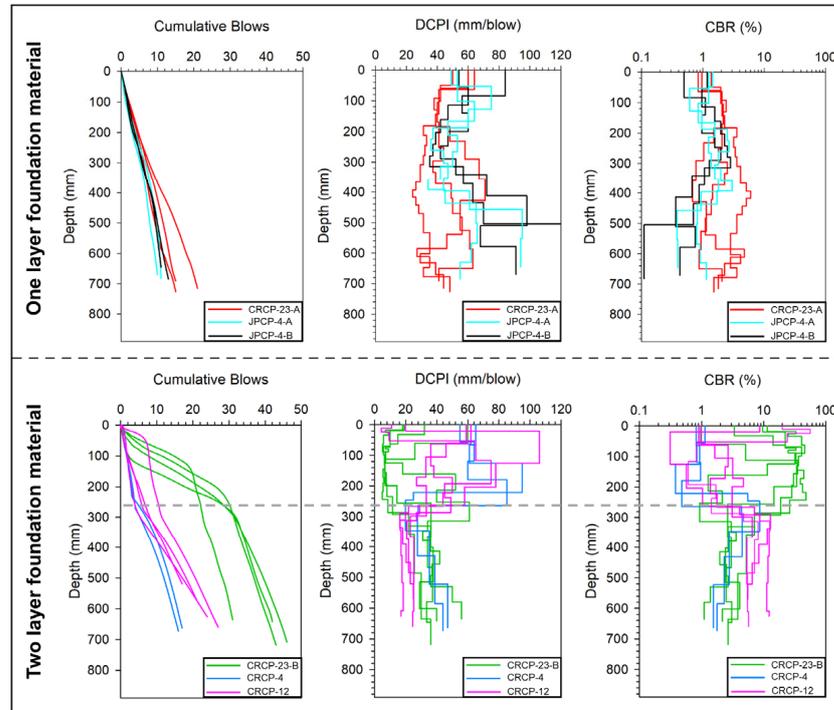
The DCP tests were conducted to quantitatively analyze the bearing capacity of the pavement foundation. For each test site, two to four core holes were selected to conduct DCP tests after drilling surface cores. The testing blows, DCPI, and CBR versus depth profiles of the six sites are shown in Figure 8. Based on the test results, the pavement foundation-bearing capacity conditions of the six sites can be separated into two groups. The DCP-CBR values of sites CRCP-23-A, JPCP-4-A, and JPCP-4-B were relatively uniform, and no obvious boundary can be observed in their DCP-CBR profiles. However, for sites

CRCP-23-B, CRCP-12, and CRCP-4, the DCP-CBR values of the top 250 mm foundation material are very different from those of the bottom materials. The top layers of sites CRCP-12 and CRCP-4 are much softer than their bottom materials. This led to noticeably premature failures compared to sites JPCP-4-A and JPCP-4-B, despite their shorter service life, as illustrated in Figure 6.

Figure 8. DCP test results versus depth profiles of the foundation materials of the test sites.

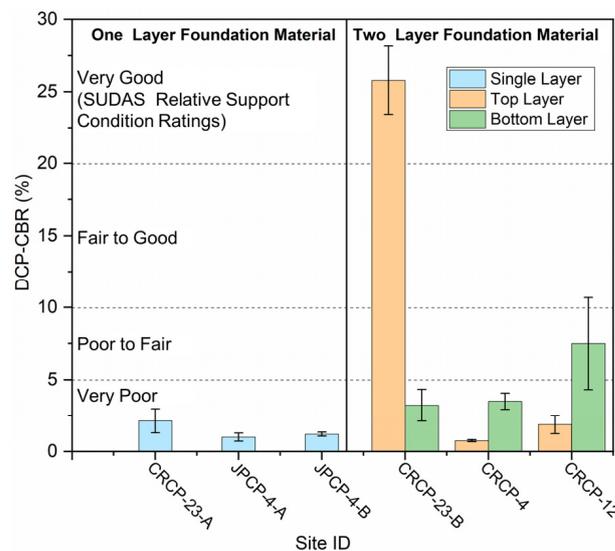
To evaluate the relative support conditions of the six test sites, the in-situ DCP-CBR values are compared to the Iowa Statewide Urban Design and Specifications (SUDAS) rating [52], which was developed to evaluate the support conditions for subbase and subgrade layers of rigid and flexible pavement systems based on the CBR values. Figure 9 compares the DCP-CBR of the two groups of test sites with the SUDAS rating.

Figure 9. Comparison of DCP test results with the SUDAS pavement foundation relative support condition rating.

At all test sites, the top layer of site CRCP-23-B was rated as very good support conditions, which is much higher than that of the bottom material and other sites. The difference is caused by material gradation. The top layer material of CRCP-23-B contains a higher gravel content than those of other sites as shown in Figure 7. This indicates that a higher content of coarse particles can significantly enhance the bearing capacity of the foundation.

The average DCP-CBR values of sites CRCP-23-A, JPCP-4-A, and JPCP-4-B are below 5%, which are rated as very poor support conditions. Regarding sites CRCP-23-B, CRCP-4, and CRCP-12, the top subgrade layer of sites CRCP-4 and CRCP-12 showed lower average DCP-CBR values than the bottom materials, corresponding to very poor support. At site CRCP-23-B the average CBR of the top layer was approximately eight times higher than that of the bottom material. The average DCP-CBR of the top layer was 25.8%, indicating good support. Compared to CRCP-4, despite having the same service life, sites JPCP-4-A and JPCP-4-B exhibited lighter pavement damage but still had lower bearing capacities. This phenomenon is attributed to the pavement design approach of Jointed JPCP. The reinforcement placement method in CRCP may more readily lead to stress concentration areas, thereby resulting in cracks. Additionally, field observations noted well-sealed joints at Sites JPCP-4-A and JPCP-4-B. Similarly, compared to Site CRCP-23-A, despite having the same service life, site CRCP-23-A showed more joint deterioration and D-cracking, as shown in Figure 6. This suggests that higher bearing capacity can help delay deterioration, thereby extending the service life of the pavement. However, despite this higher bearing capacity of the top layer, Figure 2 demonstrates that severe random cracking still occurred at this site. It indicates that the bearing capacity of the foundation is influenced by both the bearing capacities of the top and bottom layers. Even if the top layer of the foundation has good support conditions, poor support of the bottom layer similarly affects the overall bearing capacity of the foundation, ultimately leading to premature failure of PCC pavement.

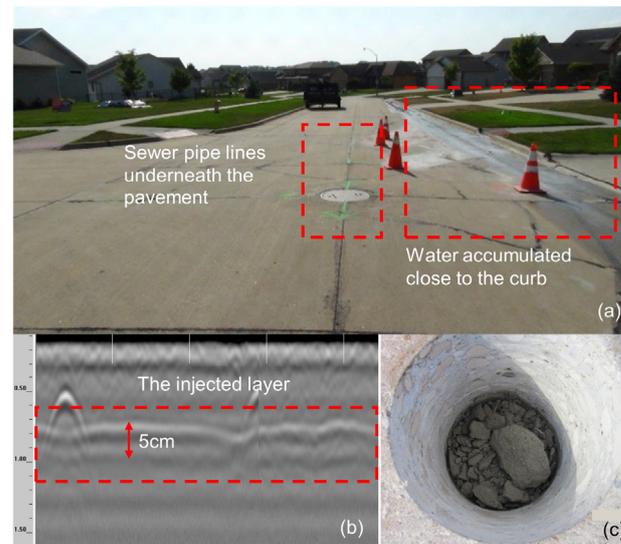
The drainage performance of the pavement foundation layer significantly affects the performance and durability of the pavement surface system. At the CRCP-12 site, Photos taken during the field investigation process are shown in Figure 10a. Field observations revealed severe random and corner cracking in the pavement and the water accumulated close to the curb. The water accumulation can cause insufficient bearing capacity of the foundation. Reduction in the bearing capacity of the subgrade materials may not only lead to a non-uniform support condition but also cause subgrade erosion. Additionally, the test section of the site CRCP-12 is close to a manhole and sewer pipelines (i.e., green paint marks the pipeline directions in Figure 10), where the subgrade material is likely less well-compacted, which makes it more susceptible to scoured and loose material. The GPR scan results show that a 5 cm thick layer was observed between the concrete and the bottom foundation layer as shown in Figure 10b. This was confirmed by the observation at the bottom of the core hole shown in Figure 10c. This further suggests that the pressure-injected layer was applied to address the erosion and loosening of less compacted materials.

**Figure 10.** (a) Faulted concrete slab, (b) GPR 2D scan result, and (c) injected material at Site CRCP-12.

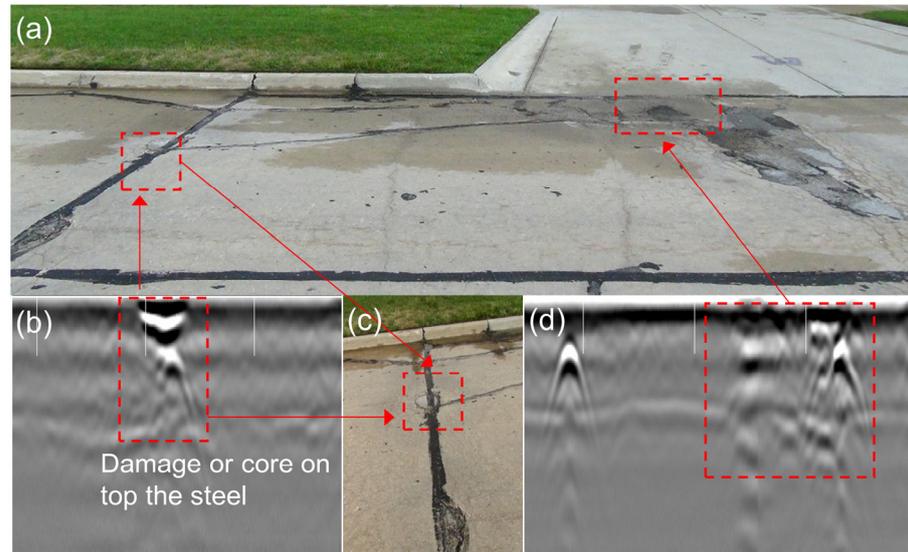
Figure 11 shows the observed cracking pattern and corresponding GPR scan results at site CRCP-23-A. Figure 11a shows a photo taken during the field investigation, also depicting water accumulation near the curb and severe random cracks and corner cracks on the pavement. The cracks allow water to seep into the foundation, which may accelerate

the corrosion of the rebar. The GPR survey, as illustrated in Figure 11b,d, indicates the potential existence of a predictable pattern in the occurrence of crack locations. The GPR results seem to indicate the formation of random cracks within the concrete slab, especially in areas between the rebars. This pattern suggests that the cracking might initiate at or near one of the rebars. The occurrence of cracks between the rebars could be attributed to stress concentrations or material defects due to rebar corrosion in these areas.

**Figure 11.** (a) Distresses observed at site CRCP-23-A, (b) GPR 2D scan result, (c) Magnified view of part of the distress, (d) GPR 2D scan result.

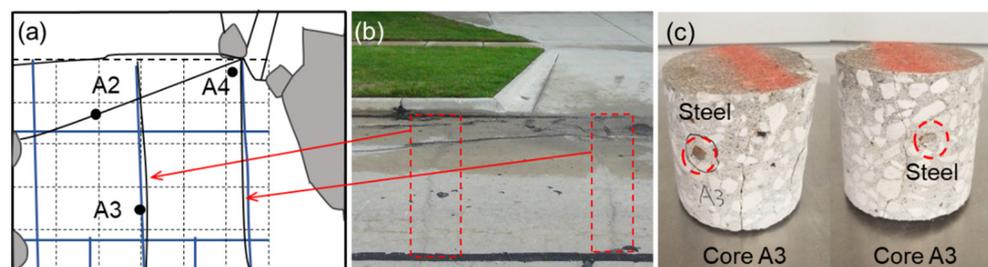
Further investigation was conducted by drilling a core A3, from a transverse crack to determine if the crack originated from the rebar, as depicted in Figure 12a. The GPR result and field observations results show that two small transverse cracks propagated along the transverse rebars, also shown in Figure 12a,b. However, observation of core A3 shown in Figure 12c illustrates that the interface may not be the cracking initiation point. Instead, it may behave as a stress concentration area where the initiated cracks may follow the rebars to propagate. The DCP results shown in Figure 9 and CHP results shown in Table 3 illustrate the poor bearing capacity and drainage performance at site CRCP-23-A, which indicate that when the subgrade layer is not strong enough, lacking the necessary strength, it fails to adequately support vehicular loads. This could result in the formation of stress concentration areas in the areas around the rebars, leading to the development and propagation of cracks in these specific regions.

**Figure 12.** (a) Schematic of crack locations, reinforced bars, and cores, (A2, A3, and A4 are the labels for the core sampling locations) (b) transverse cracks that developed along the transverse rebars, and (c) images of Core A3 at Site CRCP-23-A.

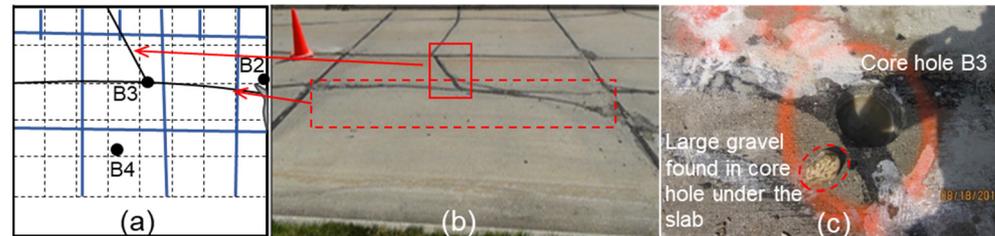
Furthermore, at site CRCP-23-B, special attention was paid to the intersection of severe transverse and longitudinal cracks at core B3, as shown in Figure 13a,b. After drilling the core sample, an unexpectedly large gravel particle was found beneath core B3, as depicted

in Figure 13c. It suggested a stress concentration area might have formed beneath the core B3 under the influence of vehicular loads. Additionally, the presence of the large gravel particle could have altered the direction of crack propagation, preventing it from following the path of the reinforcing bars.

**Figure 13.** (a) Schematic of crack locations, reinforced bars, and cores, (B2, B3, and B4 are the labels for the core sampling locations) (b) location of the cracks, and (c) a large gravel particle in core hole B3 at site CRCP-23-B.5.
