Article

Cyclic Crack Monitoring of a Reinforced Concrete Column under Simulated Pseudo-Dynamic Loading Using Piezoceramic-Based Smart Aggregates

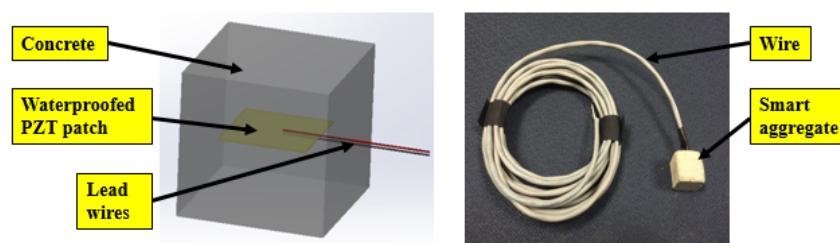
Figure 1. Structure of a smart aggregate.

Piezoelectric materials, exhibiting piezoelectricity that can convert mechanical strain to electrical signals and vice versa, have been widely used as ultrasonic transmitters and receivers in many applications. Lead Zirconate Titanate (PZT) is one of the most popular materials among piezoelectric materials. Since PZT material is fragile and easily damaged, a smart aggregate (SA) was designed by embedding a waterproofed PZT patch with lead wires into a concrete block [39]. The schematic structure and a photo of smart aggregate are shown in Figure 1. The detailed parameters of the rectangular PZT patch is provided in Table 1. Due to the stable physical properties of concrete, the designed SAs are capable of acting as embedded transducers to perform the structural health monitoring in real-time. When SAs are installed in the reinforcing cage before concrete casting, we used wires to especially fix the SAs with the reinforcing cage. Just like an aggregate in concrete, our smart aggregate will be surrounded by the liquid cement. Both a chemical and physical bond will form between the cement and the SA during the curing process and therefore good bonding is ensured.

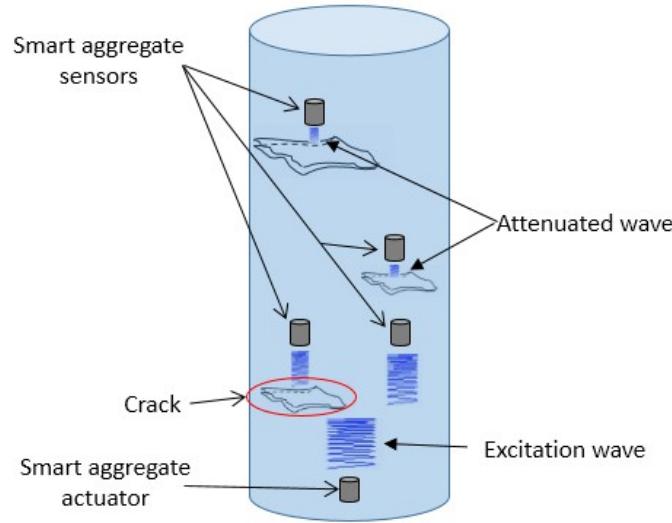
Figure 2. Schematic diagram of smart aggregate-based active sensing approach.

Figure 2 gives an example to illustrate the smart aggregate-based active sensing approach for multi-crack detection in a concrete column. As shown in Figure 2, one smart aggregate functions as an actuator to generate guided waves propagating in the concrete structure. Other distributed

smart aggregates are used as sensors to detect the wave responses. If a crack appears in the structure, it acts as a stress relief in the wave propagation path. Therefore, the energy of the received signal from corresponding SA sensors will attenuate.

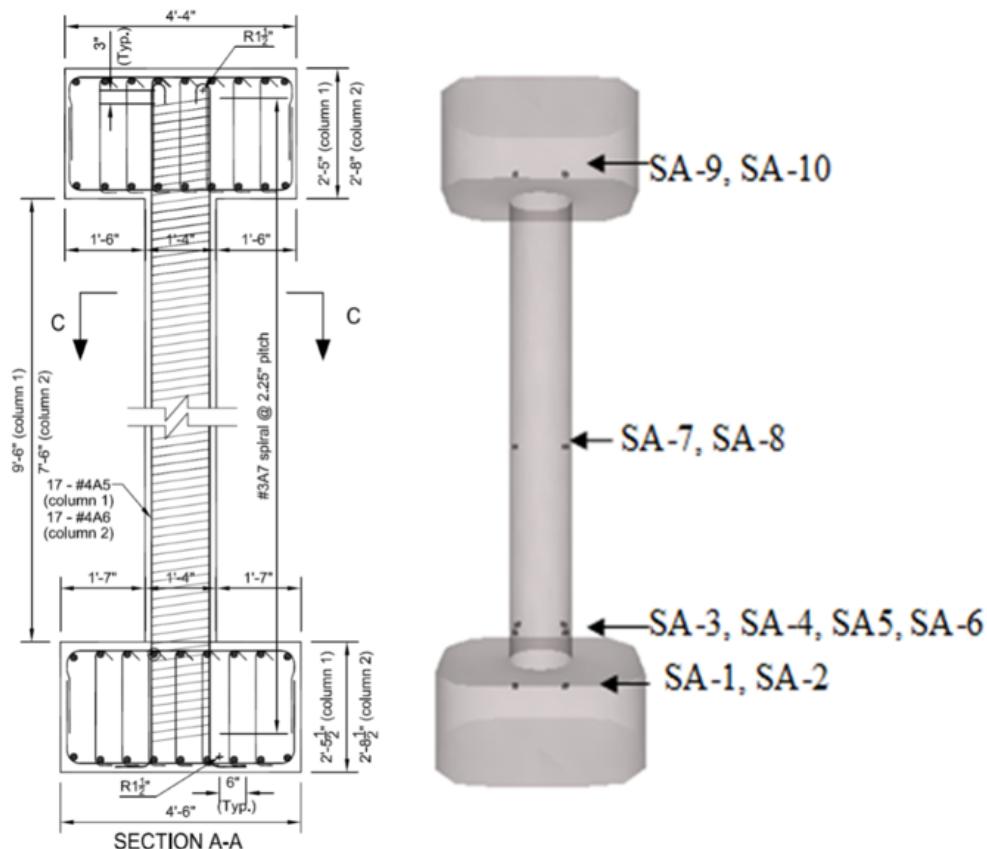
Figure 3. Location of smart aggregates in the concrete column.

An RC column instrumented with 10 smart aggregates was fabricated at Prestressed Engineering Company, LLC in Blackstone, IL, USA. The location of smart aggregates in the concrete column is shown in a structural drawing and a three-dimensional view, as shown in Figure 3. Figure 4 shows pictures of some smart aggregates installed in the rebar cage of the column.

column can be seen in Figure 5. Using the smart aggregate designation shown in Figure 3, SA-1 was used as the actuator to generate repeated swept sine wave through a function generator. The amplitude, period, and the frequency range of the swept sine wave are 10 V, 3 s, and 100 Hz–10 kHz, respectively. SA-3 through SA-10 were used as sensors to detect the signal. The sensing signal was recorded by a NI-6353 data acquisition system. The sampling frequency of the data acquisition system is 100 kS/s per channel.

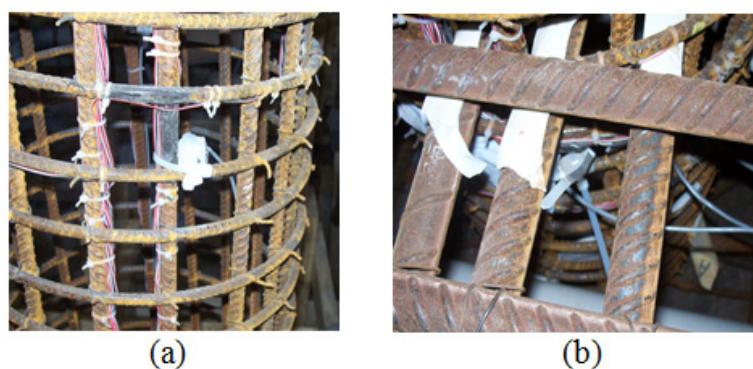
Figure 4. (a) A smart aggregate fixed on the rebar cage; (b) A smart aggregate was installed in the base.

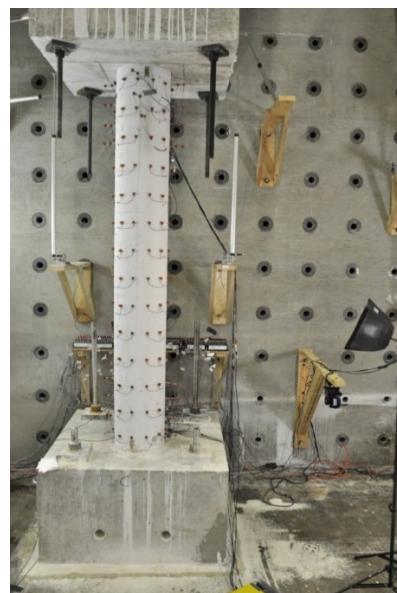
Figure 5. The concrete column specimen after casting.

A series of 330 kip actuators called “Load and Boundary Condition Boxes” (LBCDs) were placed at the top of the full-scale column to apply load to the specimen. The test concrete column was mounted to a strong floor using all-thread rods. The column was instrumented with linear variable differential transformer (LVDTs), strain gauges mounted on the reinforcing steel, Krypton displacement cameras (Metris Design, Leuven, Belgium), in addition to the smart aggregates. A photo of the casted concrete

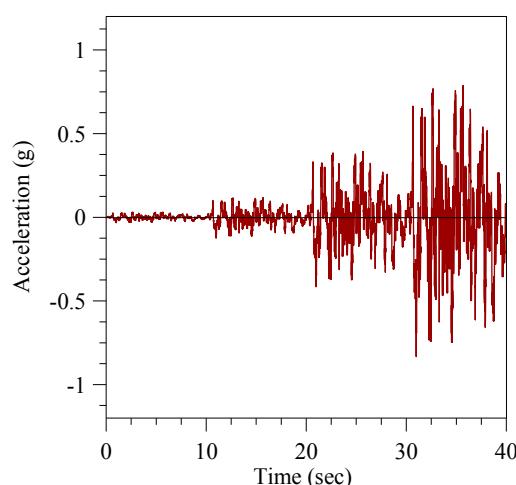
Figure 6. Loading protocol: acceleration record.

During the test, the concrete column was assumed to be a column in a curved bridge subjected to a simulated pseudo-dynamic earthquake record. After each step of the record, the stiffness of the column was calculated and the next step of the earthquake record was adjusted using a finite element analysis to account for any decrease in stiffness in the system. The simulated earthquake record represented a 40 s earthquake. The magnitude of the acceleration was increased every 10 s. Figure 6 shows the acceleration record used in this loading test. Structural health monitoring tests were performed periodically during the approximately 40-h test.

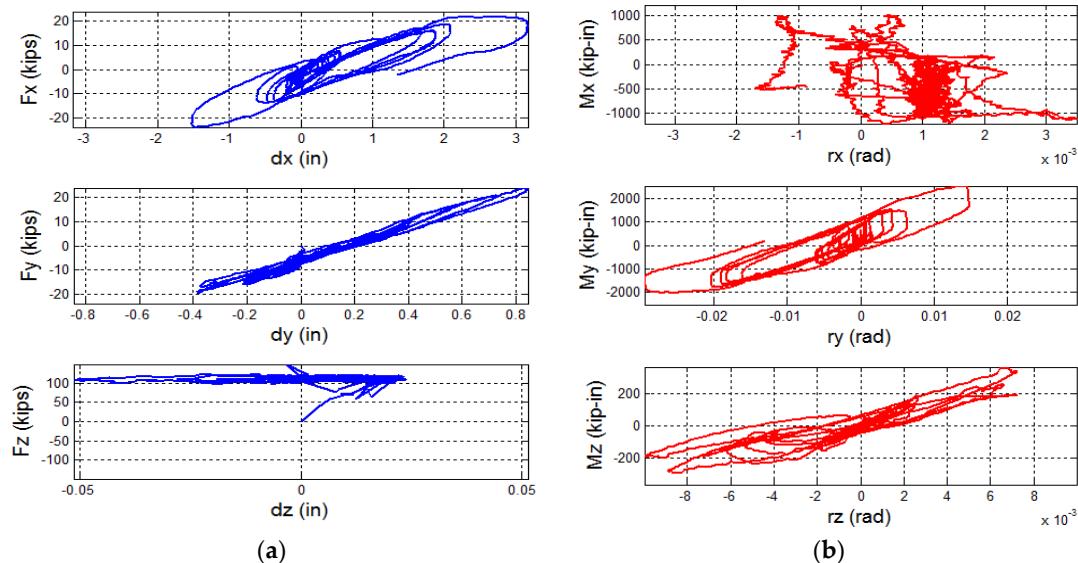
Figure 7. Force-displacement and moment-curvature relationships in the x -, y - and z -directions.
(a) Force-displacement relationships; **(b)** Moment-curvature relationships.

The test was stopped due to the actuators in the x -direction running out of stroke. At that point, the concrete column had yielded and was exhibiting spalling, but had not yet failed. Figure 7 shows the force-displacement and moment-curvature relationships in the x -, y - and z -directions for the concrete column, respectively. A photo of the yielded concrete column after test is shown in Figure 8.

As shown in Figure 7, the x -direction had the largest displacement in the test. The displacement history in the x -direction at the top of the concrete column is shown in Figure 9. During the 40-h test, 14 cycles of displacement in the x -direction were observed and marked in Figure 9.

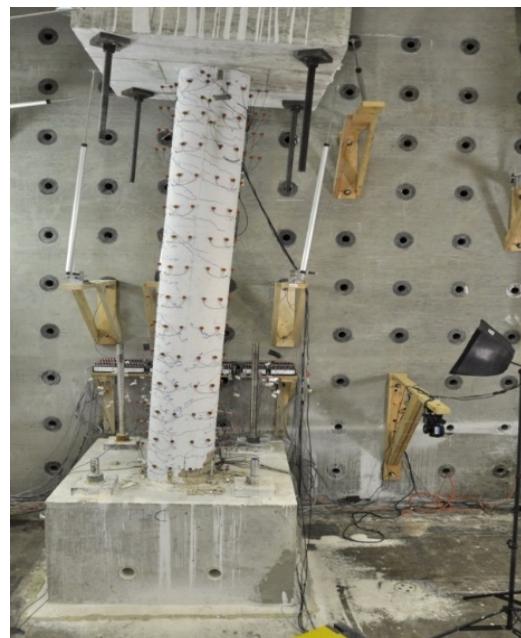
Figure 8. A photo of the concrete column yielding after test.

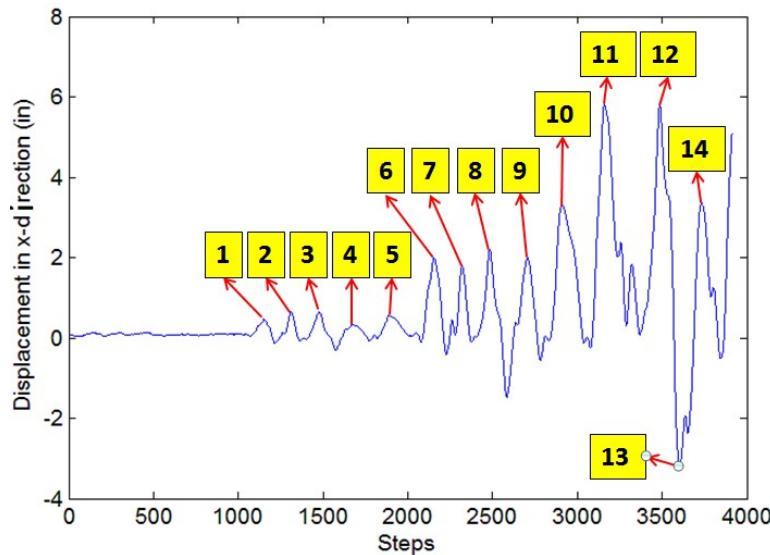
Figure 9. Displacement history in x -direction of the column.

In the first 1000 steps, the displacement of the RC column was very small, as shown in Figure 9 (0–1000 steps). Since no damage occurred during this time, the received signal of SAs did not change much. Therefore, the values of the local damage indices are also very small, as shown in Figures 10 and 11. It can be considered that the RC column was in good health during the first 1000 steps.

From Step 1100 to Step 2100, the concrete column was subject to five initial simulated pseudo-dynamic loading cycles (1–5), as shown in Figure 9. When load increased, the bottom cracks opened and the structural damage increased. When load decreased, cracks closed corresponding to the decreased damage. During this period, the peaks and valleys between the damage indices and the displacement history as shown in Figure 11 are not clearly matching to each other, but the similar increasing and decreasing trends can still be found. The possible reason is the crack open-close phenomenon in this period is not clear, since the crack formed at the bottom of the concrete column is very small under the first several loading cycles.

From Step 2100 to Step 3300, both the cycles observed in displacement history and the damage indices are in good agreement with each other. Since the highest value in each displacement cycle of the RC column was quite large, as shown in Figure 9, the major crack has existed at the bottom of the concrete column. As the concrete column was pushed to one side, the major crack opened and the values of the damage indices for each smart aggregate correspondingly increase. As the concrete column was further pushed back to its original position, the values of the damage indices decrease. Since the crack in this period is much larger than the previous step from 1100 to 2100, the propagating stress wave attenuates more than the previous period. The cycles (6–11) shown in the damage index are more clear than the previous cycles (1–5). In addition, the highest values of the damage index reached to one, which implies the concrete column was subject to severe damage in the maximum displacement of each cycle.

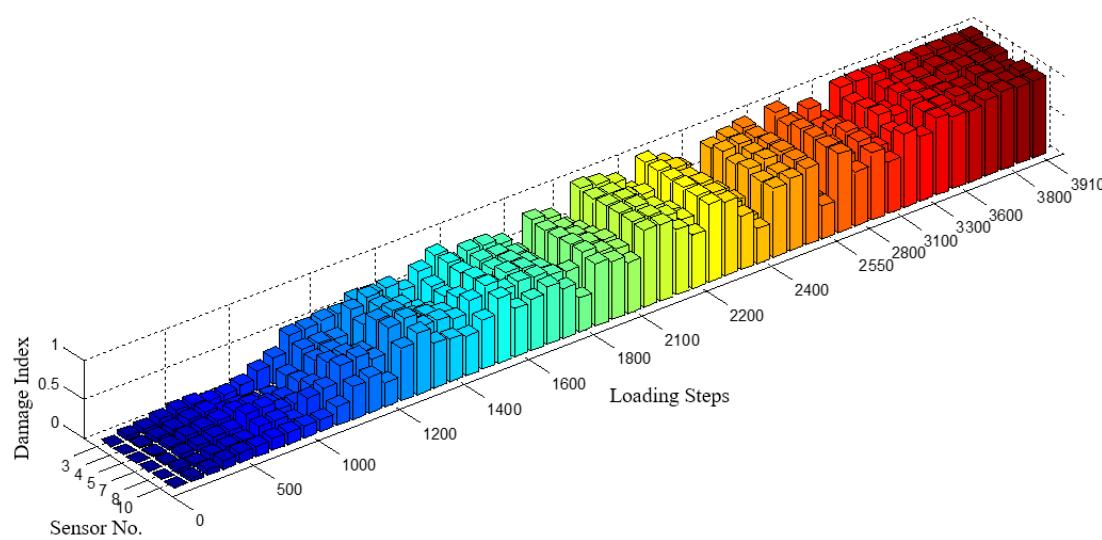
Figure 10. General damage indices throughout the test.

Figure 10 shows the wave packet-based damage indices of all the functional SA sensors during the test. The damage indices of each SA sensor present generally increasing values, which correspond to the damage development of the RC column. Before Step 1000, values of the damage indices are close to zero due to small displacement and damage within the RC column. As the load increased after Step 1000, the values of damage indices increase. After Step 3500, damage indices of all SA sensors report values close to one, which means the RC column sustained a high level of damage. The results shown in the damage indices are in good agreement with the test record [45].

Other than the general increasing trend shown in the damage indices, several local increasing and decreasing cycles can also be found in the damage indices. Since the RC column was subjected to cyclic loading, the cracks in the RC column opened and closed correspondingly. The local increasing and decreasing values shown in the damage indices detected this opening and closing of the cracks during

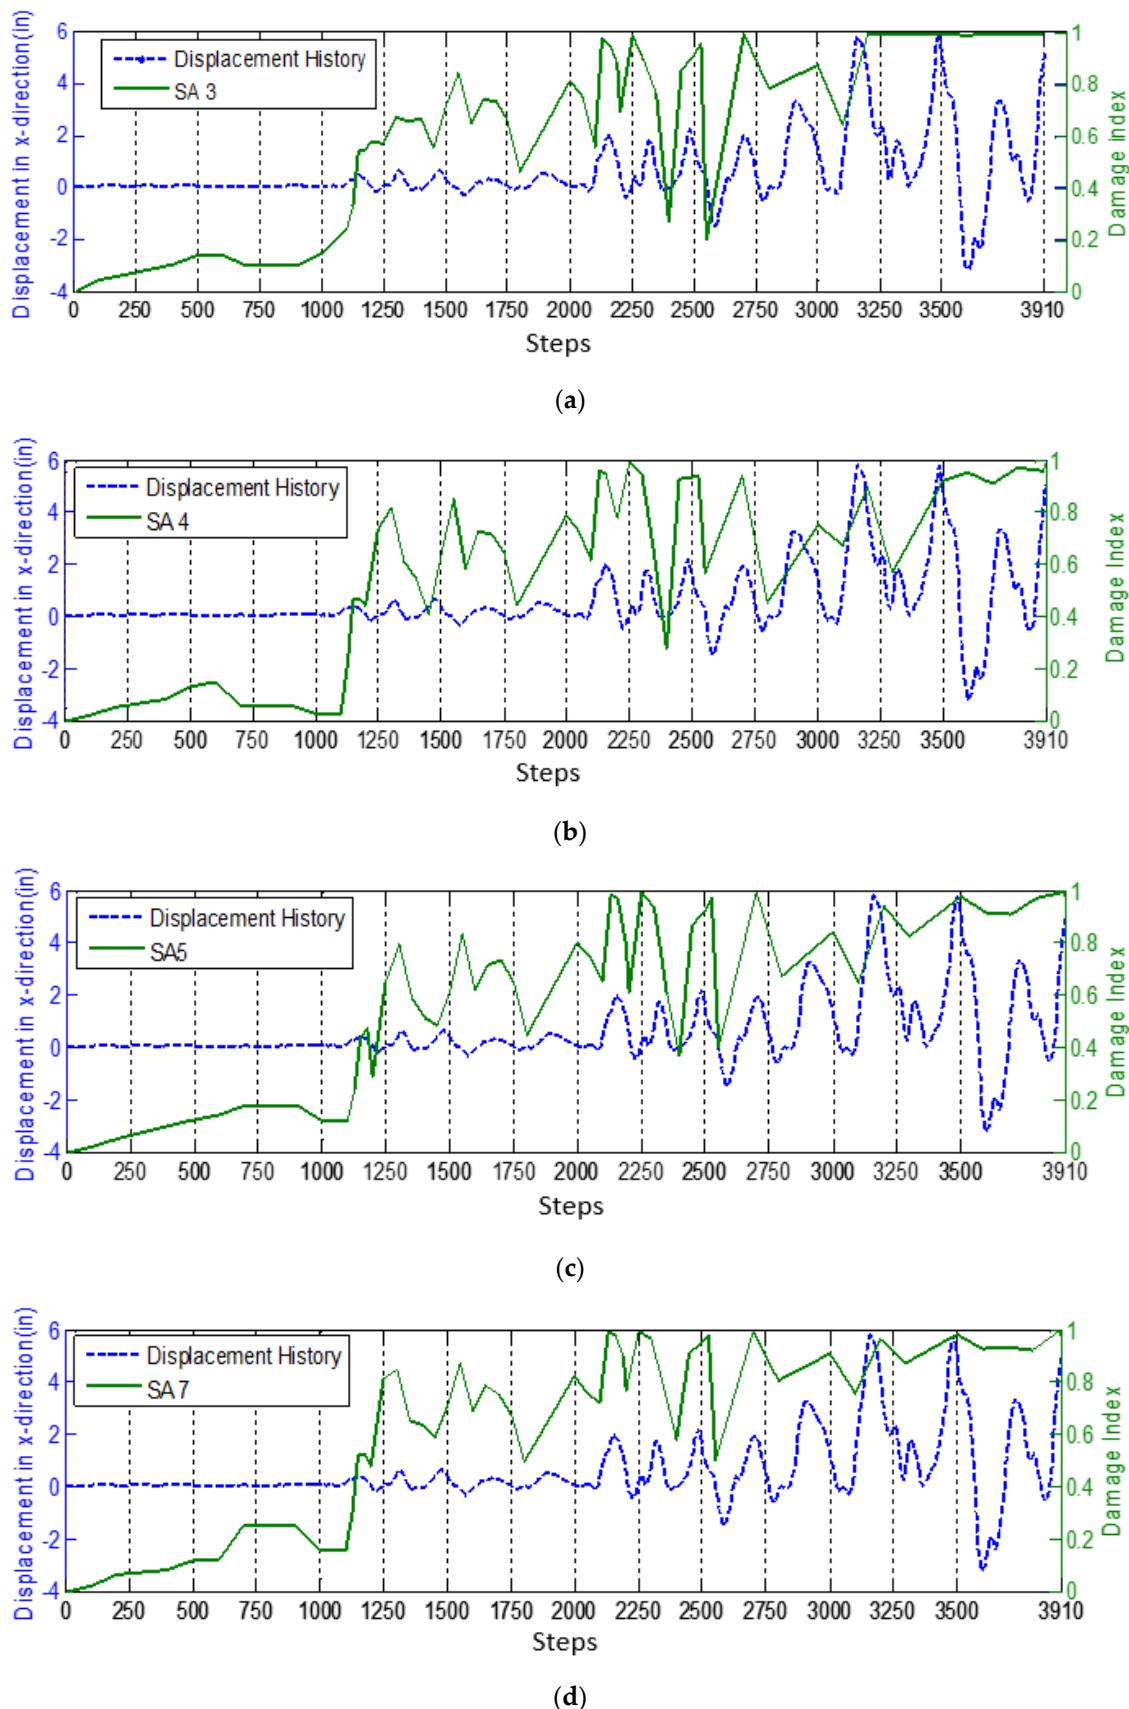
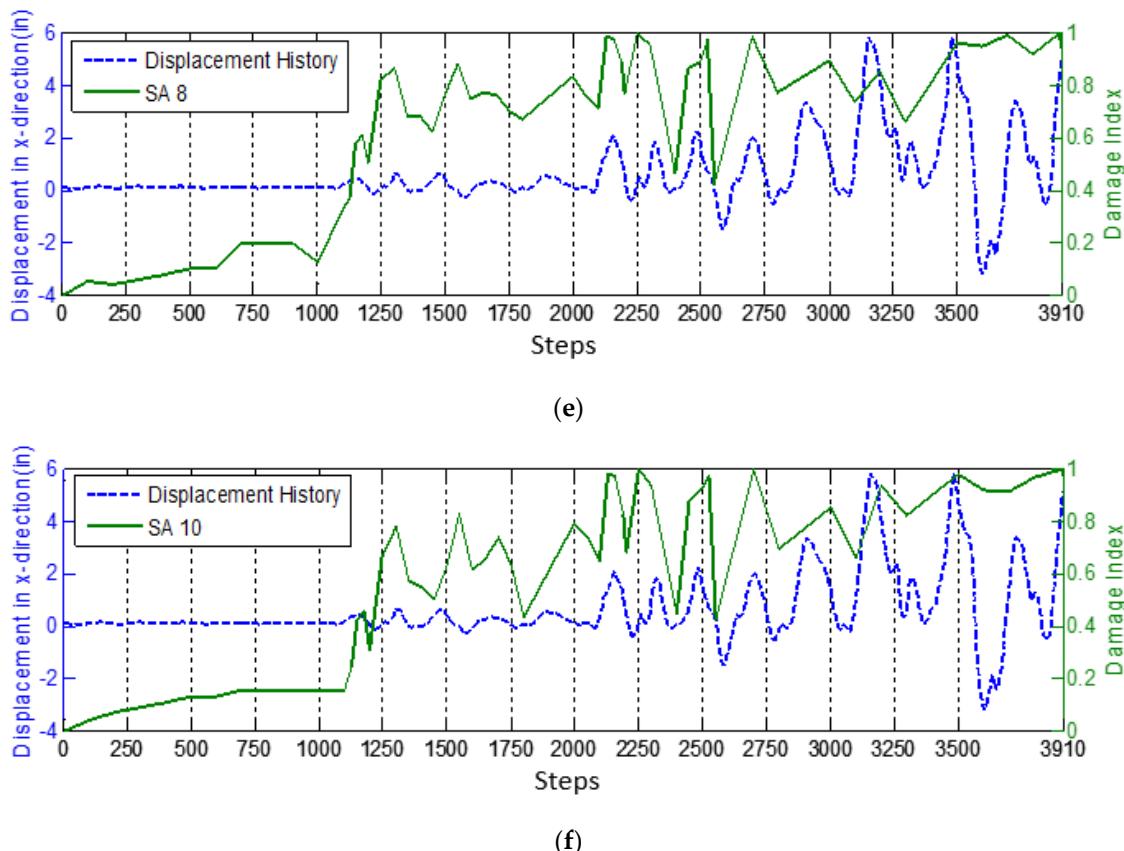
Figure 11. Overlap plots of damage indices and displacement history curves: (a) SA 3; (b) SA 4; (c) SA 5; (d) SA 7; (e) SA 8; (f) SA 10.

the test. According to different cycles of increasing and decreasing shown in the damage indices, overlay plots of the displacement history curve and damage indices of each functional SA are shown Figure 11.

As shown in Figure 11, the peaks and valleys between the damage indices and displacement history match well until approximately load Step 3250, which corresponds to the maximum load and severe damage in the column. Beyond this point, the damage indices maintain a value near one. Each peak corresponds to cracks opening and each valley corresponds to a cracks closing (or opening on the opposite side of the column).
