Article

# Remote Monitoring and Evaluation of Damage at a Decommissioned Nuclear Facility Using Acoustic Emission

This study investigates the applicability of deploying acoustic emission for the remote monitoring of selected areas at the Savannah River Site (SRS) 105-C Reactor Facility in Aiken, South Carolina (Figure 1). This is an inactive nuclear facility under surveillance and maintenance operations as well as deactivation and decommissioning operations. AE monitoring was conducted at areas known to have active corrosion damage and/or visible cracking. This allows the examination of the applicability of previously developed AE methods for corrosion damage detection and classification.

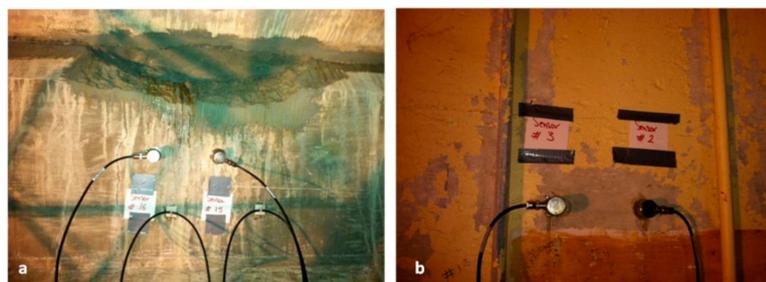
**Figure 3.** Photograph of: (a) Horizontal beam location and (b) control location.

The second location was chosen on a horizontal beam that forms the connection with the previously described column (referred to as the ‘horizontal beam location’). Two sensors (one resonant and one broadband) were installed at a distance of 12 inches below the beam to roof interface where signs of deterioration were visually observed (Figure 3a). The spacing between the sensors was 6 inches. The third location was chosen at an area where no signs of damage were observed (referred to as the ‘control location’). Two sensors (one resonant and one broadband) were installed at this location, which is shown in Figure 3b. The horizontal distance between the two sensors is 6 inches. The data collected from the control location was used to evaluate the effectiveness of data reduction approaches.

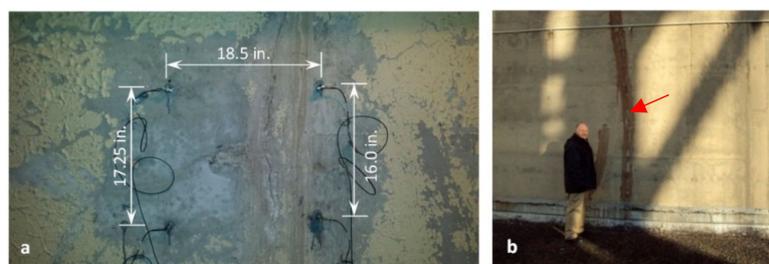
**Figure 4.** Photographs at top floor level (+48 level): (a) Sensor grid from interior and (b) vertical crack from exterior.

The wireless AE system was installed at the top floor level (also known as +48 level) to monitor a vertical crack that may penetrate an exterior wall, which is shown in Figure 4, using four resonant sensors (type PK6I). Sensor layout and spacing is also shown in the figure.

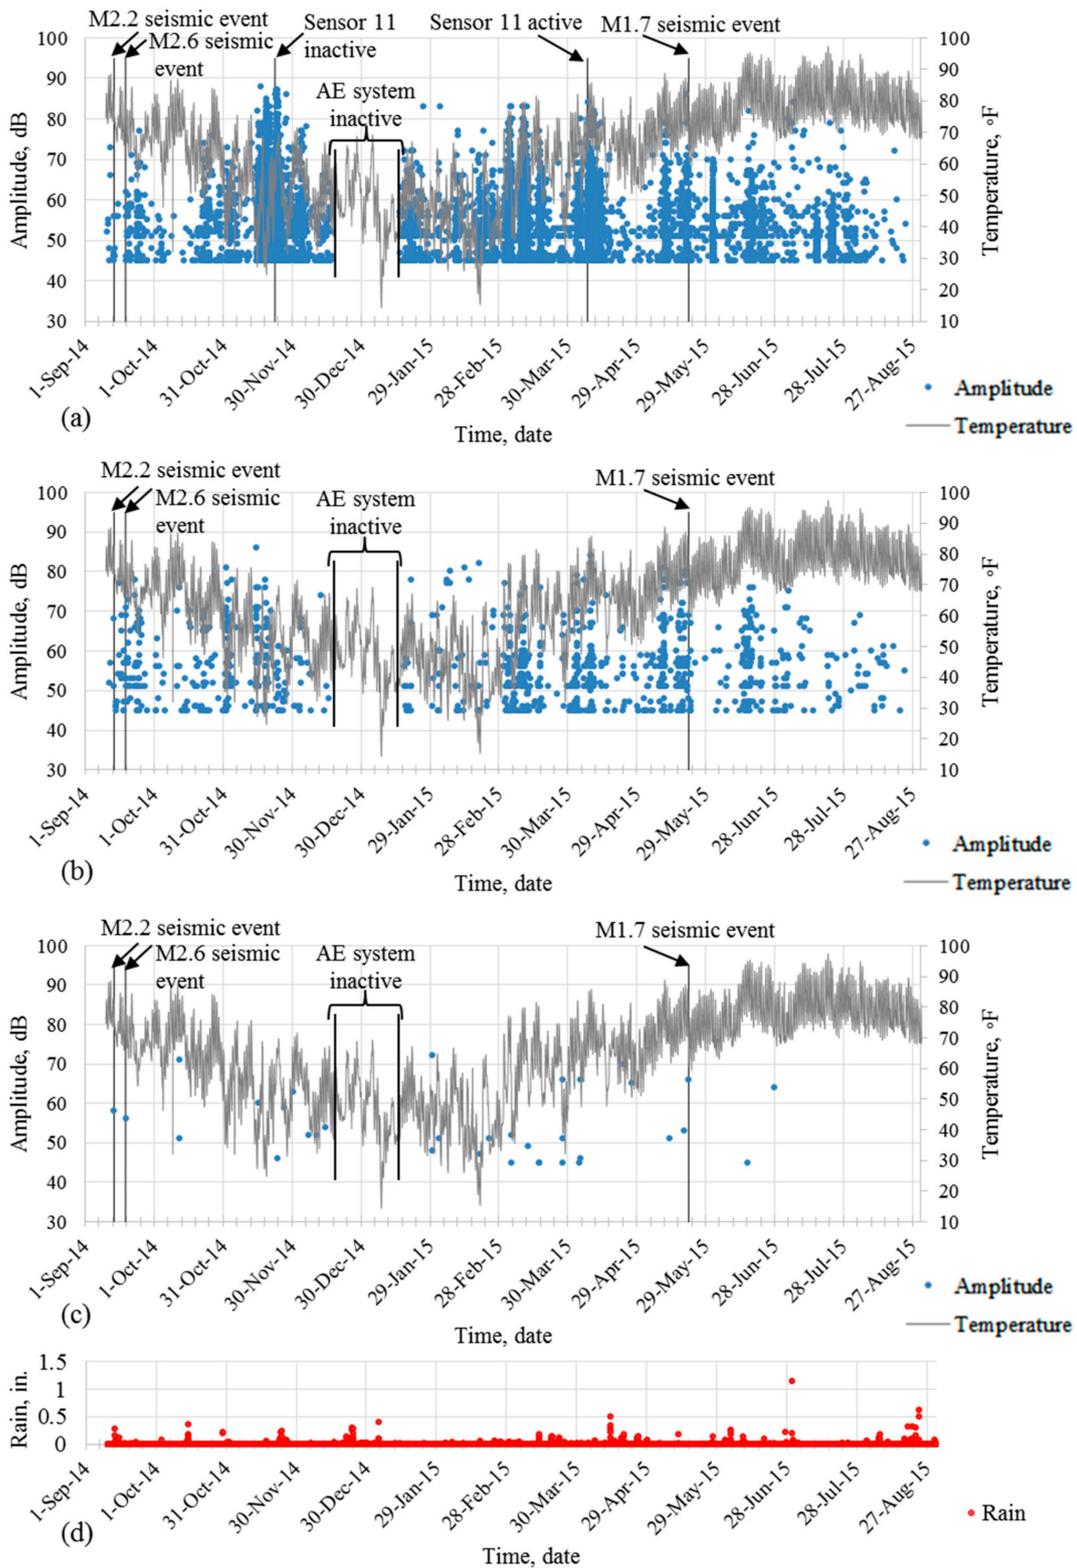
**Figure 5.** Amplitude and temperature versus time for resonant sensors: (a) Vertical column to roof interface location, (b) horizontal beam location, (c) control location, and (d) rain versus time.

Figures 5 and 6 show the AE activity detected at the three monitored locations in the crane maintenance area for the resonant and broadband sensors, respectively. As shown in the figures, AE activity at the locations associated with visually observable damage ('vertical column to roof interface location' and 'horizontal beam location') was significantly higher than the AE activity at the control location. This indicates that the filters used were suitable for this application and also that intrinsic noise such as that potentially caused by electro-magnetic interference is not an obstacle for this application. The relatively high levels of AE activity indicate that damage (corrosion and related cracking) associated with the aging of reinforced concrete is progressing at the vertical column to roof interface and the horizontal beam locations.

Rain and temperature data were provided by SRNL to investigate the effect of environmental conditions on AE activity. Seasonal temperature fluctuations affected the data more significantly than daily temperature fluctuations. This may be attributed to the low coefficient of thermal expansion of concrete, which causes volumetric changes to be associated with prolonged exposure to temperature differentials. As a general statement, increased AE activity was recorded when temperatures decreased during the winter months. Rain events were not as closely correlated to AE activity as were temperature fluctuations. However, associated moisture and repeated wet/dry cycling from rain events may lead to acceleration of the degradation process. During one of the site visits, remnants of a crack sealing material were found on the floor of the 105-C building, which indicates one potential source of moisture intrusion in this area.

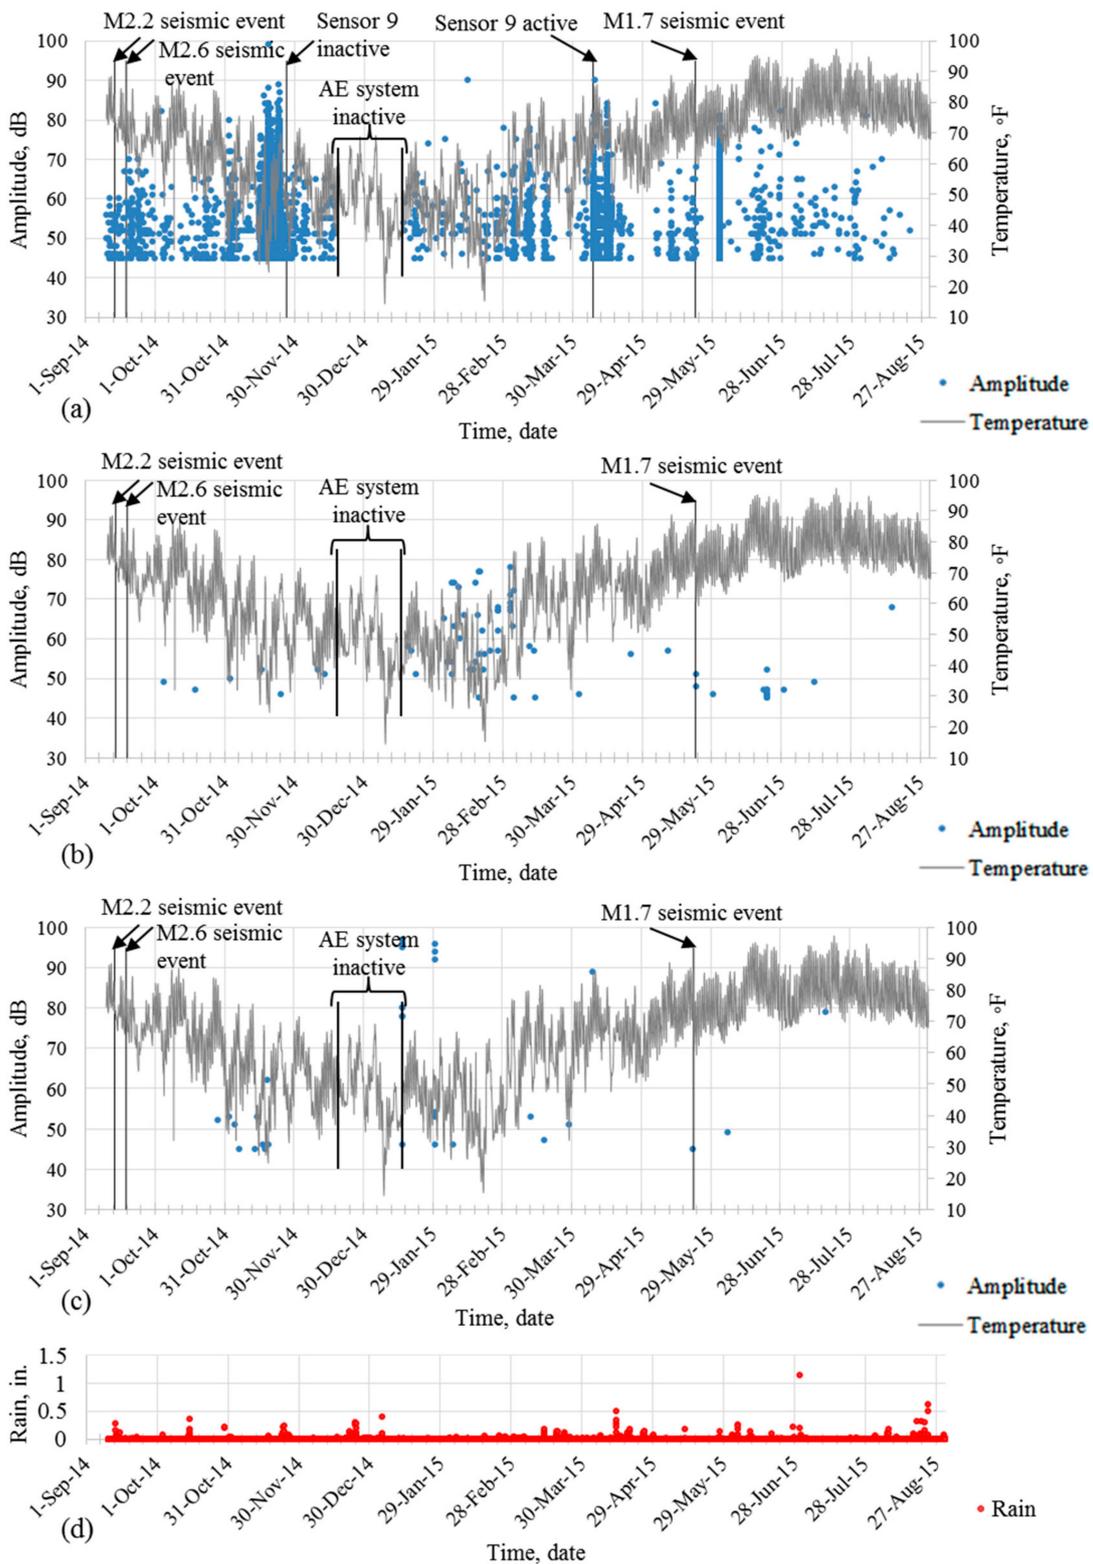
**Figure 6.** Amplitude and temperature versus time for broadband sensors: (a) Vertical column to roof interface location, (b) horizontal beam location, (c) control location, and (d) rain versus time.

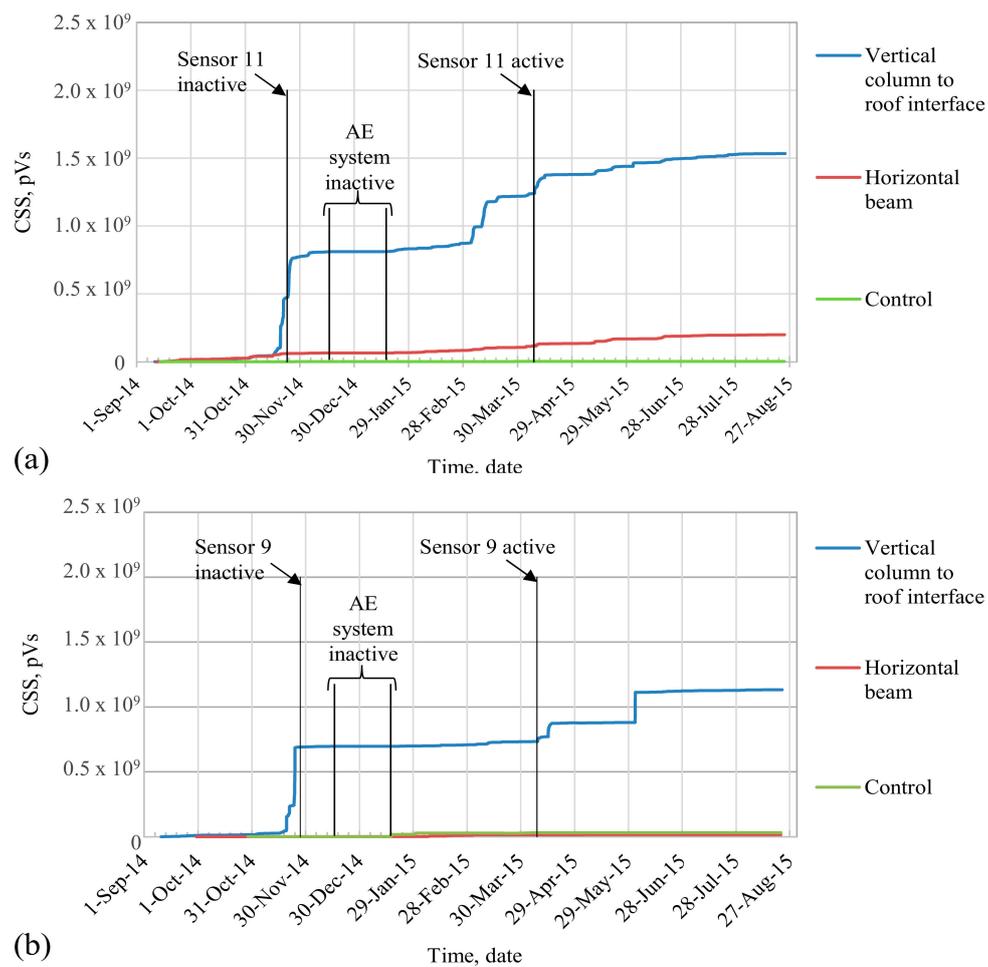
Figure 7. Cumulative signal strength (CSS) of: (a) Resonant sensor and (b) broadband sensors.

Figure 7a,b show the cumulative signal strength (abbreviated as CSS) at each monitored location for resonant and broadband sensors, respectively. Signal strength of an AE hit is a measure of the area under the recorded signal envelope (sometimes referred to as MARSE, Measured Area under the Rectified Signal Envelope) [13]. Higher levels of signal strength are associated with higher levels of energy release due to crack growth events.

In both Figure 7a,b, it is apparent that sharp changes in the slope of cumulative signal strength that indicate sharp increases in damage progression related to the vertical column to roof interface location occurred in several different instances. For example, a sharp increase in damage growth is noticed at the end of November, between 4 March 2015 and 13 March 2015, and between 8 April 2015 and 15 April 2015. These sharp increases were noticed for both the resonant and broadband sensor types. As expected, the broadband sensors exhibit slightly lower values of cumulative signal strength due to the relatively low sensitivity of this sensor type.

The highest change of slope for resonant and broadband sensors at the vertical column to roof interface occurred at the end of November in 2014. This sudden increase in cumulative signal strength was accompanied by localized spalling of concrete, which may have caused the detachment of two sensors previously mentioned. This spalling supports the findings that significant damage occurred during this time period.

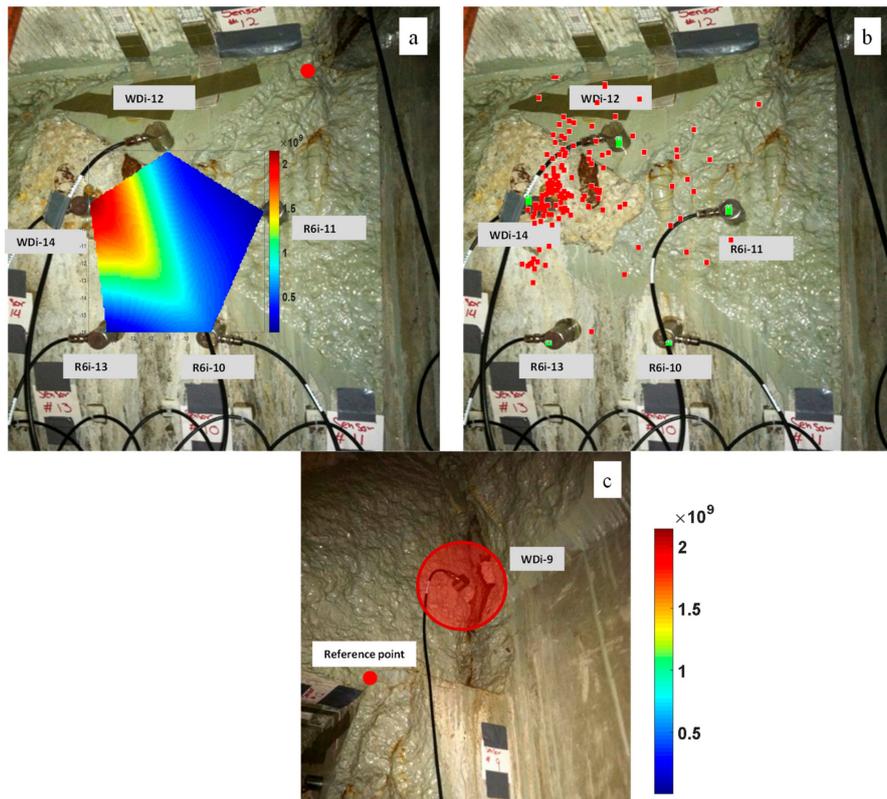
**Figure 8.** Vertical column to roof interface: (a) Signal strength contour plot at elevation face sensors, (b) source location at elevation face sensors, and (c) signal strength contour plot at the side face sensor.

Figure 8a is a visual representation of the intensity of damage at each sensor location using a contour plot. The plot is based on cumulative signal strength results (units of pico-Volt seconds) where high cumulative signal strength is plotted in red, which indicates high damage while low cumulative signal strength is plotted in blue. This indicates lower damage. The contour plots show relative intensity of AE activity.

As seen in the plot, the highest normalized cumulative signal strength values were detected at the top left of the elevation face sensors and at sensor 9 at the side of the vertical column. The 2D source location results (for the data detected from the five sensors at the same plane) show that most AE events were also detected at the top left of the sensor grid, which suggests that damage is progressing at this location (Figure 8b). Figure 8c likewise indicates very high damage progression in the vicinity of sensor 9 with the highest value of normalized CSS detected at sensor 9.

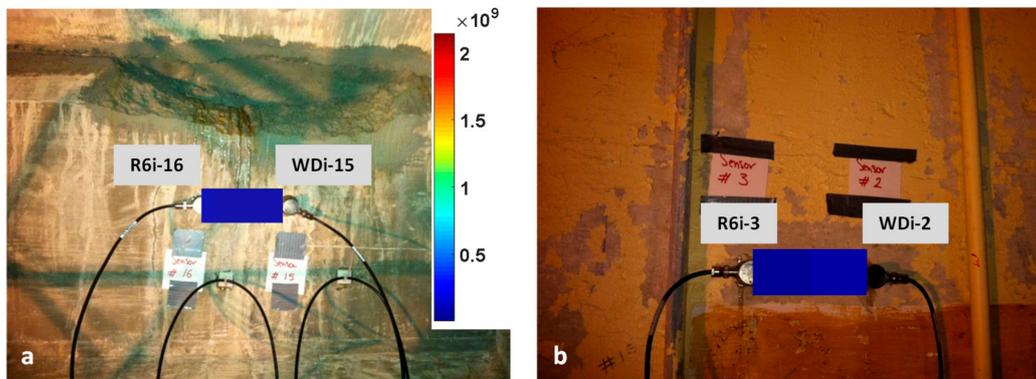
**Figure 9.** Signal strength contour plot: (a) Horizontal beam location and (b) control location.

Figure 9 shows similar contour plots at the horizontal beam and control locations. Similar to the vertical column to roof interface location, normalized data was used to generate the plot. The same contour scale seen in Figure 8 was used to generate the plots. As seen in Figure 9, lower damage occurred at the horizontal beam location (Figure 9a) and the control location (Figure 9b) when compared to vertical column-to-roof interface location.

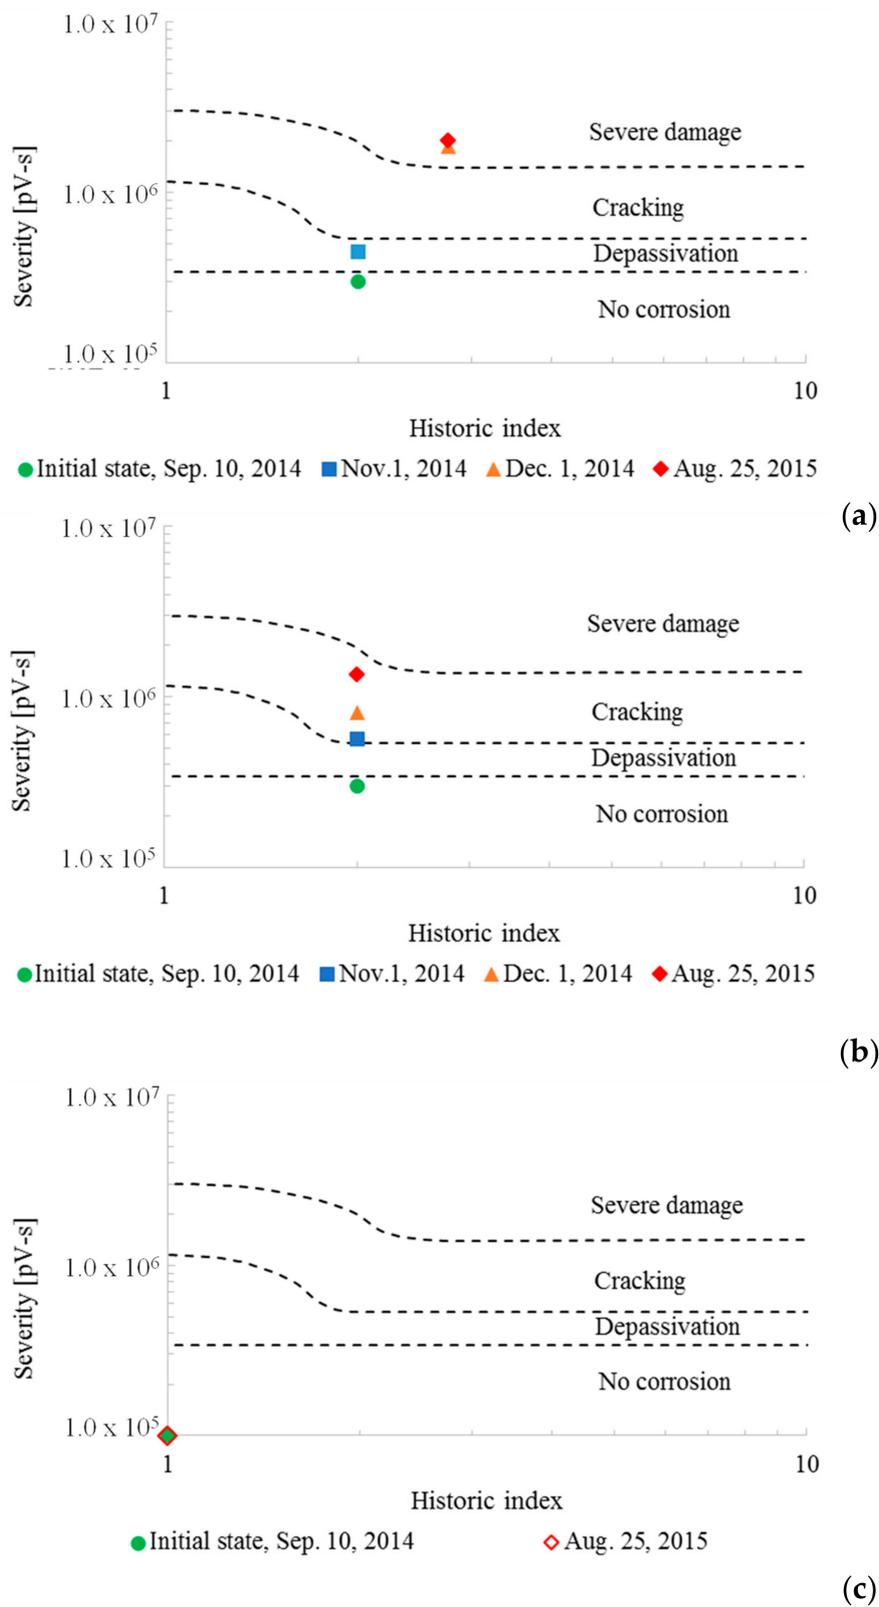
**Figure 10.** Intensity Analysis results for resonant sensors: (a) roof to column interface, (b) horizontal beam location, and (c) control location.

Figures 10 and 11 are plots of Intensity Analysis results from the period beginning 10 September 2014 and ending 25 August 2015 for data recorded from resonant and broadband sensors, respectively. For the majority of field applications, only resonant sensors would be utilized due to the increased sensitivity of this sensor type in comparison to broadband sensors. The use of resonant sensors, therefore, reduces the number of sensors needed for a given application. However, resonant sensors do not provide high fidelity representations of the frequency content in comparison to broadband sensors. One purpose of using the two different sensor types is to investigate the associated differences in the results. The limits of the Intensity Analysis chart were developed based on data from resonant sensors [2]. Thus, it is expected that data collected from broadband sensors may yield underestimated damage classification if the same limits are used.

The preliminary estimation of damage was based on visual inspection during the initial visit to 105-C and was located near the border between the ‘no damage’ and the ‘depassivation’ regions of

the chart (severity = 300,000 and historic index = 2.0) for both the vertical column to roof interface location and the horizontal beam location. This assumed level of damage underestimated the actual condition of the structures since these areas are known to have ongoing corrosion damage. Ideally, this initial point would be established through a combination of methods including visual inspection and electrochemical methods. Electrochemical methods, however, were not collected during this part of the study. For the control location, no damage was assumed and, therefore, the initial point was located at the left corner in the 'no corrosion' region of the chart.

Acoustic emission activity during the monitoring period (approximately one year) at the vertical column to the roof interface location indicated a progression from the initial state to the severe damage state for both sensor types. It is noted that the results of IA after approximately 2 months of monitoring (1 November 2014) showed that corrosion is ongoing at this location. On 1 December 2014, Intensity Analysis results indicated that severe damage occurred. For monitoring over this relatively short duration, such a progression from the initial state to the 'severe' damage state is indicative of a relatively high level of ongoing damage growth in the monitored areas. For this plot, the term 'cracking' refers to micro-cracking that is generally non-visible while 'severe damage' refers to visible cracking that may be accompanied by spalling. This result is supported by the spalling that occurred at this location during the monitoring period.

Acoustic emission data from the resonant sensor and the broadband sensor at the horizontal beam location progressed from the initial state to the cracking state over the duration of the monitoring period. This result is also an indication of ongoing damage growth at this location when the relatively short monitoring period is considered. The broadband sensor results (Figure 11b) indicated less damage than the resonant sensor results (Figure 10b) especially during the first 3 months of monitoring. This can be attributed to the lower sensitivity of the broadband sensors.

In contrast to the roof interface location and the horizontal beam location, the intensity analysis results for the control location indicate no damage progression during the monitoring period and, therefore, the initial state and final state coincide (plot on top of one another) for the control location.

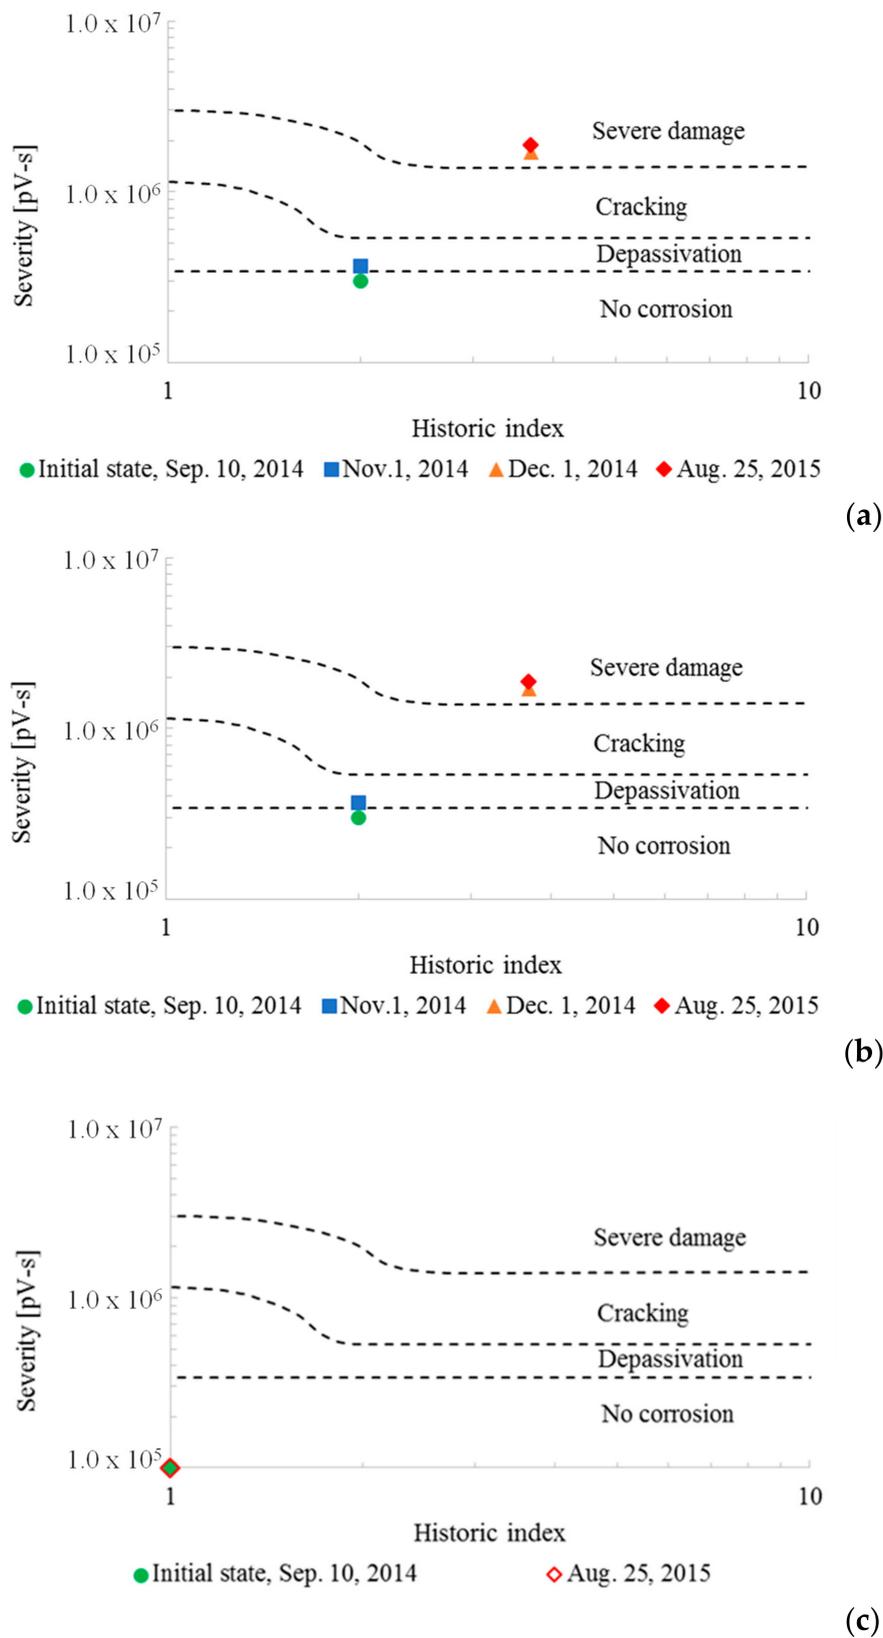
**Figure 11.** Intensity Analysis results for broadband sensors: (a) roof to column interface, (b) horizontal beam location, and (c) control location.

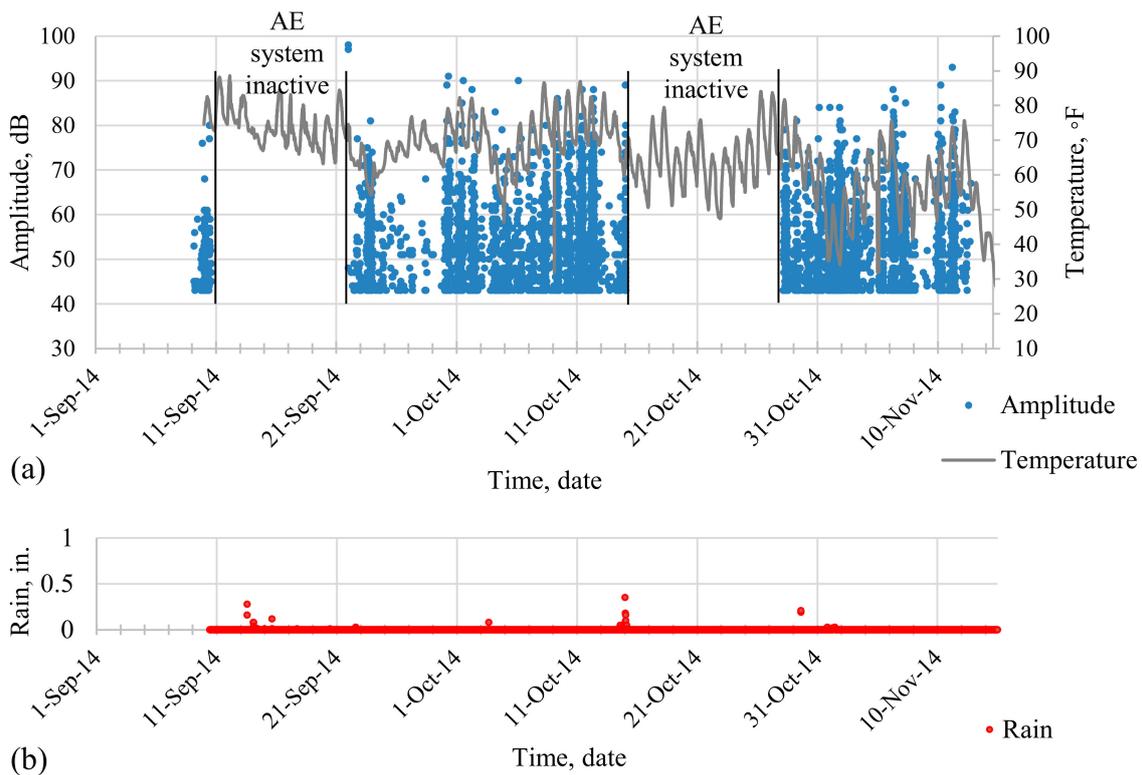
**Figure 12.** (a) Amplitude and temperature versus time for four wireless sensors at the +48 level and (b) rain versus time.

As described for the wired system data, the raw data was analyzed and appropriate data filters were used to separate meaningful data from spurious emissions. The limits of the data filters are shown in Table 2. Figure 12 shows acoustic emission activity in terms of amplitude versus time (showing both rain and temperature data) collected between 9 September 2014 and 13 November 2014 from the wireless acoustic emission system. This data set contains a significant number of hits with amplitude exceeding 80 dB. These hits are of relatively high amplitude and may be correlated to ongoing damage.

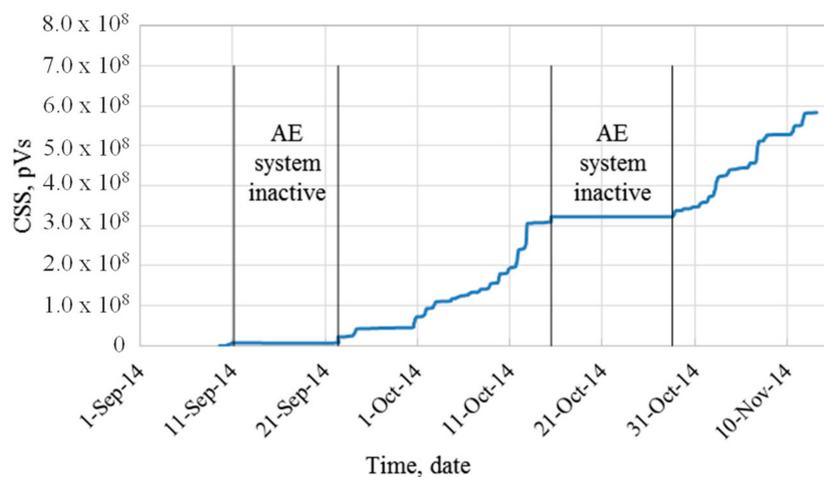
**Figure 13.** Cumulative signal strength (pVs) versus time (days) for four wireless sensors at the +48 level.

One objective of monitoring this location was to assess whether the large vertical crack in the wall is still active. This vertical crack has a width between 0.125 and 0.25 inches with several small hairline cracks extending from it in the horizontal direction. Figure 13 plots the cumulative signal strength (units of pico-Volt seconds) versus time (days) for the collected signals over the monitoring period. An increasing trend in the acoustic emission activity is observed in the figures, which indicates that damage may be progressing at this location.

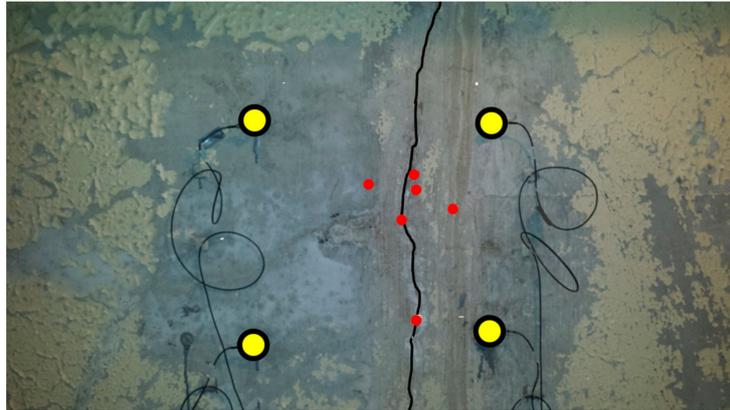
**Figure 14.** Source location results at the +48 level. Red dots indicate located AE events.

To further investigate the trends in this data set, triangulation algorithms were used to investigate if AE events were generated from crack growth. Figure 14 shows the source location results from filtered acoustic emission data. In this figure, each red dot indicates a located acoustic emission event, which means that all four sensors received data with a specified time increment. The time increment

was determined based on the characteristic wave speed of the structure, which was experimentally determined during the installation site visit, and the geometry of the sensor grid. Source location from raw data was inconclusive since it showed acoustic emission activity throughout the monitored area. The 6 acoustic emission events from the filtered data set were located in the vicinity of the vertical crack. These results imply that crack growth or friction between crack surfaces was ongoing in this area during the monitoring period.

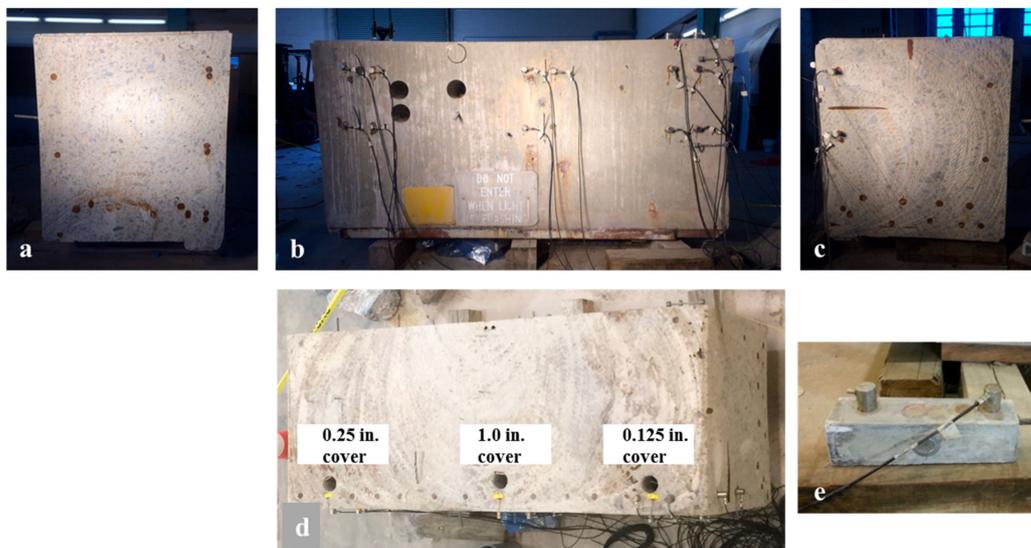
**Figure 15.** Aged concrete block specimen: (a) Left side view, (b) front view, (c) right side view, (d) top view, and (e) control location.

The test was initiated by placing 3% NaCl solution in the drilled holes to a depth of 3 inches on 2 December 2014. The solution was maintained in the drilled holes for two months to ensure that chloride concentration reached a needed level for corrosion initiation [29,30]. Wet/dry cycles were then initiated (three days wet and four days dry) on 19 February 2015 to accelerate the corrosion process. A galvanic cell was created during the wet days by inserting a copper plate in the cored locations. Figure 15d shows the ‘as measured’ concrete cover after the cores were drilled.

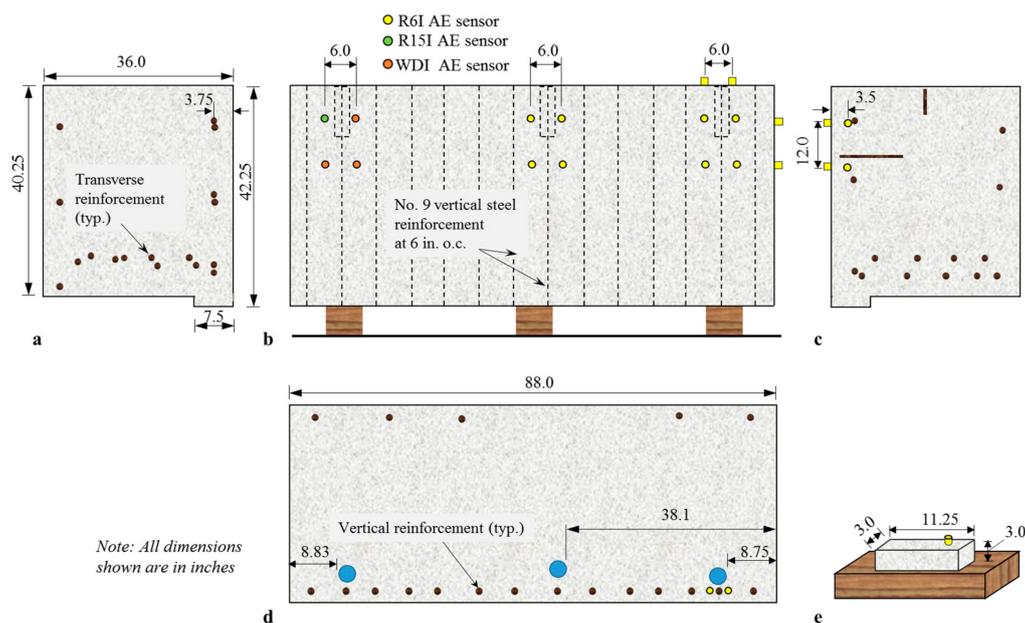
**Figure 16.** Schematic of aged reactor concrete test block: (a) Left side view, (b) front view, (c) right side view, (d) top view, and (e) control location.

calculate corrosion current ( $I_{corr}$ ) and corrosion current density ( $i_{corr}$ ). These parameters can be used to estimate the corrosion rate ( $CR$ ). Figure 16 shows a schematic of the test setup and acoustic emission sensor layout to monitor the corrosion process of the reinforcing bars. A schematic of the aged concrete block control specimen is also shown in this figure.

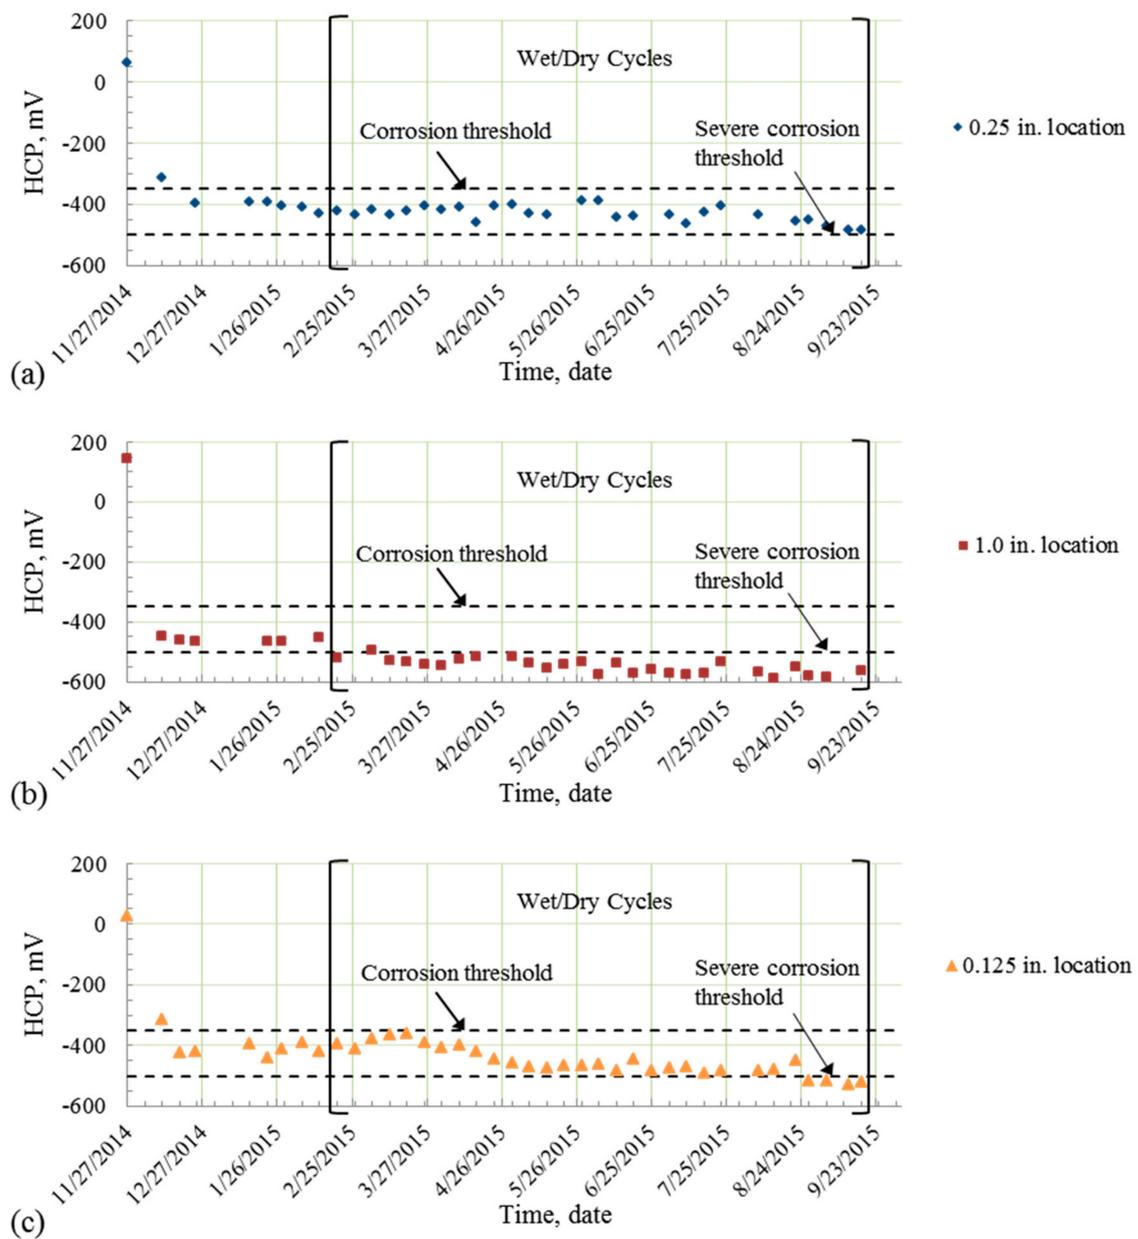
**Figure 17.** Half-cell potential measurements at: (a) 0.25-inch concrete cover location, (b) 1.0-inch concrete cover location, and (c) 0.125-inch concrete cover locations.

Initial electrochemical measurements known as the half-cell potential were taken prior to the initiation of the conditioning period. These measurements indicated a passive state of steel reinforcement. The NaCl solution was then placed in the cored areas on 2 December 2015 and electrochemical readings were recorded weekly thereafter. As shown in Figure 17, three weeks after conditioning, half-cell potential values were observed to be more negative than  $-350$  mV (referred to as the corrosion threshold) at all three locations. At the conclusion of the wet/dry cycles, half-cell potential readings indicated high corrosion risk in one of the three locations (0.25 inch cover location) and severe corrosion damage (more negative than  $-500$  mV) in the other two locations (0.125 inch and 1.0 inch cover locations). The 1.0 inch cover location is known to have leakage associated with it since the NaCl solution drained continuously from this location from the commencement of the testing. While chloride diffusion is often assumed to be the primary initiator of corrosion damage, the presence of cracking in the concrete matrix may have a more profound effect on corrosion in some instances. The 0.125 inch cover and the 0.25 inch cover locations did not experience similar issues with leakage. The bottom of the hole at the 1.0 inch cover location was sealed with epoxy in the first week of April in 2015.

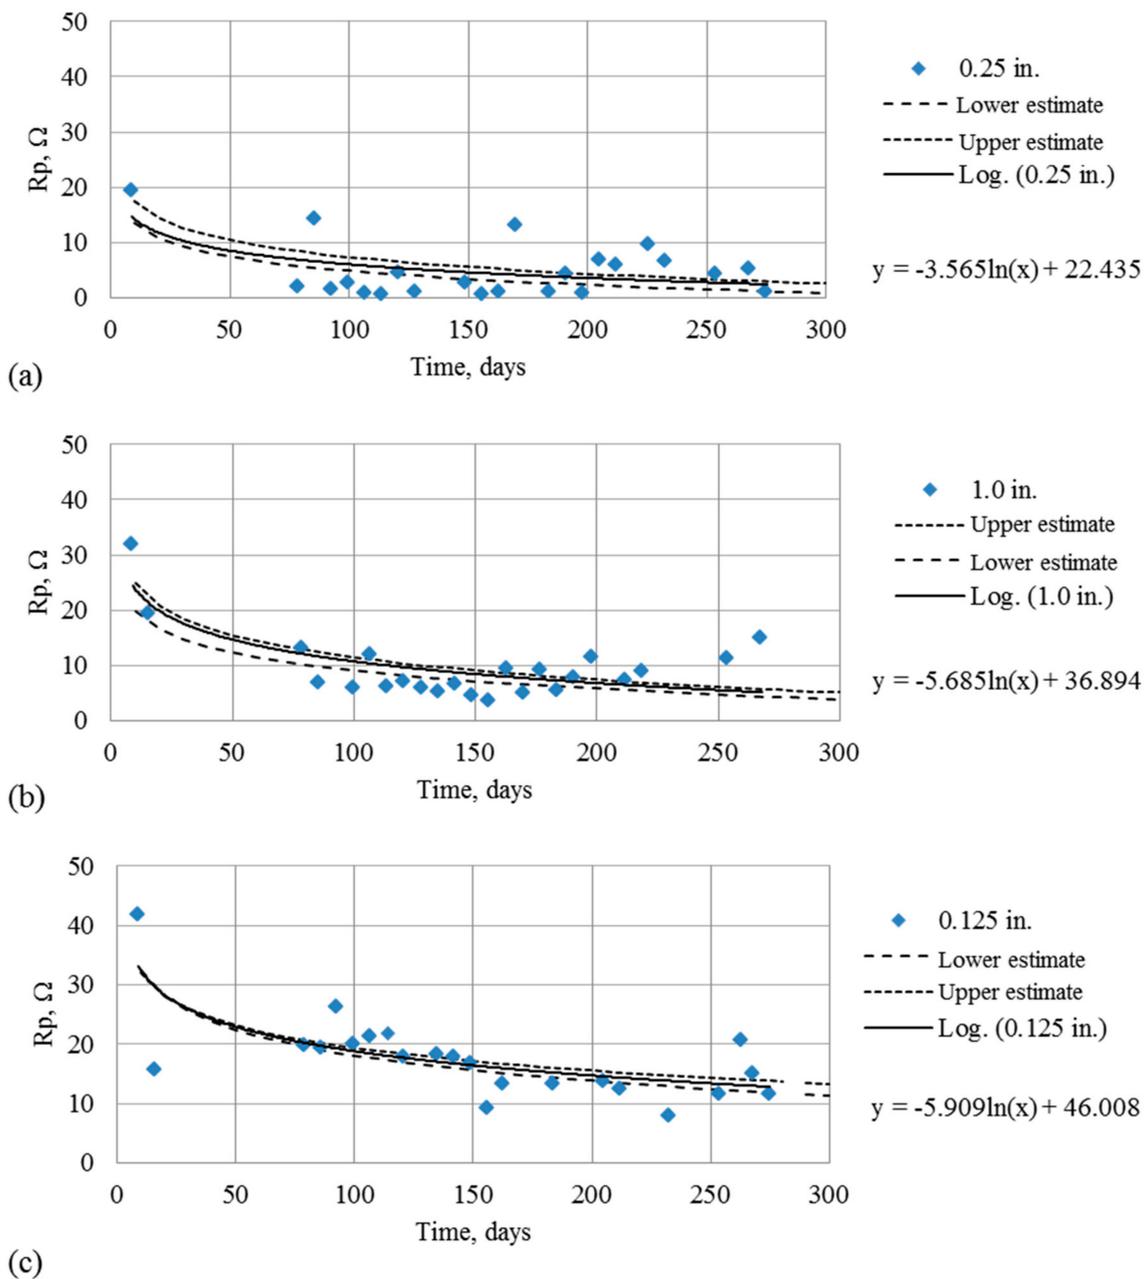
**Figure 18.** Linear polarization resistance (LPR) measurements at: (a) 0.25-inch concrete cover location, (b) 1.0-inch concrete cover location, and (c) 0.125-inch concrete cover location.

Figure 18 shows linear polarization resistance results at the three locations with a logarithmic fit of the data points. The x-axis in Figure 18 represents the number of days after the solution was placed in the cored areas (initiated on 2 December 2014). The results indicate that all locations had relatively high corrosion rates since the polarization resistance was less than 100 ohms [4]. As seen in the figure, data was not collected between 24 December 2014 and 19 February 2015 (between 22 and 79 days) due to a malfunction with the potentiostat/galvanostat cable over that time period. This was addressed and the testing was resumed after 29 February, 2015. Since these readings are taken weekly over a time span of 300 days and due to the instantaneous nature of the readings, trends in the data set are more important than readings taken on a particular day. Therefore, trend lines with both upper and lower estimates are shown in the figures. A statistical method was used to eliminate outliers with low values to obtain the upper estimate and eliminate outliers with high values to obtain the lower estimate.

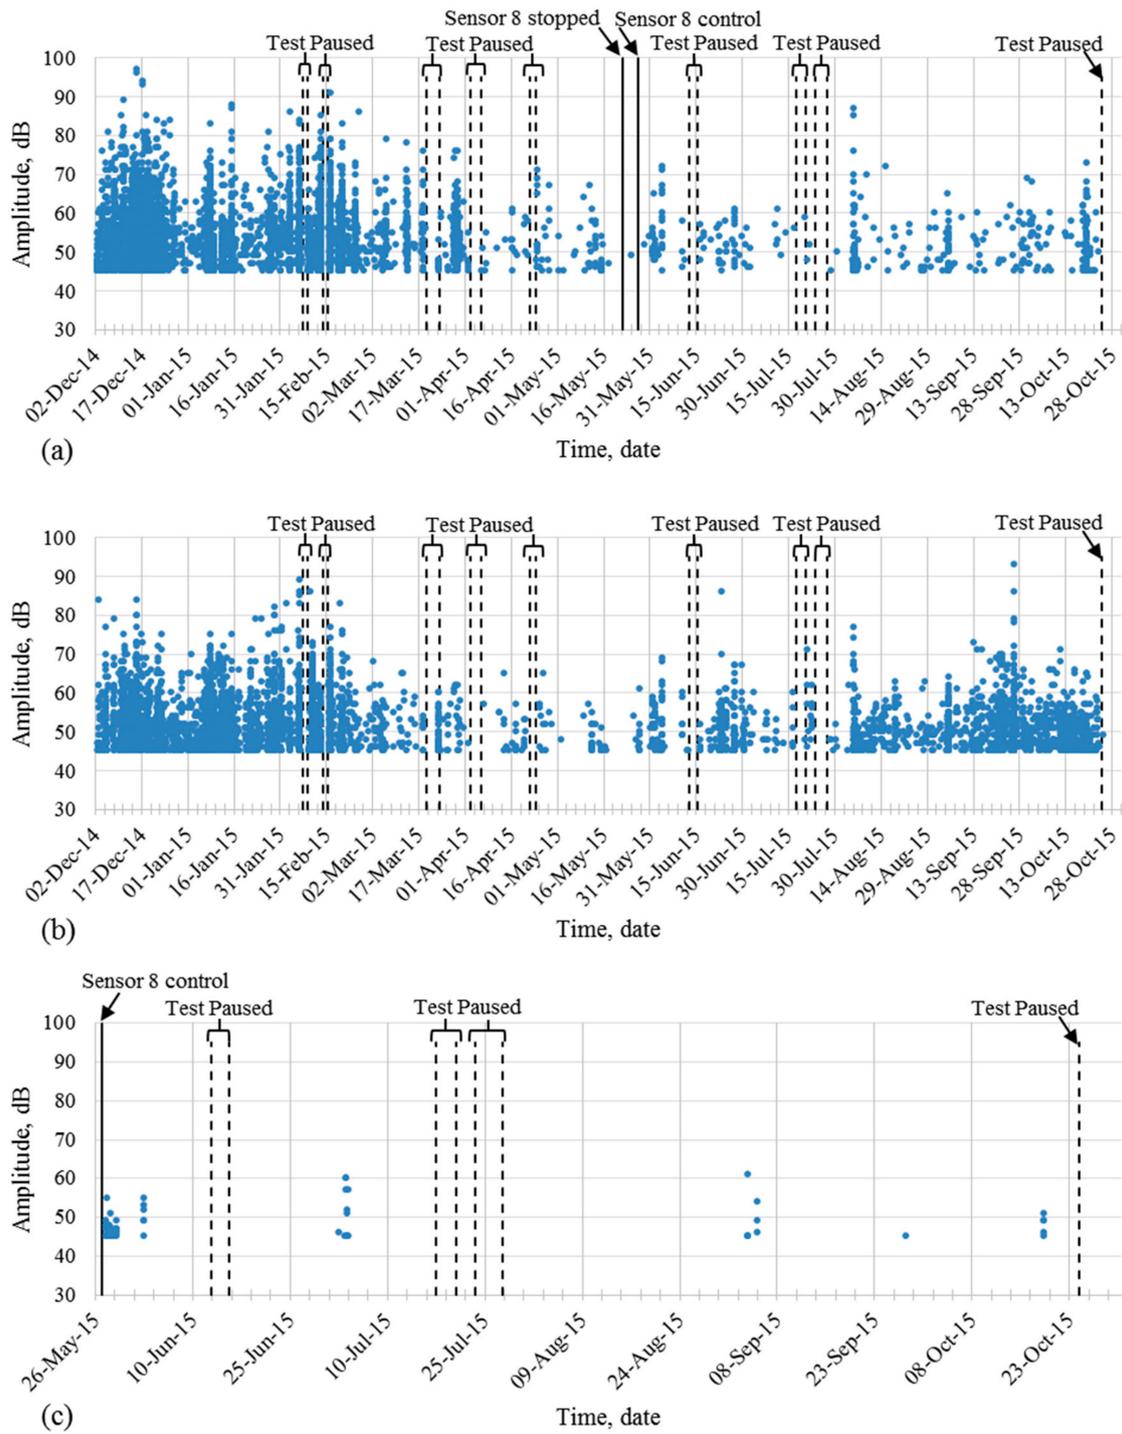
**Figure 19.** AE data recorded from resonant sensors on the reactor concrete block specimen: (a) 1.0-inch concrete cover location, (b) 0.125-inch concrete cover location, and (c) control location.

As seen in Figures 19 and 20, acoustic emission activity at the 1.0 inch concrete cover location and the 0.125 inch concrete cover location was higher than the acoustic emission activity at the 0.25 inch concrete cover location. This is attributed to the inherently higher sensitivity of the resonant sensors. It is noted that the rate of activity recorded at 1.0 inch concrete cover locations decreased during wet days after sealing the bottom of the hole.

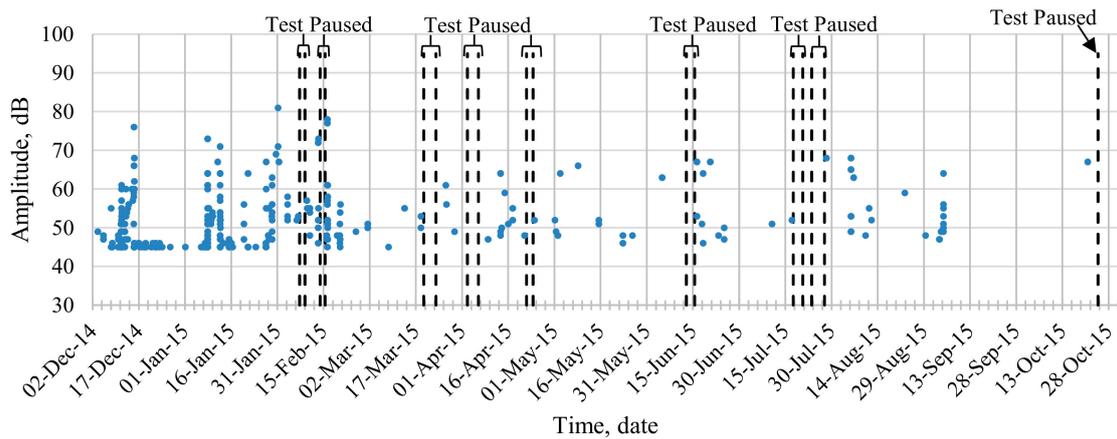
**Figure 20.** AE data recorded from broadband sensors on the reactor concrete block specimen at the 0.25-inch concrete cover location.

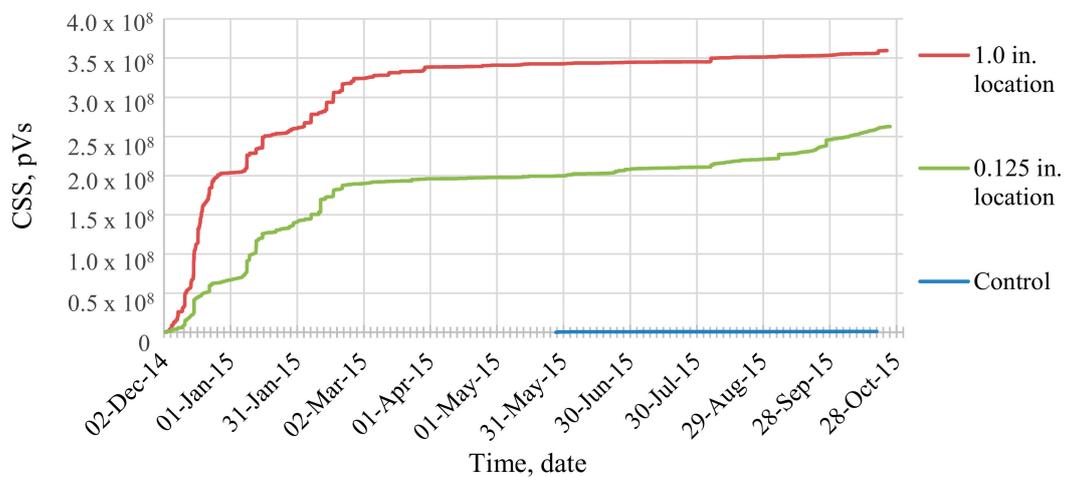
**Figure 21.** Cumulative signal strength from resonant sensors on the aged concrete block specimen.

Figure 21 shows cumulative signal strength versus time at locations monitored using resonant sensors. It can be seen from this figure that cumulative signal strength increases rapidly at the beginning of the test, which corresponds to a period of rapid damage growth associated with corrosion initiation, enters a dormant period, and then increases slightly near the end of the testing period for the 1.0 inch and 0.125 inch locations. This trend in the data mirrors a trend noticed in the linear polarization resistance plots. The magnitude of the cumulative signal strength is greater for the 1.0-inch location when compared to the 0.125-inch location, which indicates increased acoustic emission activity and, therefore, increased damage growth at the 1.0-inch location. This is consistent with the electrochemical readings at this location and may be attributable to the presence of cracking in this location. The control location has minimal cumulative signal strength magnitude as would be expected. The relatively low cumulative signal strength magnitude at the control location demonstrates that unwanted acoustic emission data caused by ongoing laboratory activities in the vicinity of the test block specimen were minimized in the data sets.
