Article

# Remote Monitoring and Evaluation of Damage at a Decommissioned Nuclear Facility Using Acoustic Emission

This study investigates the applicability of deploying acoustic emission for the remote monitoring of selected areas at the Savannah River Site (SRS) 105-C Reactor Facility in Aiken, South Carolina (Figure 1). This is an inactive nuclear facility under surveillance and maintenance operations as well as deactivation and decommissioning operations. AE monitoring was conducted at areas known to have active corrosion damage and/or visible cracking. This allows the examination of the applicability of previously developed AE methods for corrosion damage detection and classification.

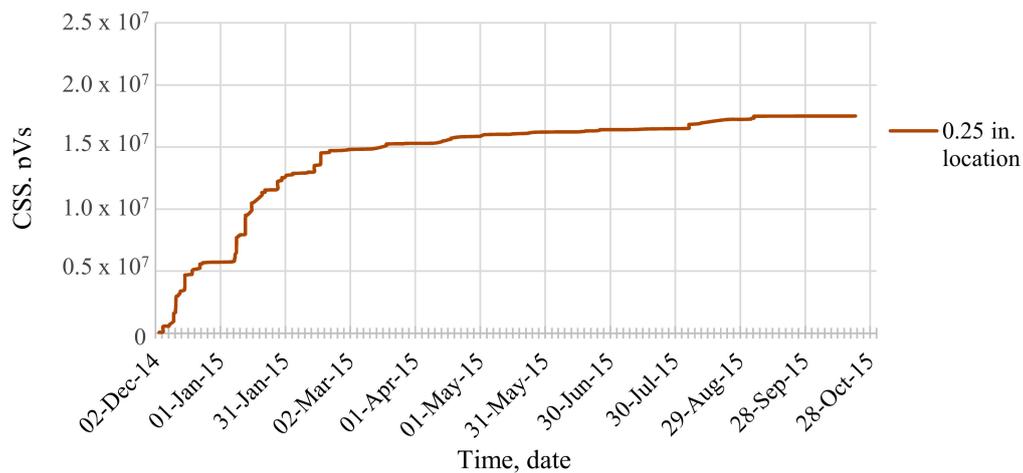
**Figure 22.** Cumulative signal strength versus time from broadband sensors on the aged concrete block specimen.

The broadband sensor data shows a similar trend of rapidly increasing damage early in the testing period, which is followed by a relatively dormant period at the 0.25 inch location. This is shown in Figure 22. The magnitude of cumulative signal strength from the broadband sensors is lower in comparison to the resonant sensors, which is expected due to the lower sensitivity of the broadband sensors.

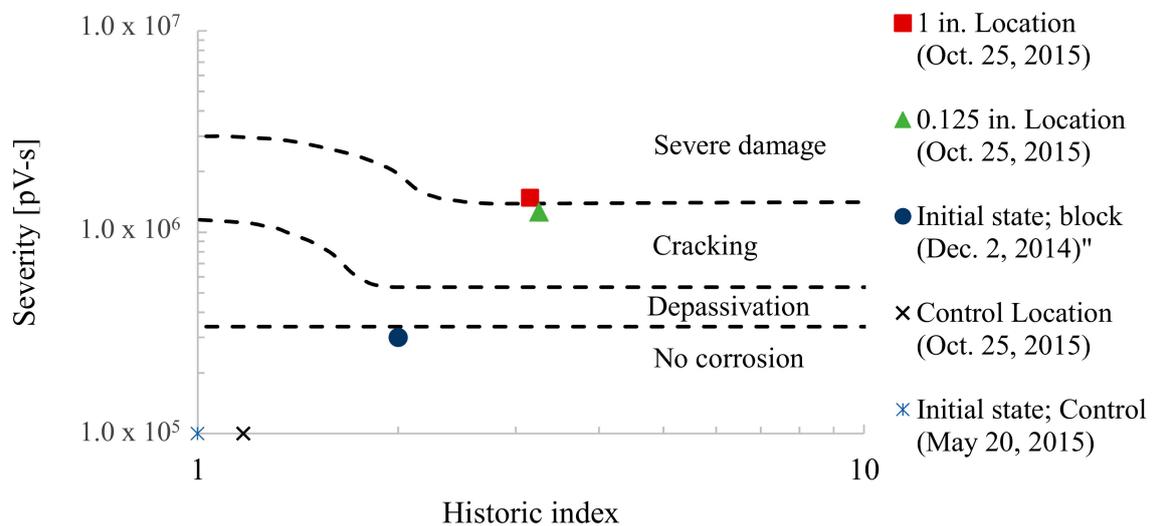
**Figure 23.** Intensity Analysis for resonant sensors on the reactor concrete block specimen.

Figures 23 and 24 show the Intensity Analysis results calculated at each location. The estimation of initial damage for the aged concrete block specimen based on visual inspection and electrochemical results was located near the border between the ‘no damage’ region and the ‘depassivation’ region of the chart. For the control location, a lower initial damage state was used since no corrosion damage is expected in this specimen. AE activity from the resonant sensors at the 1.0-inch concrete cover location progressed from the initial state to the severe damage zone over the duration of the monitoring period. AE activity from the resonant sensors at the 0.125-inch concrete cover location progressed from the initial state to the border of the cracking and severe damage zones. For the broadband sensors at the 0.25-inch concrete cover location, acoustic emission activity progressed from the initial state to the border of the cracking and severe damage zones.

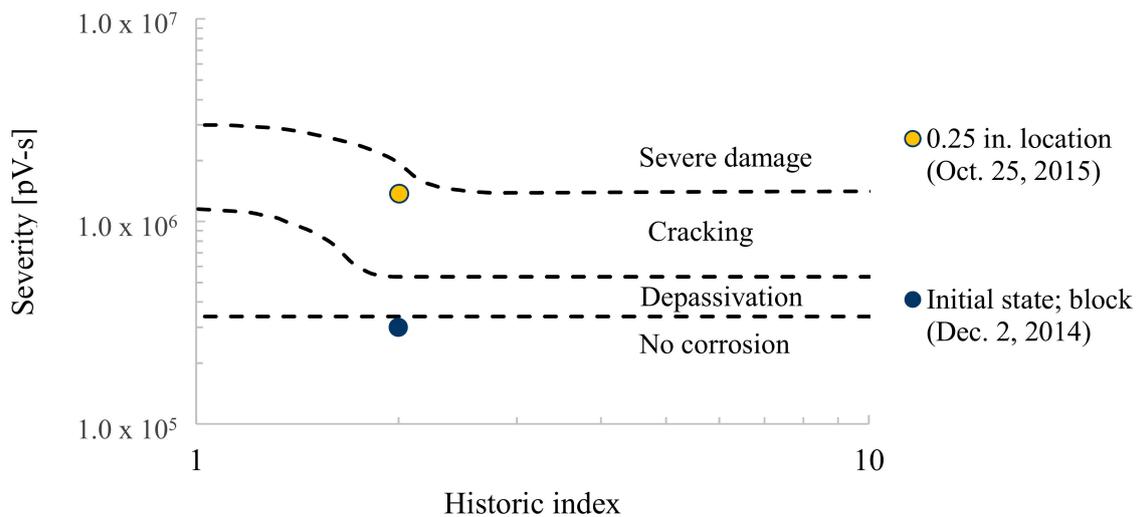
**Figure 24.** Intensity Analysis for broadband sensors on the reactor concrete block specimen.
