## Article

# Full-scale Studies of Improving Energy Performance by Renovating Historic Swedish Timber Buildings with Hemp-lime

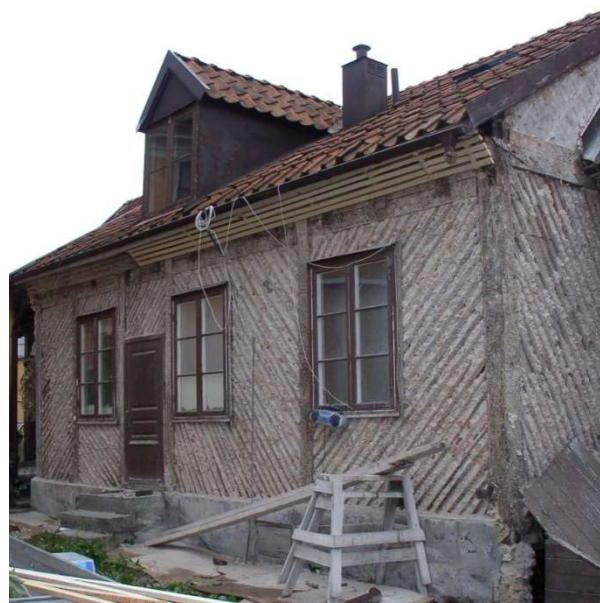
**Figure 1.** Exposed render on a post-and-plank house in Visby, under renovation and being re-rendered in 2003. The wooden slats were preserved, as well as the inner layer of lime mortar.

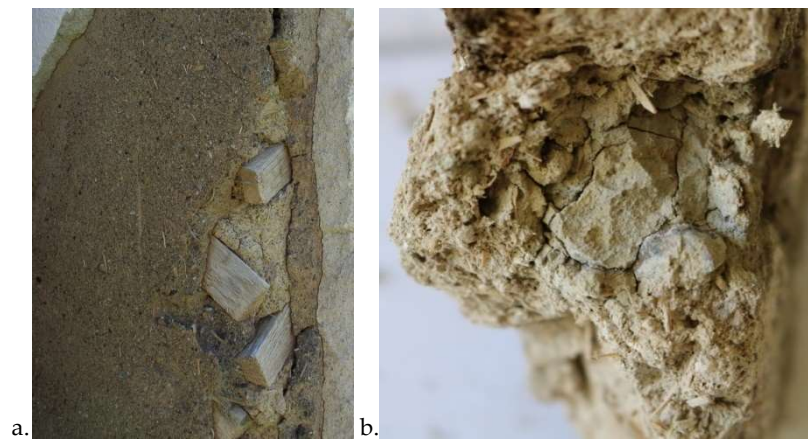
**Figure 2.** (a) Clay mortar with straw in an inner layer between wooden slats on a rendered timber house in Sweden. Photo: Kristin Balksten. (b) Old mortars from a rendered facade in Visby. It contains clay, a little lime and straw, and was used as mortar in the inner 5 cm layer between wooden slats, behind a lime render. Photo: Sofie Nygren.

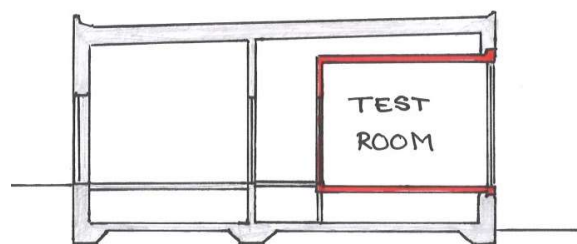
Figure 3. Schematic section of the test room at the EBD-lab.

Two full-scale wall sections were constructed at the Energy and Building Design laboratory (EBD-lab) at Lund University (see Figure 3). This is a facility where the energy performance of entire wall sections can be tested. There are two individual test rooms with fully insulated internal walls, floors and ceilings. The façade sections for these rooms can be lifted out and new façades put in. The test façades were south-facing. As there was only one external wall per test room, there was only one wall through which there was energy loss towards the outdoor climate. Energy use for heating the test rooms was monitored over a one-year period. Energy loss through the internal walls, floor, and roof was kept to a minimum by keeping the indoor temperature in the surrounding lab at ambient temperature.

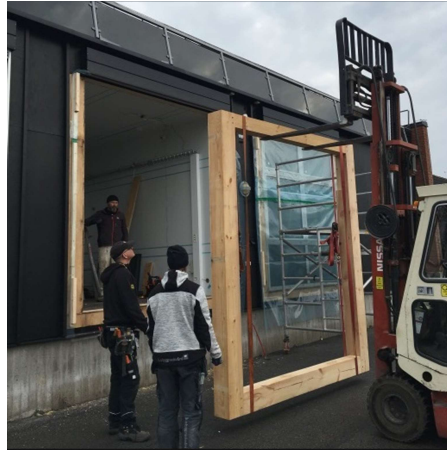
**Figure 4.** The post-and-beam structure is lifted into place.

The wall sections measured 2.7 × 3.1 m (width × height). Traditional post-and-plank walls were built in each external wall section (see Figures 4–9). One wall section (A) was built as a traditional post-and-plank wall with a lime render while the other wall section (B) was a post-and-plank wall with a hemp-lime render. These walls resembled a historic post-and-plank wall *before* renovation and a historic post-and-plank wall *after* renovation with hemp-lime. Both of the walls had a lime render as an external wall finish.

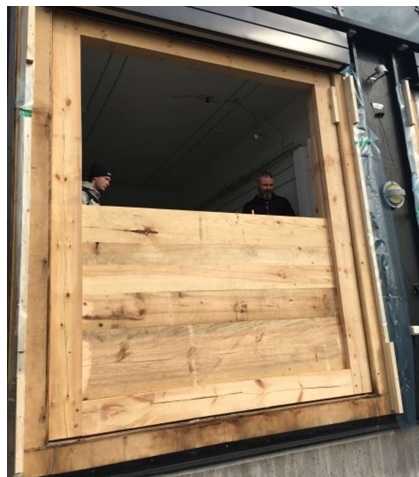
**Figure 5.** The timber planks are fitted into place.

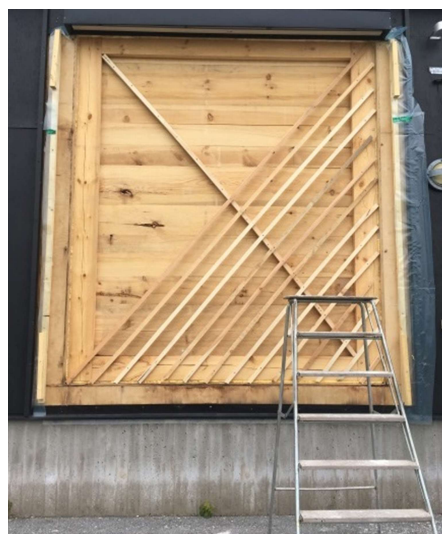
**Figure 6.** Wooden slats are placed diagonally on the timber for carrying the render.

Both façades had wooden slats embedded in the (hemp-) lime render (see Figures 6 and 7). The slats comprised approximately 12% of the rendered material. This means that 88% consisted of lime render (room A) and hemp-lime render (room B), respectively.

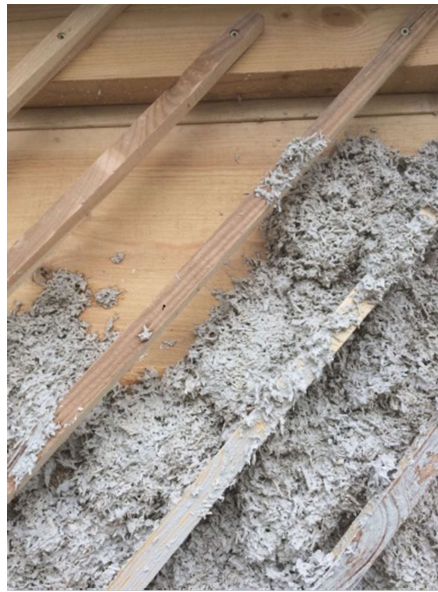
**Figure 7.** Applying the hemp-lime onto the wall surface.

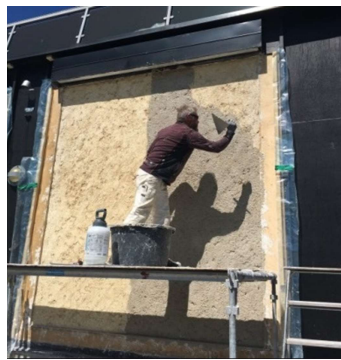
**Figure 8.** Applying a lime render to one section of the hemp-lime façade.

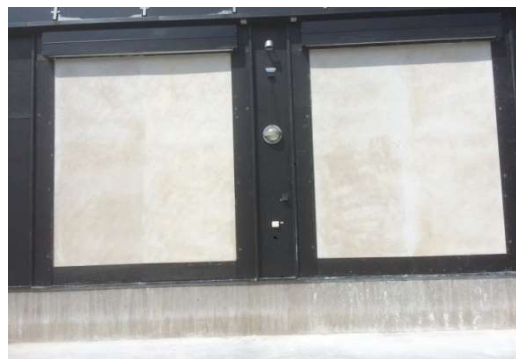
**Figure 9.** The finished test façades, summer 2017. To the left façade A (lime), to the right façade B (hemp-lime).

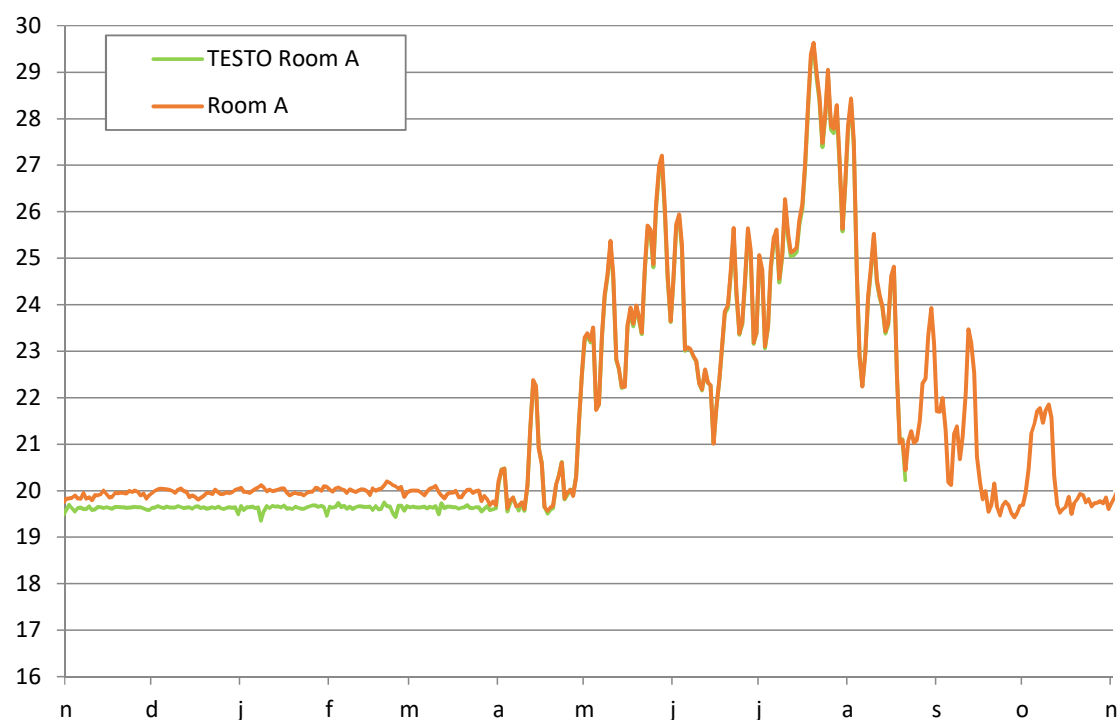
**Figure 10.** Daily mean indoor temperatures in room A, as measured by the ventilation system (Room A) and by the TESTO device (TESTO Room A).

The room temperature measured by the ventilation system was compared to the room temperatures measured by a TESTO device in each room during one year; from 7 November 2017 to 12 November 2018 (see Figures 10 and 11).

In general, the room temperatures measured by the ventilation system were somewhat higher than the temperatures measured by the TESTO devices. This was particularly the case during the heating season. When comparing the average temperatures measured over the heating season (7 November–15 May), the difference between the average temperature measured by the ventilation system and that by the TESTO devices was 0.27 °C in room A and 0.24 °C in room B. This is only a small difference, and could be explained by the measurements having been made in two different places in the rooms.

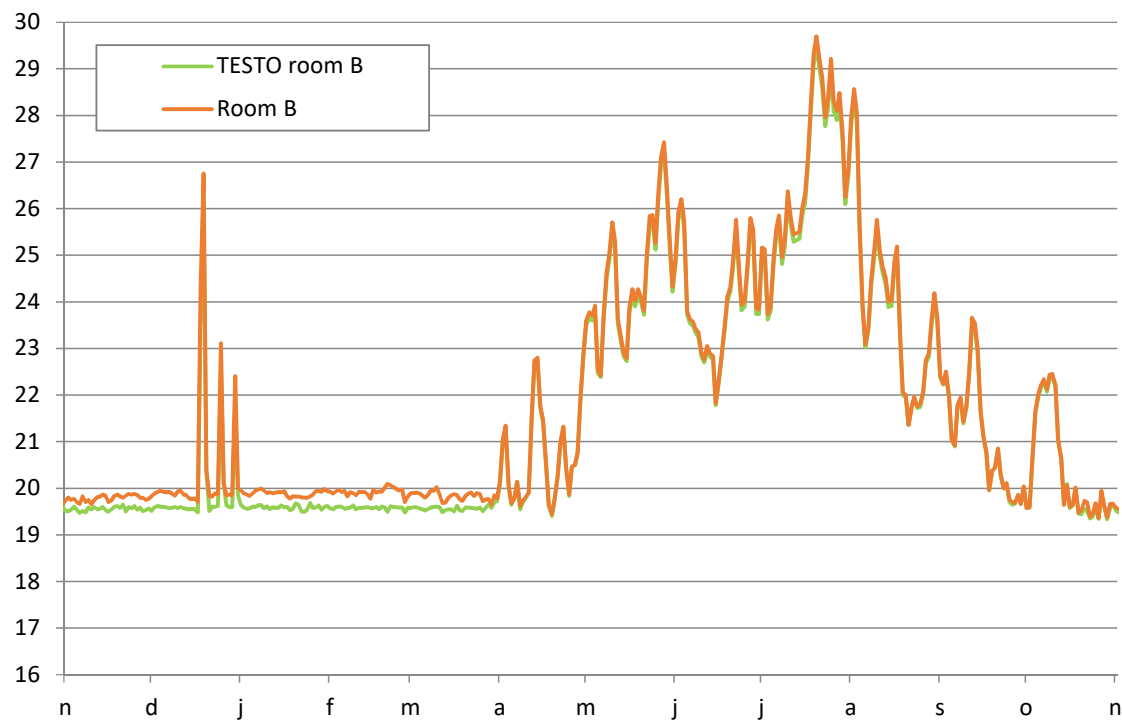
**Figure 11.** Daily mean indoor temperatures in room B, as measured by the ventilation system (Room B) and by the TESTO device (TESTO Room B).

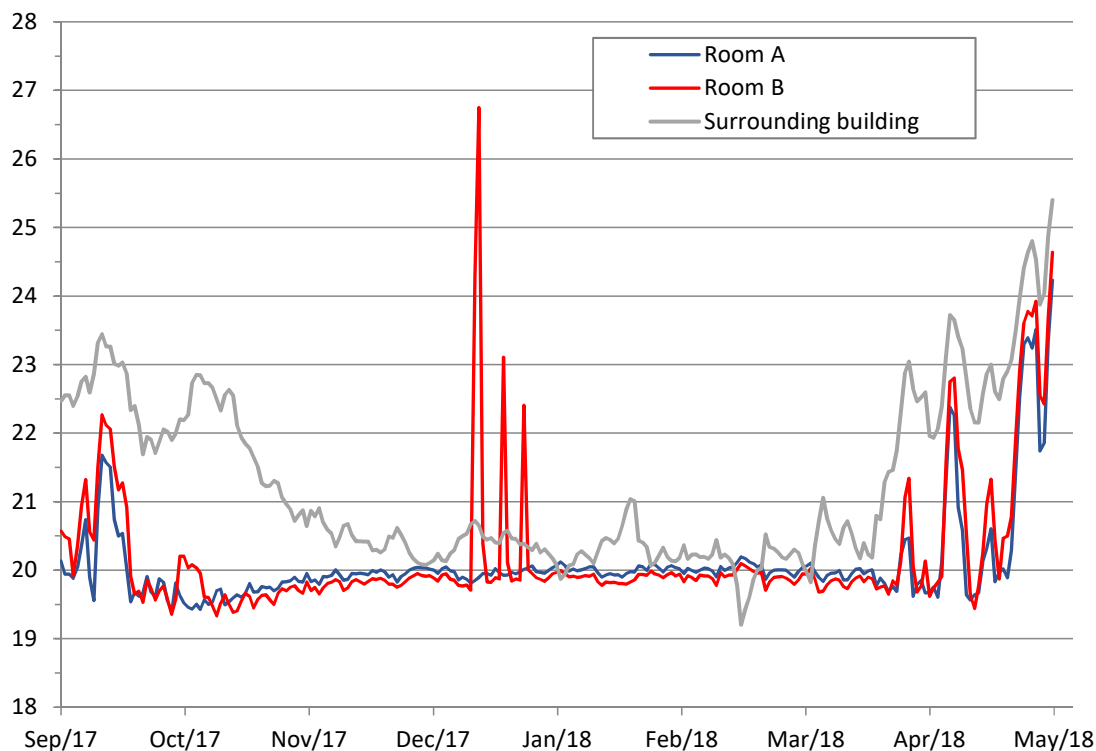
**Figure 12.** Temperature in test rooms (A and B) and in the surrounding building.

The temperature in the space surrounding the test rooms (room C) was most of the time a little bit warmer than inside the test rooms (see Figure 12). This difference accounted for a total of 6589.7 degree hours for room A and 6418.5 degree hours for room B (see Table 1). This difference was only accounted for on days when the average outdoor temperature was <19.0 °C, and ignored for days when the average outdoor temperature ( $\bar{T}_e$ ) was  $\geq 19.0$  °C.

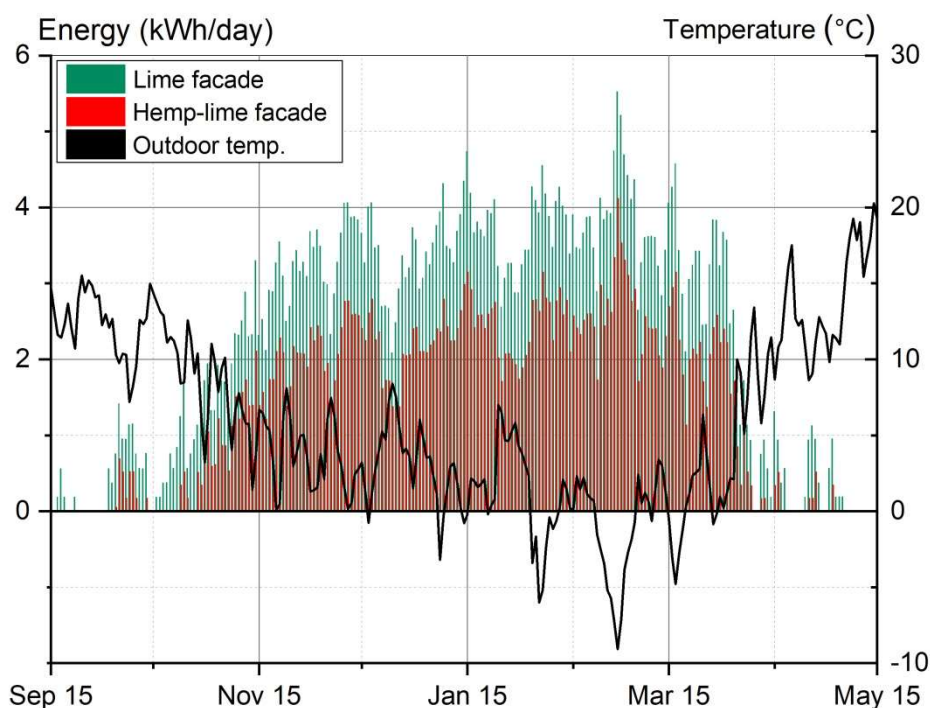
**Figure 13.** Energy use per day for room A (lime wall) and B (hemp-lime wall) as well as average daily outdoor temperature, from 15 September 2017 to 15 May 2018.

Energy use per day for the rooms as well as average outdoor temperature is shown in Figure 13.

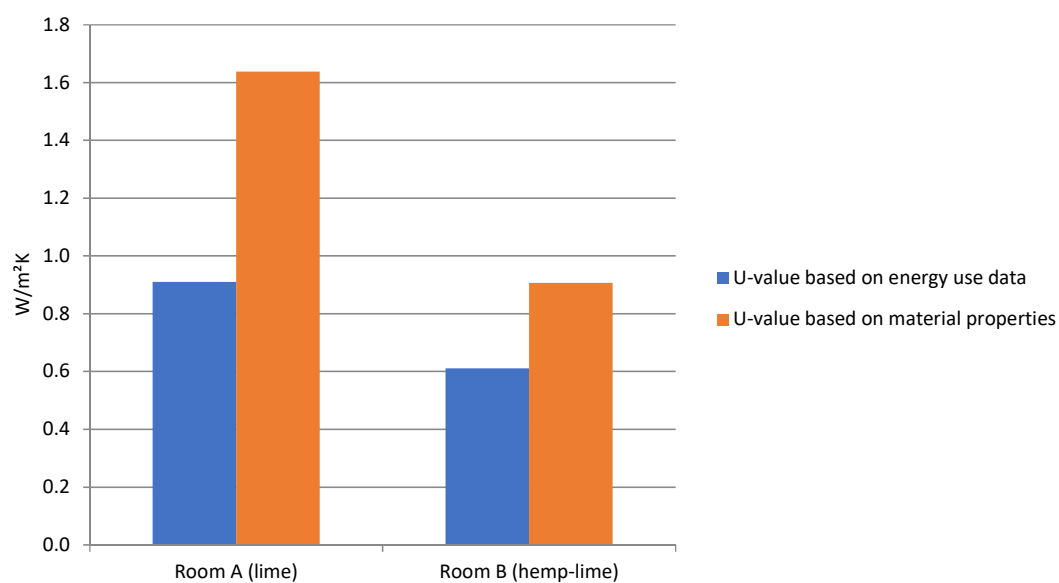
**Figure 14.** Thermal transmittance through the test walls based on energy use data and U-value based on material properties.

Comparing the thermal transmittance of the two façades before and after renovation, there is a clear difference in both cases (see Figure 14). Looking at the calculated U-values based on material properties, there is a reduction of 43%. The U-values based on energy use data were lower in both cases than the calculated U-values. The reduction in U-values between façades A and B based on energy use data was 33% (see Table 5).

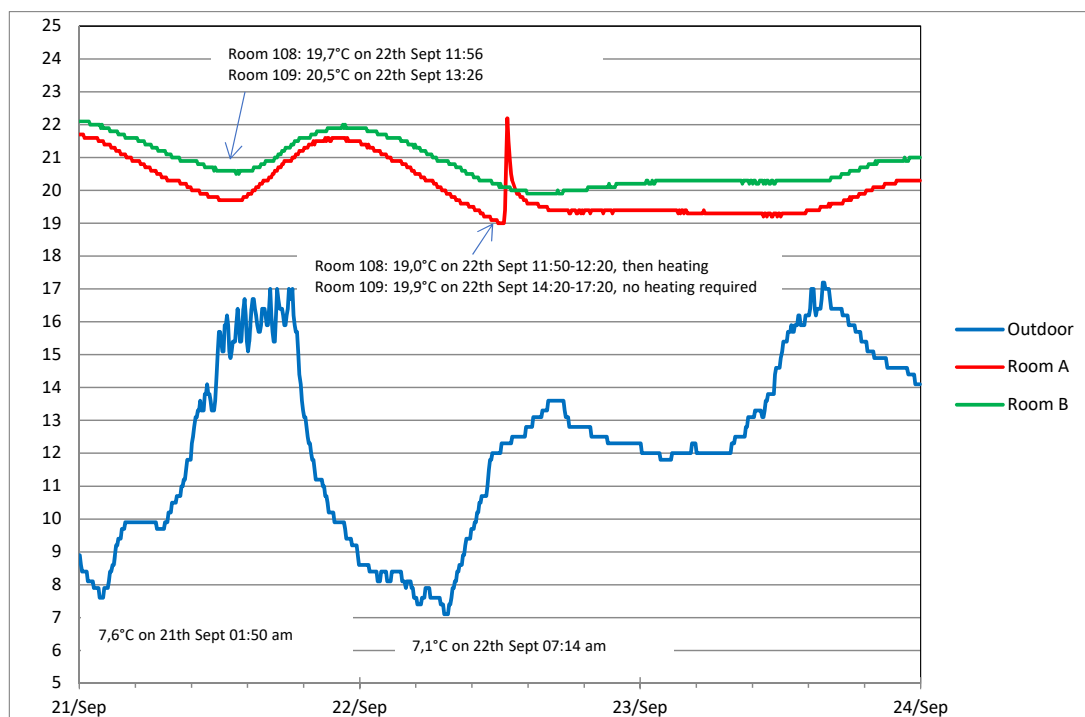
**Figure 15.** Changes in indoor climate in rooms A and B compared to outdoor temperature during 21–24 September 2017.

There was a thermal buffering effect that could be observed for both façades. This was most clear in late summer/early autumn, when there were relatively large diurnal differences in temperature, but no heating was required yet, or only sporadic heating took place. In September, the temperature differences between day and night were quite pronounced, but hardly any heating was required yet (see Figure 15).

When the outdoor temperature changed, it took a while for the indoor temperature to change as well. For example, on 21 September at 01:50 am, the outdoor temperature was at its lowest at 7.6 °C. This could be observed in room A approximately 10 hours later, when the indoor temperature was at its lowest at 19.7 °C. In room B, there was a delay in temperature change compared to room A: the indoor temperature was at its lowest 11.5 hours after the outdoor temperature reached its lowest point. The lowest temperature in room B was then 20.5 °C, before it went up again. In short, the difference in delay was 1.5 hours, and the difference in indoor temperature was 0.8 °C, with room B being the warmer room.

One day later, on 22 September, the outdoor temperature was at its lowest at 7.1 °C at 07:14 in the morning. The effect of this low outdoor temperature was observed in room A only 4.5 hours later when the indoor temperature was as low as 19.0 °C, and heating was required. In room B, the temperature went down to 19.9 °C, which was at 14:20 am, approximately seven hours after the lowest outdoor temperature had occurred. In addition, in room B, no heating was required. In short, the difference in delay was 2.5 hours, and the difference in indoor temperature was 0.9 °C, with room B being the warmer room. In addition, no heating was required in room B, whereas heating started in room A when temperatures reached 19.0 °C.

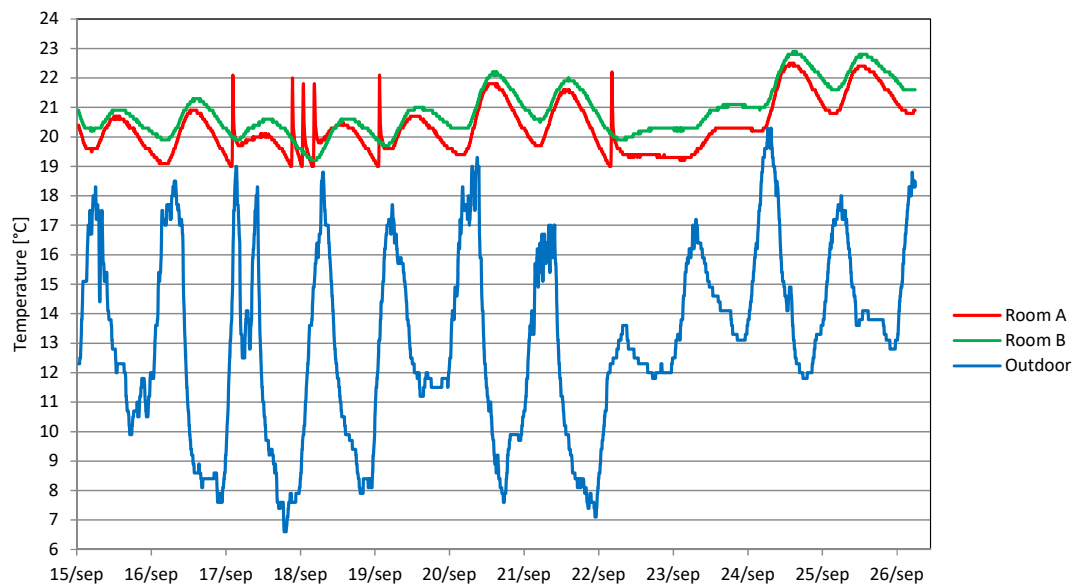
**Figure 16.** Indoor temperature in room A and room B as well as outdoor temperature from 15–26 September 2017. The second y-axis shows energy use for space heating of room A (room B required no space heating during this period).

In both rooms, TESTO devices (measuring temperature and relative humidity) were installed on the wall surface. Figure 16 shows the indoor temperatures in both rooms as well as the outdoor temperature from 15 to 26 September 2017. During this period, room B did not require any energy for space heating, while room A used 1.1 kWh. Each time there was a low outdoor temperature, the temperature in room A decreased sooner than in room B. During this 11 day period, room B had

a slightly higher indoor temperature than room A: 20.3 °C compared to 20.0 °C, even though room A required some energy for space heating.

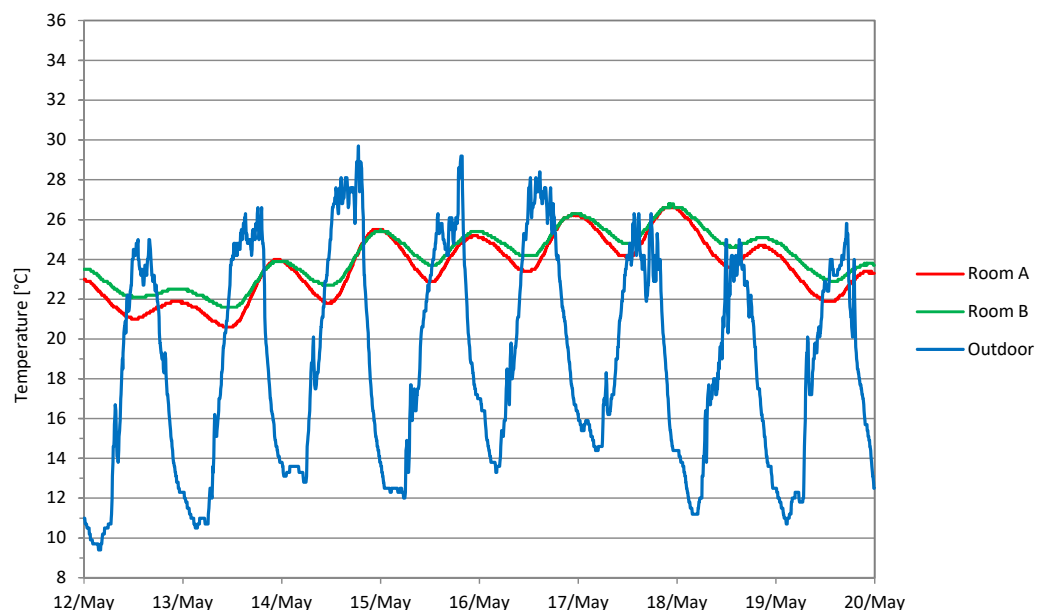
**Figure 17.** Indoor temperature in room A and room B as well as outdoor temperature during early summer, 12 through 19 May 2018.

During the summer months, no energy use was required for space heating. At higher outdoor temperatures, the indoor temperature in room A was consistently a little bit higher than in room B (see Figure 17). Also, at lower outdoor temperatures the temperature in room A was a little bit lower than in room B. In other words, the diurnal temperature variation had a larger impact on room A. This same phenomenon could be observed at even higher temperatures, when outdoor temperatures reached over 30 °C (see Figure 18).

Analyzing the peak-to-peak amplitudes during these two time periods, there is a difference between the two rooms of 0.8 °C in May and 0.7 °C in August (see Table 6). This indicates that the indoor temperature in room B is more stable, with smaller temperature fluctuations, than in room A.

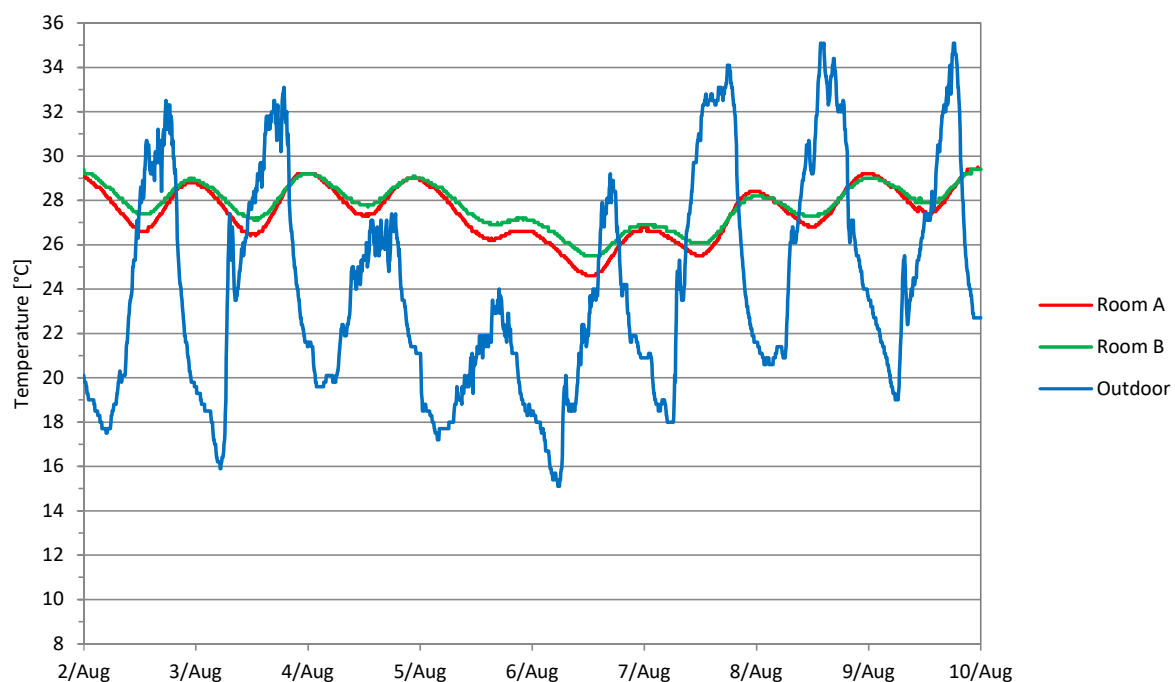
**Figure 18.** Indoor temperature in room A and room B as well as outdoor temperature during the summer, 2 through 9 August 2018.
